90-09-10 TEXAS INSTRUMENTS: Amendment 39-6565. Docket No. 89-ANE-38.

Applicability: To circuit breaker Models 6TC6-7.5 and -10 and 6TC20-7.5 and -10, all with date codes 8150 and earlier.

94-21-06 PACIFIC SCIENTIFIC COMPANY, HTL/KIN-TECH DIVISION:
Amendment 39-9048. Docket 94-NM-73-AD.

Applicability: Lap belt assemblies and restraint systems, as listed in Pacific Scientific Service Bulletin 1108435-25-01, dated April 28, 1994, and Pacific Scientific Service Bulletin 1108460-25-01, dated April 28, 1994; as installed on aircraft and rotorcraft, certificated in any category.

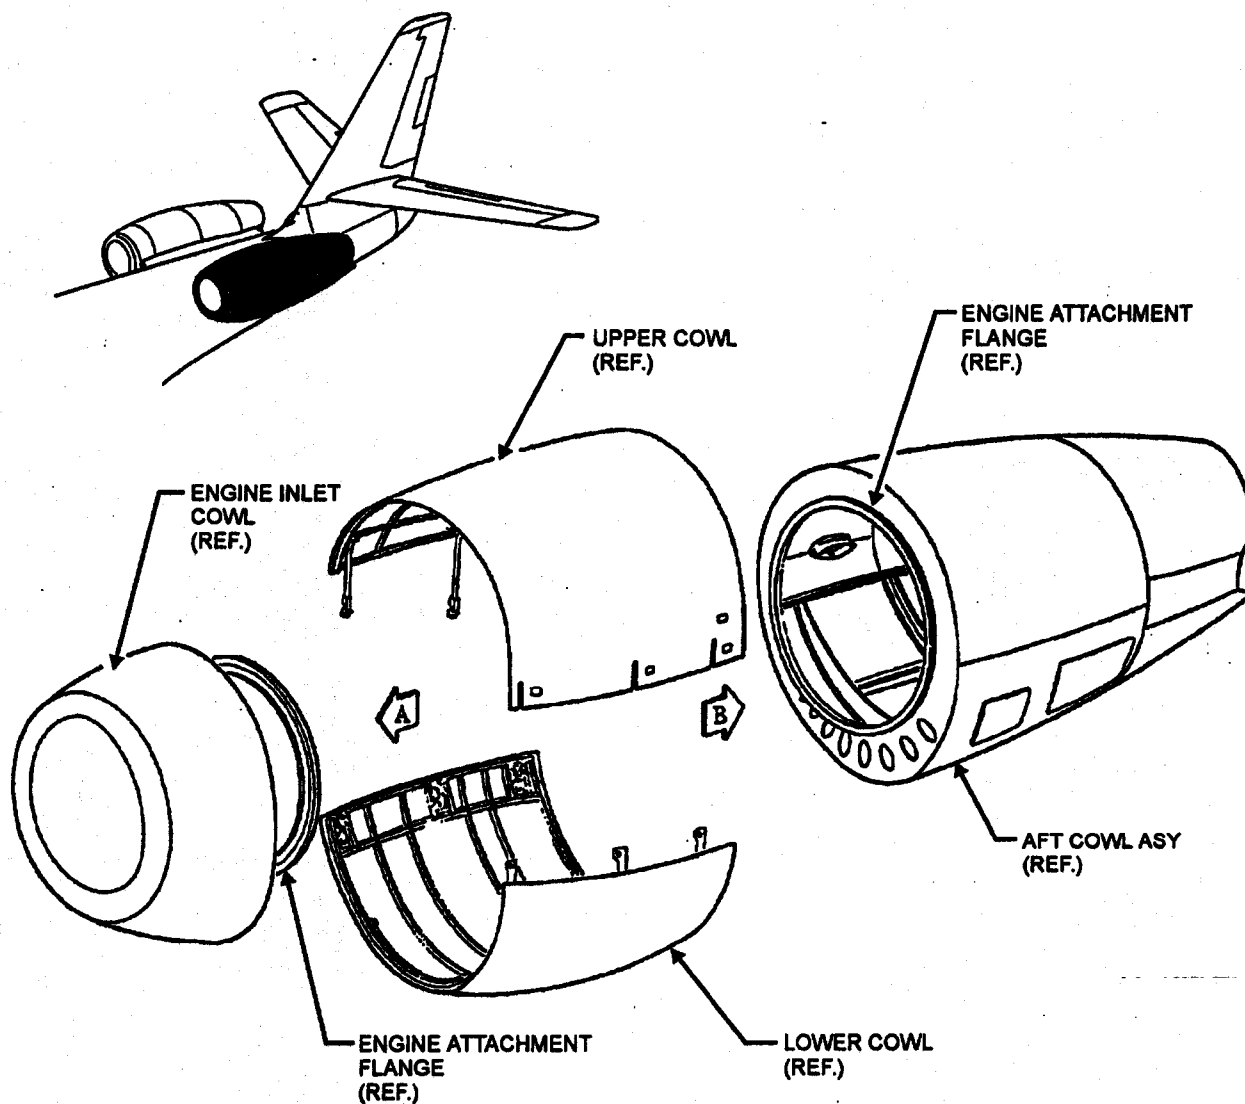
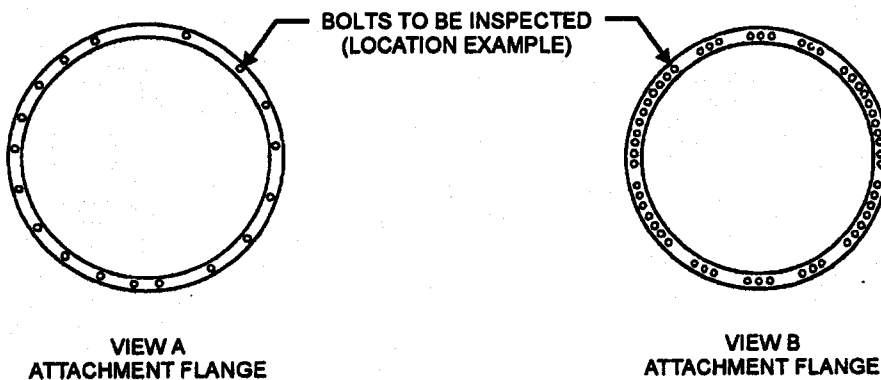
Nacelle Assembly
FIGURE 1

Bolt part numbers NAS1303 and NAS6603 are the only approved bolts to attach the inlet cowl and the aft nacelle to the engine flanges. On some aircraft, bolt part number AN3 have been found installed on the engine flanges. AN3 bolts are not approved and are considered as fatigue critical bolts for this application.

3. Verify the installed bolts are the approved part numbers NAS1303 or NAS6603. If approved bolts are installed proceed to Step 6. Refer to Figure 2.
4. Remove and replace any unapproved bolt part number with an approved bolt part number. Refer to 1124/1124A Westwind Illustrated Parts Catalog, Chapters 54-20-00 and 78-30-00 for proper bolt part numbers.

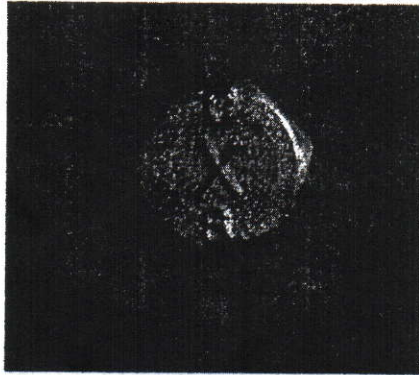
AN3 BOLT
UNAPPROVED PART NUMBER

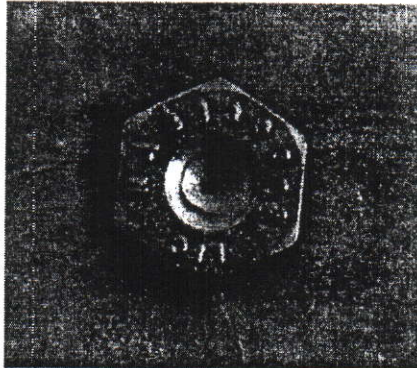
NAS1303 BOLT
APPROVED PART NUMBER

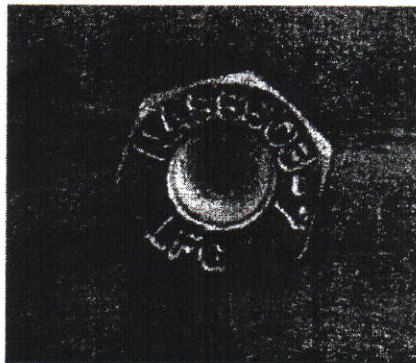
NAS6603 BOLT
APPROVED PART NUMBER
