SERVICE BULLETIN

SERVICE BULLETIN INDEX

24-WESTWIND

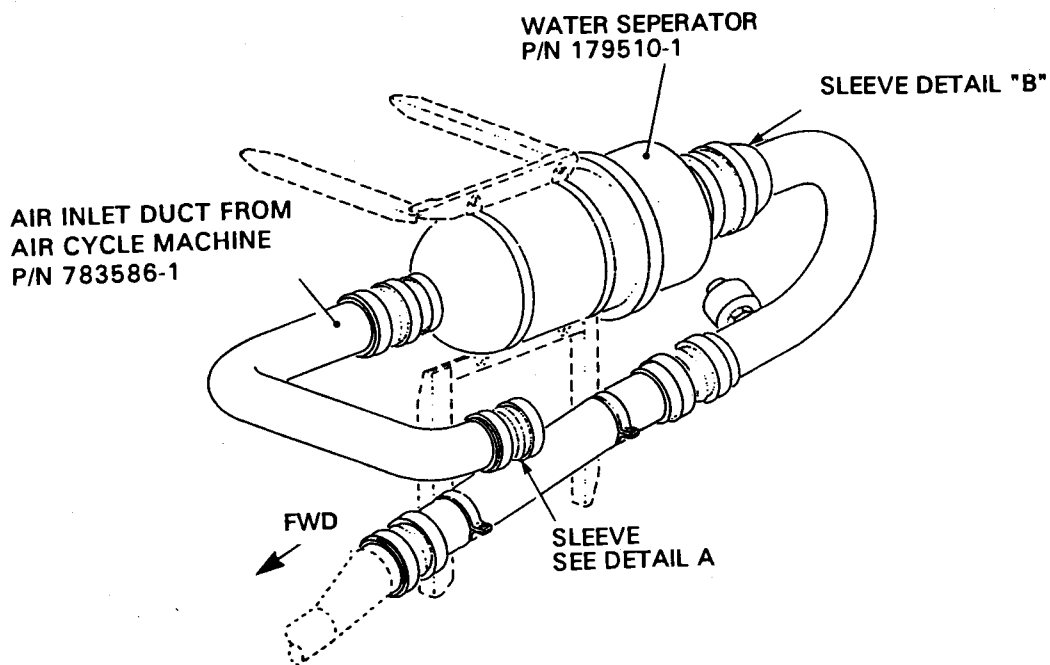
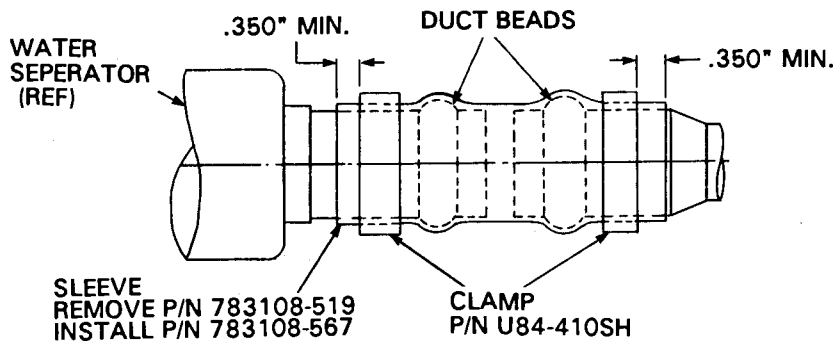
WATER SEPERATOR
FIGURE 1

This service bulletin provides instruction for inspection, and replacement if required, of the water separator duct sleeves.

- A. Gain access to forward baggage compartment and remove the rear panel.
- B. Inspect the sleeve P/N 783108-519 and clamps P/N U84-260SH that connect the water separator inlet duct P/N 783586-1 to the air cycle machine outlet port for proper installation. Clamps must be clear of the duct beads and the sleeve ends must protrude 0.350 inches minimum beyond the duct clamps. Refer to Figure 1 Detail "A". If found to be correct, check that the clamps are torqued to 20-25 inch pounds and proceed to step G. If not correct, proceed as follows:

- G. Install the rear panel in the forward baggage compartment.
- H. Gain access to rear baggage compartment and remove the forward access panel.
- I. Inspect the sleeve P/N 783108-509 and clamps P/N U84-410SH on the water separator outlet duct. For proper installation clamps must be clear of the duct beads. The sleeve ends must protrude 0.350 inches minimum beyond the duct clamps. Refer to Figure 1, Detail "B". If found to be correct, check that the clamps are torqued to 20-25 inch pounds and proceed to step 2.N. If not correct, proceed as follows:

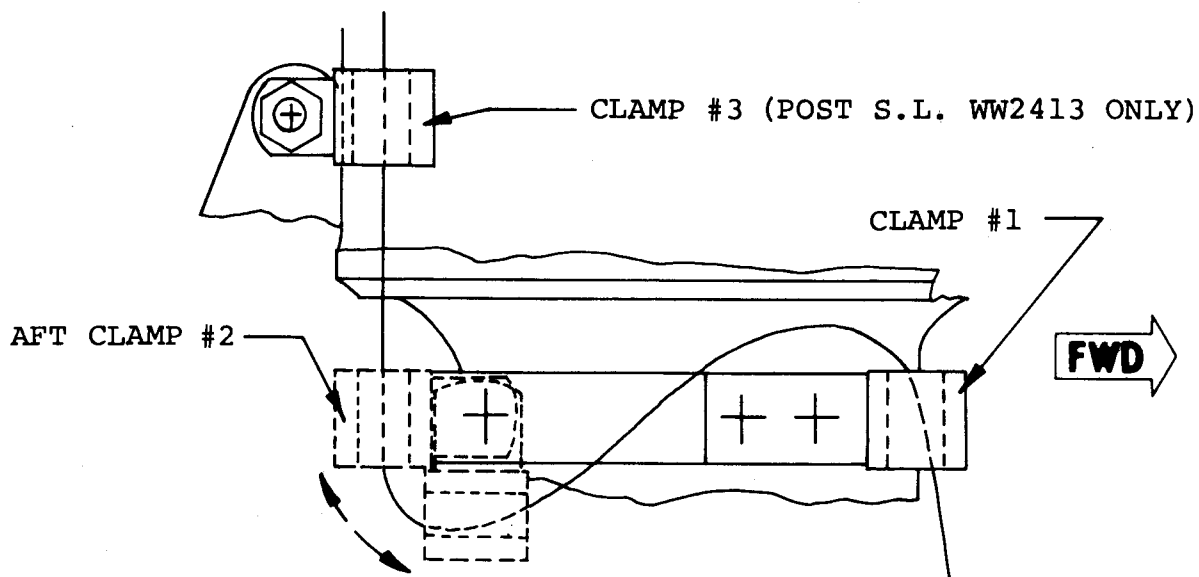
FIGURE 1: EXISTING INSTALLATIONS

NOTE: CLAMP #2 WILL BE FOUND IN EITHER POSITION AS SHOWN, ON EXISTING INSTALLATIONS.
