# IAI WESTWIND

## SERVICE BULLETIN

1124 SERVICE BULLETIN INDEX

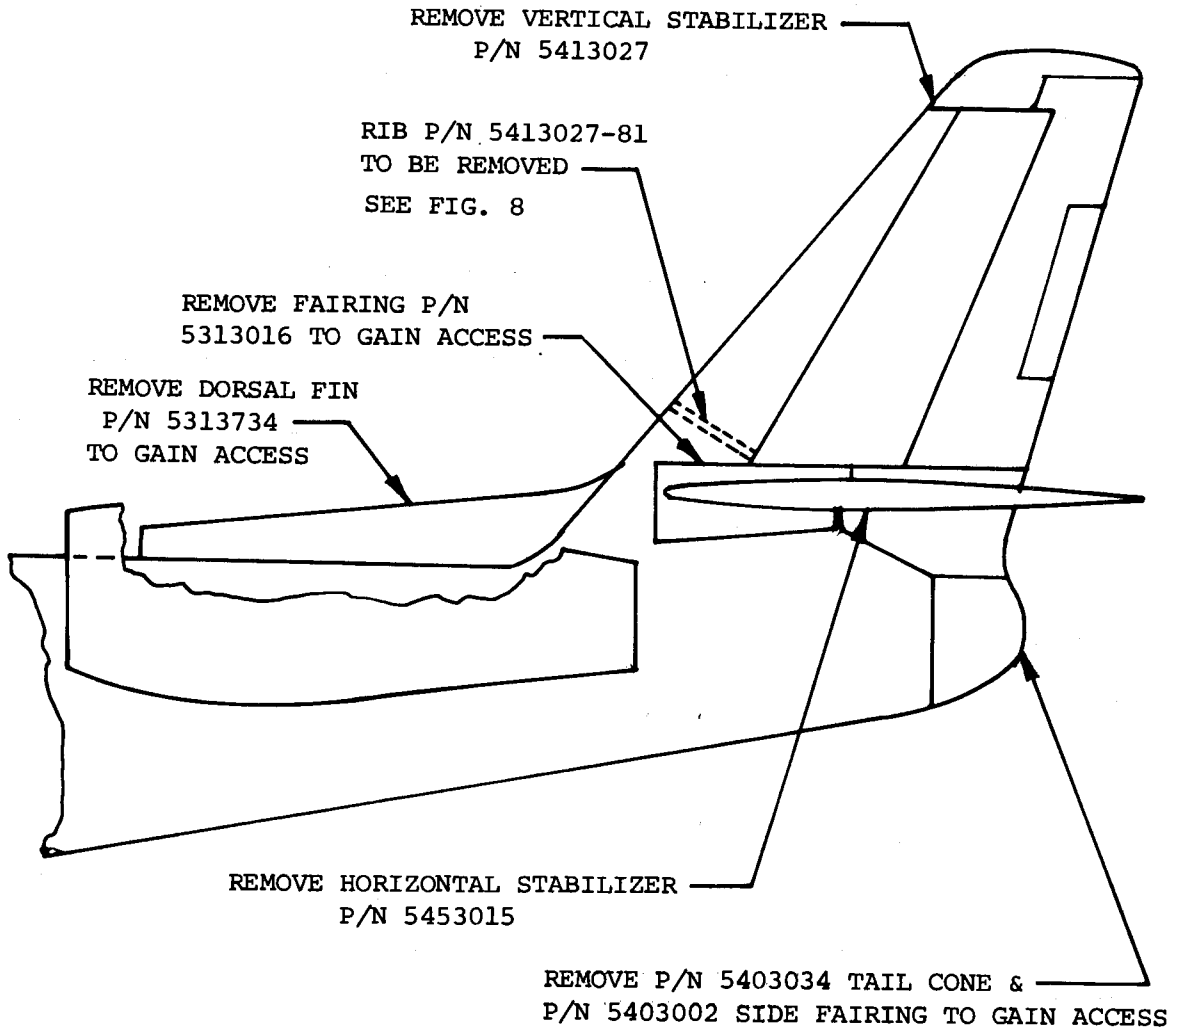
FIGURE 1

VIEW SHOWING PARTS TO BE REMOVED FROM A/C

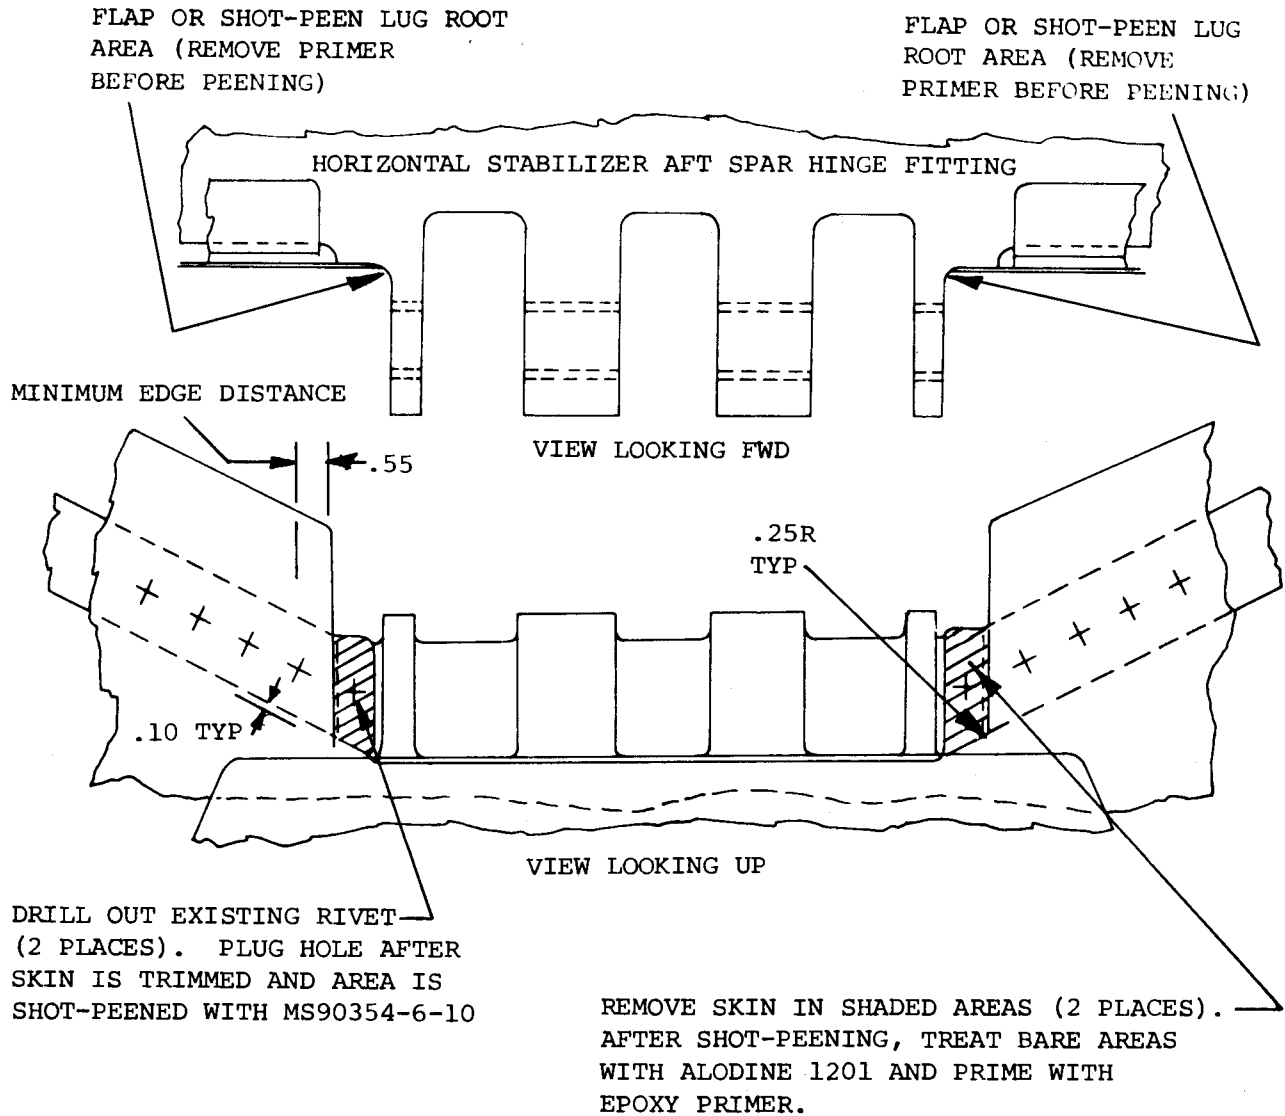
FIGURE 4

SHOT-PEEN AREA

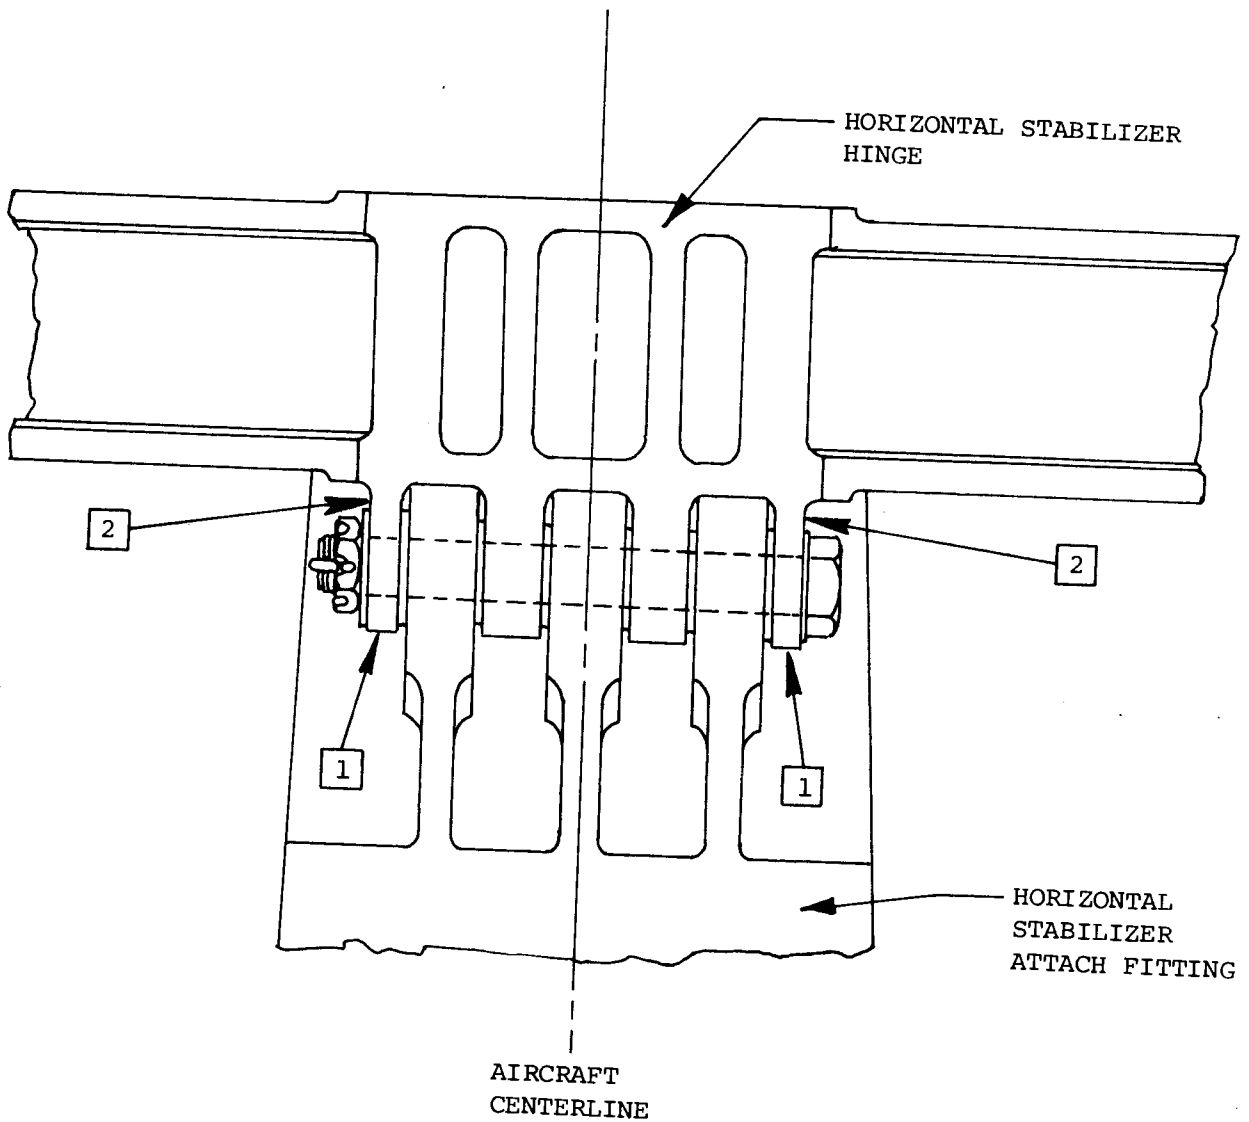
FIGURE 13

HORIZONTAL STABILIZER HINGE INSPECTION

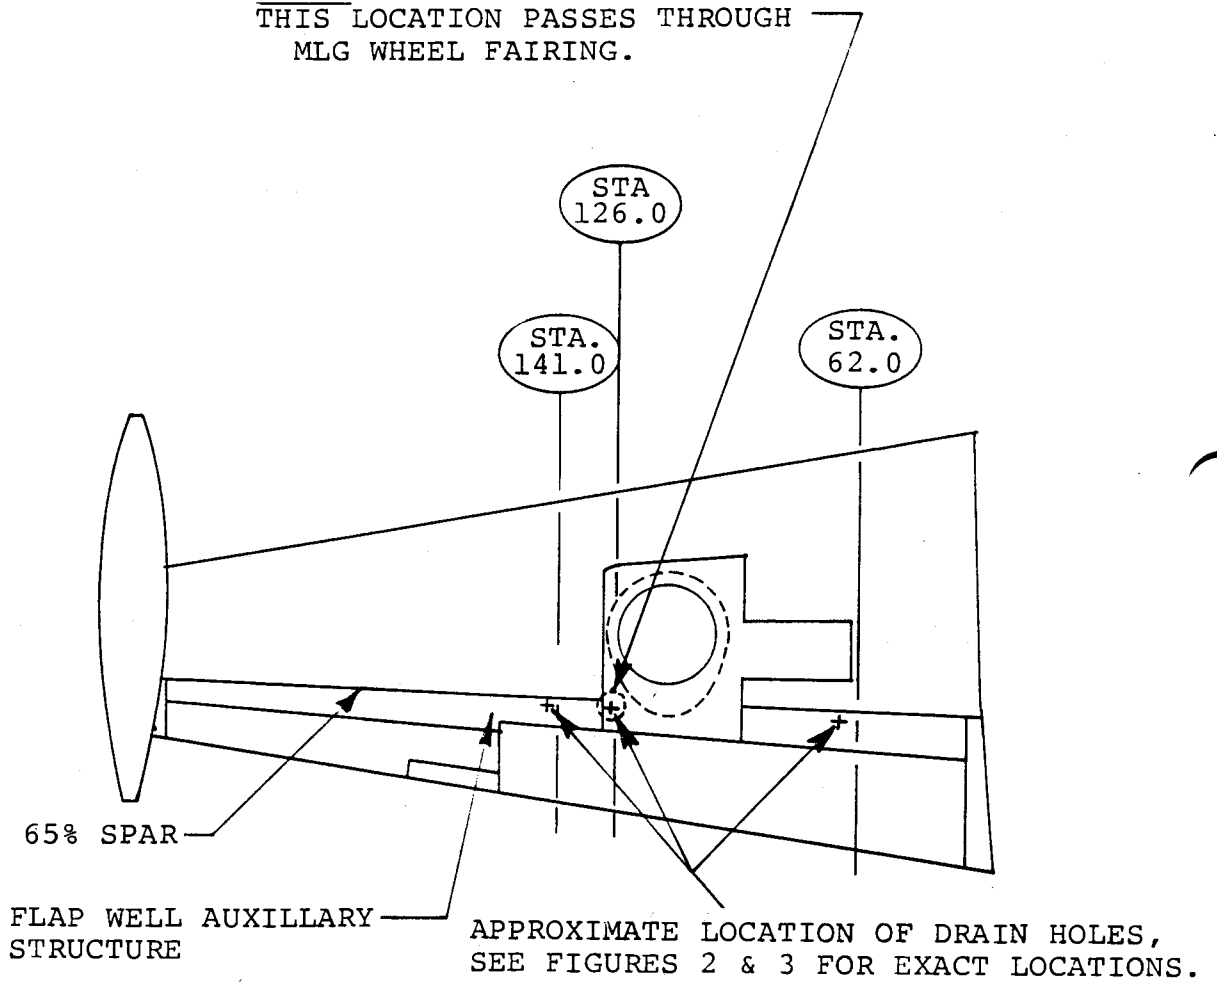
FIGURE 1

APPROXIMATE LOCATION OF DRAIN HOLES, SEE FIGURES 2 & 3 FOR EXACT LOCATIONS.
