## **LETTER OF TRANSMITTAL**

**TO: HOLDERS OF 1124/1124A WESTWIND MANUALS**

## SERVICE DATA

### SERVICE DATA CHAPTER INDEX

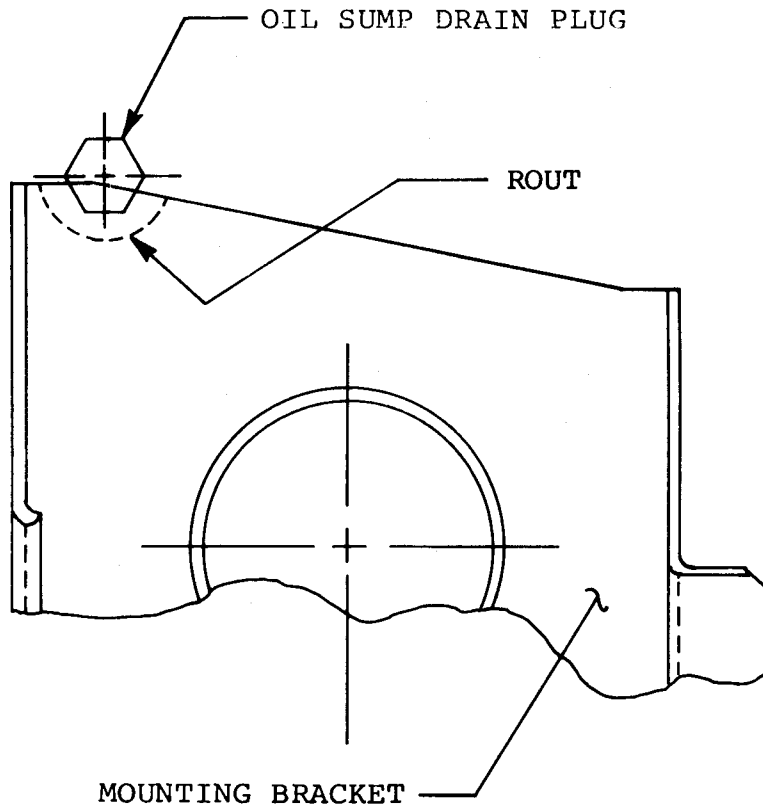
FIGURE 1: VIEW LOOKING UP AT BOTTOM OF COOLING TURBINE

As shown in Figure 1, the cooling turbine mounting bracket  
blocks access to the oil sump drain plug. Routing out the  
bracket, as shown, will allow the drain plug to be removed  
and replaced with a socket wrench. Trim no more material  
than necessary from the bracket.

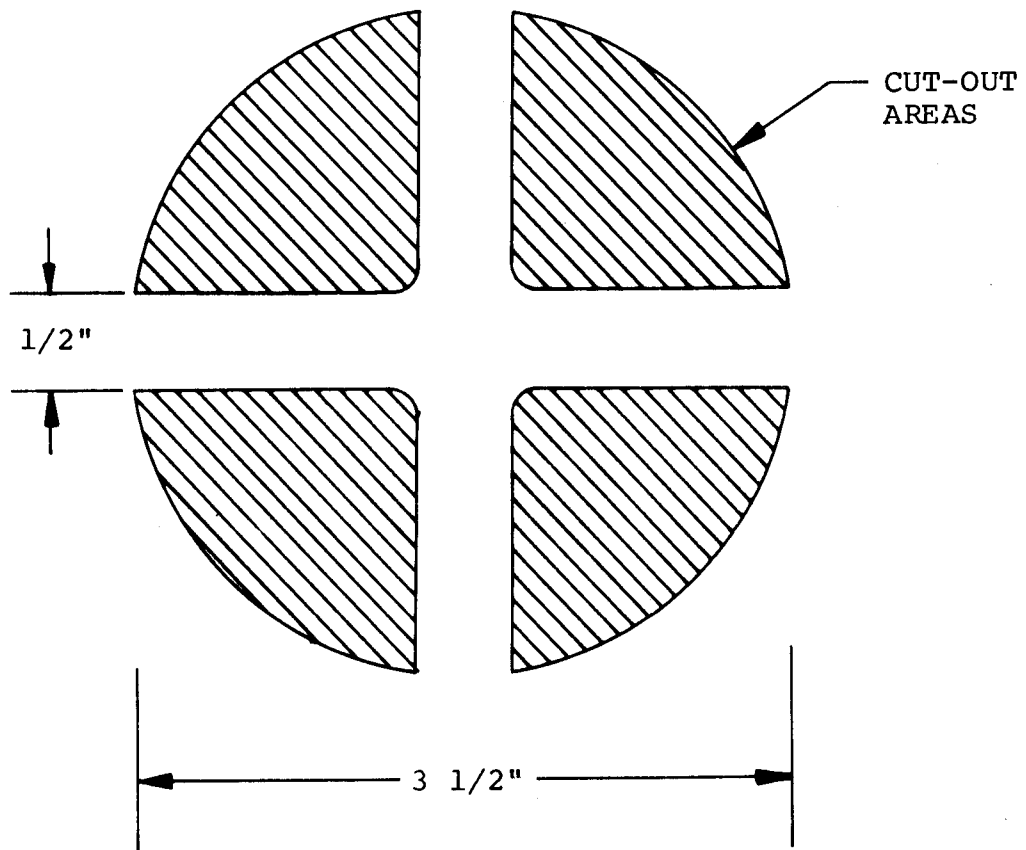
FIGURE 2

CUT-OUT SPEAKER GRIDS (6 PLACED)

- (7) Modify remaining speaker grids including grid for speaker located behind the Divan (if installed).
- (8) Reinstall cabin side-panels and return aircraft to service.

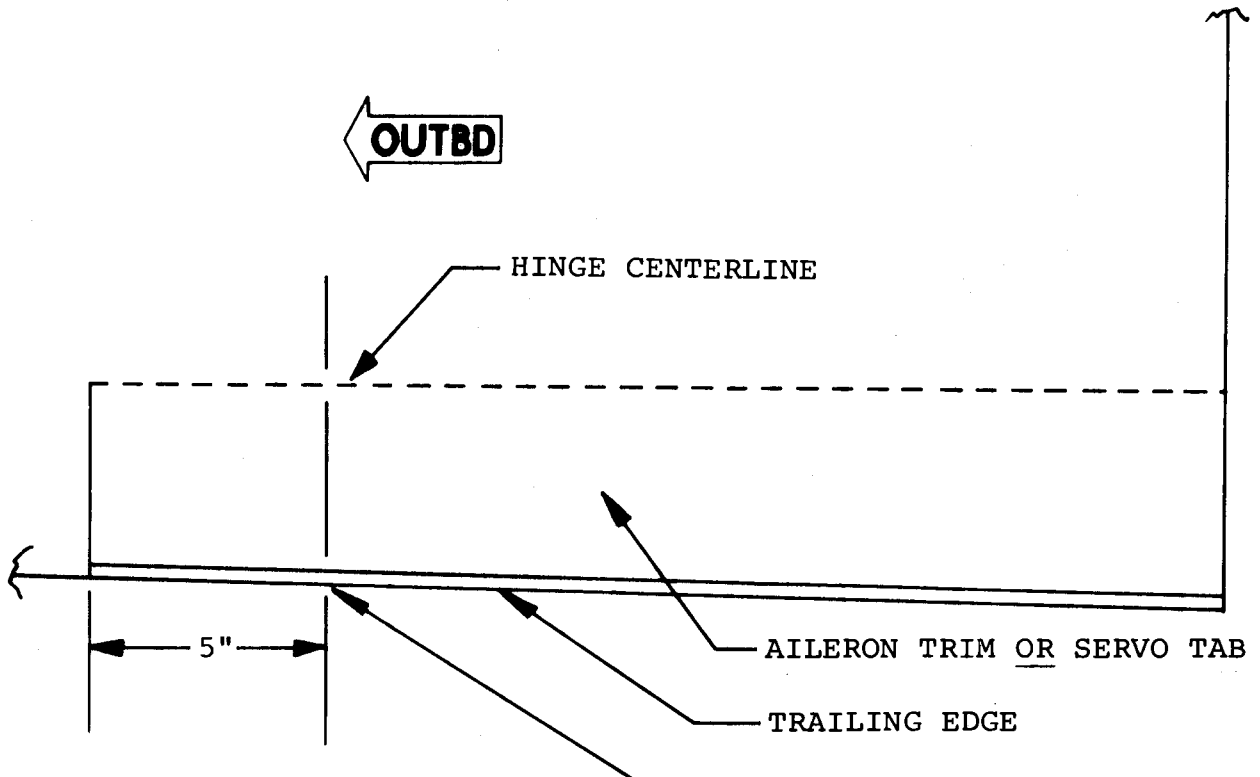
MEASURE TAB FREEPLAY AT THIS POINT  
APPLY 1 POUND FORCE ADJACENT  
TO DIAL INDICATOR MEASUREMENT  
POINT.

- (2) Apply up/down force of 1 pound to tab trailing edge adjacent to the dial indicator measurement point.
- (3) Note tab freeplay. Limits should not exceed:  
Aileron Trim Tab (LH) = 0.085 inch.  
Aileron Servo Tab (RH) = 0.043 inch.
- (4) If freeplay exceeds stated limits, check all rod-ends and bolts installed for wear. Replace worn components as required.

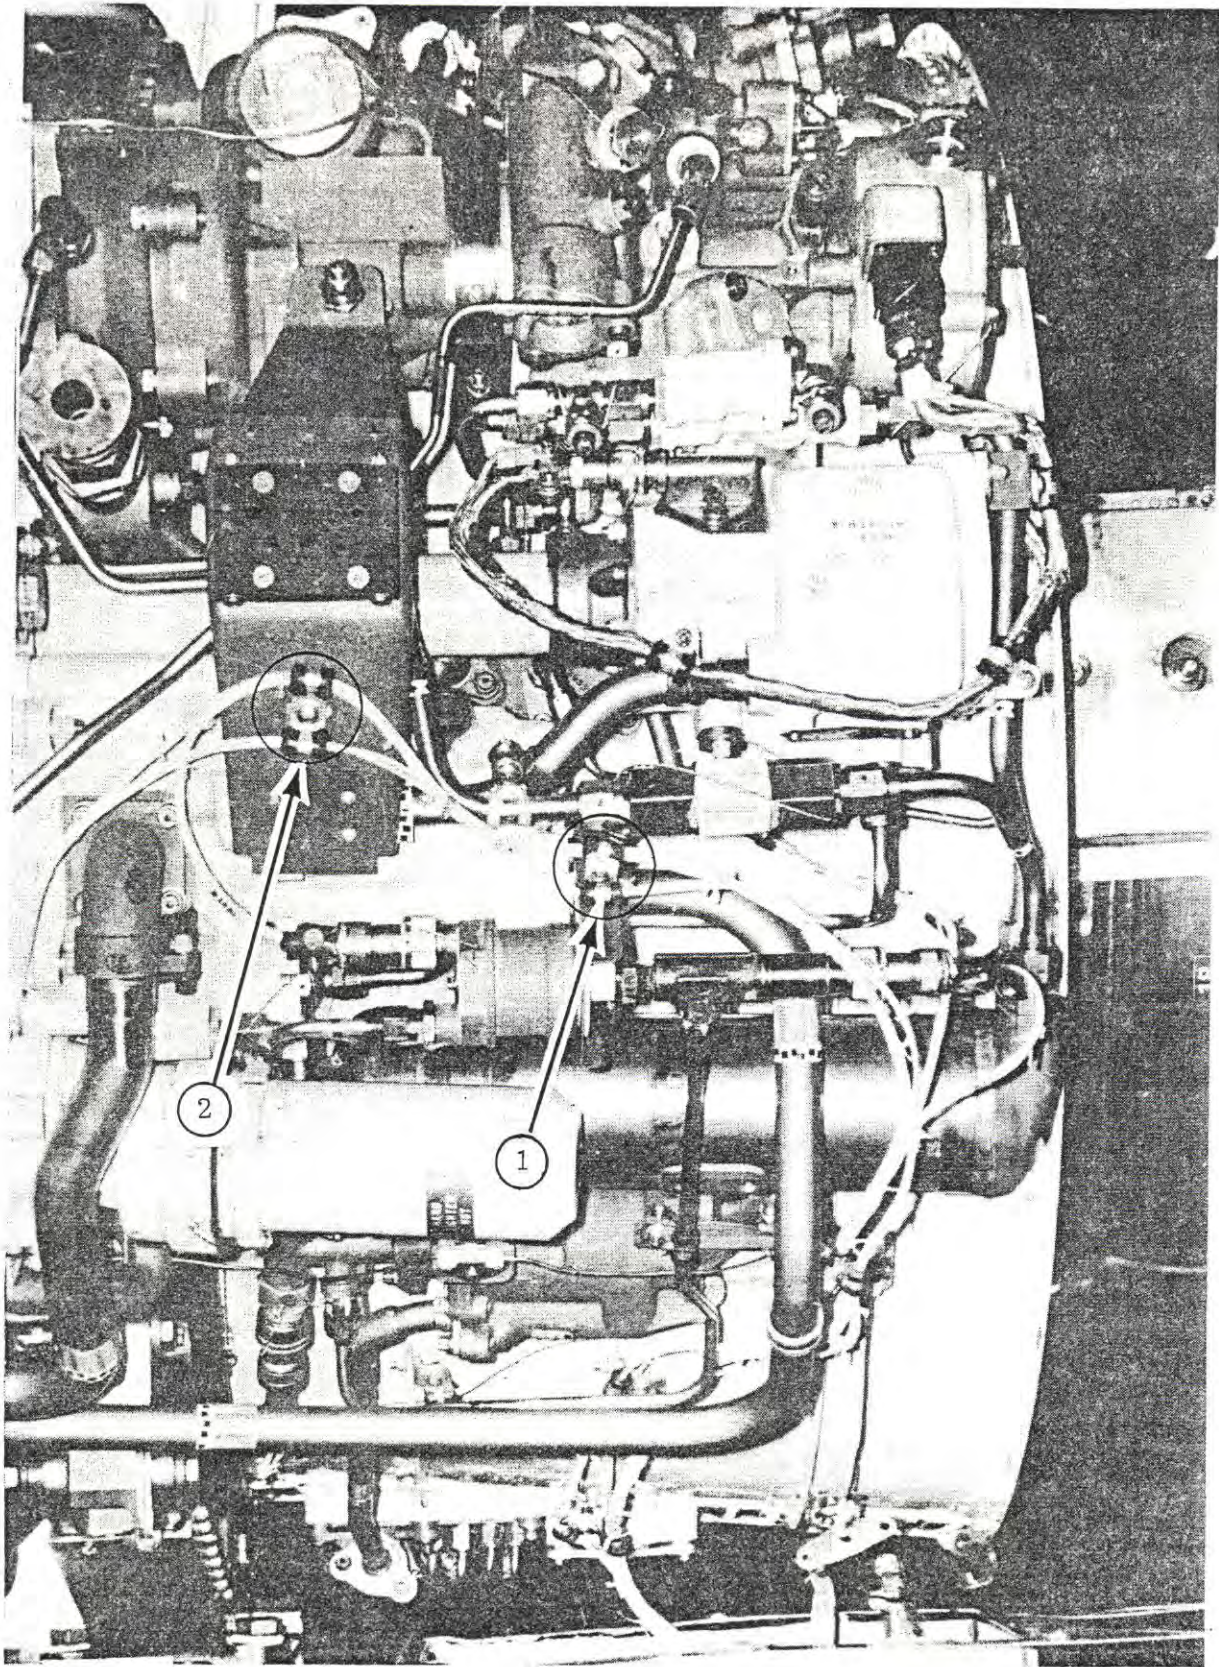
FIGURE 1

This routing should maintain proper clearance of wires from nacelle door frames.

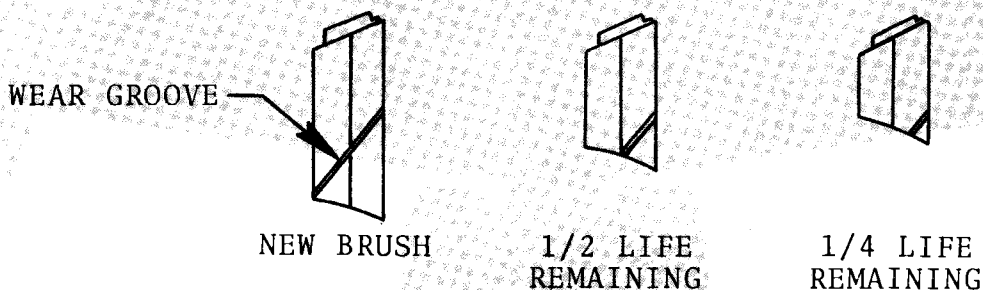
Figure 2. Illustration of Brush Wear Stages

1. The brush inspection data contained in the Westwind Maintenance Manual, Chapter 80-10-00, referred to in Chapter 5-20-00, Page 237, Para. 8.C. is applicable to the General Electric starter generator only.
2. Refer to your Lear Siegler Maintenance Manual, File No. 237-00, dated March 15, 1979, for brush inspection and replacement procedures.
3. Figure 2 of the manual illustrates brush wear stages. If the wear groove indication is compared to operating hours, you should be able to predict the approximate time that brush replacement will be required.
