SERVICE INFORMATION LETTER

SERVICE INFORMATION LETTER INDEX

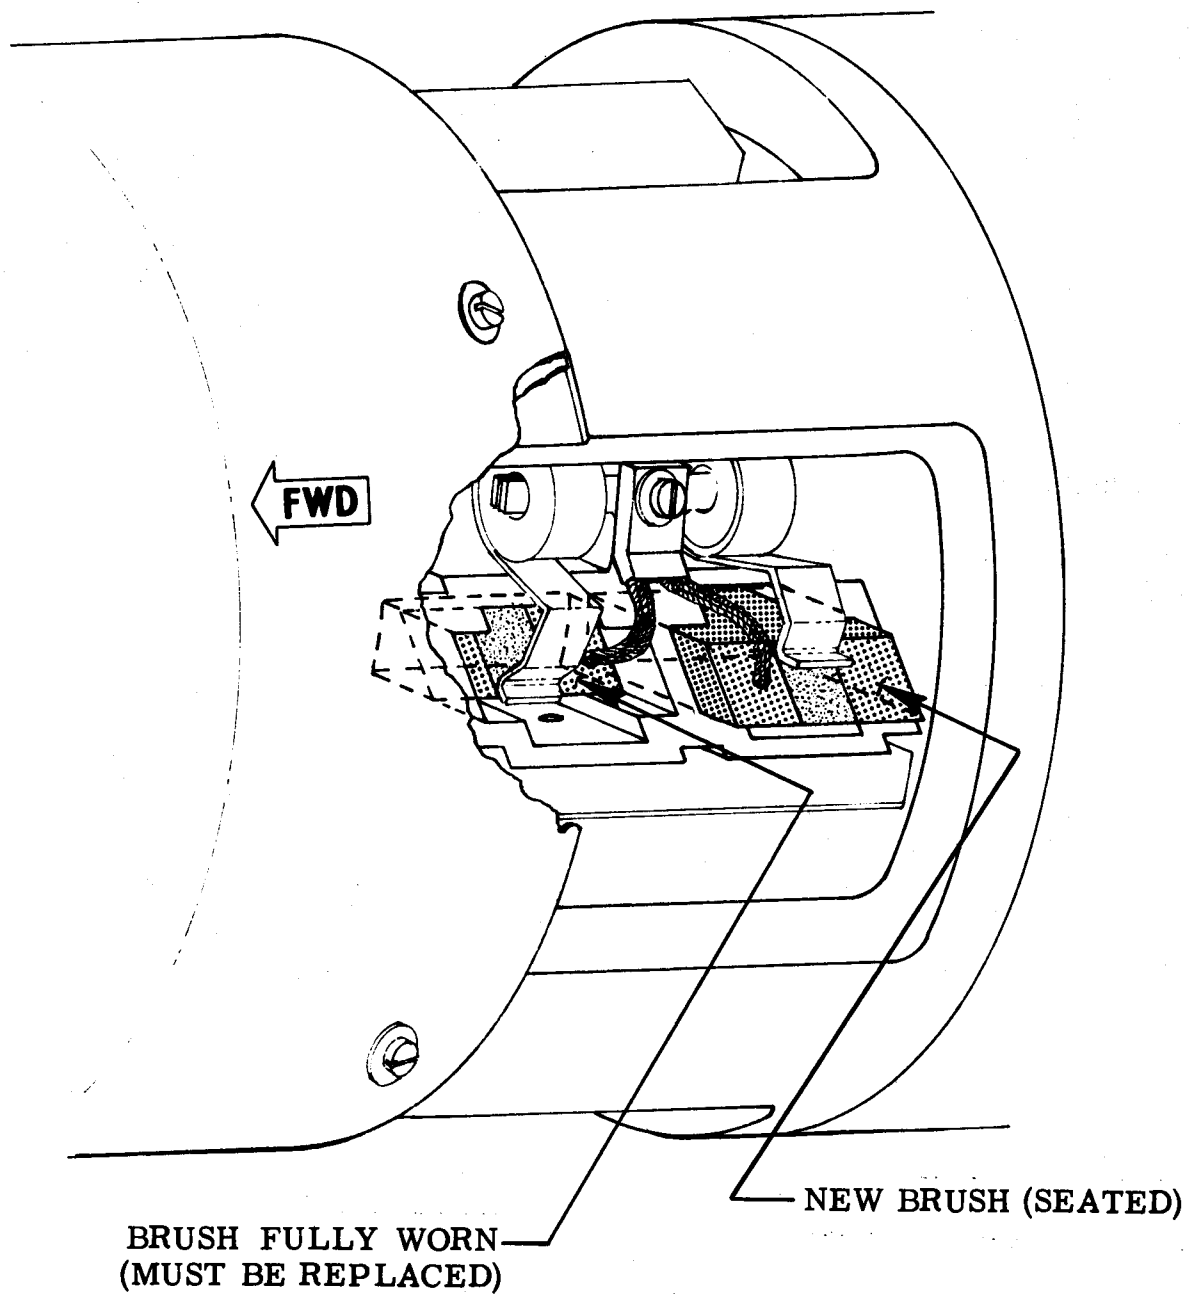
5. A newly installed brush has an approximate over all length of 1.38 inch (Seated). It is recommended the brush assemblies be replaced when brushes are worn to a length of .875 inch, or 450 operating hours, whichever occurs first. Brushes must be replaced when worn to a .70 inch overall length. (SEE FIGURE 2).

CONTINUED USE OF THE STARTER-GENERATOR WITH ANY BRUSH OF MINIMUM LENGTH OR LESS WILL LIKELY RESULT IN DAMAGE TO THE COMMUTATOR AND FAILURE OF THE STARTER-GENERATOR.

BRUSH FULLY WORN
(MUST BE REPLACED)

NEW BRUSH (SEATED)

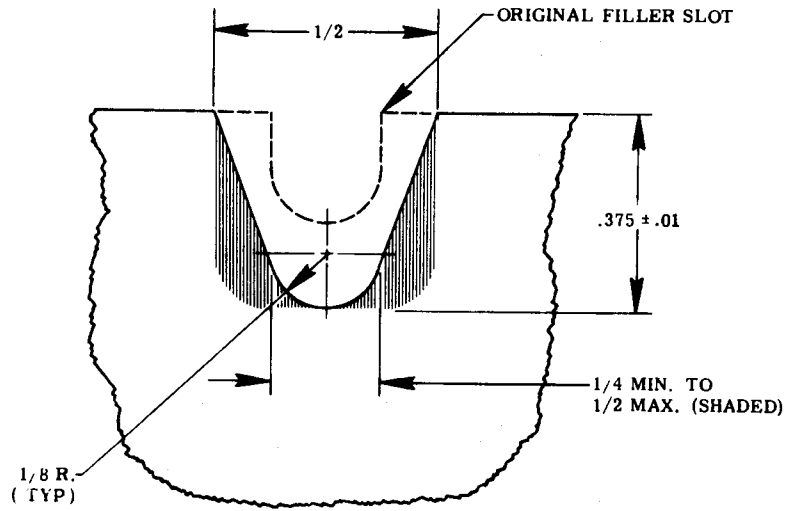
FIGURE 1

DETAIL - MODIFICATION OF FILLER SLOTS
(TYP. 2 PLACES)

9. Using a rotary file and right angle power tool, increase size of standpipe filler slots to a max. depth of $.375 \pm .01$ inch (See Figure 1).
10. Vacuum sweep chips from reservoir.
11. Remove shop towels and vacuum sweep reservoir and standpipe to remove remaining chips. Wipe reservoir walls to ensure removal of metal dust. Purge reservoir and standpipe with shop air.
12. Install reservoir drain plugs, rinse reservoir and fittings with skydrol until system is clean of all filings. Reconnect supply and return lines to reservoir fittings.
13. Inspect filter element for condition and Vendor Part Number. Vendor P/N 032667 is superceded by P/N 031324, or 031324-02-60. Use Vendor P/N 031324, or 031324-02-60 only.

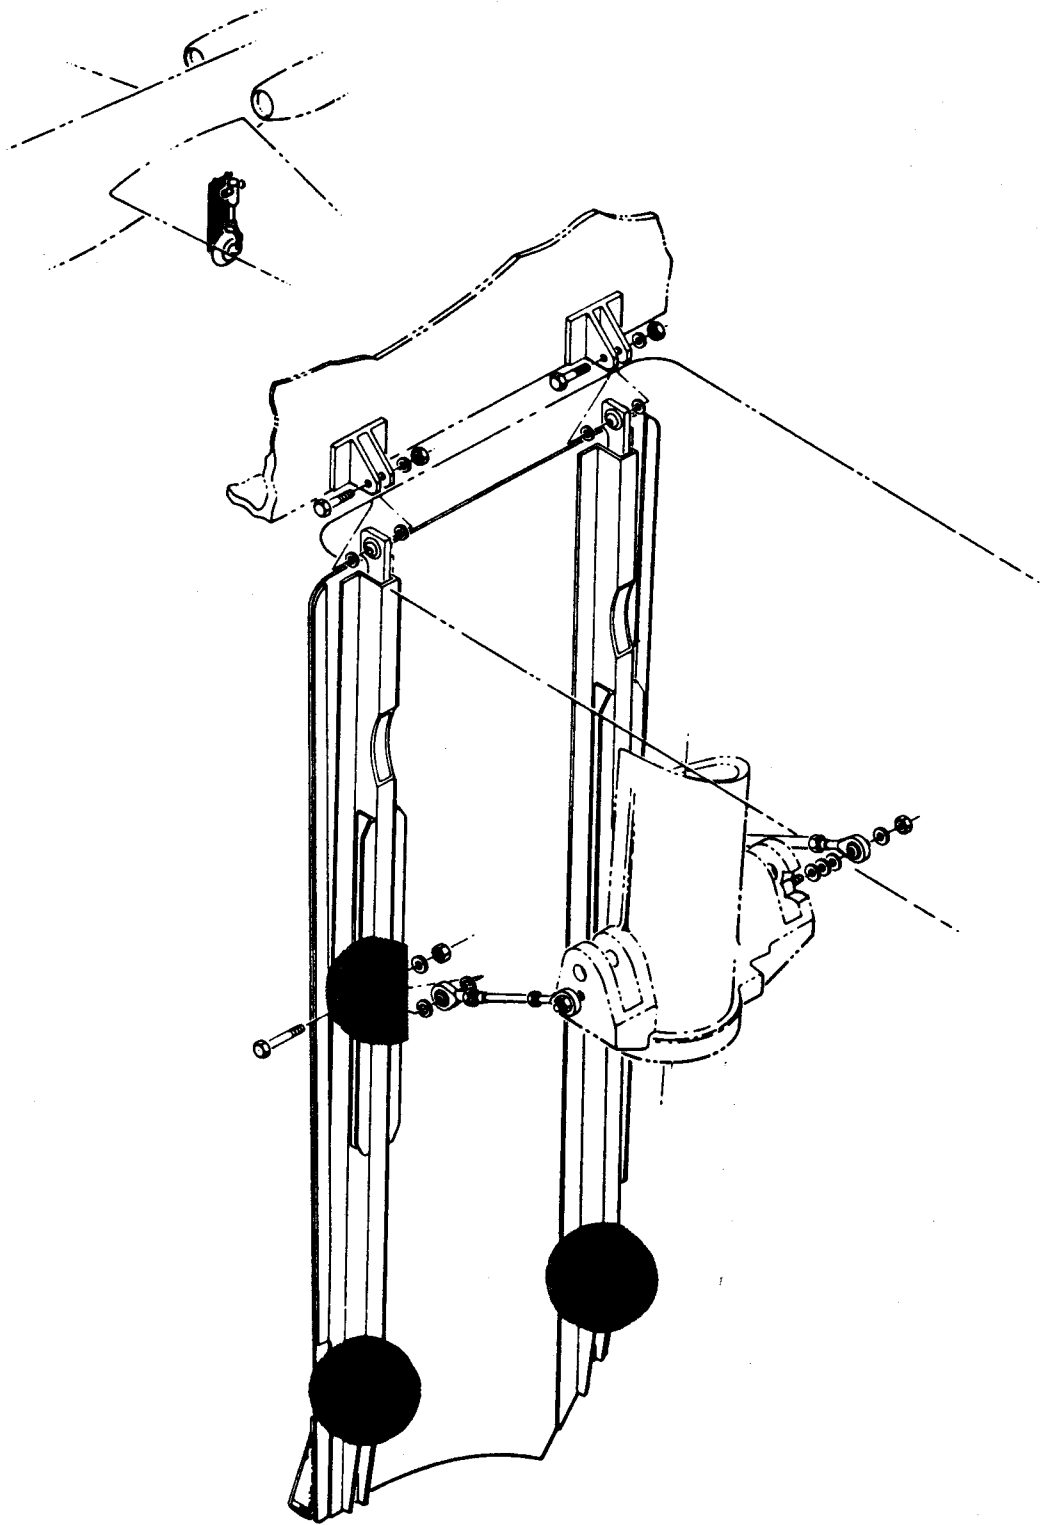
FIGURE 1 INSPECTION OF STRUT
DOOR

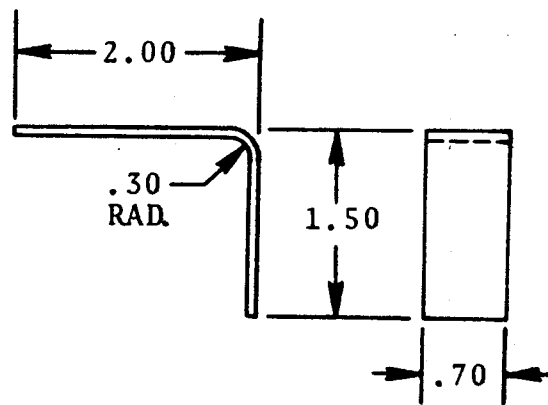
FIGURE 2 REPAIR OF CRACKED
5263018-13 CLIP

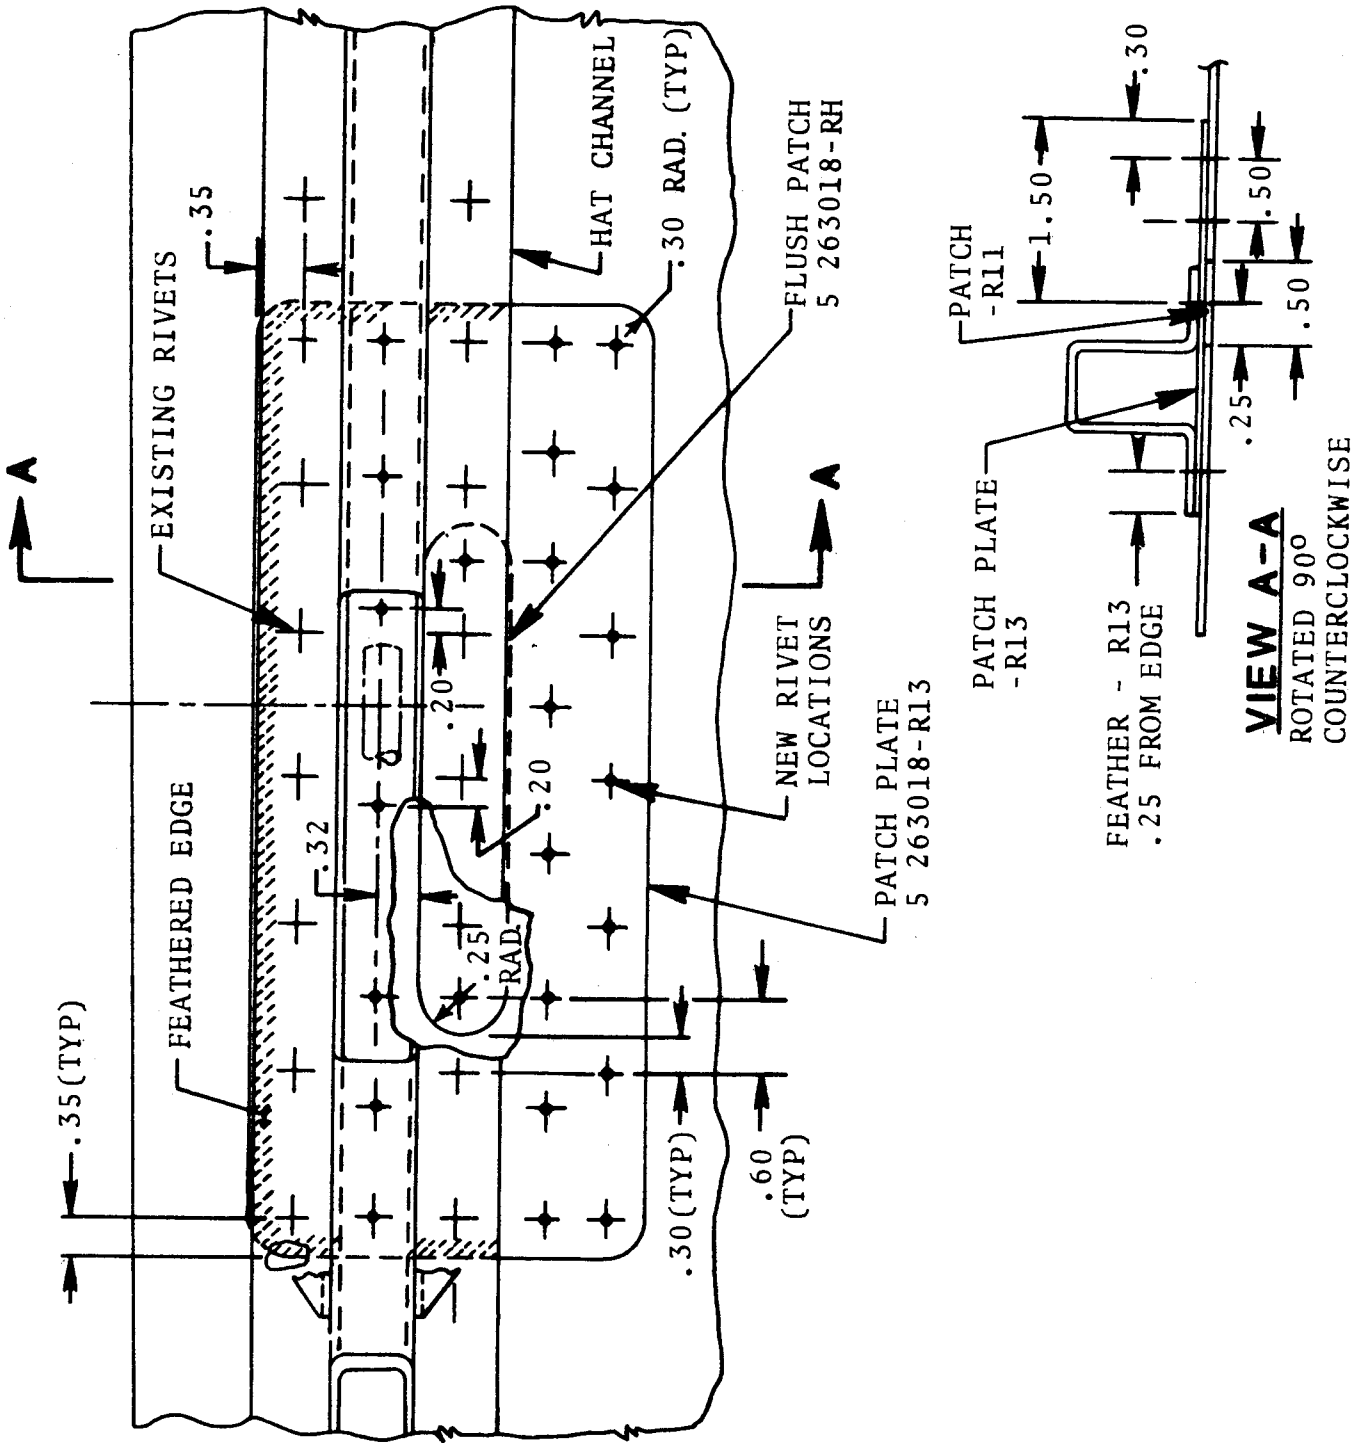
FIGURE 3 REPAIR OF CRACK RUNNING ALONG RIVET LINE OF HAT CHANNEL IN DOOR SKIN.
