90-09-10 TEXAS INSTRUMENTS: Amendment 39-6565. Docket No. 89-ANE-38.

Applicability: To circuit breaker Models 6TC6-7.5 and -10 and 6TC20-7.5 and -10, all with date codes 8150 and earlier.

94-21-06 PACIFIC SCIENTIFIC COMPANY, HTL/KIN-TECH DIVISION:  
Amendment 39-9048. Docket 94-NM-73-AD.

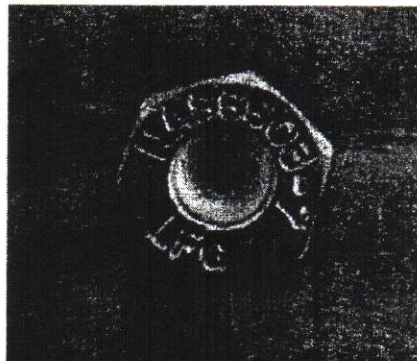
**NAS6603 BOLT**  
**APPROVED PART NUMBER**
