90-09-10 TEXAS INSTRUMENTS: Amendment 39-6565. Docket No. 89-ANE-38.

Applicability: To circuit breaker Models 6TC6-7.5 and -10 and 6TC20-7.5 and -10, all with date codes 8150 and earlier.

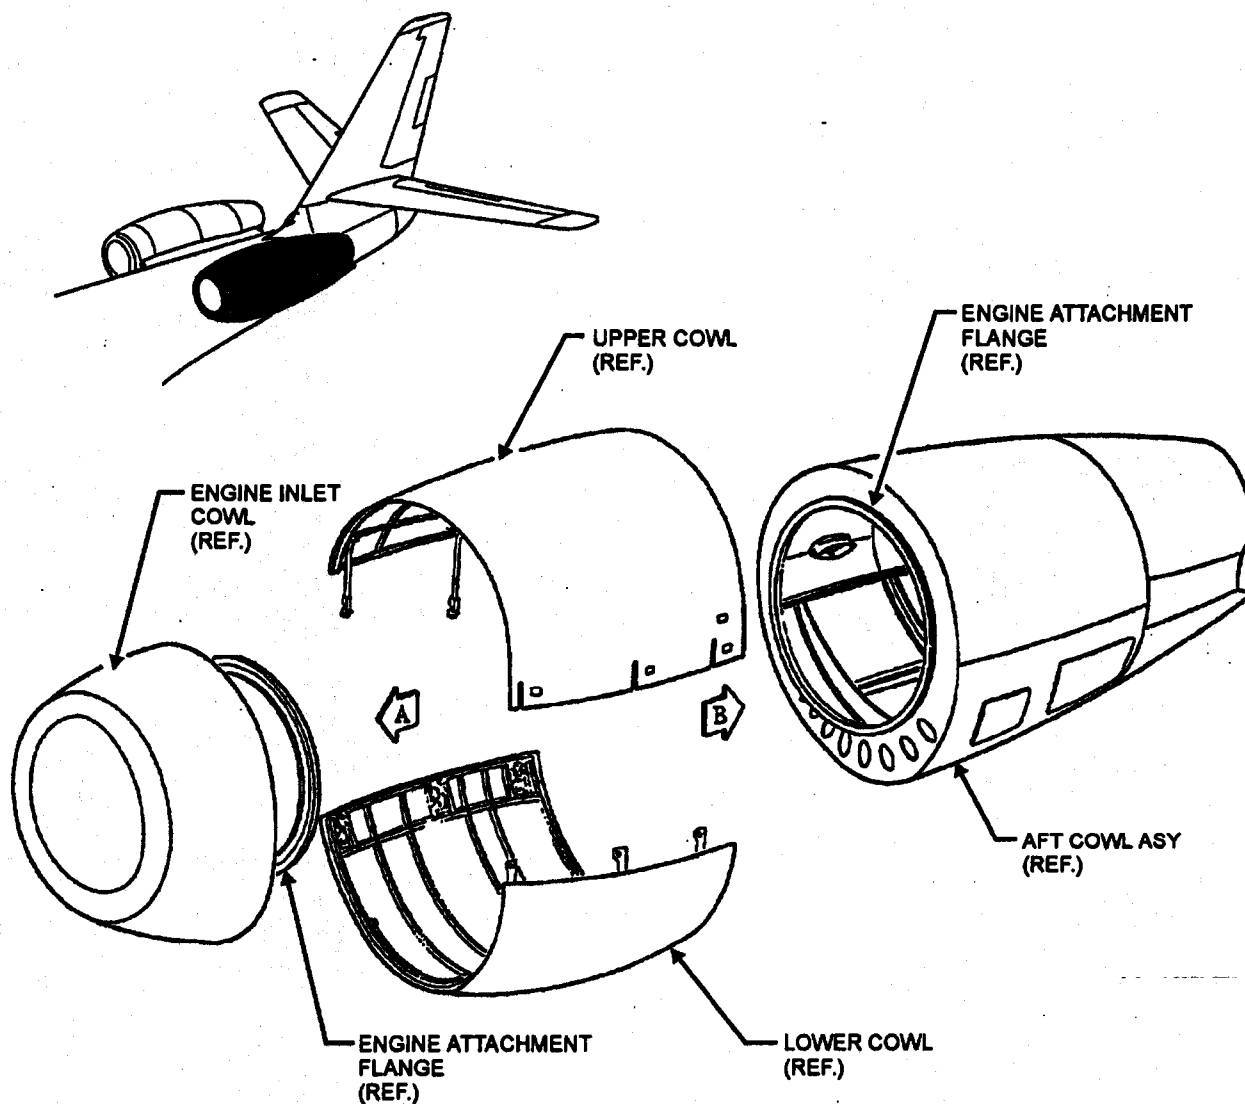
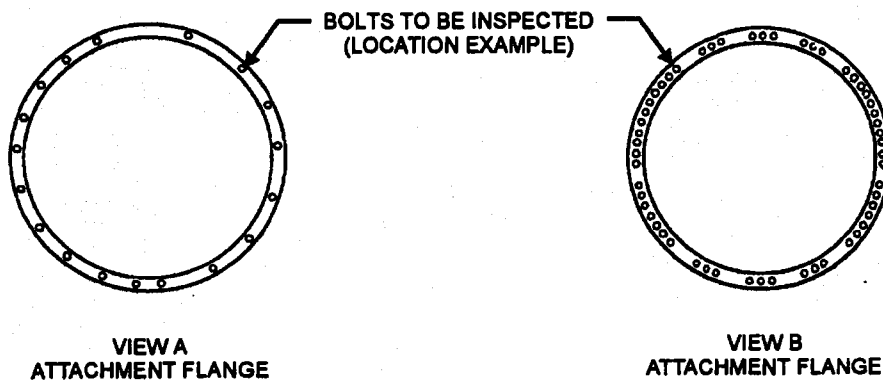
Nacelle Assembly
FIGURE 1

Bolt part numbers NAS1303 and NAS6603 are the only approved bolts to attach the inlet cowl and the aft nacelle to the engine flanges. On some aircraft, bolt part number AN3 have been found installed on the engine flanges. AN3 bolts are not approved and are considered as fatigue critical bolts for this application.

3. Verify the installed bolts are the approved part numbers NAS1303 or NAS6603. If approved bolts are installed proceed to Step 6. Refer to Figure 2.
4. Remove and replace any unapproved bolt part number with an approved bolt part number. Refer to 1124/1124A Westwind Illustrated Parts Catalog, Chapters 54-20-00 and 78-30-00 for proper bolt part numbers.

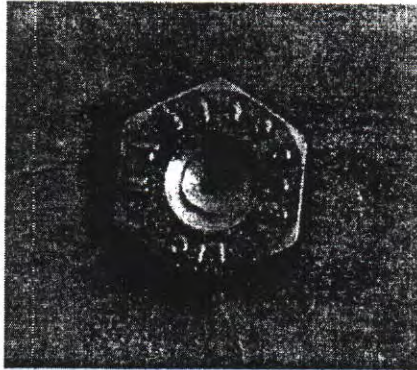
NAS1303 BOLT
APPROVED PART NUMBER

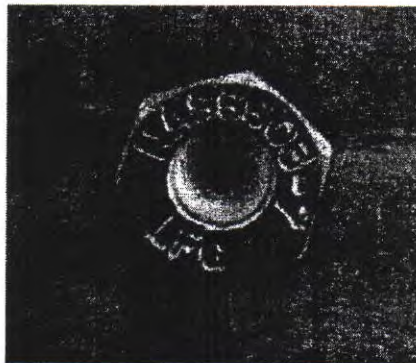
NAS6603 BOLT
APPROVED PART NUMBER
