## **SERVICE BULLETIN**

### **SERVICE BULLETIN INDEX**

# **24-WESTWIND**

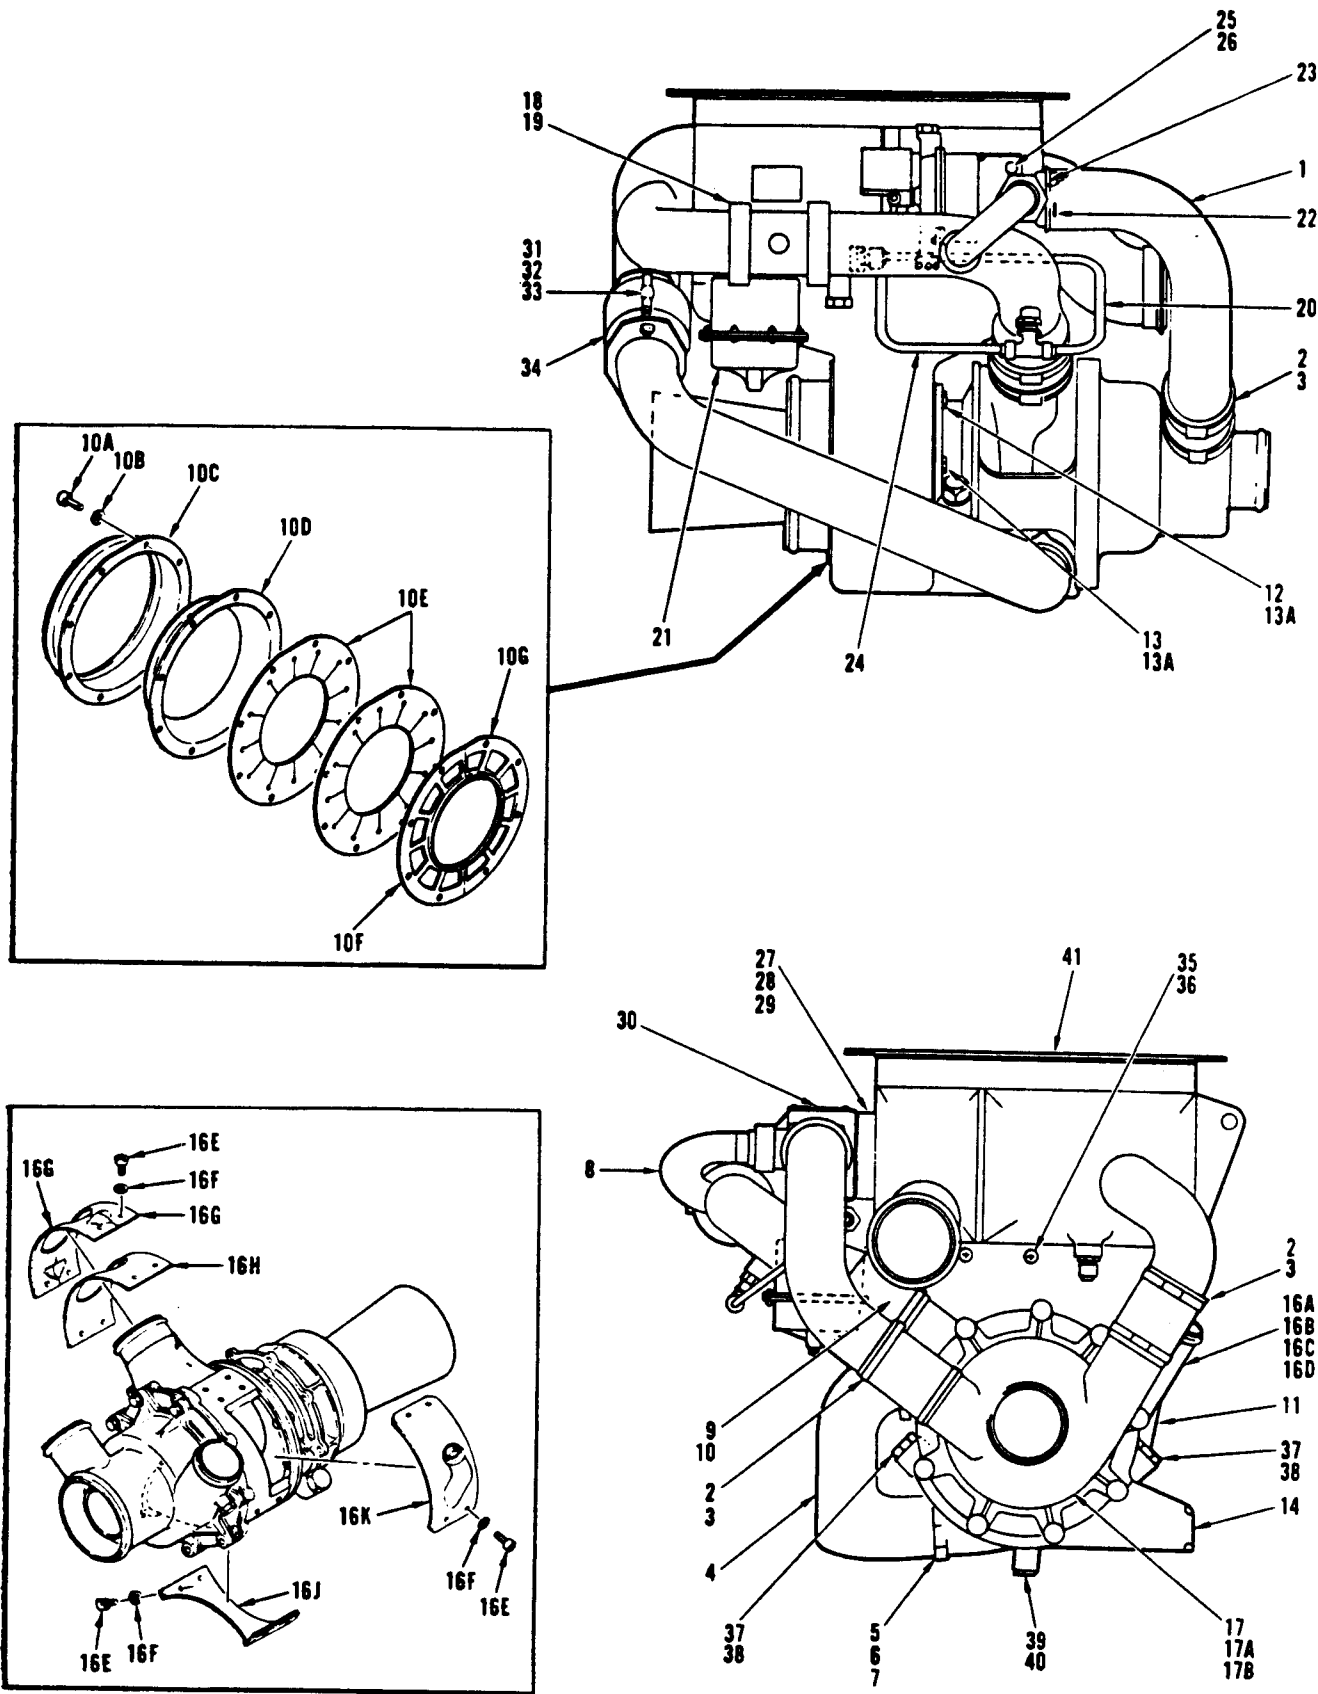
Aircraft Refrigeration Unit  
Part No. 2200165-2 and 2200165-3  
Figure 1

- (1) Problem. High cooling turbine failure rates have been experienced by some operators. Examination of returned turbines has revealed overheat to be responsible for over 50 percent of turbine failures.

- (2) Background. Early in the 1124 program, high cooling turbine failure rates were reported. High bearing temperatures were responsible and this condition was addressed through incorporation of a bearing cooling modification which lowered bearing temperatures and provided increased turbine life. A further life increase is still possible. Evidence of overspeed as well as overheat was still present on some units after installation of the bearing cooling modification. Analysis indicated that reduced ram air flows in some flight regimes can produce both an overspeed condition as well as higher temperatures to the cooling turbine as a result of this reduced cooling air flow. An Overtemperature Protection System was developed and made available for field evaluation. This system was deemed successful and has been incorporated into the 1125 ASTRA Environmental Control System.

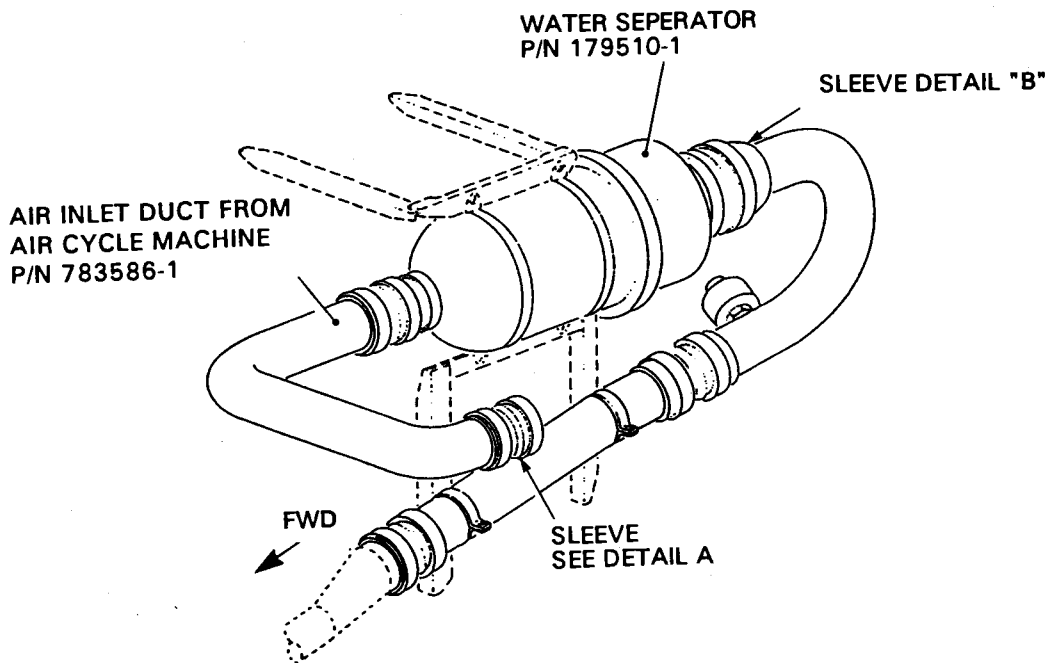
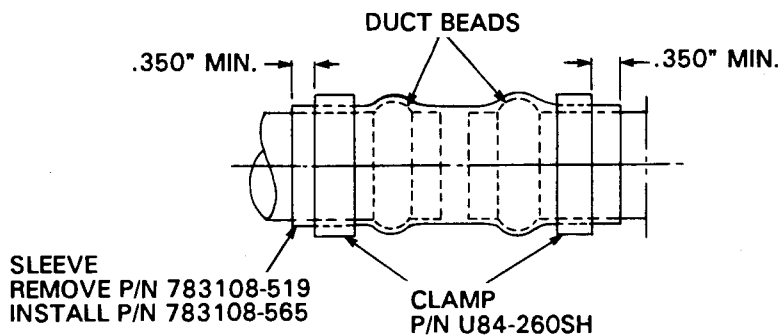
**DETAIL A**

This service bulletin provides instruction for inspection, and replacement if required, of the water separator duct sleeves.

- A. Gain access to forward baggage compartment and remove the rear panel.
- B. Inspect the sleeve P/N 783108-519 and clamps P/N U84-260SH that connect the water separator inlet duct P/N 783586-1 to the air cycle machine outlet port for proper installation. Clamps must be clear of the duct beads and the sleeve ends must protrude 0.350 inches minimum beyond the duct clamps. Refer to Figure 1 Detail "A". If found to be correct, check that the clamps are torqued to 20-25 inch pounds and proceed to step G. If not correct, proceed as follows:

- G. Install the rear panel in the forward baggage compartment.
- H. Gain access to rear baggage compartment and remove the forward access panel.
- I. Inspect the sleeve P/N 783108-509 and clamps P/N U84-410SH on the water separator outlet duct. For proper installation clamps must be clear of the duct beads. The sleeve ends must protrude 0.350 inches minimum beyond the duct clamps. Refer to Figure 1, Detail "B". If found to be correct, check that the clamps are torqued to 20-25 inch pounds and proceed to step 2.N. If not correct, proceed as follows:
