SERVICE BULLETIN

SERVICE BULLETIN INDEX

24-WESTWIND

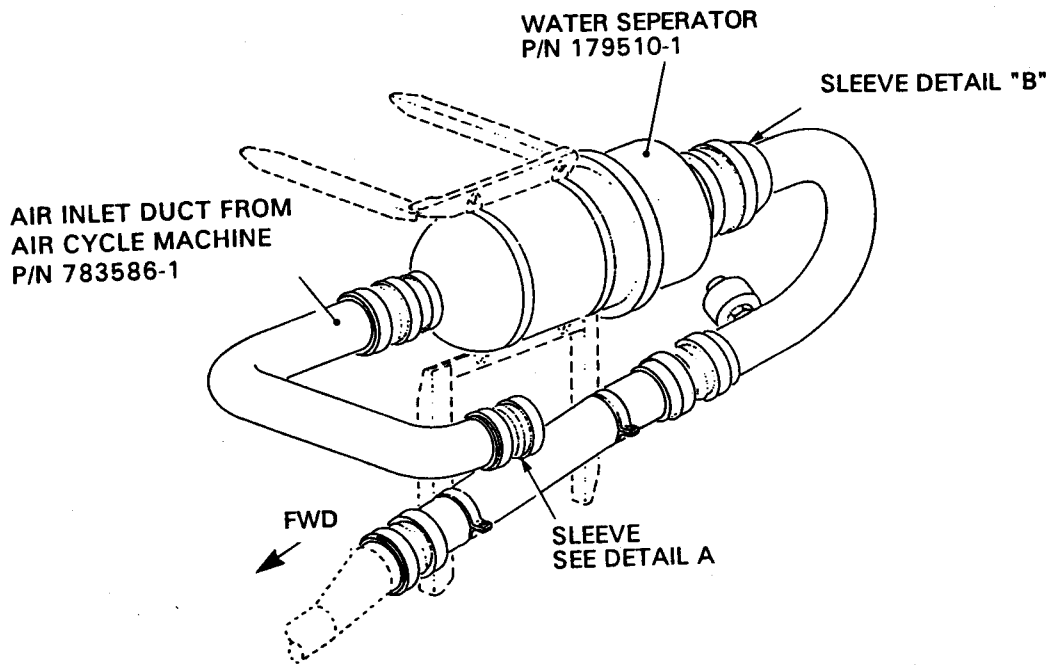
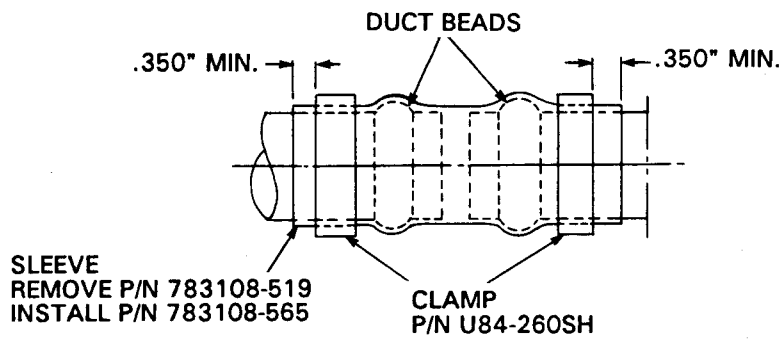
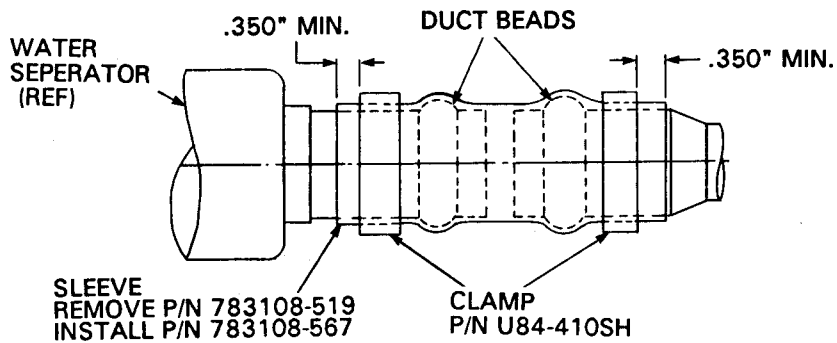
WATER SEPERATOR
FIGURE 1

This service bulletin provides instruction for inspection, and replacement if required, of the water separator duct sleeves.

- A. Gain access to forward baggage compartment and remove the rear panel.
- B. Inspect the sleeve P/N 783108-519 and clamps P/N U84-260SH that connect the water separator inlet duct P/N 783586-1 to the air cycle machine outlet port for proper installation. Clamps must be clear of the duct beads and the sleeve ends must protrude 0.350 inches minimum beyond the duct clamps. Refer to Figure 1 Detail "A". If found to be correct, check that the clamps are torqued to 20-25 inch pounds and proceed to step G. If not correct, proceed as follows:

- G. Install the rear panel in the forward baggage compartment.
- H. Gain access to rear baggage compartment and remove the forward access panel.
- I. Inspect the sleeve P/N 783108-509 and clamps P/N U84-410SH on the water separator outlet duct. For proper installation clamps must be clear of the duct beads. The sleeve ends must protrude 0.350 inches minimum beyond the duct clamps. Refer to Figure 1, Detail "B". If found to be correct, check that the clamps are torqued to 20-25 inch pounds and proceed to step 2.N. If not correct, proceed as follows:

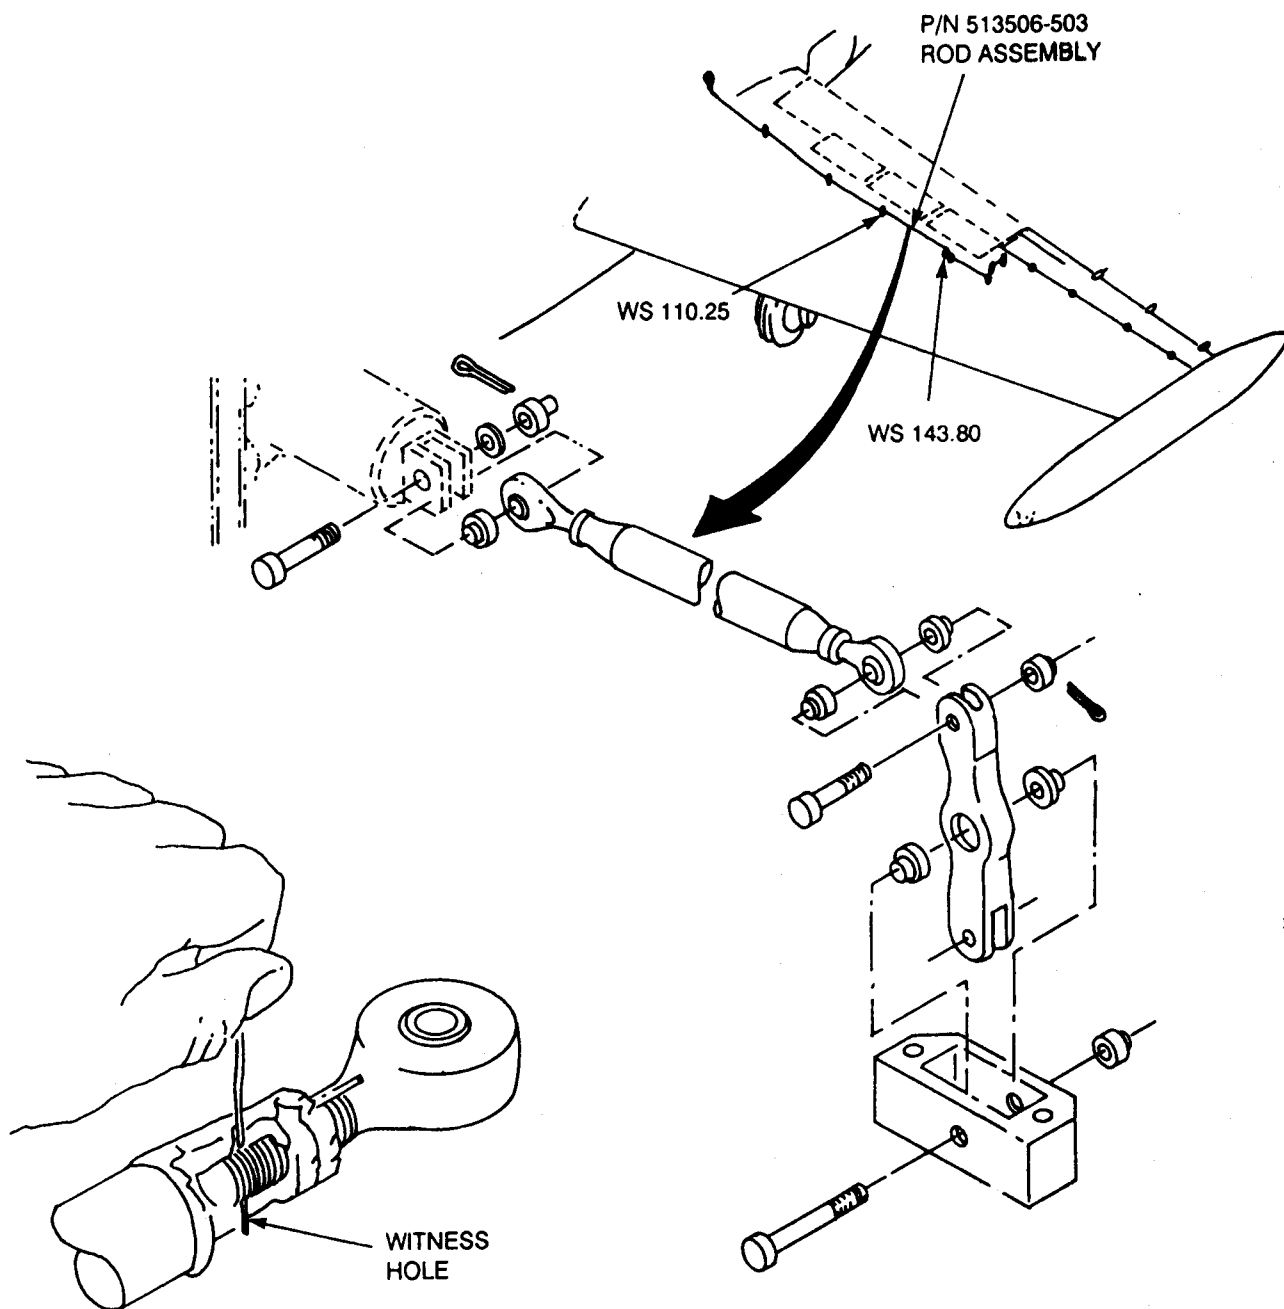
CAUTION:
IF SAFETY WIRE WILL PASS THROUGH
BOTH WITNESS HOLES, ROD END IS
EXTENDED PAST LIMITS.

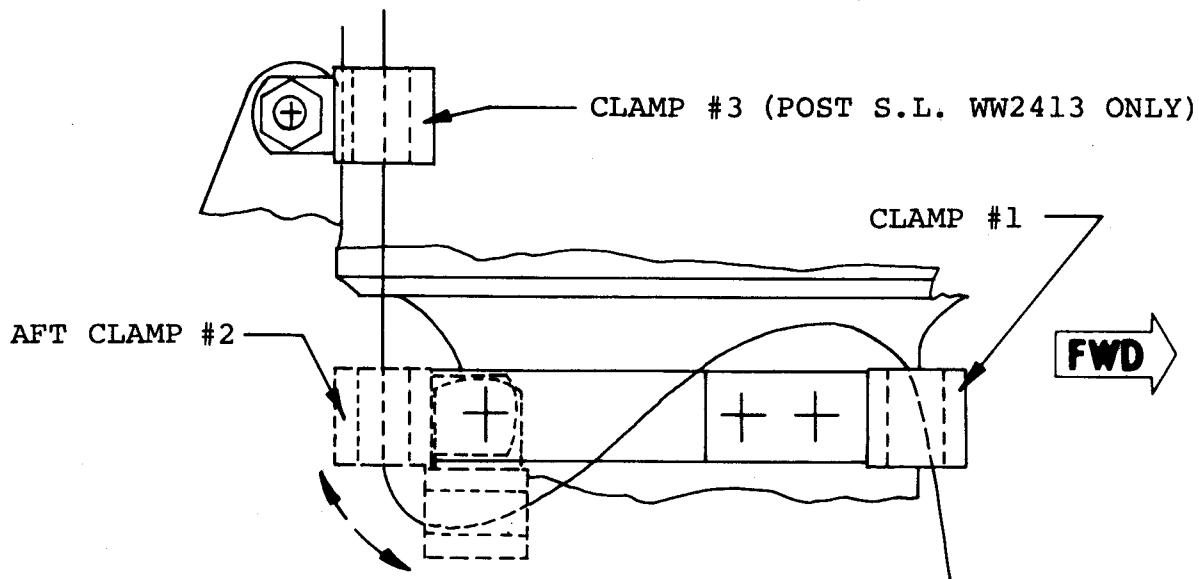
FIGURE 1: EXISTING INSTALLATIONS

NOTE: CLAMP #2 WILL BE FOUND IN EITHER POSITION AS SHOWN, ON EXISTING INSTALLATIONS.
