IAI WESTWIND

SERVICE BULLETIN

1124 SERVICE BULLETIN INDEX

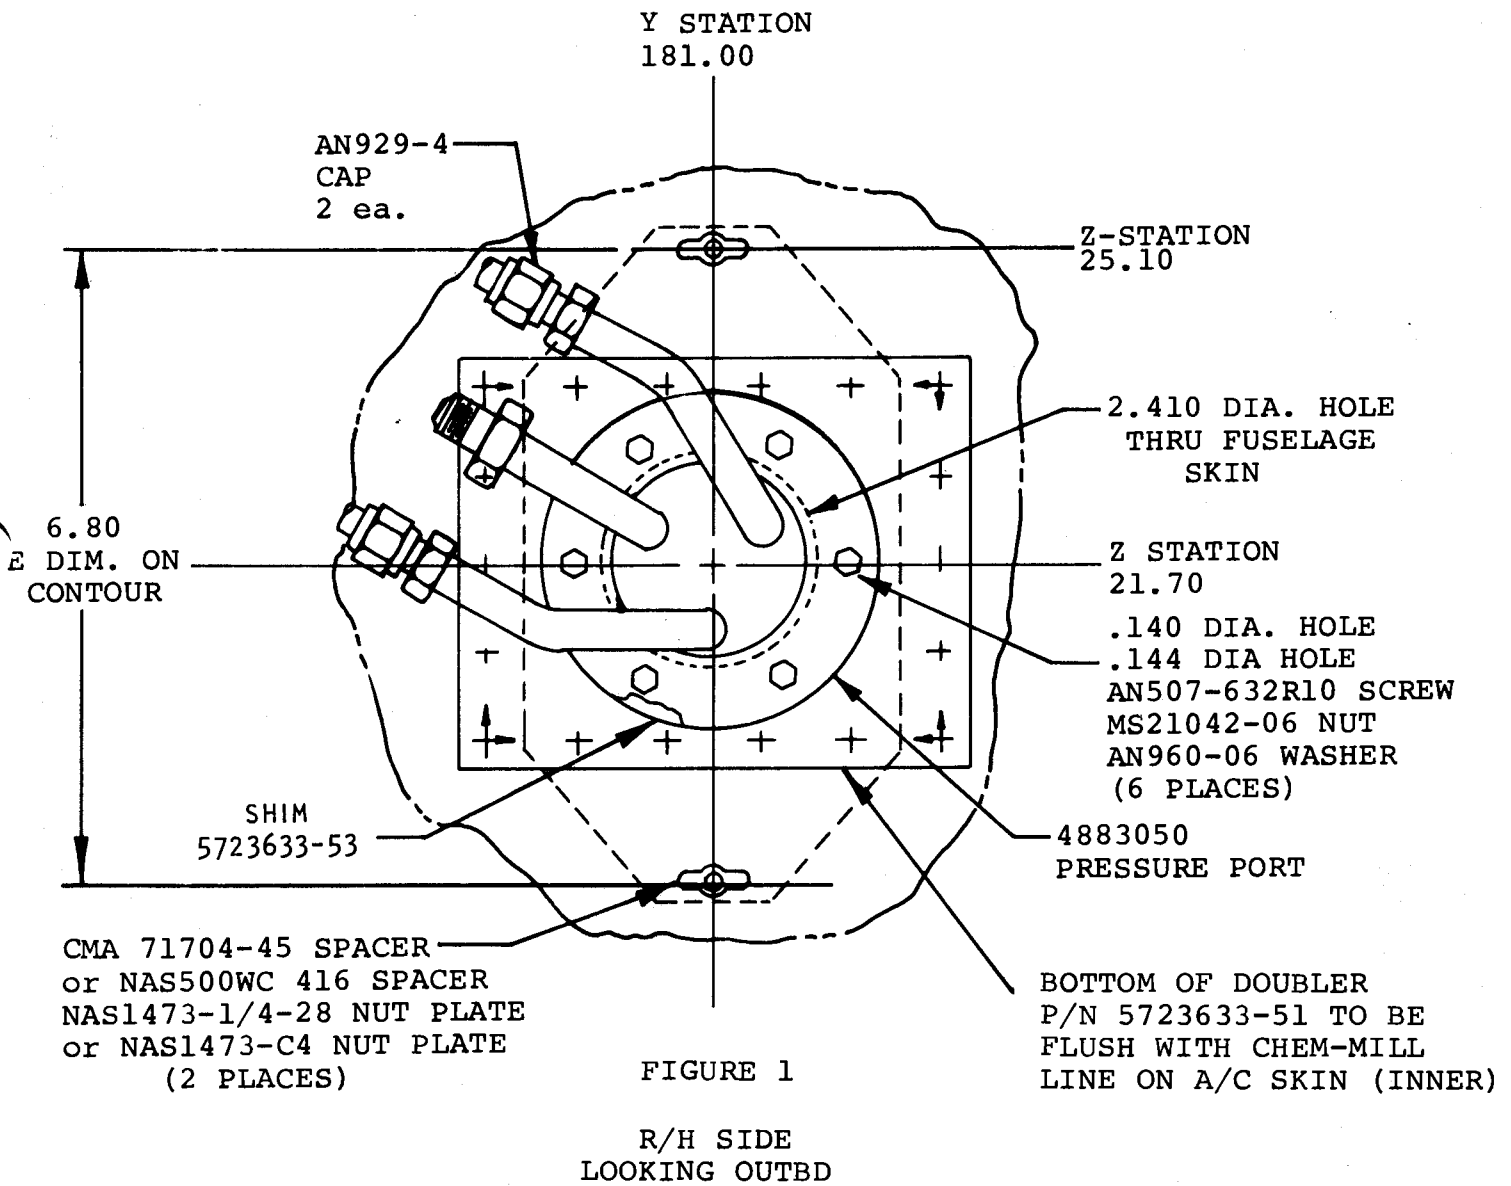
FIGURE 1A

DOUBLER P/N 5723633-51

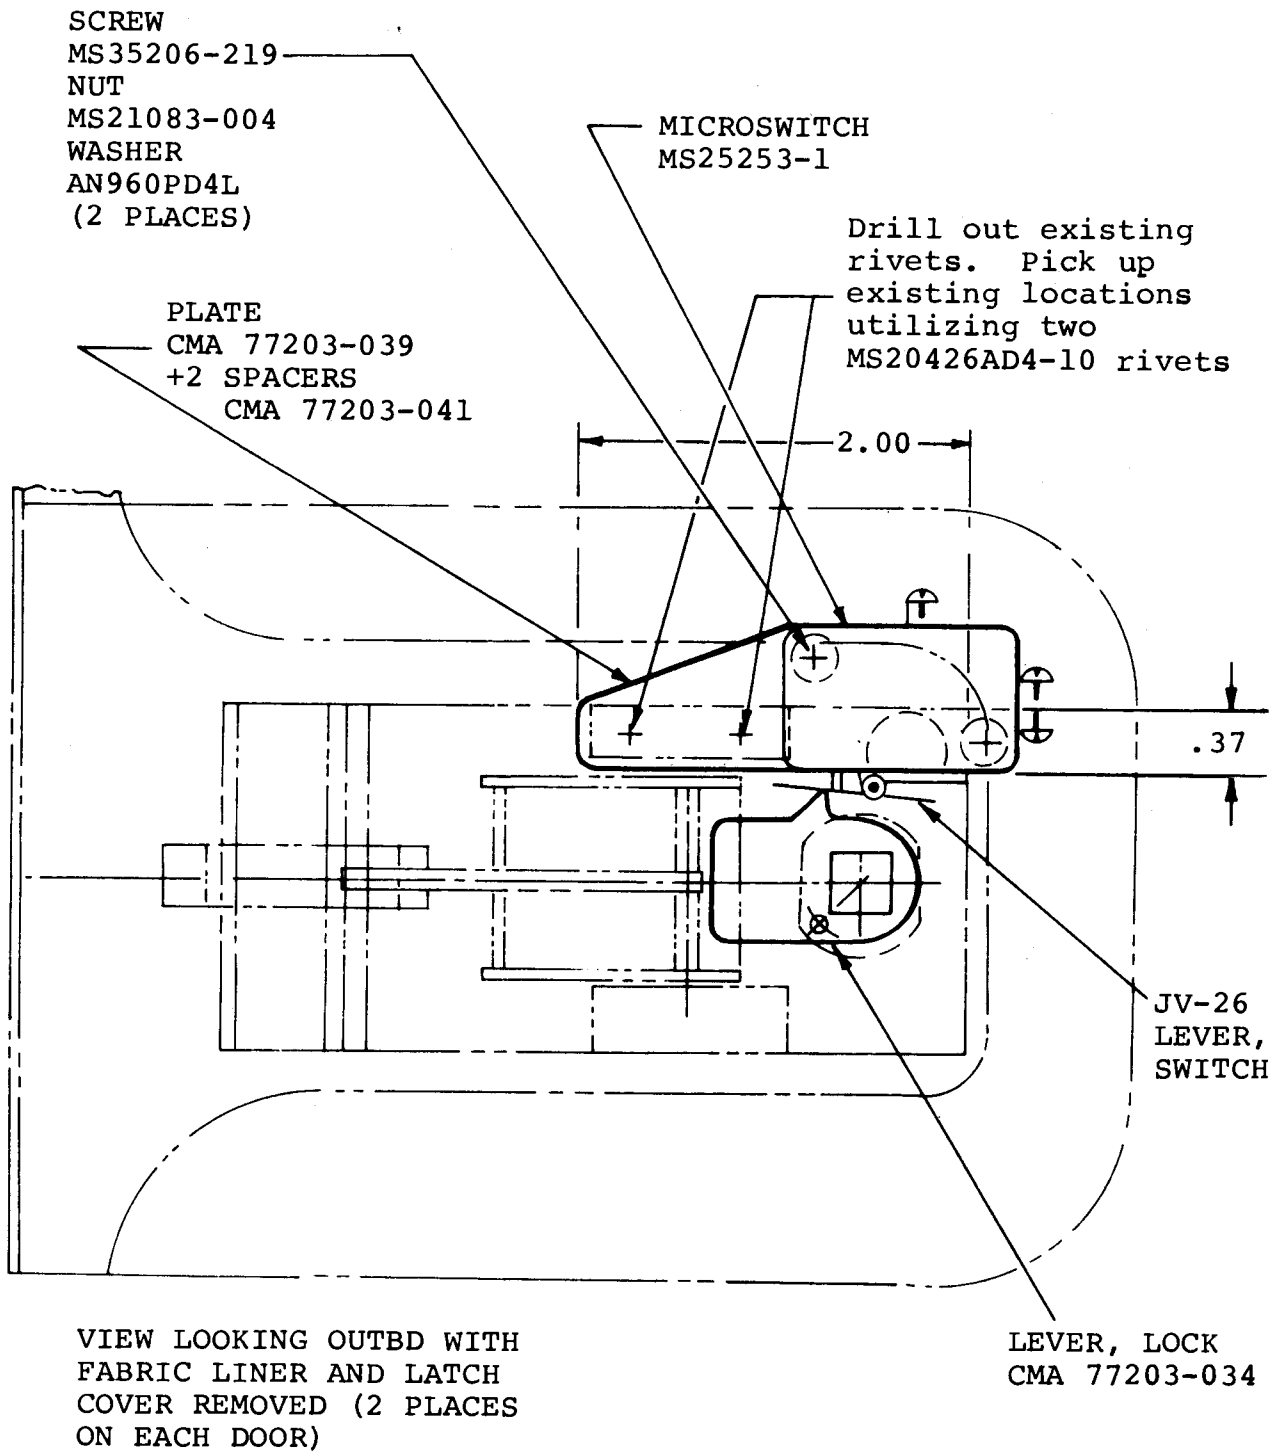
FIGURE 1

NEW MICROSWITCH INSTALLATION

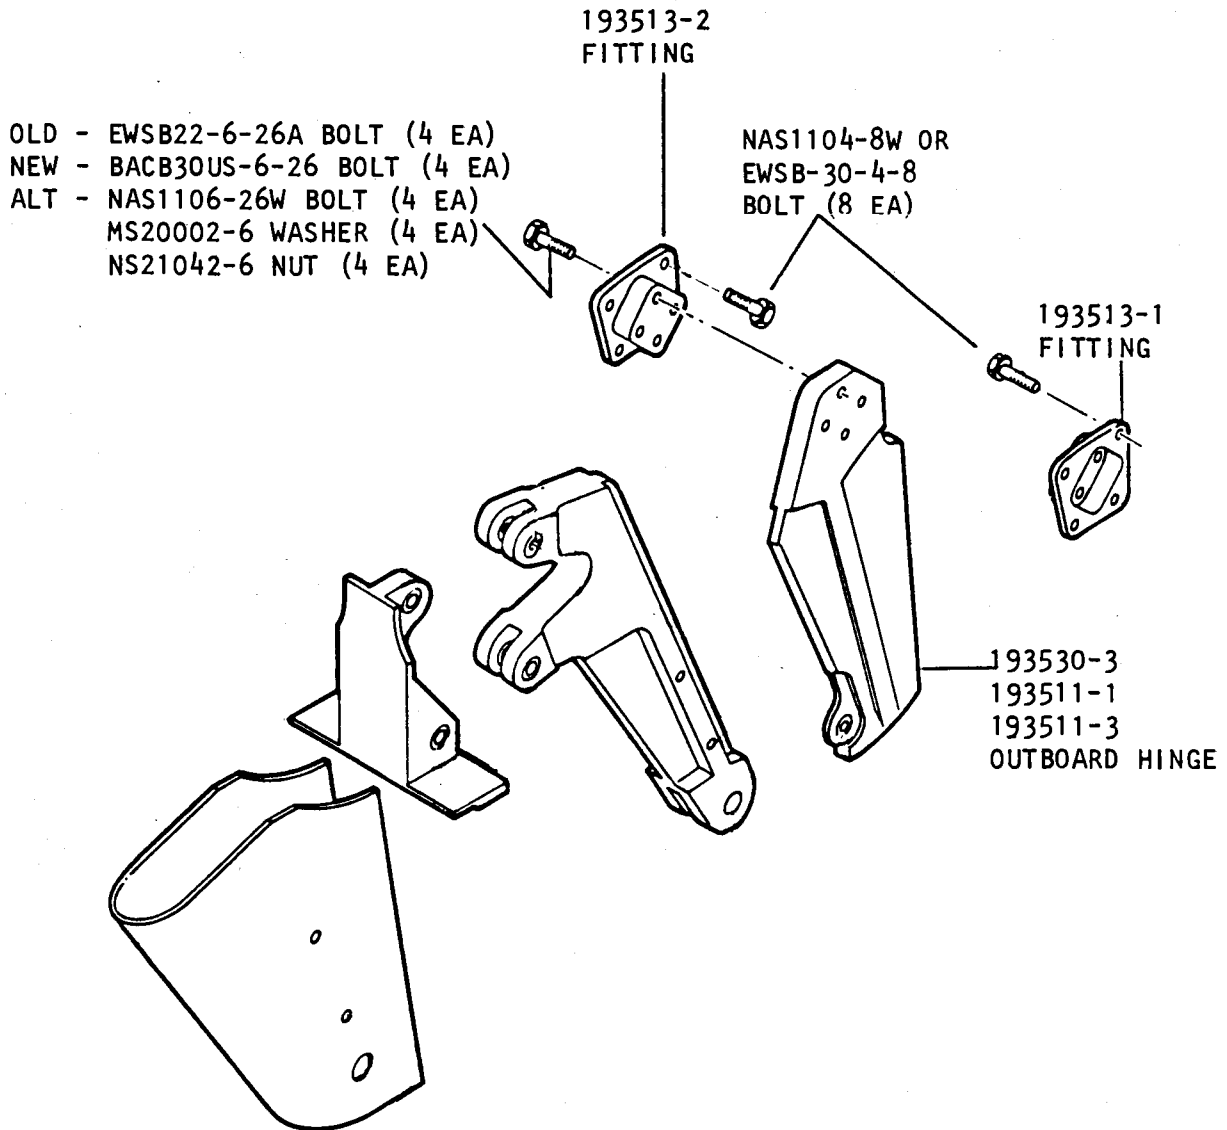
FIGURE 1

WING-TO-FLAP ATTACH FITTING

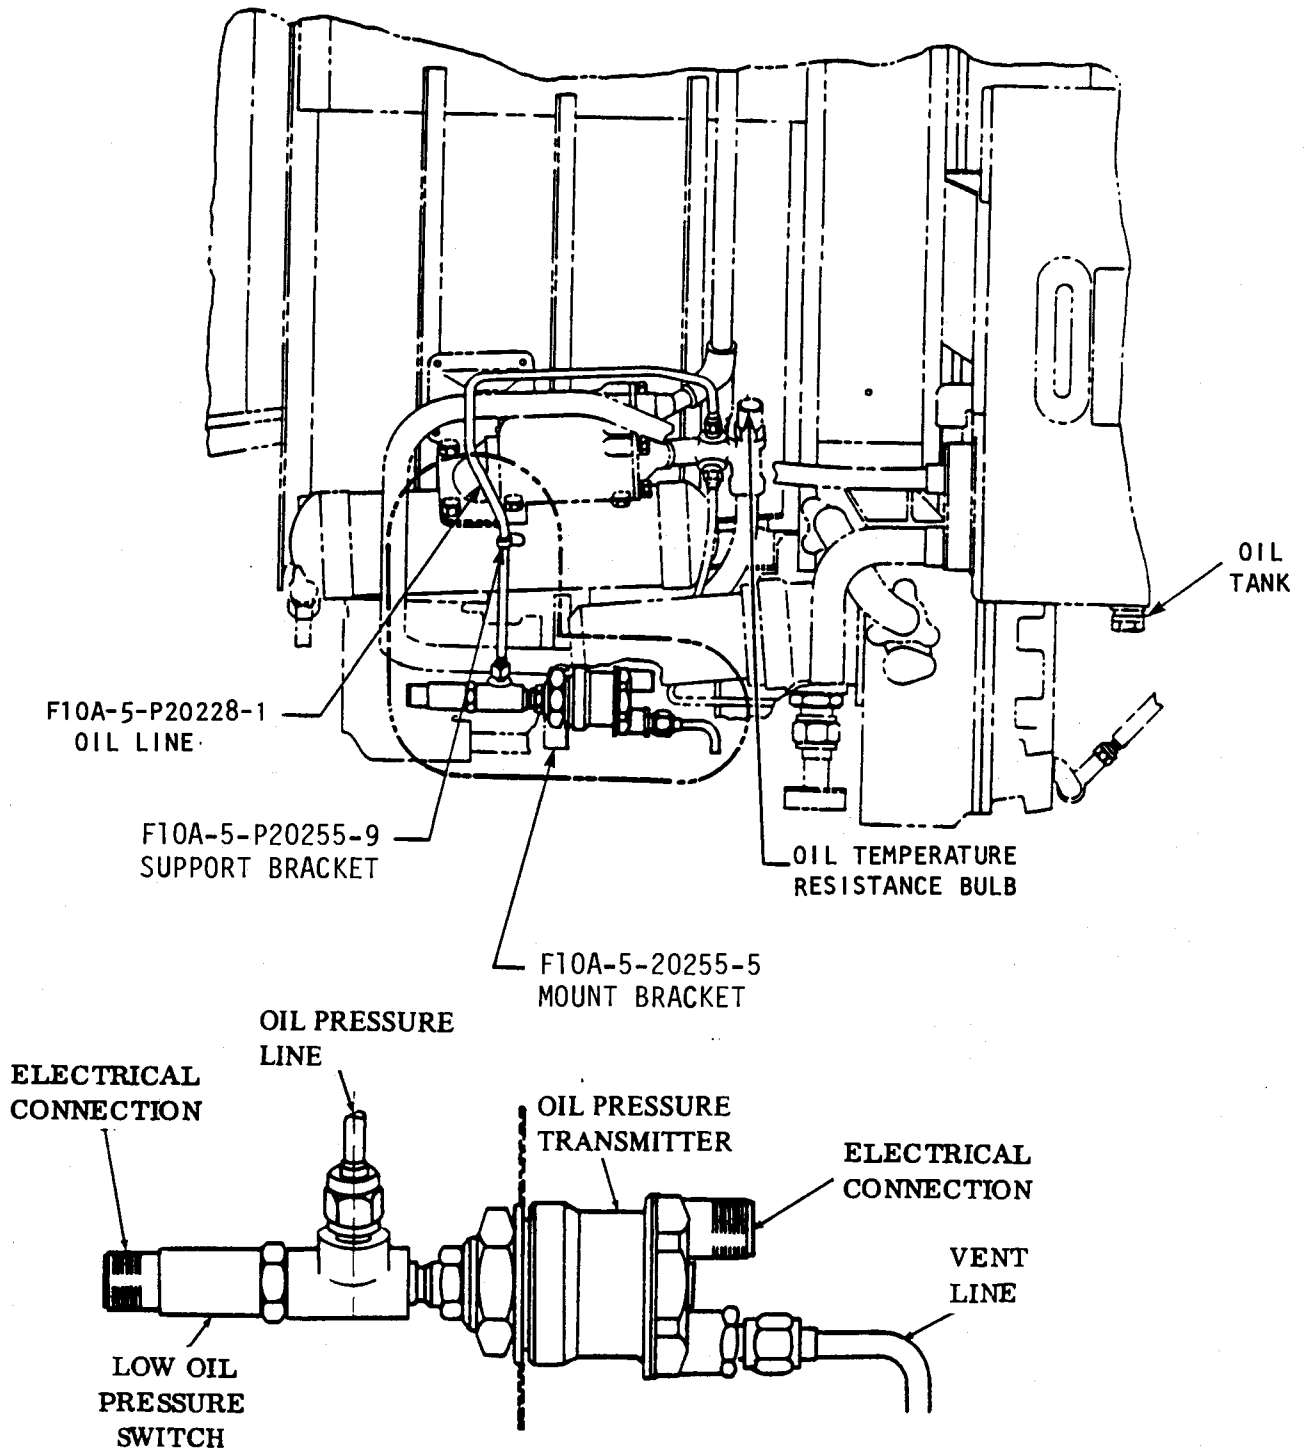
FIGURE 1

EXISTING ENGINE OIL PRESSURE SYSTEM INSTALLATION
