IAEWESTWIND

SERVICE BULLETIN

1124 SERVICE BULLETIN INDEX

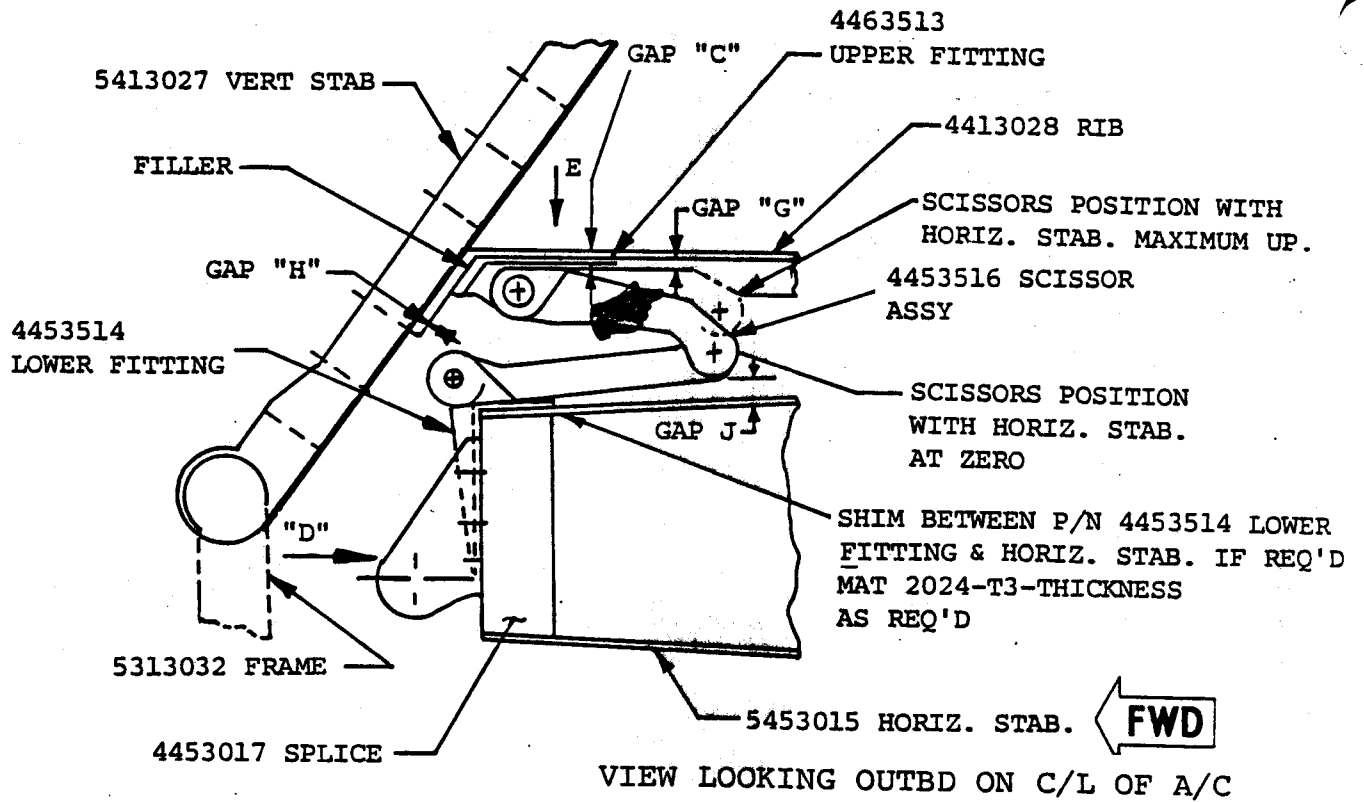
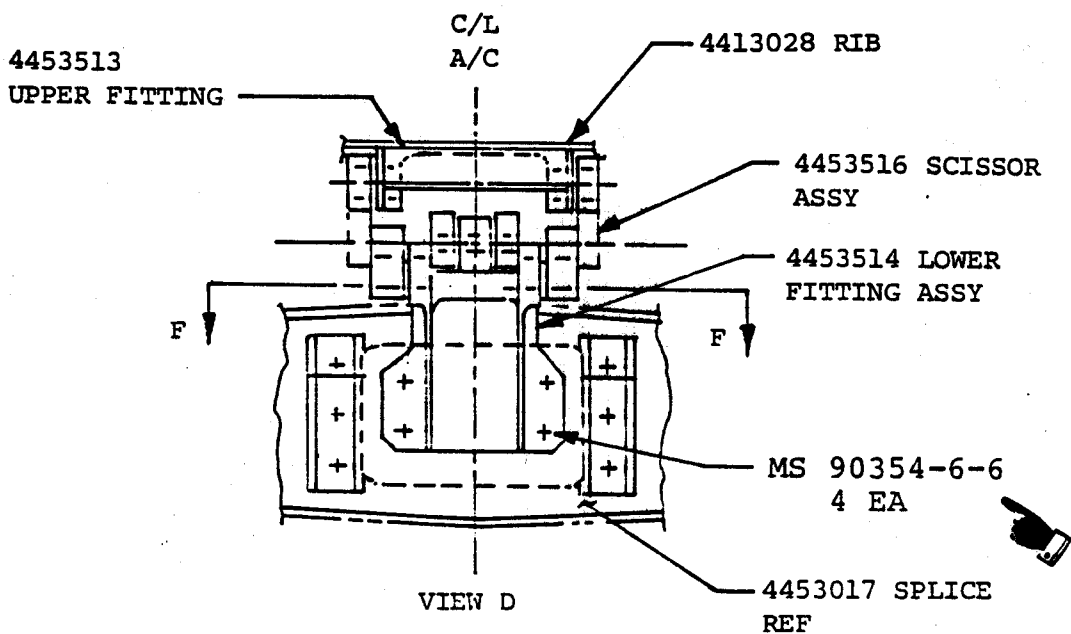
FIGURE 11

(page 19) If the reading of the dial indicator exceeds 0.010" on either lug, it is recommended to perform the improved installation as per Para. D.

INSTALLATION OF SCISSORS ASSY

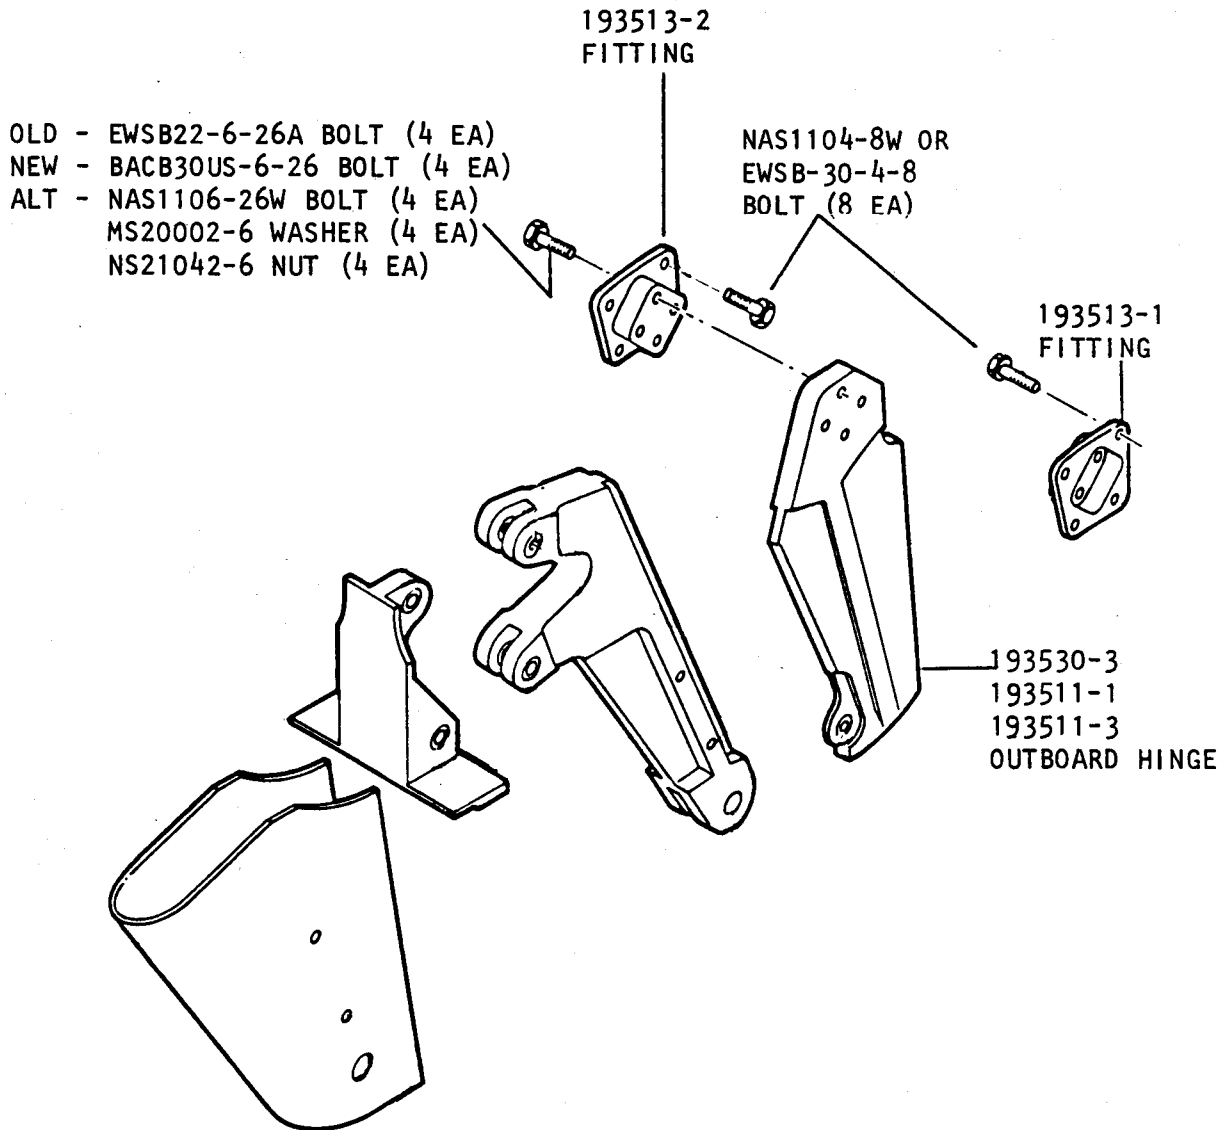
FIGURE 1

WING-TO-FLAP ATTACH FITTING

Service Bulletin No. 1124-57-092 dated April 10, 1987 titled "Wings - Flap Hinge Fasteners - Inspection/Replacement" has been accomplished this date _____.

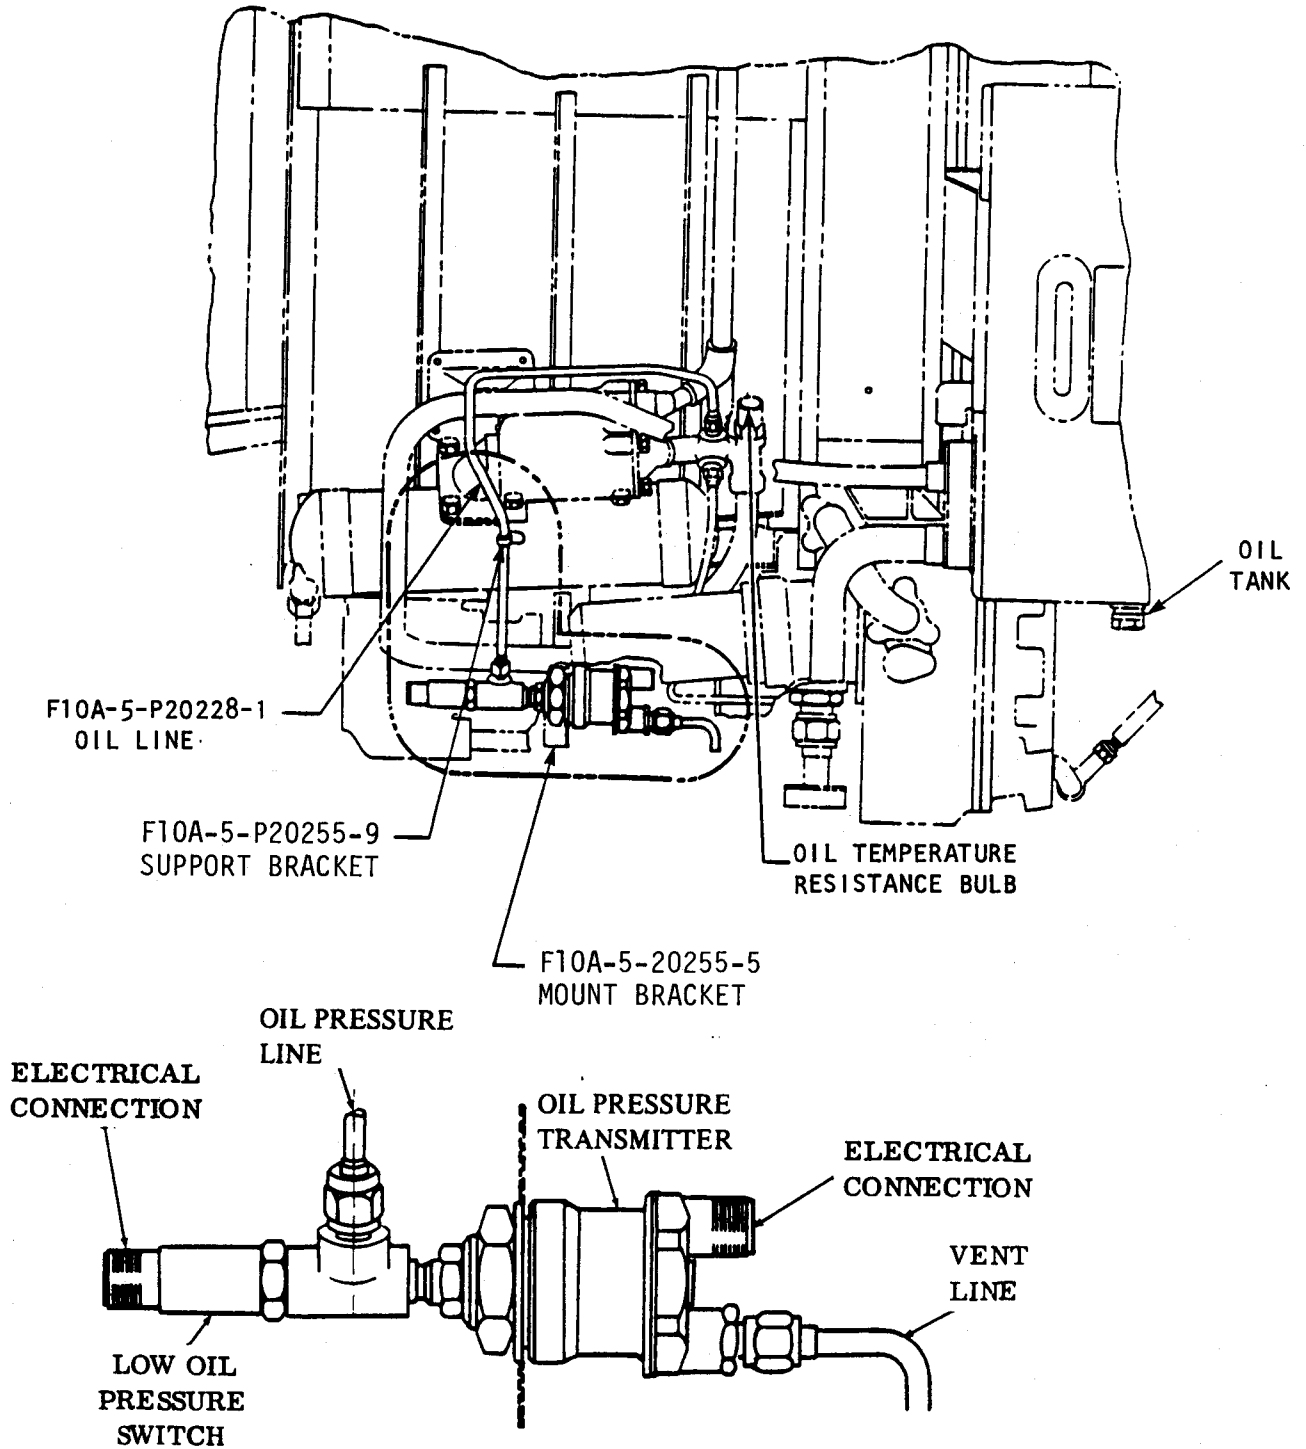
FIGURE 1

EXISTING ENGINE OIL PRESSURE SYSTEM INSTALLATION

Service Bulletin No. 1124-79-093 dated March 14, 1988, titled "Oil - Engine - Oil Pressure Indication Installation", has been accomplished this date _____.
