LETTER OF TRANSMITTAL

TO: HOLDERS OF 1124/1124A WESTWIND MANUALS

SERVICE DATA

SERVICE DATA CHAPTER INDEX

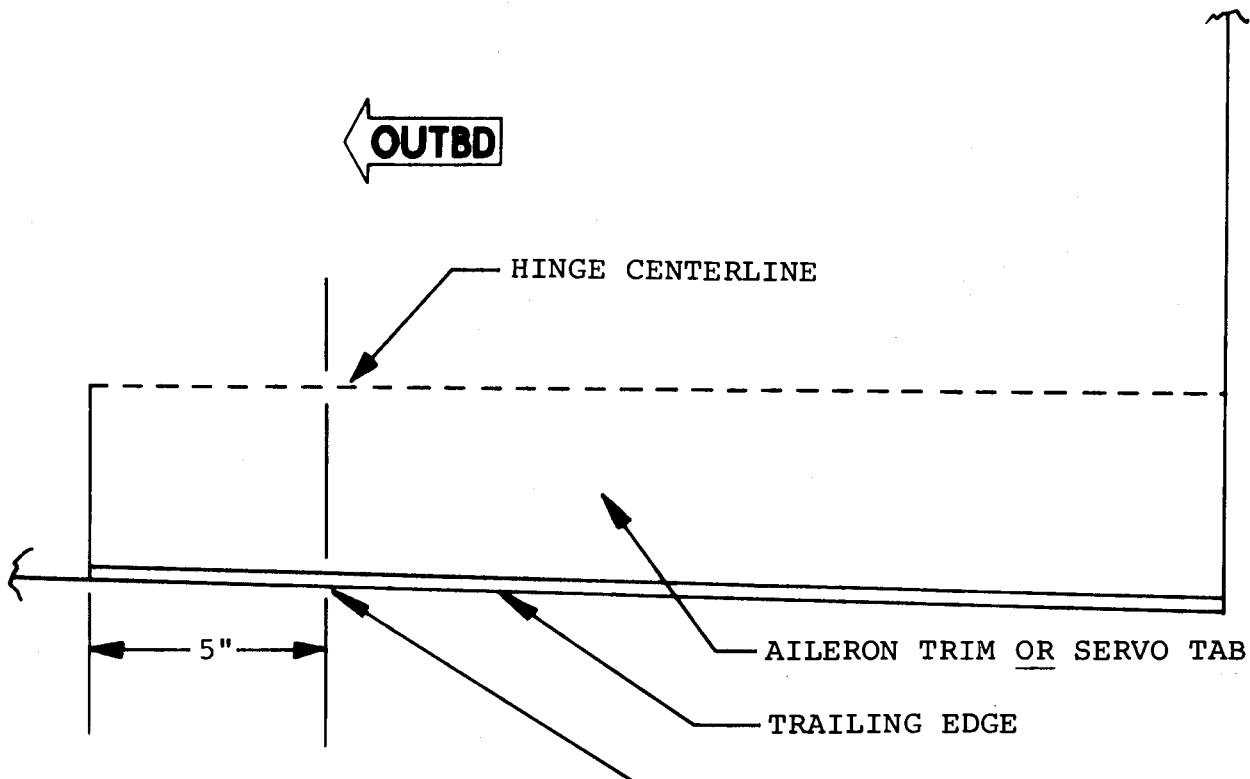
MEASURE TAB FREEPLAY AT THIS POINT
APPLY 1 POUND FORCE ADJACENT
TO DIAL INDICATOR MEASUREMENT
POINT.

- (2) Apply up/down force of 1 pound to tab trailing edge adjacent to the dial indicator measurement point.
- (3) Note tab freeplay. Limits should not exceed:
Aileron Trim Tab (LH) = 0.085 inch.
Aileron Servo Tab (RH) = 0.043 inch.
- (4) If freeplay exceeds stated limits, check all rod-ends and bolts installed for wear. Replace worn components as required.
