LETTER OF TRANSMITTAL

TO: HOLDERS OF 1124/1124A WESTWIND MANUALS

SERVICE DATA

SERVICE DATA CHAPTER INDEX

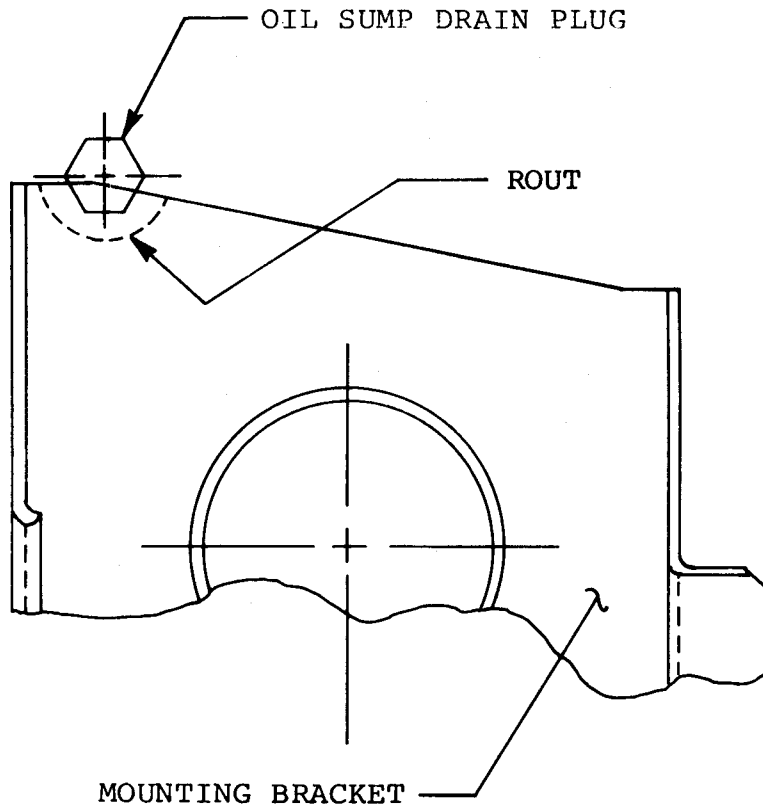
FIGURE 1: VIEW LOOKING UP AT BOTTOM OF COOLING TURBINE

As shown in Figure 1, the cooling turbine mounting bracket
blocks access to the oil sump drain plug. Routing out the
bracket, as shown, will allow the drain plug to be removed
and replaced with a socket wrench. Trim no more material
than necessary from the bracket.

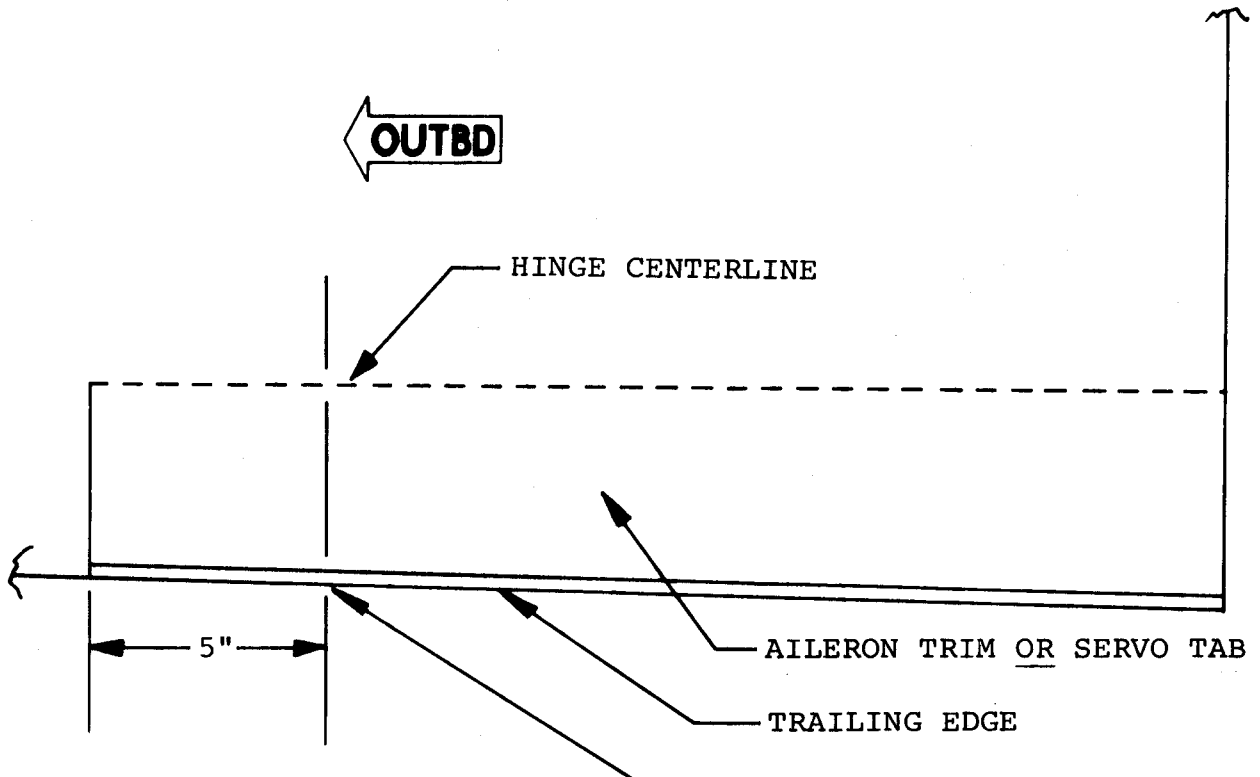
MEASURE TAB FREEPLAY AT THIS POINT
APPLY 1 POUND FORCE ADJACENT
TO DIAL INDICATOR MEASUREMENT
POINT.

- (2) Apply up/down force of 1 pound to tab trailing edge adjacent to the dial indicator measurement point.
- (3) Note tab freeplay. Limits should not exceed:
Aileron Trim Tab (LH) = 0.085 inch.
Aileron Servo Tab (RH) = 0.043 inch.
- (4) If freeplay exceeds stated limits, check all rod-ends and bolts installed for wear. Replace worn components as required.

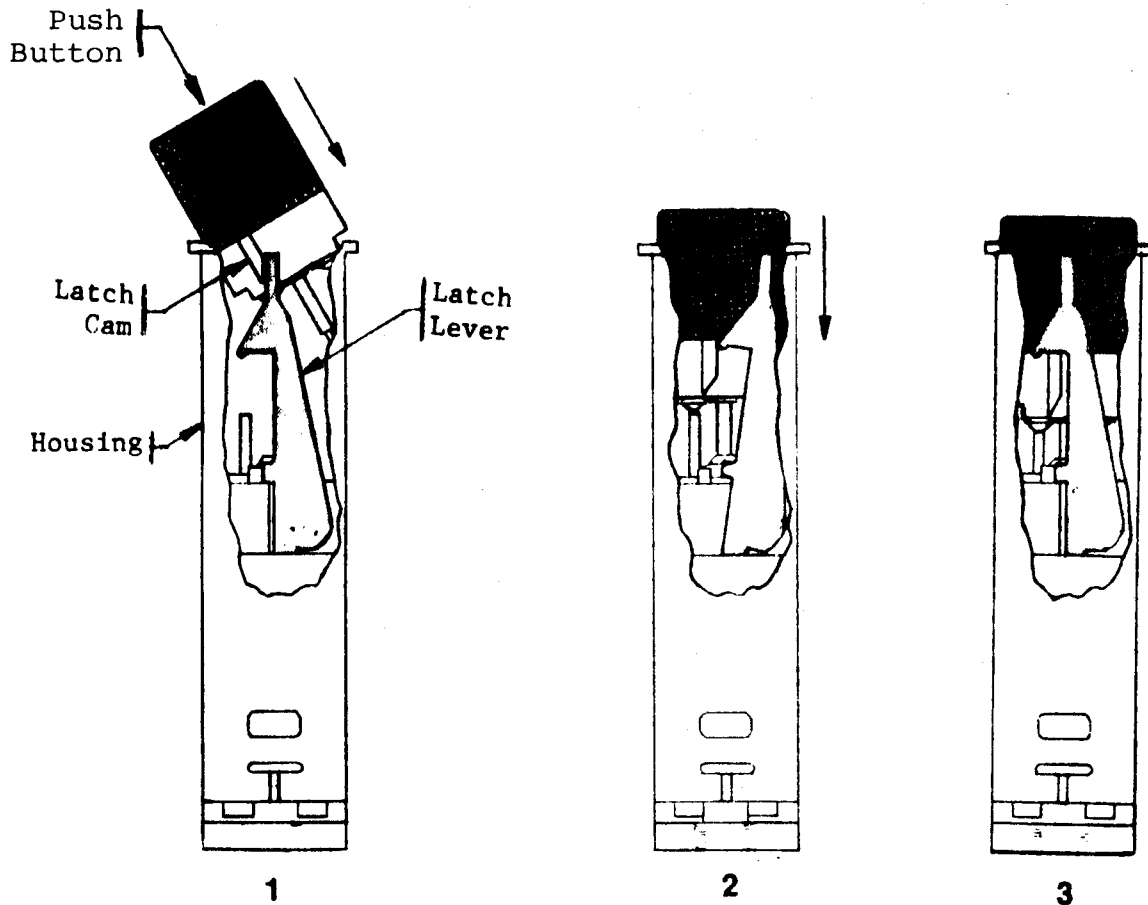
CAUTION: Do not force pushbutton into housing without allowing the cam to move the latch lever into the proper locking position. Forcing the pushbutton may trap the latch lever between the cam and the housing causing the pushbutton to jam and be nonoperative. INSTALL LAMPS IN PUSHBUTTON BEFORE INSERTING IN HOUSING. THIS IS IMPORTANT FOR EASY REMOVAL OF PUSHBUTTON.

1. Position pushbutton so bottom of legend faces latch lever. This places cam on the pushbutton in position to engage the latch lever. Tilt the pushbutton so that angle on the cam will push the latch lever to the right as the pushbutton is advanced into the housing toward the switch/indicator module.
2. The pushbutton is advanced downward into the housing, and at the same time straightened up to index into the switch/indicator module. This will allow the latch lever to ride on the side of the cam, moving it outward.
3. As the pushbutton is pushed downward into the engaged position, the latch lever will move over the top of the cam, locking onto the cam. This engagement of the latch lever will retain the pushbutton in the switch/indicator housing, while allowing for additional downward movement for switch actuation.

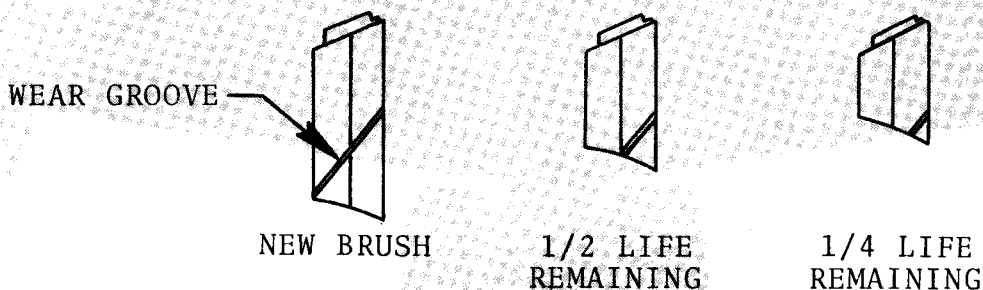
EFFECTIVITY: MODEL 1124/1124A WESTWIND, all serial numbers.

1. The brush inspection data contained in the Westwind Maintenance Manual, Chapter 80-10-00, referred to in Chapter 5-20-00, Page 237, Para. 8.C. is applicable to the General Electric starter generator only.
2. Refer to your Lear Siegler Maintenance Manual, File No. 237-00, dated March 15, 1979, for brush inspection and replacement procedures.
3. Figure 2 of the manual illustrates brush wear stages. If the wear groove indication is compared to operating hours, you should be able to predict the approximate time that brush replacement will be required.
