SERVICE INFORMATION LETTER

SERVICE INFORMATION LETTER INDEX

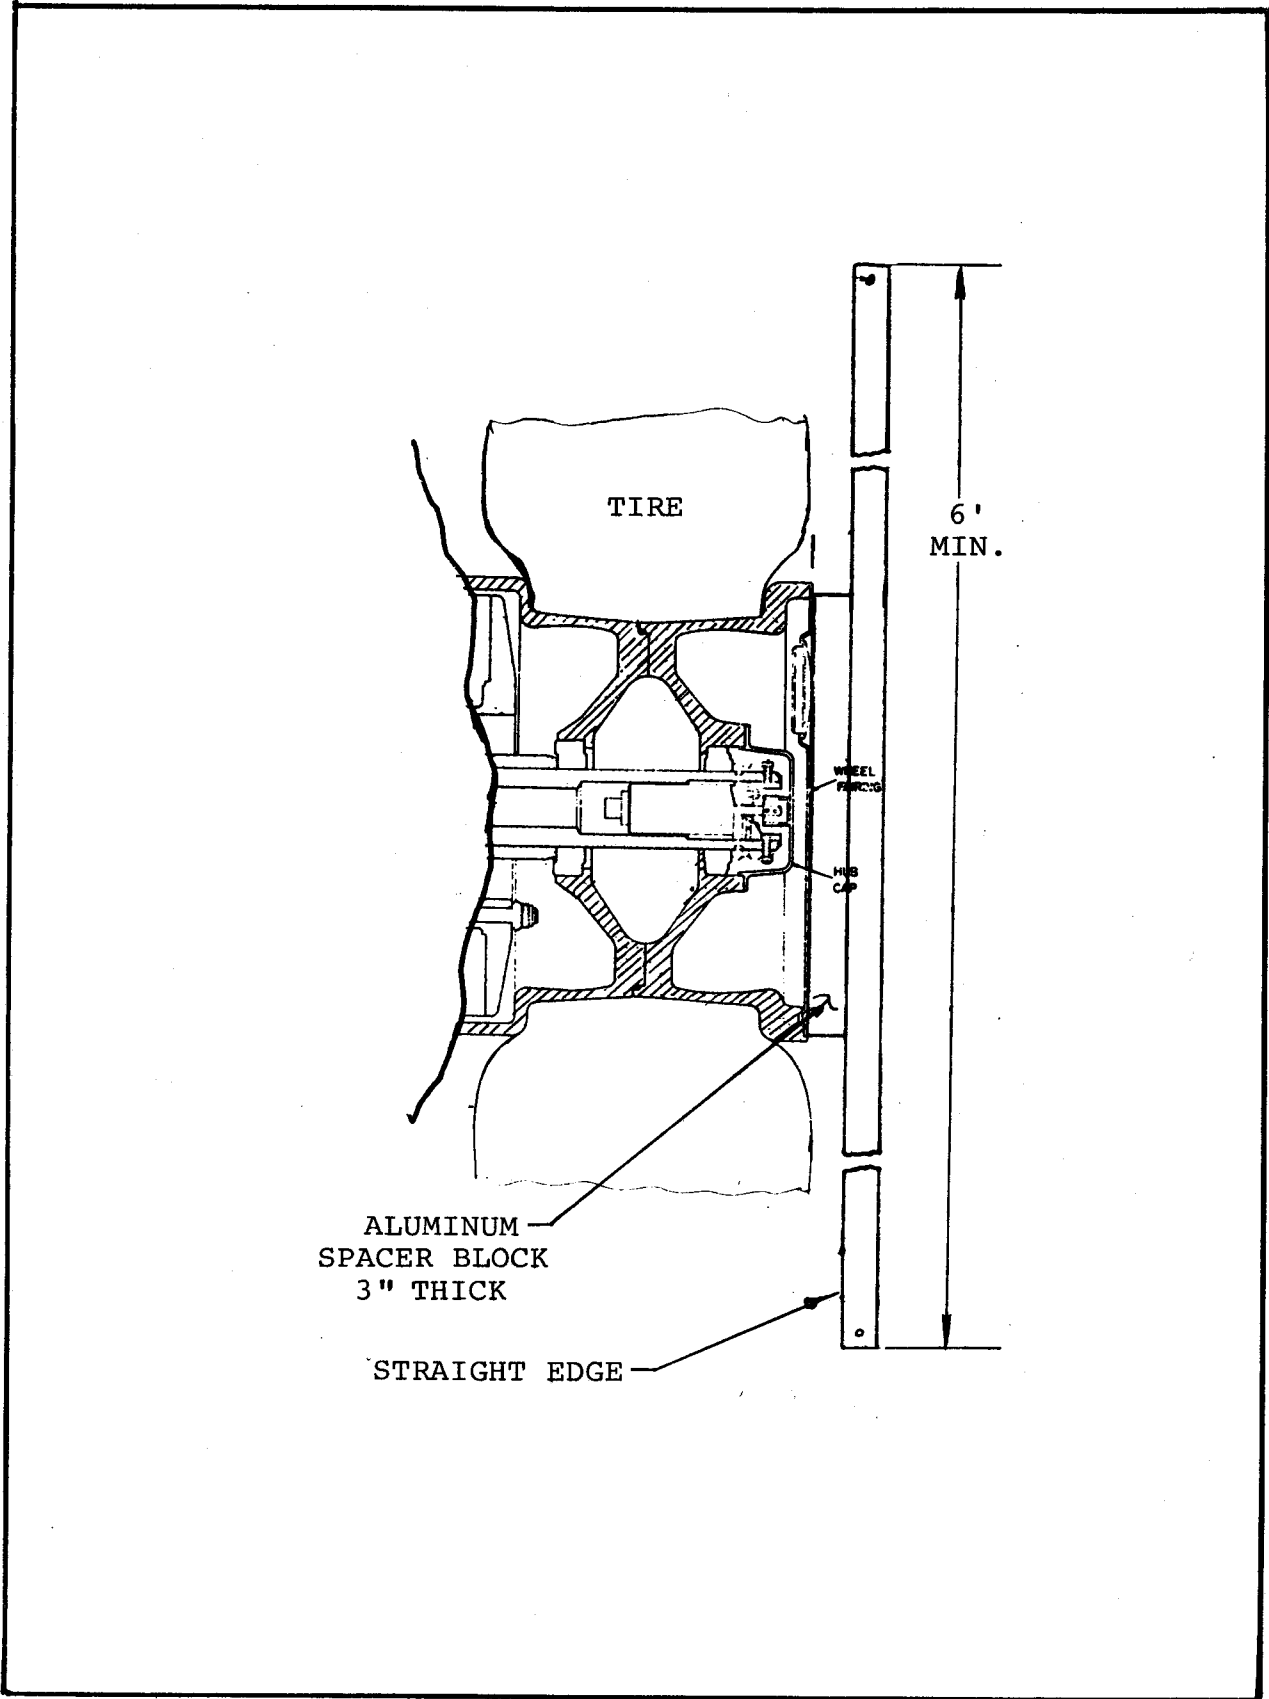
Figure 2

PARALLELISM ADJUSTMENT

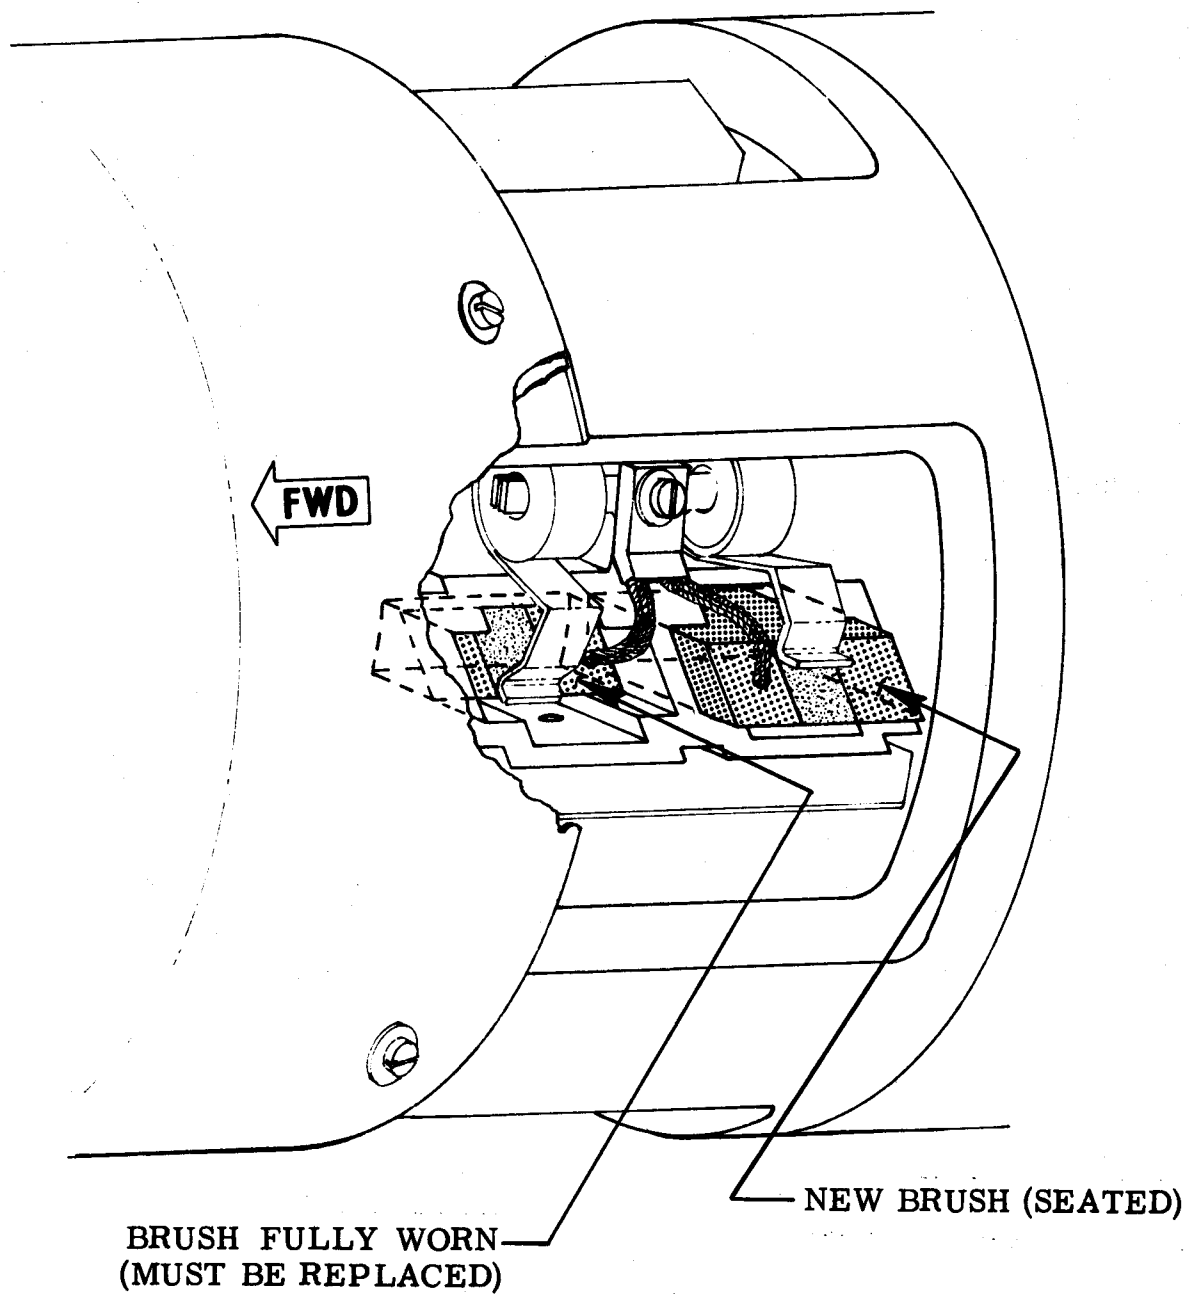
5. A newly installed brush has an approximate over all length of 1.38 inch (Seated). It is recommended the brush assemblies be replaced when brushes are worn to a length of .875 inch, or 450 operating hours, whichever occurs first. Brushes must be replaced when worn to a .70 inch overall length. (SEE FIGURE 2).

CONTINUED USE OF THE STARTER-GENERATOR WITH ANY BRUSH OF MINIMUM LENGTH OR LESS WILL LIKELY RESULT IN DAMAGE TO THE COMMUTATOR AND FAILURE OF THE STARTER-GENERATOR.

BRUSH FULLY WORN
(MUST BE REPLACED)

NEW BRUSH (SEATED)

6. Make a judgement of remaining usable brush wear length and estimated operating hours. Any brush with less than 50 hours estimated operating time remaining requires the starter-generator to be scheduled for brush assembly replacement.

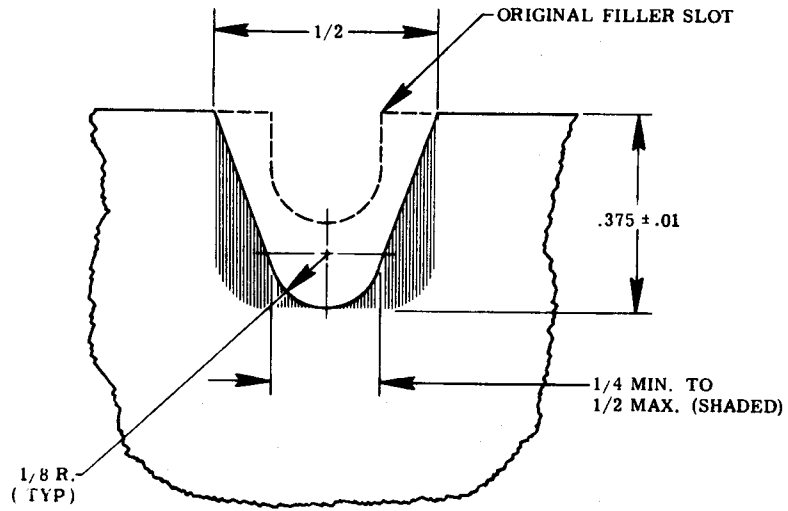
FIGURE 1

DETAIL - MODIFICATION OF FILLER SLOTS
(TYP. 2 PLACES)

9. Using a rotary file and right angle power tool, increase size of standpipe filler slots to a max. depth of .375±.01 inch (See Figure 1).
10. Vacuum sweep chips from reservoir.
11. Remove shop towels and vacuum sweep reservoir and standpipe to remove remaining chips. Wipe reservoir walls to ensure removal of metal dust. Purge reservoir and standpipe with shop air.
12. Install reservoir drain plugs, rinse reservoir and fittings with skydrol until system is clean of all filings. Reconnect supply and return lines to reservoir fittings.
13. Inspect filter element for condition and Vendor Part Number. Vendor P/N 032667 is superceded by P/N 031324, or 031324-02-60. Use Vendor P/N 031324, or 031324-02-60 only.

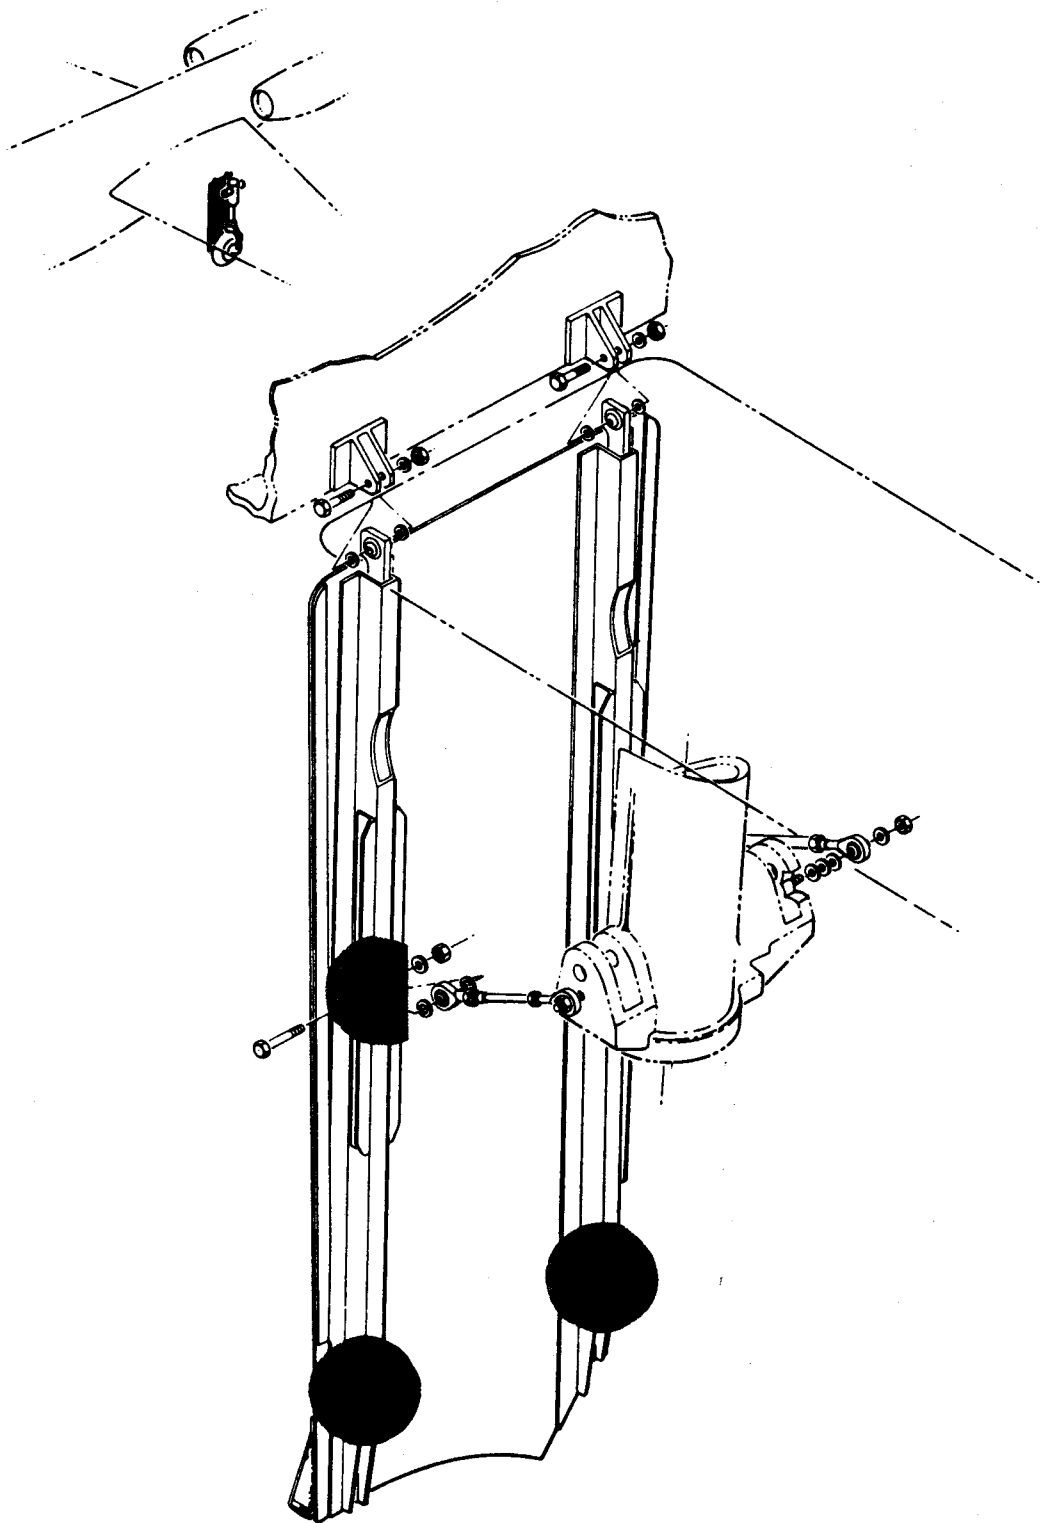
FIGURE 1 INSPECTION OF STRUT DOOR

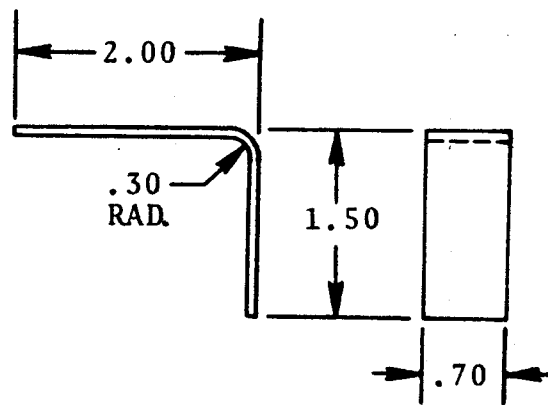
FIGURE 2 REPAIR OF CRACKED
5263018-13 CLIP

DETAIL OF CLIP P/N 5 263018-R3

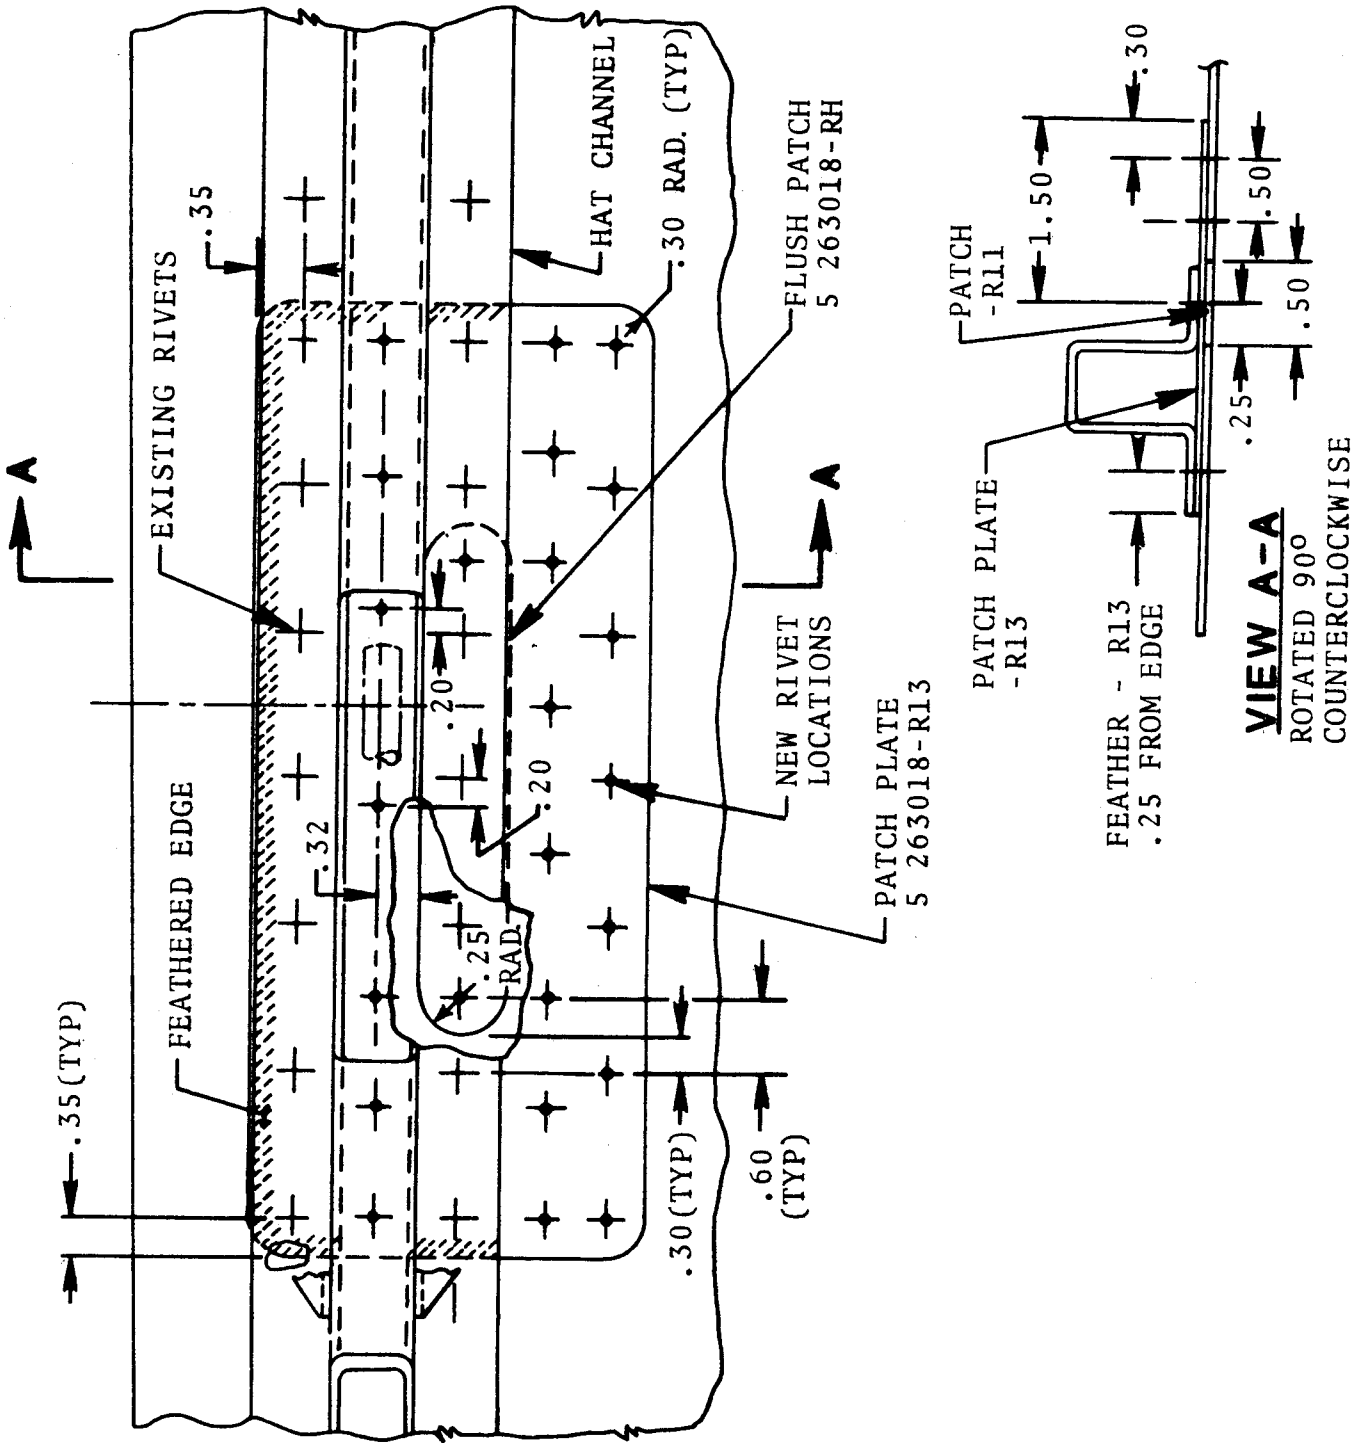
FIGURE 3 REPAIR OF CRACK RUNNING ALONG RIVET LINE OF HAT CHANNEL IN DOOR SKIN.
