SERVICE BULLETIN

SERVICE BULLETIN INDEX

24-WESTWIND

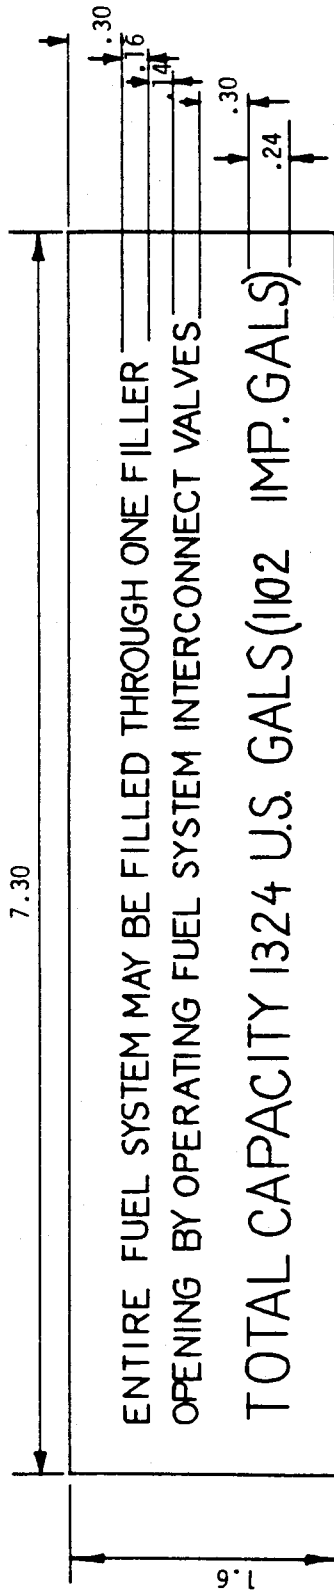
RIGHT FUEL FILL PORT
DECAL P/N 113001-188
EFFECTIVITY: 1124A, ALL
SERIAL NUMBERS

Replace existing (3 each) placards on the overwing fuel filler ports and a section of single point refueling data placard. Install replacement placards or utilize other suitable methods of placarding.

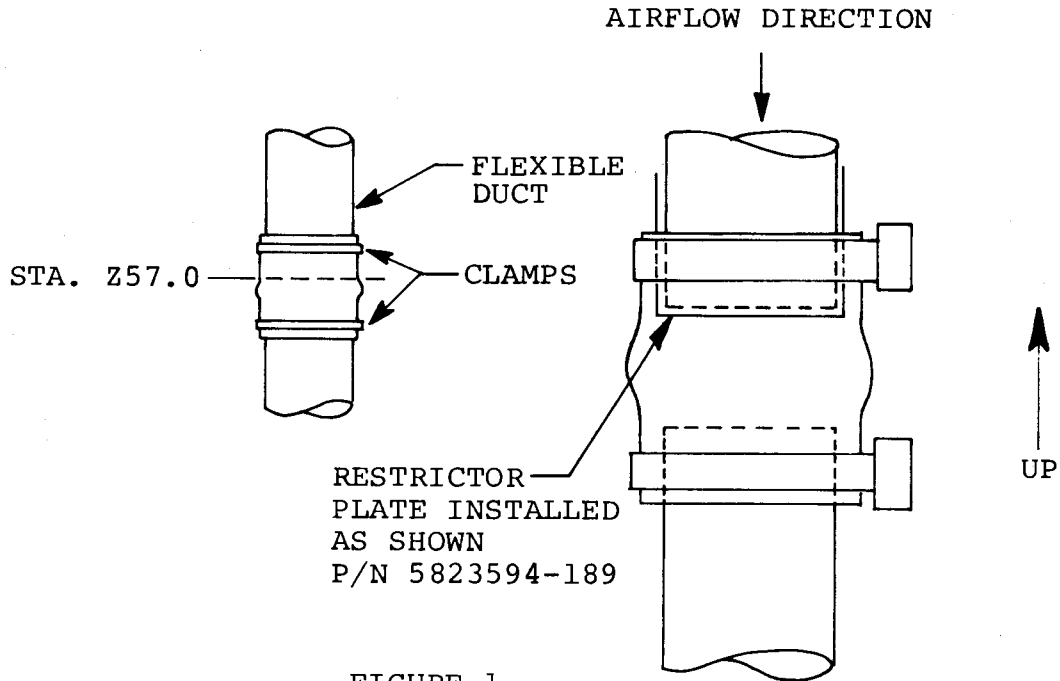
FIGURE 1

To reduce cooling airflow and resultant cold soaking inside both DC contactor boxes and the immediate area near subject air outlet which contributes to condensation in high humidity environments following extended flights.

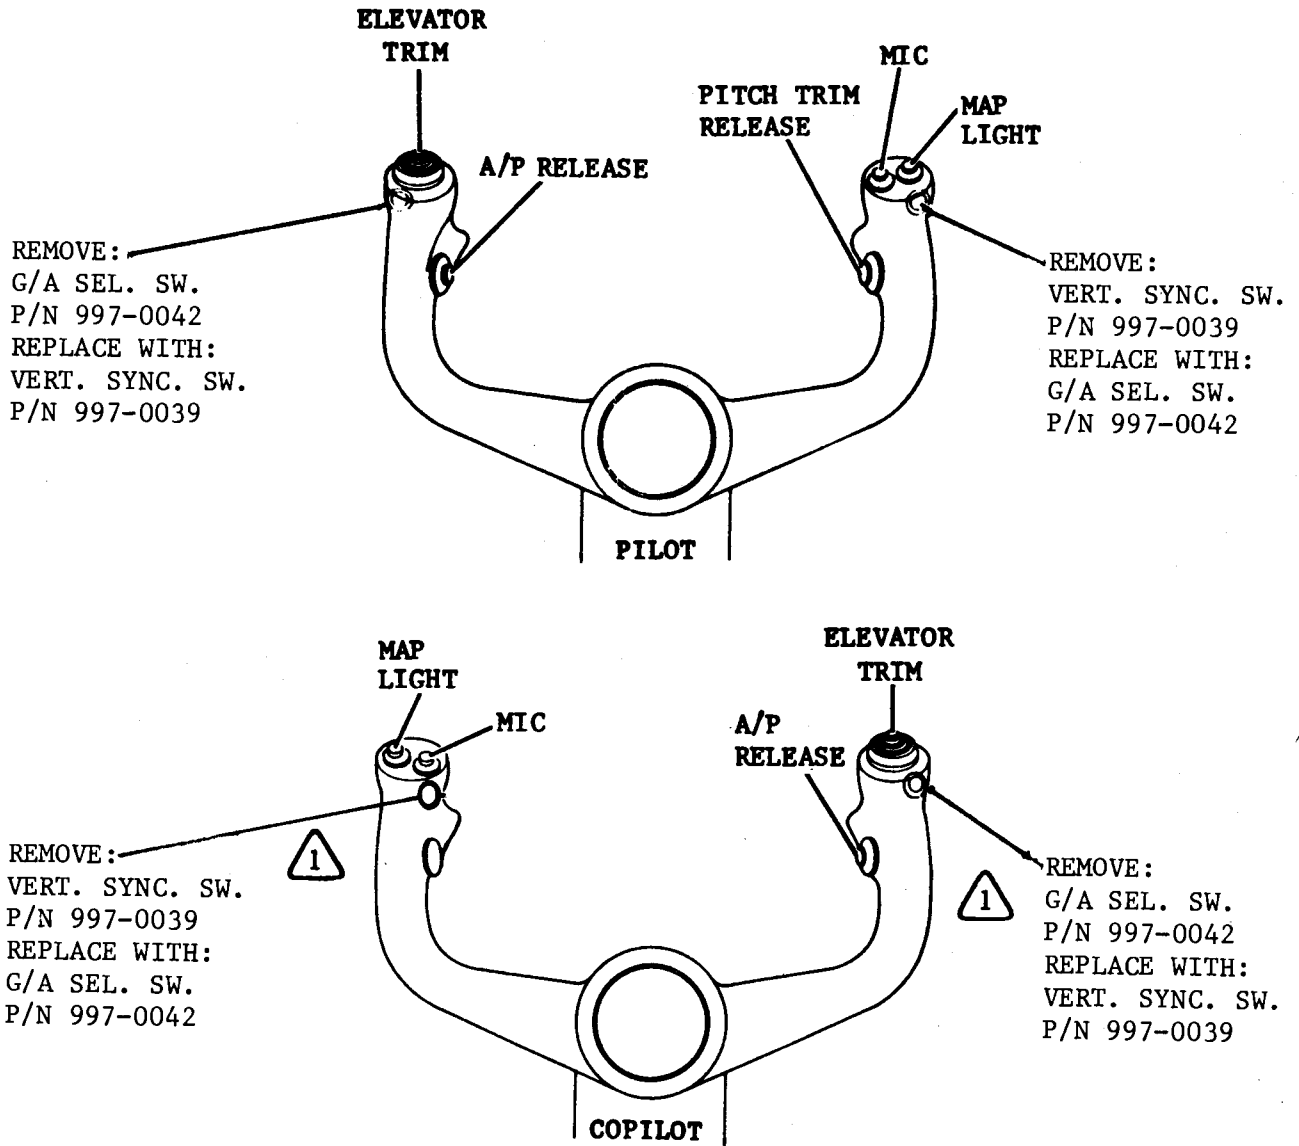
FIGURE 1 PILOT AND CO-PILOT CONTROL WHEEL SWITCH MODIFICATION

VERT SYNC AND G/A BUTTON INSTALLED ON THE COPILOT CONTROL WHEEL ONLY ON AIRCRAFT EQUIPPED WITH 2ND FLIGHT DIRECTOR

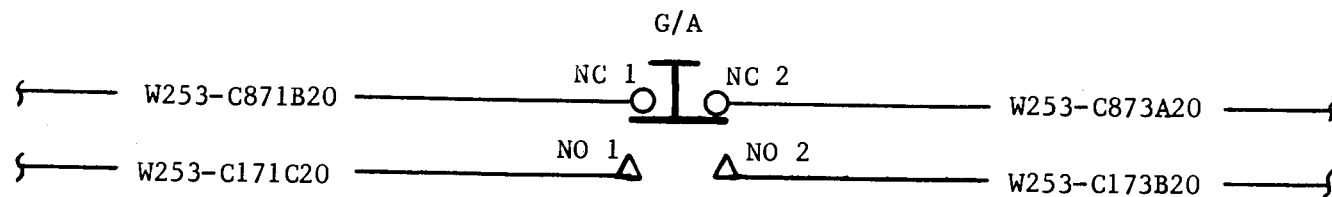
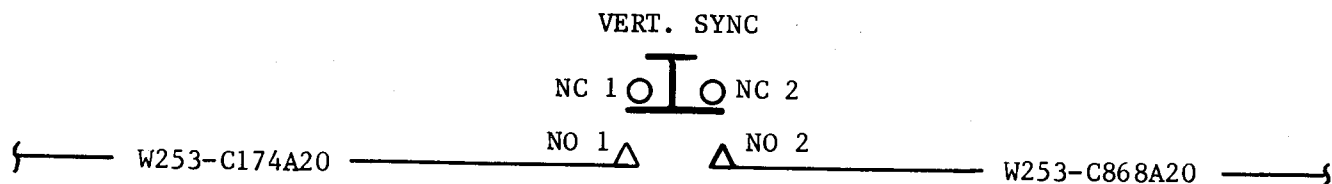
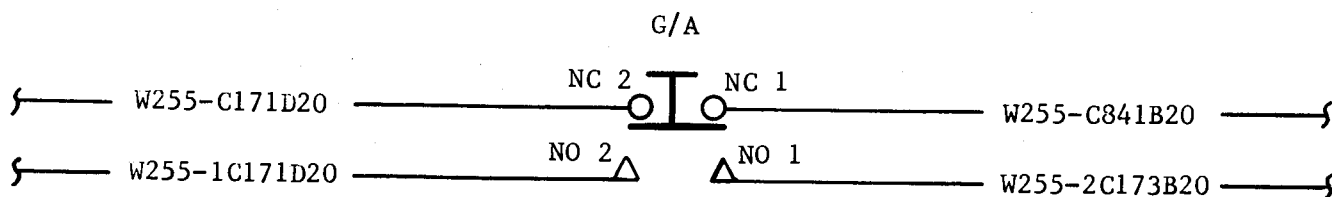
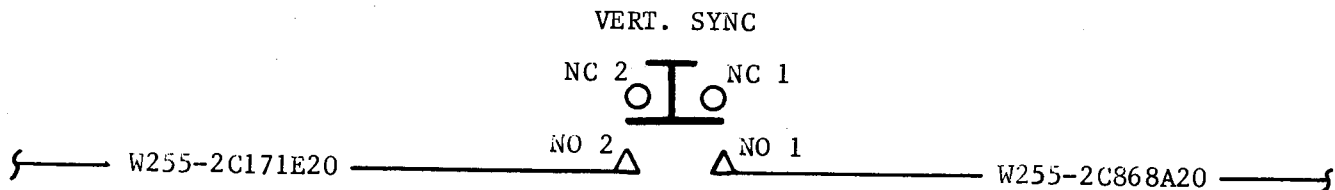
FIGURE 2 G/A AND VERTICAL SYNC SWITCH WIRING

PILOT'S CONTROL WHEEL

CO-PILOT'S CONTROL WHEEL

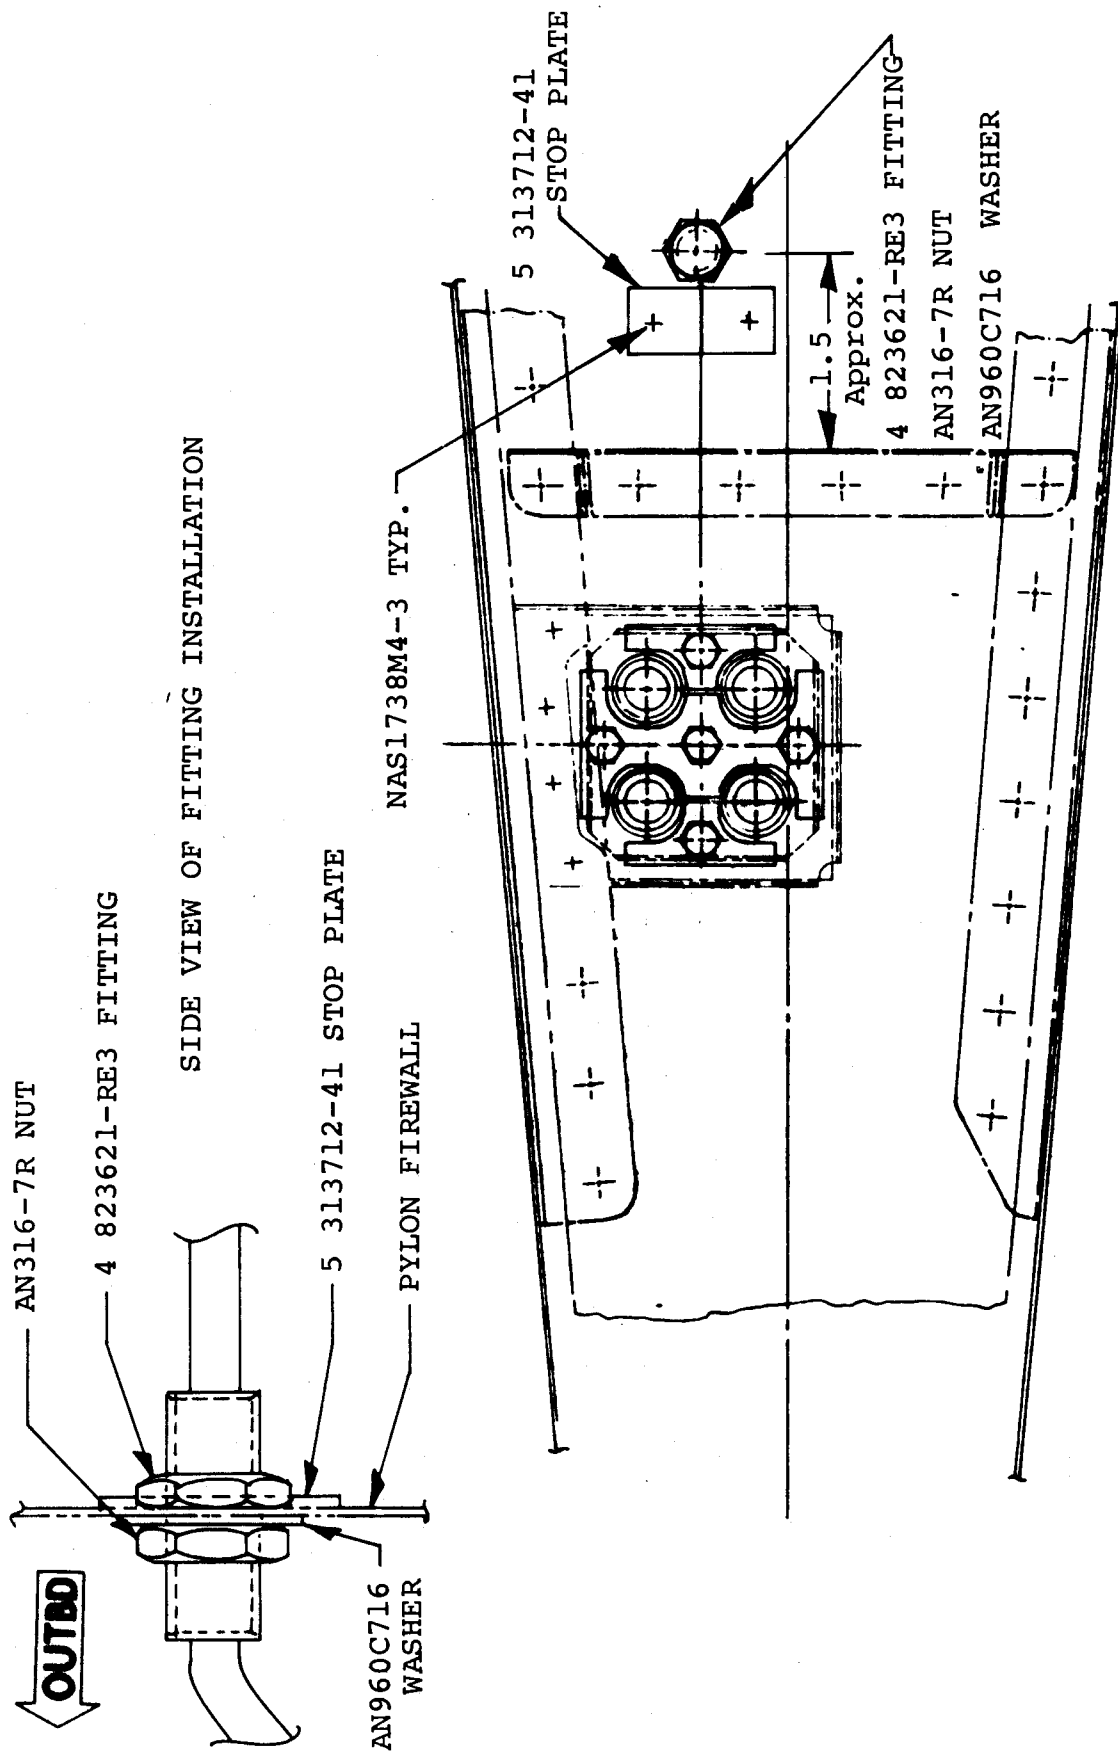
FIGURE 1: VIEW LOOKING INBD., L/H PYLON

- (1) Rerouting and replacement of the existing starter/generator field leads will eliminate chafing and resultant short circuits.
- (2) Installation of shielded leads from the starter generator will reduce EMI radiation (required if H-Field antennas are to be installed).

The starter/generator field circuit leads are replaced with shielded, twisted-pair wire and rerouted to avoid chafe points.

Ensure that the connections to GCU pins A and D correspond to starter/generator terminal connections A and D. Reversed connections will damage the GCU when power is applied.

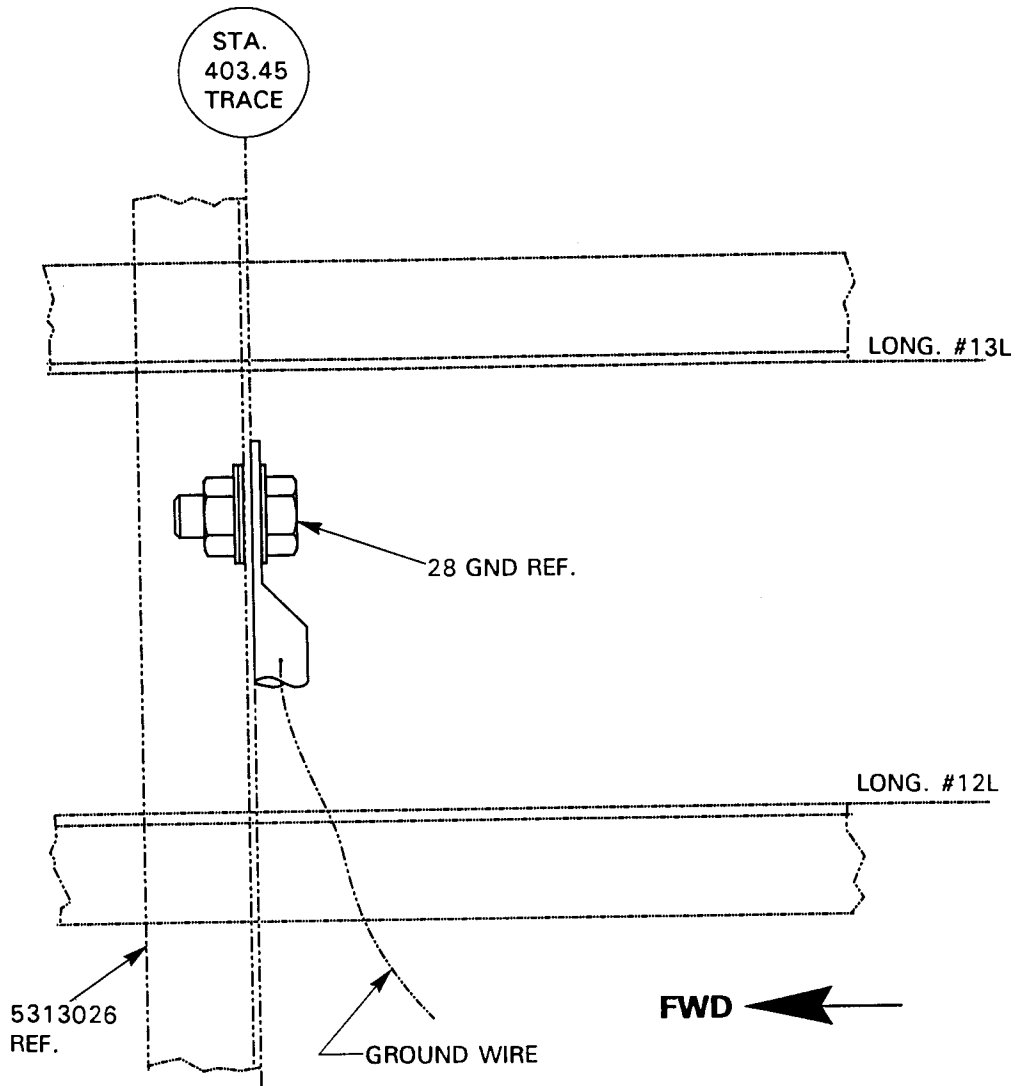
FIGURE 3

VIEW LOOKING OUTBOARD

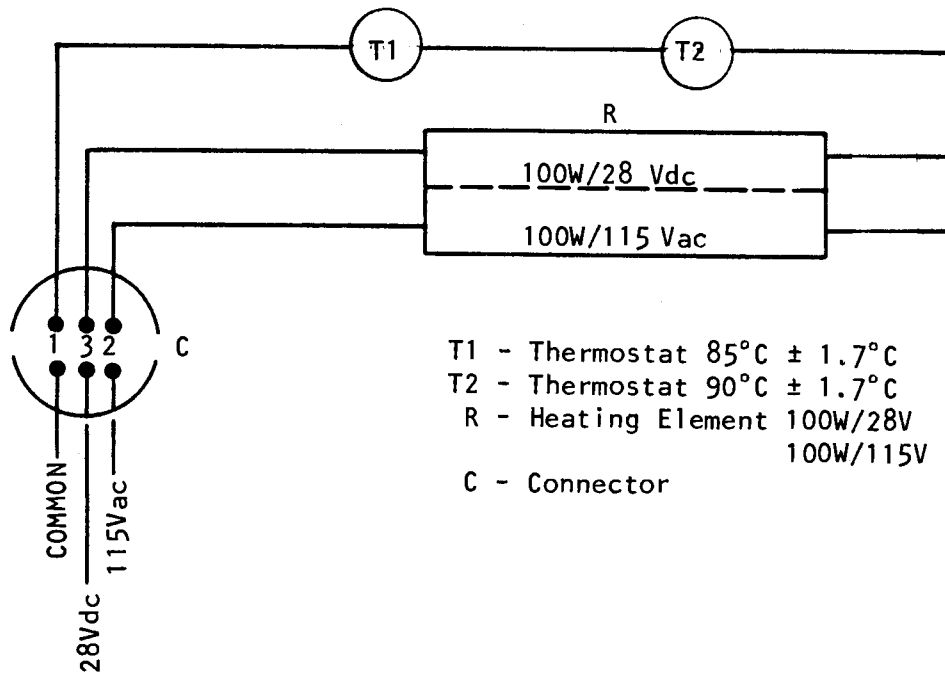
Figure 2

Electrical Schematic
Hot Liquid Container

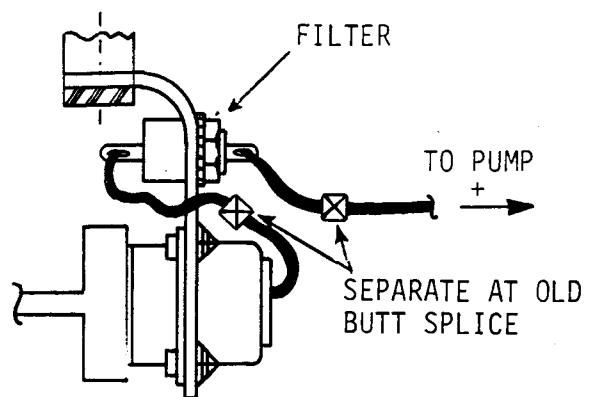
FIGURE 5

To eliminate possibility of EMI filter dormant failure that might lead boost pump to become inoperative.

FUEL BOOST PUMP EMI FILTER/BRACKET INSTALLATION

For aircraft with filters installed on brackets attached to pumps (see Figure 5).

RECONNECT WIRES WITH
NEW BUTT SPLICE AND
DISCARD FILTER

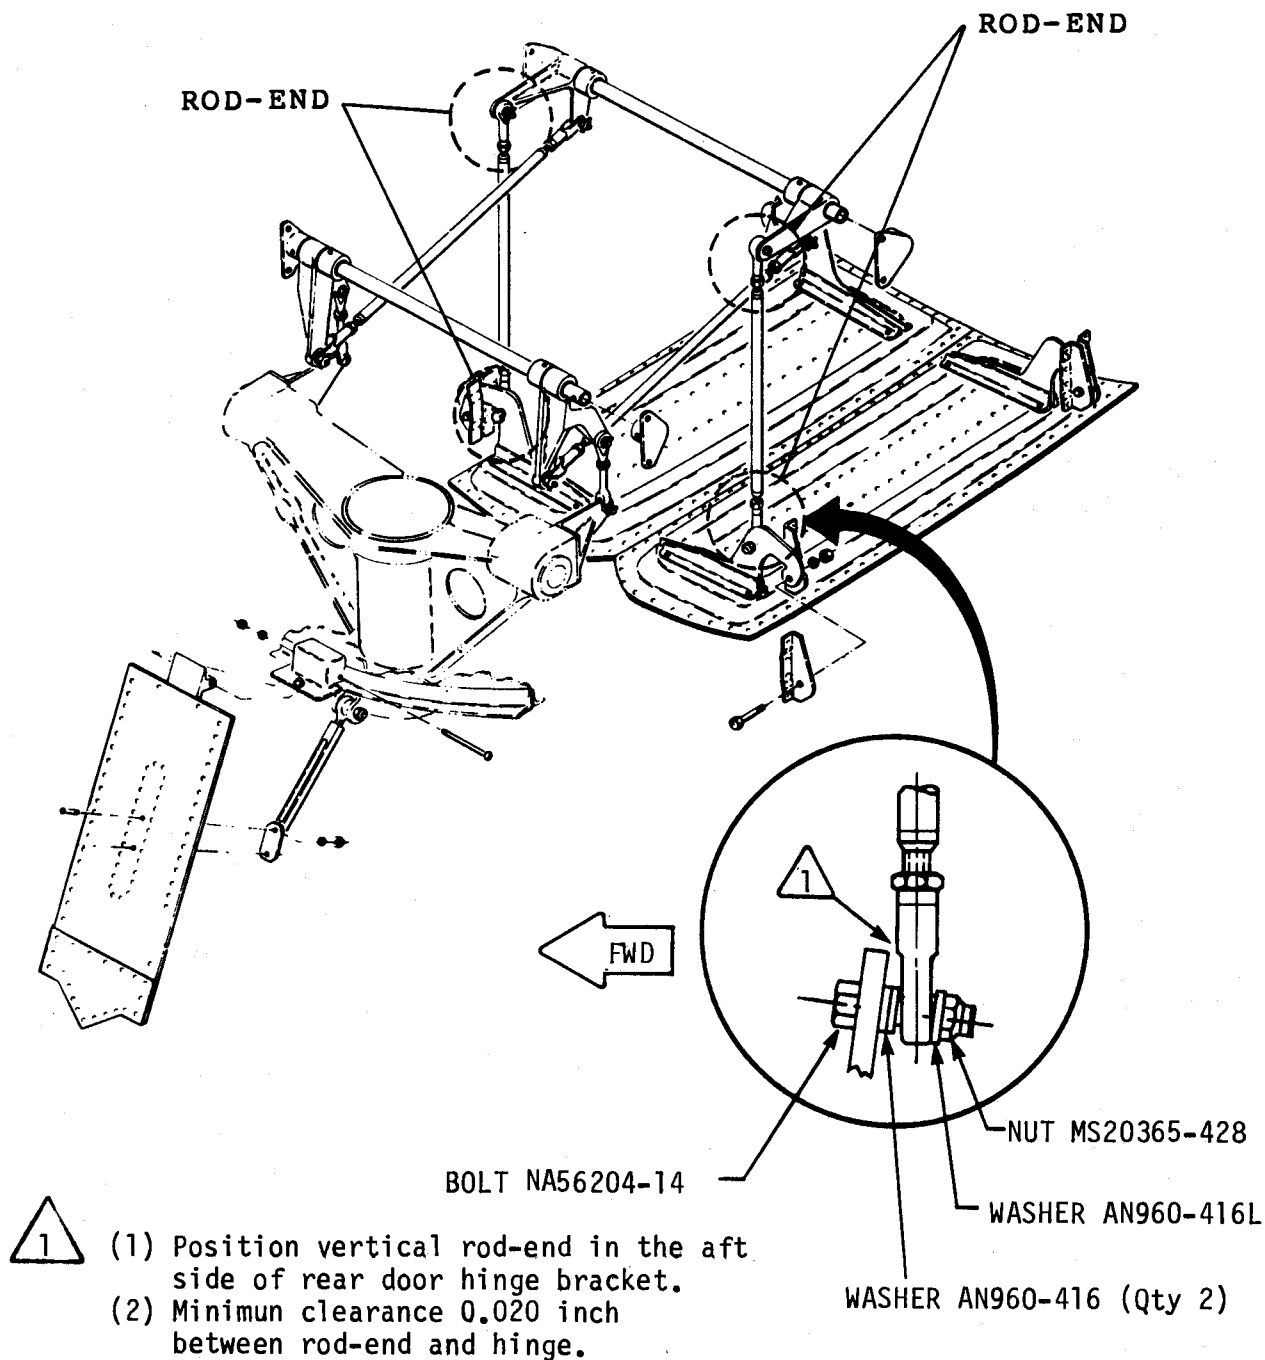
FIGURE 1

SUBJECT: LANDING GEAR - F44-14 ROD-ENDS - INSPECTION/REPLACEMENT

- A. Gain access to rod-ends installed in NLG door system (see Figure 1).
- B. Inspect rod-ends to determine if witness holes are present.
- C. If rod-ends have witness holes, no further action is required.
- D. If rod-ends do not have witness holes, remove and replace with rod-ends P/N F44-14MT in accordance with 1124/1124A Maintenance Manual chapter 32-20-00 maintenance practices.

Ensure that rigging of NLG doors are not altered during replacement (see Figure 1).
