# IAI WESTWIND

## SERVICE BULLETIN

1124 SERVICE BULLETIN INDEX

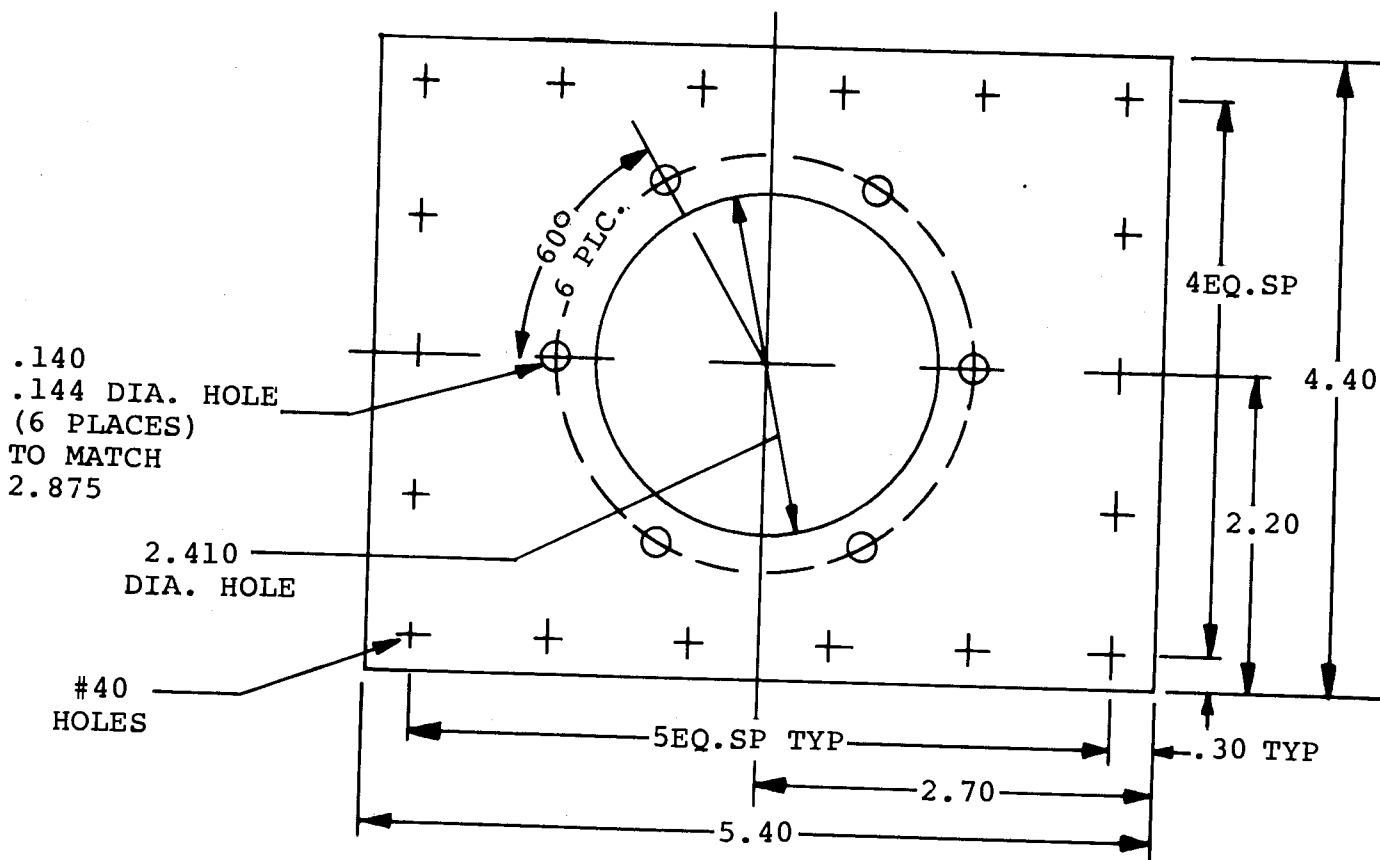
FIGURE 1A

DOUBLER P/N 5723633-51

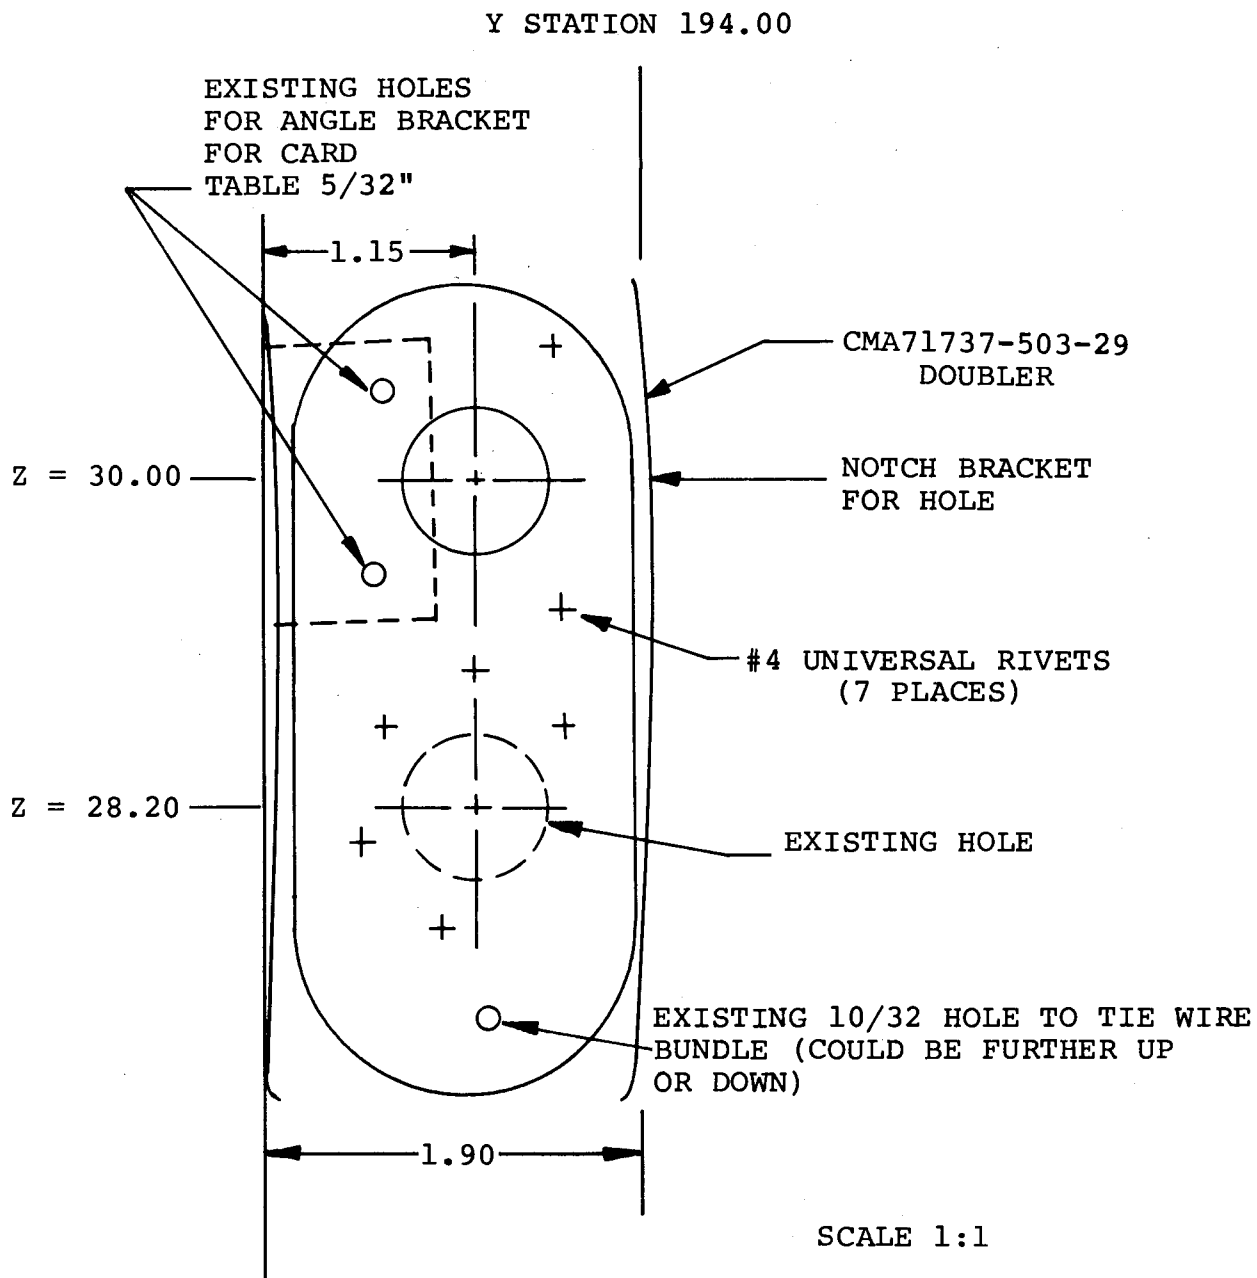
FIGURE 1C

VIEW LOOKING FWD AT STATION 194.00 R/H SIDE

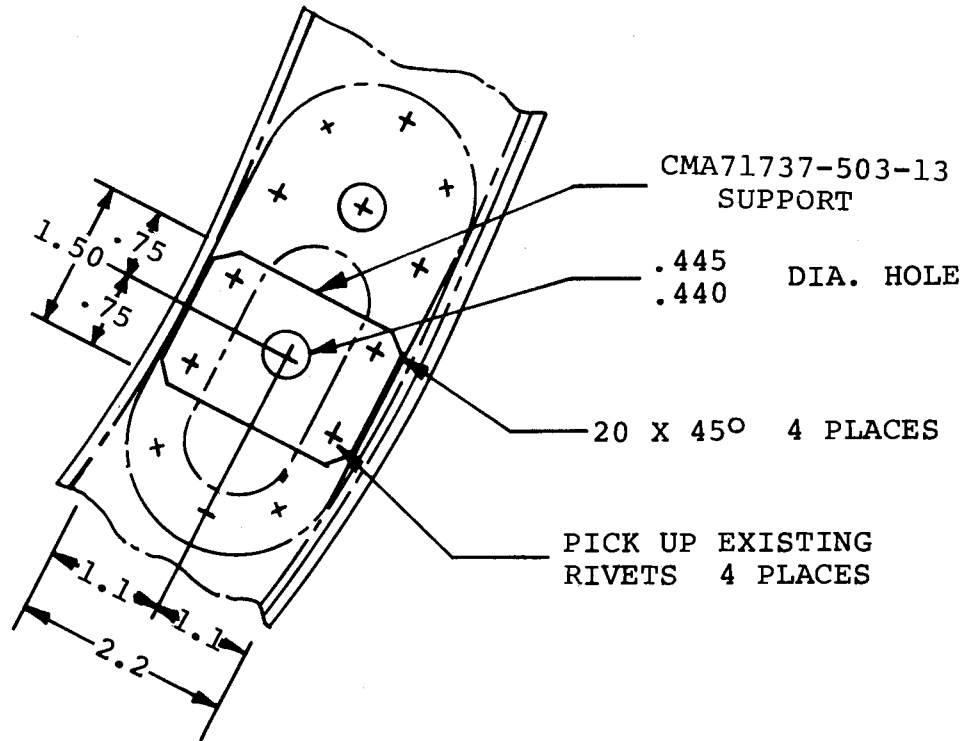
FIGURE 6

VIEW LOOKING AFT  
FRAME 44.50

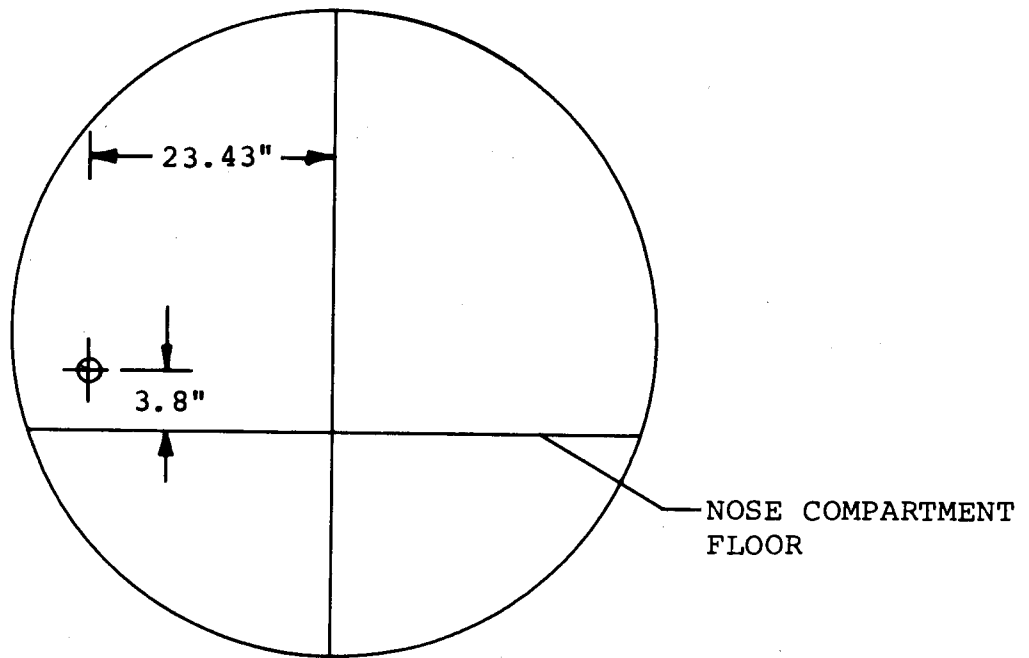
FIGURE 3

FORWARD PRESSURE BULKHEAD LOOKING AFT

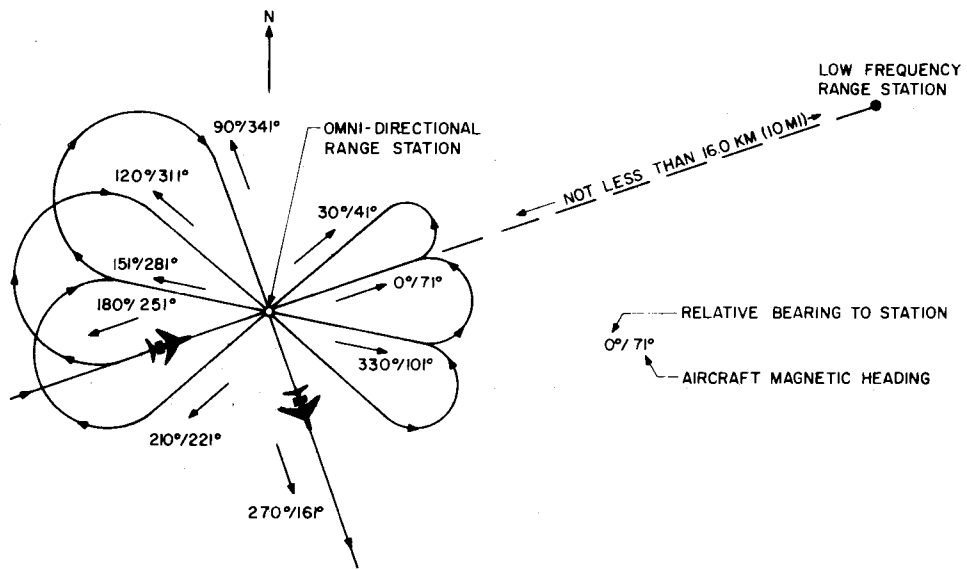
ADF-60 System, Calibration Pattern  
Figure 2-35

- e. Repeat step d for each remaining aircraft magnetic heading. The test pattern should be flown with alternate left and right turns to prevent excessive precession of the gyros. The flight pattern of an aircraft performing this is shown in figure 2-35.

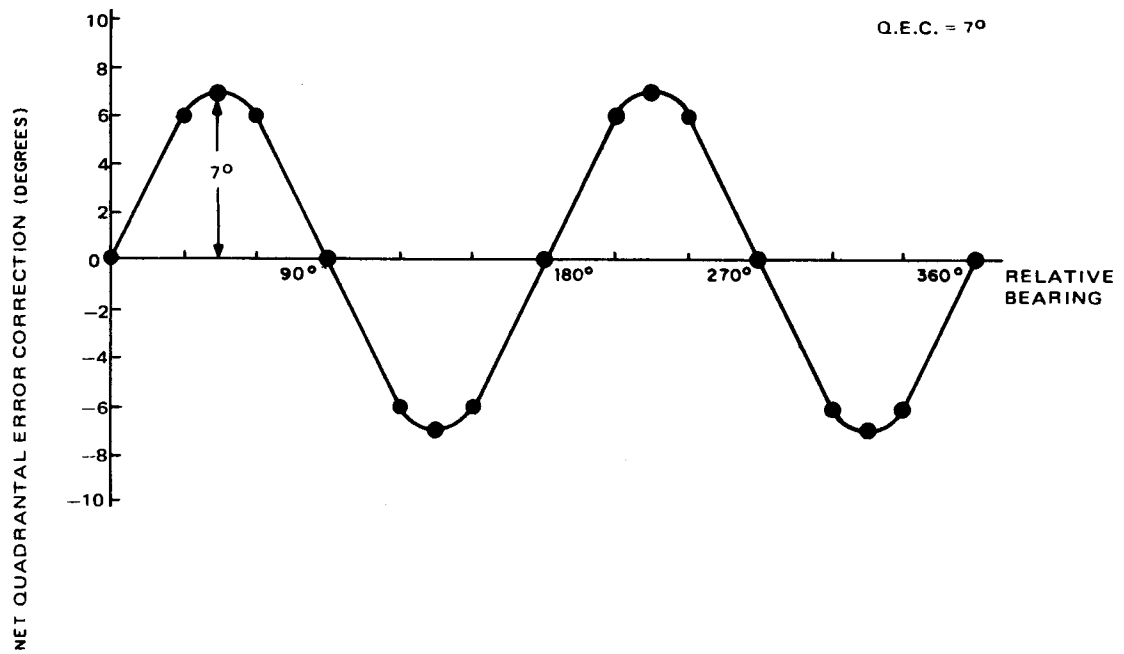
Sample Quadrantal Error Correction Curve  
Figure 2-36

- g. Plot a graph of NET QEC against relative bearing to station. Figure 2-36 shows a sample graph using the data from figure 2-34.
- h. Critically examine QEC curve to see if it is reasonably regular and symmetrical. If it is not, check antenna location for aerials, projections near the antenna, and large openings in the fuselage (doors) which could cause irregularities in the rf field. If irregularities cannot be accounted for, repeat calibration using a different station and frequency. If second calibration produces a differently shaped curve, then the installation is questionable and the cause must be sought and eliminated.

Referring to figure 2-36, the peak value of QEC is 7°. This is the required NET QEC of the ADF-60 system as installed in the aircraft.

For sample error correction curve, figure 2-36, an additional 7 degrees of QEC are required. For an initial strapping of 10 degrees, the total required QEC is 17 degrees. Jumper wire connecting 4-8, 12-20 would be removed and 4-16 should be strapped (from figure 2-38).

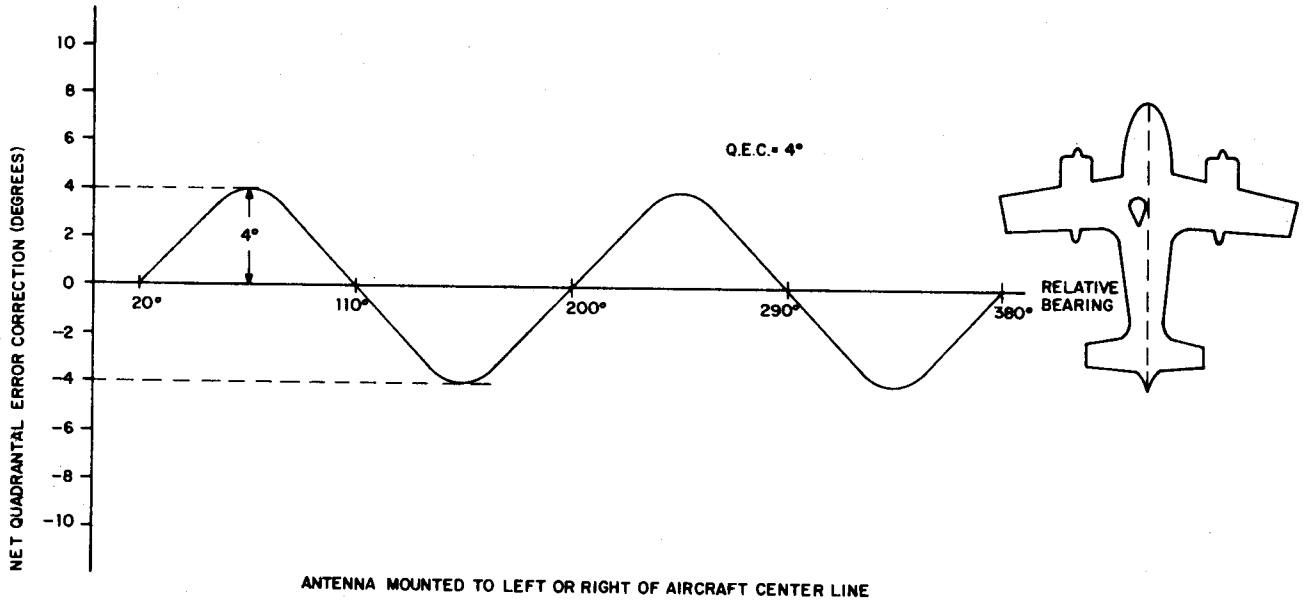
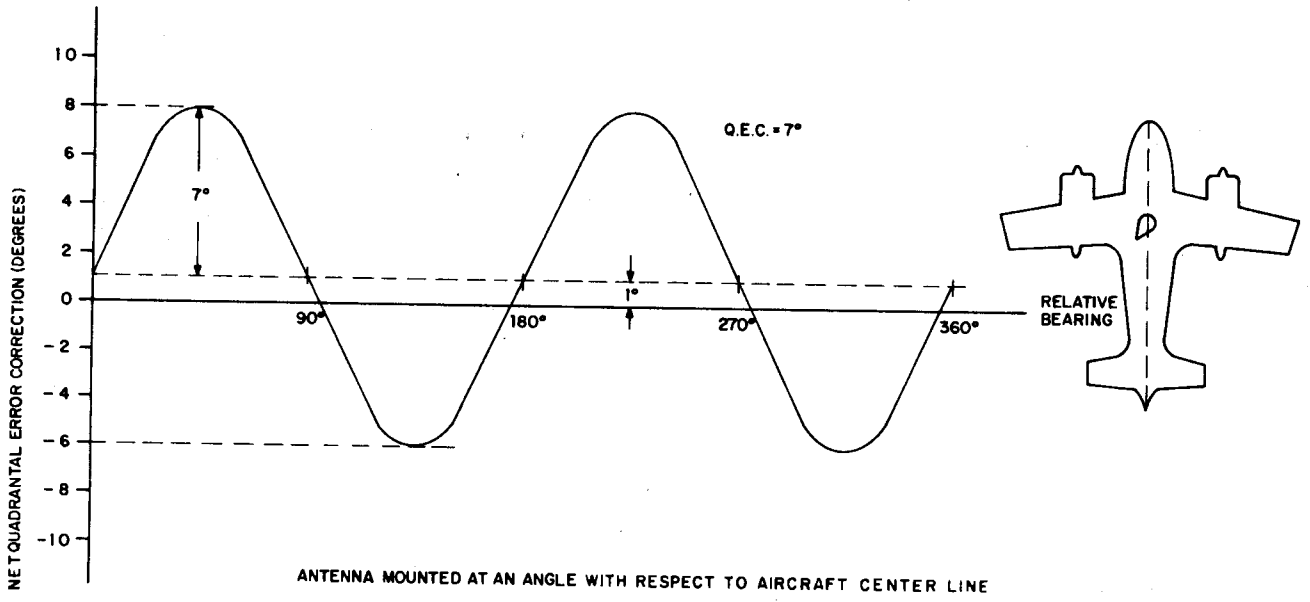
Quadrantal Error Correction Curves for Antenna Alignment Errors  
Figure 2-37

aligned with respect to the aircraft fuselage. Refer to figure 2-37.

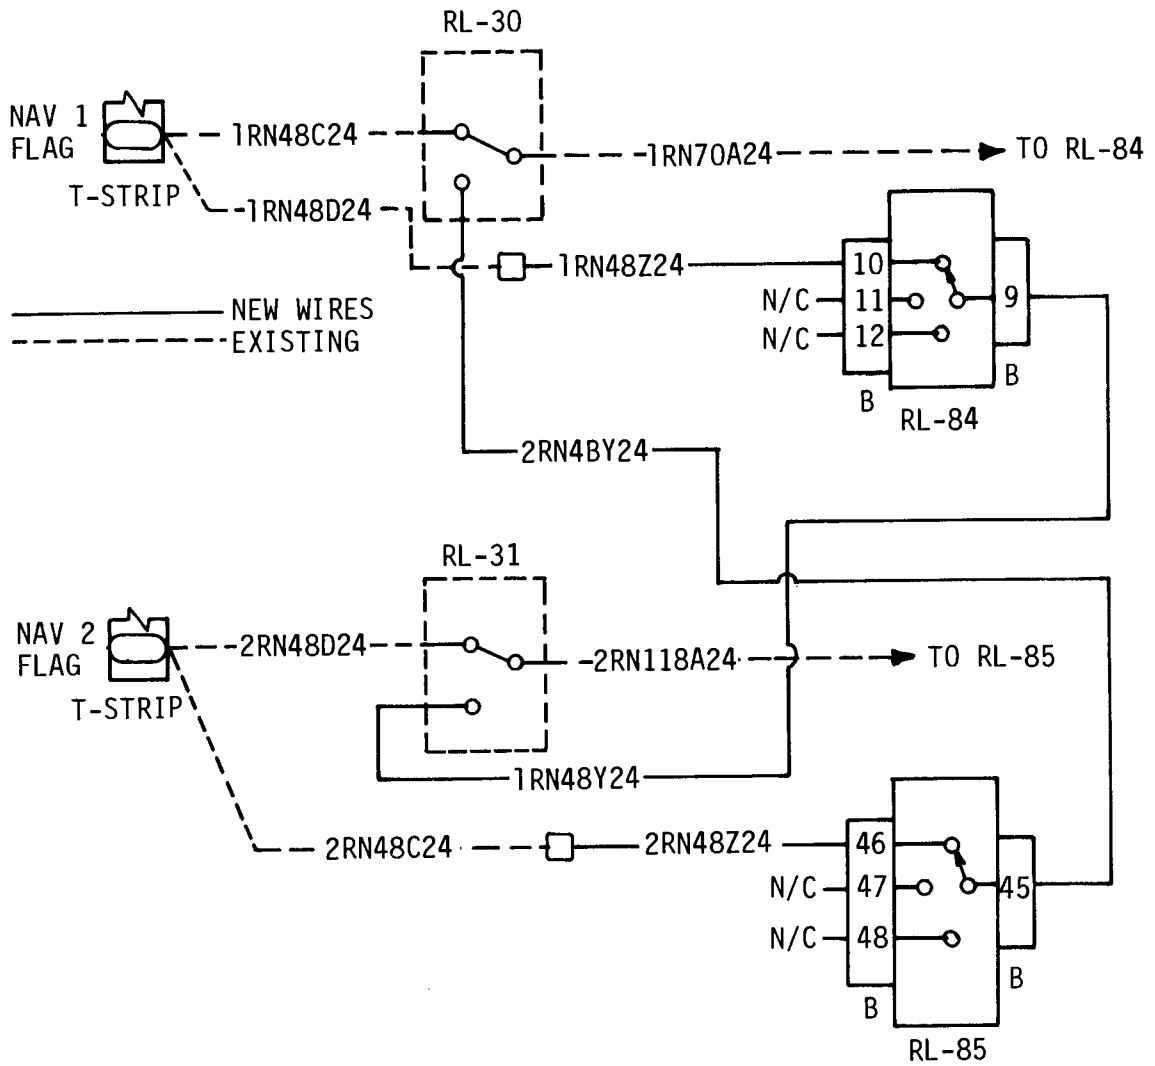
FIGURE 1

NAV FLAG SWITCHING

- C. Remove wire 1RN80A22 from RL84B-9 and the jumper wires from RL84B-10 and/or RL84B-11. Splice these wires together.
- (1) This will result in a pilot "RPT NAV 2" annunciation whenever "RPT NAV 2" is depressed, regardless of information displayed on the Pilot HSI. This prevents switching the HSI into a possible invalid operating condition.

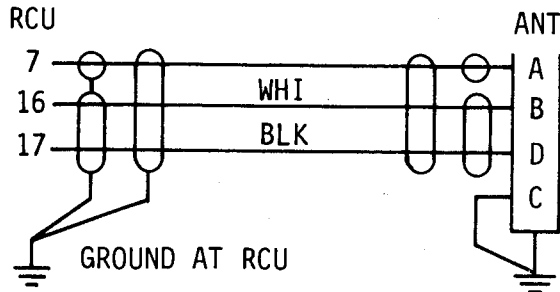
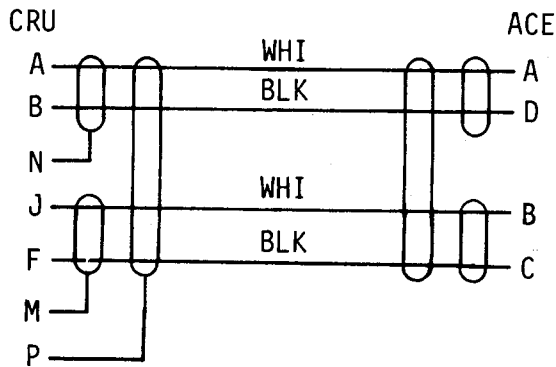
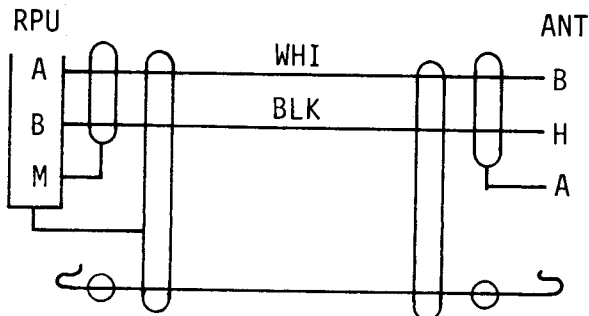
Replacement of existing VLF/Omega "E-Field" antenna to receiver/computer wiring with cabling containing greatly improved shielding will eliminate aircraft-generated electrical noise from degrading the VLF signals presented to the system for navigation.

- E. Bypass any connectors observed between antenna and receiver/computer, permitting an uninterrupted cable run.
- F. Connect new wiring as shown on Figure 1. Shield grounds must connect as shown.
- G. Ensure antennas are properly bonded. Should rebonding be necessary, apply Iridite to bare metal contact surfaces prior to reassembling and sealing antenna.

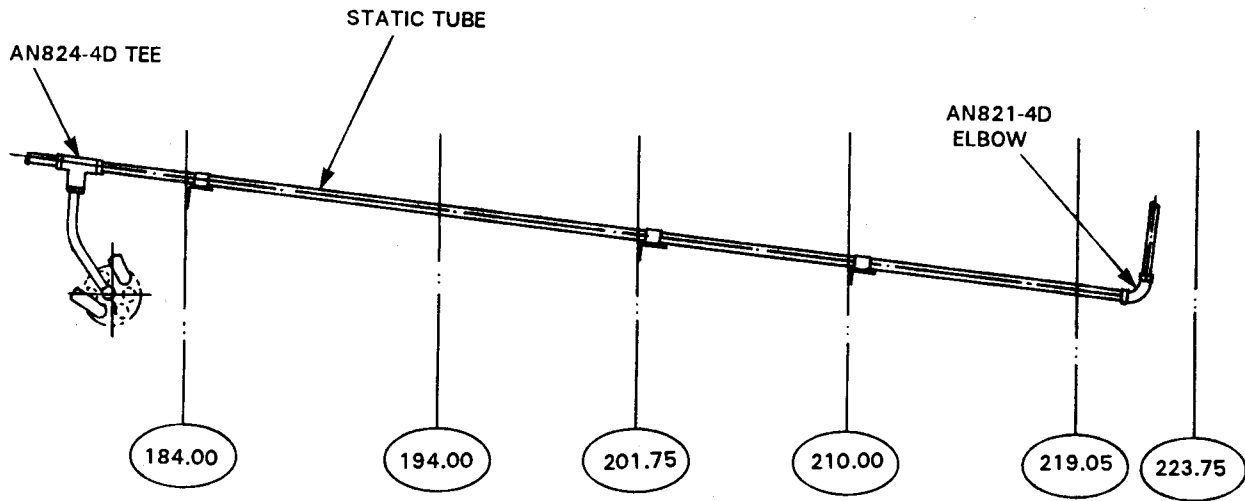
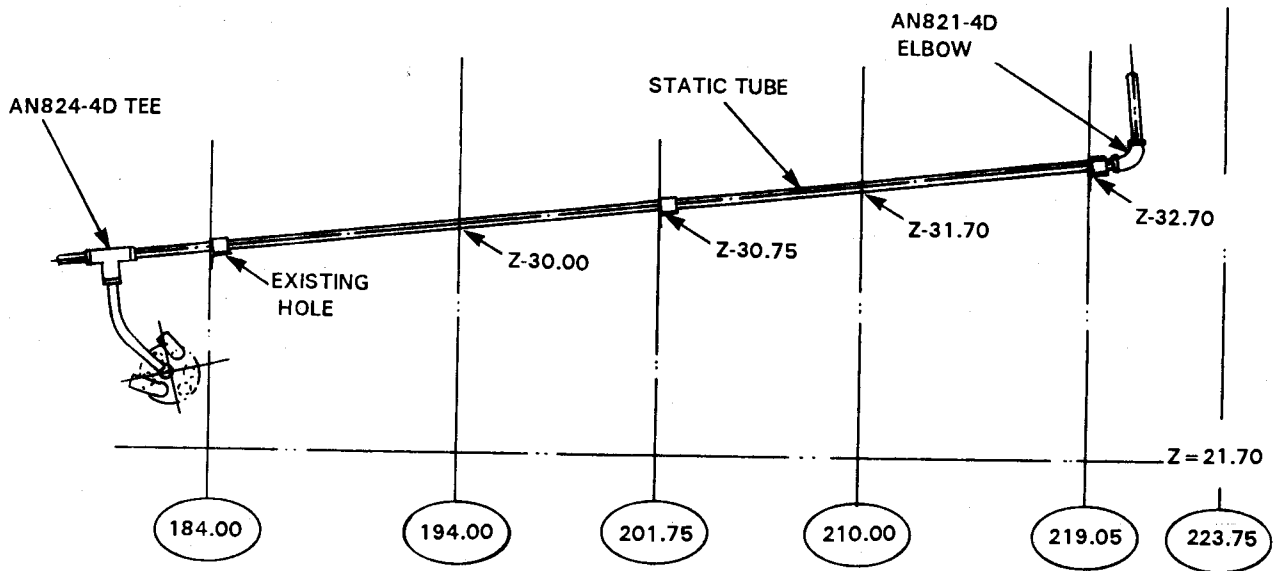
VIEW LOOKING OUTB'D R.H.S.  
FIGURE 1

INCORRECT SLOPE

CORRECT SLOPE

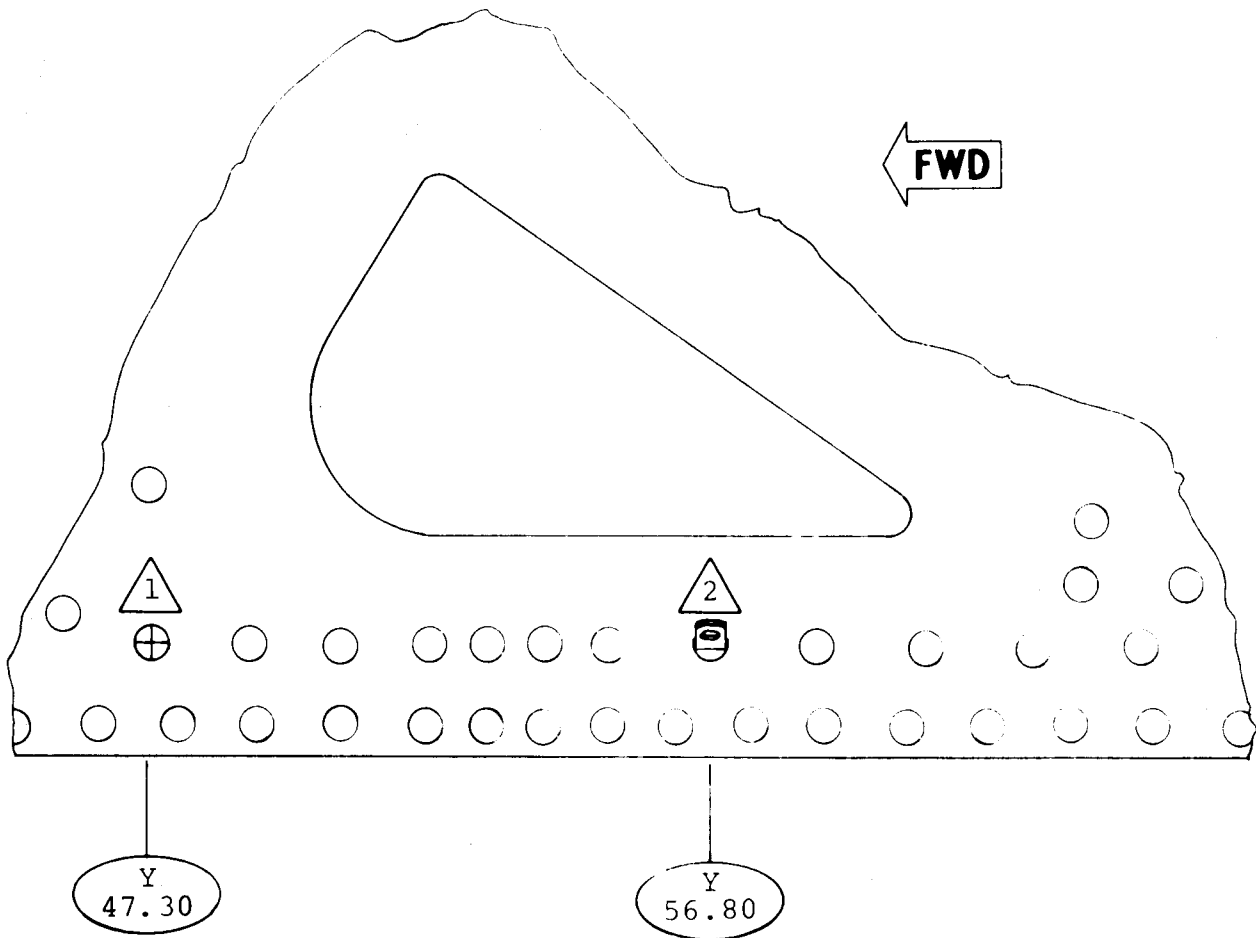
FIGURE 1 DOOR-STAY EYE-BOLT RELOCATION

VIEW LOOKING AT PILOTS DV WINDOW

1. REMOVE EYE BOLT P/N5123617-15 AND RELOCATE BETWEEN STATION Y-53.00 & Y-56.80 ACCORDING TO MAXIMUM OPEN POSITION. USE ONE OF EXISTING SCREWS LOCATED BETWEEN THESE STATIONS.

2. REMOVE SCREW AND RELOCATE TO STATION Y-47.30 WHERE EYE-BOLT WAS REMOVED

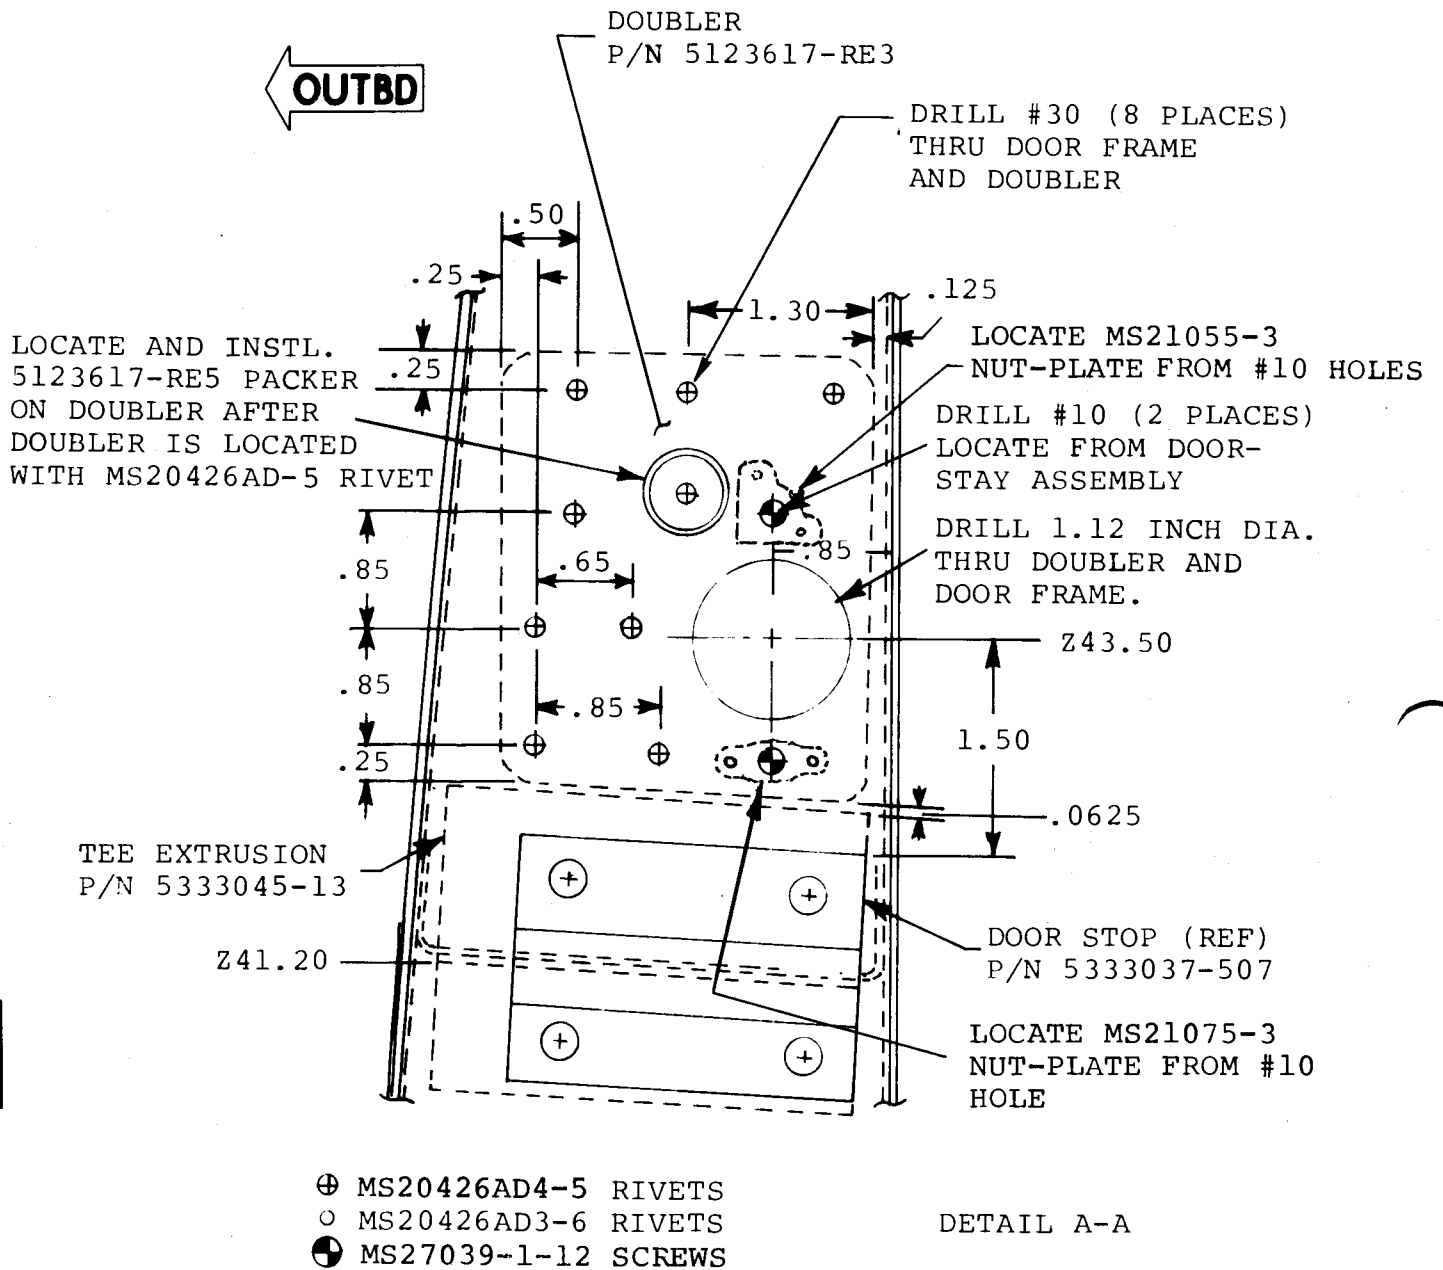
FIGURE 3 DOUBLE AND DOOR-STAY INSTALLATION

VIEW LOOKING AT AFT EDGE OF DOOR

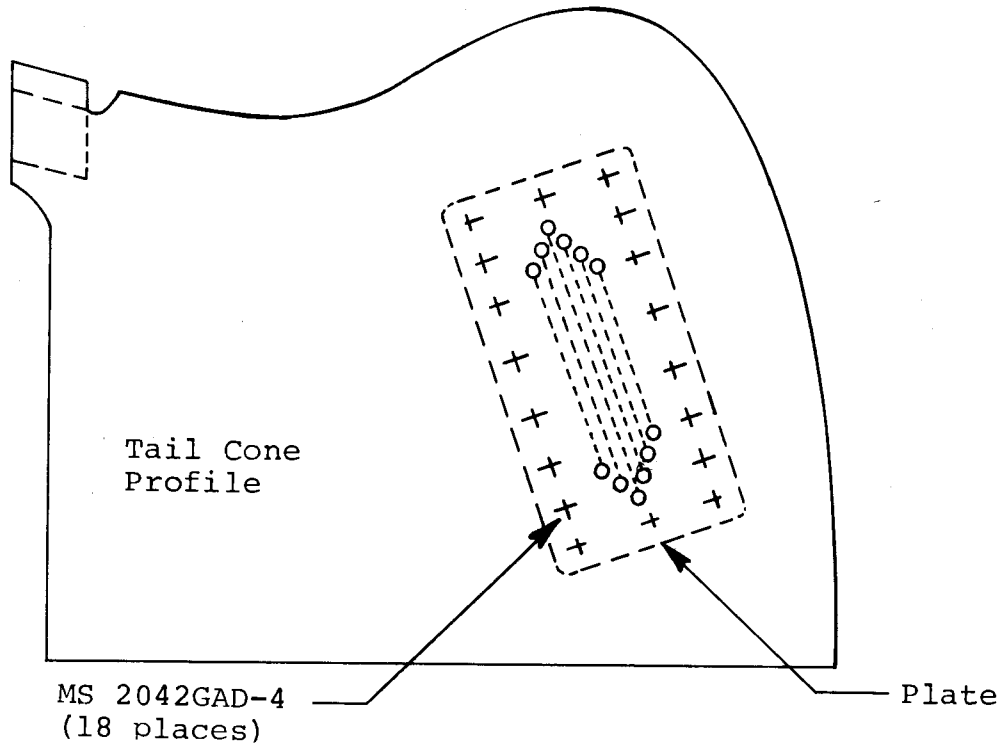
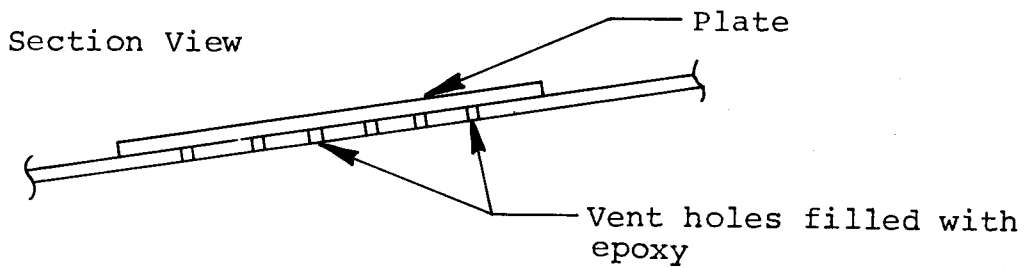
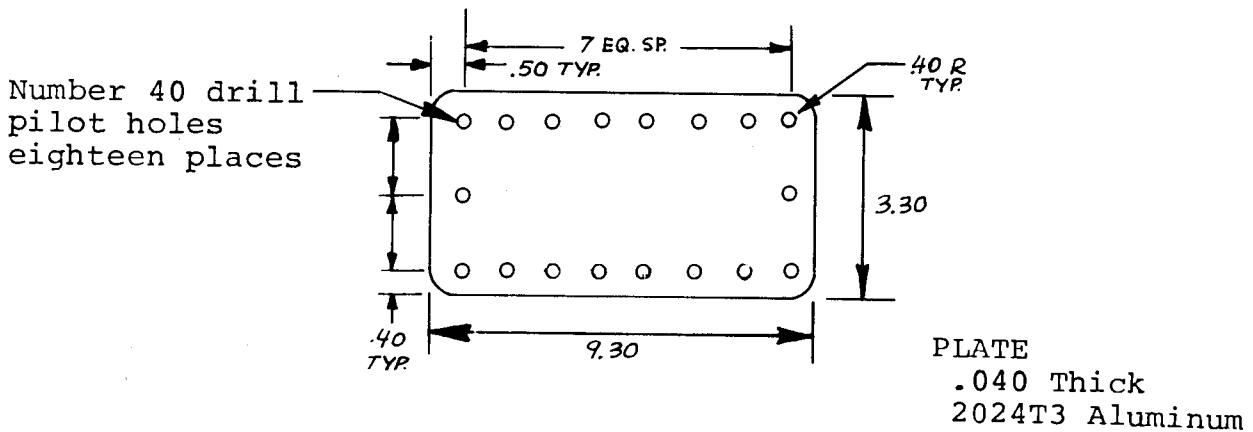
FIGURE 1

To reduce excessive airflow to electronic equipment.  
To eliminate the collection of rain water and/or moisture in the tail cone area.

CLOSURE OF TAIL CONE VENT HOLES

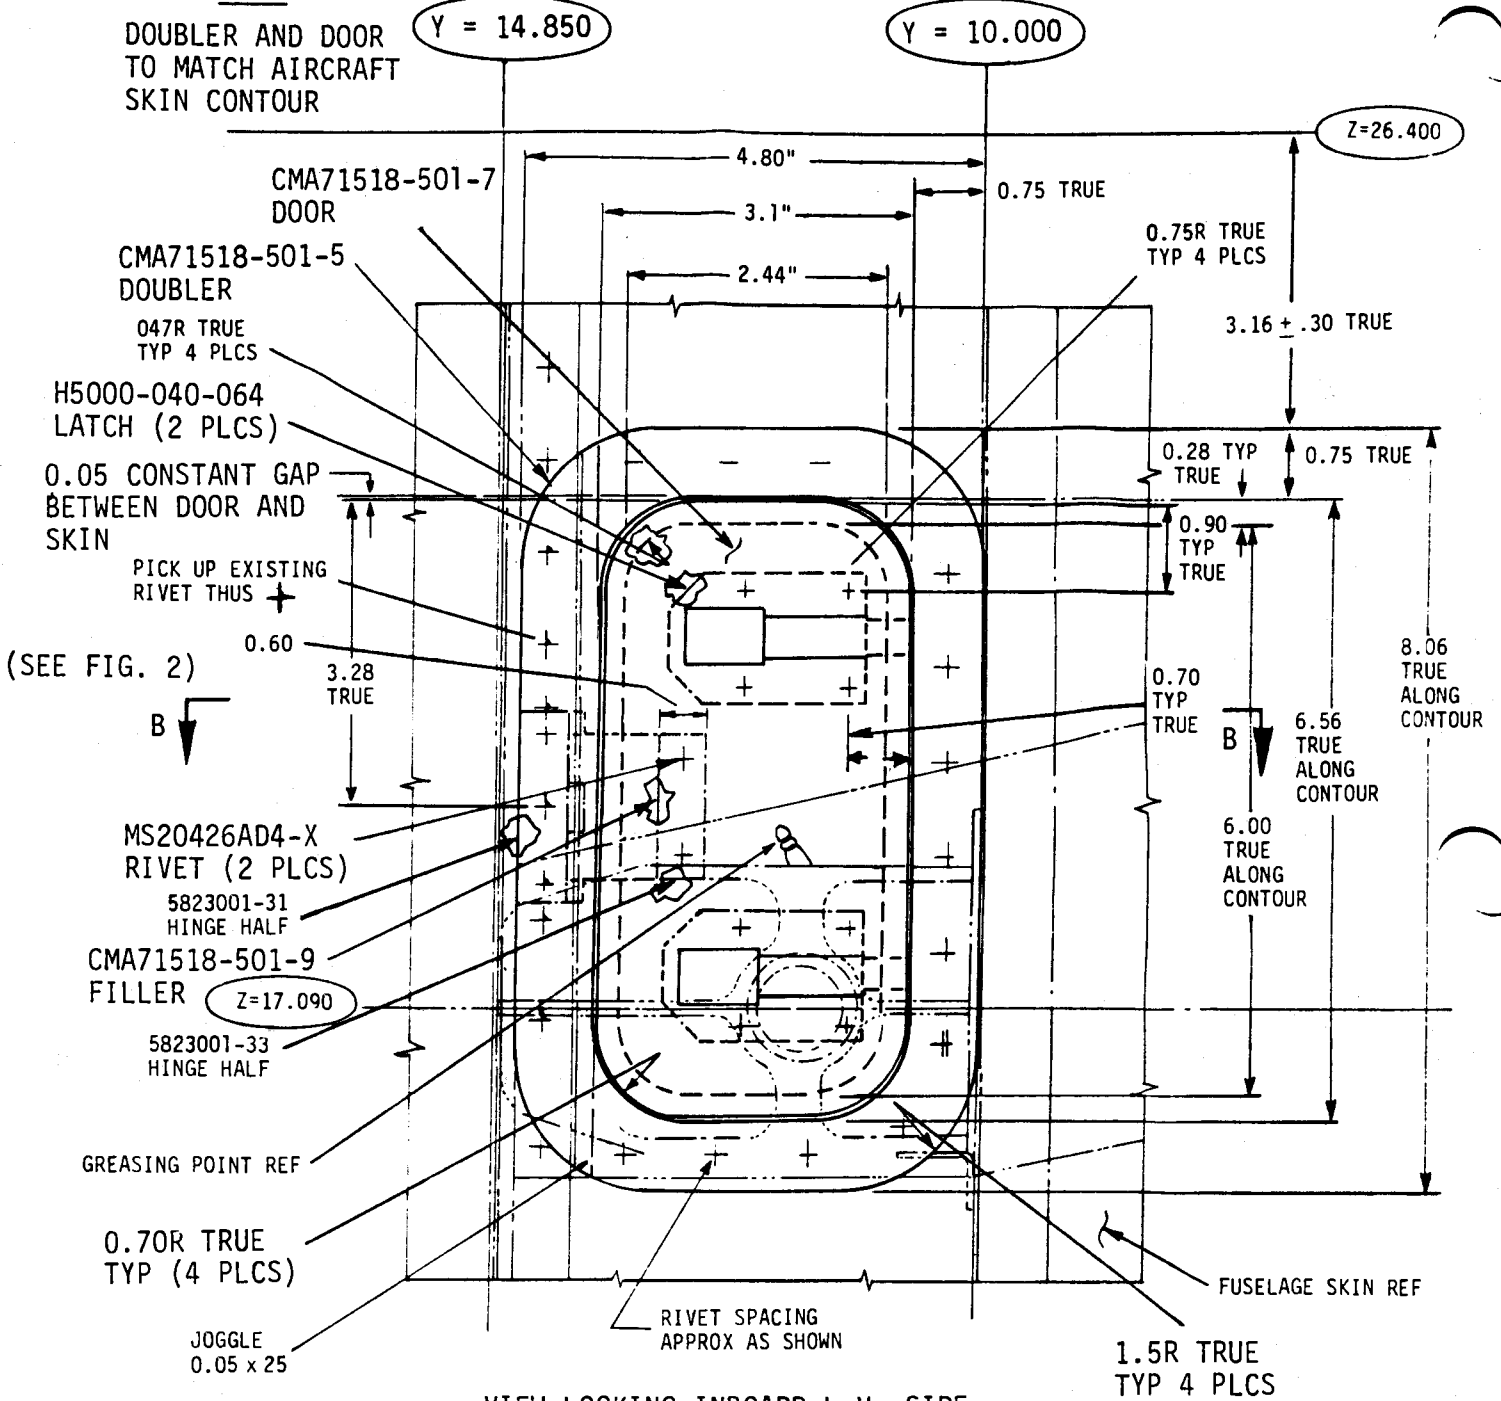
FIGURE 1

ACCESS DOOR INSTALLATION - LH SHOWN RH OPPOSITE

- A. Gain access to nose landing gear area by removing the radome.
- B. Cut access hole in L/H fuselage skin and radius corners. R/H installation typical unless otherwise noted. (Refer to Figure 1.)

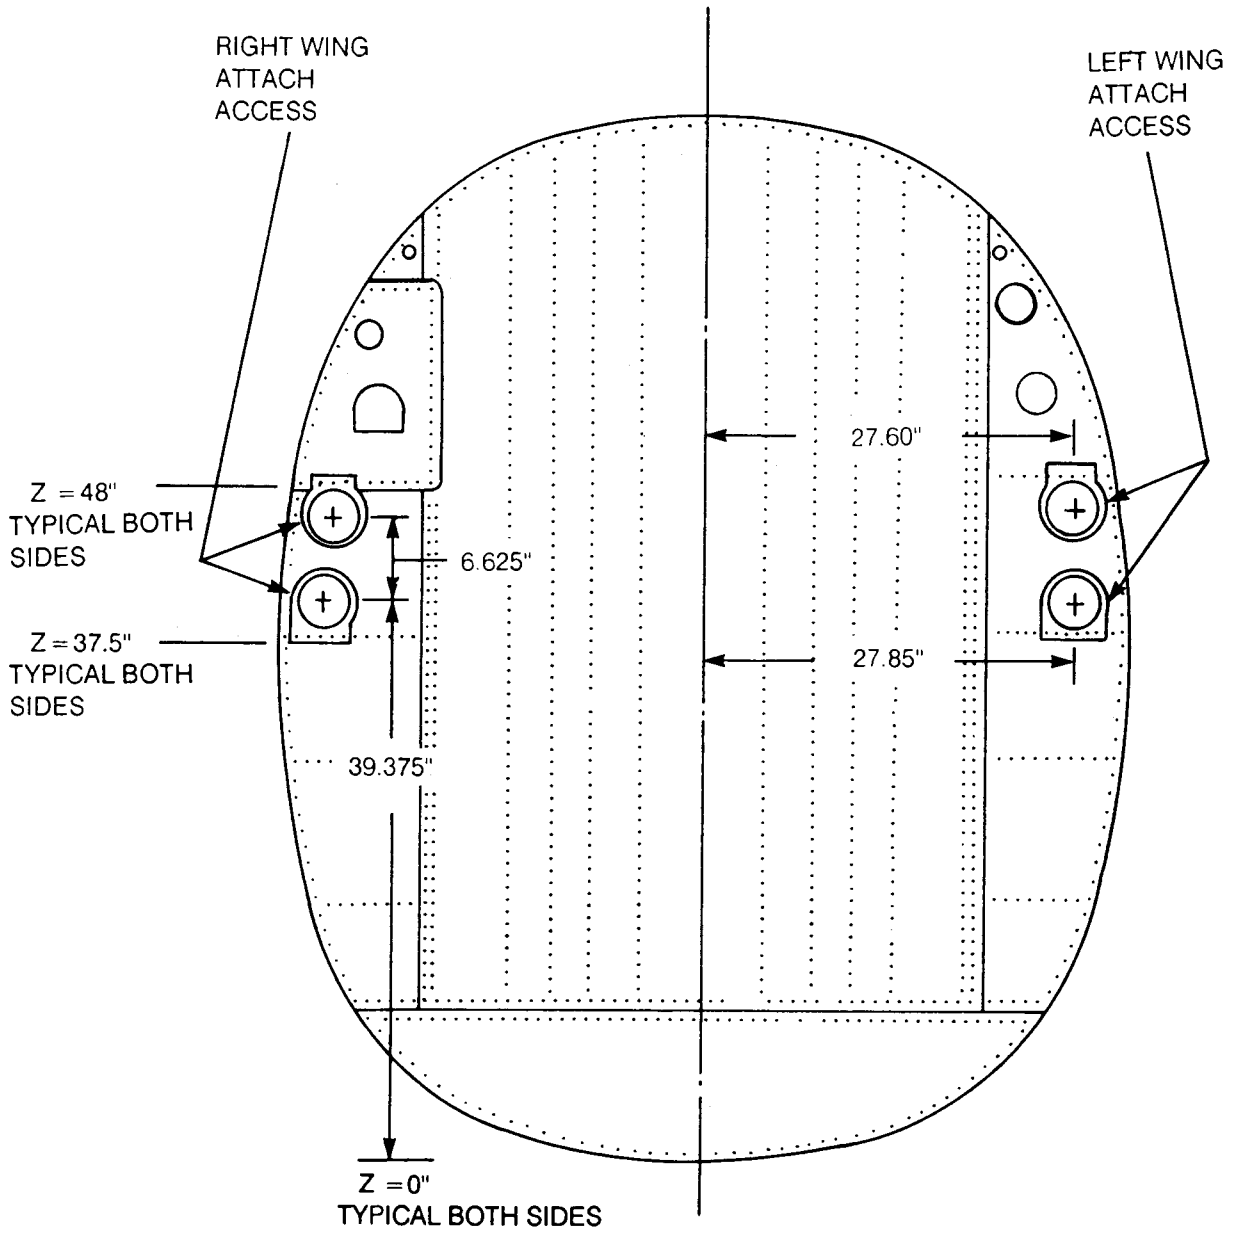
Figure 1

AFT PRESSURIZED BULKHEAD ASSEMBLY  
VIEW - LOOKING AFT  
STA 269.879

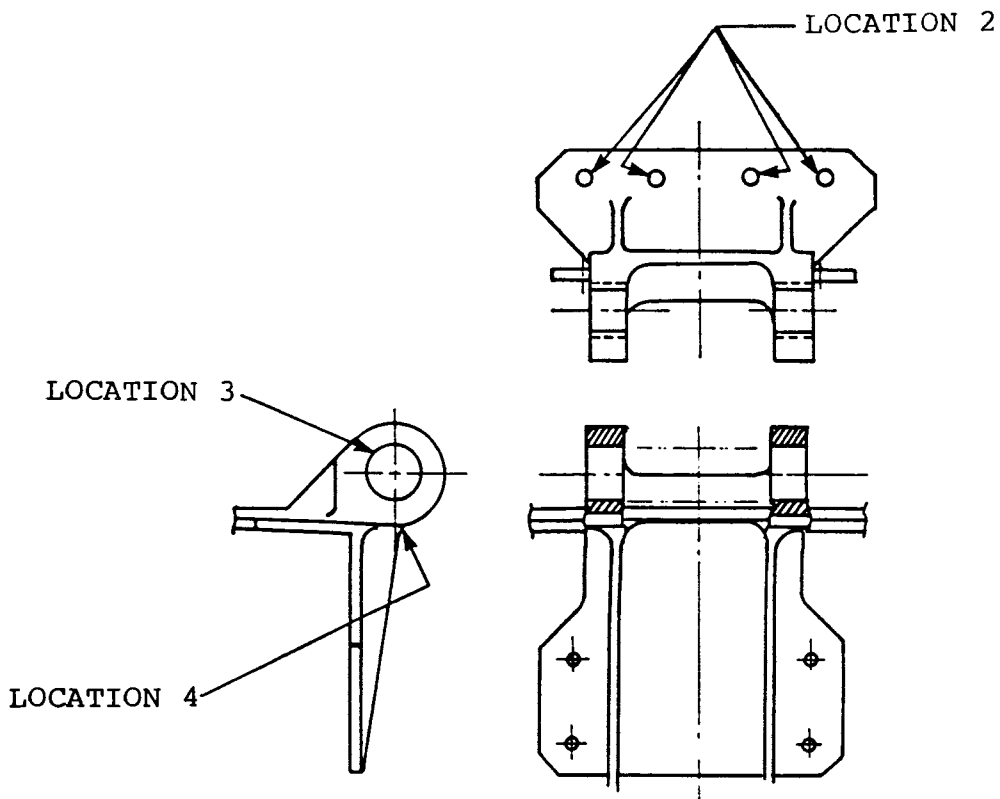
LOWER FITTING P/N 453514-503  
FIGURE 2

Several cracked and/or loosened lower fittings of scissors assembly have been detected in service.

B. Without scissor removal, visually inspect for cracks at the following locations:

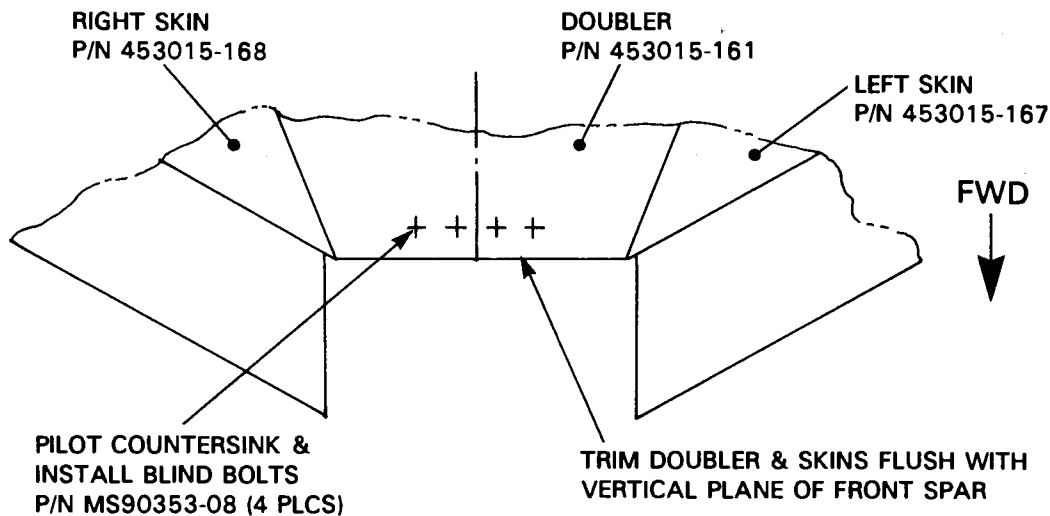
FIGURE 2

Reports from the field indicate that some stabilizer lower scissor fittings P/N 453514 have loosened or cracked in service. Reference Service Bulletin No. 1124-55-097.

- (6) Drill out all fasteners attaching lower scissor fitting P/N 453514 to horizontal stabilizer.
- (7) Pilot countersink four (4) holes in doubler, P/N 453015-161 on top of stabilizer. Inspect hole condition. Refer to Figure 2 View "B".
- (8) Clamp-up doubler, P/N 453015-161 and skins, P/N 453015-167, left hand and -168 right hand. Refer to Figure 2 View "B".
- (9) Install four (4) blind bolts, P/N MS90353-08 or -U08, grip as required. If necessary use first standard over size. Fasteners are to be installed wet with sealant P/N PR1422. Refer to Figure 2 View "B".
- (10) Ensure that upper and lower doublers and skins are trimmed flush with vertical plane of the forward spar, P/N 453017, to clear new scissor/actuator fitting, P/N 453504.

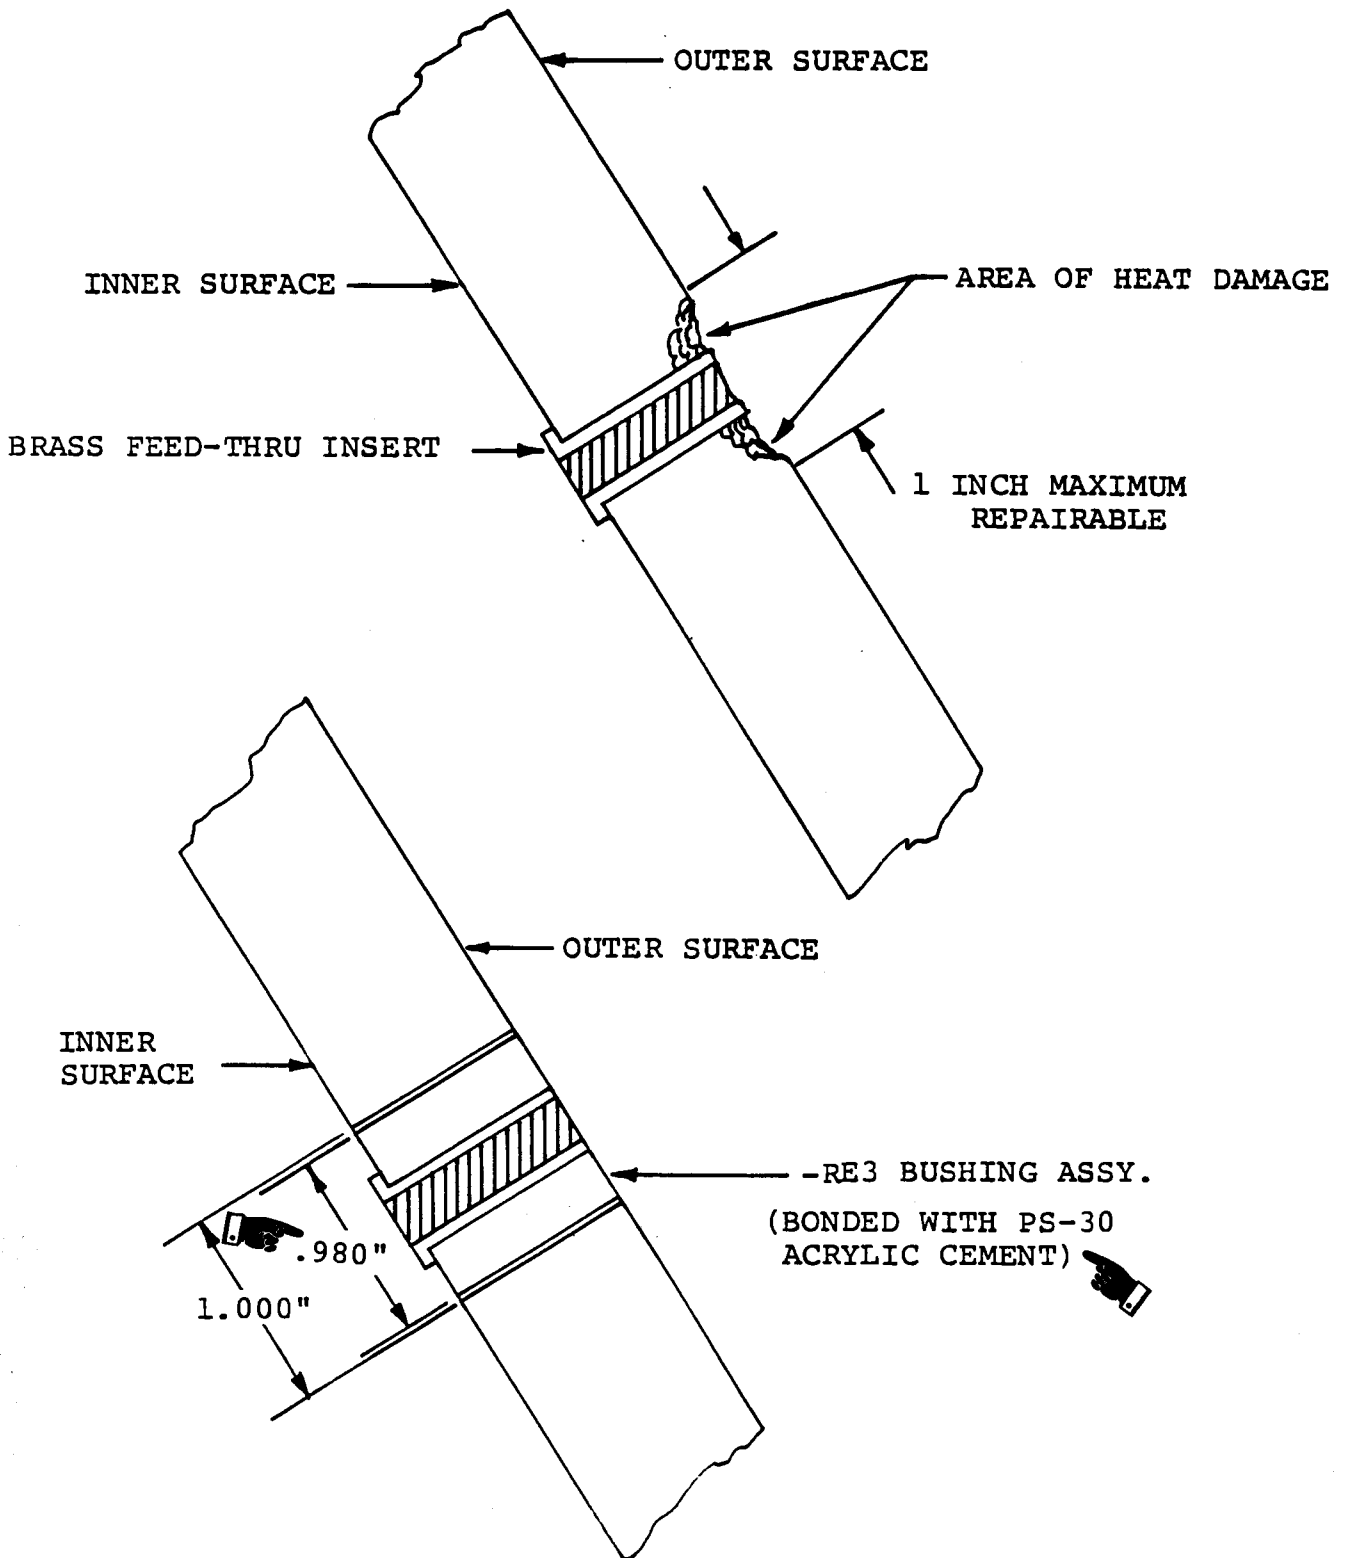
FIGURE 1

The windshield repair procedure provided may be used on windshield heat probe feed-through locations which have suffered localized heat damage due to arcing of the contact at that position.

Remove existing feed-through bushing, remove heat-damaged acrylic material, counterbore 1-inch hole through windshield at damage location and install P/N A01WW5343025-RE3, bushing assembly.
