# IAI WESTWIND

## SERVICE BULLETIN

1124 SERVICE BULLETIN INDEX

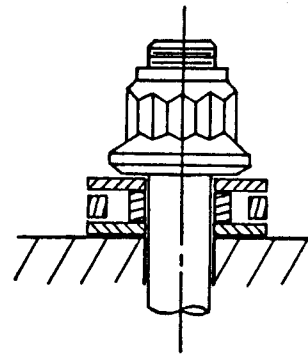
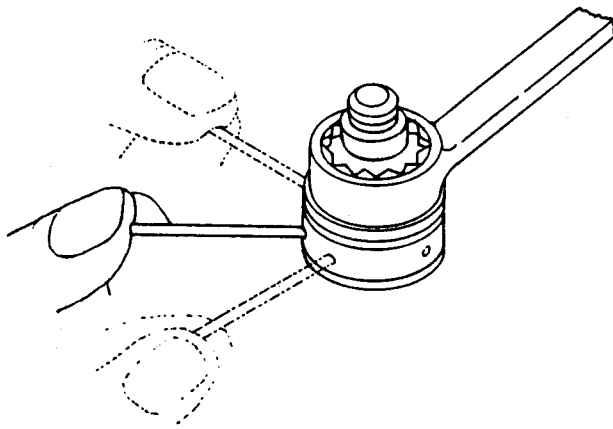
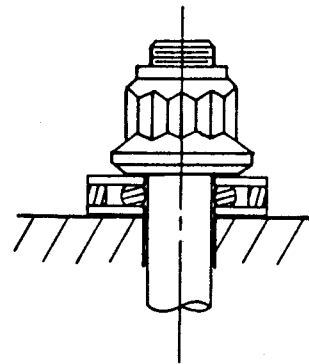
FIGURE 2

Do not overtighten. If nut is tightened more than 1/8 turn beyond point where outer PLI washer becomes immovable, the entire bolt, nut and washer assembly must be replaced.

INSTALLATION OF PRE-LOAD INDICATING WASHERS UNDER NUTS

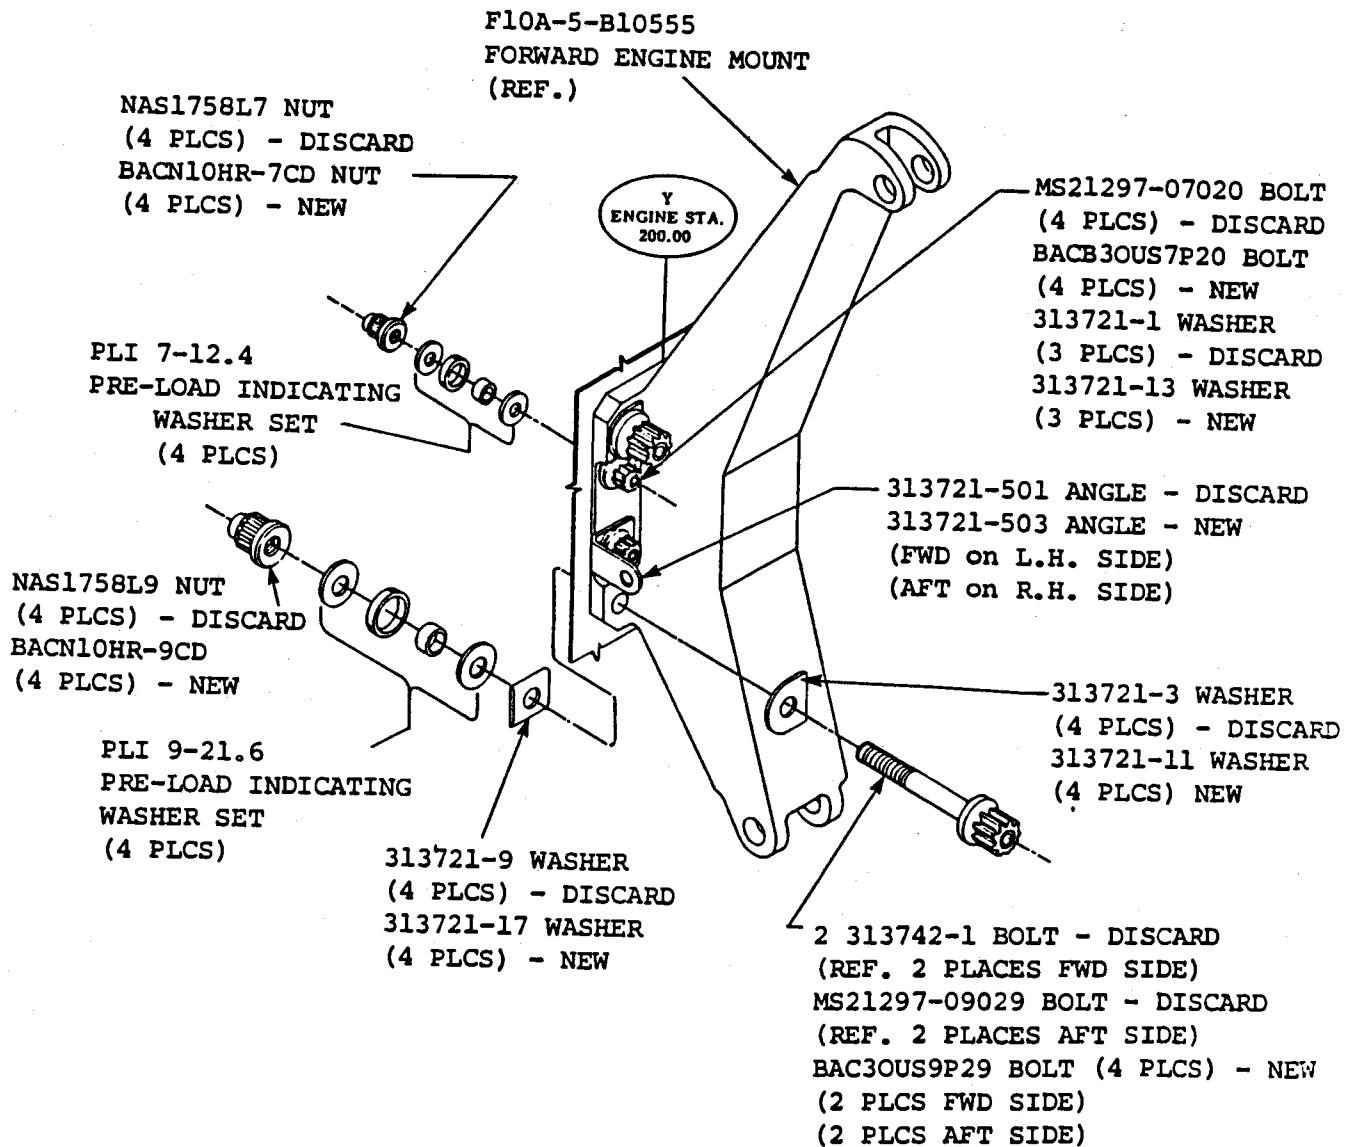
FIGURE 1

INSTALLATION OF FORWARD ENGINE MOUNT  
ATTACHMENT FASTENERS

To prevent potential stress corrosion failure of the forward engine mount mounting bolts and nuts made from H-11 steel.

- (1) Remove old fastener, discard bolt, nut and PLI washer.
- (2) Check for surface defects in fastener holes such as corrosion, scratches, nicks or cuts intersecting a part surface.
- (3) Nuts, bolts and threads shall be free of all burrs, nicks, dents and sharp edges.
- (4) No lubricant shall be used on the fastener or in the hole.
- (5) Install new bolt in hole with washers per Figure 1.
- (6) Install new PLI washer assembly as required and assemble per Figure 2.

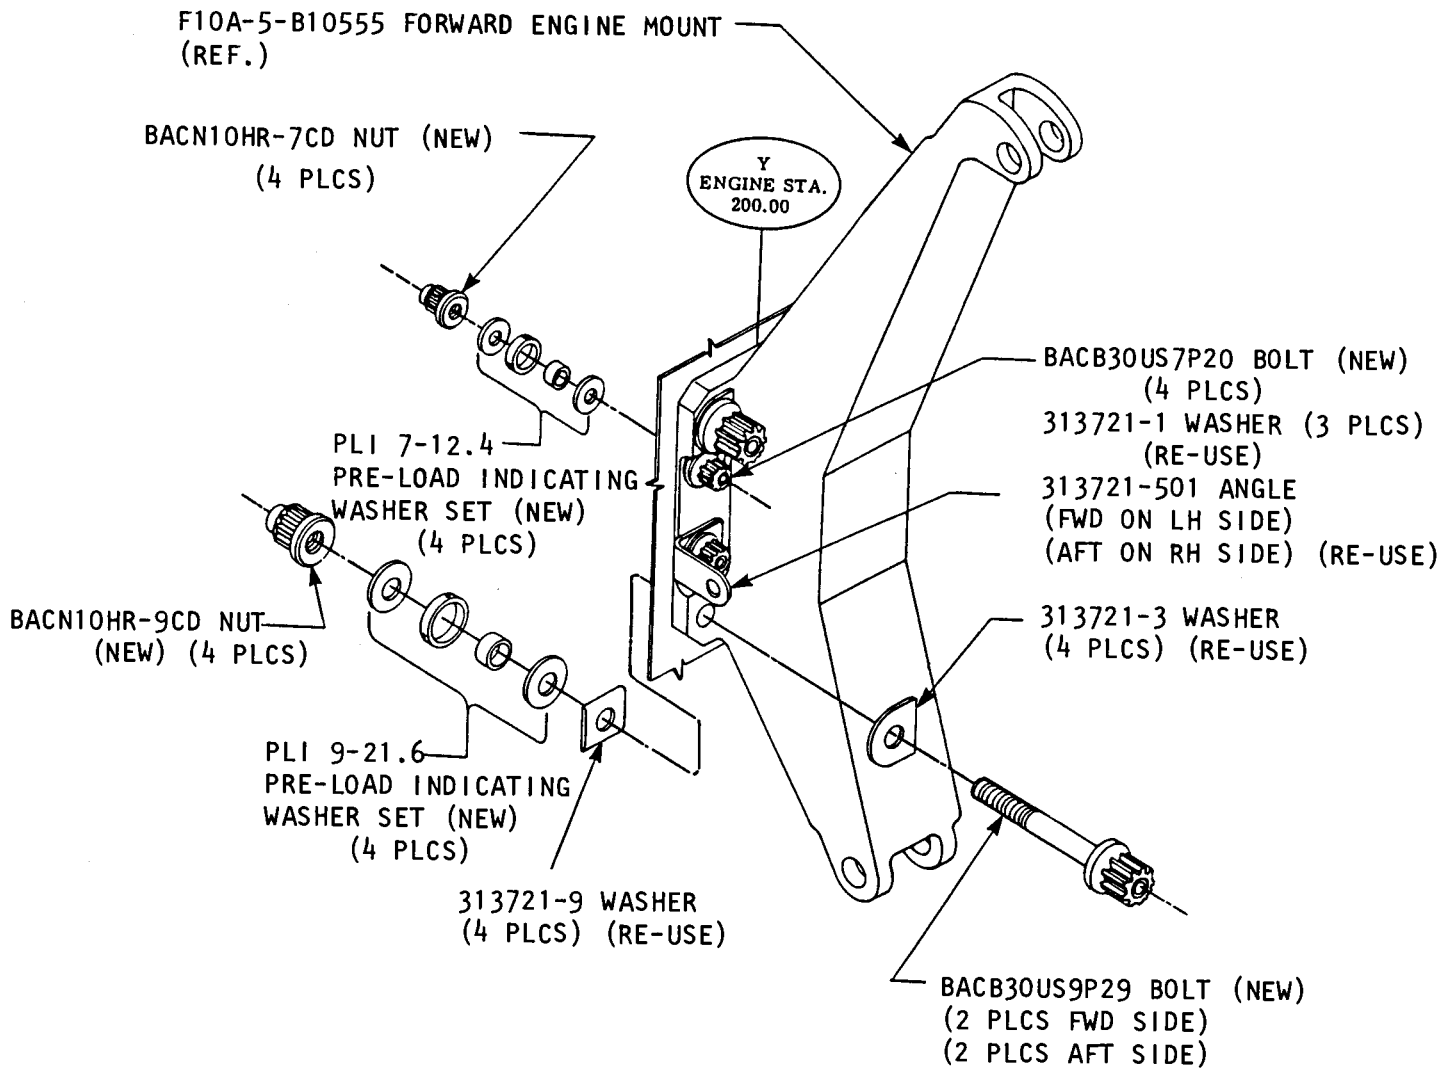
FIGURE 1

INSTALLATION OF FORWARD ENGINE MOUNT  
ATTACHMENT FASTENERS

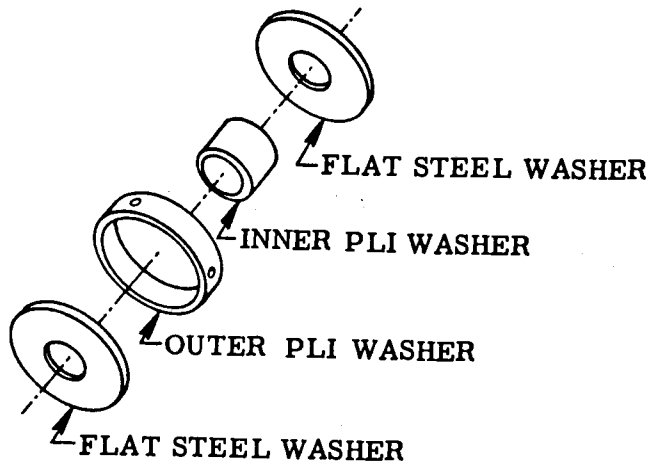
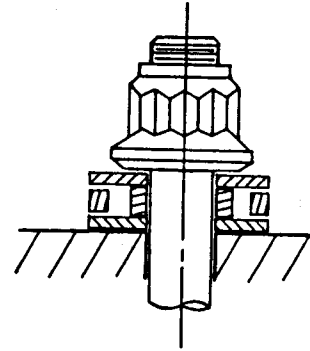
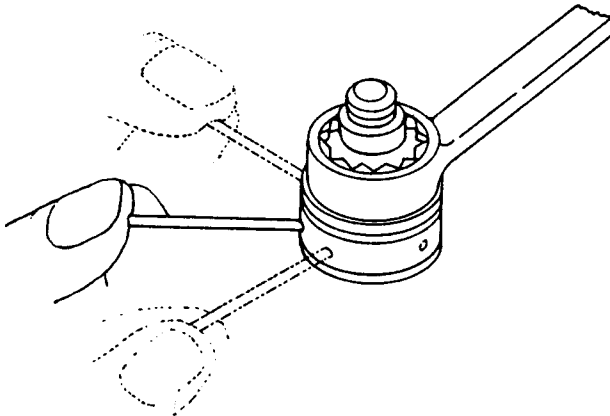
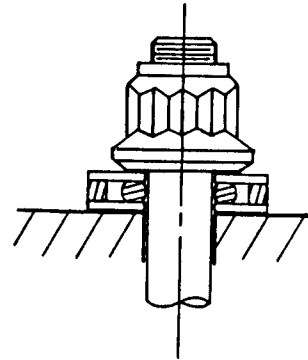
FIGURE 2

Do not overtighten. If nut is tightened more than 1/8 turn beyond point where outer PLI washer becomes immovable, the entire bolt, nut and washer assembly must be replaced.

INSTALLATION OF PRE-LOAD INDICATING WASHERS UNDER NUTS

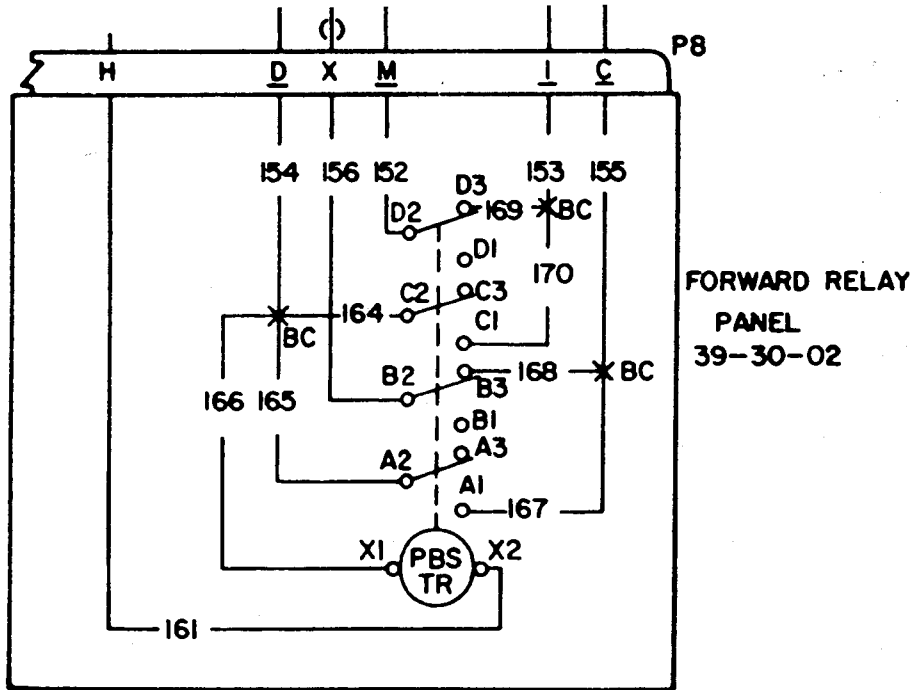
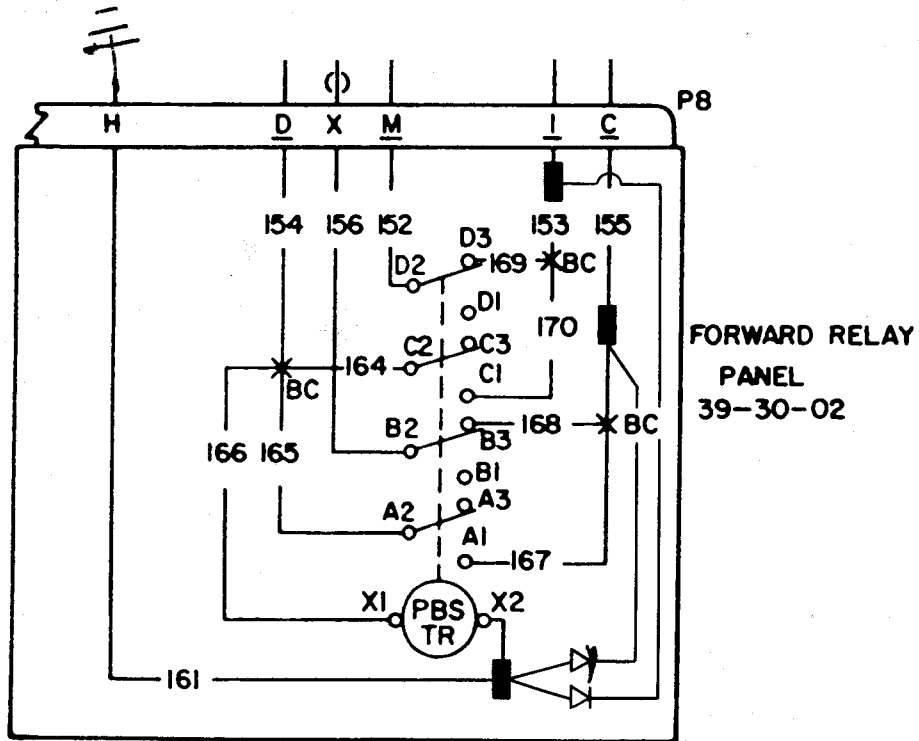
**PIGGY BACK SOLENOID TEST RELAY WIRING  
FIGURE 1**

**BEFORE**

**AFTER**

- B. Revise 1124/1124A Westwind Wiring Diagram Manual, Chapter 78-30-01 to reflect changes accomplished by this service bulletin.
- C. Complete the attached Certificate of Compliance and return to Astra Jet Corporation in New Castle, Delaware.

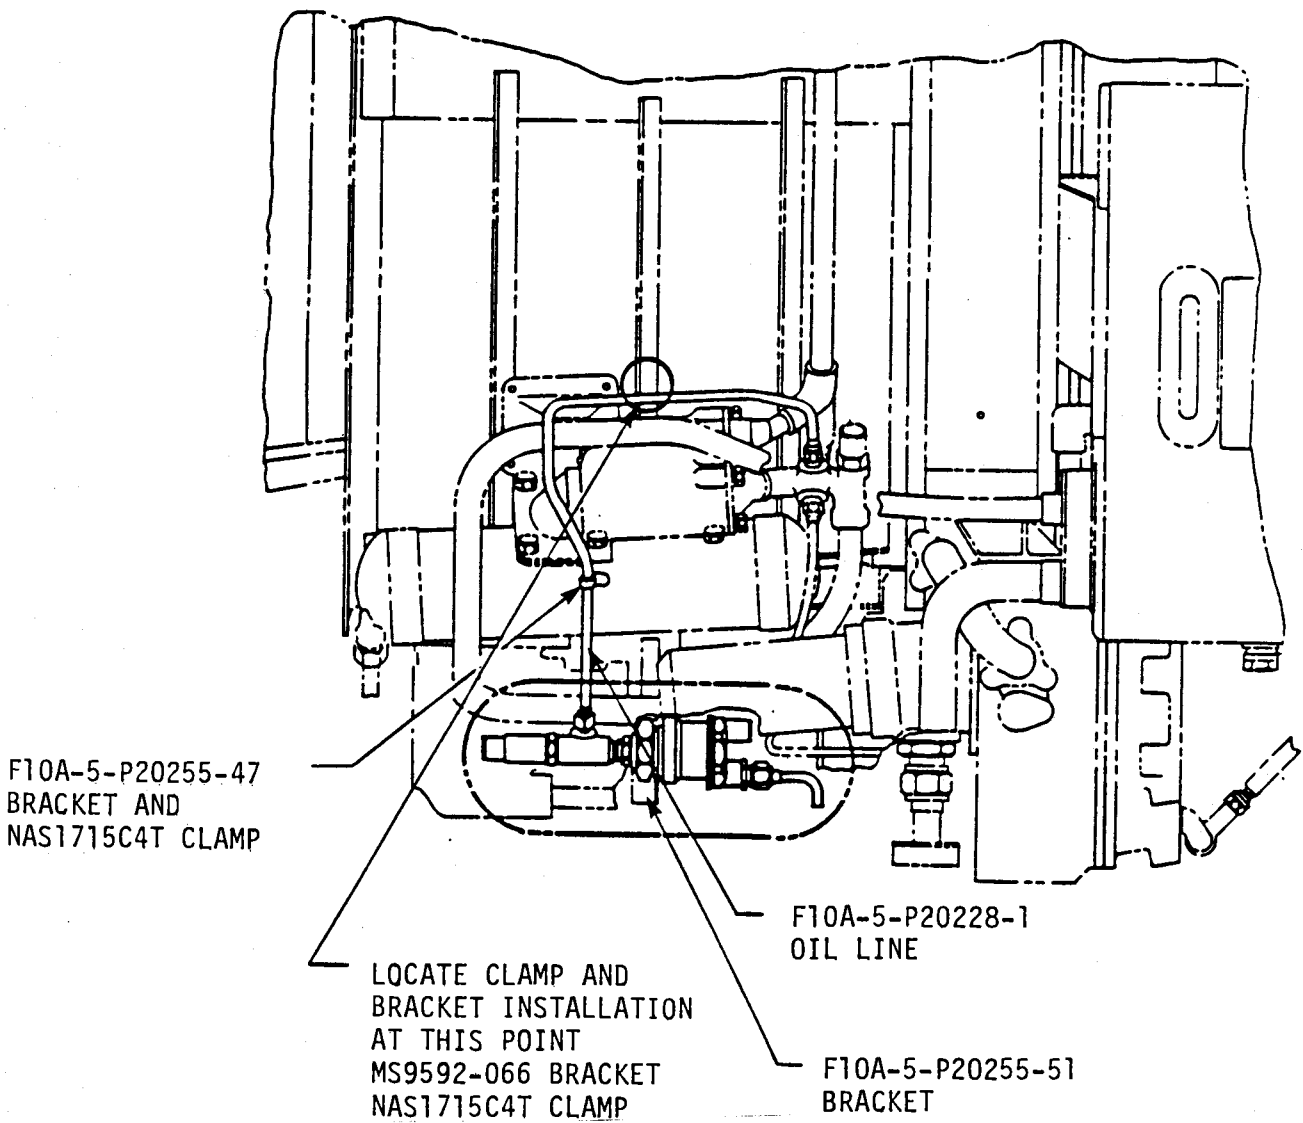
FIGURE 2

To check for defects (chafing, leakage) in engine oil pressure line, P/N F10A-5-P20228-1, install improved and additional engine oil pressure component brackets and support clamping.

NEW ENGINE OIL LINE INSTALLATION

- (3) Replace leaking, chafed or damaged lines with new unit.
  - (a) Perform leak check as required when oil line is disturbed.
- (4) Reinspect each 50 hours until Part B is accomplished.
