## **LETTER OF TRANSMITTAL**

**TO: HOLDERS OF 1124/1124A WESTWIND MANUALS**

## SERVICE DATA

### SERVICE DATA CHAPTER INDEX

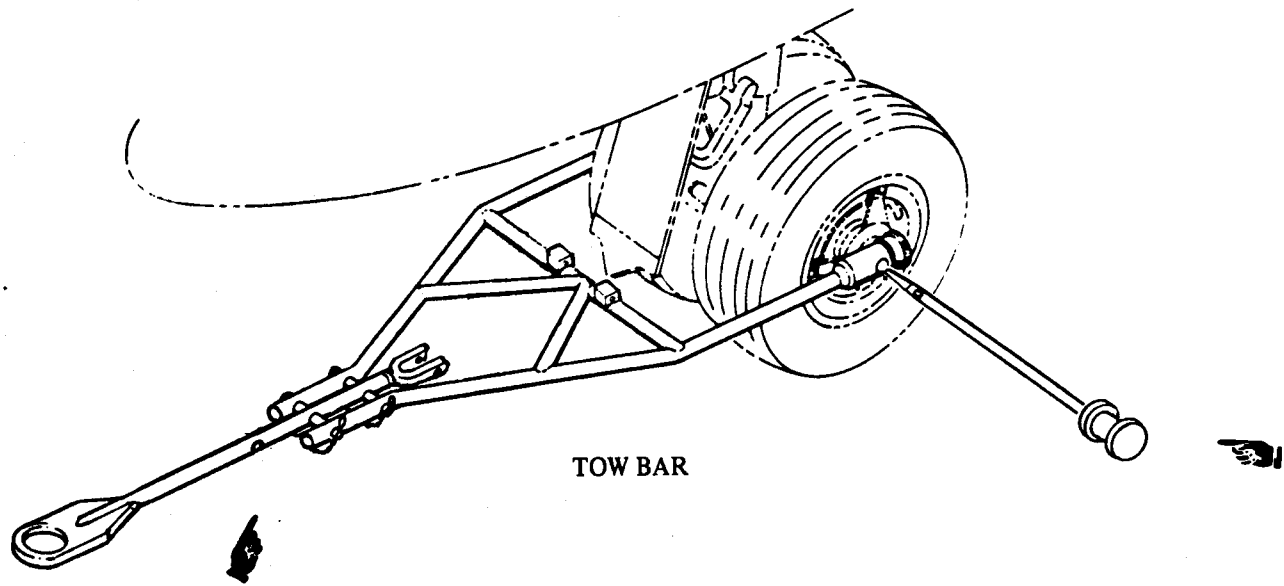
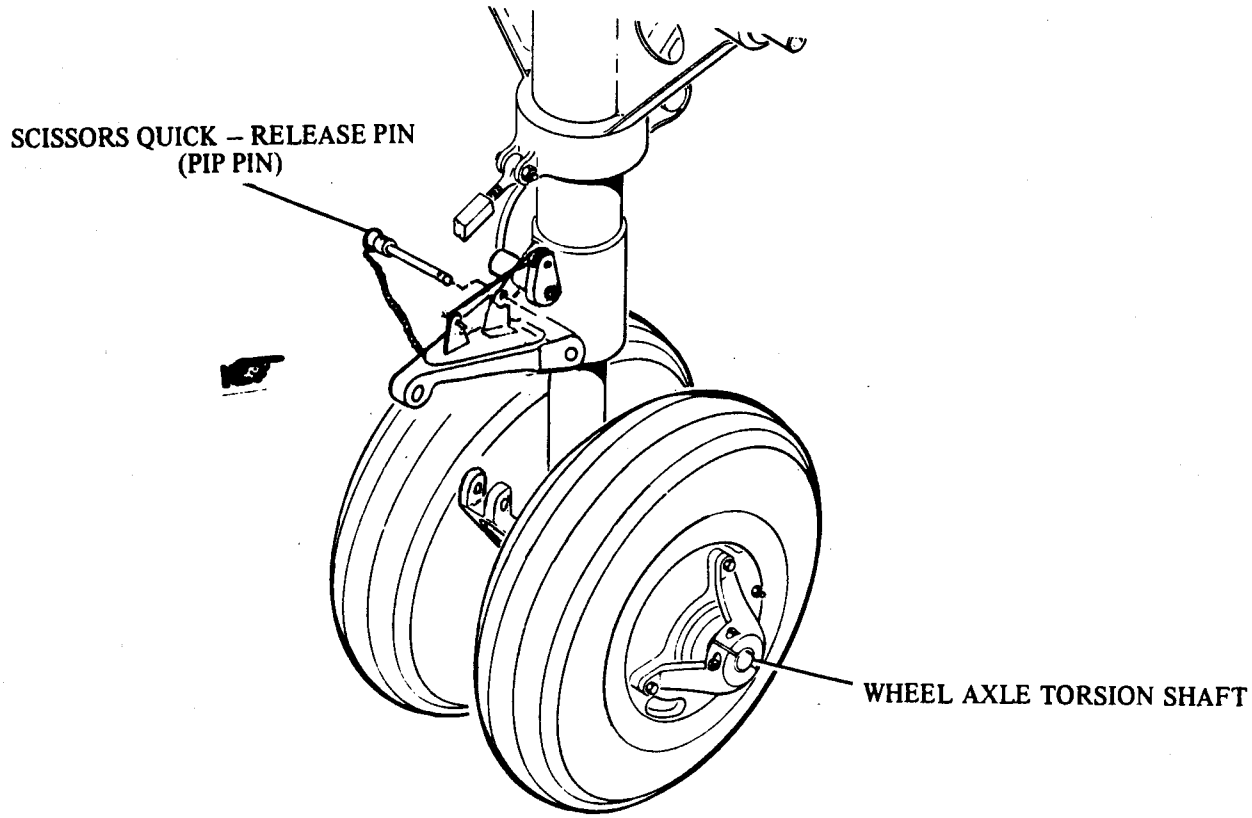
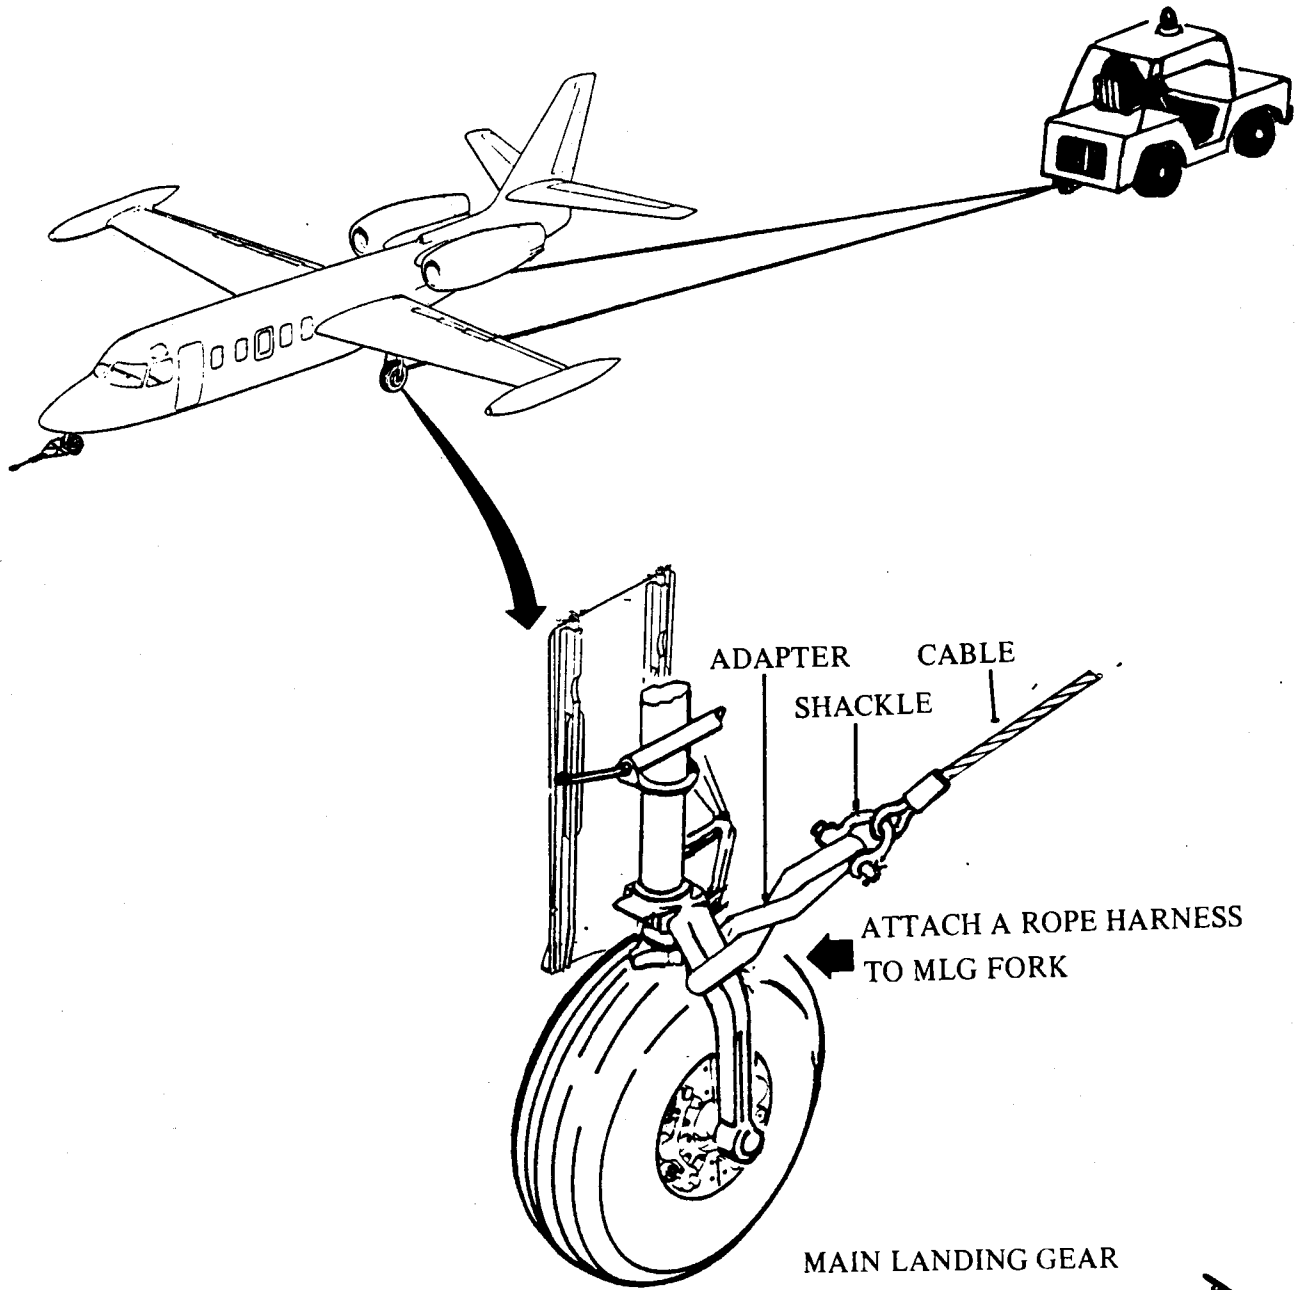
Towing and Tow Bar Installation  
Figure 1 (Sheet 1 of 2)

To prevent damage to the nose landing gear and steering linkage, personnel involved in towing operations of Westwind aircraft are encouraged to:

1. Review the towing procedures in the 1124/1124A Westwind Maintenance Manual [reference attached pages 1 through 4 (9-10-00)].
2. Inspect placards installed on nose gear door, reference Figure 1 below, for existence, condition and legibility. Missing or deteriorated placards should be replaced.

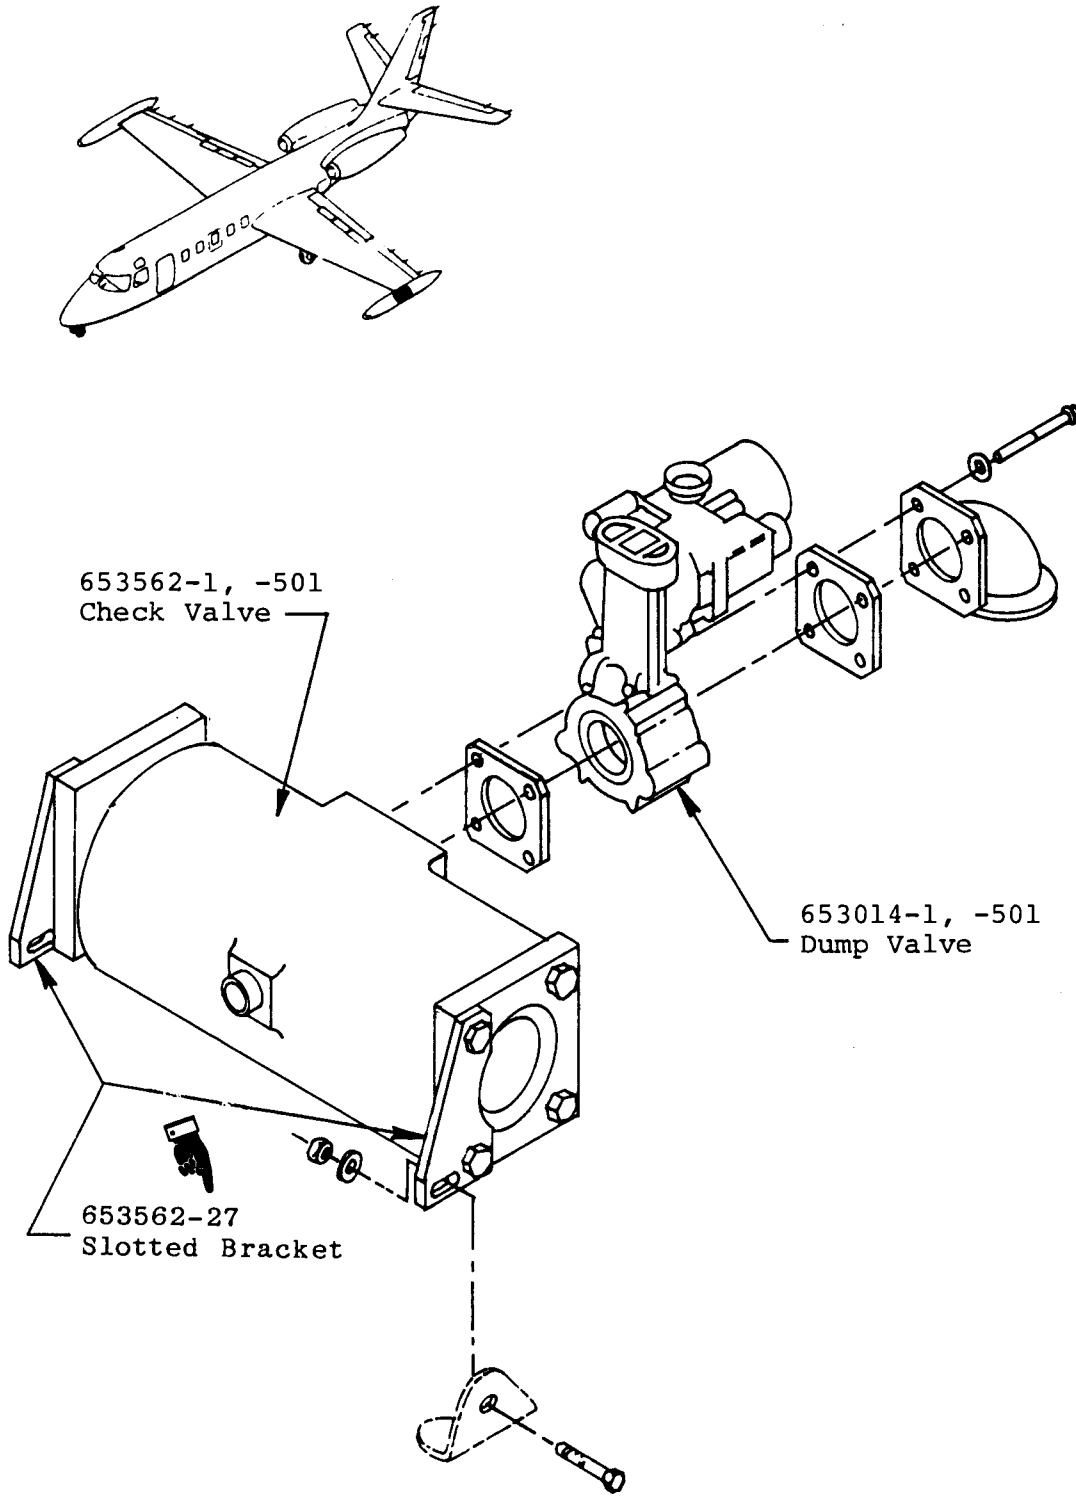
FIGURE 1 (RIGHT HAND SAME)

The referenced fuel dump valves differ in width by .250". To allow interchangeability, P/N 653562-13 or 653562-23 check valve mounting brackets are replaced with two 653562-27 brackets. The replacement brackets are slotted to allow the 653562-1, -501 check valve to be shifted forward or aft sufficiently to allow either style dump valves to be installed. It is recommended that this modification (Figure 1) be accomplished at the next dump valve replacement.

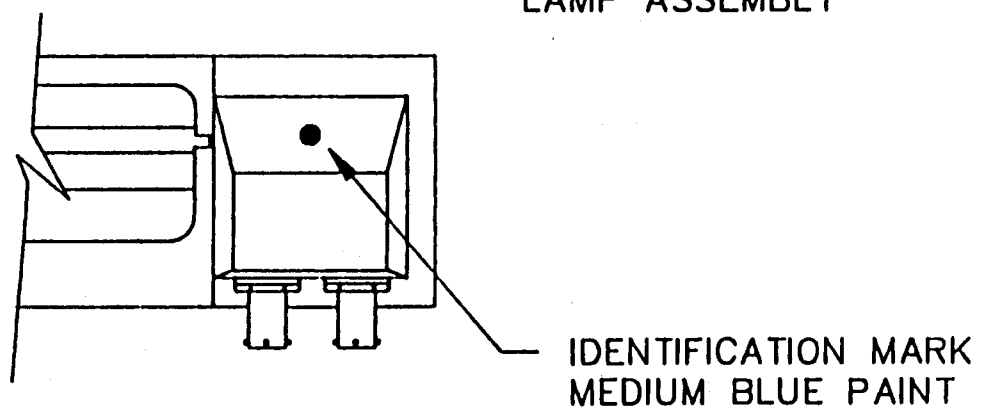
# FIGURE A-1

TYPICAL VIEW -  
ONE END OF 6 mm  
LAMP ASSEMBLY

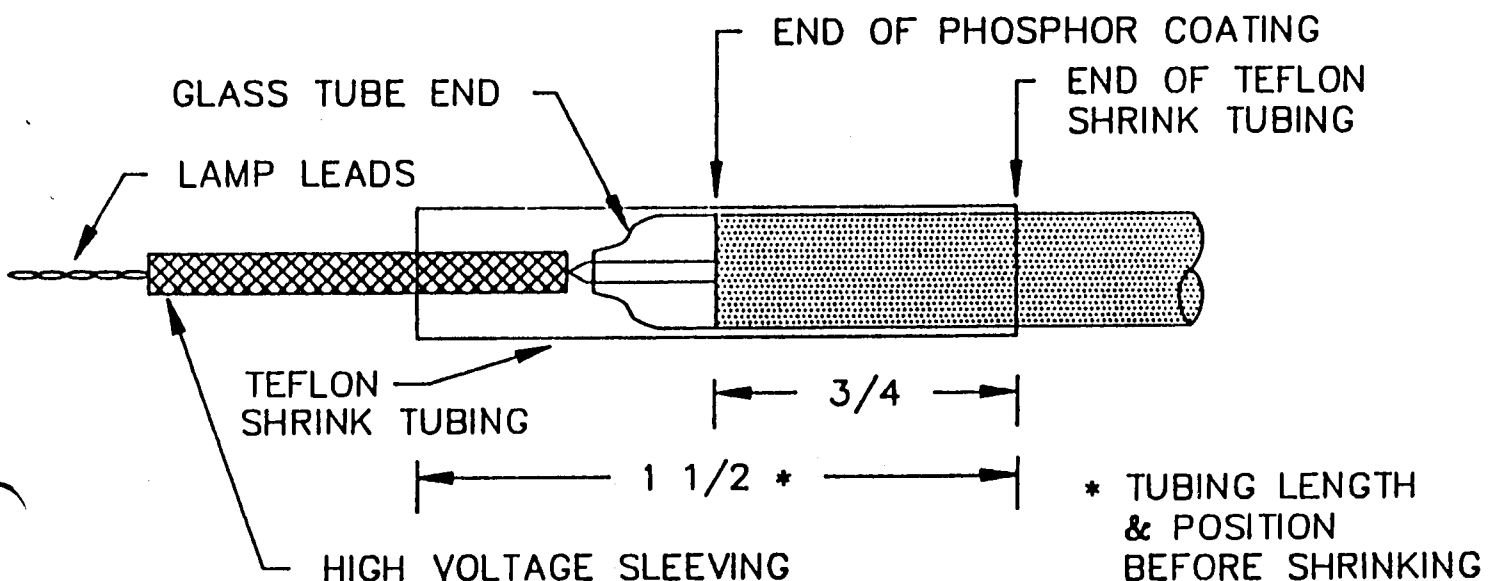
FIGURE B

TYPICAL VIEW -  
ONE END OF 6 mm LAMP  
WITH INSULATION SLEEVING RETRO-FIT

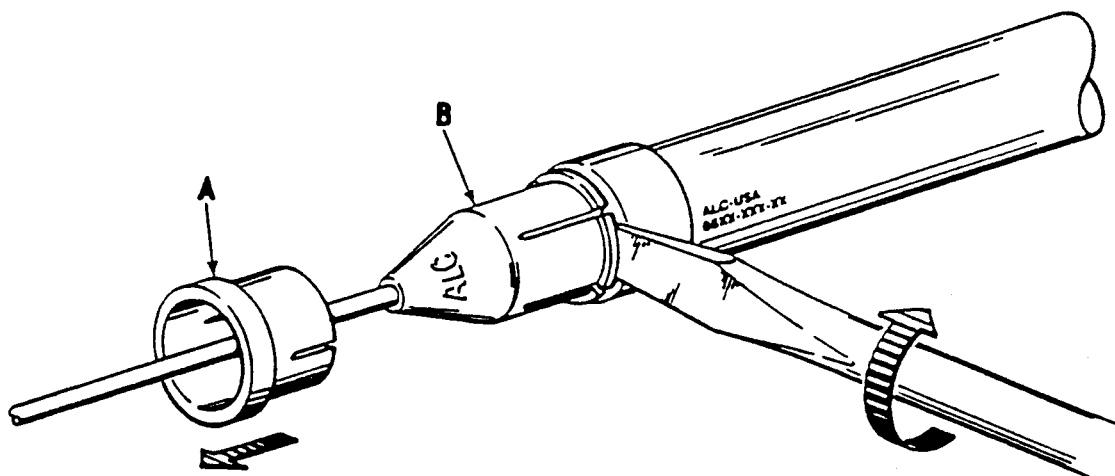
**Figure 1 REMOVAL OF LOCKING RING AND LAMP CONNECTOR BODY**

4.1.1 Remove Locking Ring (Item A) from Lamp Connector Body (Item B) by sliding ring away from lamp connector.

4.1.2 Place flat head screwdriver between Lamp Connector Body (Item B) and lamp end. Disengage Lamp Connector Body from lamp end by carefully twisting screwdriver.

4.1.3 Remove and discard Contact Pin (Item D) by cutting wire as close as possible to start of insulation.

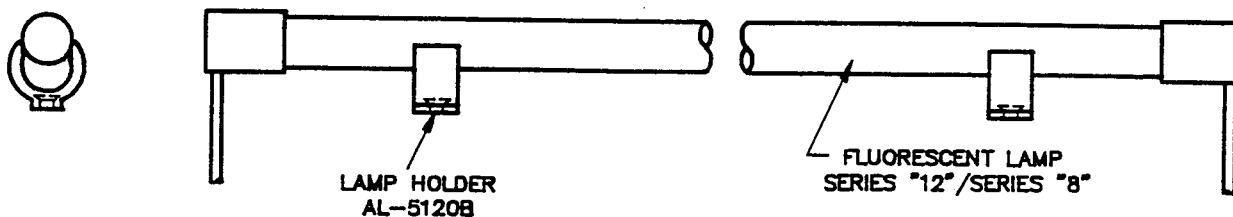
Figure 4 LAMP PLACEMENT

The lamp holder has been redesigned to facilitate removal and installation of lamps. The new part, AL-5120B, is a direct replacement for 31.87/AL-0519 Lamp Holder.

4.4.1 Place lamp on top of the holders (see Figure 4).

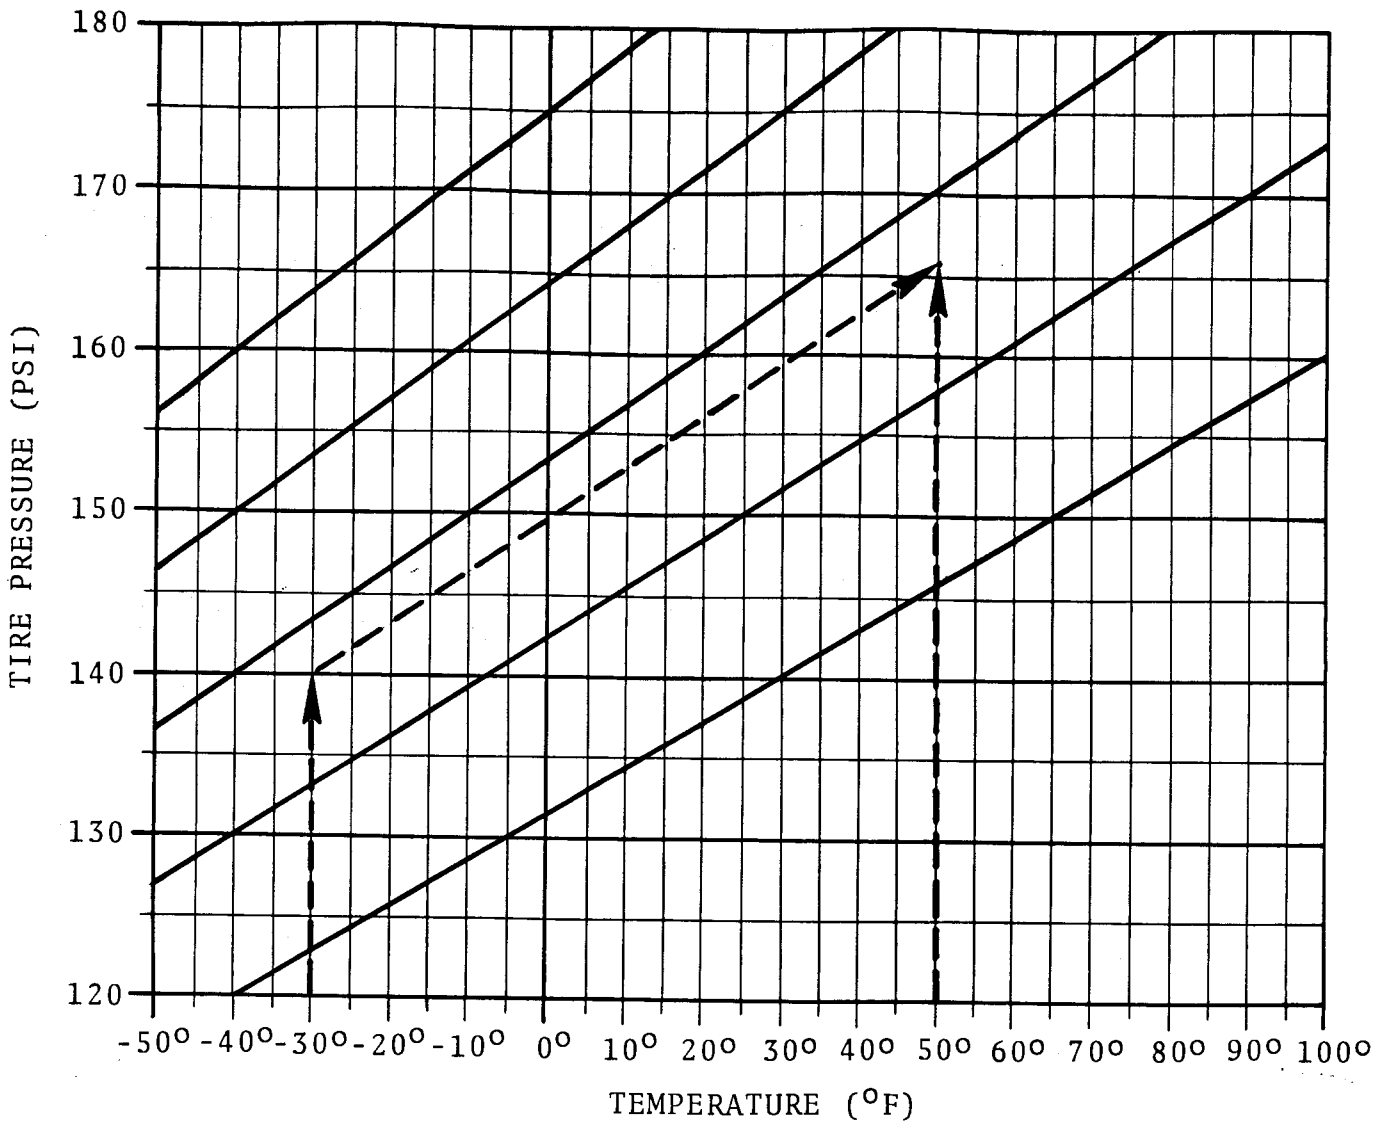
FIGURE #1

Since it has not been possible to duplicate the rapid tire pressure loss under controlled conditions, we suggest the following precautions be taken when operations are considered into or out of an area where the ambient temperature is below  $10^{\circ}\text{F}$ :

3. The allowed leakage rate of a mounted and inflated tire is 5% or approximately 8 psi in 24 hours. Also, tire pressure will fluctuate with temperature. For each 5°F of temperature change the tire pressure will change approximately 1.5 psi. For these reasons, TIRE PRESSURE SHOULD BE CHECKED DAILY. If large temperature changes are to be encountered, then tire pressure should be serviced prior to each flight. When operations are to be made from a moderate temperature to a colder temperature, then tire pressure should be adjusted so that the pressure upon arrival will be approximately 140 psi. Use Figure 1 as a guide to adjust tire pressure to maintain a minimum of 140 psi. After returning to moderate temperatures, tire pressure should be reduced to the recommended pressure of 155 psi.

Figure 1 illustrates that with an expected destination temperature of  $-30^{\circ}\text{F}$ , tire pressure should be increased to 166 psi with an ambient temperature of  $50^{\circ}\text{F}$ .

4. Goodyear recommends a maximum tire pressure of 166 psi be observed, however in some cases it may be necessary to exceed this value to insure adequate tire pressure upon arrival at a destination where very cold ambient temperatures are expected. Be advised that operations with tire pressures in excess of 166 psi will tend to reduce wheel and bolt life, depending on gross weight and taxi distances.

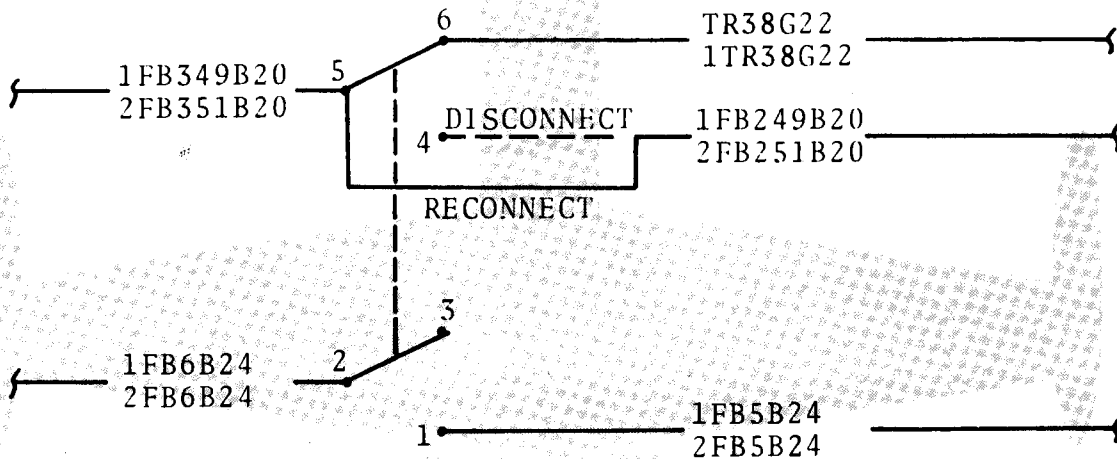
S31(#1) or S32(#2) DG SELECTOR SWITCH

The following modification will allow operation of the flight director and RNS 300 systems, without heading warning, when compass switch is moved to "DG" or free position.

These changes will still allow for proper system failure warnings.

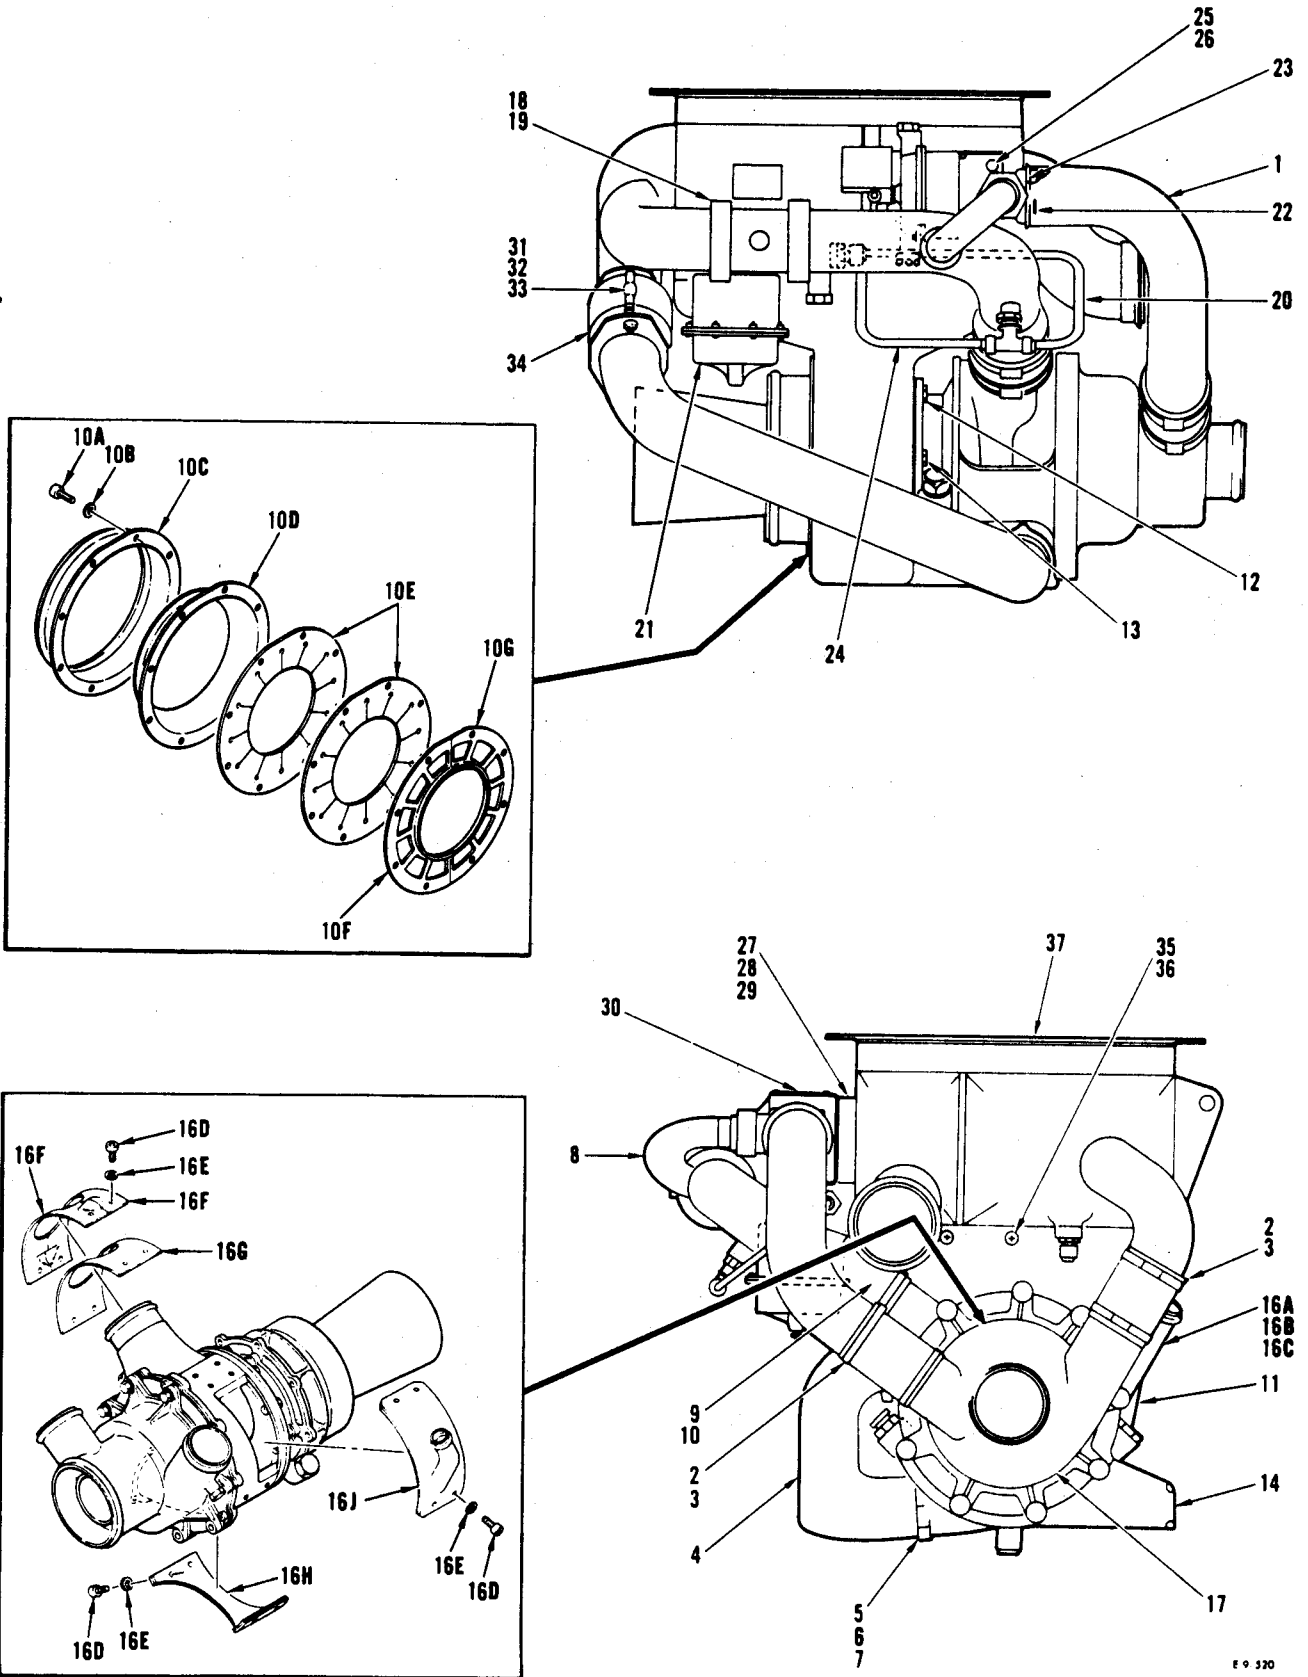
Aircraft Refrigeration Unit  
Figure 1

NOTE: Install turbine in sequence noted during removal. When installing turbine bracket assembly (14, figure 1), torque the two turbine bolts 20 to 25 pound-inches.

Replace 572375-3 Cooling Turbine with 572375-2 Cooling Turbine and add adapter assembly and cover plate to provide for connection to heat exchanger ram air inlet duct.

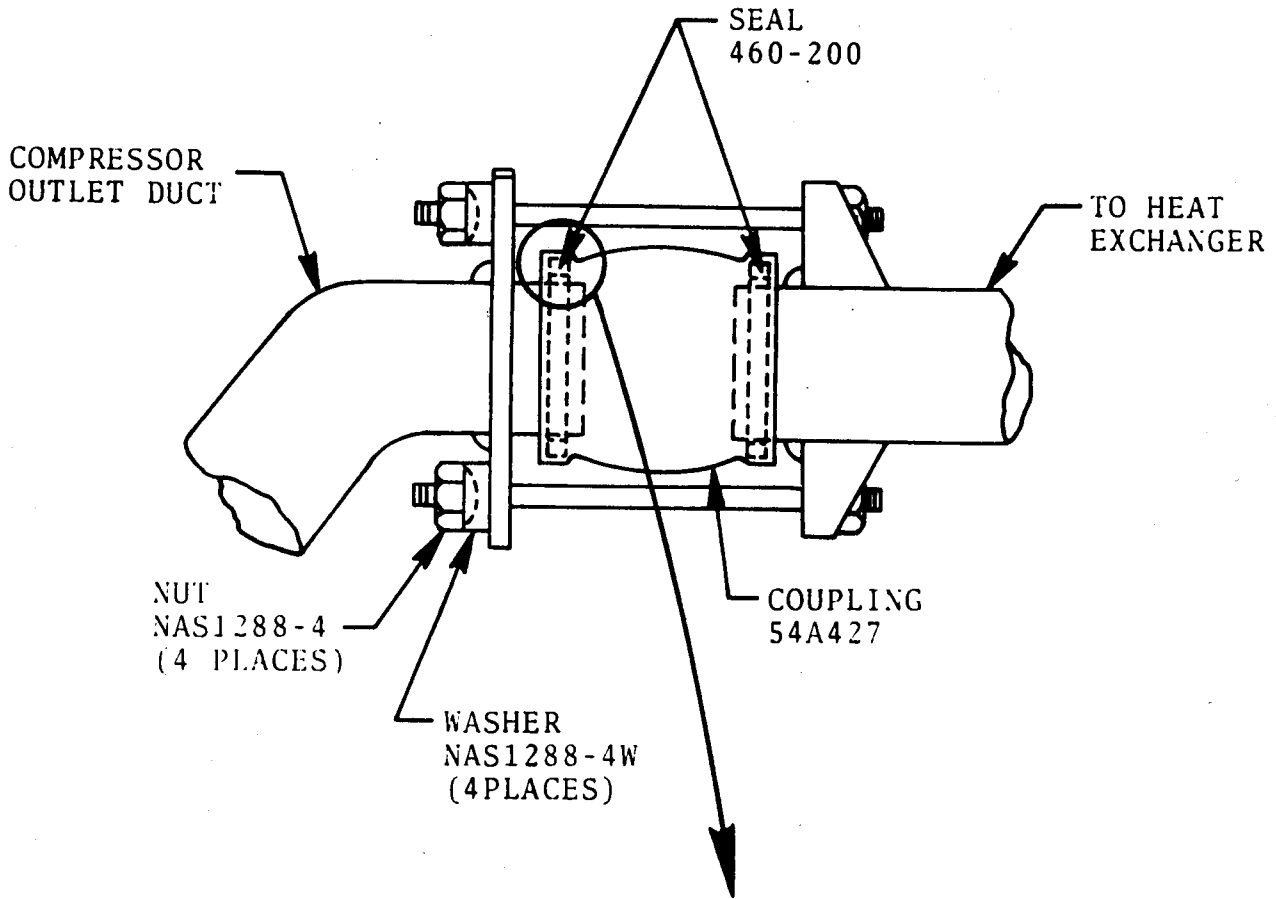
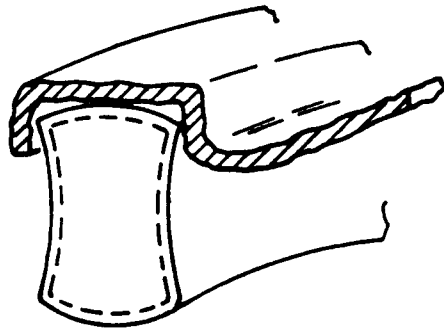
FIGURE 1 COOLING TURBINE  
COUPLING

To further assure proper installation of refrigeration unit caution should be exercised in assembly of the Peri-Seal Coupling P/N 54A27 (located in the duct from the compressor outlet of the turbine to the secondary heat exchanger). New seals P/N 460-200 should be installed wherever Peri-Seal Coupling is disassembled or leakage is suspected. Reassemble Peri-Seal Coupling per Figure 1.

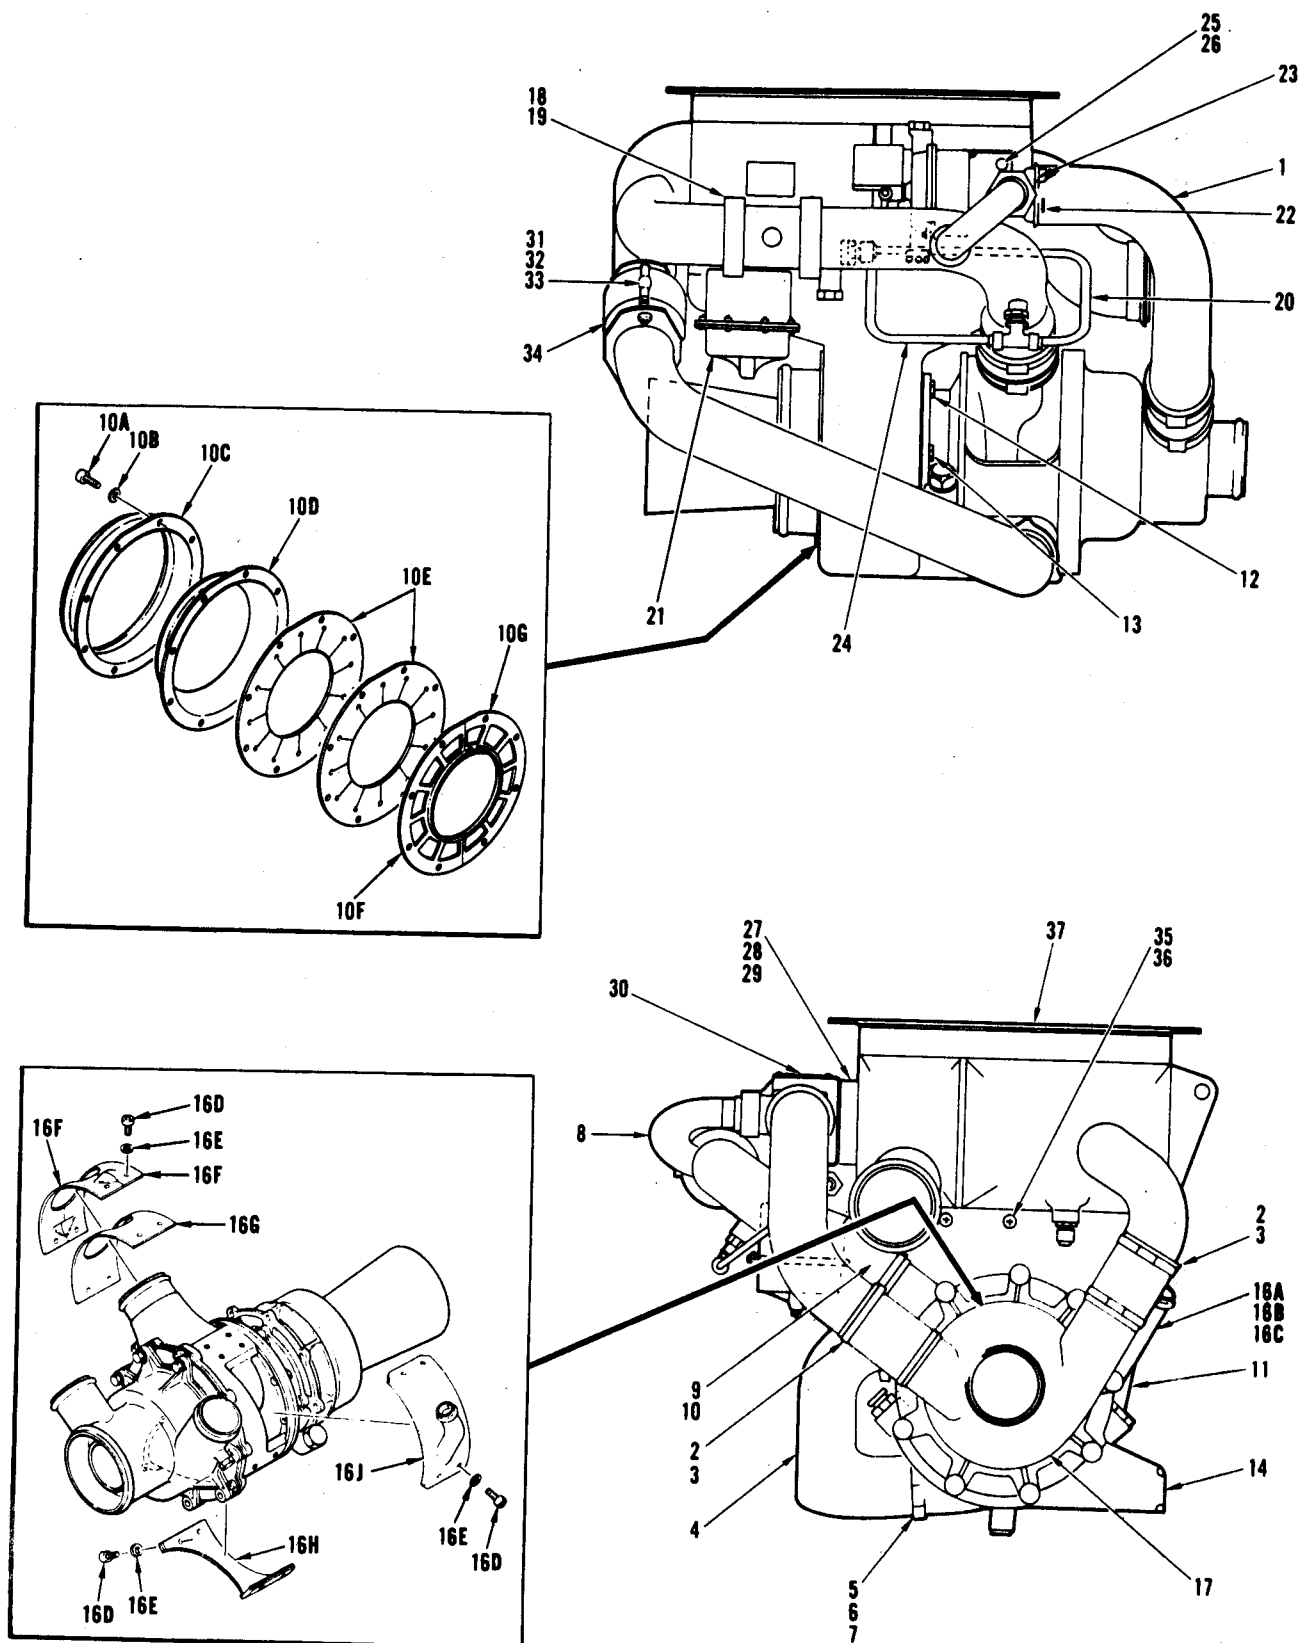
Figure 2. Aircraft Refrigeration Unit

- e. Remove screws (10A), washers (10B), flange (10C), dampener (10D), flappers (10E), and retainer halves (10F, 10G). If flappers (10E) are torn, wrinkled, or show evidence of deterioration, replace flappers.

- j. Install replacement cooling turbine (17) in plenum assembly (11) with bolts (12, 13); cross-tighten bolts. After bolts are installed, check that cooling turbine does not bind.
