SERVICE INFORMATION LETTER

SERVICE INFORMATION LETTER INDEX

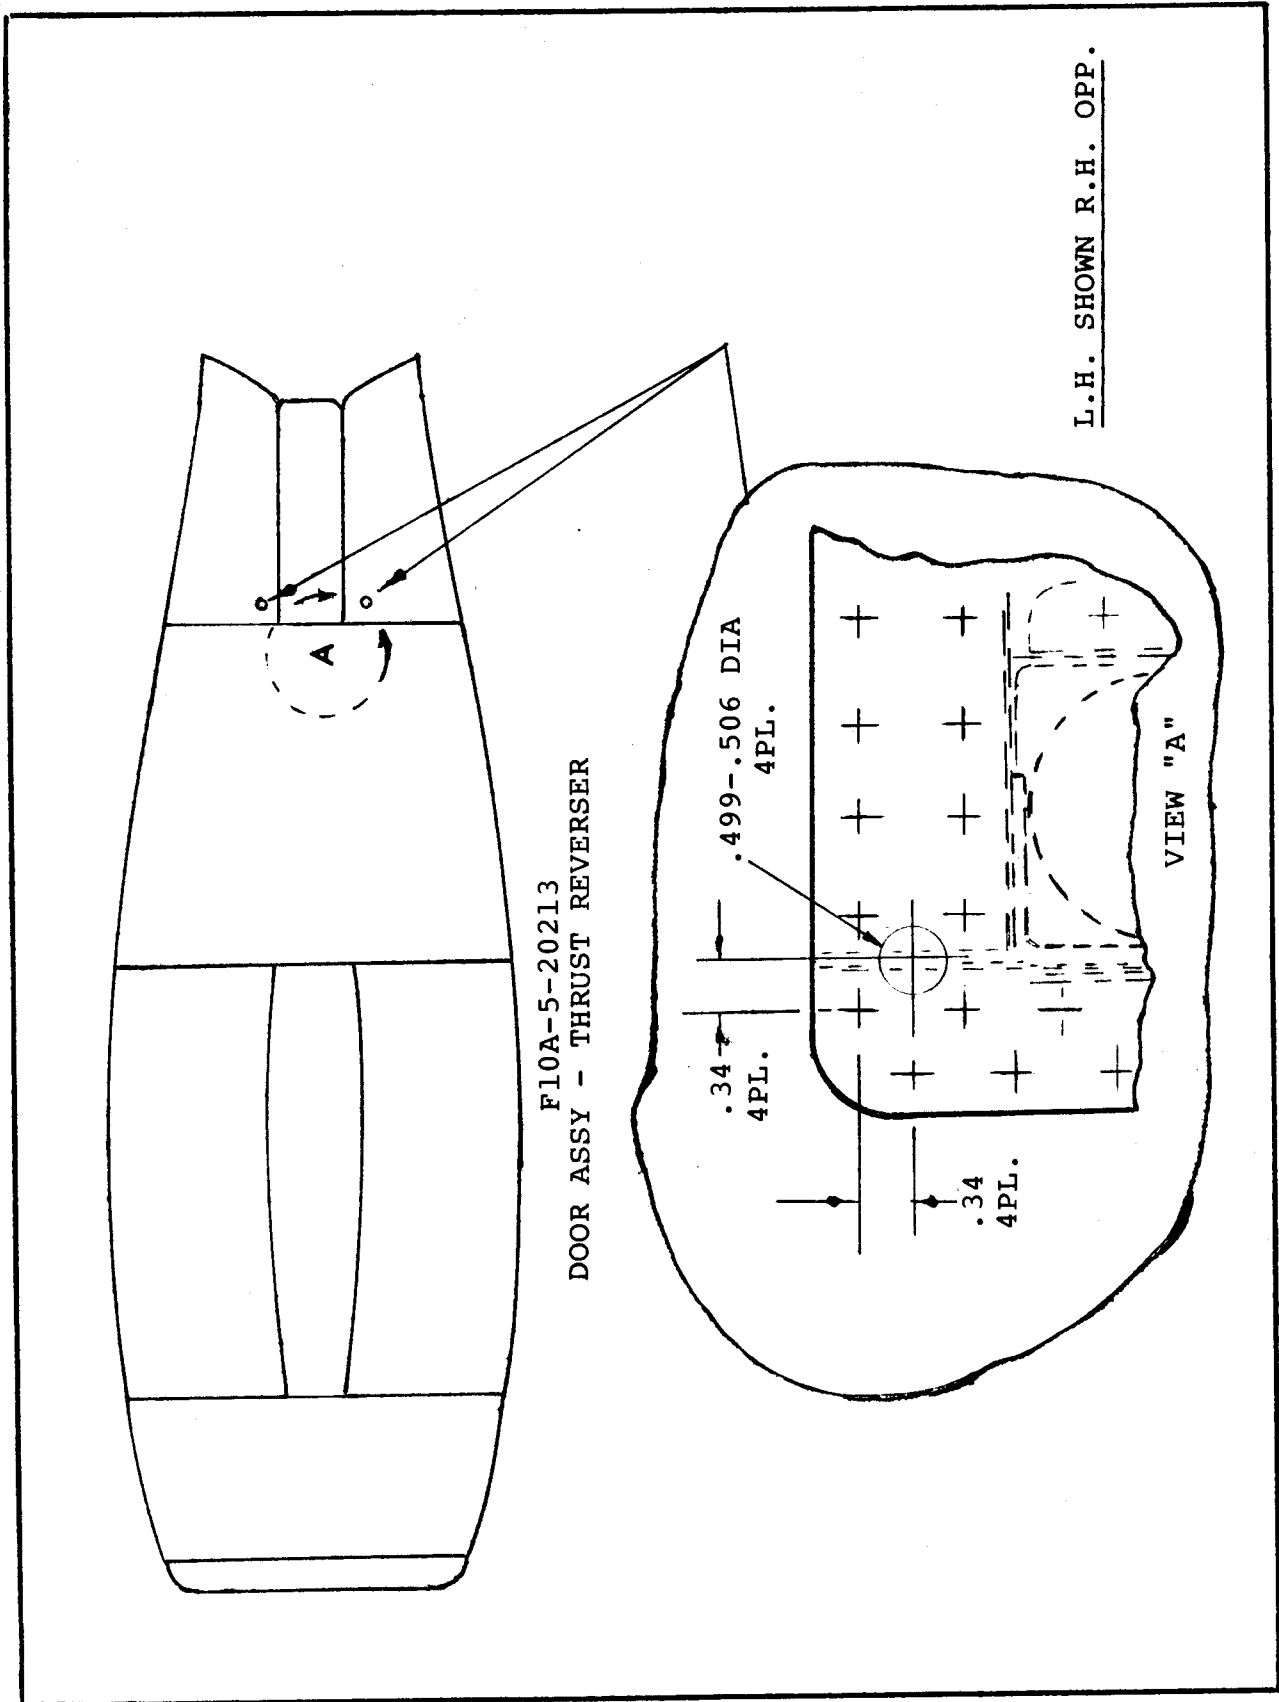
F10A-5-20213
 DOOR ASSY - THRUST REVERSER

Make appropriate entry in aircraft permanent maintenance records as follows: Service Letter No. WW-2401 Dated _____, entitled "Inspection Hole In T/R Doors", accomplished (DATE) _____.

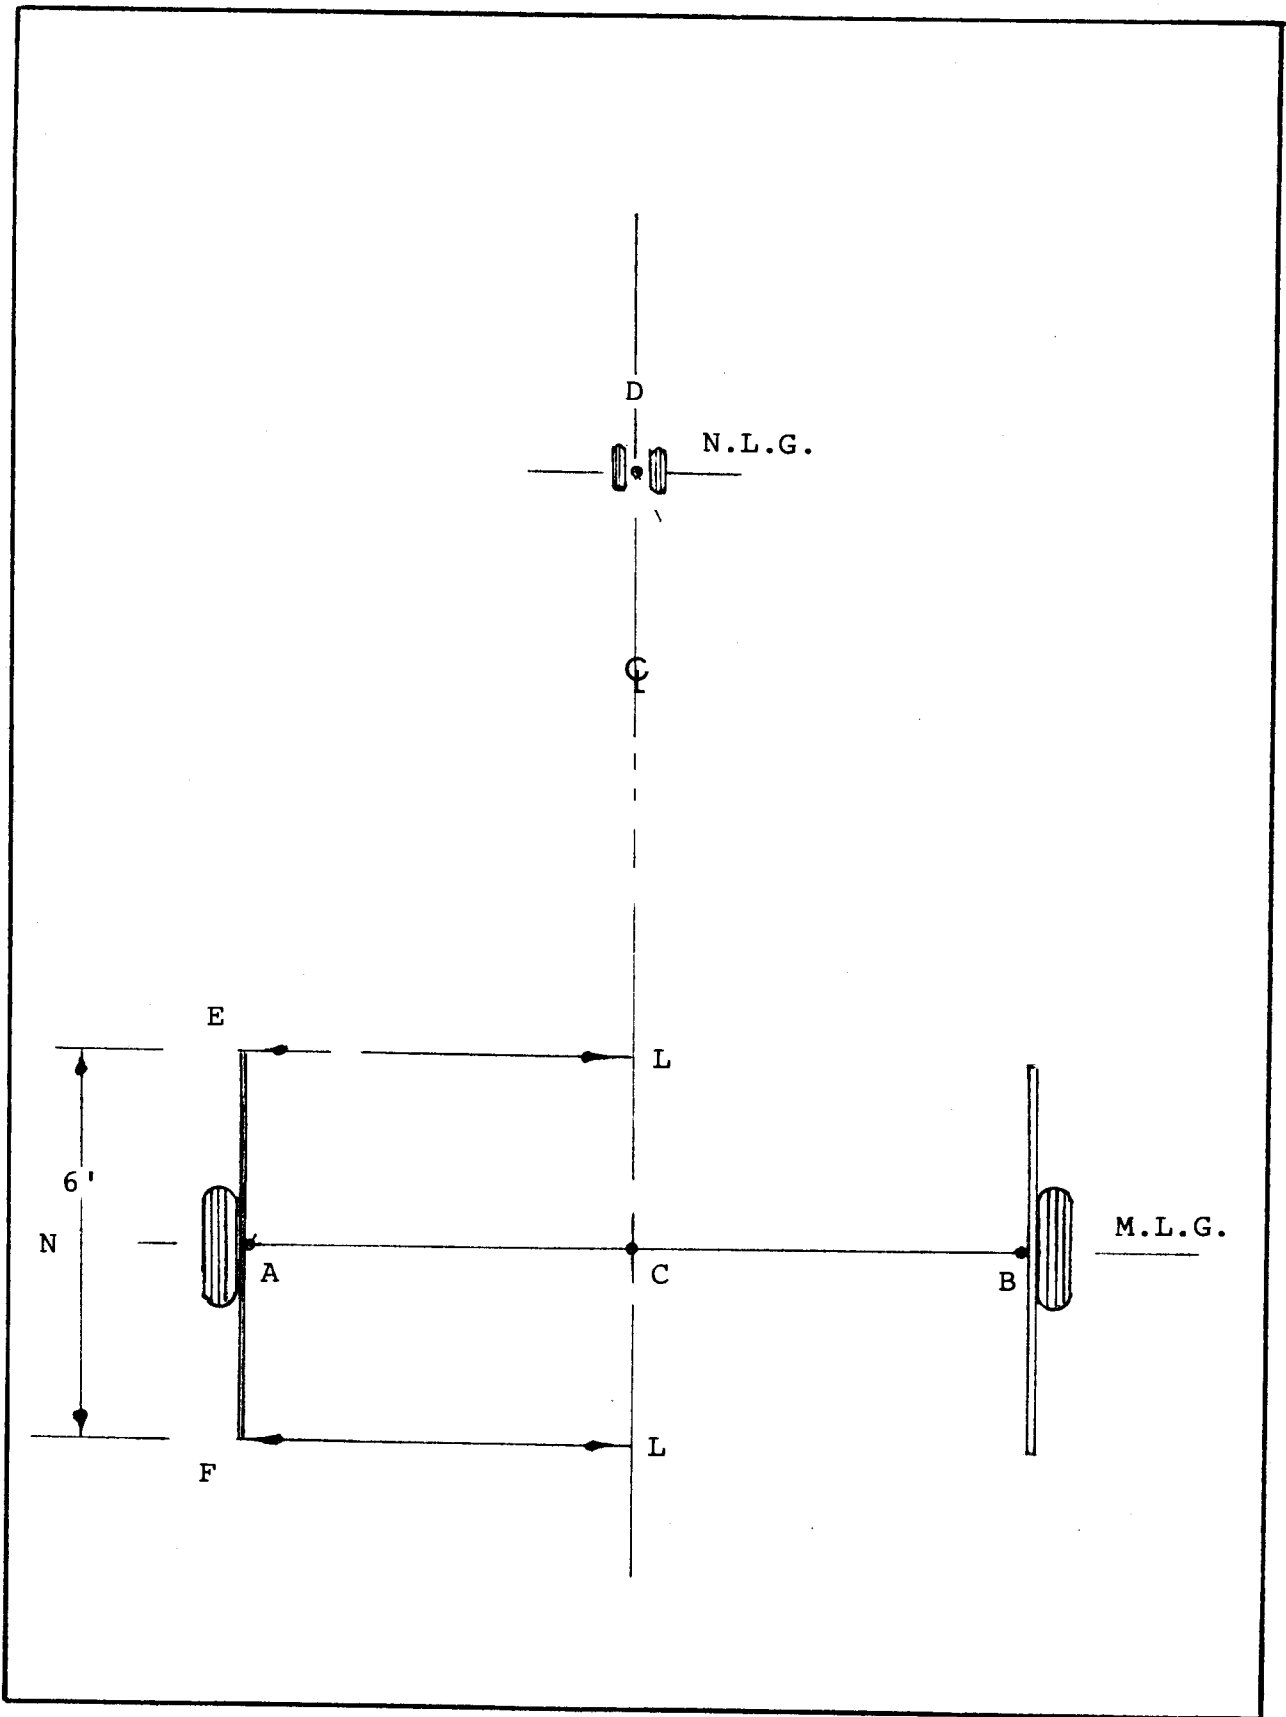
FIGURE 1

PURPOSE: CHANGE OF PARALLELISM PROCEDURES TO MINIMIZE TIRE WEAR BY TOE-OUT ADJUSTMENT.

- d. Repeat steps 5 and 7 to check adjustment.
 - e. Install locking key on upper end of lower scissor arm.
 - f. Install bolt, washer and nut securing the locking key to the upper end of lower scissor arm. Torque nut to 50-70 in/lbs.
8. Remove straight edge and spacer from wheel.
9. Repeat step (7) on the opposite wheel.
10. Replace fuses in jet pack and check standby horizon operation.
11. Remove the aircraft from jacks.

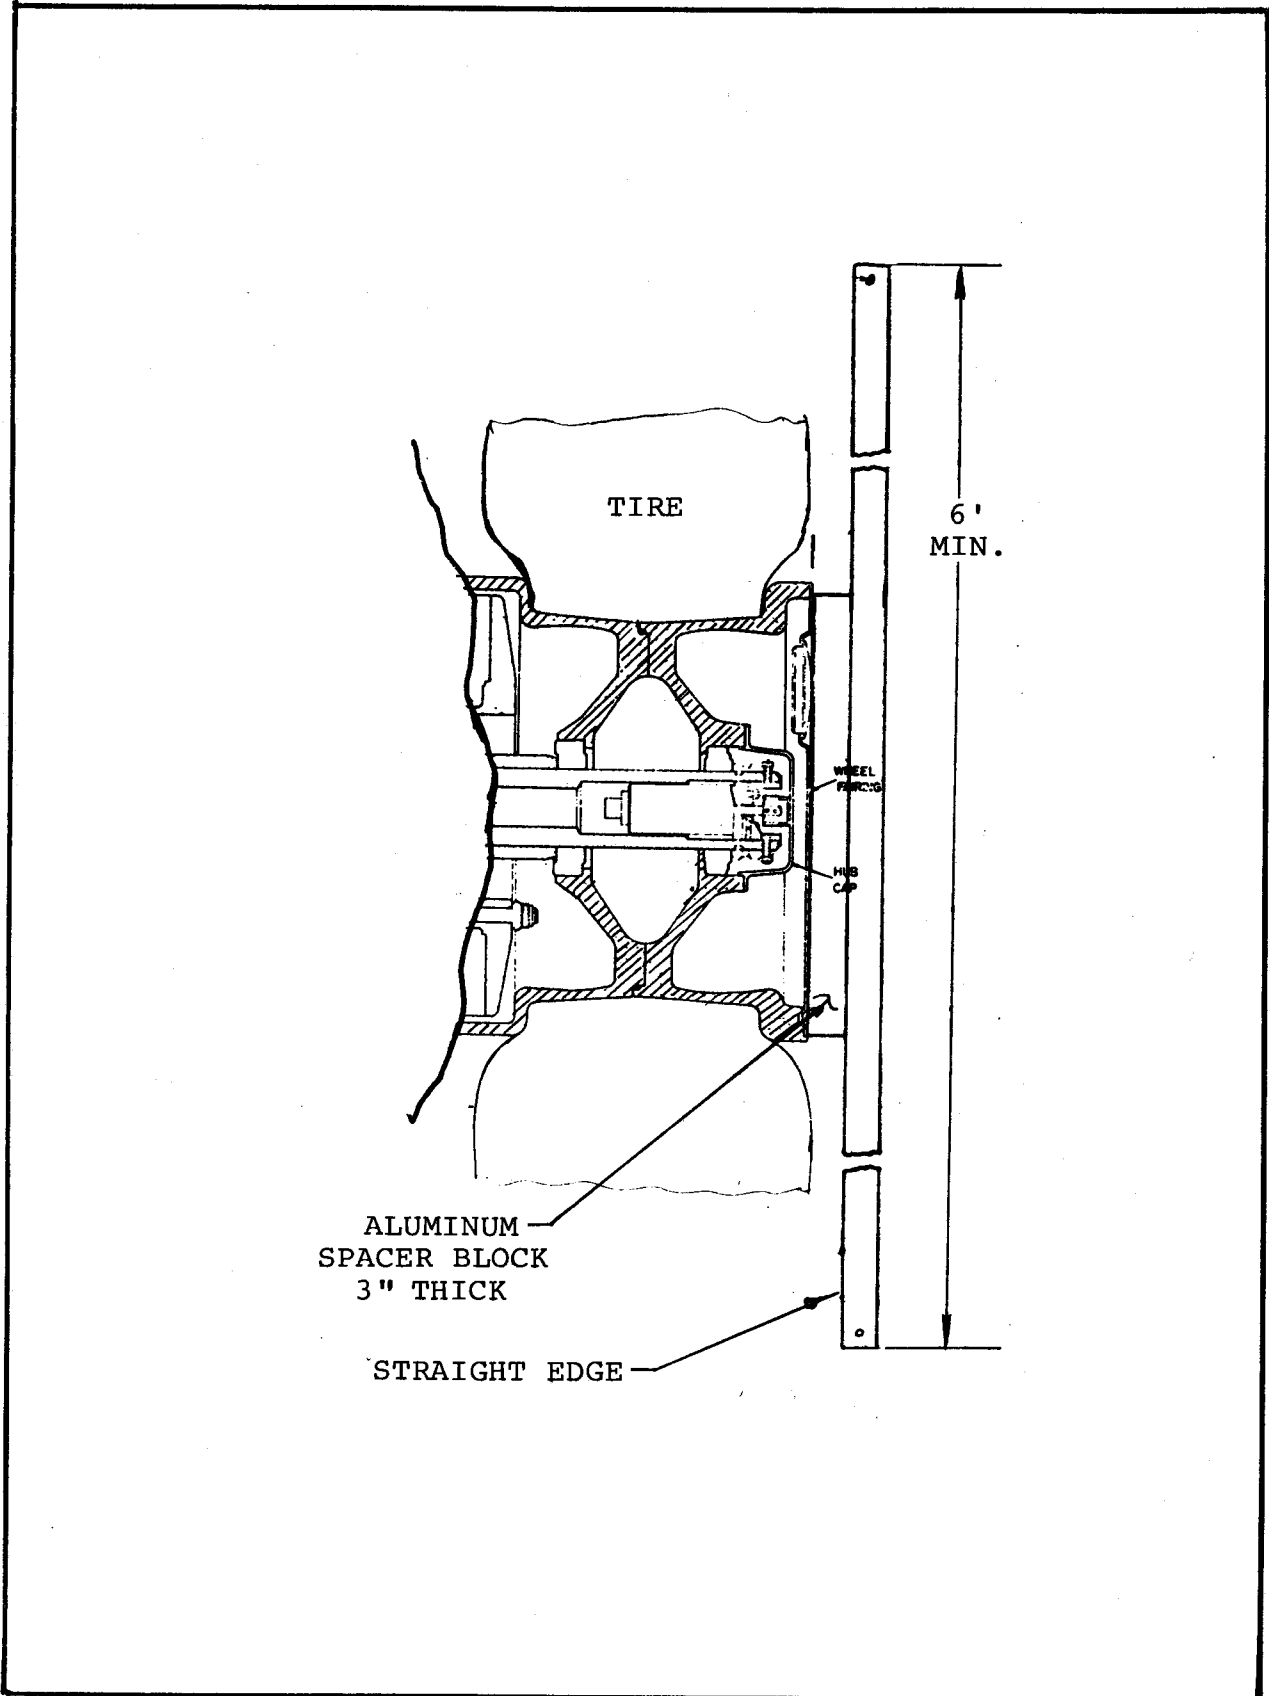
Figure 2

PARALLELISM ADJUSTMENT

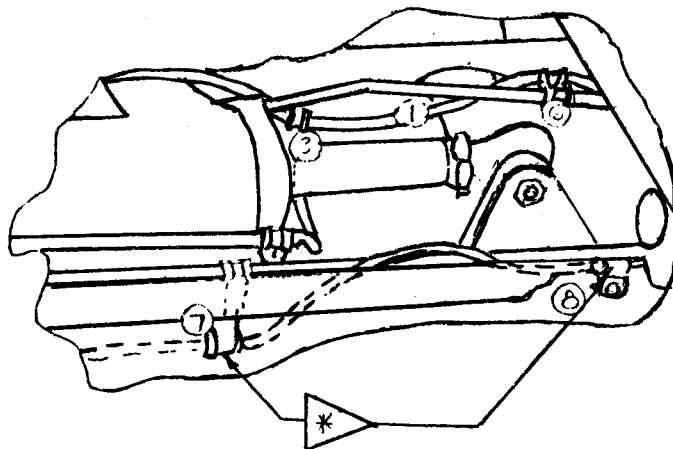
FIGURE 1

THRUST REVERSER WIRING
(L/H NACELLE ONLY)

WRAP SUFFICIENT TAPE AT 7 & 8
(GT100AY0101108) AROUND WIRE
BUNDLE TO RESTRICT SLIDING
THRU CLAMPS

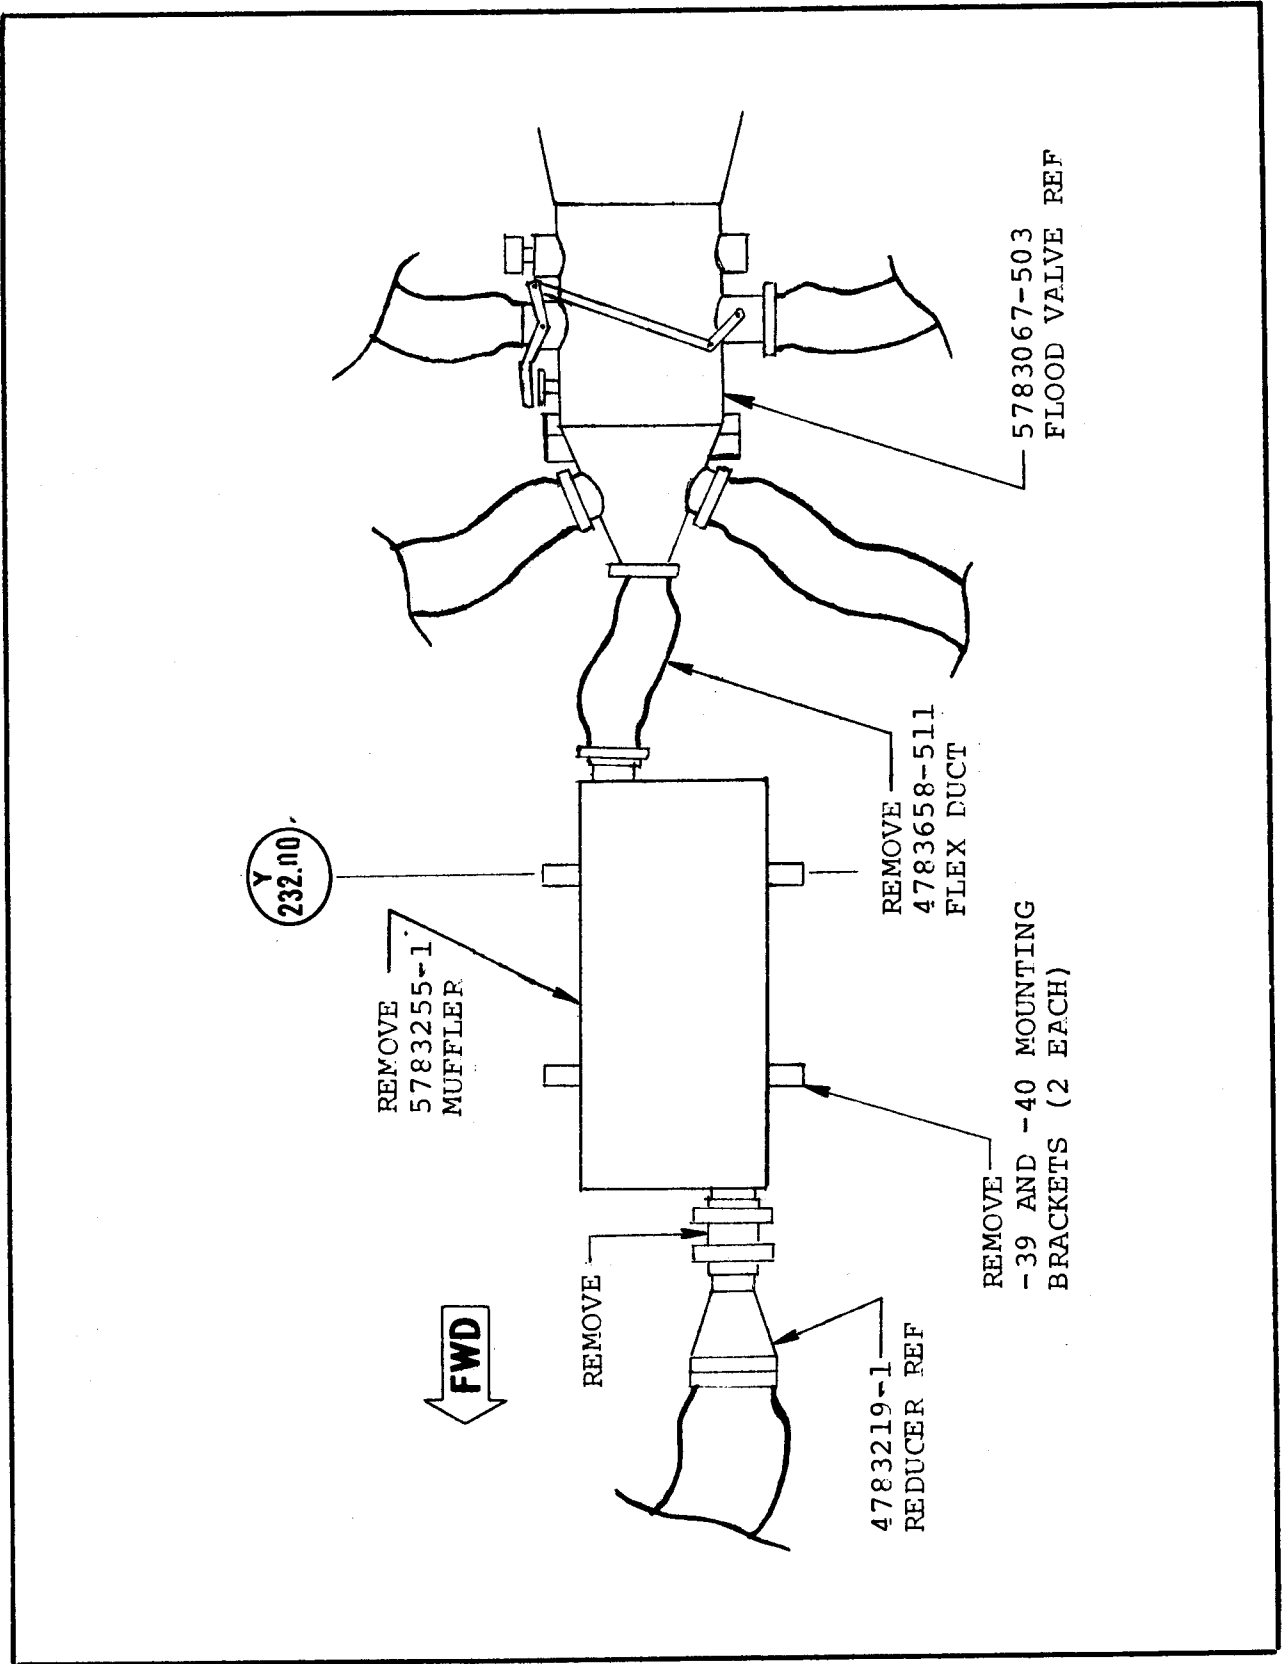
FIGURE 1

EFFECTIVITY: MODEL 1124 AIRCRAFT, S/N 187, 188, AND 189
SUBJECT: REMOVAL OF AIR-CONDITIONING MUFFLER
COMPLIANCE: AT NEXT 150 HOURS INSPECTION.
APPROVAL: I.A.I. ENGINEERING.
PURPOSE: TO INCREASE THE FLOW OF CONDITIONED AIR
TO COCKPIT.

1. Gain access to air-condition muffler under the floor in rear cabin area.
2. Remove floor as required to enable work.
3. Disconnect and remove Muffler P/N 5783255-1, Flex Duct P/N 4783658-511, coupling duct, and Clamps P/N U84-210SH. Drill out rivets of -39 and -40 muffler mounting brackets; remove brackets. (SEE FIGURE 1)
4. Install Flex Duct P/N 4783658-523 between Reducer P/N 4783219-1 and Flood Valve P/N 5783067-503, using 2 each Clamps P/N U84-210SH originally removed (SEE FIGURE 2).
5. Relocate one -40 bracket to provide support for Flex Duct P/N 4783658-523, and secure with NAS1398D4-2 rivets. Install Clamp P/N MS21919DG35; locate and drill .190 dia. hole in -40 bracket for proper alignment of Flex Duct. Secure Clamp to bracket with AN3C4 Bolt, AN960-10L Washers (2 required), and MS20365-1032 Nut. (SEE FIGURE 2)
6. Close up floor and reinstall interior.

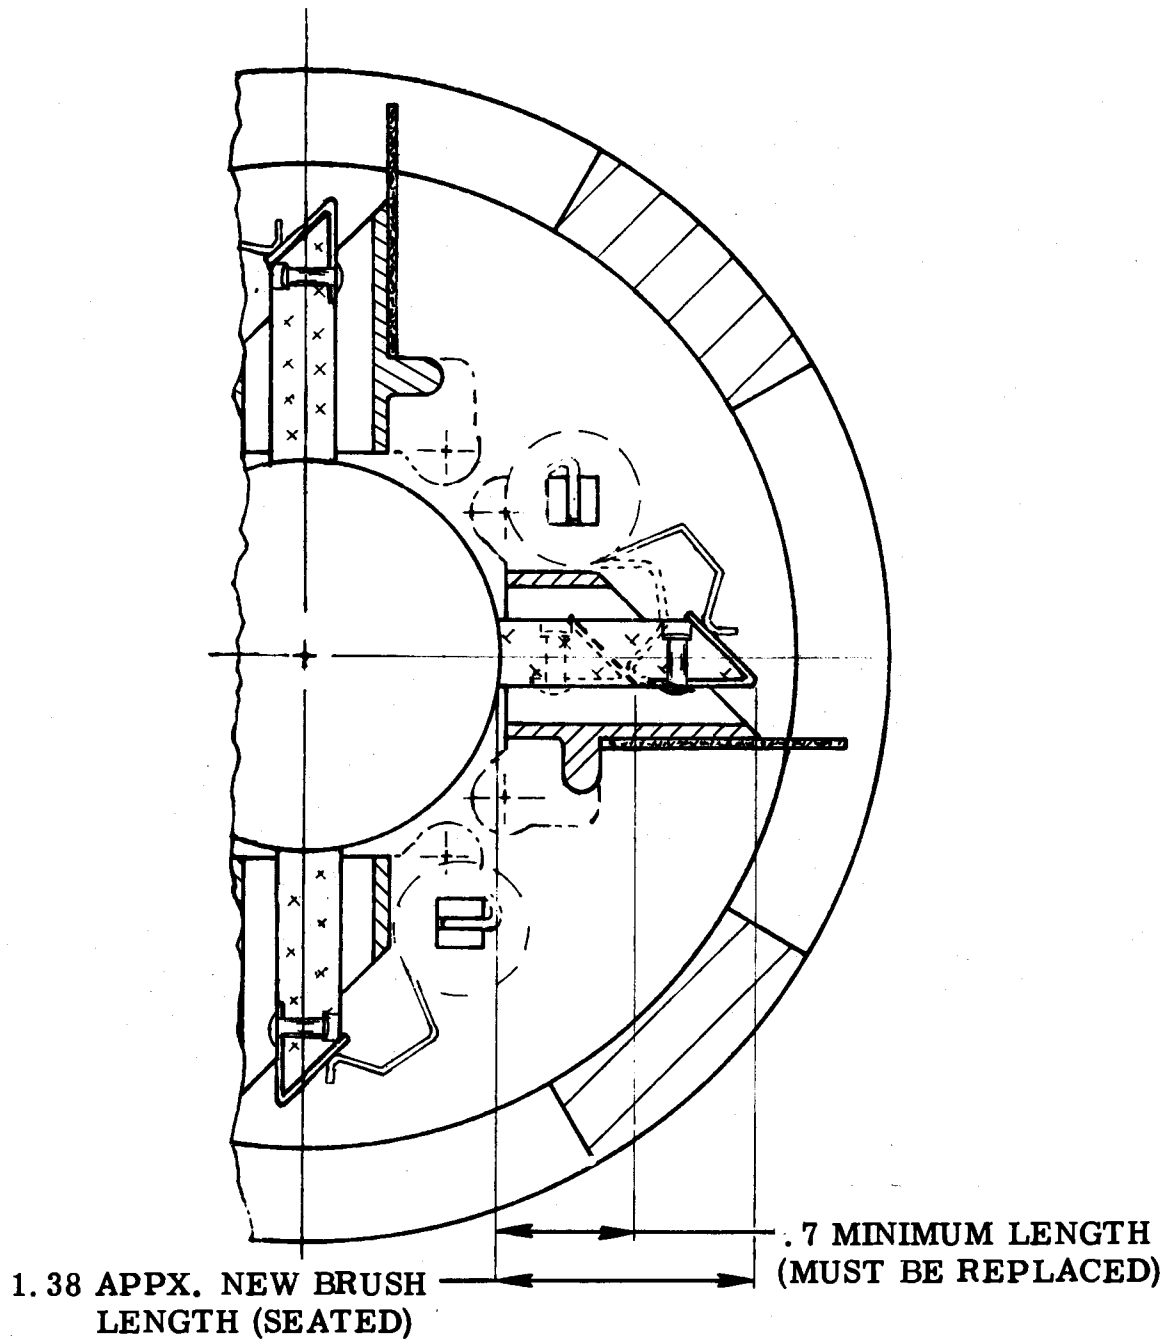
MEASUREMENT OF STARTER-GENERATOR BRUSHES

5. A newly installed brush has an approximate over all length of 1.38 inch (Seated). It is recommended the brush assemblies be replaced when brushes are worn to a length of .875 inch, or 450 operating hours, whichever occurs first. Brushes must be replaced when worn to a .70 inch overall length. (SEE FIGURE 2).

CONTINUED USE OF THE STARTER-GENERATOR WITH ANY BRUSH OF MINIMUM LENGTH OR LESS WILL LIKELY RESULT IN DAMAGE TO THE COMMUTATOR AND FAILURE OF THE STARTER-GENERATOR.

- (1) A uniform wear rate may not be assumed.
 - (2) Reports indicate one starter-generator may experience a higher wear rate than the other unit.
 - (3) Reports indicate aft brushes (nearest windings) may experience greater wear than forward brushes.
 - (4) Due to operating circumstances, a particular brush(s) may abruptly experience an accelerated wear rate.
7. Inspect the armature's commutator surface. An excessively worn, grooved or discolored commutator requires immediate starter-generator maintenance or replacement. The commutator surface should be a brownish color. "Bluish" discoloration indicates overheating conditions; check for electrical overloading causes and for starter-generator cooling air leaks or restrictions. Blackened discoloration indicates "arcing" due to poor brush/commutator contact.

BRUSH FULLY WORN
(MUST BE REPLACED)

6. Make a judgement of remaining usable brush wear length and estimated operating hours. Any brush with less than 50 hours estimated operating time remaining requires the starter-generator to be scheduled for brush assembly replacement.

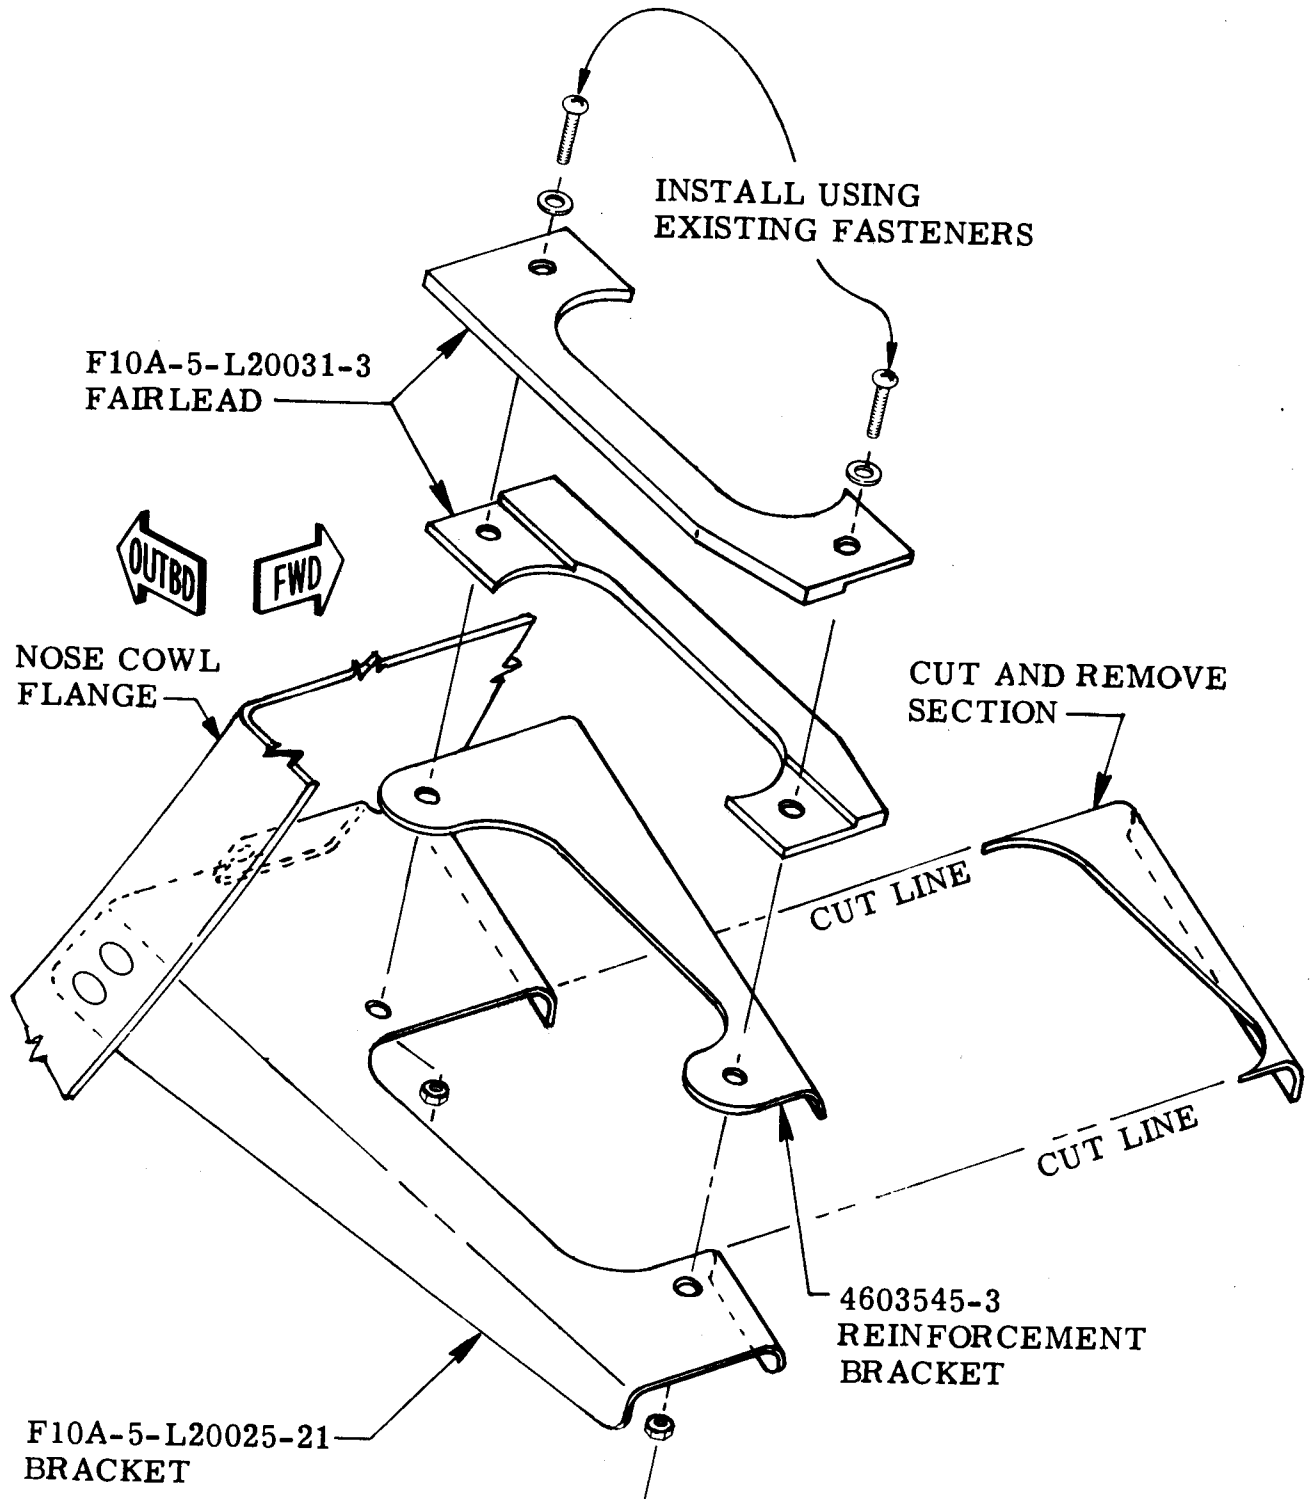
FIGURE 1

GENERATOR CABLES SUPPORT BRACKET INSTALLATION
- REWORK -

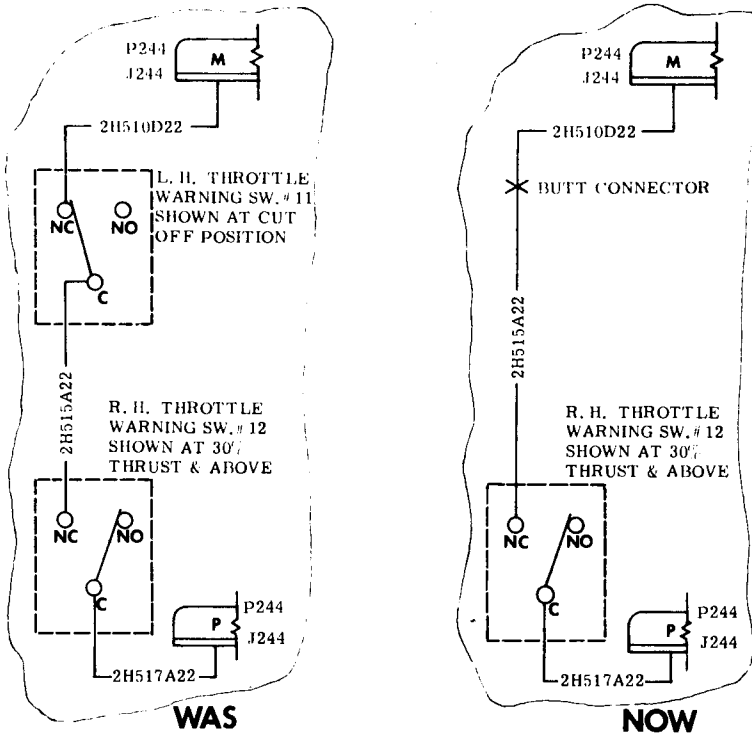
WIRING MODIFICATION-SWITCH # 11
FIGURE 1

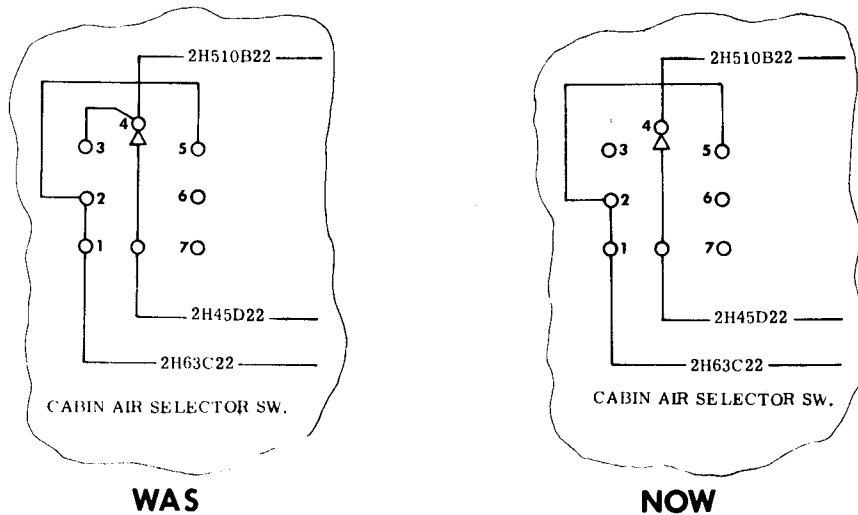
WIRING MODIFICATION-CABIN AIR SELECTOR SWITCH
FIGURE 2

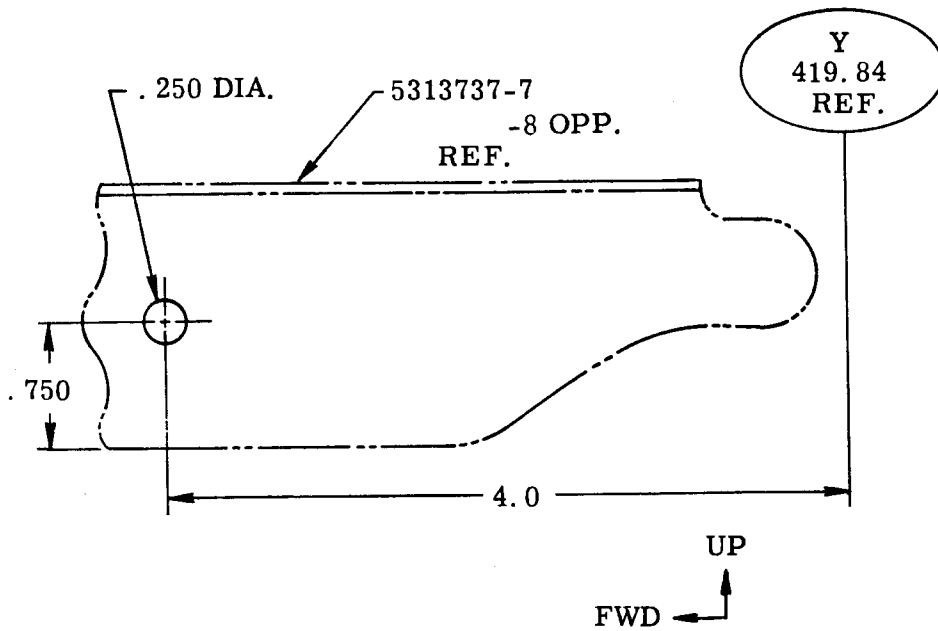
FILTER INSTALLATION
FIGURE 1

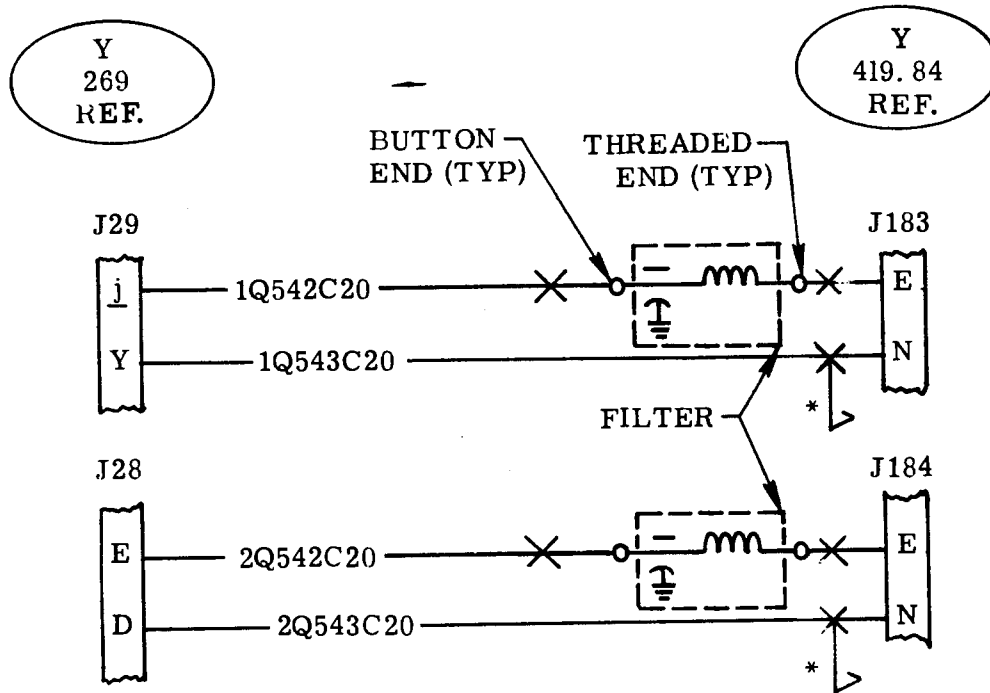
FILTER INSTALLATION
FIGURE 2

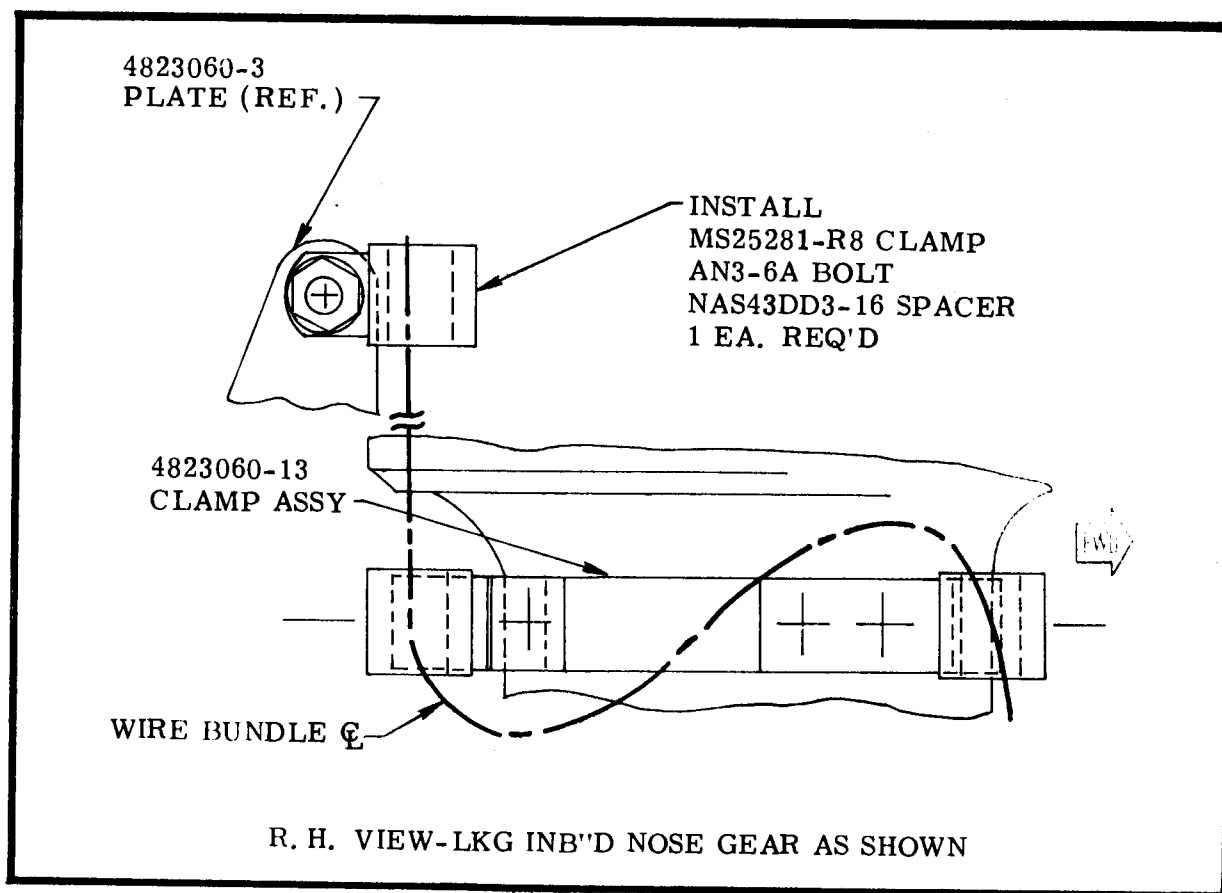
FIGURE 1

Make appropriate entry in aircraft permanent maintenance records as follows:
Service Letter No. WW-2413, dated December 20, 1977, entitled "Wire Chaffing
in Nose Gear Well" accomplished _____ (Date).

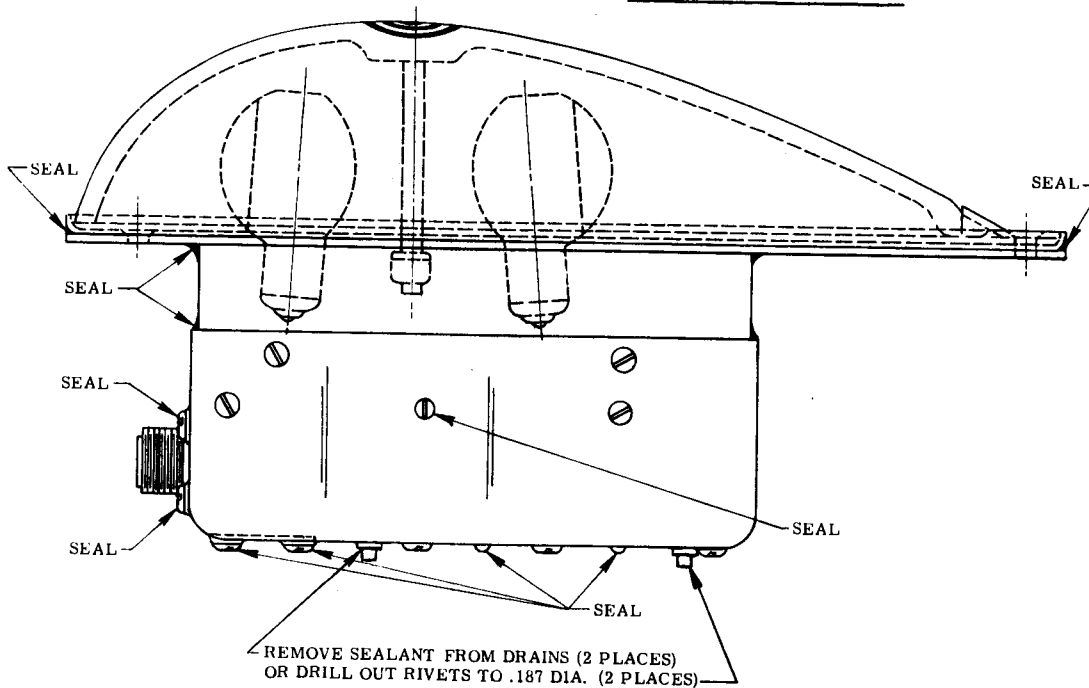
FIGURE 1

CLEARANCE OF DRAINS AND APPLICATION OF SEALANT

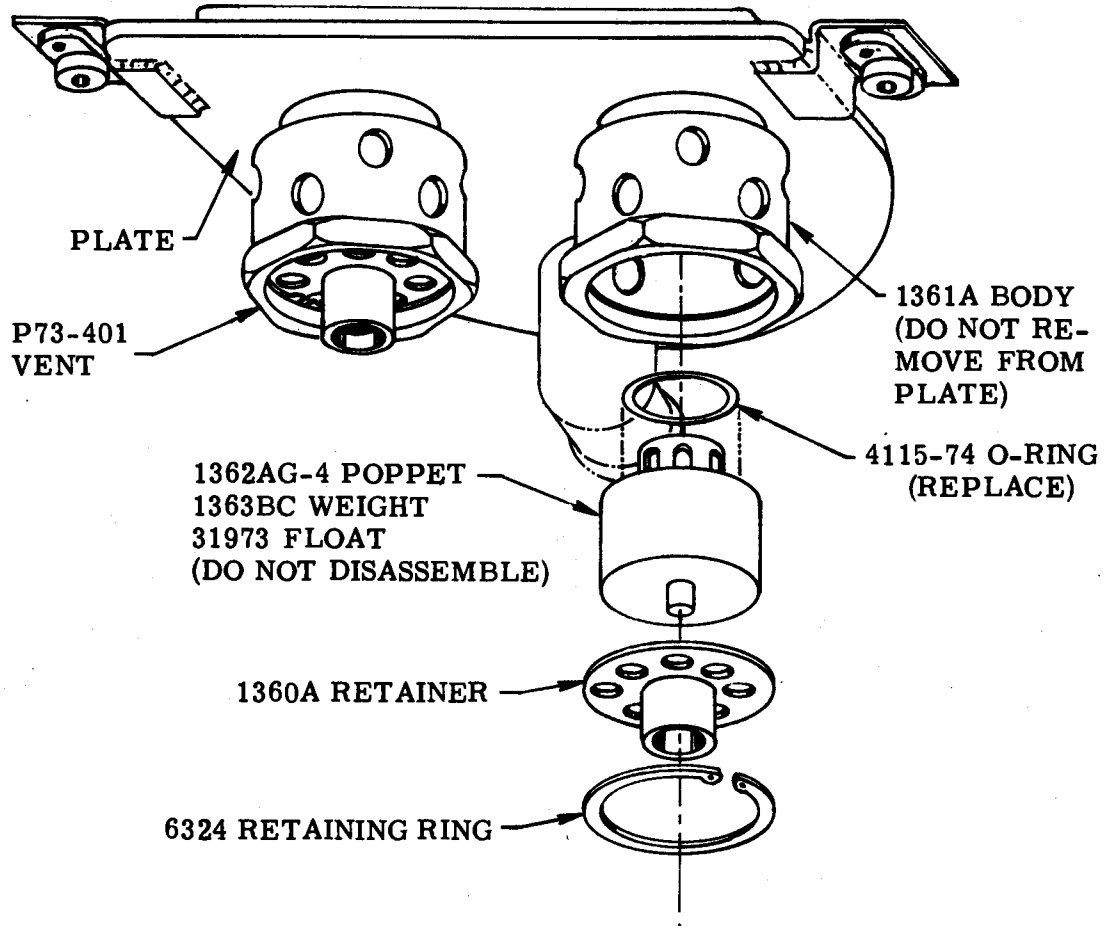
FIGURE 1

TYPICAL 5653112 FUEL VALVE ASSEMBLY

4. Perform inspection of O-rings and functional testing of the fuel vent valve assembly as follows:
 - A. Prior to installation, inspect for any surface defects on the O-rings; if no defects are detected, assemble the valves. (SEE FIGURE 1)

- D. Remove assembly from fuel and check tubing for fuel, indicating seal leakage. If any leakage is detected, replace faulty O-ring(s) and repeat immersion test until no leakage is detected.

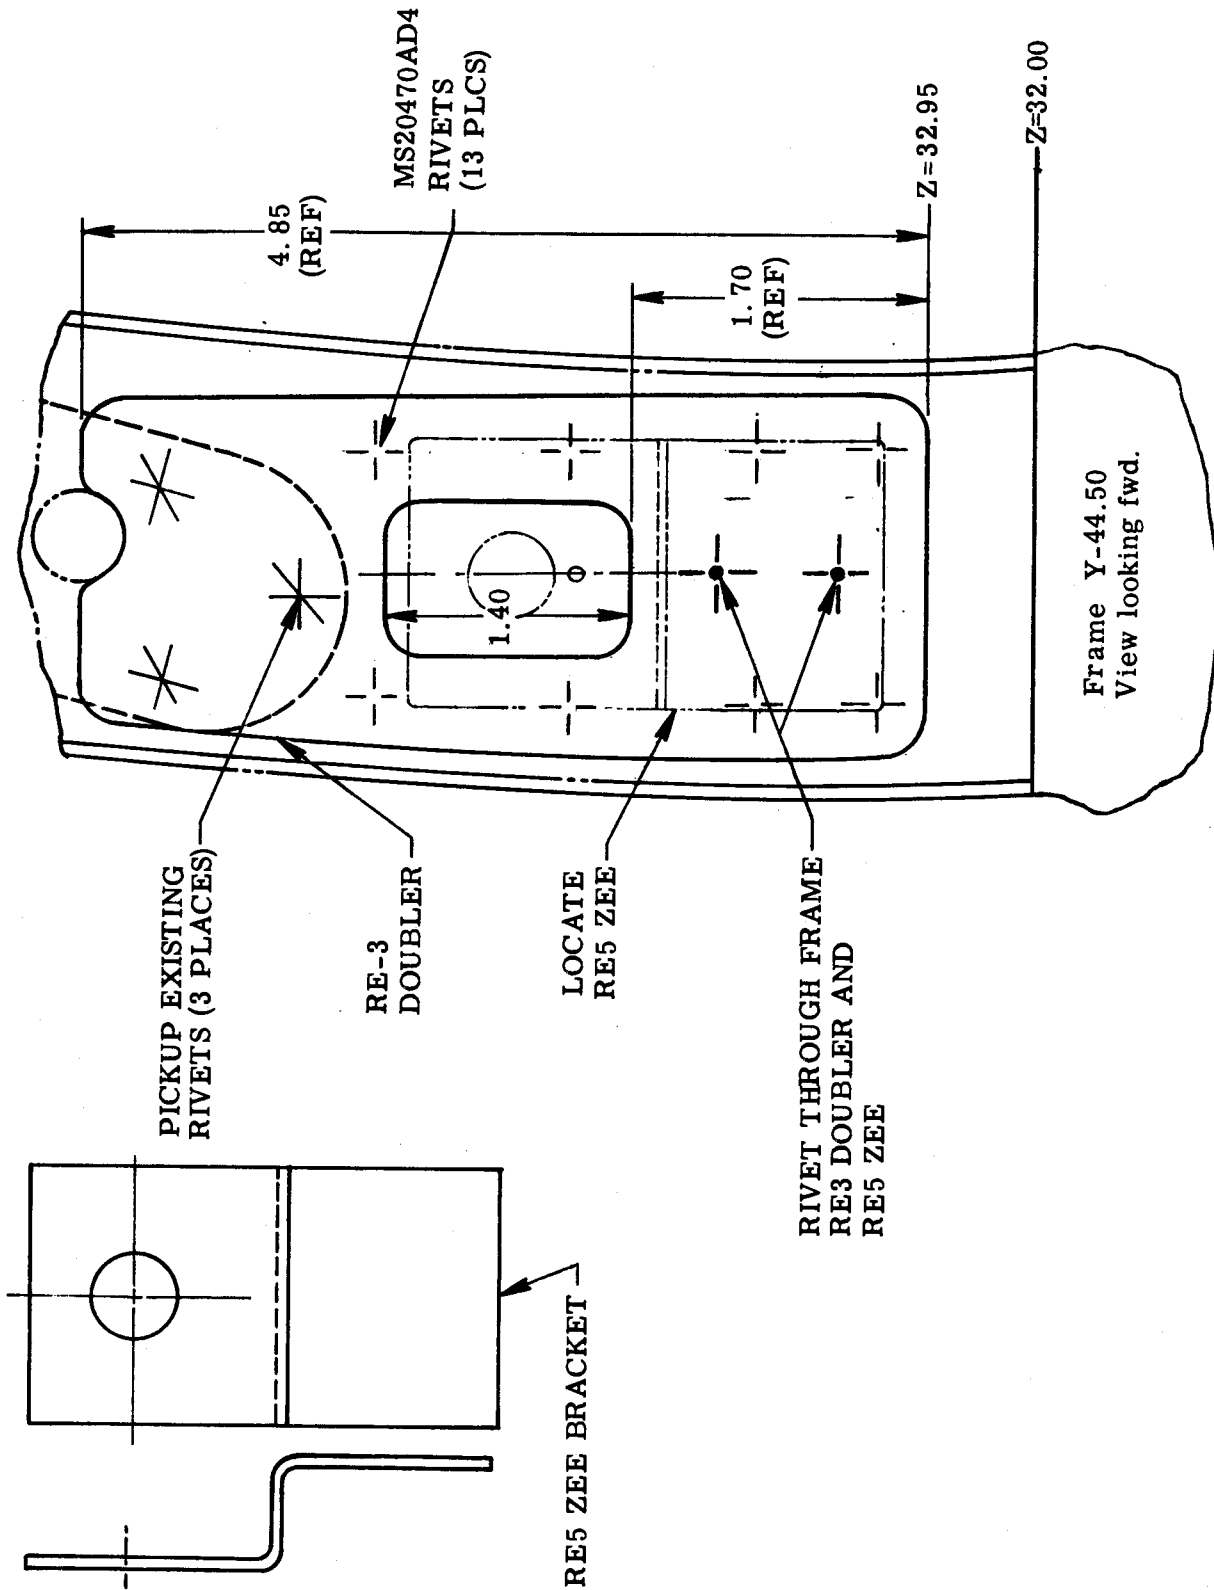
FIGURE 1

DOUBLER AND BRACKET INSTALLATION

6. Install RE3 doubler and RE5 zee bracket on Fus. Sta. 44.50 frame in accordance with Figure 1.
7. Temporarily replace pilots side panel to permit locating and marking position for RE7 placard installation. Mark center of hole to be drilled to accommodate nose steering sensitivity switch installation.

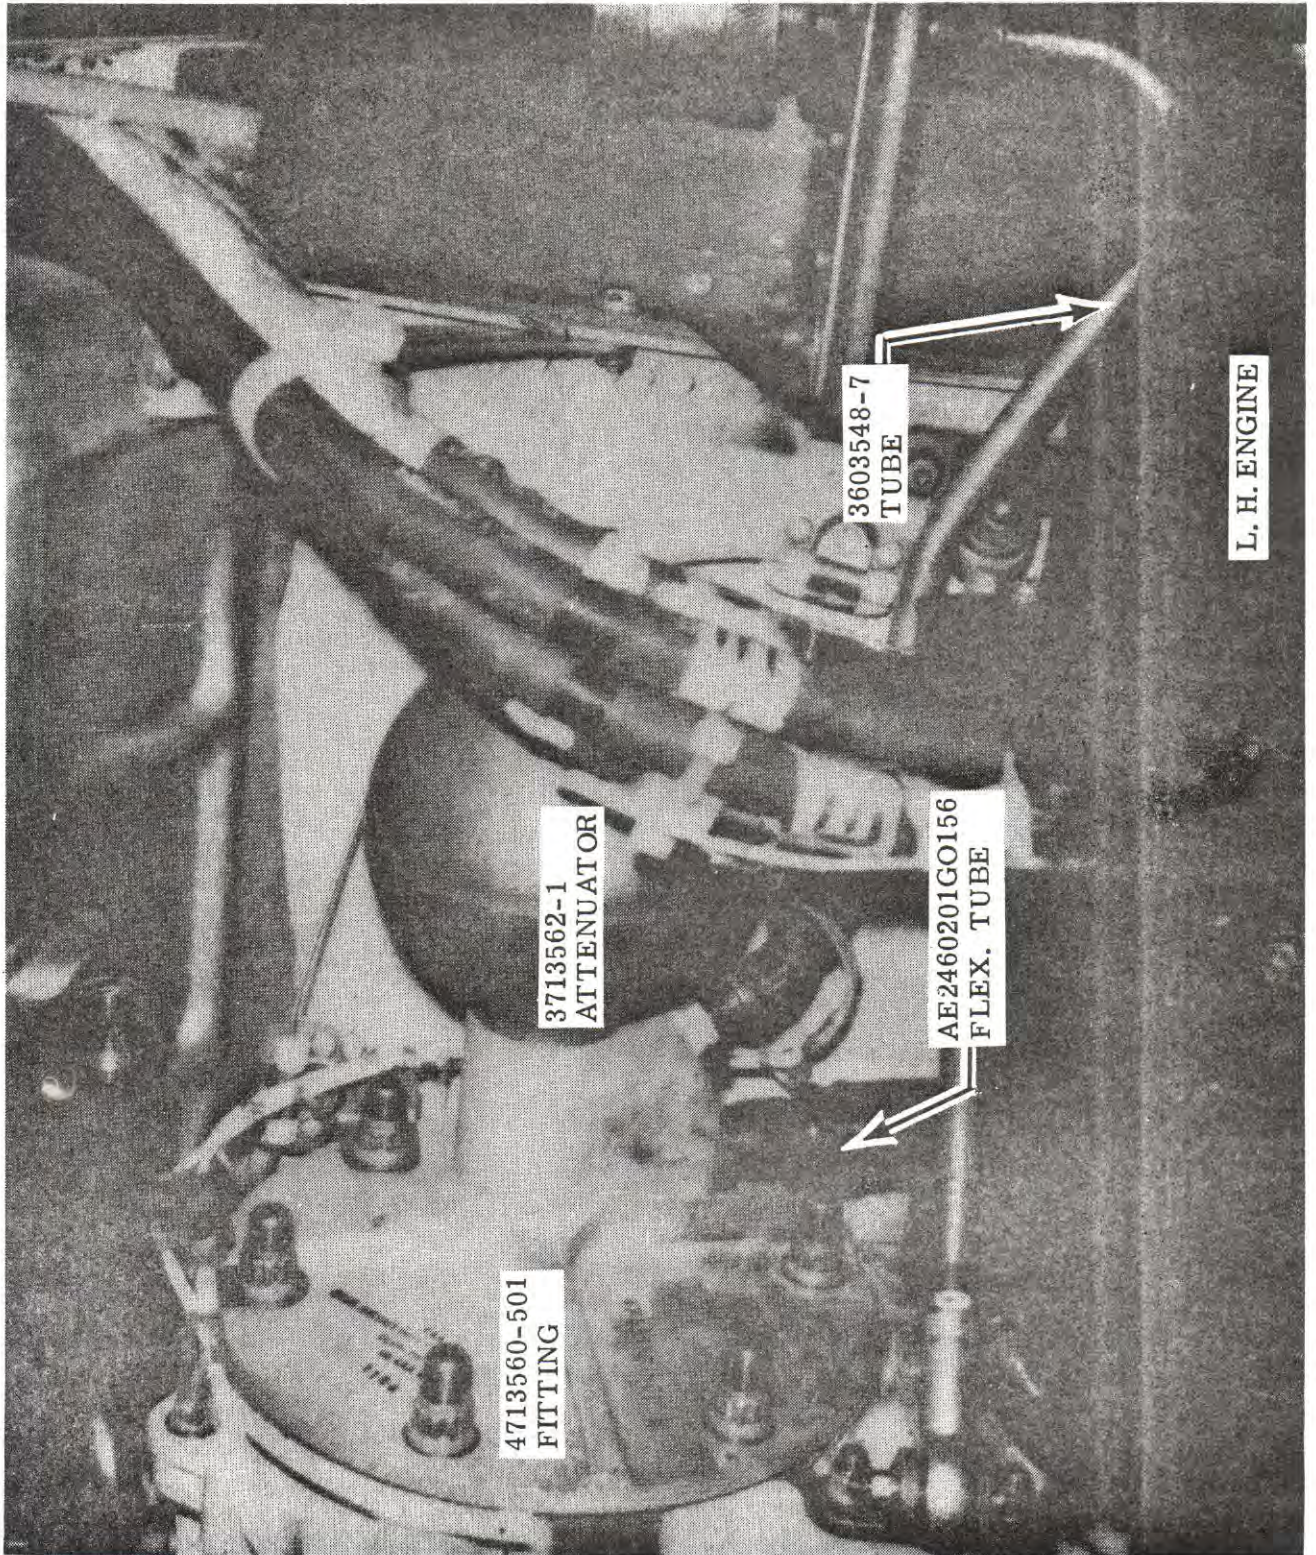
FIGURE 2

ATTENUATOR INSTALLATION

8. Install an AN815-6J union with S0309-906 O-ring in the inlet port of each P/N 4713560-501 fitting, per Figure 6.
9. Install new Fitting P/N 4713560-501, with new MS9136-01 gasket, on R. H. forward pad of the accessory gearbox on each engine. (See Figures 2 and 3).
