SERVICE INFORMATION LETTER

SERVICE INFORMATION LETTER INDEX

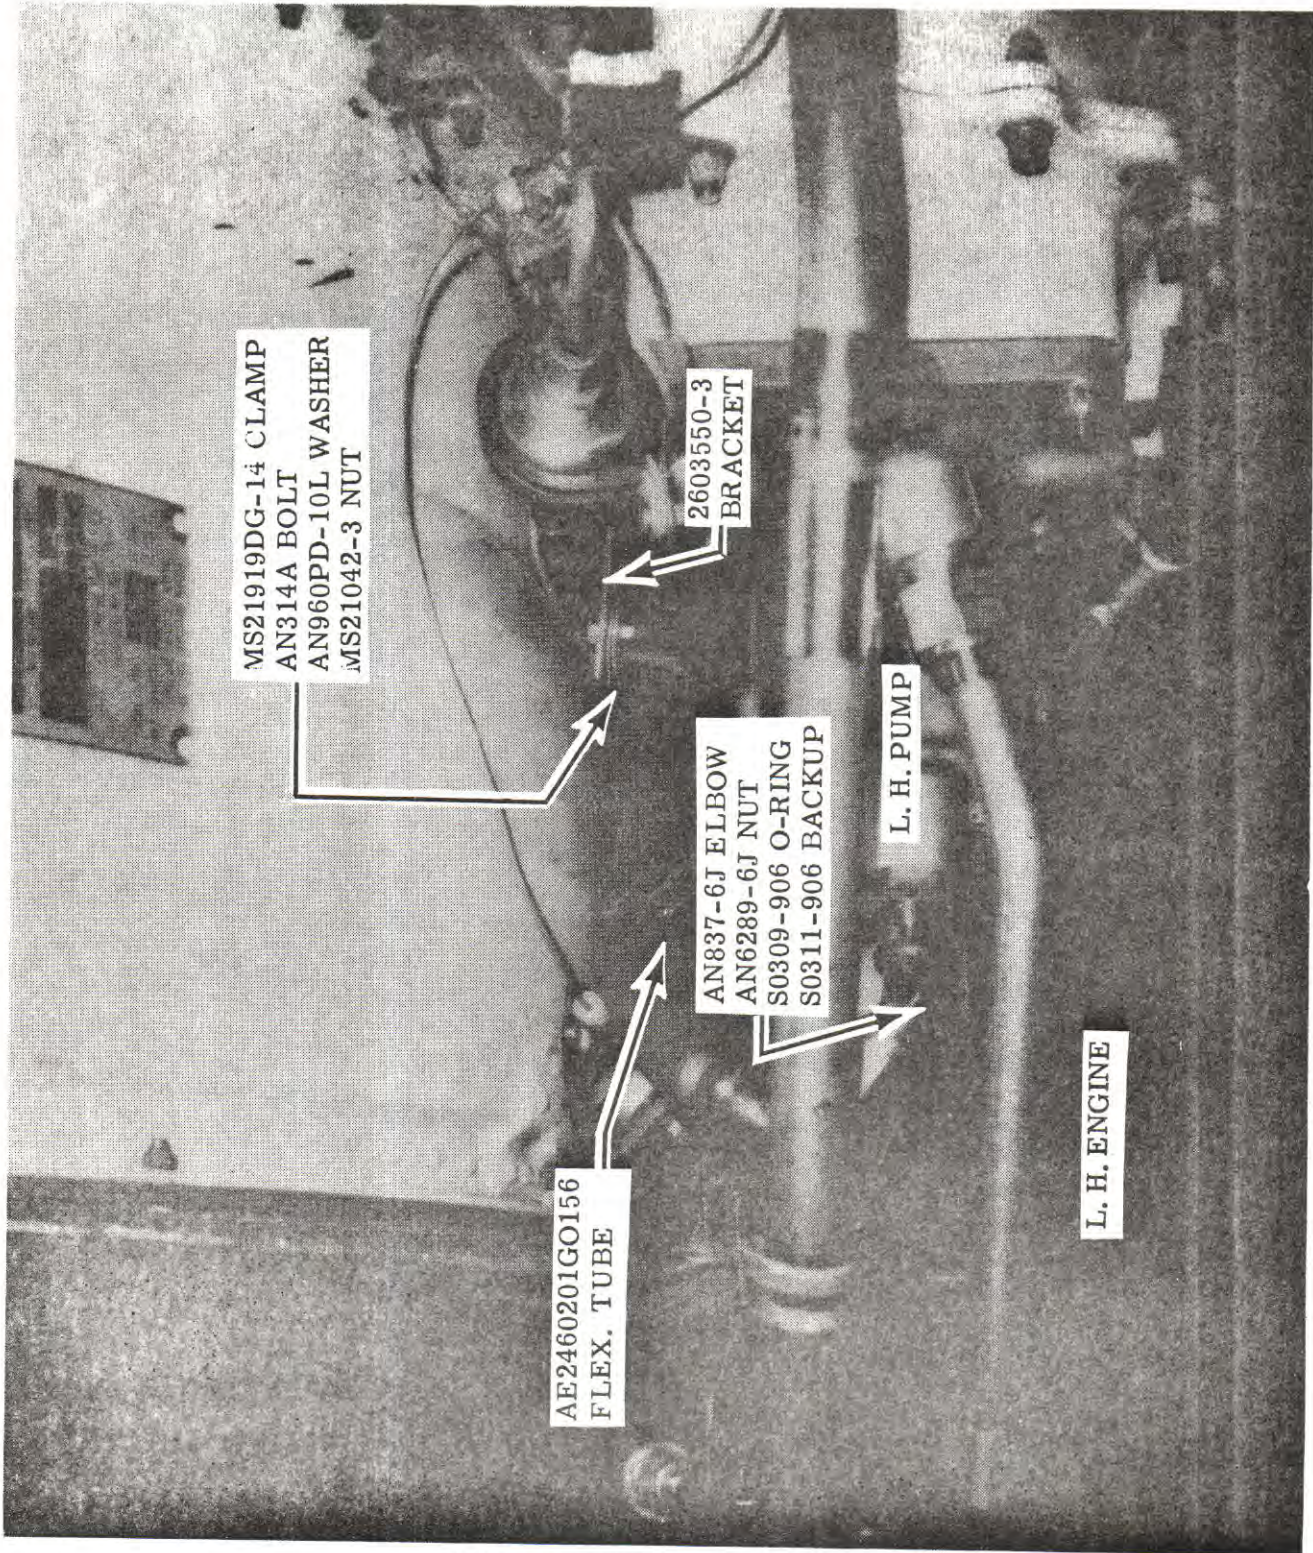
FIGURE 3

ATTENUATOR INSTALLATION

19. Install new tube P/N 3603548-7 between outlet port of fitting P/N 4713560-501 and quick disconnect fitting, per Figure 3.
20. Refer to Figure 6 and install a sleeve P/N 3713561-501, attenuator P/N 3713562-1, with a S0309-910 O-ring on each accessory drive pad fitting P/N 4713560-501. Torque and safety wire attenuators, per Figure 3.

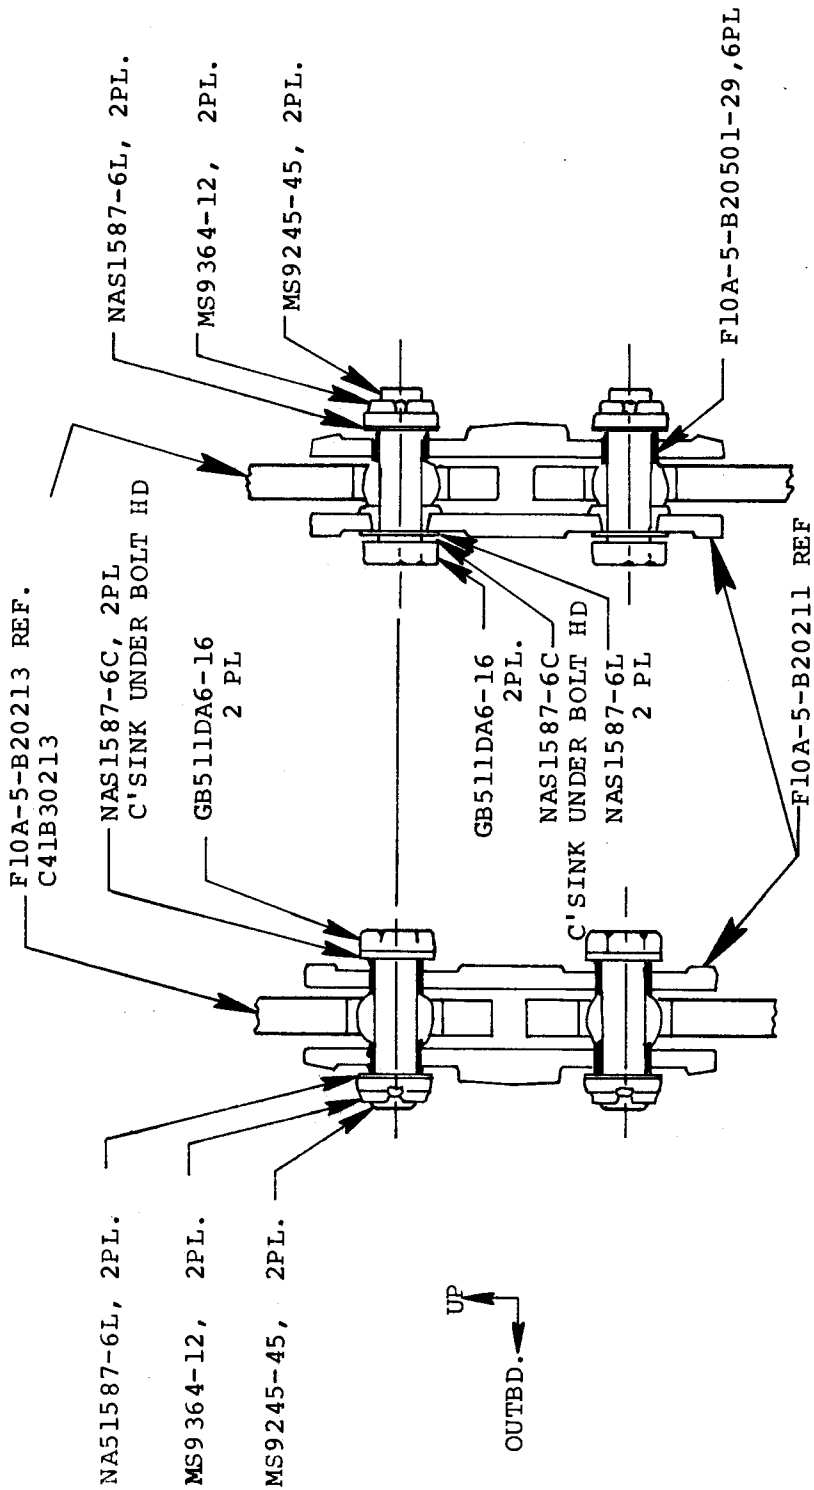
FIGURE 1

NOTE: Observe the outer lug of the outboard pivot joint for signs of fretting, scoring, etc. If fretting is observed, polish out the wear marks, checking to be sure that the lug thickness does not go under .100 inch.

LH NAC-T/R DOOR PIVOT

5. Rotate the T/R doors and check for the following condition at the pivots:
 - A. Inboard pivot joint - the bolt, shoulder bushing, sleeve bushing and self aligning ball are designed to remain stationary relative to the axial rotation of the T/R door. This is because the bolt is clamped to the fitting.

- B. Outboard pivot joint - the bolt, sleeve bushing and self aligning ball are designed to rotate with the T/R door. However, depending on the relative friction of the joint, the bolt assembly may remain stationary during rotation of the door.
6. If it is found that the inboard pivot hardware is rotating, the following procedure is recommended:
- A. Remove cotter pin and back off castellated nut to be sure it is loose.
- B. Torque nut up to a minimum of 90 in-lb; then continue tightening until cotter pin hole is aligned with slots in nut.

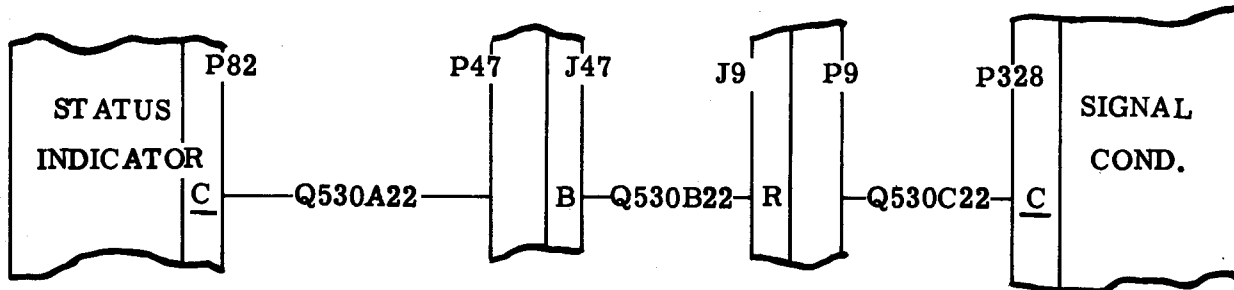
FIGURE 1

WIRING SCHEME

3. Gain access to signal conditioner unit in aircraft nose compartment.
4. Install per Figure 1 and identify new wires as follows:
 - A. Wire Q530C22 between pin C of P328 connector and pin R of P9 connector.

- D. Install and secure P328 connector at signal conditioner, and install and secure P82 connector at status indicator.

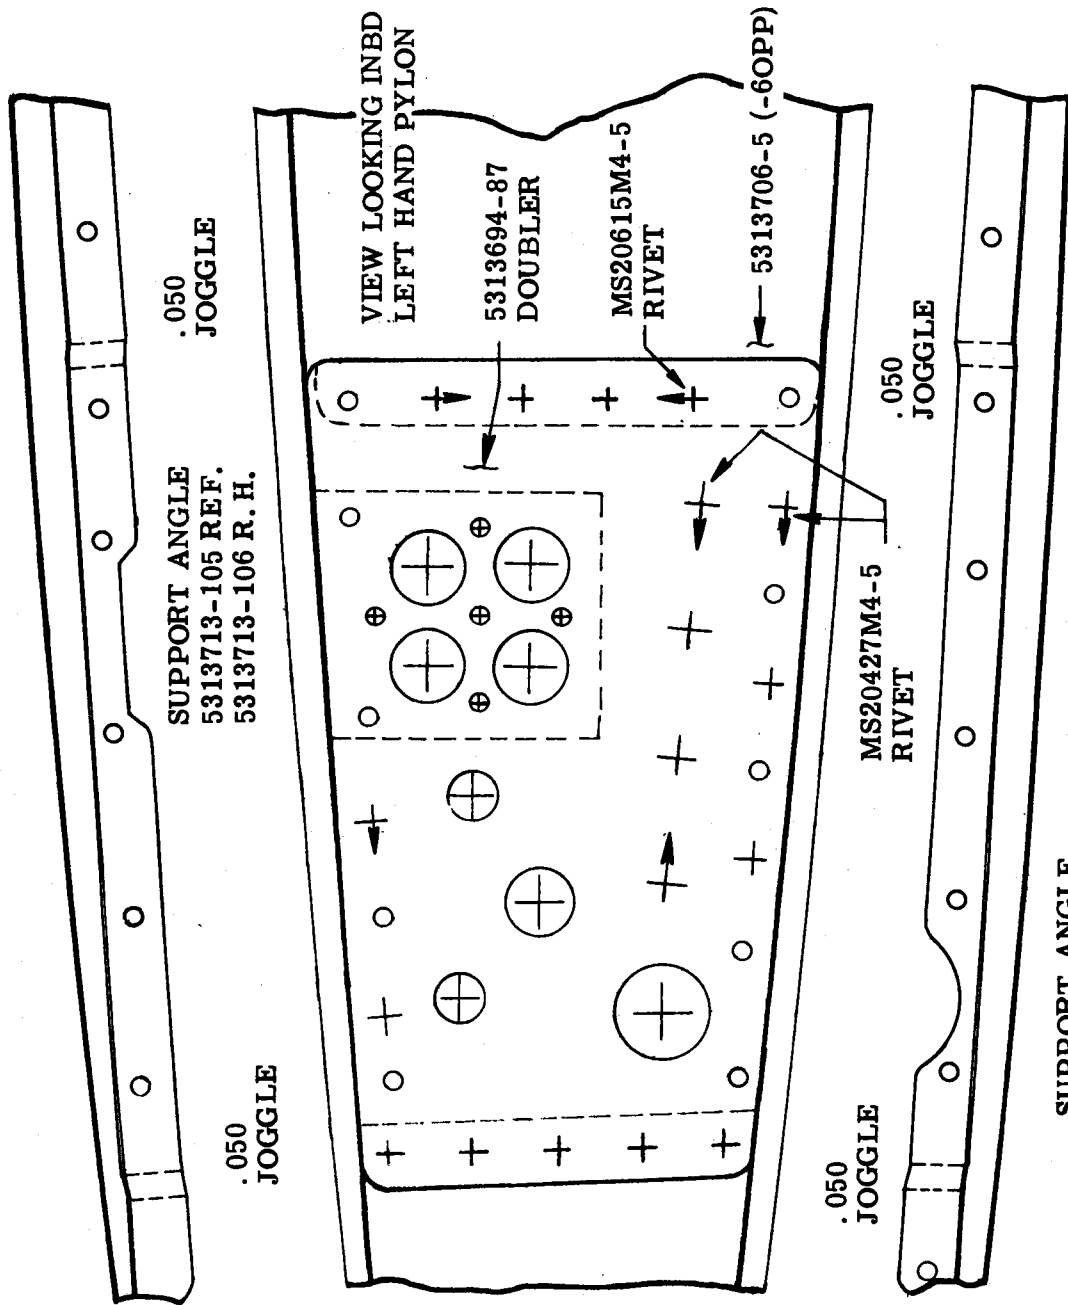
DOUBLER INSTALLATION
 Figure 1

3. Remove electrical cables support plate and withdraw electrical cables from firewall.
4. Inspect firewall for cracks. If firewall is cracked, proceed as follows:

- A. Remove existing firewall beginning at forward end and make a vertical cut aft of cracked area.
 - B. Fabricate a replacement section using 301 1/2 hard stainless .016 thick. Match drill holes to existing firewall and replace section, picking up existing rivet pattern. Fabricate and install a 1.25 inch wide doubler over butt joint using AISI 321 annealed stainless .025 thick.

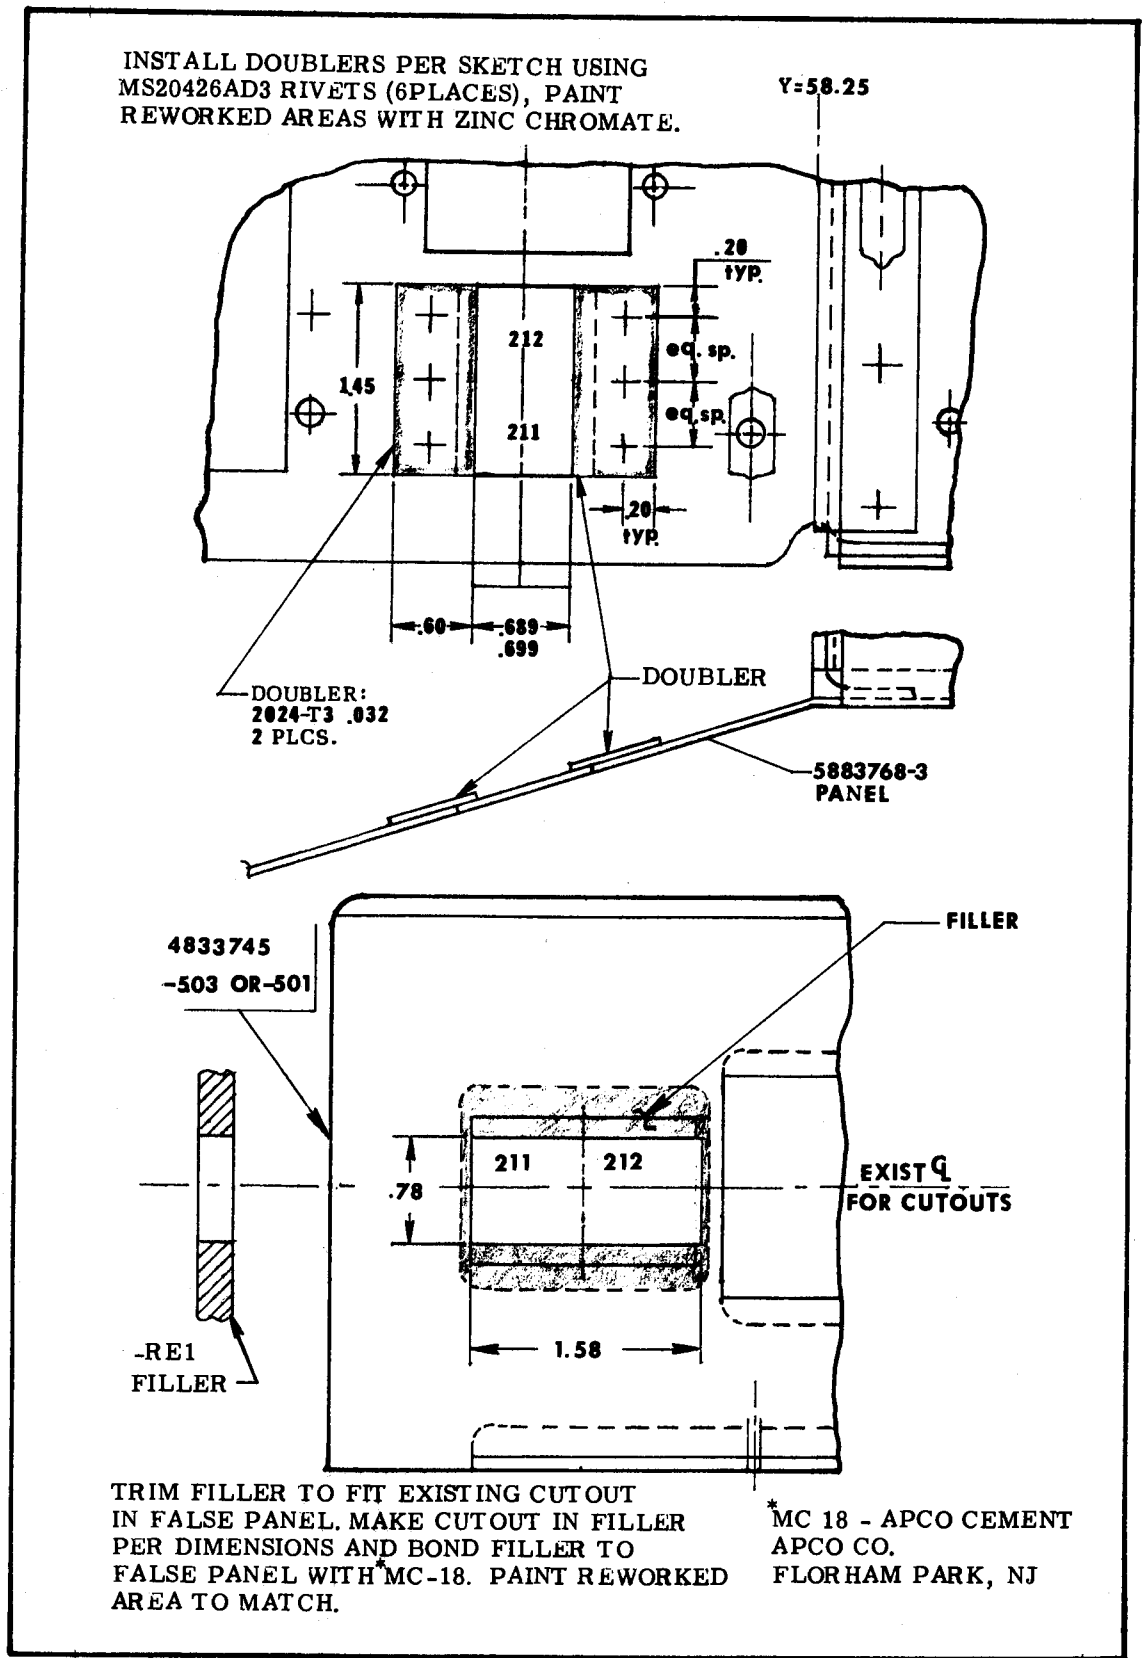
FIGURE 1

SWITCH PANEL REWORK SCHEME

INSTALL DOUBLERS PER SKETCH USING MS20426AD3 RIVETS (6 PLACES), PAINT REWORKED AREAS WITH ZINC CHROMATE.

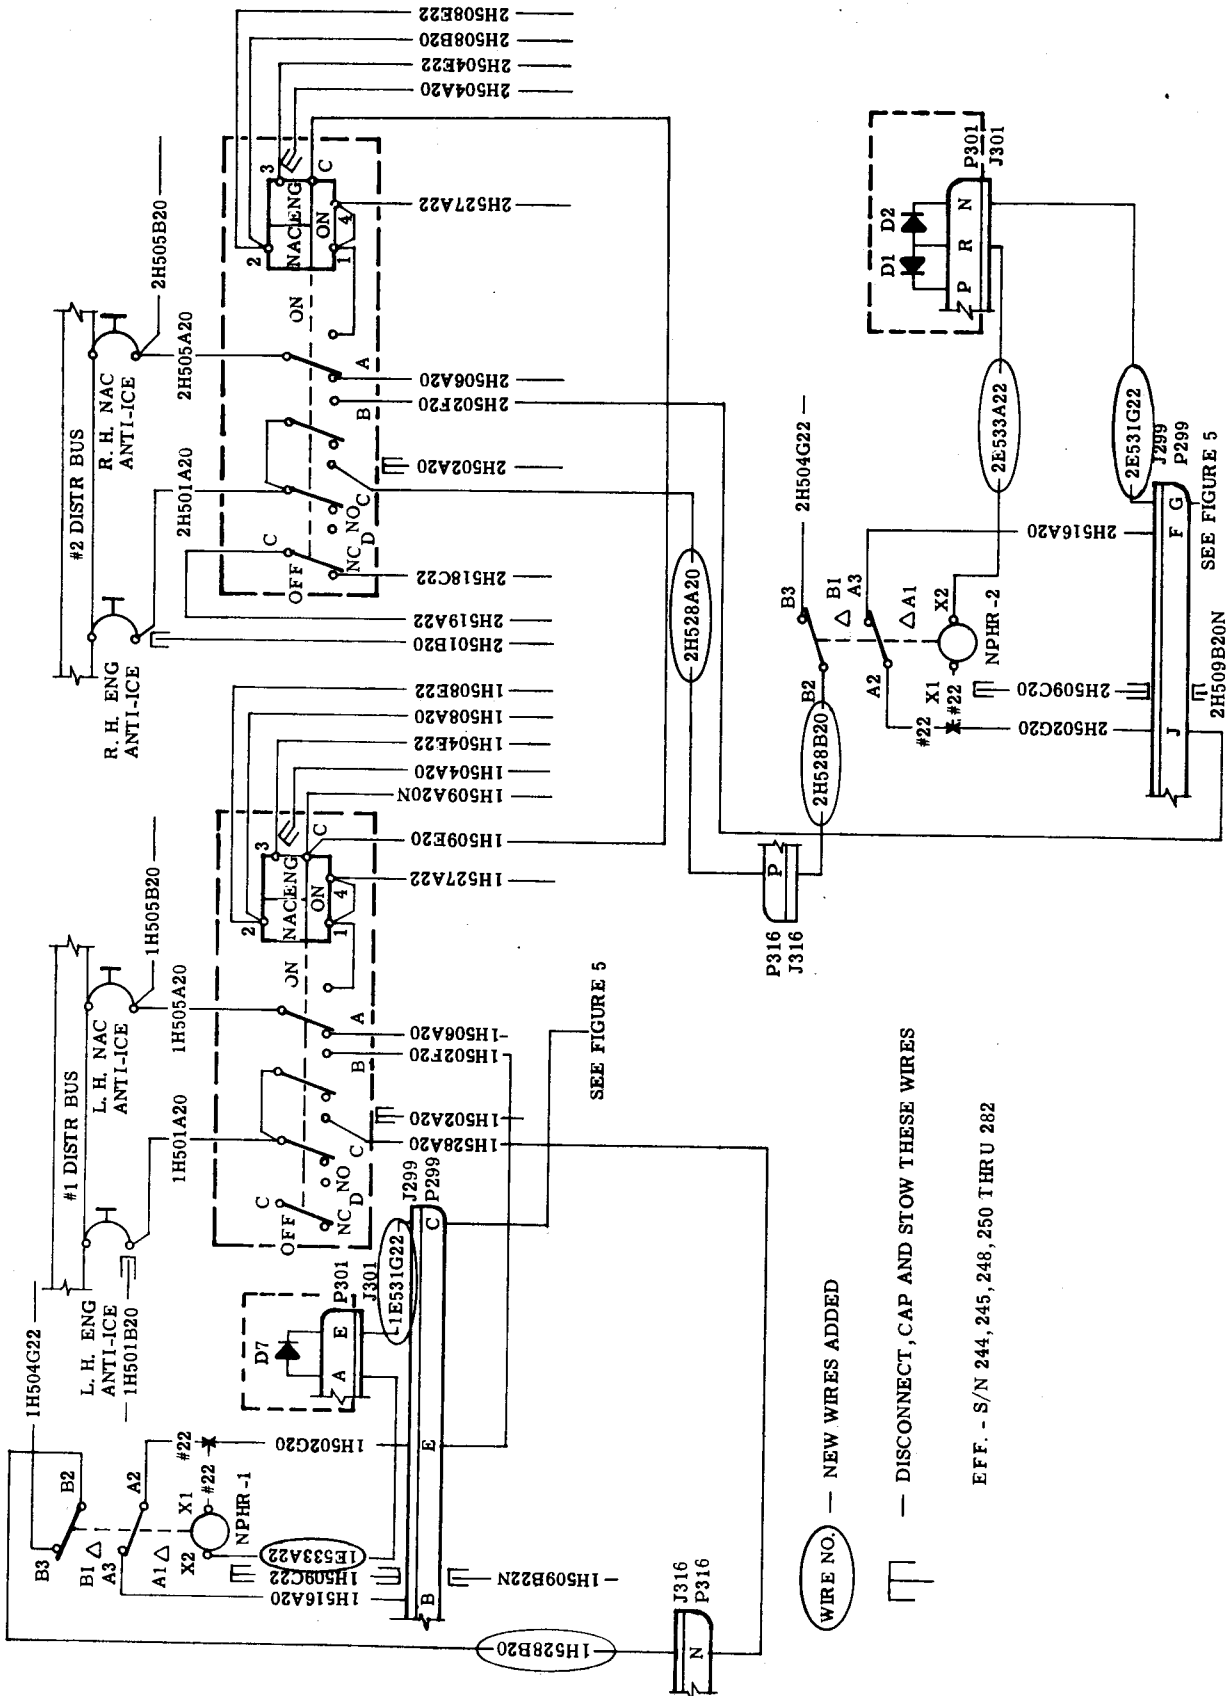
ANTI-ICE SWITCH WIRING SCHEME
CONICAL SPINNER ENGINE
FIGURE 4

1. Aircraft S/N's 152, 154, 181, 187 thru 243, 246, 247 and 249 shall have the existing NAC/ENG Anti-Ice control switch replaced with new switches P/N 6883743-72 when conical spinner engines are permanently installed. Refer to Figures 2 or 3, as applicable.
2. Aircraft S/N's 244, 245, 248 and 250 thru 282 were equipped with 6883743-72 NAC/ENG Anti-Ice control switches during production (See Figure 6 for existing wiring scheme). These switches must be rewired per Figure 4 Wiring Scheme when Conical Spinner engines are installed.

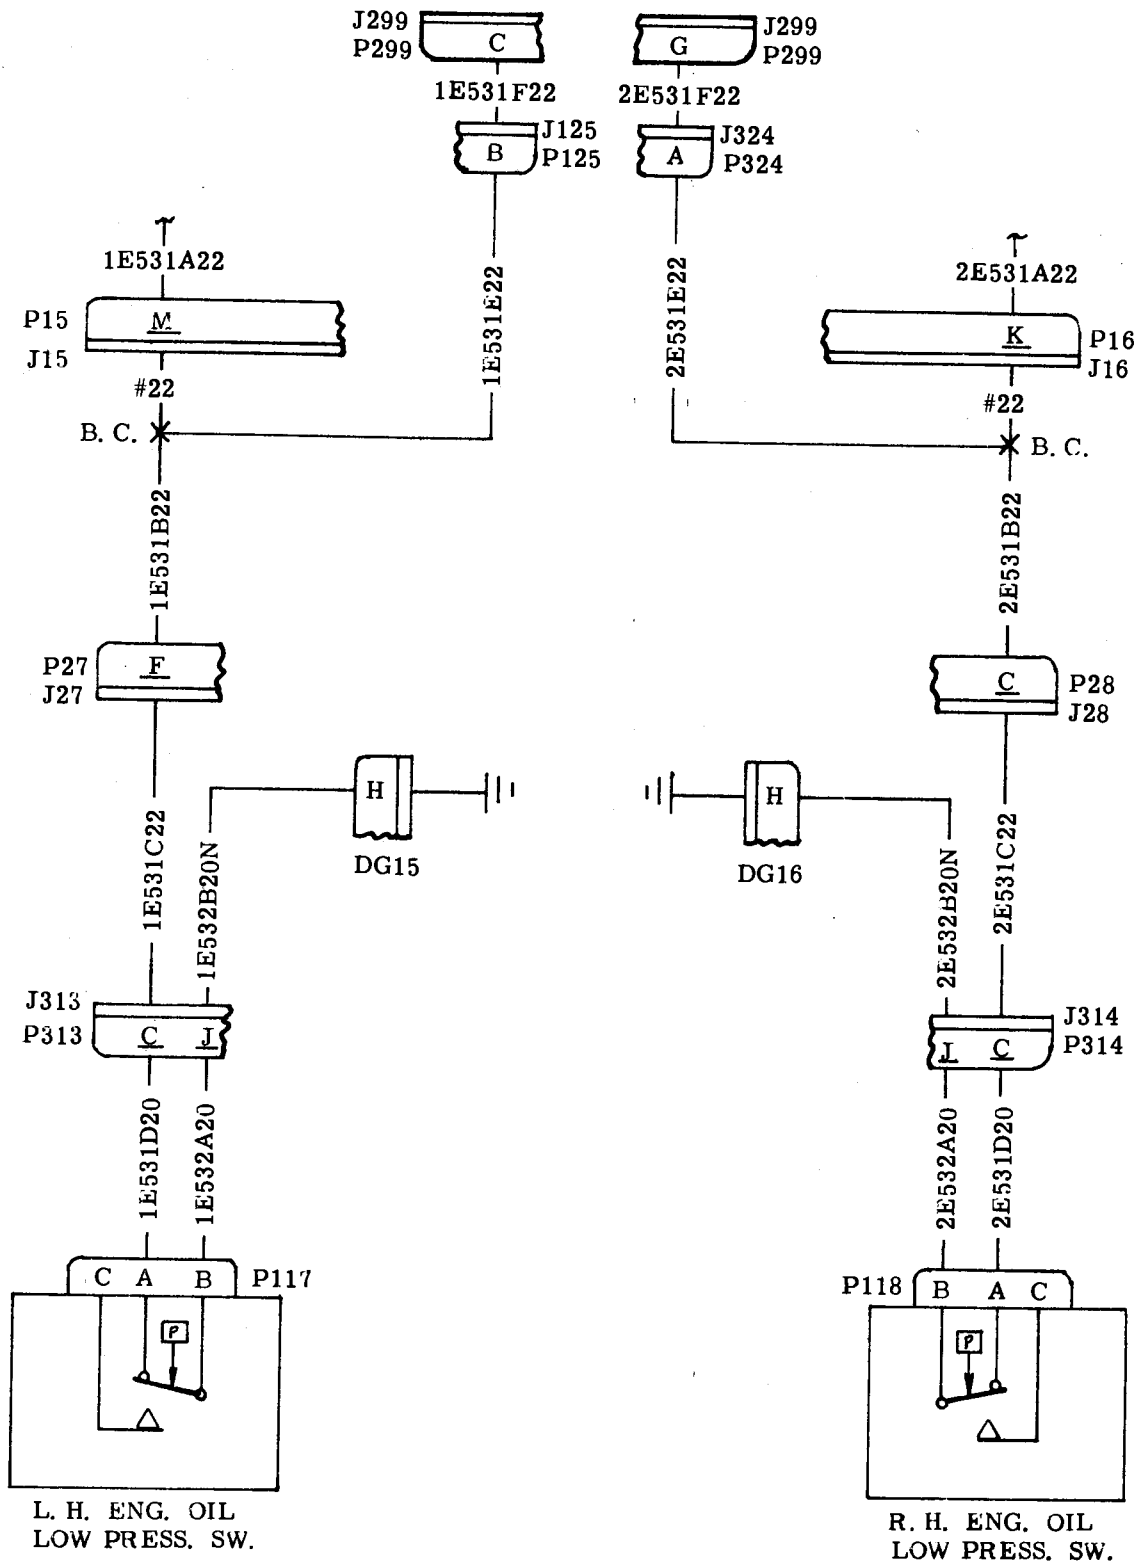
LOW PRESSURE SWITCH WIRING SCHEME
CONICAL SPINNER ENGINE
FIGURE 5

— DISCONNECT, CAP AND STOW THESE WIRES

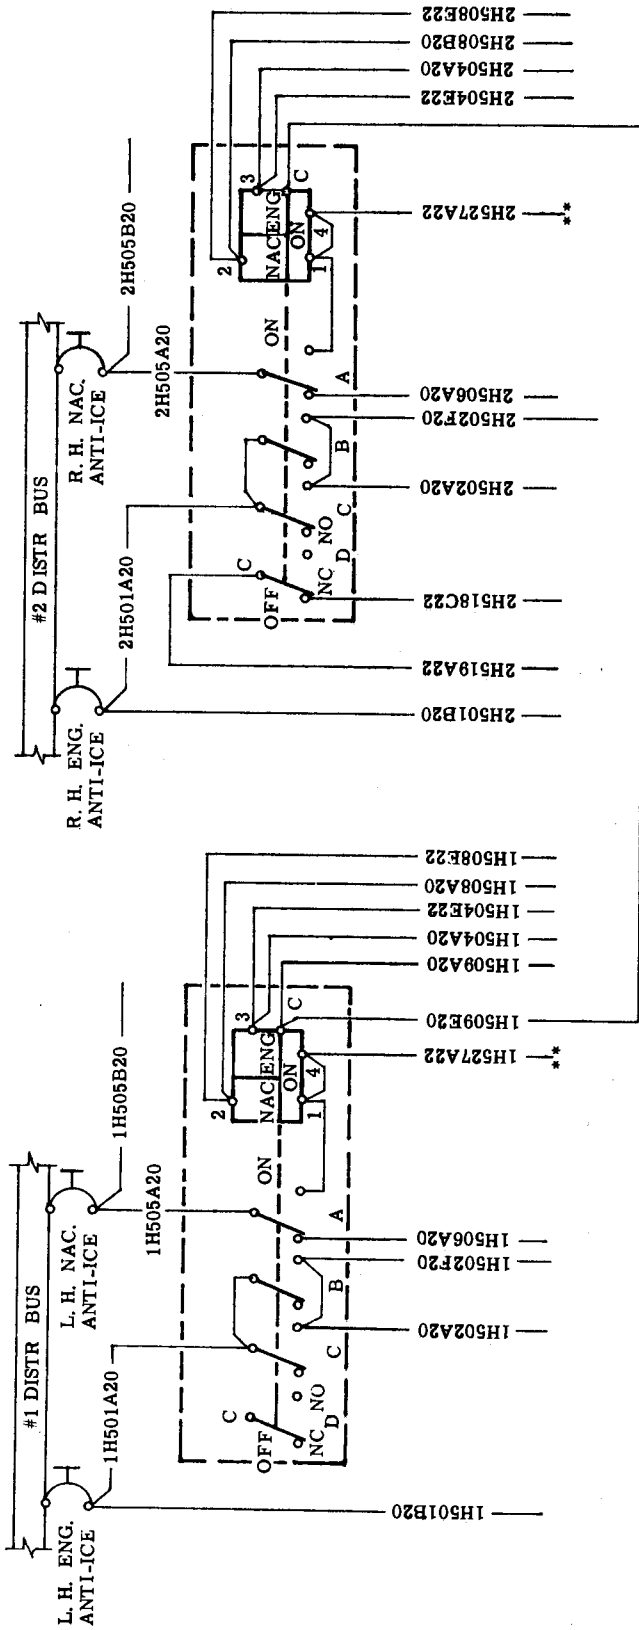
ANTI-ICE SWITCH WIRING SCHEME
 SWITCH P/N 6883743-72
 FIGURE 6

10. Repeat Step 9 to remove connectors P338 and P340 in RH nacelle (Conical Spinner engine only).
11. If engines are mixed per Para. 2 of Special Conditions, replace non-conical spinner engine Anti-Ice control switch, aircraft S/N 152, 154, 181, 187 thru 243, 246, 247 and 249 and wire switch per Figure 6.

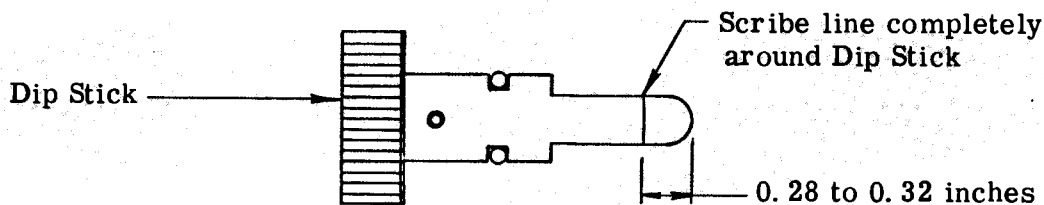
1. Gain access to and remove oil dipstick from cooling turbine. Cover dipstick port to prevent entry of foreign material.
2. Using an electric pencil (or any suitable marking tool) scribe a line completely around periphery of dipstick, as per sketch.

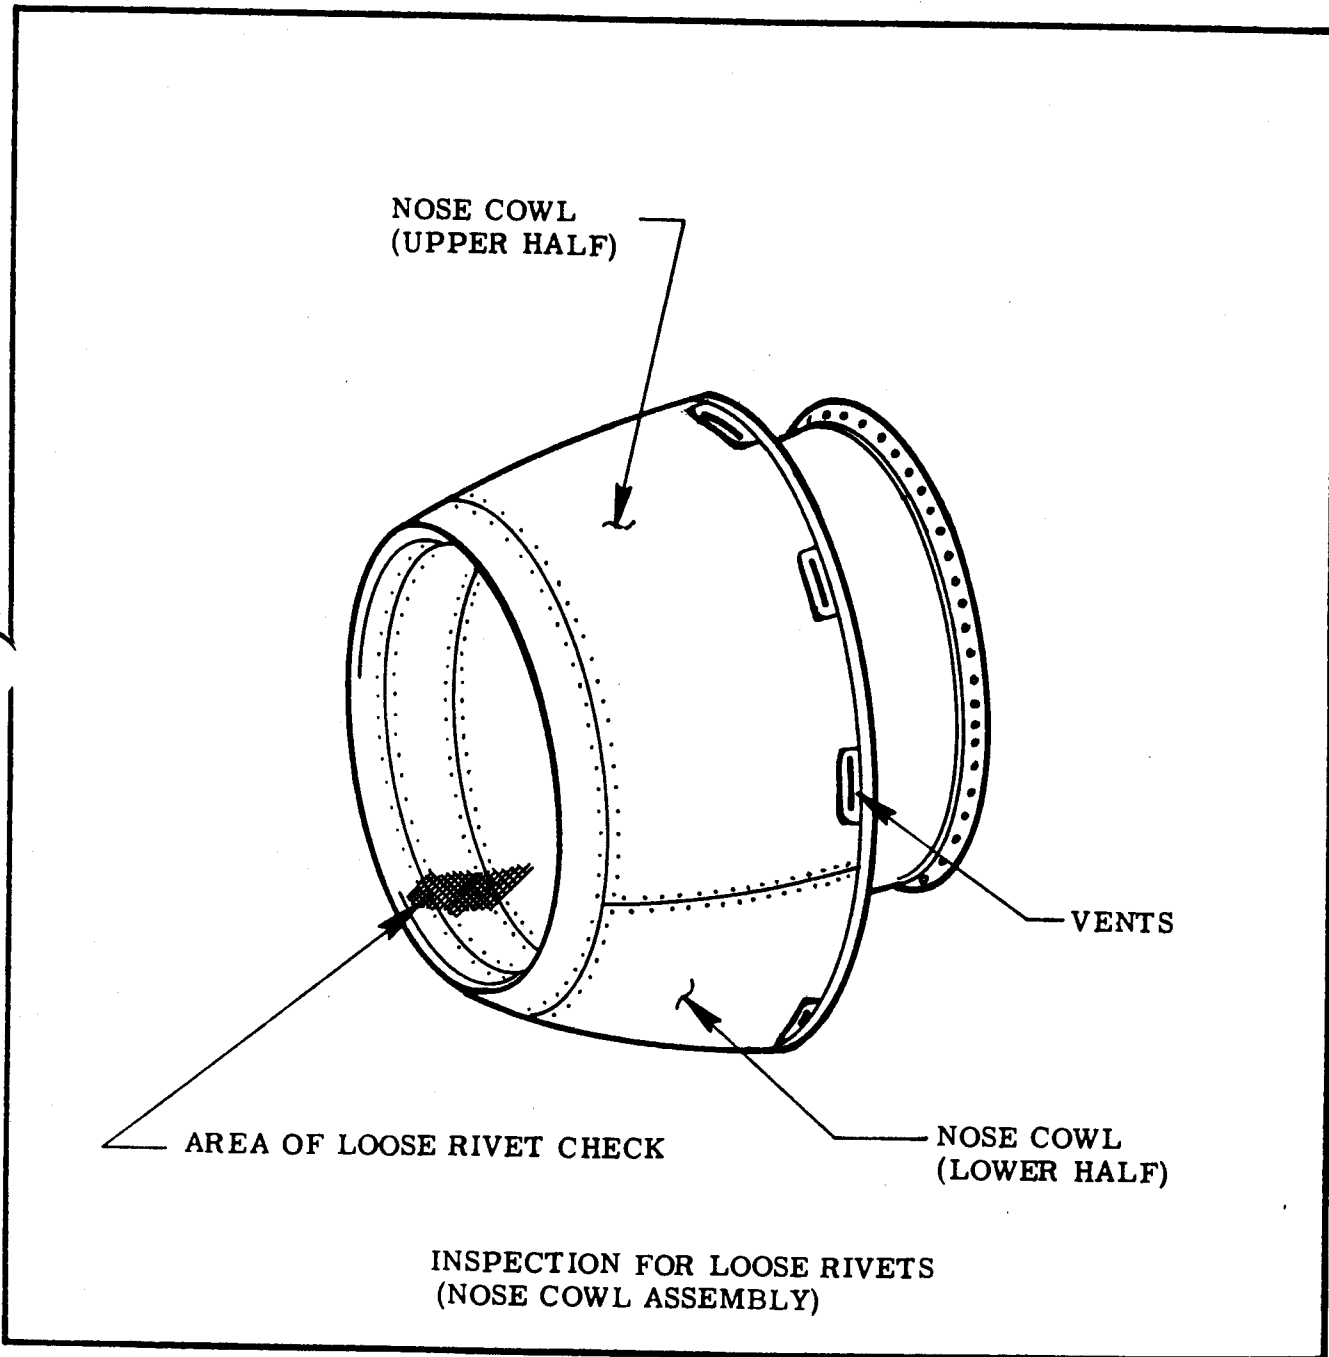
FIGURE 1

<u>CONDITION</u>	<u>LOOSE RIVETS</u>	<u>FRAME CRACKED</u>	<u>DISPOSITION</u>
1	No	---	No further action required. Return aircraft to service. Reinspect at 150 hours.
2	Yes	No	<p>A. If twelve (12) or more defective rivets are found in one frame or if six (6) or more adjacent rivets are defective, proceed to Step F.</p> <p>B. If there are defective rivets, but not exceeding the criteria of A above, the inlet shall be considered acceptable for flight with a requirement to recheck for defective rivets every 150 hours. Proceed to Step G.</p>
3	Yes	Yes	<p>A. If the mid-frame shows flange cracking along 50% or more of the circumference, or if the mid-frame is cracked in two (2) parts in any area, (a flange crack through a lightening hole is an example) proceed to Step F.</p> <p>B. If there are defective rivets and cracked frames but not exceeding the criteria of 2.A. and 3.A. above, the inlet is considered acceptable with a requirement to check for defective rivets and cracked frames every 50 hours. Proceed to Step G.</p>

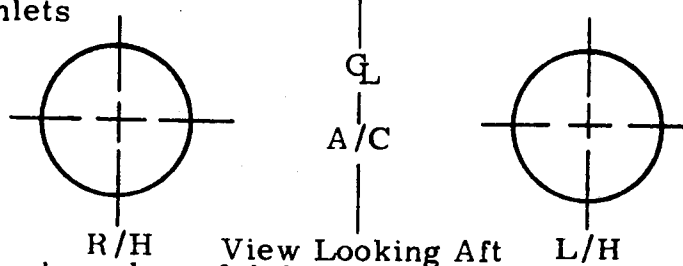
Indicate approximate location and number of loose or missing rivets found in the LH & RH Nacelle Inlets

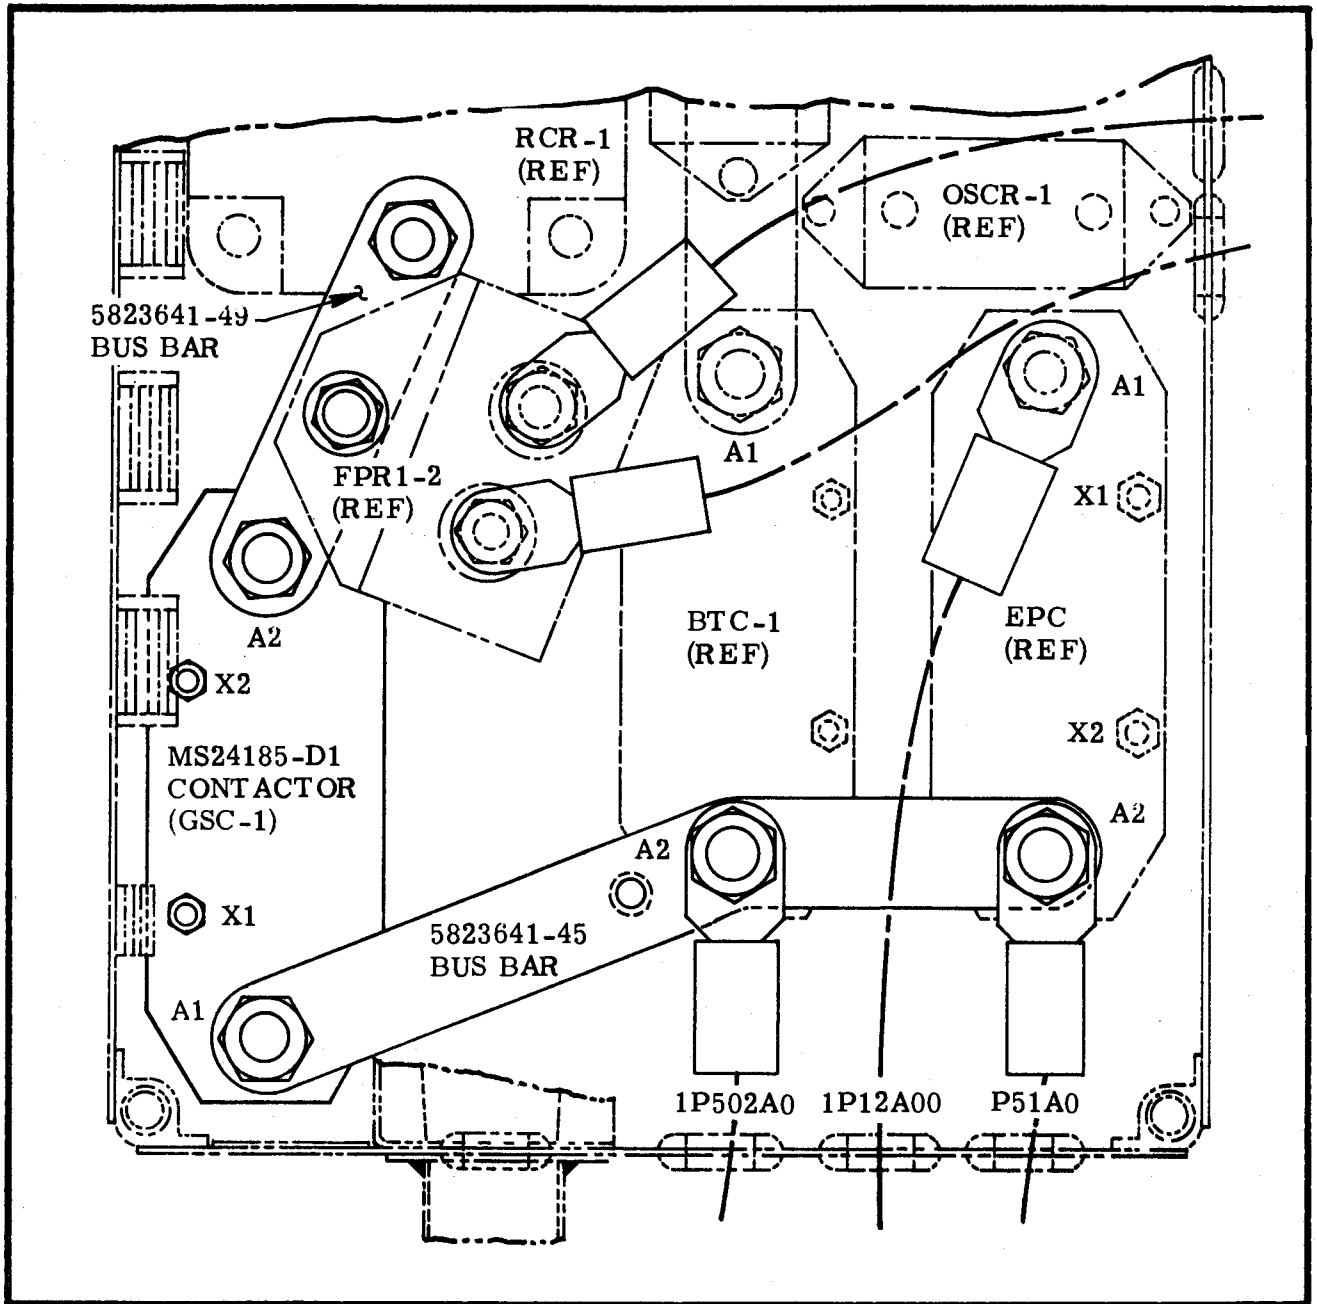
FIGURE 1

L. H. DC CONTACTOR BOX

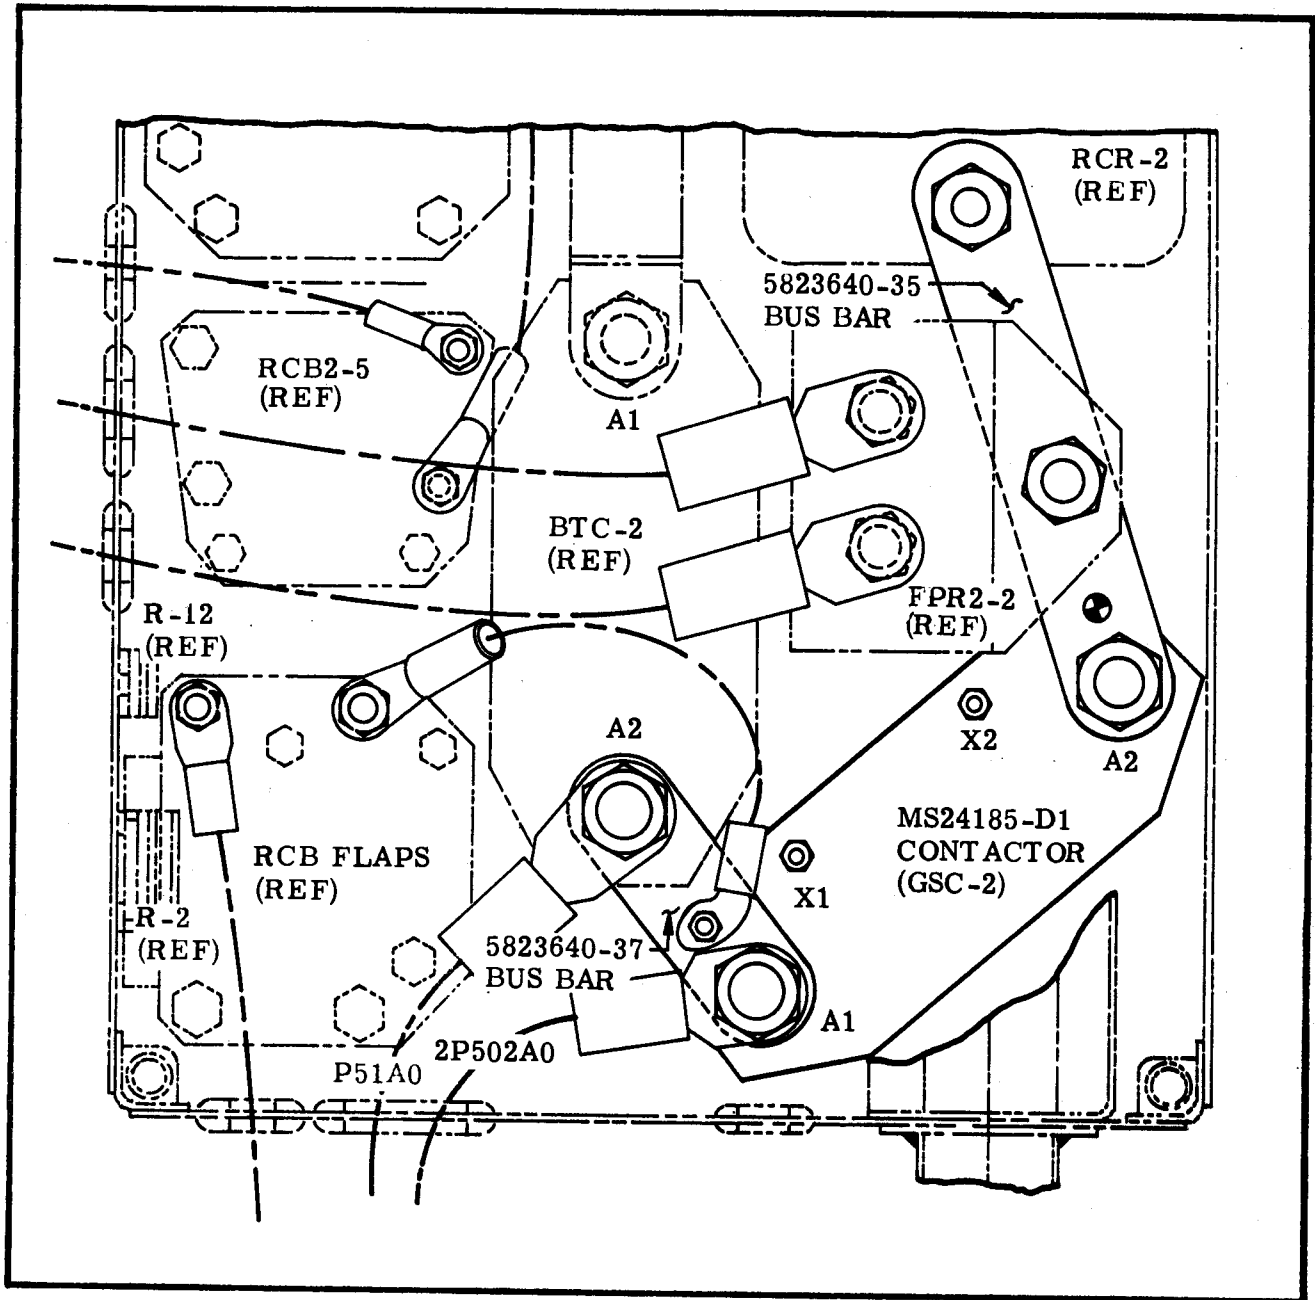
FIGURE 2

R. H. DC CONTACTOR BOX

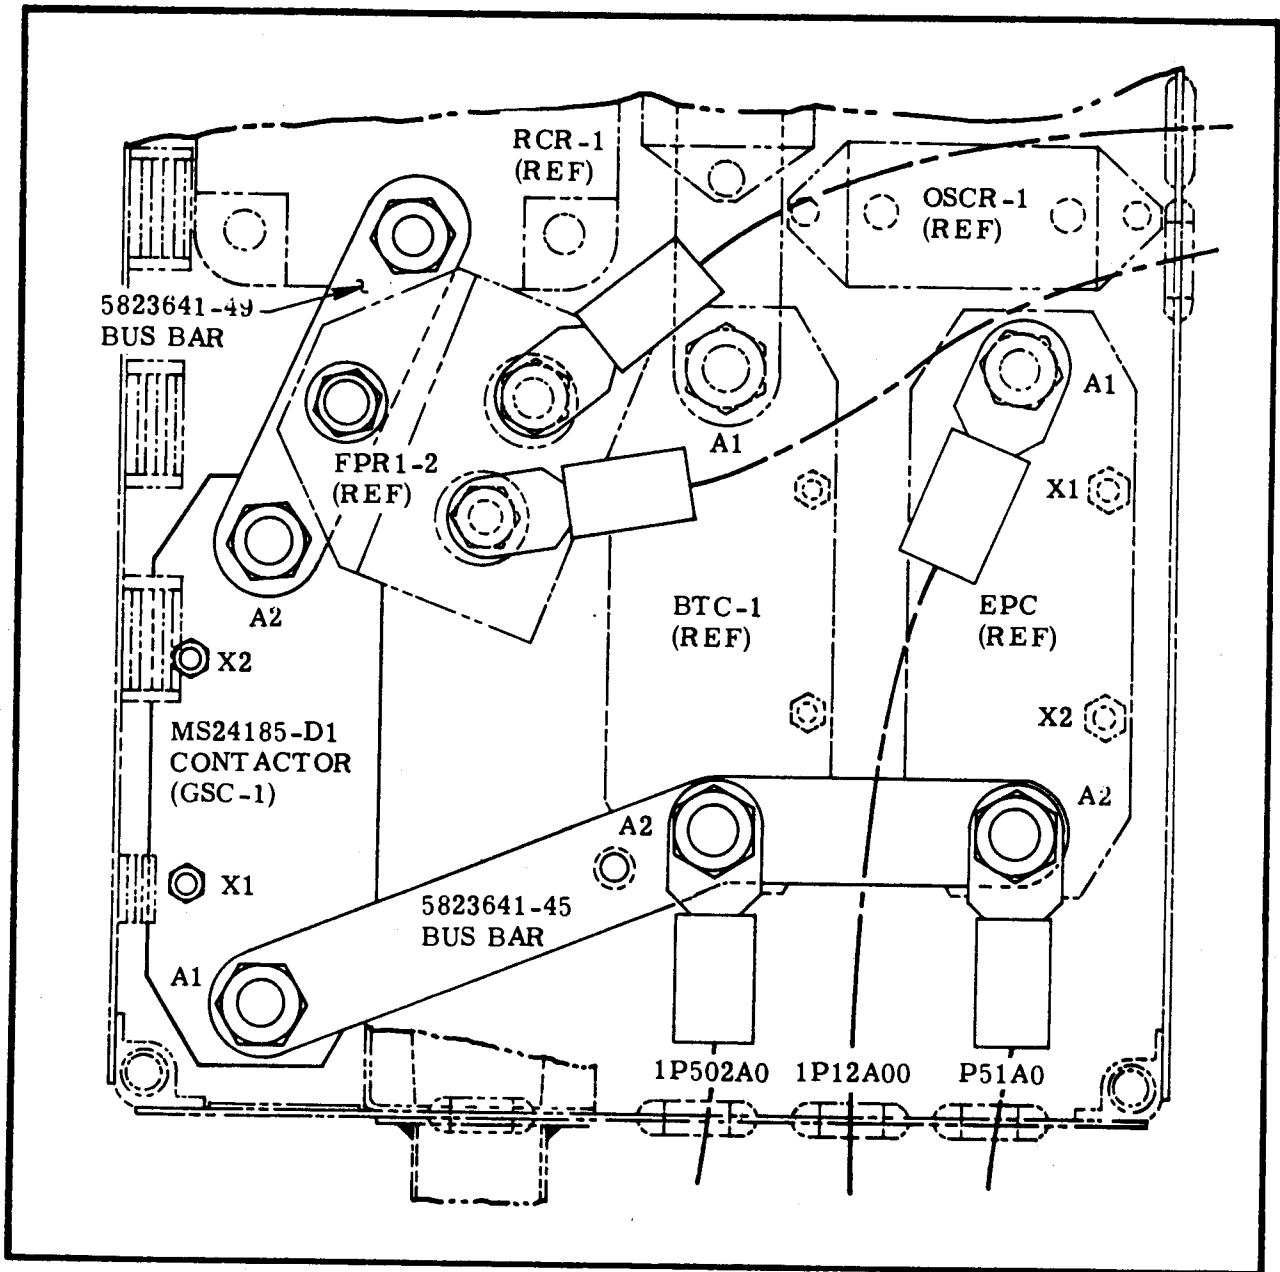
FIGURE 1

L. H. DC CONTACTOR BOX

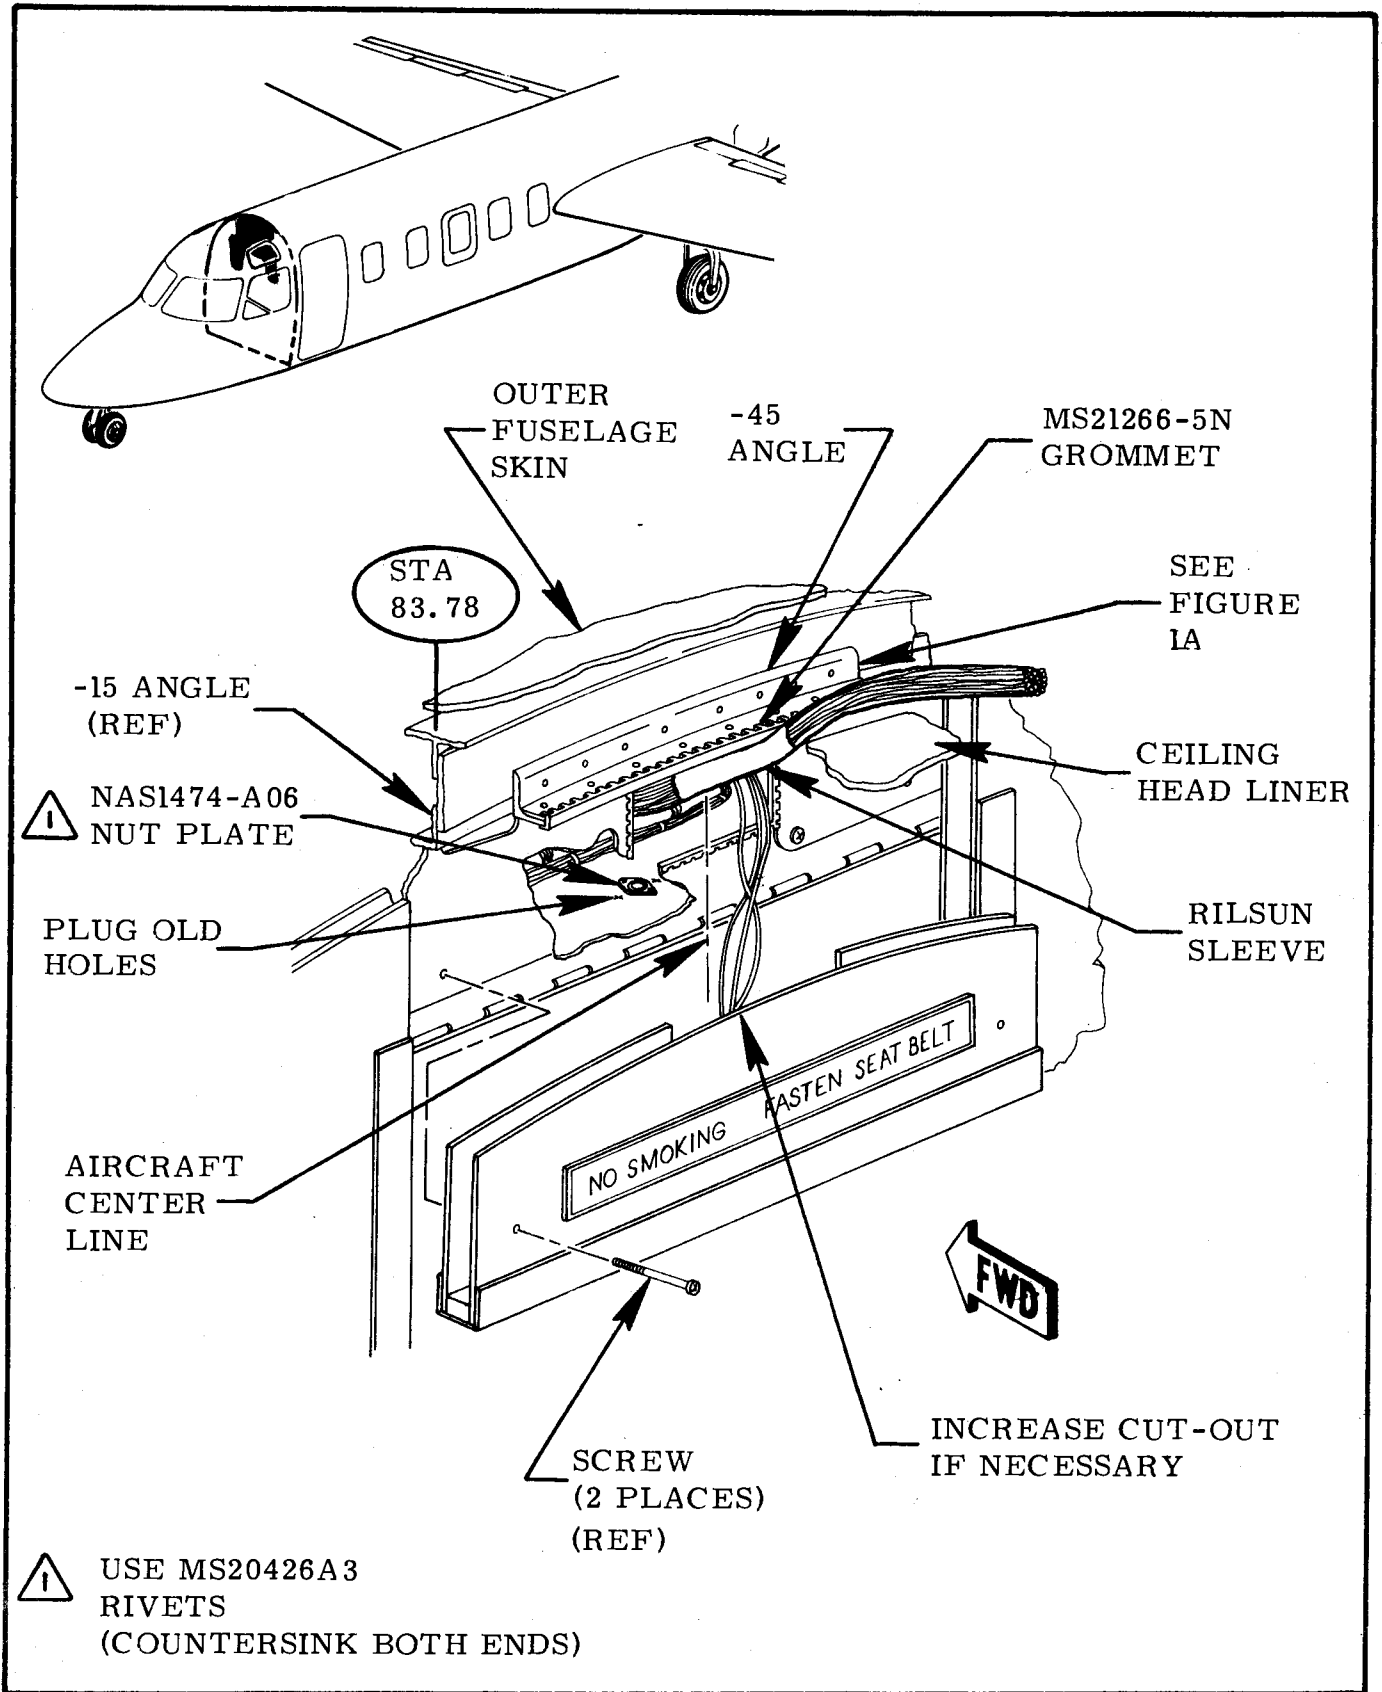
FIGURE 1

WIRE BUNDLE INSTALLATION

1. Remove cabin headliner aft of warning sign, located at Fus. Sta. Y-83.78.
2. Release aft circuit breaker panel, located on fwd side of Fus. Sta. Y-83.78.
3. Inspect wire bundle for chafing and/or adequate clearance between fuselage frame and warning sign, (See Figure 1).
4. If evidence of chafing is detected, repair damaged wires as necessary.
5. If additional clearance or chafe protection for wire bundle is required, one or more of the following procedures should be used.
 - A. Spread wire bundle, in order to reduce diameter.
 - B. Add "Rilsun" sleeve chafe protection to wire bundle.
 - C. Increase cut-out of warning sign support structure adjacent to wire bundle.
 - D. Trim edge of 5313548-45 angle, add RE-3 strip and bond MS21266-5N grommet to fuselage frame per details of Figure 1.

- E. On aft circuit breaker panel, replace center aft nutplate (MS21075-06) with NAS1474-A06 nutplate per detail of Figure 1, and plug existing holes of original nutplate installation.
6. Replace equipment removed for Inspection/Rework purposes and return aircraft to service.
