SERVICE INFORMATION LETTER

SERVICE INFORMATION LETTER INDEX

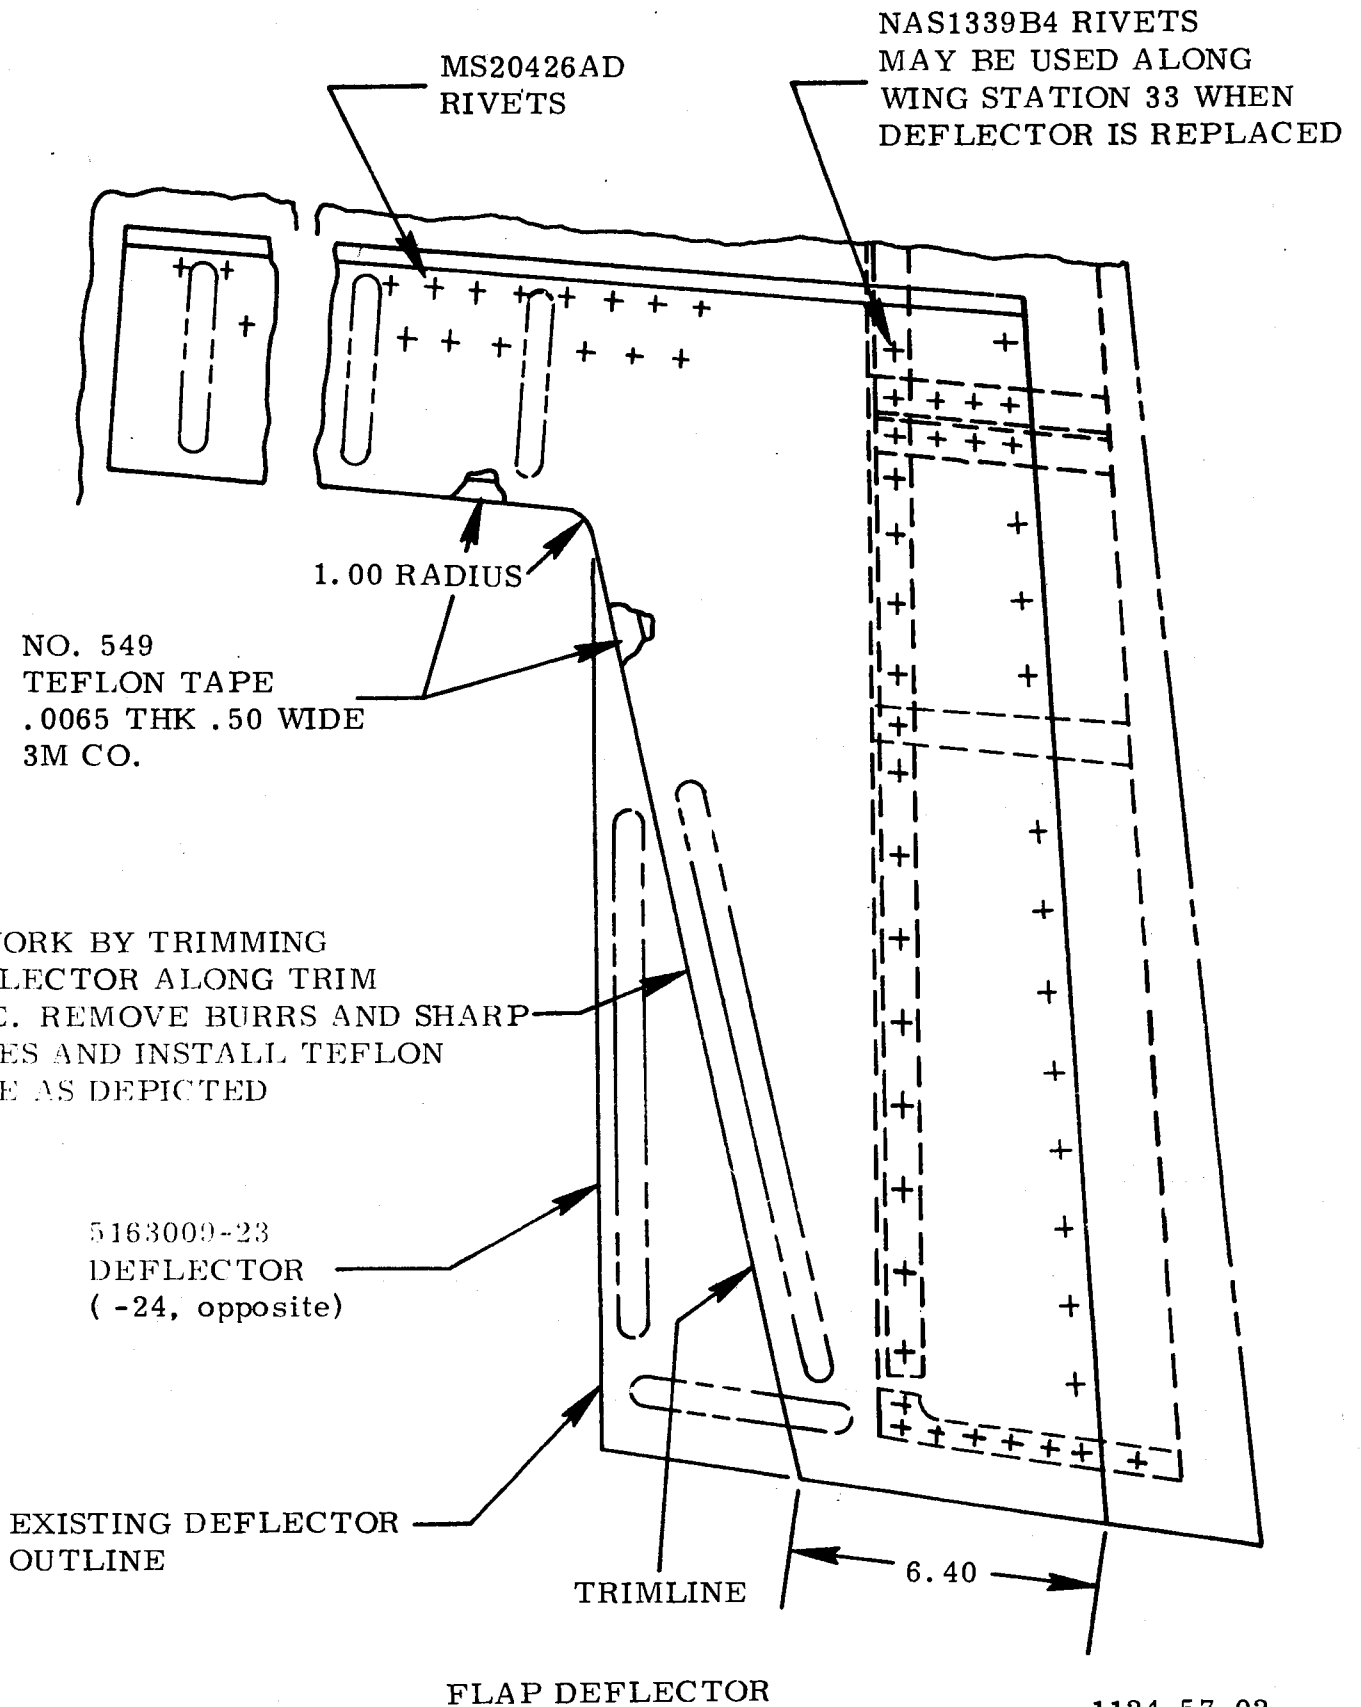
FIGURE 1

REASON: CRACKS OCCURRING IN DEFLECTORS ARE DIFFICULT TO REPAIR, REWORK OF DEFLECTOR OR REPLACEMENT WITH REDESIGNED DEFLECTOR IS RECOMMENDED

1. Extend and/or remove wing flap, if required, to permit rework or replacement of flap deflector.
2. Refer to Figure 1, which depicts deflector installation, and rework per rework details. If replacement is required, drill out existing rivets to remove deflector.
3. Install replacement deflector, picking up existing rivet holes, per Figure 1.
4. Prime and paint reworked area to match existing paint.
5. Reinstall components removed to permit rework and return aircraft to service.

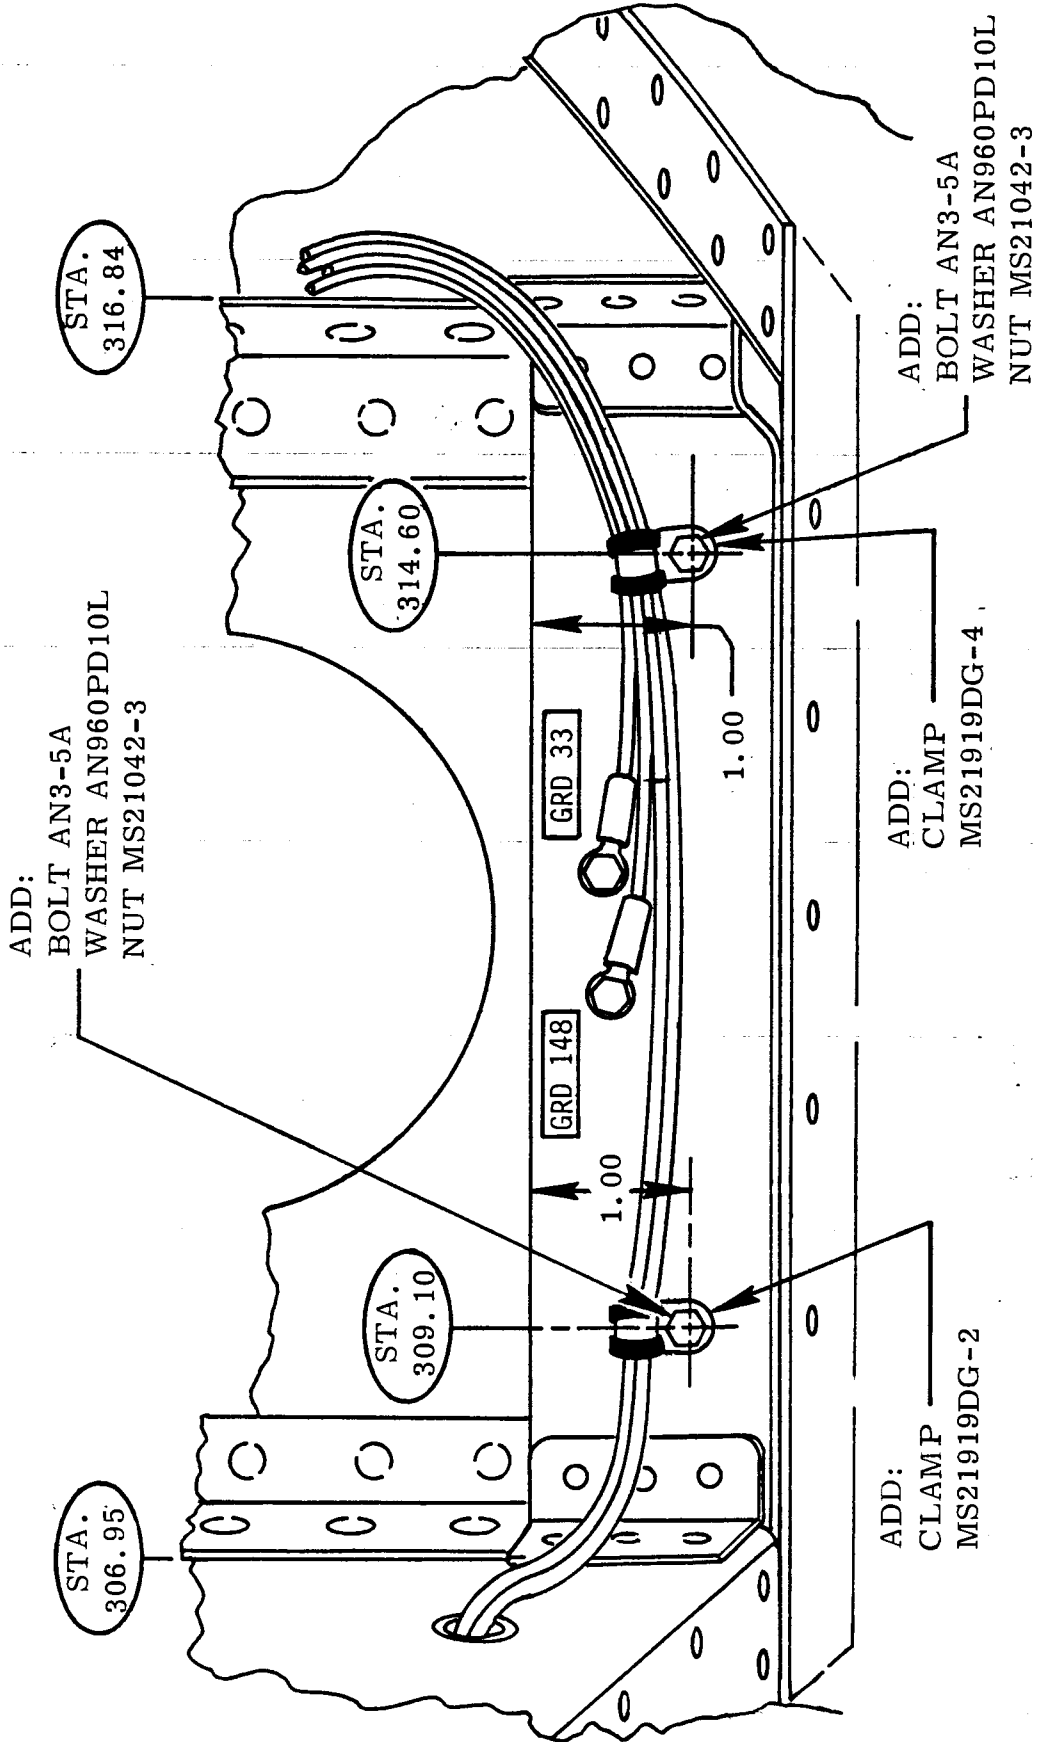
FIGURE 1 WIRE BUNDLE CLAMPING

VIEW LOOKING INBD AT LEFT HAND SIDE OF FUEL SUMP (R.H. OPP.)

1. Remove LH and RH fuel boost pump access panels.
2. Refer to Figure 1, for wiring installation and inspect boost pump ground wires for evidence of chafing. Replace damaged wires, if required.
3. Install cable clamp wire supports per Figure 1, on LH and RH sides.
4. Reinstall boost pump access panels.

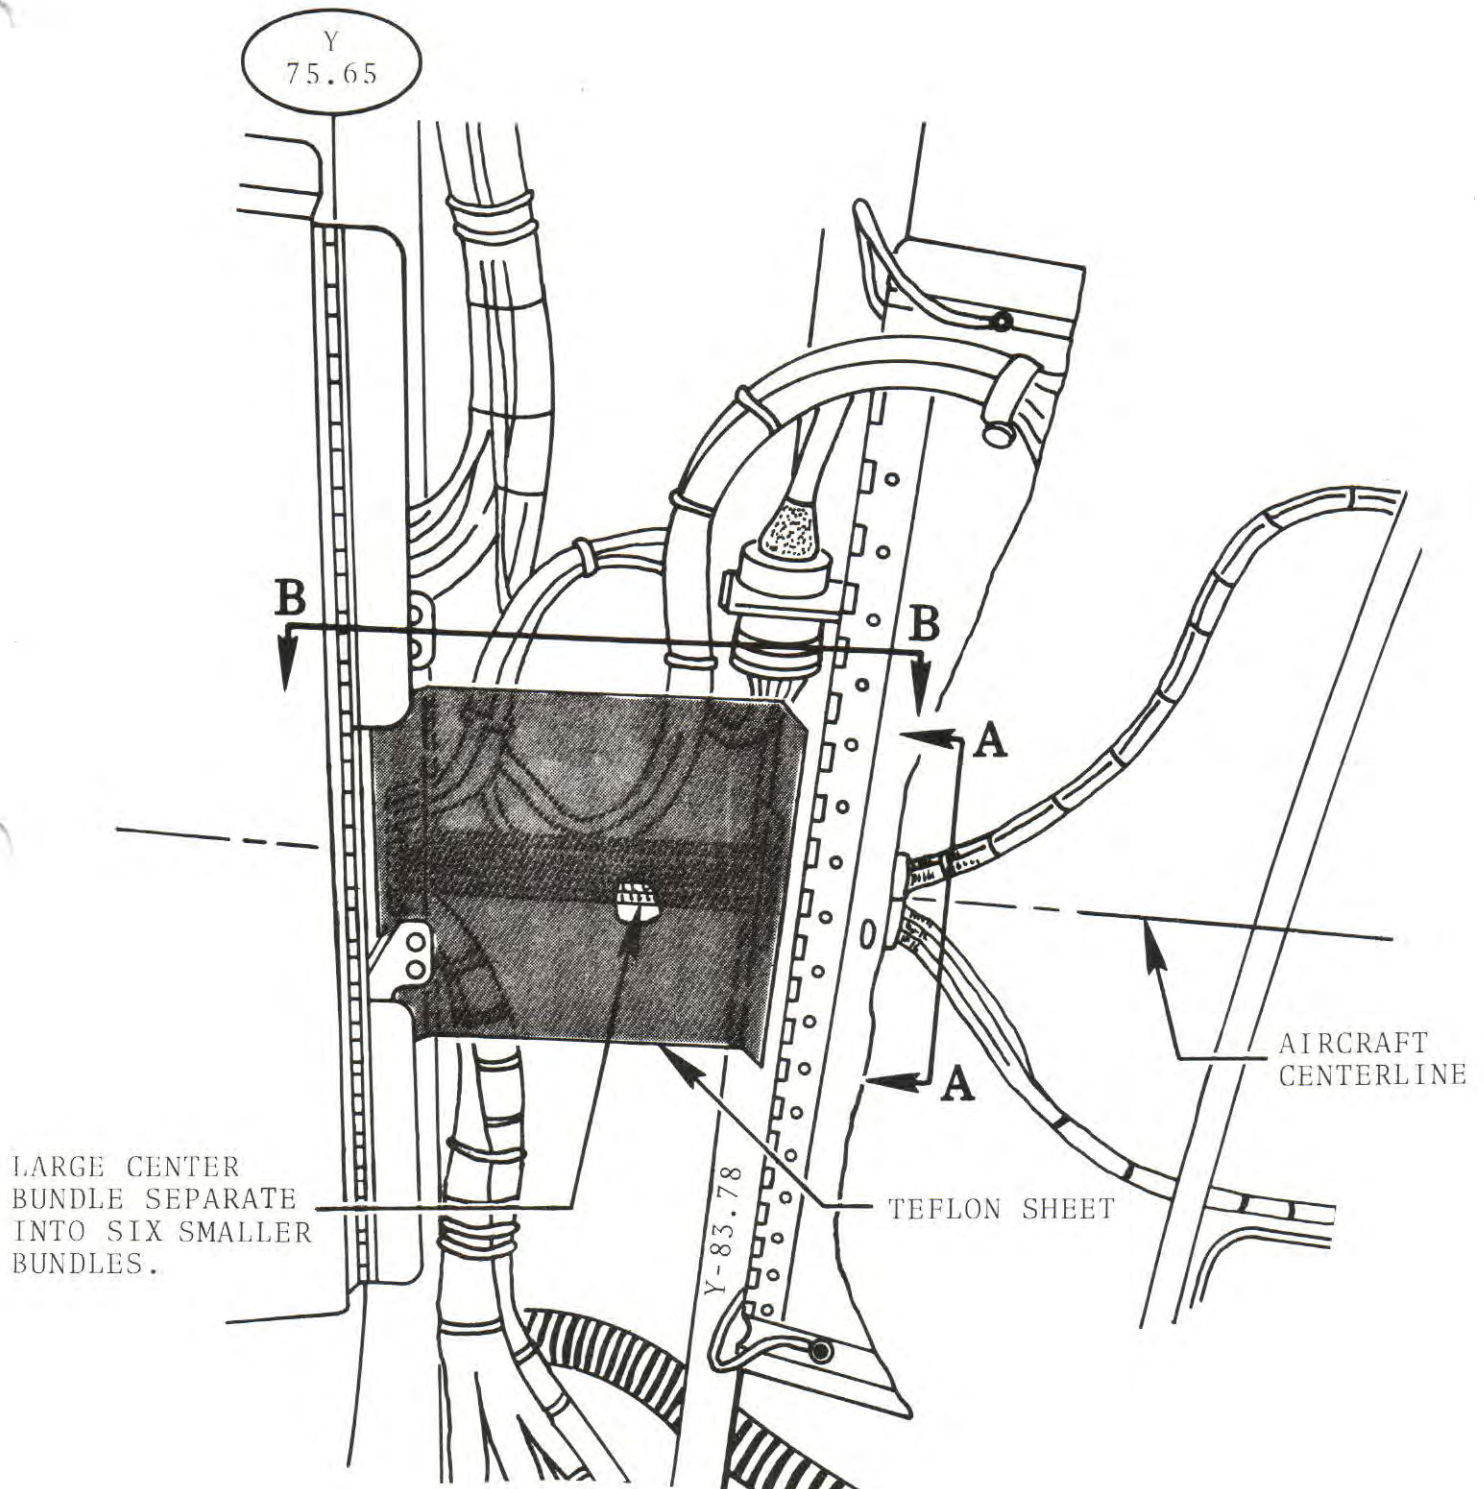
FIGURE 1 REWORK AREA

VIEW LOOKING UP WITH COCKPIT AFT CIRCUIT BREAKER PANEL OPEN

1. Turn off all electrical power and disconnect batteries.
2. Remove cabin headliner aft of warning sign located at Fus. Sta. Y= 83.780.
3. Unlatch forward and aft cockpit overhead circuit breaker panels and allow them to swing down.
4. Check wire bundles in area over both circuit breaker panels for chafing, pay special attention to large bundle at center aft edge of forward panel.
5. Protect or repair chafed wires as necessary before proceeding to step 6.
6. With forward and aft circuit breaker panels down, spread center wire bundle coming from fwd overhead panel, passing over aft overhead panel (Going to Terminal Board AB & AC) to a minimum of six separate bundles as shown on Figure 1.
 - (a) Wrap each bundle with scotch tape.
 - (b) Maintain bundle separated by installing pendant cable ties.
 - (c) Check bundles for adequate clearance to circuit breaker terminals as panels are closed.

LARGE CENTER BUNDLE SEPARATE INTO SIX SMALLER BUNDLES.

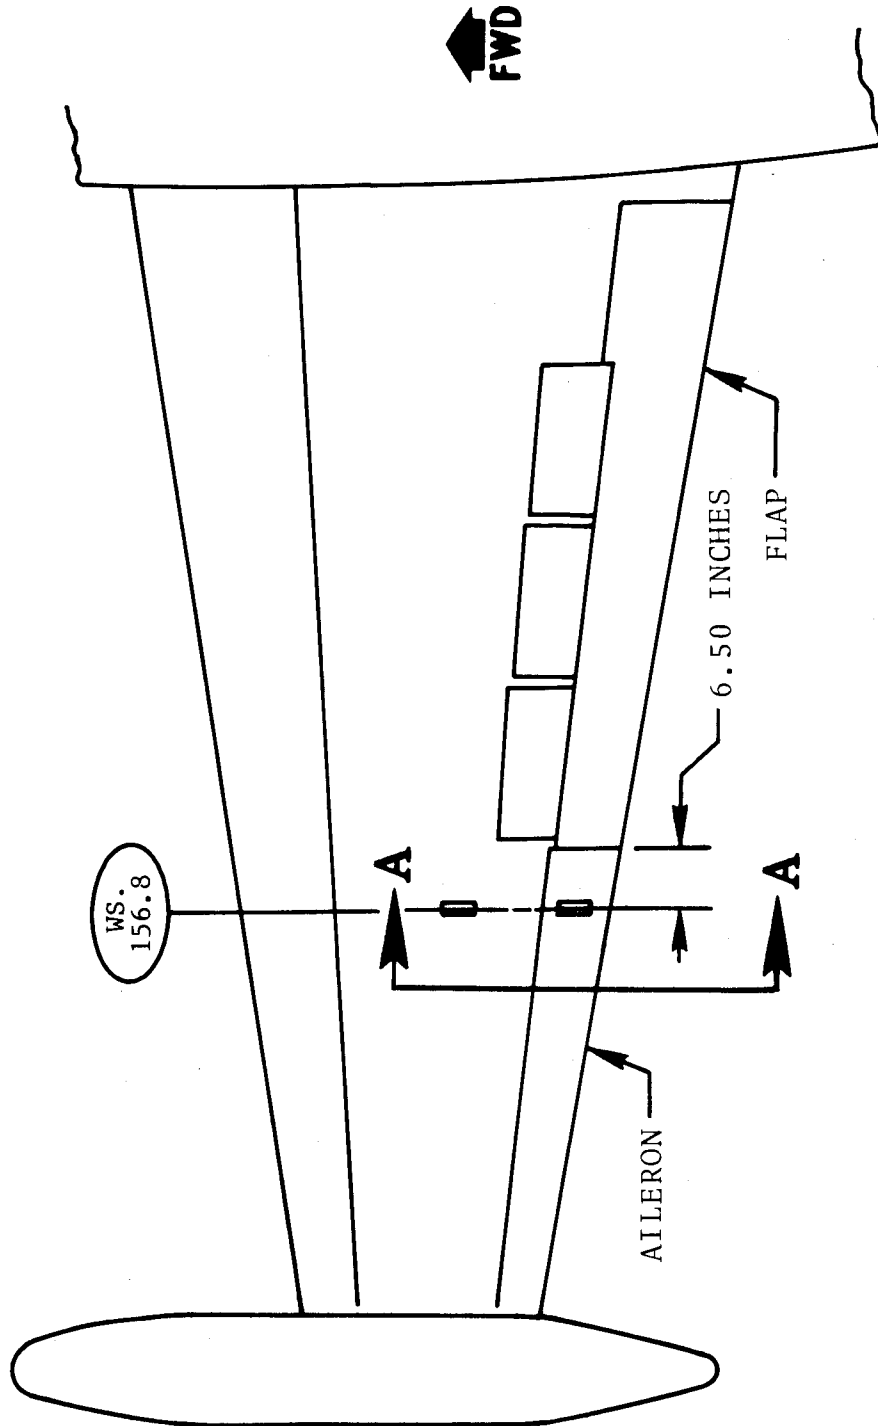
FIGURE 1 STREAMLINE RIGGING CHECK

- A. Aileron freeplay below 0.030 inch is acceptable.
- B. Aileron freeplay between 0.030 and 0.050 inch requires checking for loose bearings or attaching bolts.
- C. Aileron freeplay above 0.050 inch is unacceptable and loose or worn bearings and attaching hardware must be replaced, as required.

- 1 SET PROTRACTOR TO "0".
- 2 MOVE PROTRACTOR TO THIS LOCATION AFTER IT HAS BEEN ZEROED.
- 3 AILERON IS STREAMLINED IF PROTRACTOR READS $2^{\circ} 30' \pm 0^{\circ} 15'$.
- 4 CHECK FOR AILERON FREE PLAY (VERTICAL-MOVEMENT, PER STEP 4 OF INSTRUCTIONS, AT THIS POINT.)

1. Install a 3/16 inch rig-pin in aileron control pulley, aft of Fus. Sta. 316.00 bulkhead per Aileron and Tab - Adjustment/Test, Chapter 27-10-00, Para. 2. A. (4).
2. Check all attaching bolts between aileron control pulley and ailerons for proper torque.
3. With aileron tab in streamline position (in order to eliminate tab freeplay) measure and record the "no load" freeplay of aileron trailing edge at Wing Sta. 156.8, left and right side, Per Figures 1 and 2.
4. The total freeplay shall not exceed 0.050 inch. If necessary, replace rod end bearing assembly on push-pull rod P/N 513020-501.

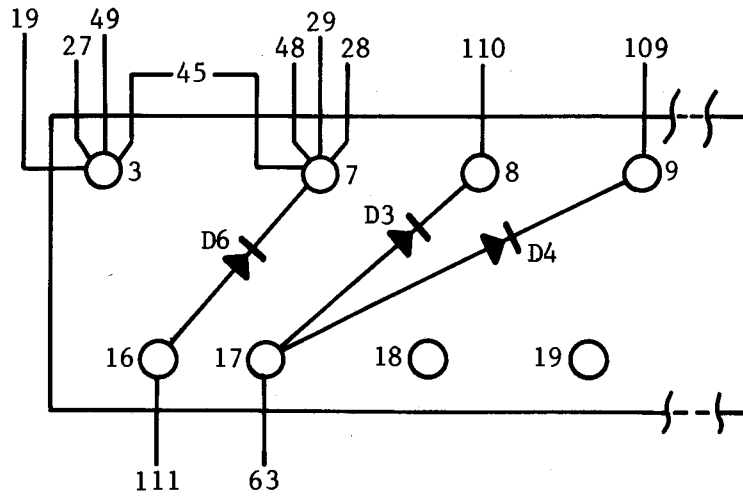
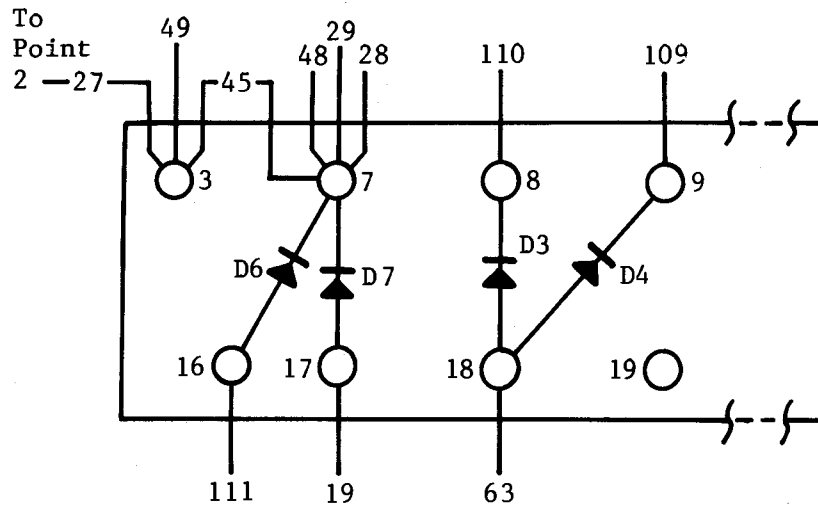
FIGURE 1 ADDITION OF DIODES

REASON: TO PREVENT LEAK PATH BETWEEN BATTERY BUS AND DISTRIBUTION BUS

FLAP CONTACTOR BOX (WAS CONFIG.)

FLAP CONTACTOR BOX (NOW CONFIG.)

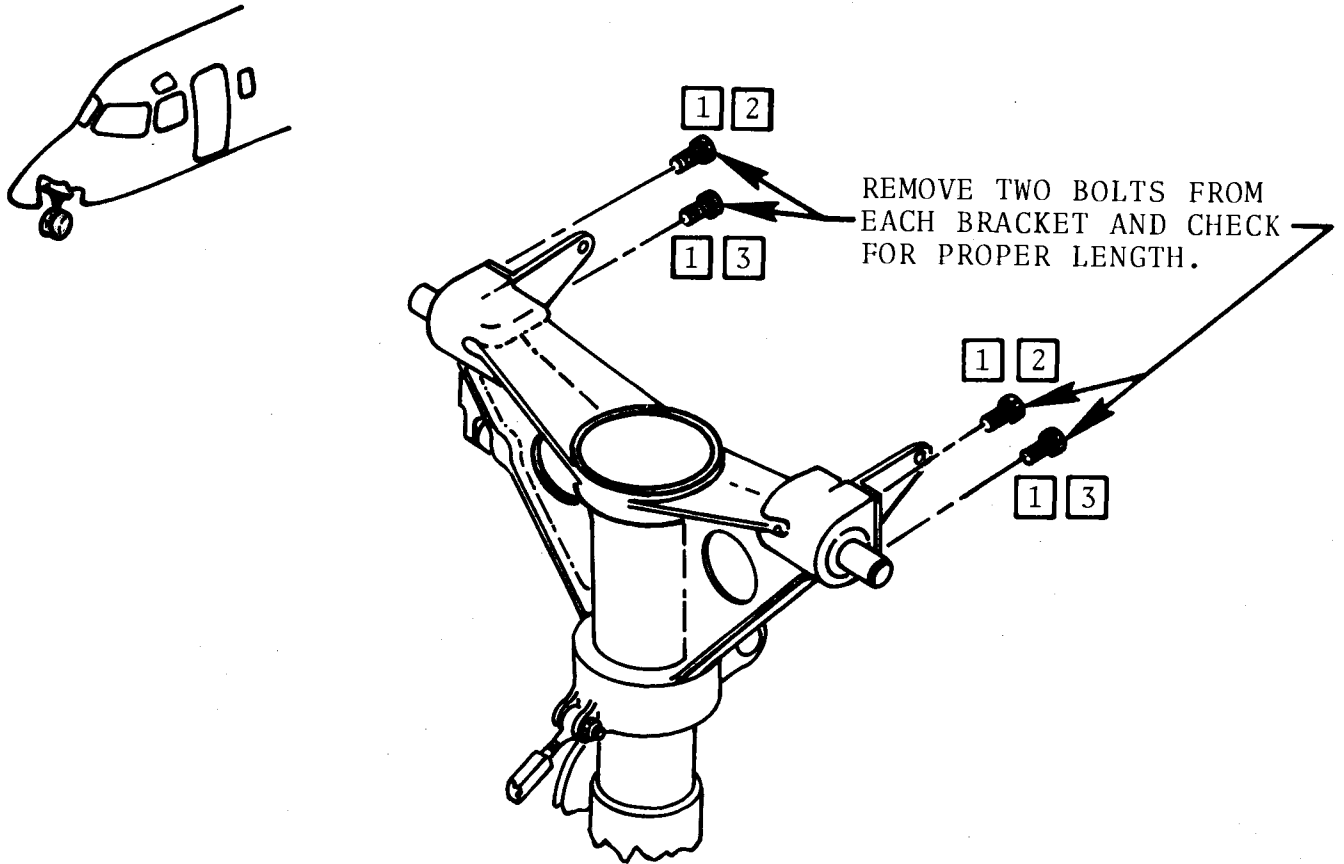
- 1 SHOULD BE AN4H6A (GRIP 5/16" LENGTH 25/32") IN THE TOP AND BOTTOM. THREE WASHERS MUST BE UNDER THE HEAD OF EACH LOWER BOLT AND ONE UNDER THE HEAD OF EACH UPPER BOLT.
- 2 TOP BOLT MUST BE AN4H6A.
- 3 ALTERNATE BOLT FOR LOWER LOCATION IS AN4H5A (GRIP 3/16" LENGTH 21/32") IF THE AN4H5A BOLT IS USED PLACE ONE WASHER UNDER ITS HEAD.

Should AN4H5A or AN4H6A bolts bottom out when installed, it will be necessary to measure hole depth, add regular thickness washers or select proper length bolt to obtain maximum thread engagement between bolt and strut outer body.

5. Replace incorrect bolts with bolt P/N AN4H6A (Upper) and P/N AH4H5A (Lower).

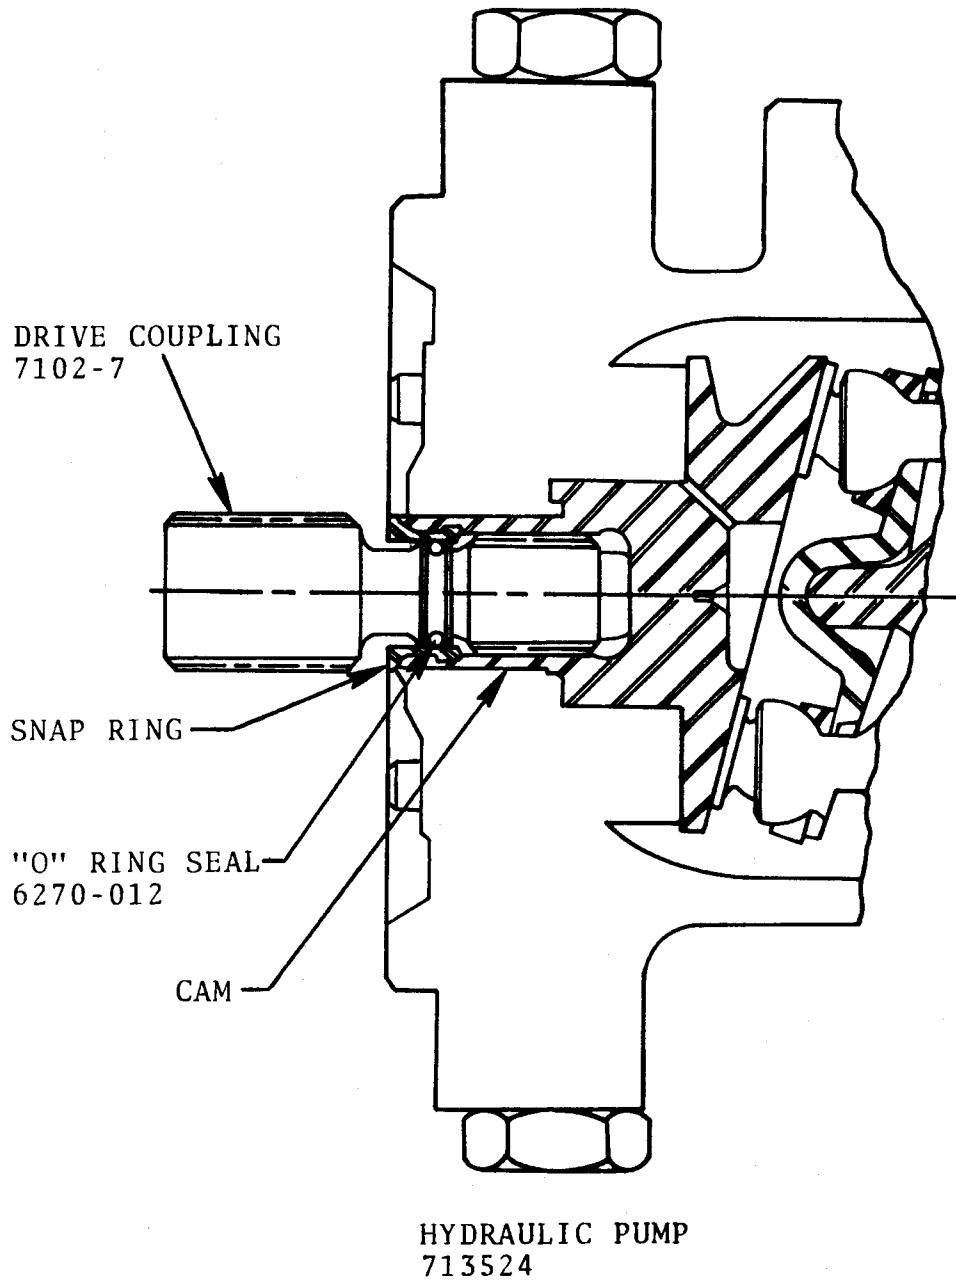
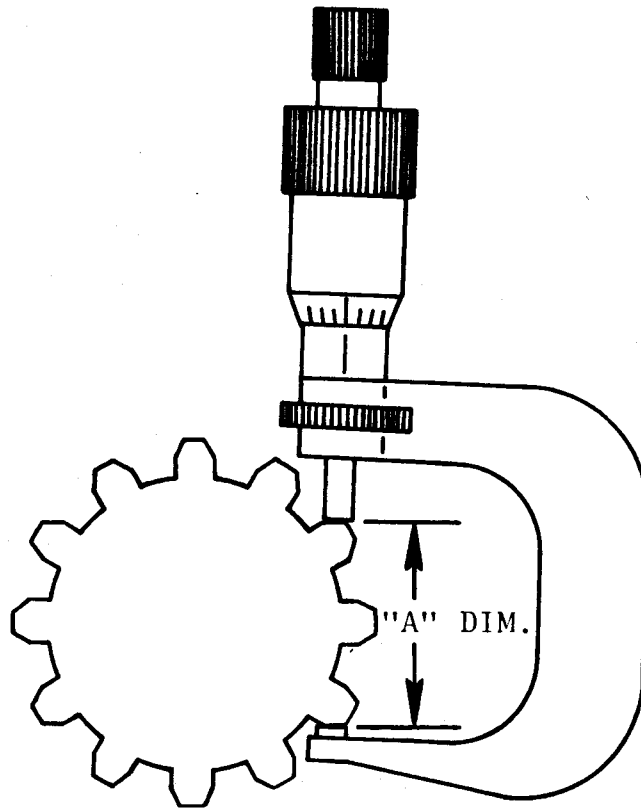
SERVICE LETTER NO. WW-2478

REASON: TO INSURE ADEQUATE LUBRICATION AND REDUCE CAM
AND COUPLING WEAR IN THE HYDRAULIC PUMP.

If splines are worn beyond limits on pump end, both coupling and cam in pump will require replacement. Pump should be returned to Atlantic Aviation for an exchange unit. If coupling is not worn beyond limits proceed with step 6.

NO. OF SPLINE TEETH	MEASUREMENT ACROSS NUMBER OF TEETH	DIM "A" MIN
10	2	.135
11	2	.174
12	3	.348
16	3	.358
21	4	.420
24	4	.511

- CANCELLED*
1. Open both engine cowlings to gain access to both engine driven hydraulic pumps.
 2. Remove hydraulic pumps from both engines.
 3. Remove drive coupling P/N 7102-7 from both pumps by removing snap ring. See Figure 1.
 4. Clean all grease from drive coupling, pump and engine female splines.
 5. Inspect drive coupling splines for excessive wear. See Figure 2 for wear limit and check procedure.

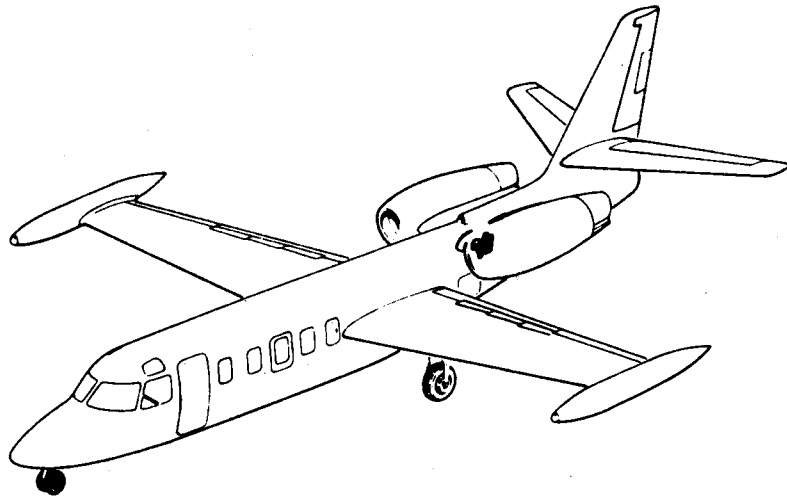
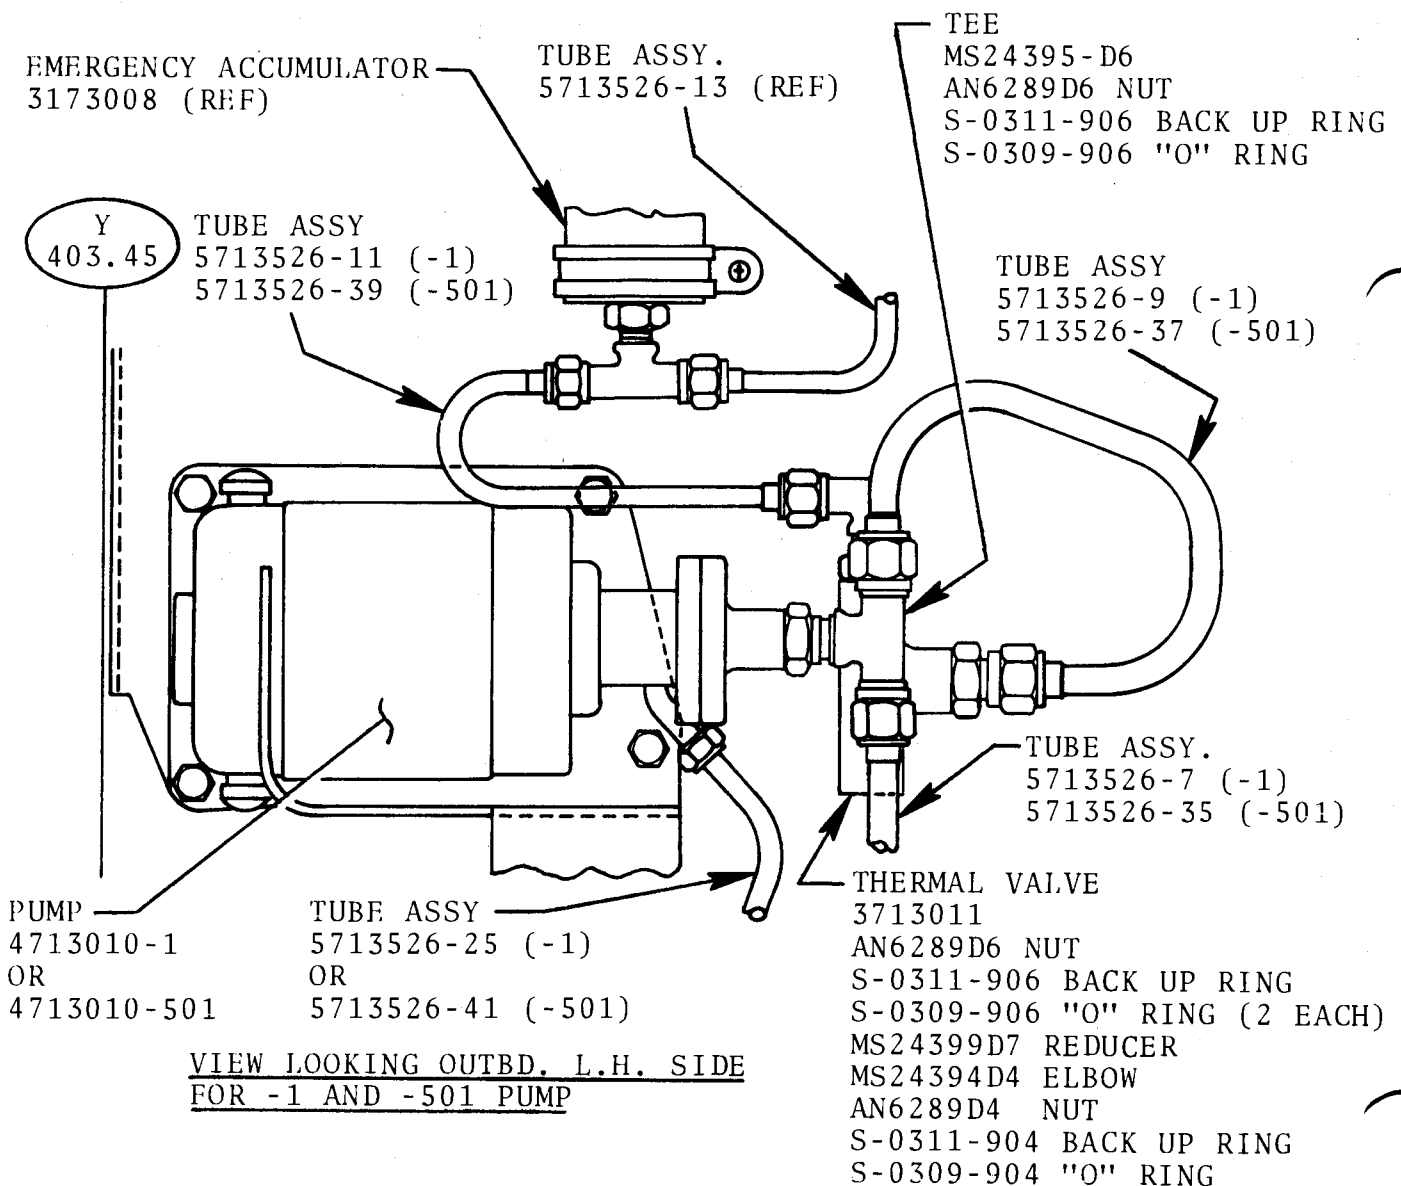
FIGURE 1 EXISTING INSTALLATIONS

REASON: HYDRAULIC PUMPS P/N 4713010-1 AND -501 HAVE BEEN DISCONTINUED BY THE VENDOR. REPLACEMENT PUMPS EITHER NEW OR OVERHAULED MAY NOT BE AVAILABLE IN SPARES STOCK.

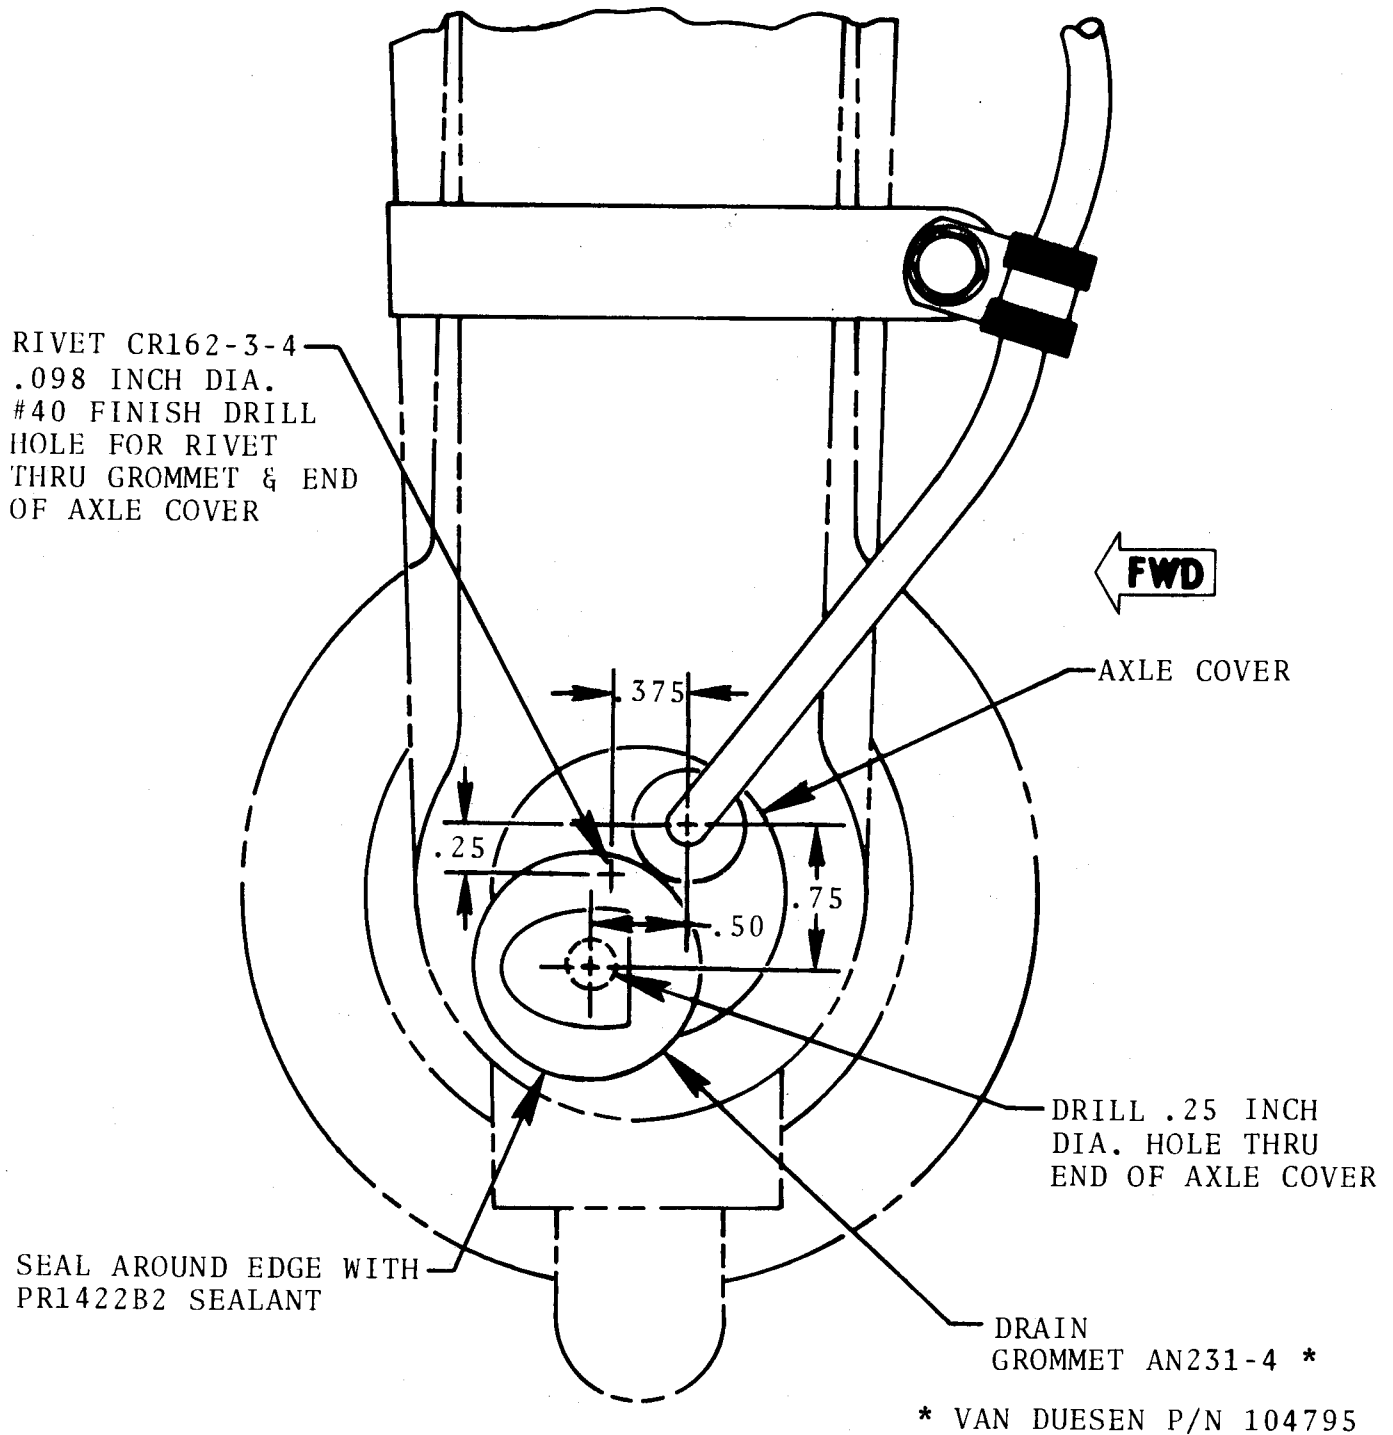
SUBJECT: MOISTURE DRAIN FOR MAIN LANDING GEAR AXLES.

REASON: TO PROVIDE FOR ESCAPE OF CONDENSATION MOISTURE FROM INSIDE MAIN GEAR AXLES.

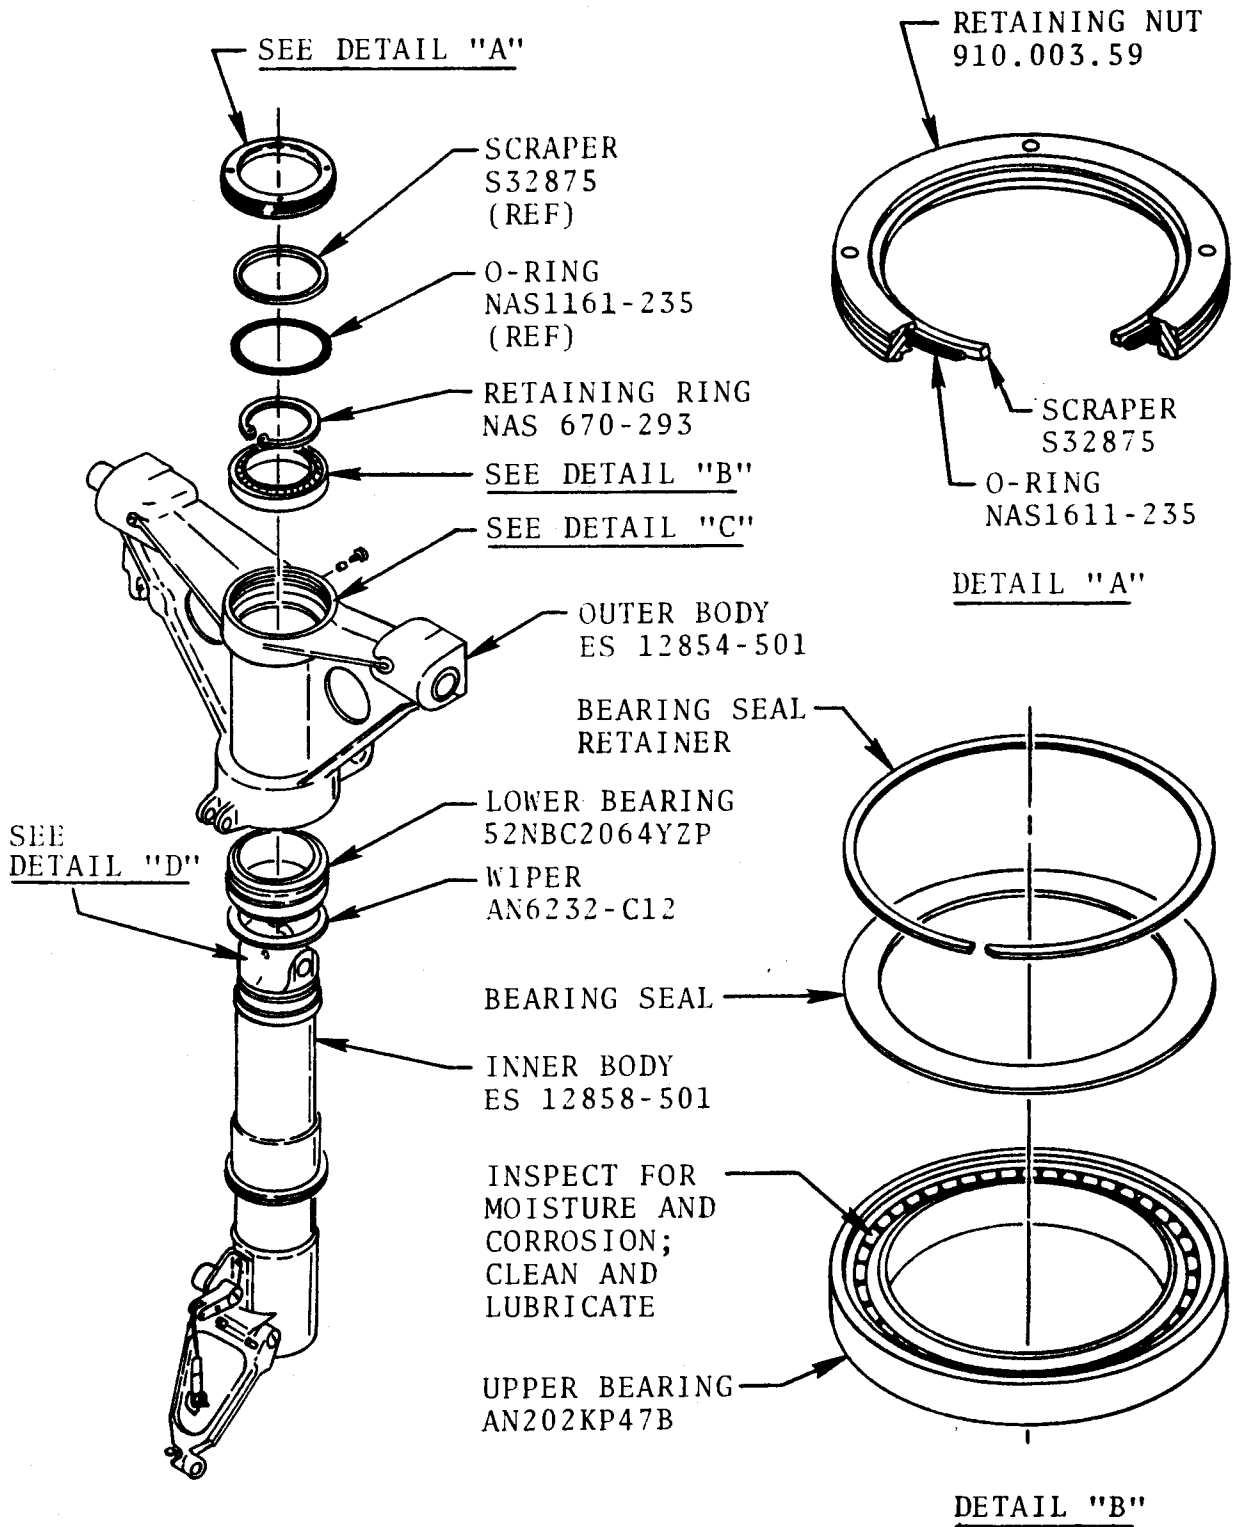
Figure 1 Nose Strut Assembly(sheet 1 of 2)

REASON: To Improve upper strut bearing retaining nut seal and reduce potential for moisture accumulation in nose strut bearings.

1. Remove inner body of nose strut from outer body per 1124/1124A Westwind Maintenance Manual, Chapter 32-20-00.
2. Remove bearing seal and retainer from one side of upper bearing. Reference Detail "B" for Figure 1. Lower bearing should not be disassembled. Inspect both bearings for evidence of moisture or corrosion.

NOTE: Defective bearings must be replaced. Leave off seal and retainer from one side of upper bearing only or remove seal and retainer from one side of new upper bearing before reassembly.

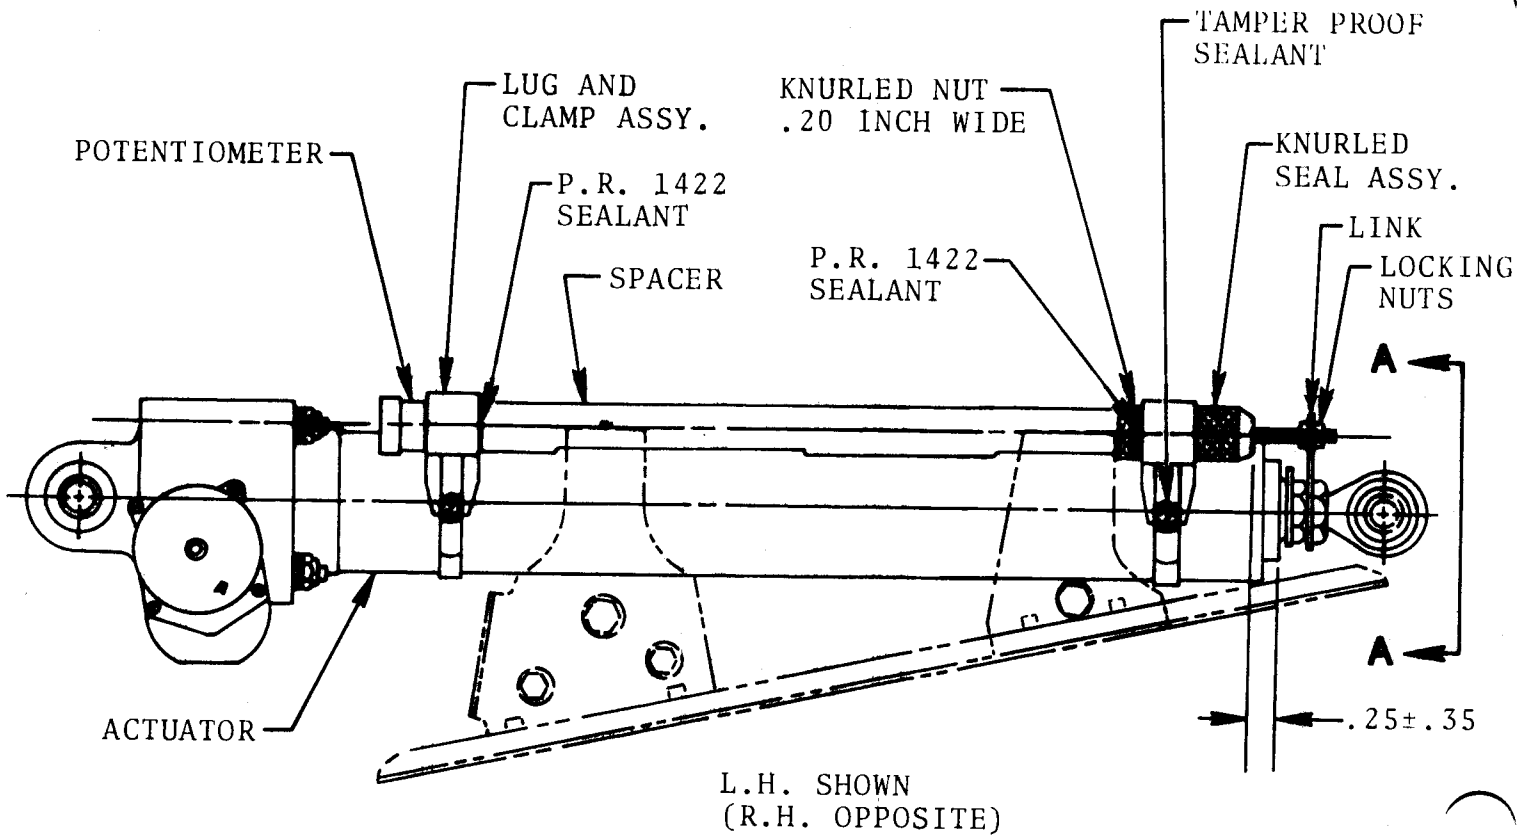
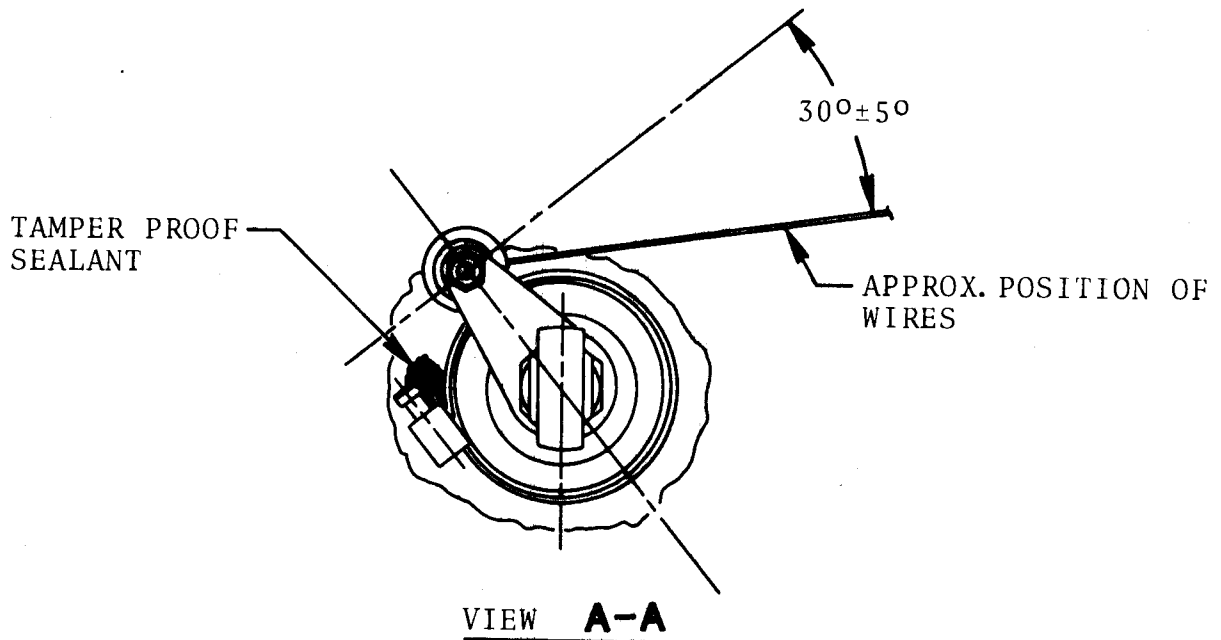
SUBJECT: REPLACEMENT OF BOTH FLAP LINEAR POTENTIOMETERS P/N 4833523-1 WITH NEW P/N 4883523-501.

- 7. Install potentiometer assembly on actuator as shown in Figure 1, leaving clamps loose for rigging.
- 8. Operate the flap system, in small steps, thru its full travel. Check clearance to adjacent parts for 0.12 inch minimum.

- B. Make sure potentiometer axis and actuator axis are parallel.
- 9. Loosen actuator rod end jam nut.
- 10. Position flaps to 12° or 15° position and connect rod to link leaving nuts loose.

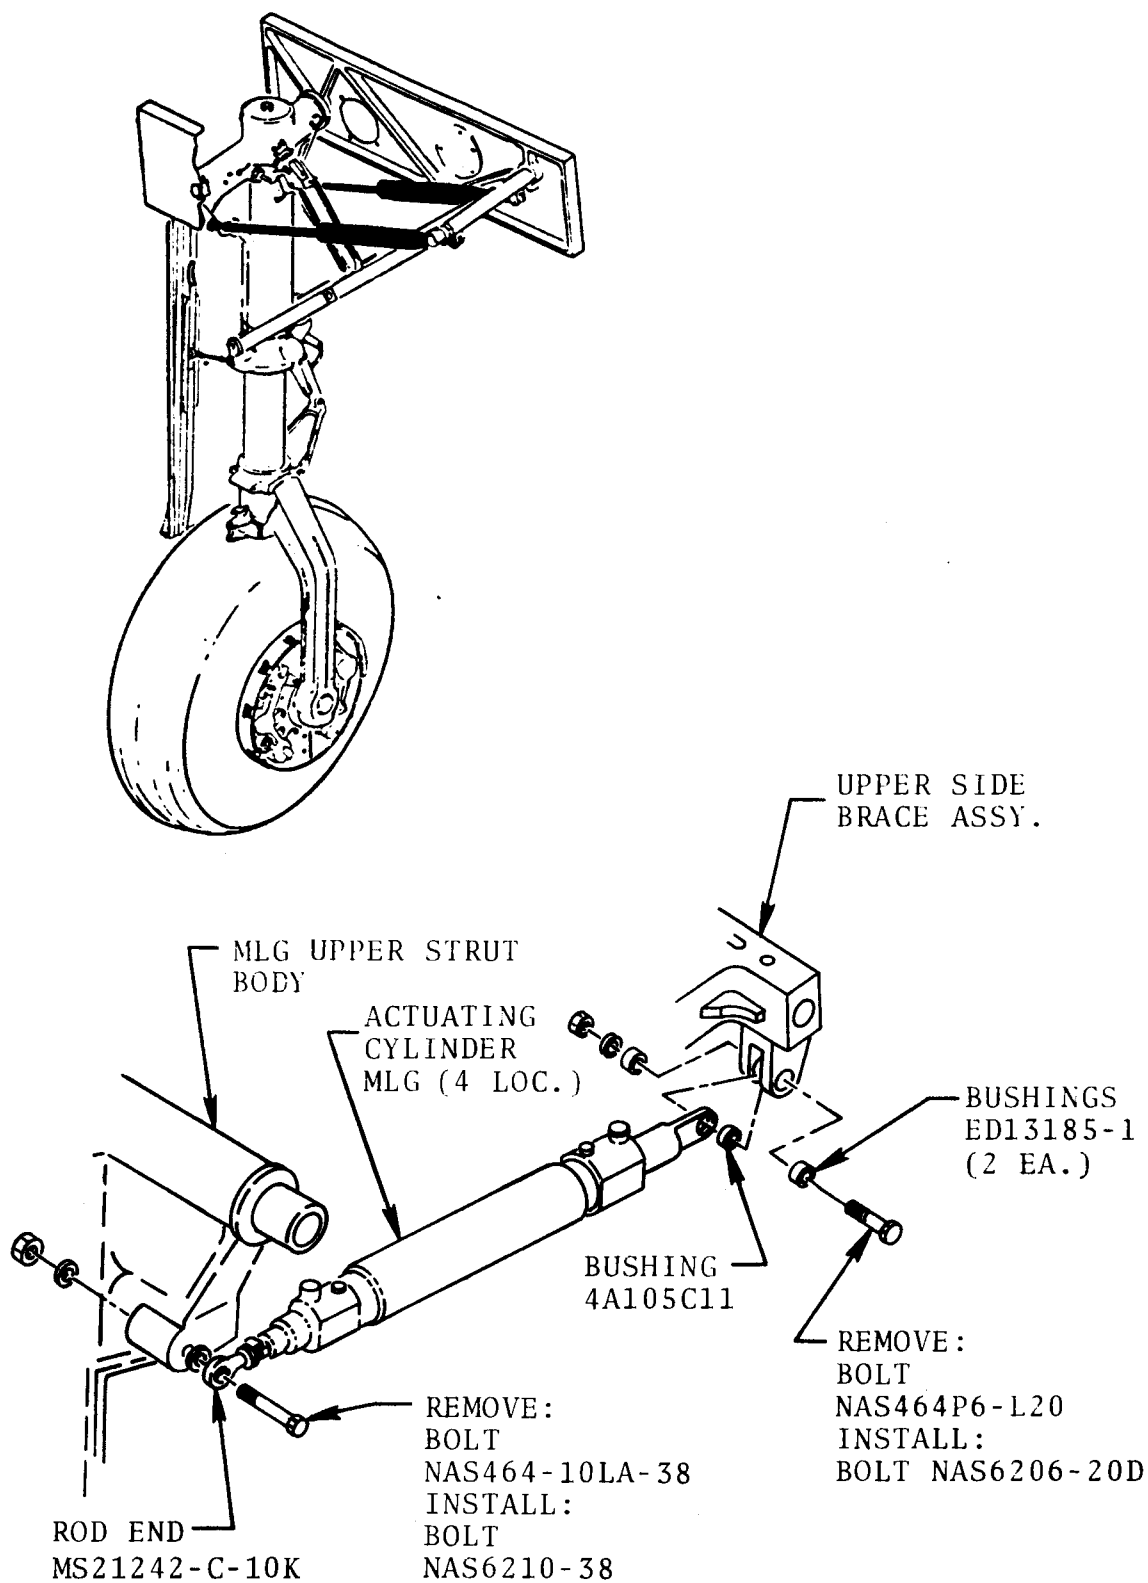
FIGURE 1 ACTUATING CYLINDER ATTACH BOLT REPLACEMENT

R This service letter requires the replacement of unplated or corroded bolts and
R inspection for corrosion at MLG actuating cylinder attach points.
R
