SERVICE INFORMATION LETTER

SERVICE INFORMATION LETTER INDEX

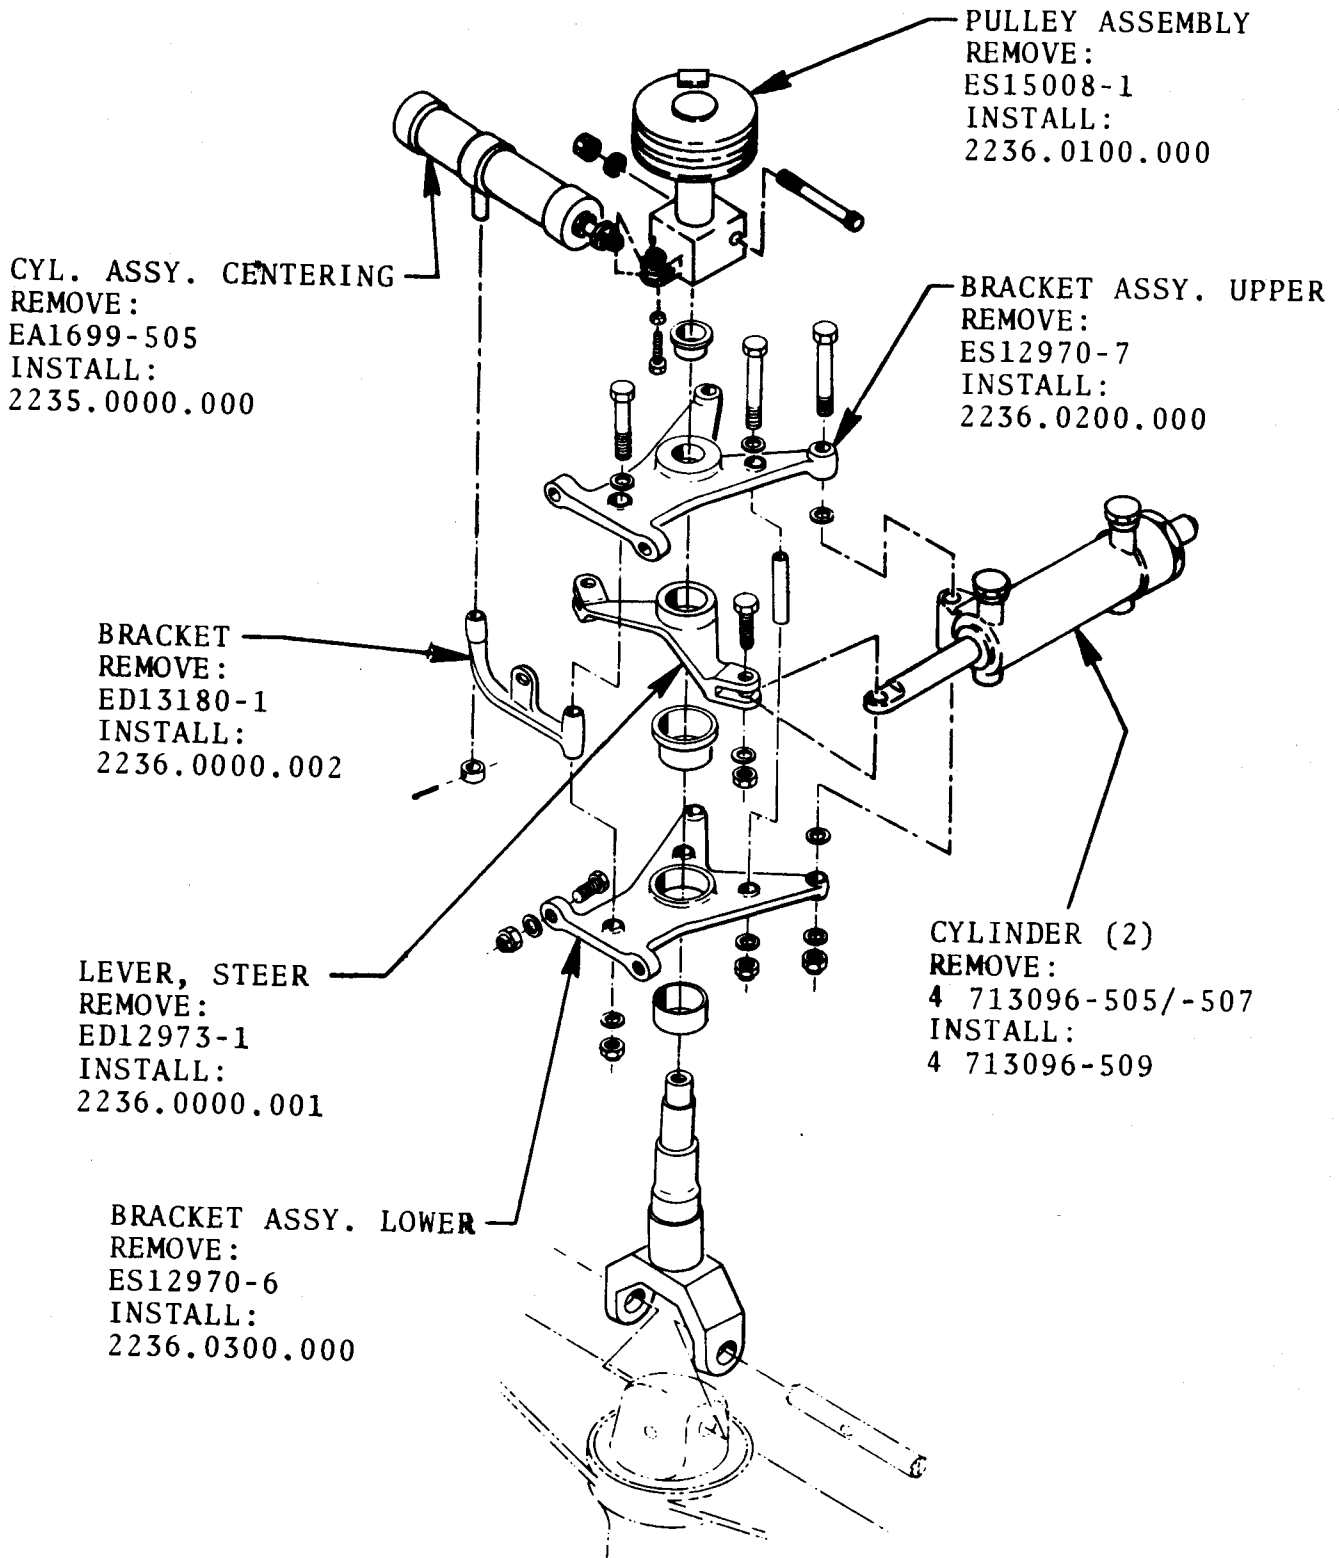
FIGURE 1 58 DEGREE NOSE
STEERING MODIFICATION

- (1) This service letter provides information for conversion of the nose landing gear steering system from a 45 degree turn radius to a 58 degree turn radius.
- (2) The 58 degree turn radius is achieved by direct replacement of selected steering components that are geometrically different in design from existing components.

NEW P/N	QTY	DESCRIPTION	OLD P/N	DISPOSITION
2235.0000.000	1	Cyl. Assy. Centering	EA1699-505	Remove old parts and dispose of as desired.
2236.0000.001	1	Lever, Steer	ED12973-1	
2236.0000.002	1	Bracket	ED13180-1	as desired.
2236.0100.000	1	Pulley Assy.	ES15008-1	
2236.0200.000	1	Bracket Assy. Upper	ES12970-7	Replace with new parts.
2236.0300.000	1	Bracket Assy. Lower	ES12970-6	
4 713096-509	2	Cylinder	4 713096-505/-507

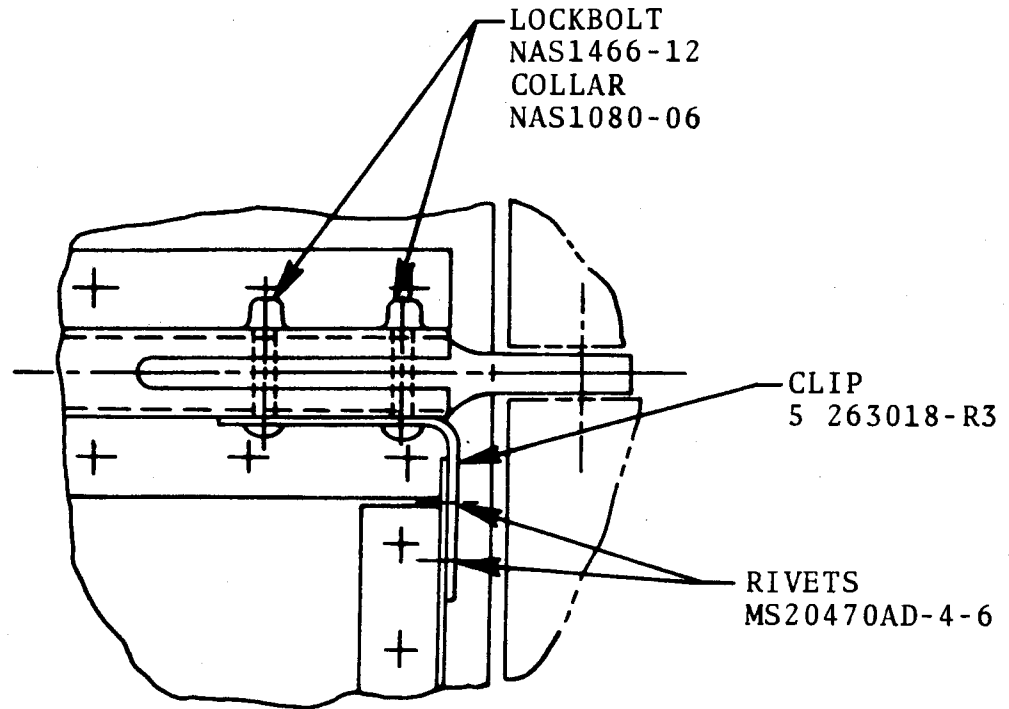
FIGURE 1 INSPECTION OF STRUT
DOOR

- A. Visually inspect the MLG strut door attachments for looseness at hinge points, actuator rod ends and rod end attach bolts. Excessive looseness should be corrected by replacing affected part or parts.
- B. Lubricate all moving parts on the MLG strut door using an oil can.
- C. Visually inspect MLG strut door hat section reinforcements and skin for cracks.

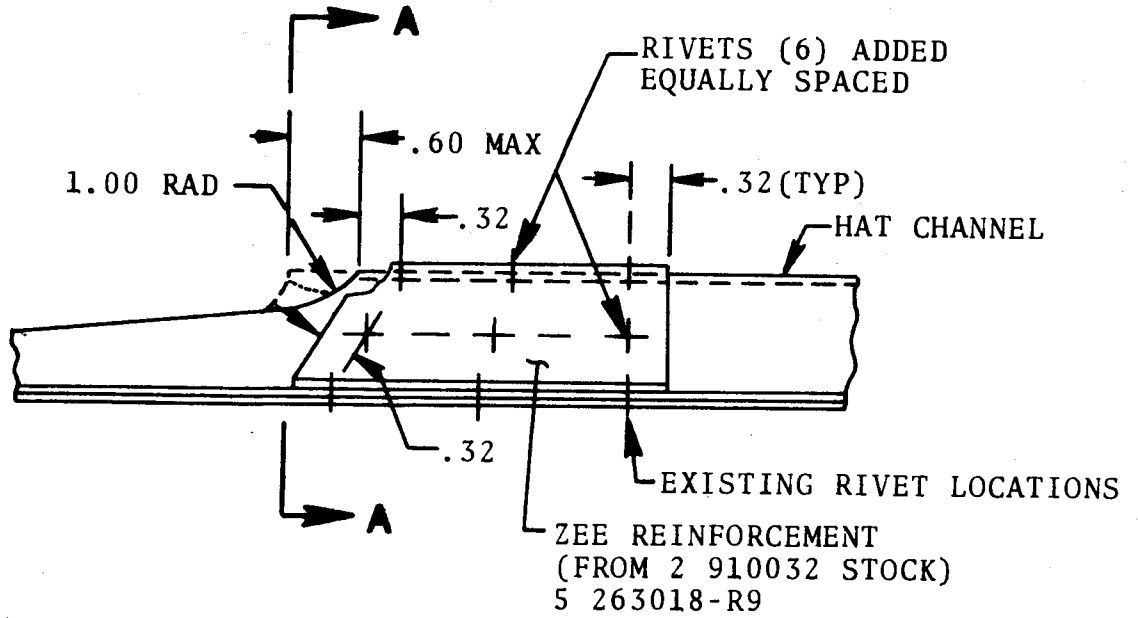
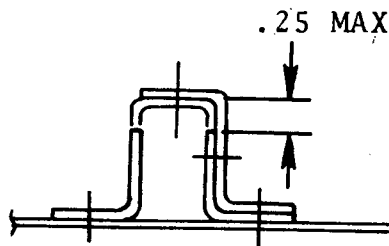
FIGURE 3 REPAIR OF CRACK RUNNING ALONG RIVET LINE OF HAT CHANNEL IN DOOR SKIN.

To establish standardized repairs for areas of the MLG strut doors that are subject to cracking. Cracking appears to be the result of operations in flight when the gear is down and the strut door is buffeting.

- (3) Finish per Step 2.E.
- G. To repair a skin crack running along one of the rivet lines where the hat channel is attached, accomplish the following:
- (1) Carefully drill out rivets attaching skin to hat channel in area of crack to allow installation of patch plate P/N 5 263018-R13.
 - (2) Cut out cracked area to allow flush patch P/N 5 263018-R11 to be fit into skin.
 - (3) Locate new patch plate P/N 5 263018-R13 and patch P/N 5 263018-R11 and drill per Figure 3. Feathered edge of patch plate should rest against door skin.

Patch plate P/N 5 263018-R13 may be fabricated from .025 Stainless Steel 1/4" Type 301. Size to be 4 inches X 8 inches with edges feathered back .025 inch from each edge. Patch P/N 5 263018-R11 may be fabricated from .050 Alclad Alum. 2024-T3. Size .50 inch X 5 inches. Ref. Figure 3 for fabrication of patch and patch plate.

- (4) Install patch and patch plate with MS20426AD-4 rivets with head on skin side. NAS1739E-4 blind rivets may be used along center of hat channel.
 - (5) Finish per Step 2.E.
- H. Repair of cracks at tapered end of hat channels may be repaired per Figure 4 or 5 depending on length of cracks as follows:
- (1) For cracks no longer than .040 refer to Figure 4.
 - (a) Trim out cracked section of hat channel as shown in Figure 4.
 - (b) Fabricate zee reinforcement P/N 5 263018-R9 from P/N 2 910032 stock per Figure 4.
 - (c) Carefully drill out three rivets holding hat channel to door skin to allow installation of zee reinforcement.

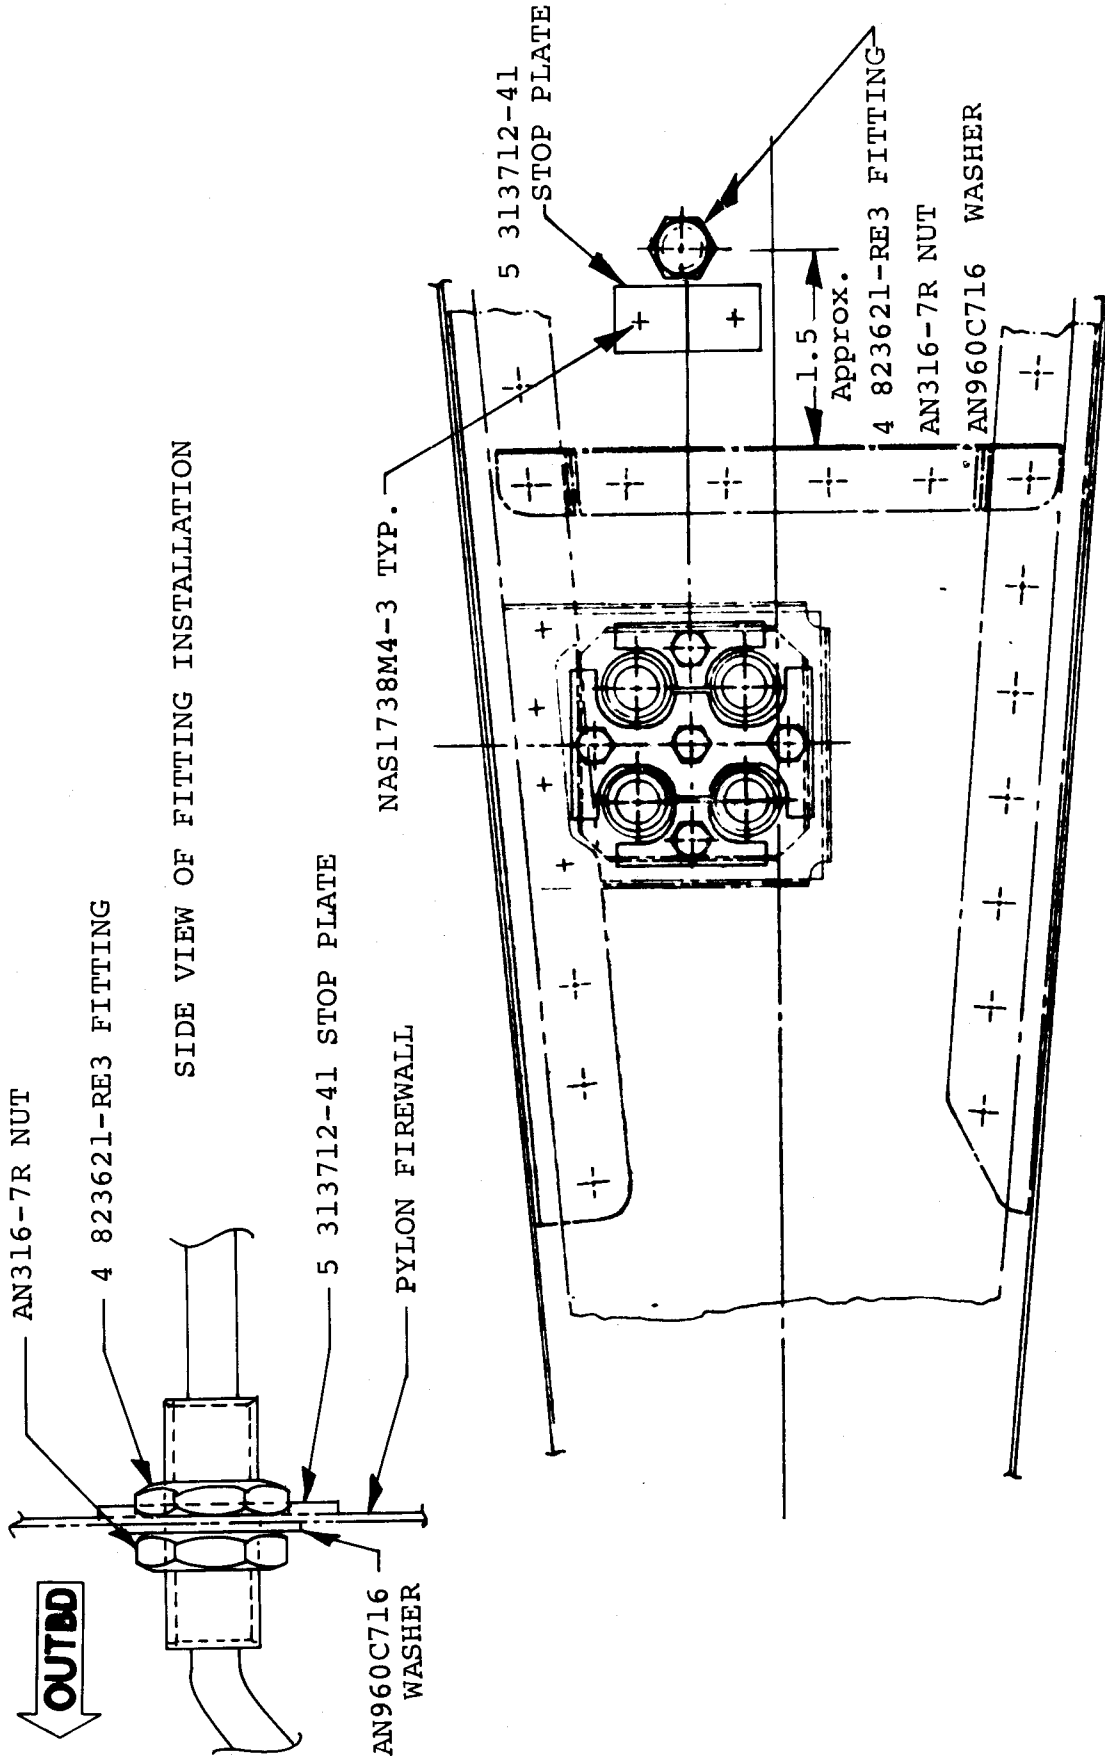
VIEW LOOKING INBD., L/H PYLON
FIGURE 1

- (1) Rerouting and replacement of the existing starter/generator field leads will eliminate chafing and resultant short circuits.
- (2) Installation of shielded leads from the starter generator will reduce EMI radiation (required if H-Field antennas are to be installed).

The starter/generator field circuit leads are replaced with shielded, twisted-pair wire and rerouted to avoid chafe points.

- CAUTION:** ENSURE THAT THE CONNECTIONS TO GCU PINS A AND D CORRESPOND TO STARTER/GENERATOR TERMINAL CONNECTIONS A AND D. REVERSED CONNECTIONS WILL DAMAGE THE GCU WHEN POWER IS APPLIED.

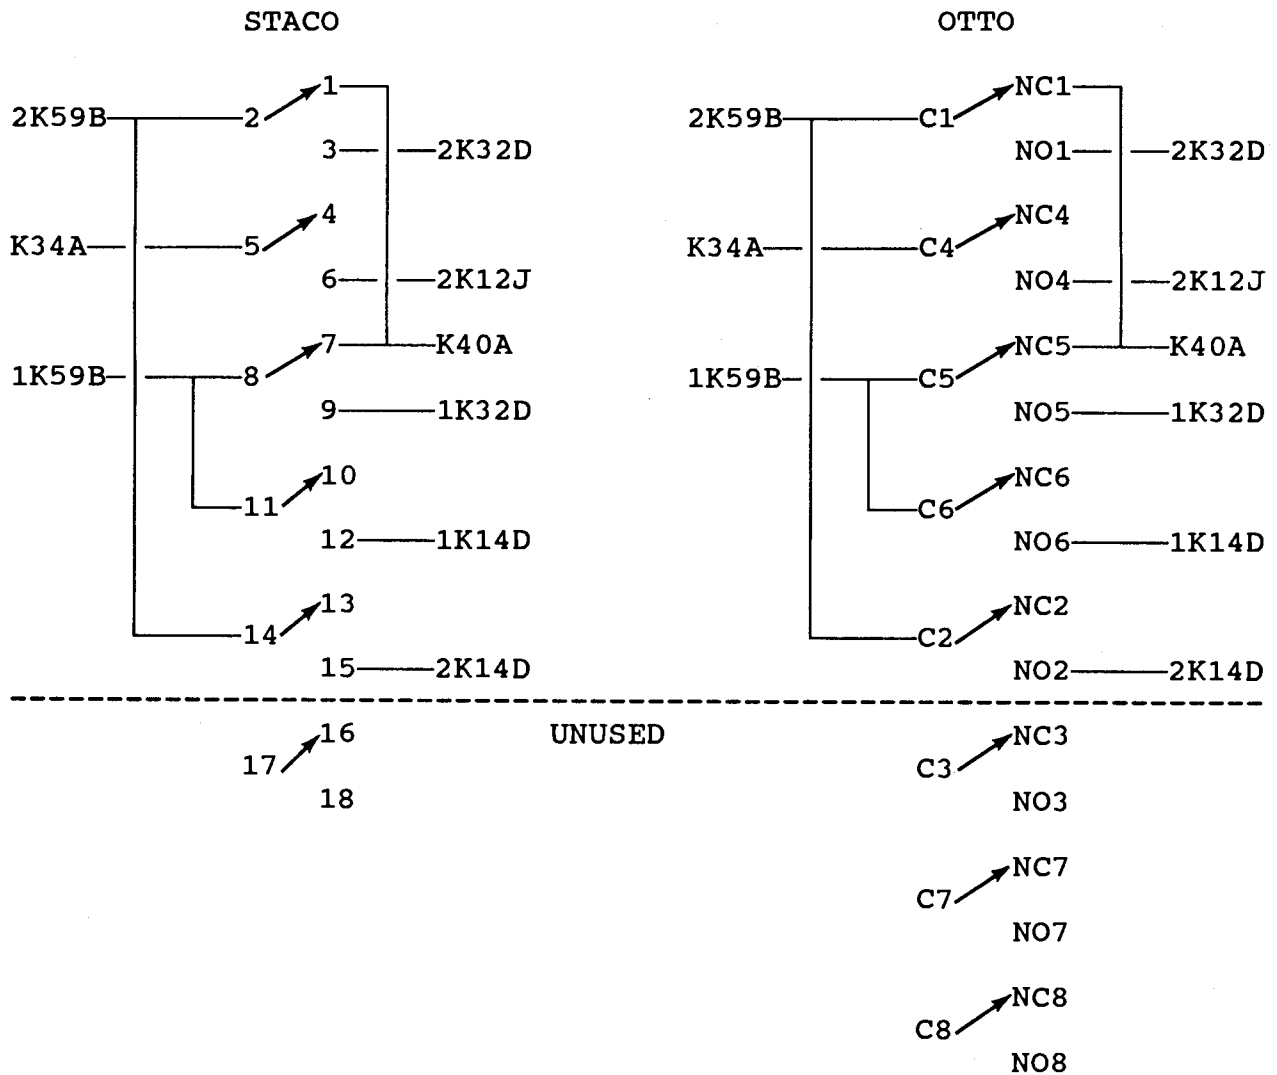
FIGURE 1

Aircraft originally were equipped with Staco P/N 30271-18N Thrust Reverse Fault Test Switches, which are no longer available. An alternate switch, P/N 10120-2, from Otto Controls is approved for replacement.

During replacement of the Thrust Reverse Fault Test Switch, replace Staco switch P/N 30271-18N with Otto Controls switch P/N 10120-2. Because terminal identification is different on the two switches, refer to Figure 1 and the 1124/1124A Westwind Wiring Diagram Manual, Chapter 78-30-01, to compare the original Staco terminal numbers and connecting wires for proper connection to Otto Controls switches.

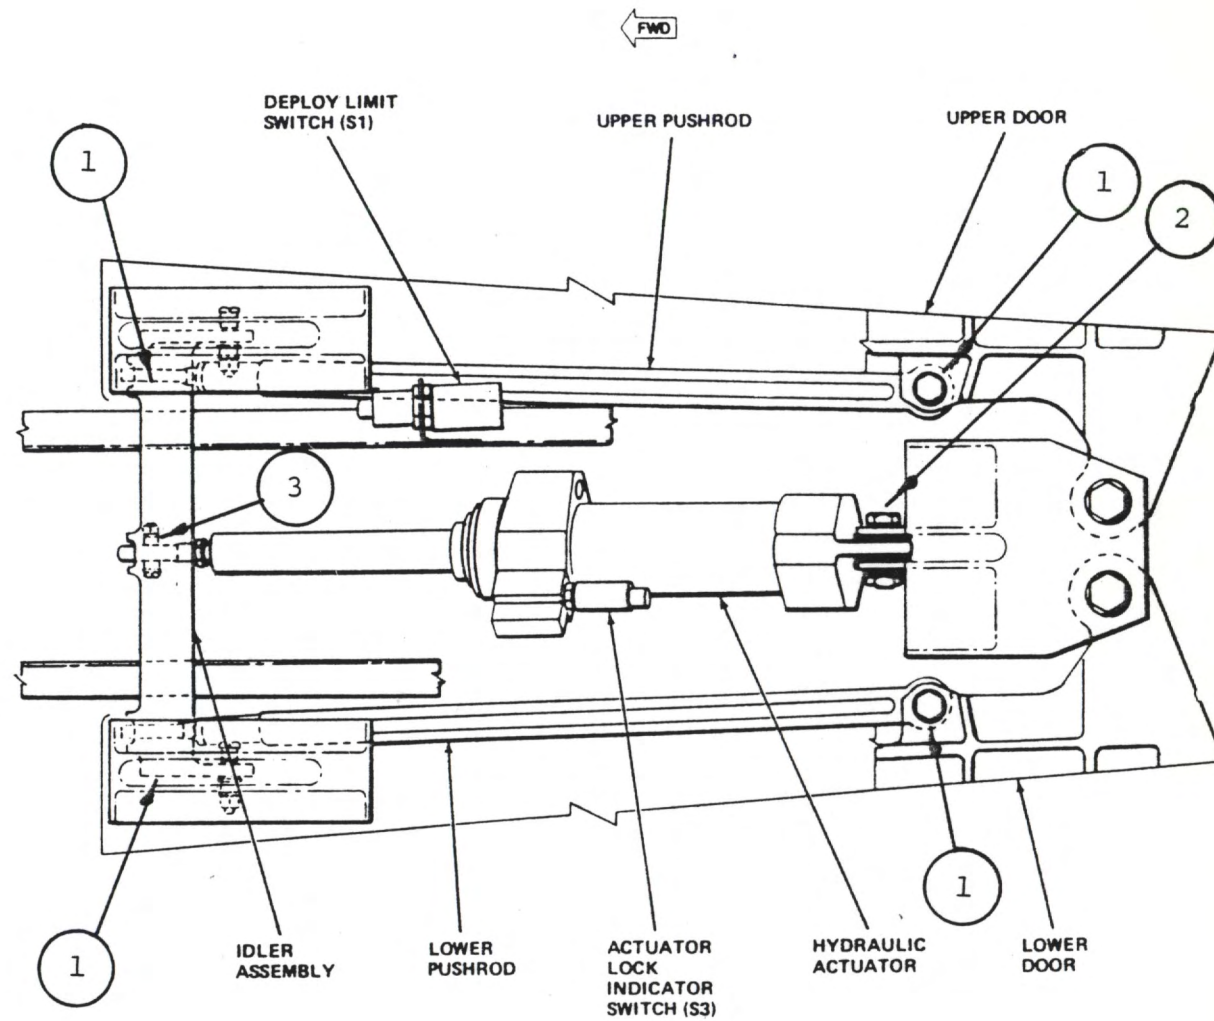
SUBJECT: BOLTS REPLACEMENT ON THRUST REVERSER CONTROLS INSTALLATION.

INDEX ON FIGURE	NEW P/N	UNIT QTY.	KEY WORD	OLD P/N	DISP. INSTR.
1	GB511BG5-15A	8	BOLT	GB511DA5-15	SCRAP
2 3	GB511BG7-15A	4	BOLT	NSA1107-15D	SCRAP
3	MS20002C7	4	WASHER	AN960-716L	USE
3	AN960-716L	4	WASHER	AN960-716	SCRAP

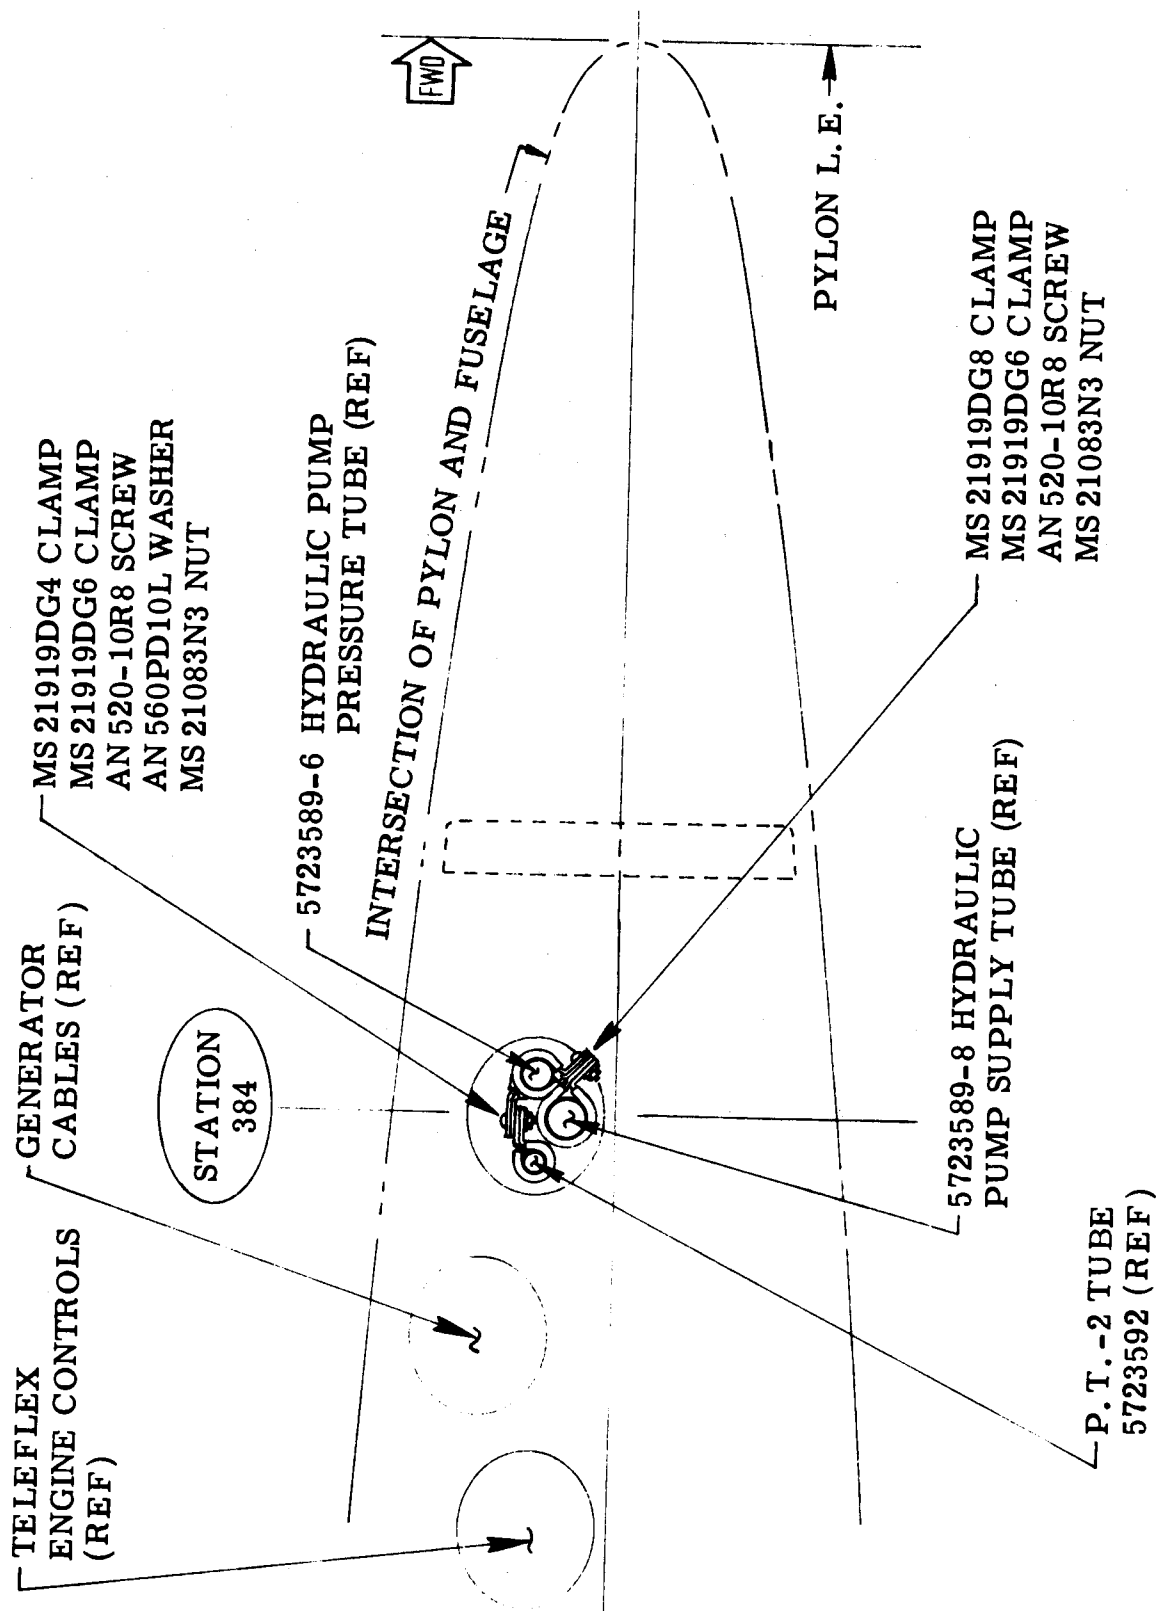
FIGURE 1

Make an appropriate entry in aircraft permanent maintenance records as follows:
 Service Bulletin No. WW-24-6, dated April 11, 1977 entitled "Chaffing of Tubes in L. H. Engine Pylon and Relocation of Nitrogen Gauges and Charging Valves,"
 accomplished _____ (DATE) _____.

INSTALLATION OF TUBING CLAMPS

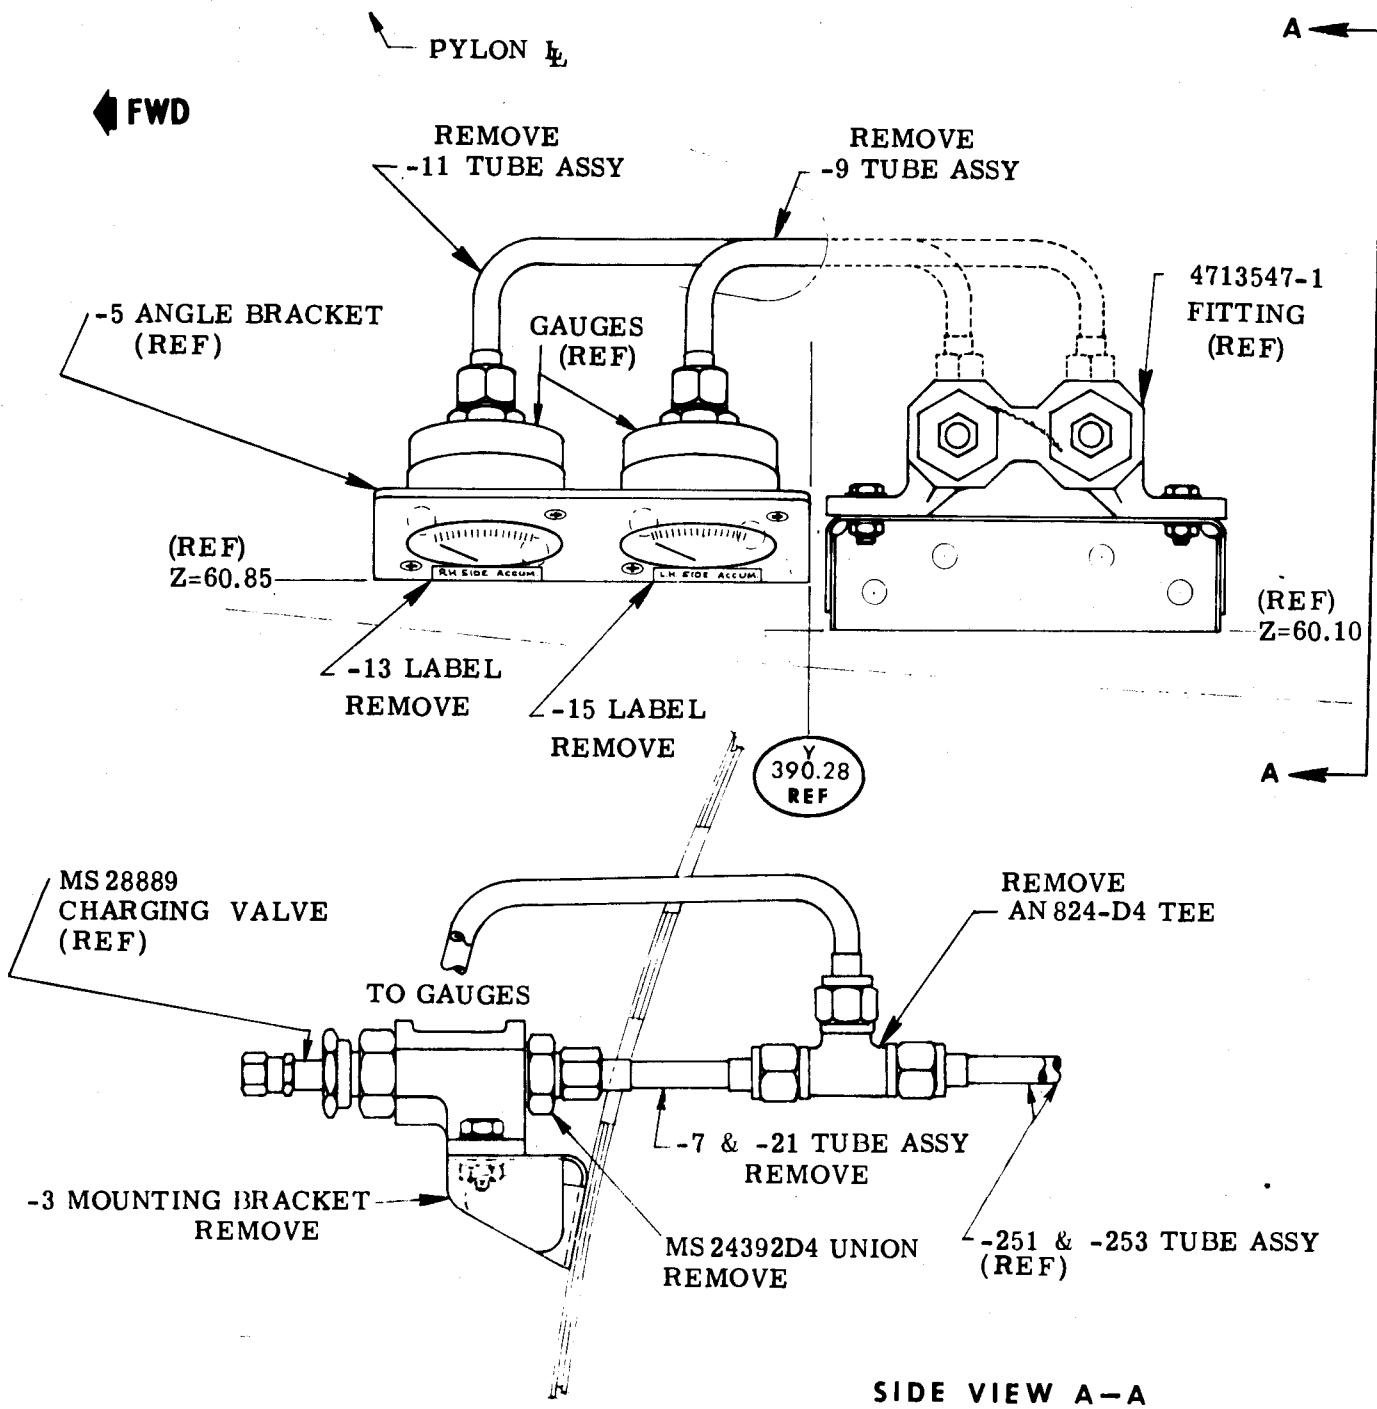
FIGURE 2

PRESENT CONFIGURATION OF NITROGEN GAUGES AND CHARGING VALVES

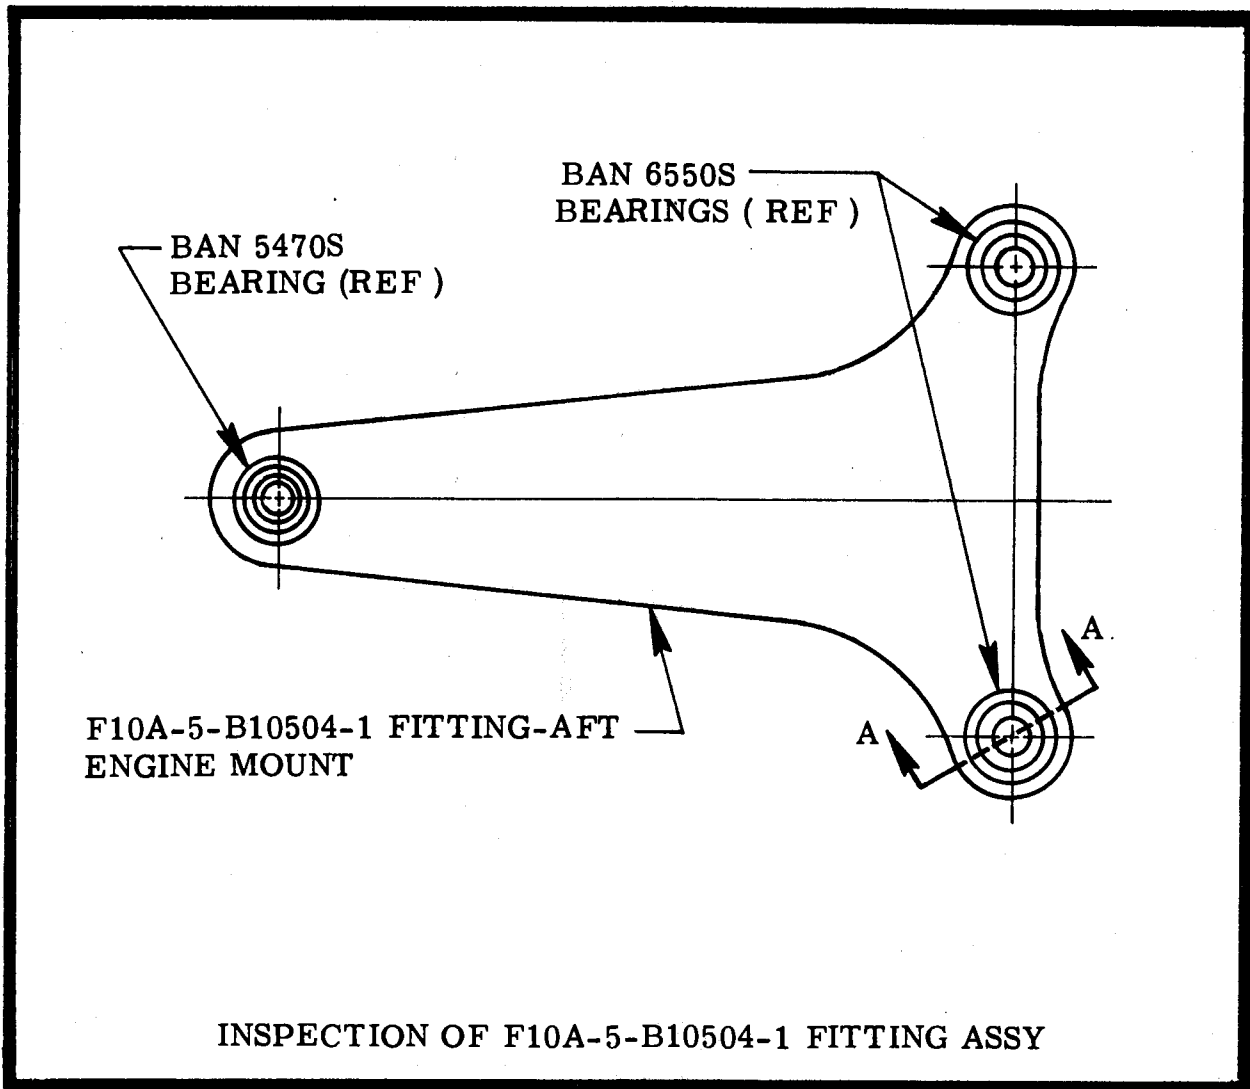
FIGURE 1

INSPECTION OF F10A-5-B10504-1 FITTING ASSY

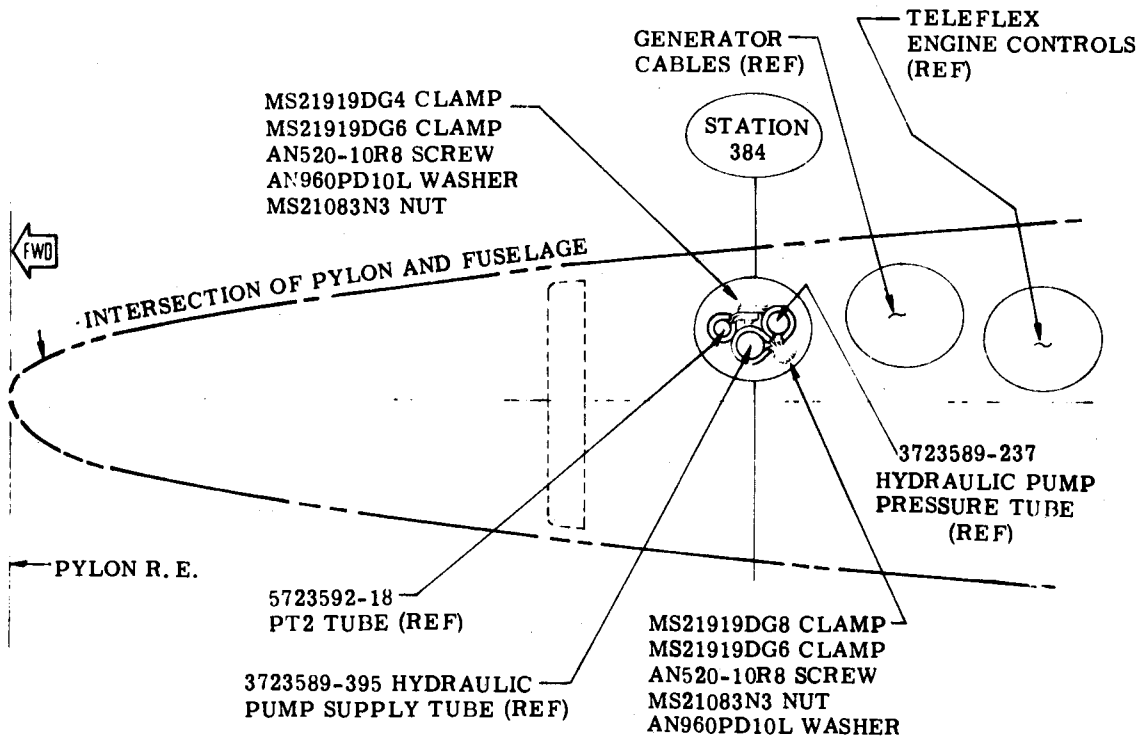
Make appropriate entry in aircraft permanent records as follows: Service Bulletin No. WW-24-10 dated, June 24, 1977, entitled, "Chaffing Of Tubes Near R. H. Pylon", accomplished (DATE) _____.

VIEW - INSIDE AIRFRAME TOWARD R. H. ENGINE PYLON
 INSTALLATION OF TUBING CLAMPS
 FIGURE 1

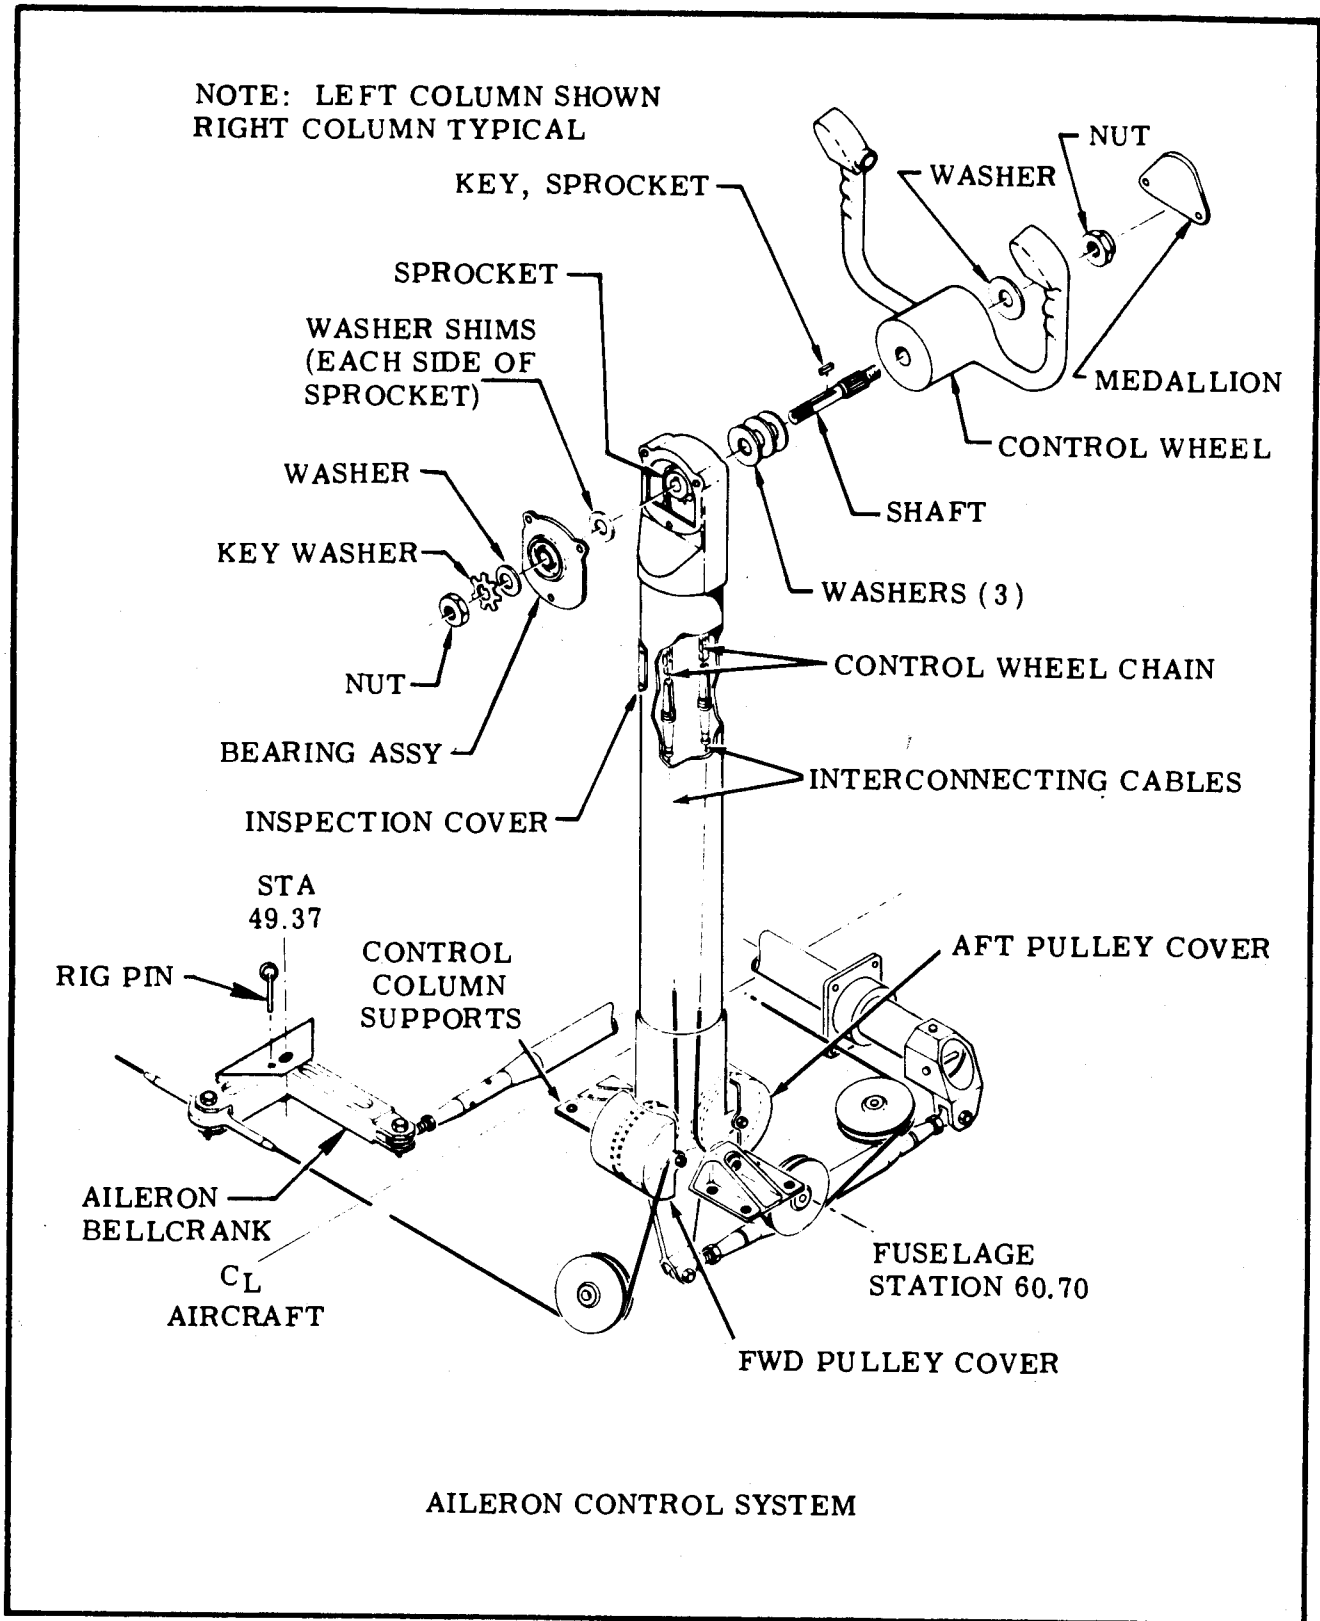
FIGURE 1

SUBJECT: REPLACEMENT OF AILERON CONTROL CHAIN ASSY P/N 3533516-1
AND SPROCKET P/N 2533049-501 IN FLIGHT CONTROL COLUMNS

1. Remove flight compartment floor carpeting. Loosen center pedestal, and remove access panel over center aileron bellcrank at fuselage Station 49.37, and lock bellcrank in neutral position using a 3/16 inch dia. rig pin in the short arm of bellcrank. (SEE FIGURE 1)

4. Remove control column inspection panels. Perform Steps 5 thru 13 for L. H. control column. (SEE FIGURES 1 & 2)
5. Remove turnbuckle safety springs, and loosen turnbuckles to provide slack in control cables.

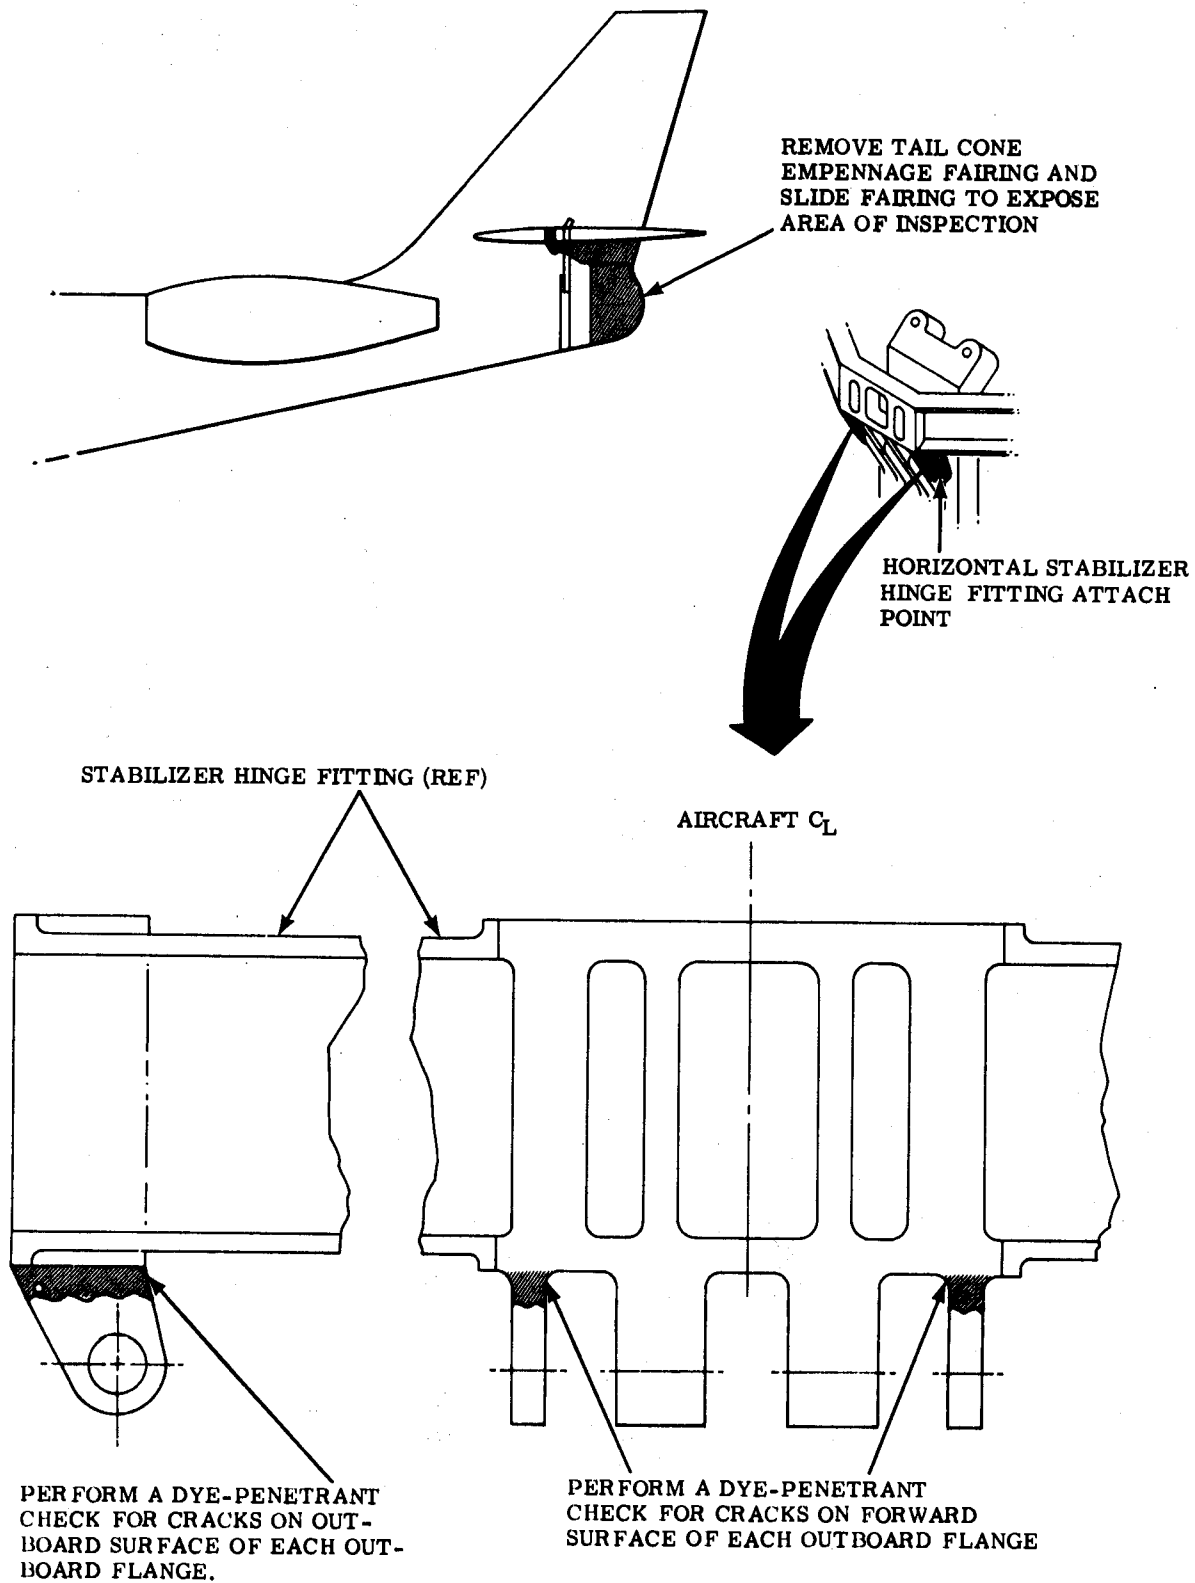
Figure 1.

PURPOSE: TO DETERMINE IF HORIZONTAL STABILIZER HINGE LUGS ARE
CRACKED. TO CHANGE HINGE PIN NUT AND TO CHANGE HINGE
PIN NUT TORQUE TO 20-30 INCH-POUNDS.

1. Remove tail cone, disconnect tail light and remove empennage fairings.
2. Remove and discard hinge pin safety wire. Do not remove hinge pin.
3. Remove paint and primer from outboard lugs of hinge (See shaded area depicted in Figure 1).
4. Perform Dye-Penetrant inspection of outer surfaces of each outboard flange and the forward surface of each outboard flange (See Figure 1).
5. If hinge is cracked, arrangements must be made with an approved Service Facility for replacement of hinge fitting.
6. If hinge is satisfactory, repaint exposed surfaces with Zinc Chromate primer.
7. Remove and discard existing hinge pin nut P/N 5403001-3. Retain existing AN960-14L washer. Inspect hinge pin threads for damage due to over-torque. If damaged replace hinge pin P/N 2453007-3.

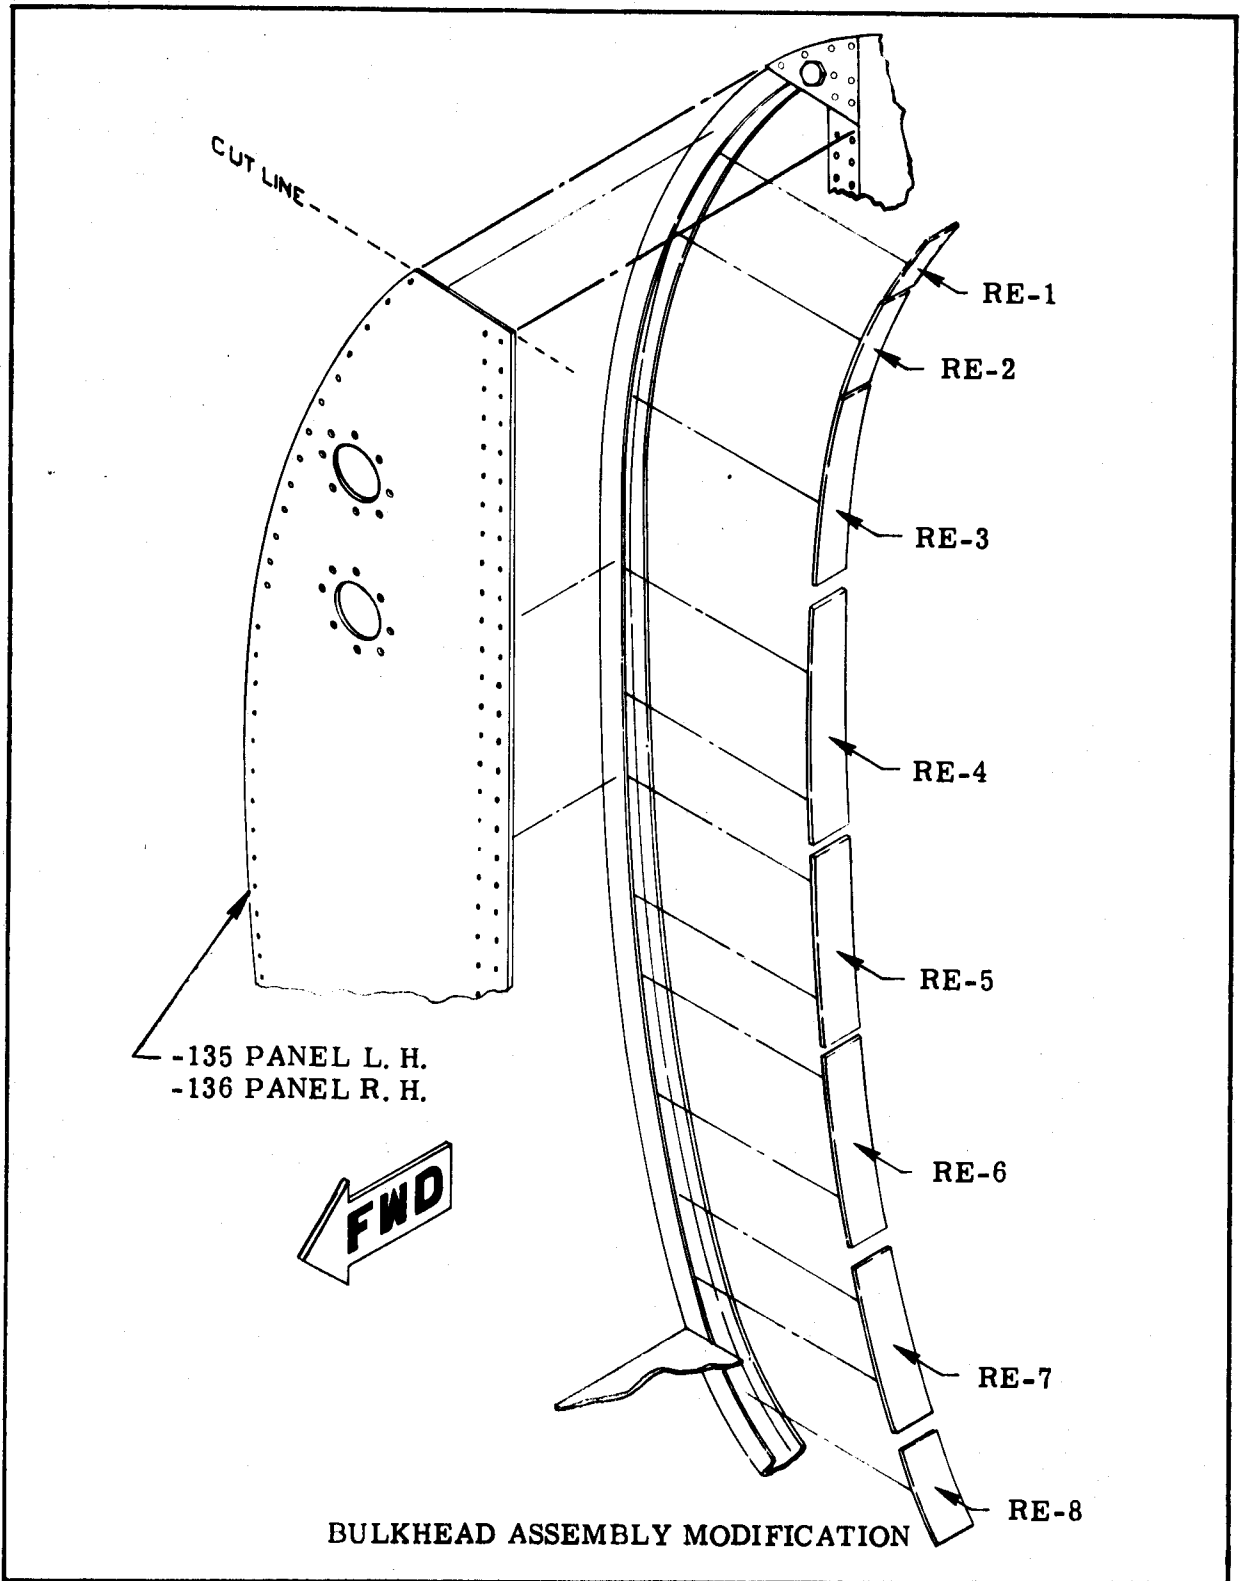
FIGURE 2

PURPOSE: TO PREVENT CRACKING OF THE "U-CHANNEL" IN THE AFT PRESSURE BULKHEAD

1. Remove interior so as to have free access to the entire area of the Aft Pressure Bulkhead Assembly.
2. Remove wiring, plugs, ducting, fittings, etc. , as necessary to facilitate removal of insulation and sound proofing covering the R. H. and L. H. panels. (SEE FIGURE 1)
3. Mark "cut line" on upper portion of R. H. and L. H. panels. Drill out rivets below "cut line" securing panels to the airframe and pull panels loose. (SEE FIGURE 2)
