SERVICE INFORMATION LETTER

SERVICE INFORMATION LETTER INDEX

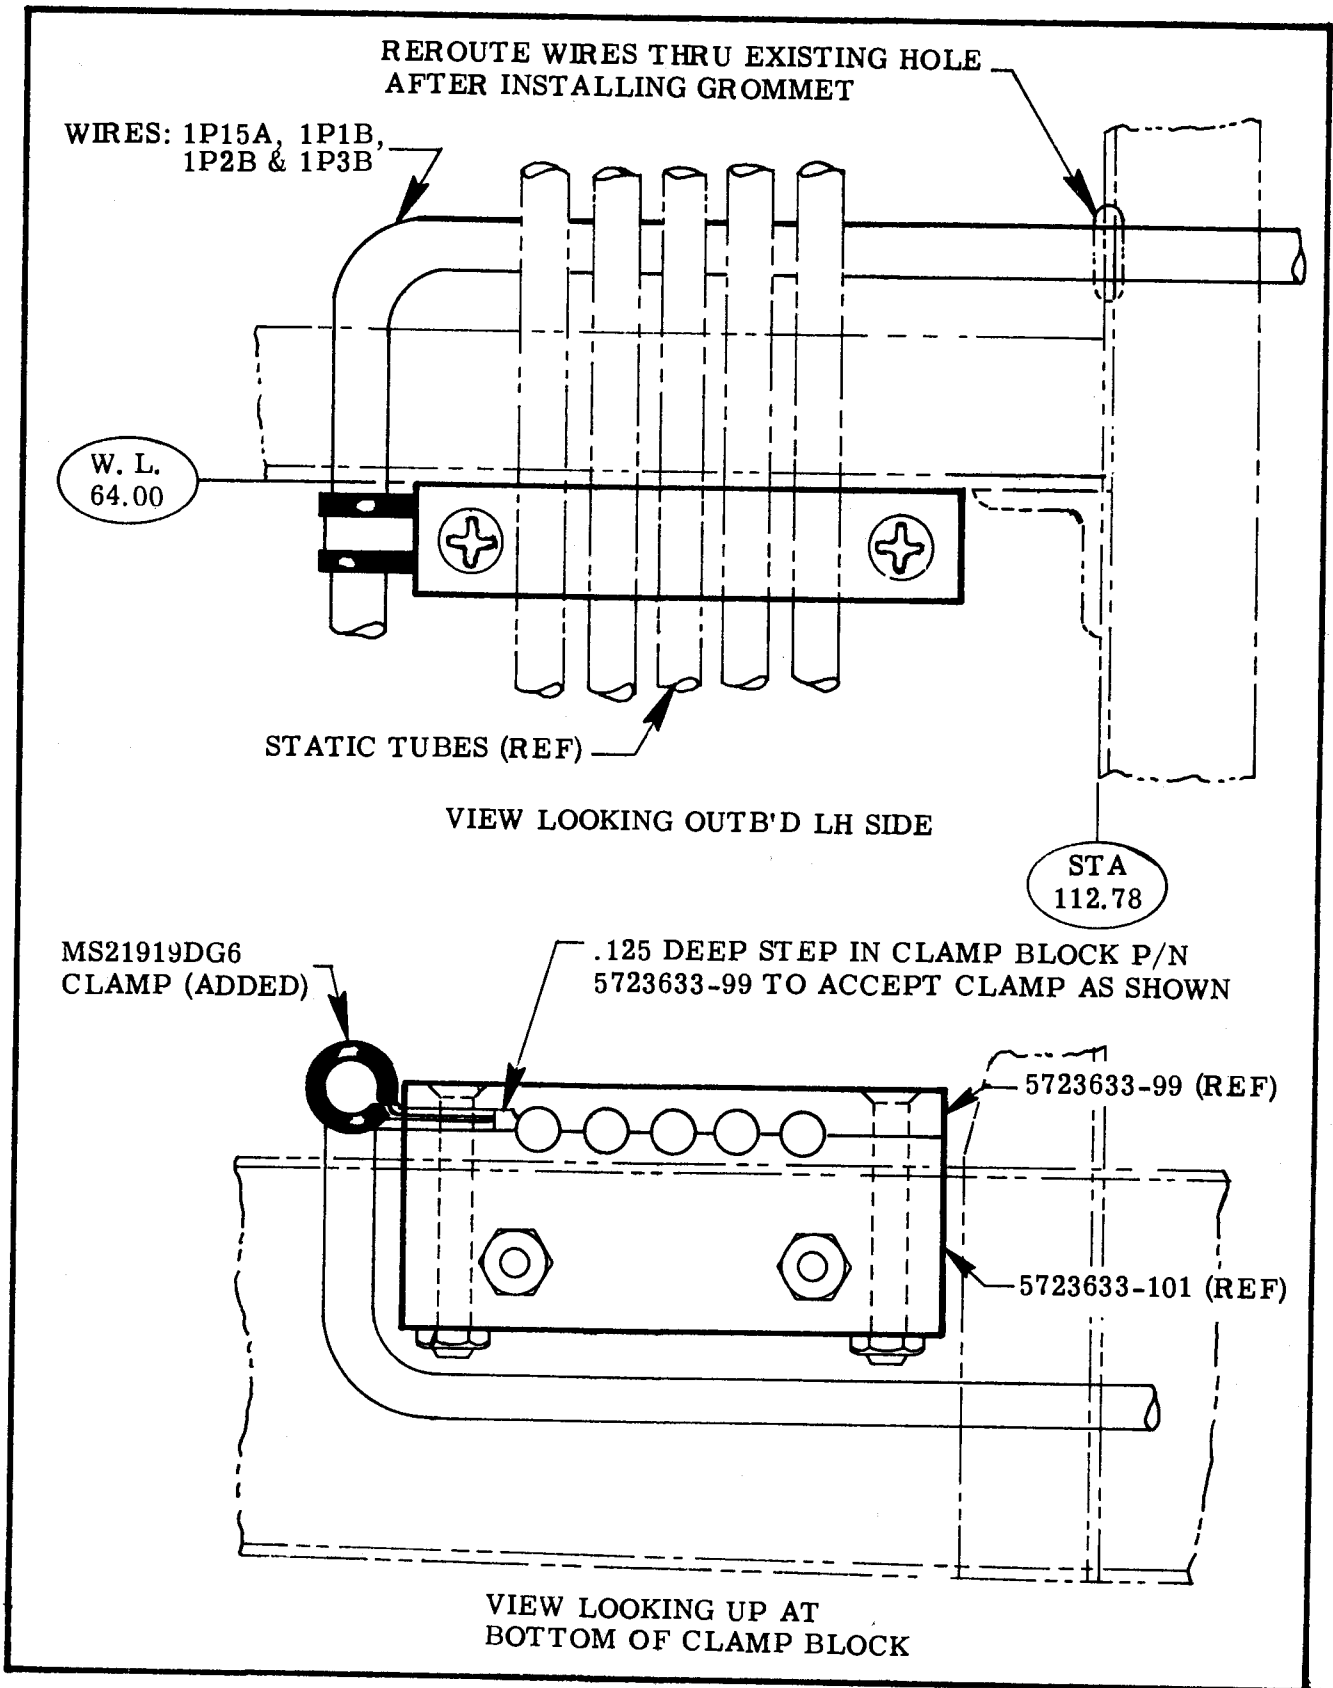
FIGURE 1

1. Remove upper hot liquid container in galley aft of Fus. Sta. 112, LH side.
2. Inspect electrical wire bundles located behind upper corner of container for evidence of chafing marks or damaged insulation.
3. If chafing is evident or damaged insulation is discovered, proceed to Part II of these Instructions. If chafing is not discovered, the aircraft may be continued in service at Operators discretion, provided the upper container is removed, loose electrical wiring is secured and a Placard is installed prohibiting the installation and use of the container until the proper routing and protection of electrical wiring is accomplished in accordance with Part II of these Instructions.

3. Reroute wires and install MS21919DG6 support clamp per Figure 1, and reconnect wires to terminal board "AC".
4. Replace or repair any wiring damaged by chafing, as determined by inspection per Part I of these Instructions.

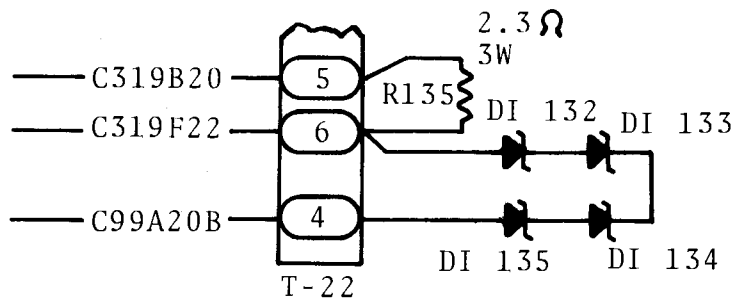
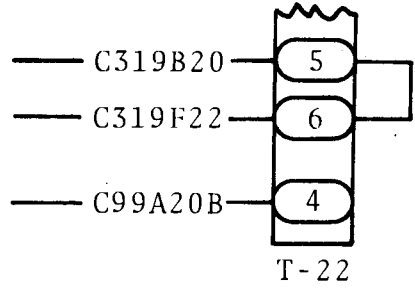
FIGURE 1

To avoid possible overheating of subject resistors or diodes due to inverter overvoltage protection circuit failure.

It is recommended that this modification be accomplished at the next 150 hour inspection.

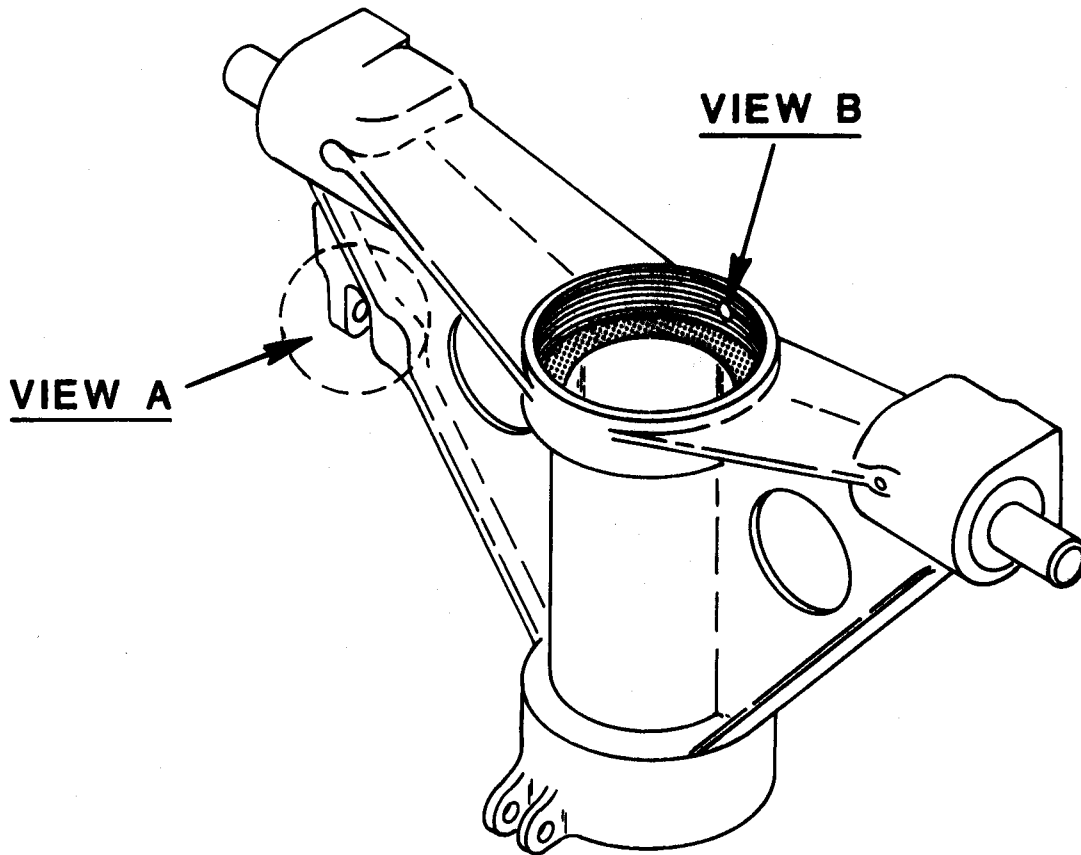
FIGURE 1 AREAS OF INSPECTION

To detect and/or relieve fatigue cracks that develop in the upper NLG outer strut-body forging.

This service bulletin details the inspection and method to detect cracks at three locations on the NLG outer strut-body.

- D. Clean outer strut-body and strip paint from areas to be inspected. See Figure 1.
- E. Inspect the following areas for cracks and/or corrosion using dye penetrant or fluorescent inspection method and a 10-power magnifying glass:

The outer strut-body forging is disqualified for further flight if a crack is detected in any of the three areas unless it can be blended out in accordance with the rework limits of 2.F. of this service bulletin. Corrosion in excess of the limits of 2.F will also disqualify the outer strut-body for flight.

It is recommended that the rework of Areas A and B be accomplished immediately if cracks are detected. If no cracks are evident it is advisable to accomplish the rework of Areas A and B as soon as practical.

- F. Cracks or corrosion found in the aforementioned inspection may be blended out with a .157 inch diameter rotary file and then polished with 400 grit paper as long as they do not exceed the following limits:
 - (1) Corrosion in the bearing bore shoulder may not exceed a depth of .039 inches.
 - (2) Cracks may not exceed .118 inches in length and .039 inches in depth.
 - (3) Treat all reworked areas with Alodine 1201.
- G. Rework of Areas A and B must be accomplished to remove cracks and may also be accomplished to relieve stress that could cause cracking in the future. Reference Figure 2. (Rework will not be necessary if it has already been accomplished. Refer to NOTES in paragraph 1.C. of this bulletin).

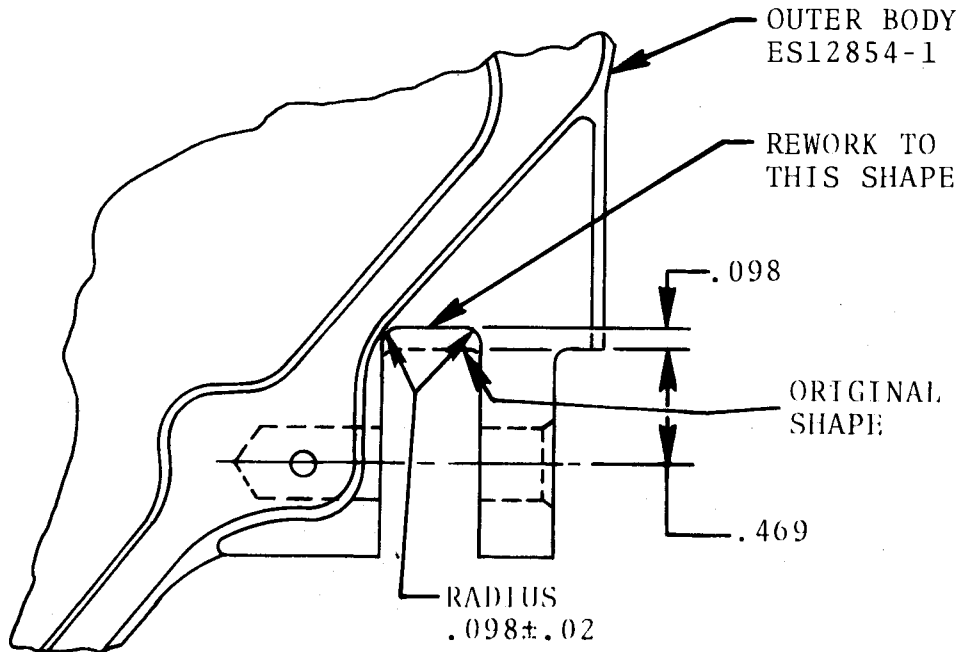
VIEW A RETRACT CYLINDER LUG AREA REWORK

Rework of Area A to relieve stress is not required on some replacement struts, i.e. P/N ES12854-501. Careful inspection of P/N ES12854-501 struts will be necessary to determine if rework has already been accomplished. See Figure 2 for dimensions. Reworked struts should be marked with an "A" in the area of the strut part number (strut part number should be located on the aft side of the barrel portion of the strut body). Struts which have been reworked but not marked or struts that are reworked in accordance with this service bulletin should be marked with "A" in the area of the strut part number.

- b. Reinspect cut area for cracks before polishing.
 - c. Polish cut area with 400 grit paper.
 - d. Treat bare metal with Alodine 1201.
- (2) Accomplish rework of Area B as follows:
- a. Drill and ream lock screw hole, through outer strut body, to a diameter of .211 + .008 inch
- .000

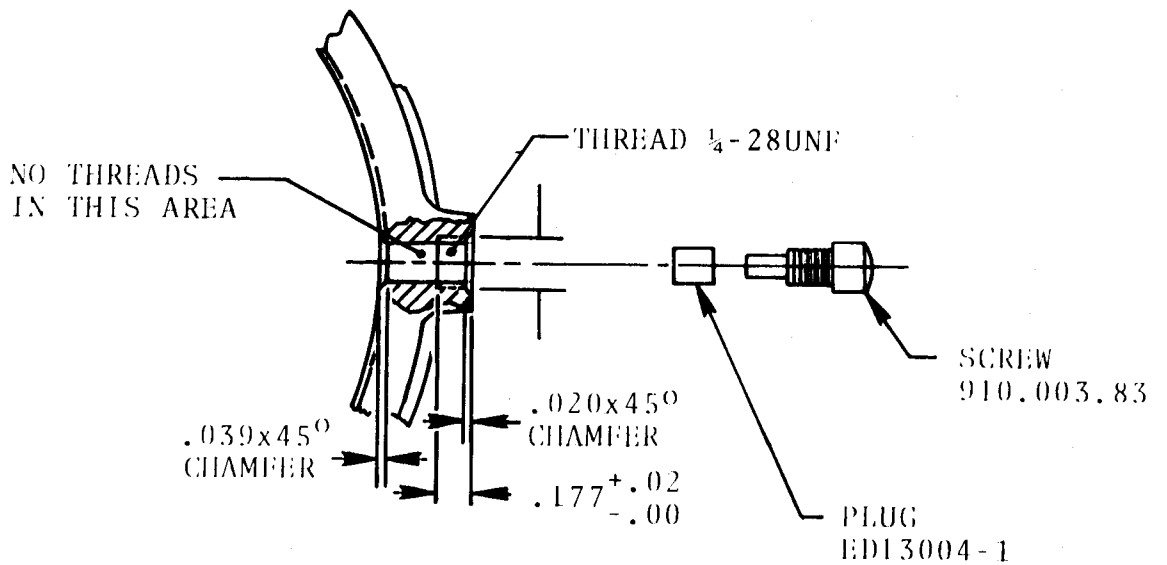
VIEW B LOCK SCREW HOLE REWORK

Rework of Area B to relieve stress is not required on some replacement struts P/N ES12854-501. Reworked struts will not have the upper bearing retaining nut lock-screw hole threaded all the way through.

- d. Carefully clean any burrs from hole and threads, especially at hole/thread intersection.
- e. Reinspect area for cracks.
- f. Polish hole and chamfered areas.
- g. Treat area with Alodine 1201.
