## **SERVICE BULLETIN**

### **SERVICE BULLETIN INDEX**

# **24-WESTWIND**

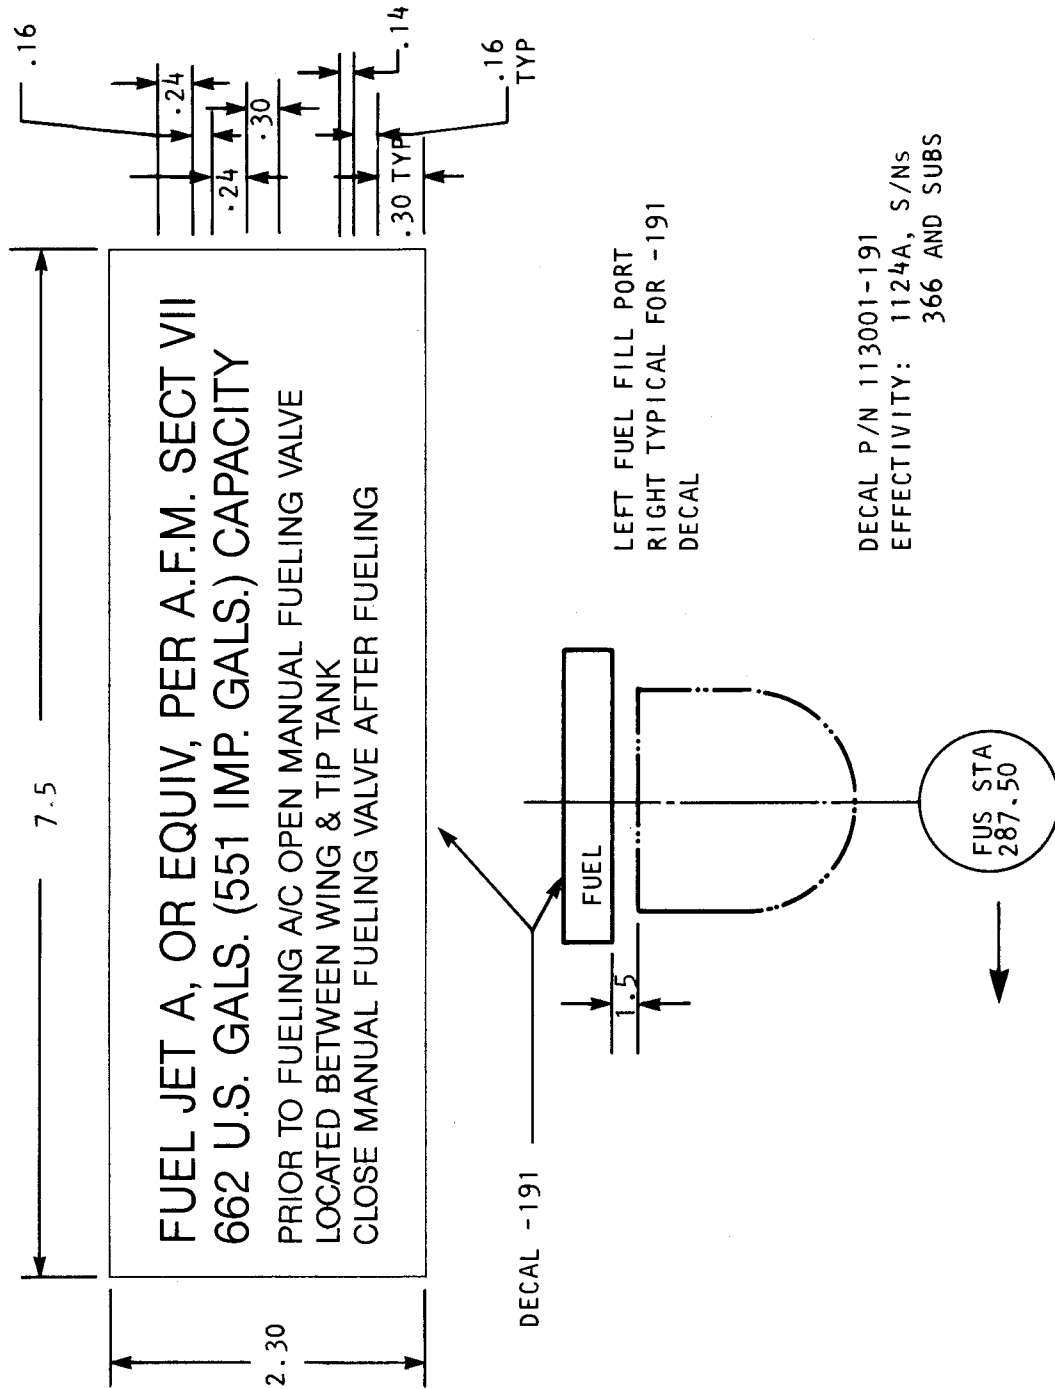
FIGURE 2

FUEL CAPACITY PLACARD LOCATION

Replace existing (3 each) placards on the overwing fuel filler ports and a section of single point refueling data placard. Install replacement placards or utilize other suitable methods of placarding.

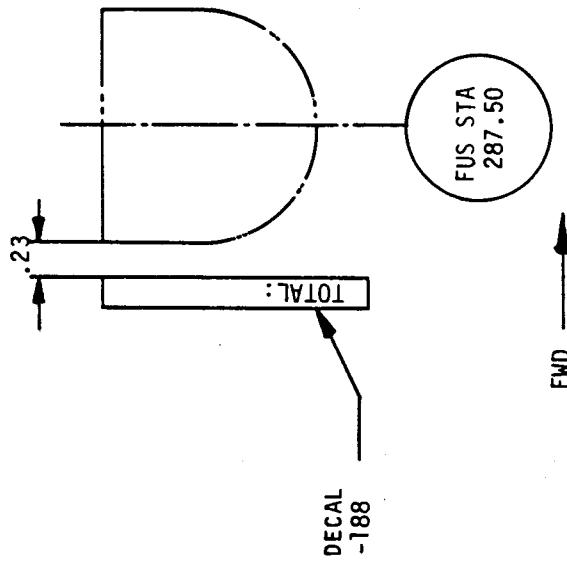
RIGHT FUEL FILL PORT  
DECAL P/N 113001-188  
EFFECTIVITY: 1124A, ALL  
SERIAL NUMBERS

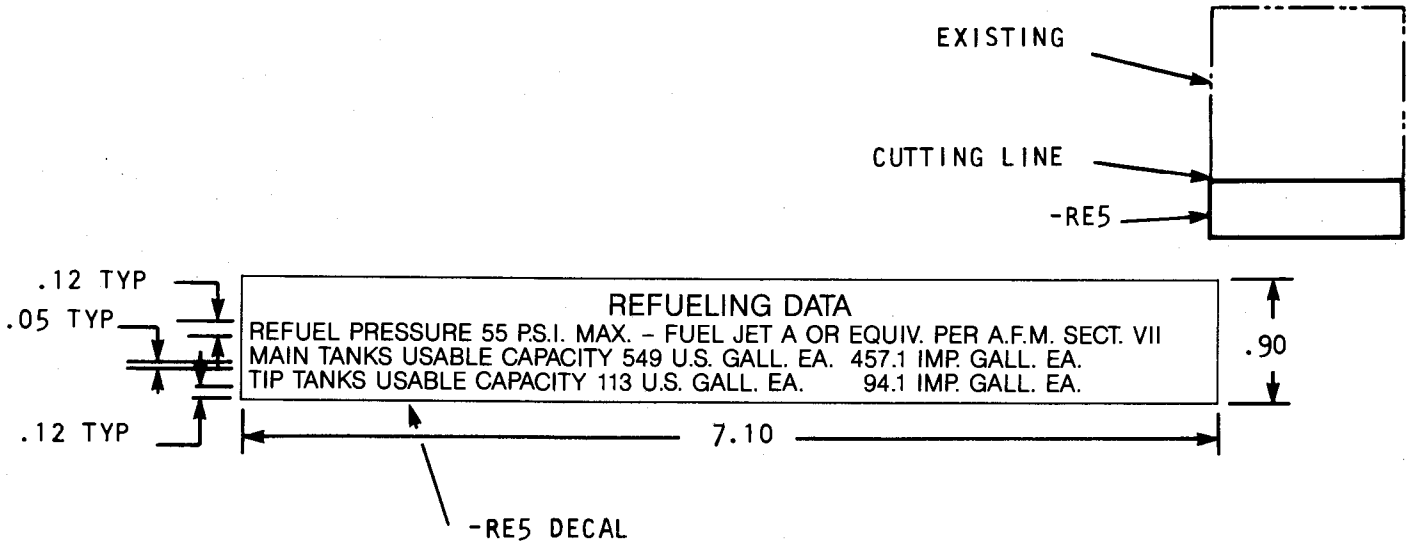
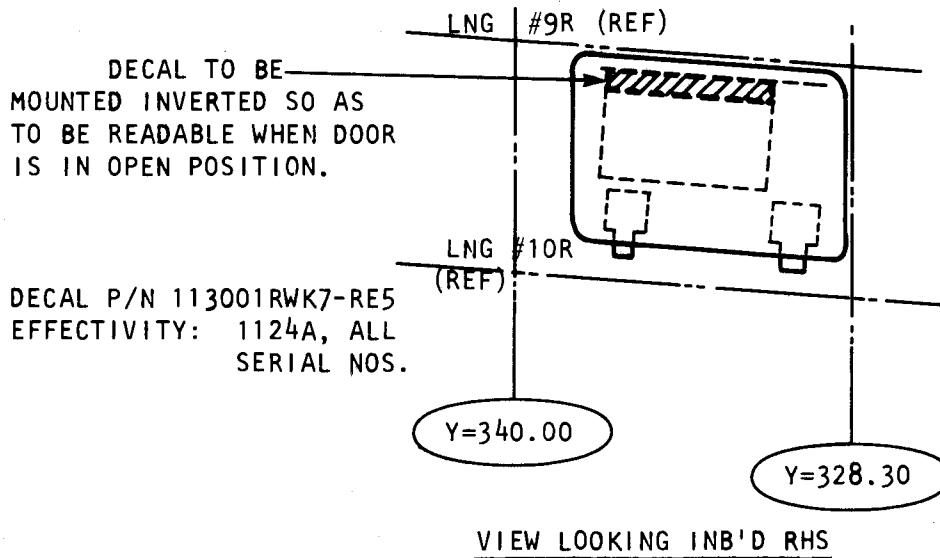
Figure 4

FUEL CAPACITY PLACARD LOCATION

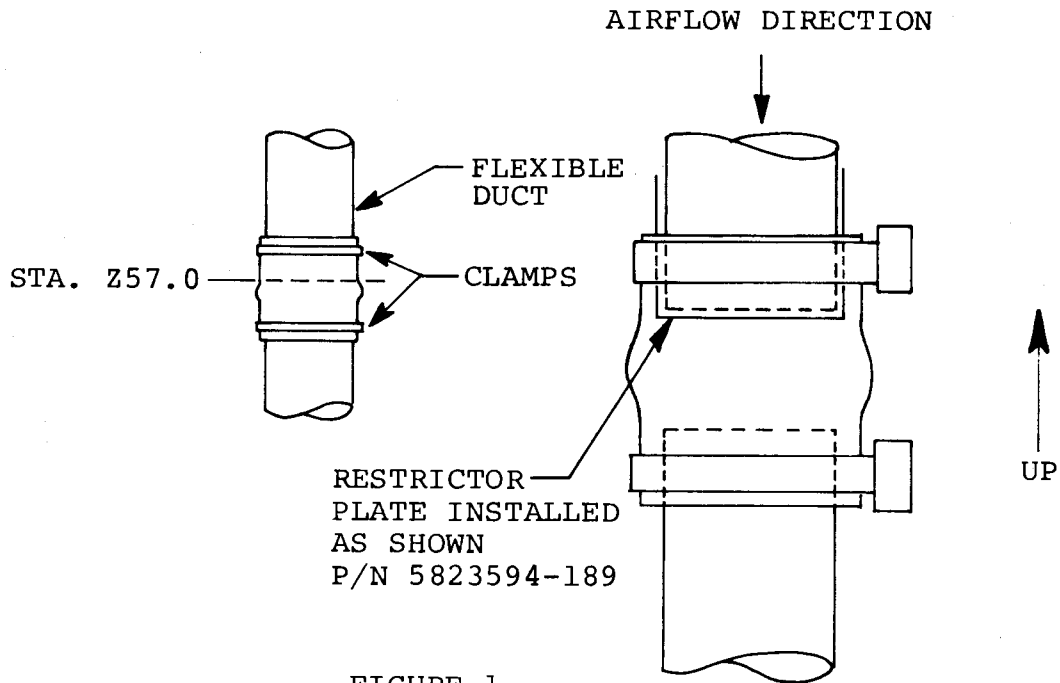
FIGURE 1

To reduce cooling airflow and resultant cold soaking inside both DC contactor boxes and the immediate area near subject air outlet which contributes to condensation in high humidity environments following extended flights.

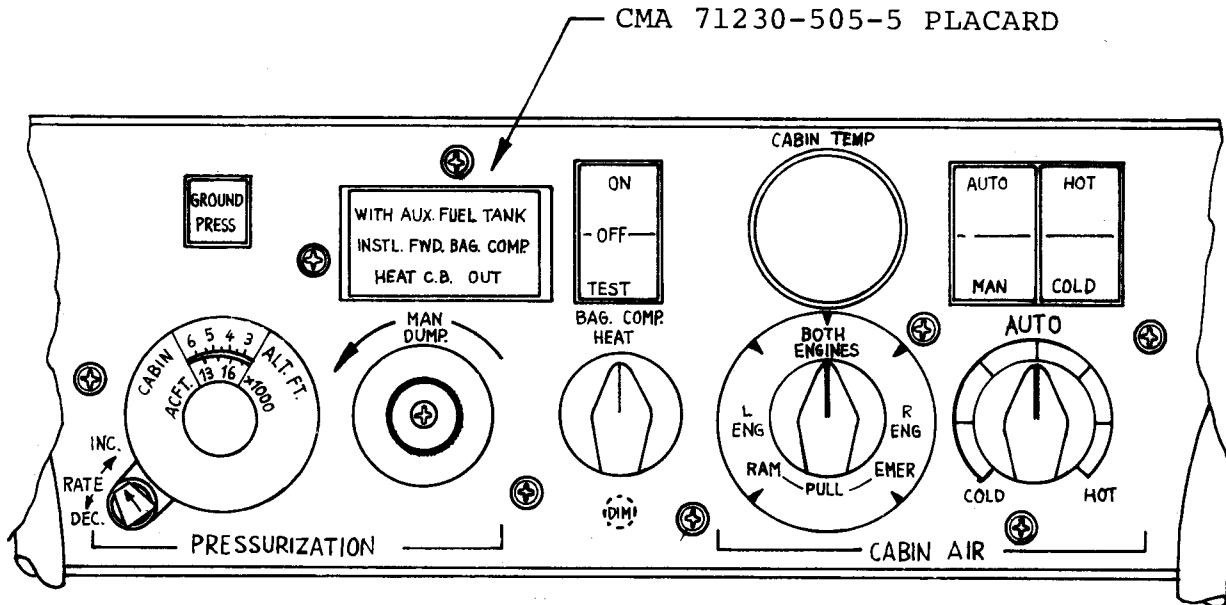
FIGURE 1A

MODEL 1124 WITH LONG RANGE FUEL TANK PROVISIONS

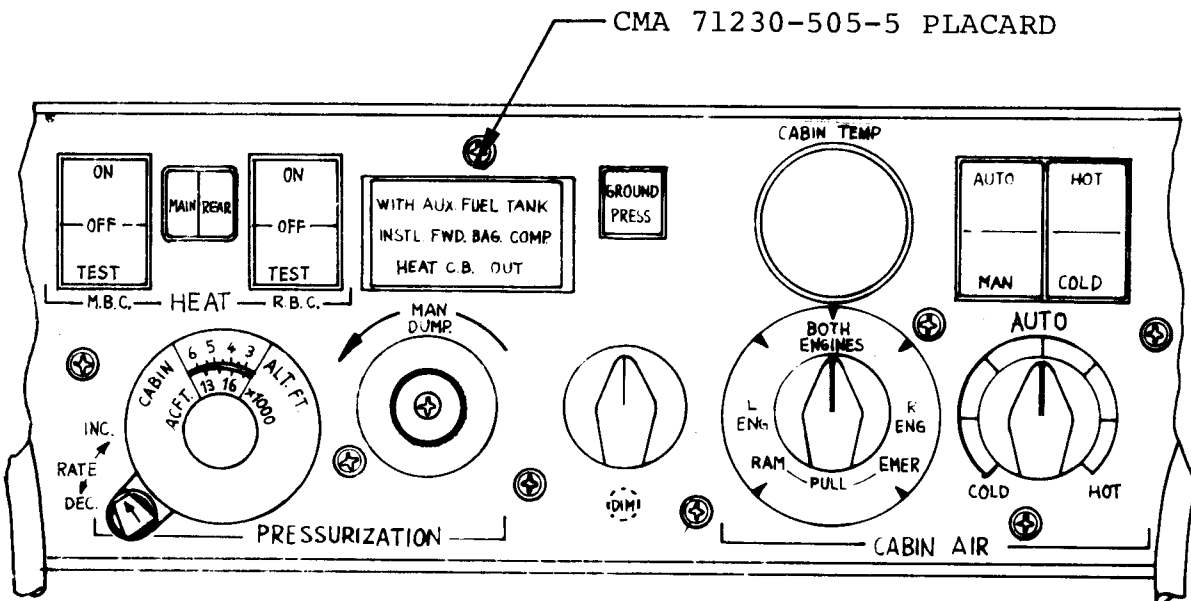
FIGURE 1B

MODEL 1124A, ALL SERIAL NUMBERS

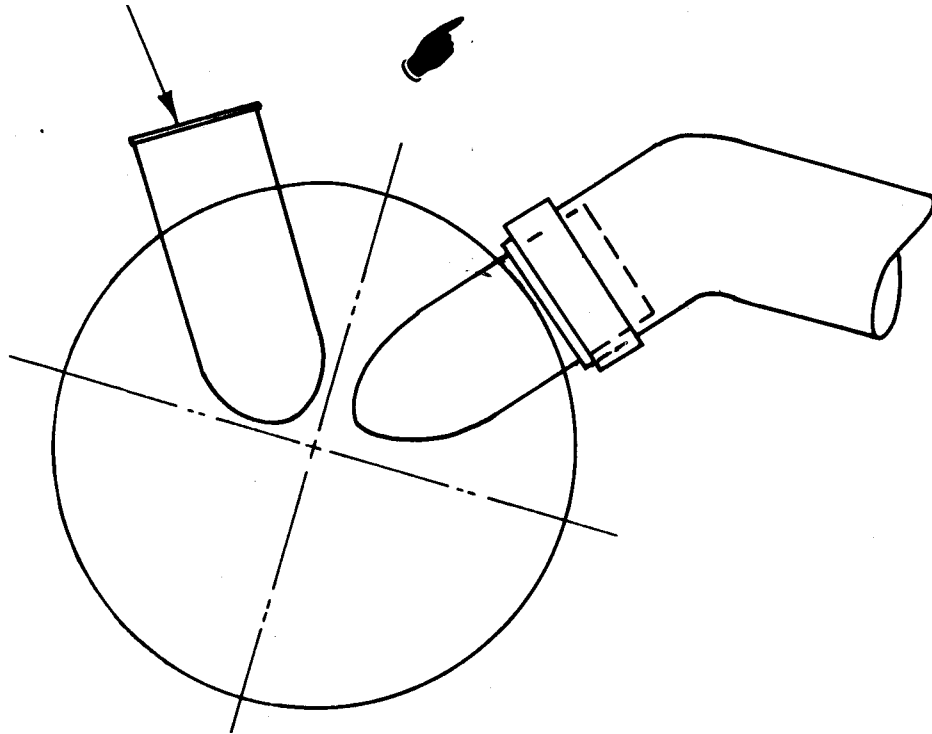
P/N 2708 "WEMAC"

INSTALL 25W783042-003 CAP  
SECURE WITH MS3367-X-X TIEDOWN STRAP

- A. Gain access as necessary to WEMAC inlet ports suspected of leakage or to all for installation of new style cap.
- B. Remove aluminum self-adhesive tape previously installed on spare port.
- C. Install new cap P/N 25W783042-003 on unused port.
- D. Secure cap with MS3367-X-X tie-down strap (or equivalent).
- E. Repeat procedure on all other WEMACs.
- F. Reinstall interior furnishings previously removed to gain access.

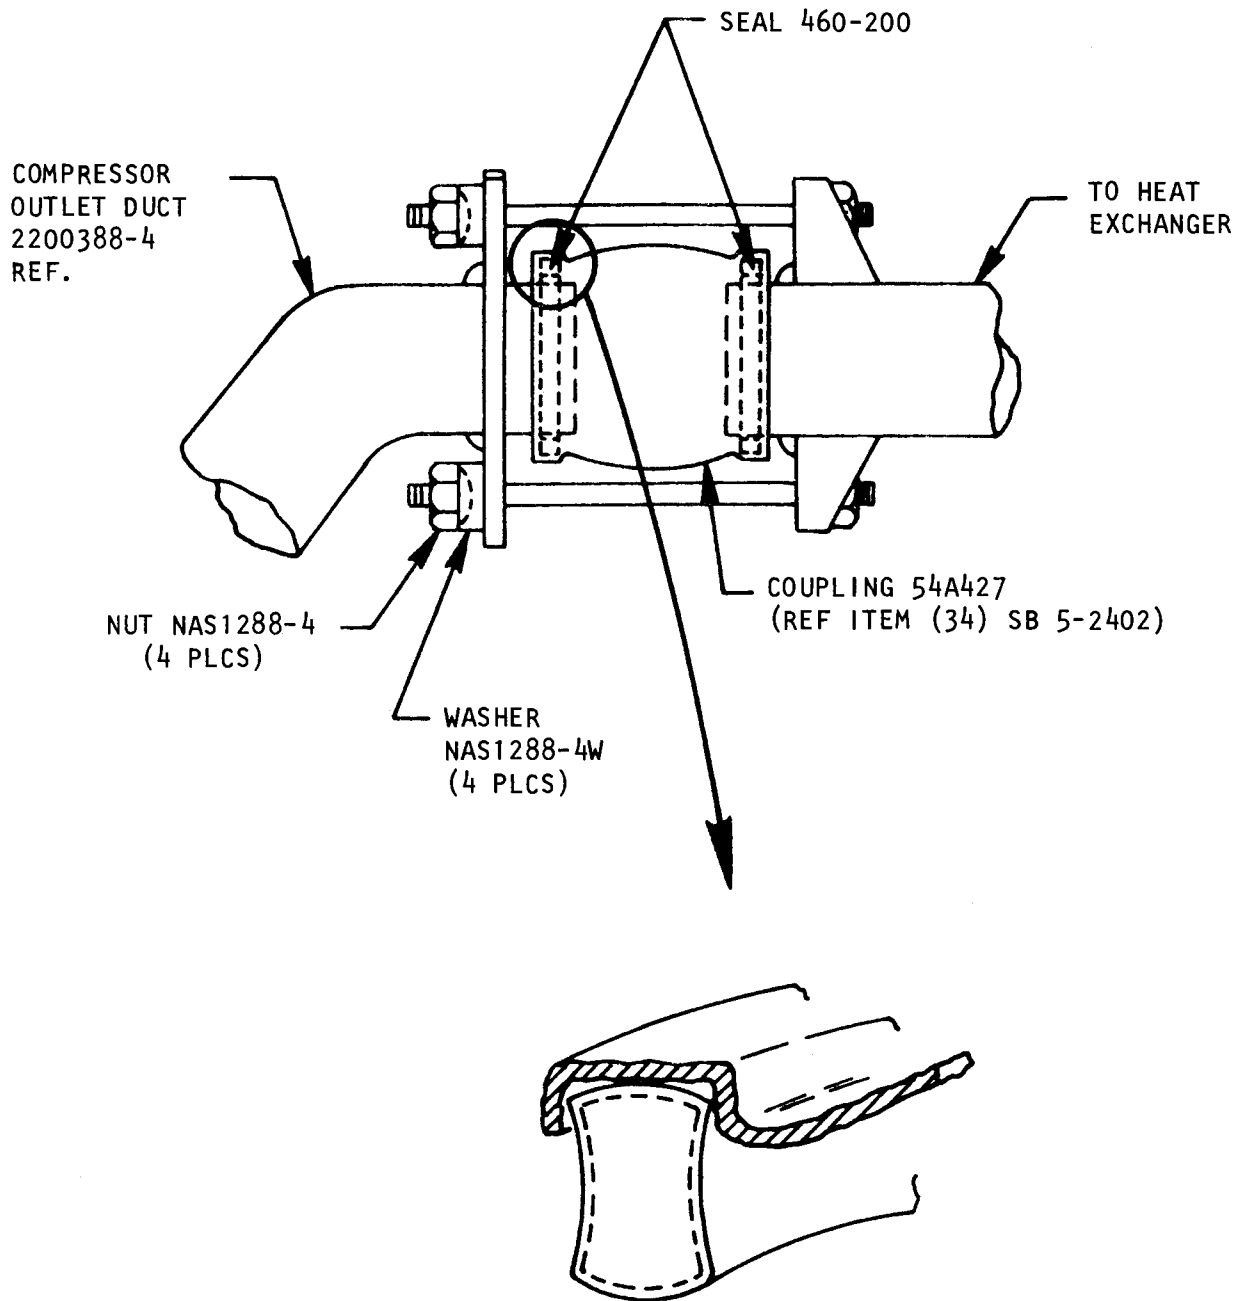
FIGURE 1  
COMPRESSOR OUTLET DUCT COUPLING INSTALLATION

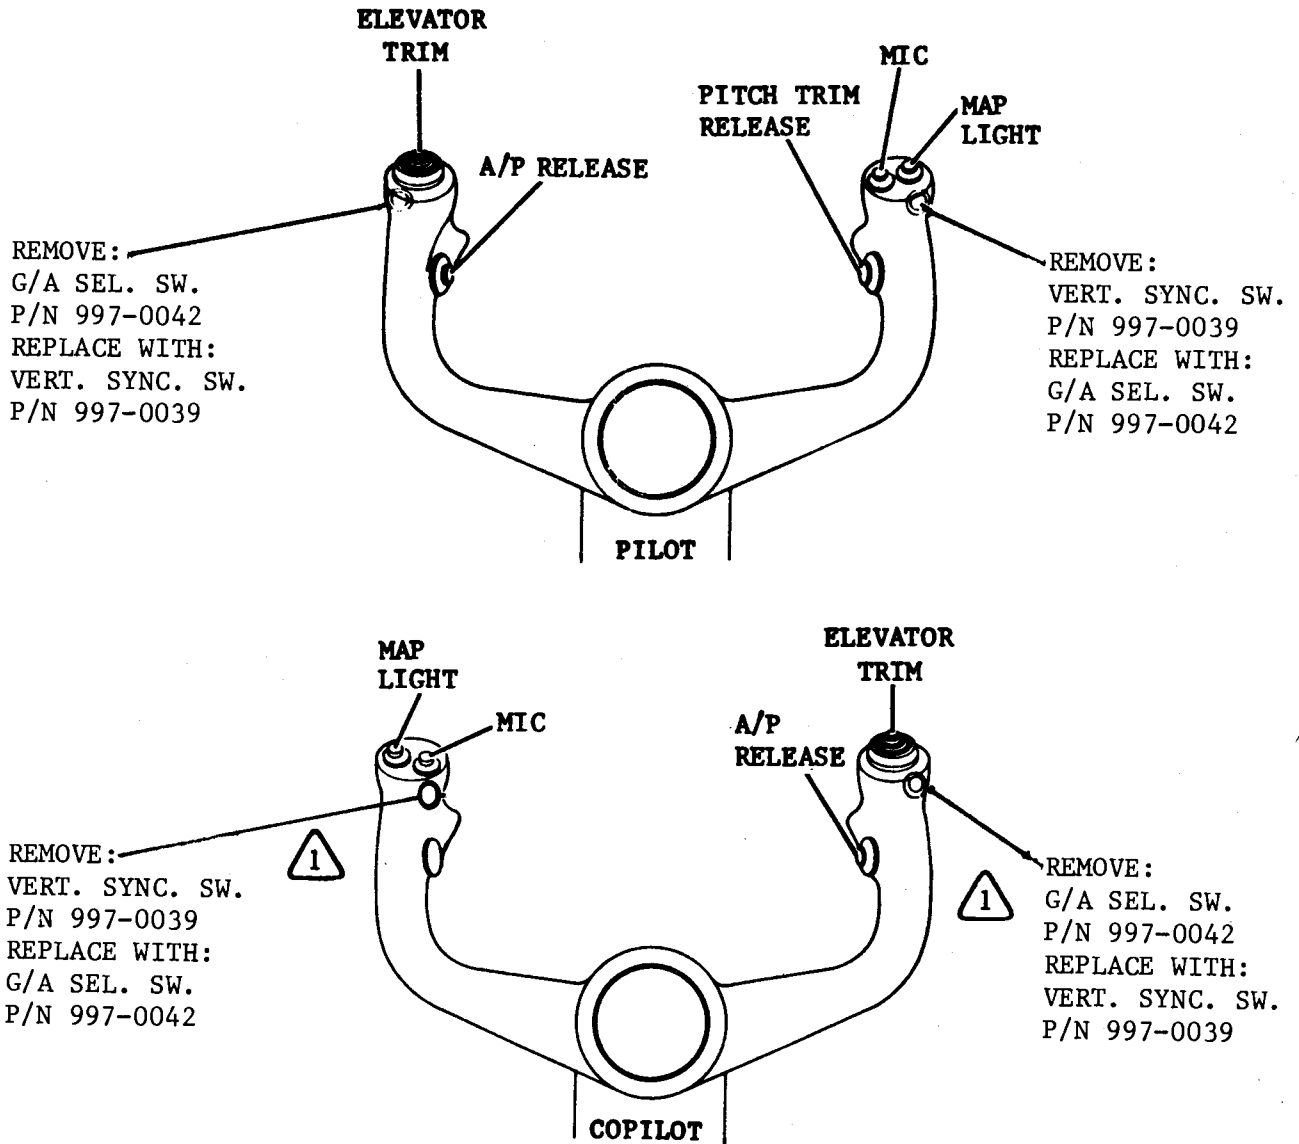
FIGURE 1 PILOT AND CO-PILOT CONTROL WHEEL SWITCH MODIFICATION

**VERT SYNC AND G/A BUTTON INSTALLED ON THE  
COPILOT CONTROL WHEEL ONLY ON AIRCRAFT  
EQUIPPED WITH 2ND FLIGHT DIRECTOR**

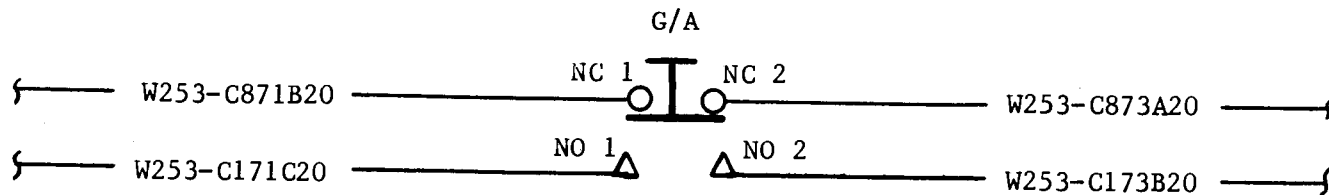
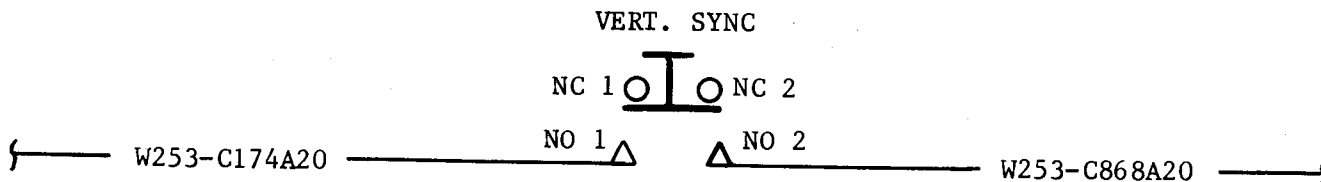
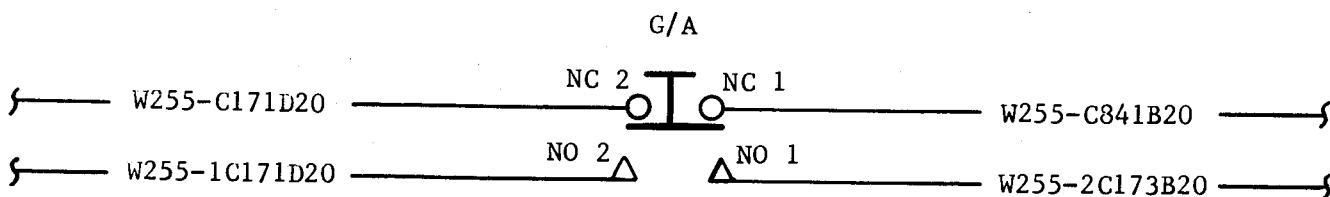
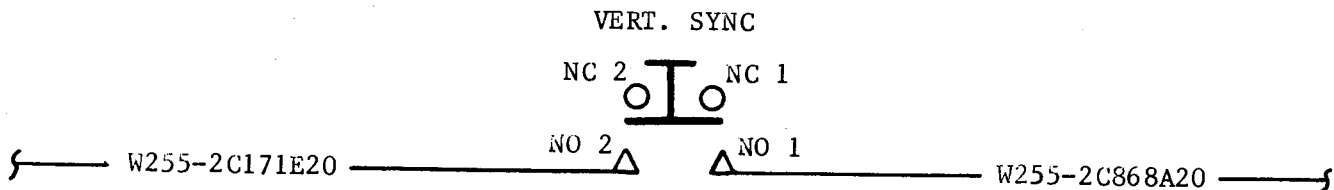
FIGURE 2 G/A AND VERTICAL SYNC SWITCH WIRING

PILOT'S CONTROL WHEEL

CO-PILOT'S CONTROL WHEEL

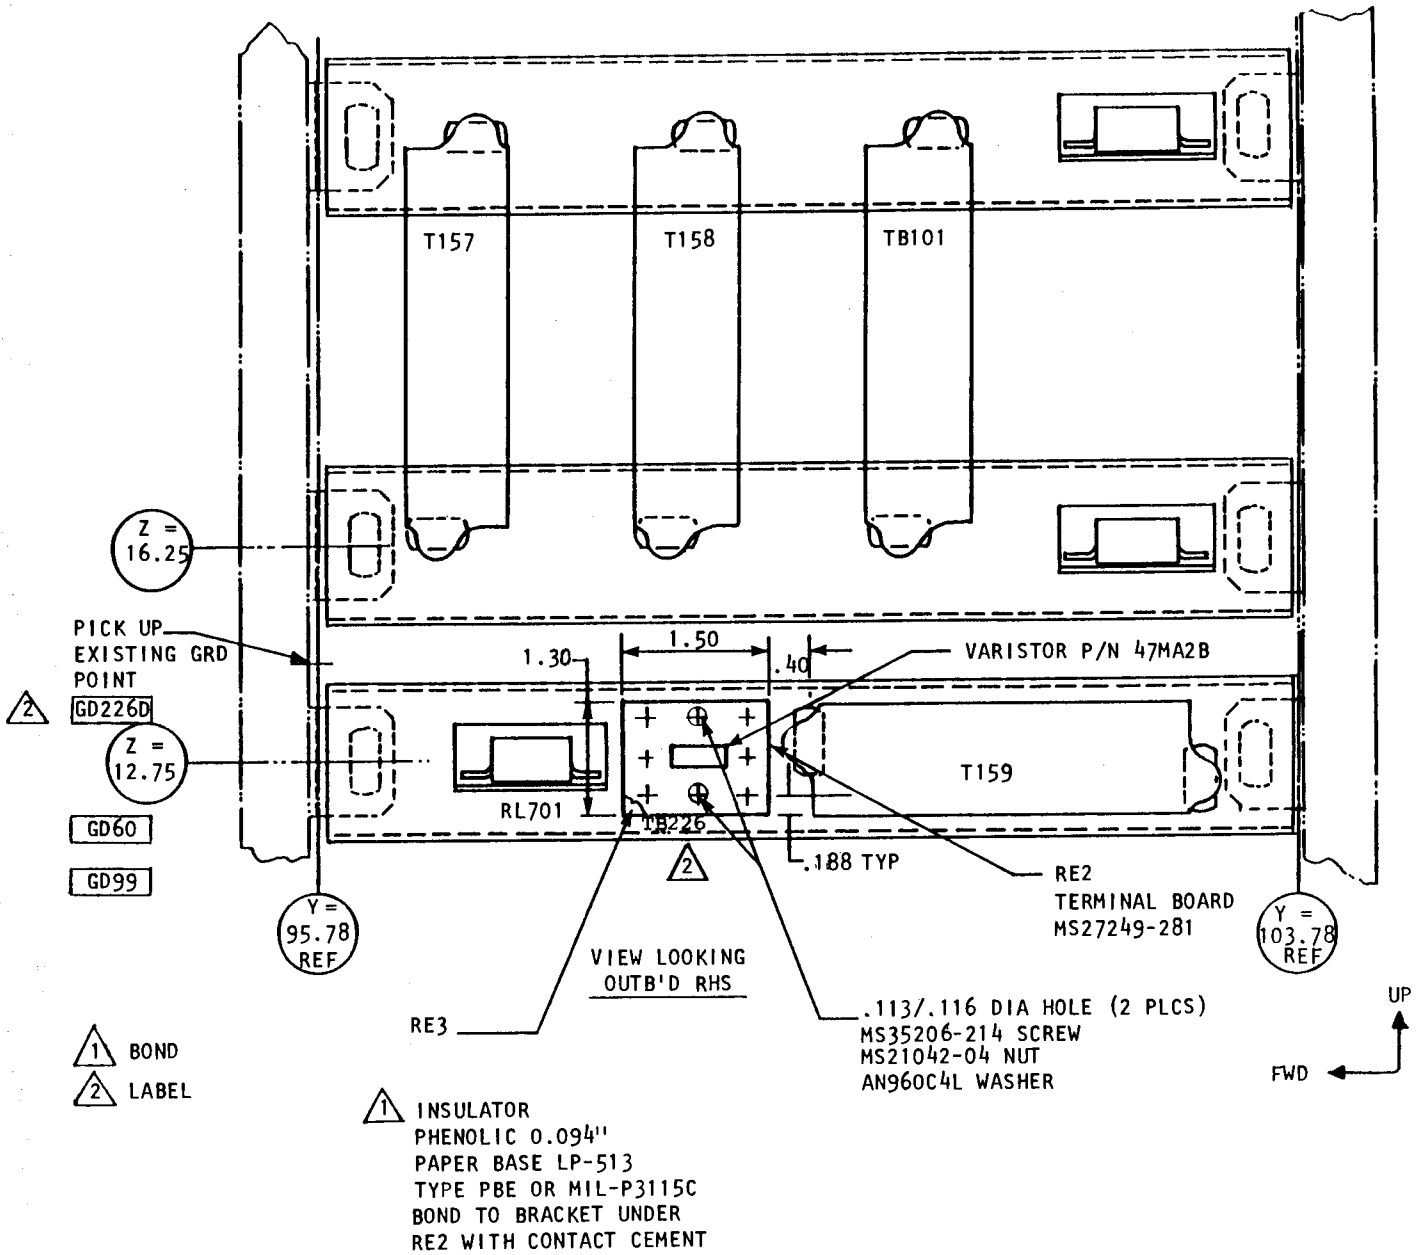
FIGURE 1

SUBJECT: AUTOFLIGHT - ELIMINATION OF 1124A OVERSPEED WARNING FAILURES

- (1) To isolate the Air Data Computer overspeed warning outputs from the Mach Warning Bell to prevent internal component damage to the ADC-80K.
- (2) To include additional VMO test circuit protection.

B. Revise 1124/1124A Wiring Diagram Manual Chapter 34-10-07 to reflect changes accomplished by this service bulletin.

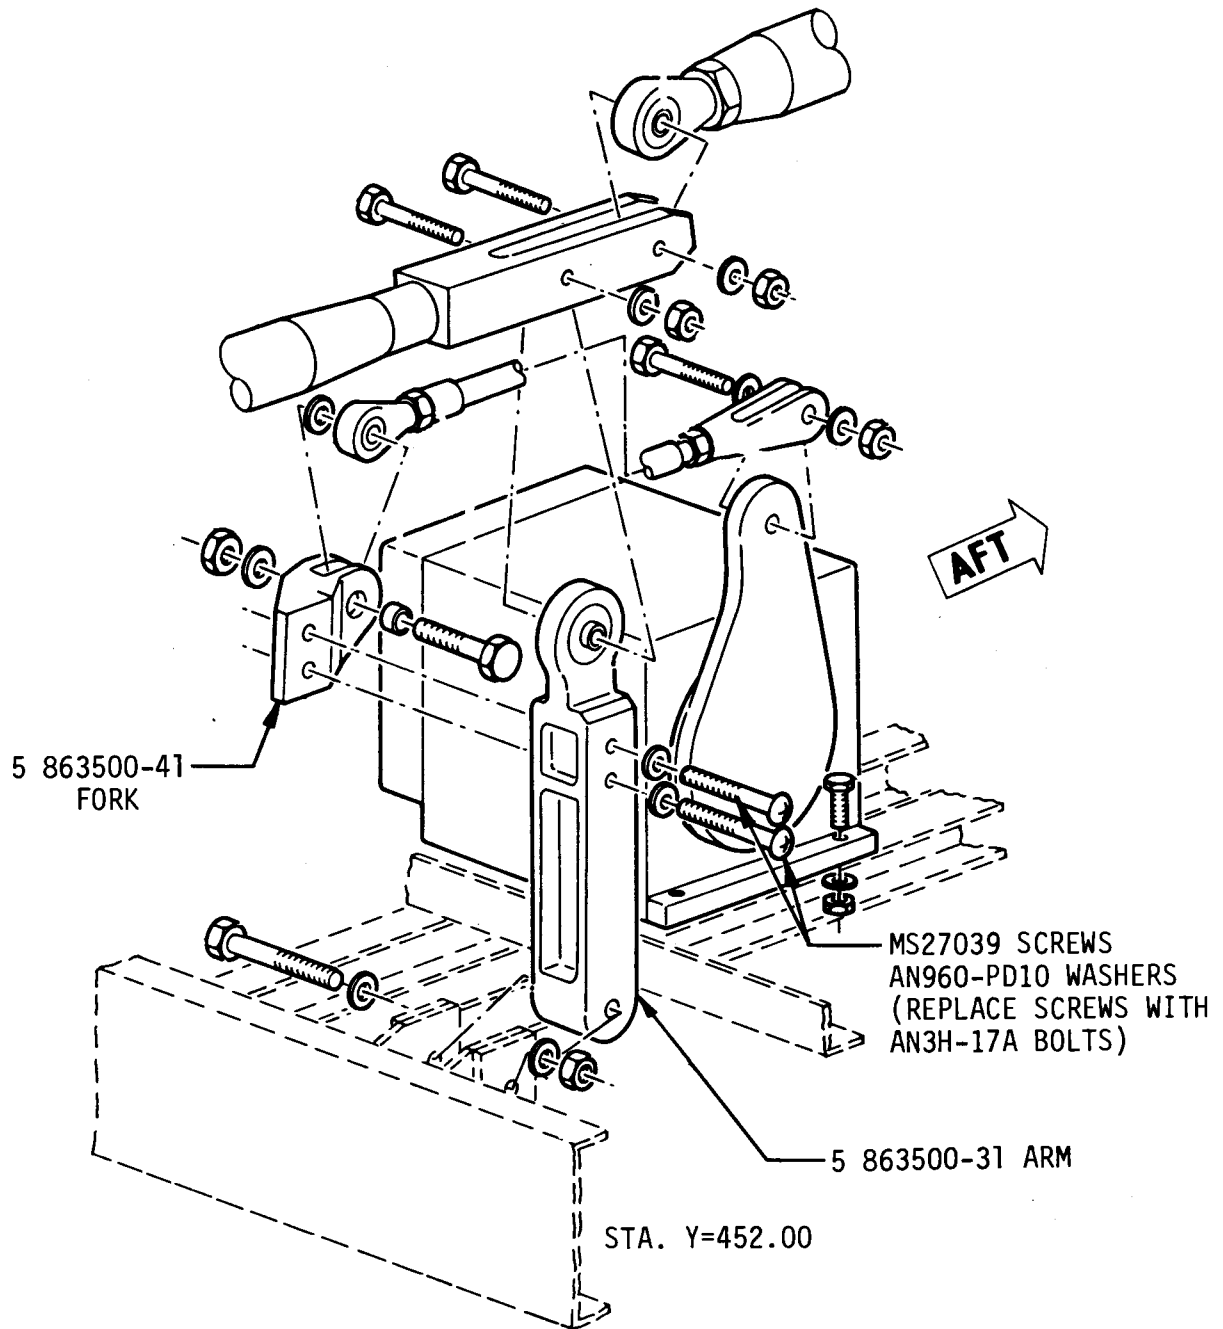
FIGURE 1

Replacement of existing select hardware to minimize the possibility of elevator and/or rudder control interference.

ELEVATOR CONTROL

Service Bulletin No. 1124-22-072A dated September 12, 1986 titled "Auto Flight - Elevator and Rudder Servo Idler Arm - Install New Attach Bolts" has been accomplished this date \_\_\_\_\_.

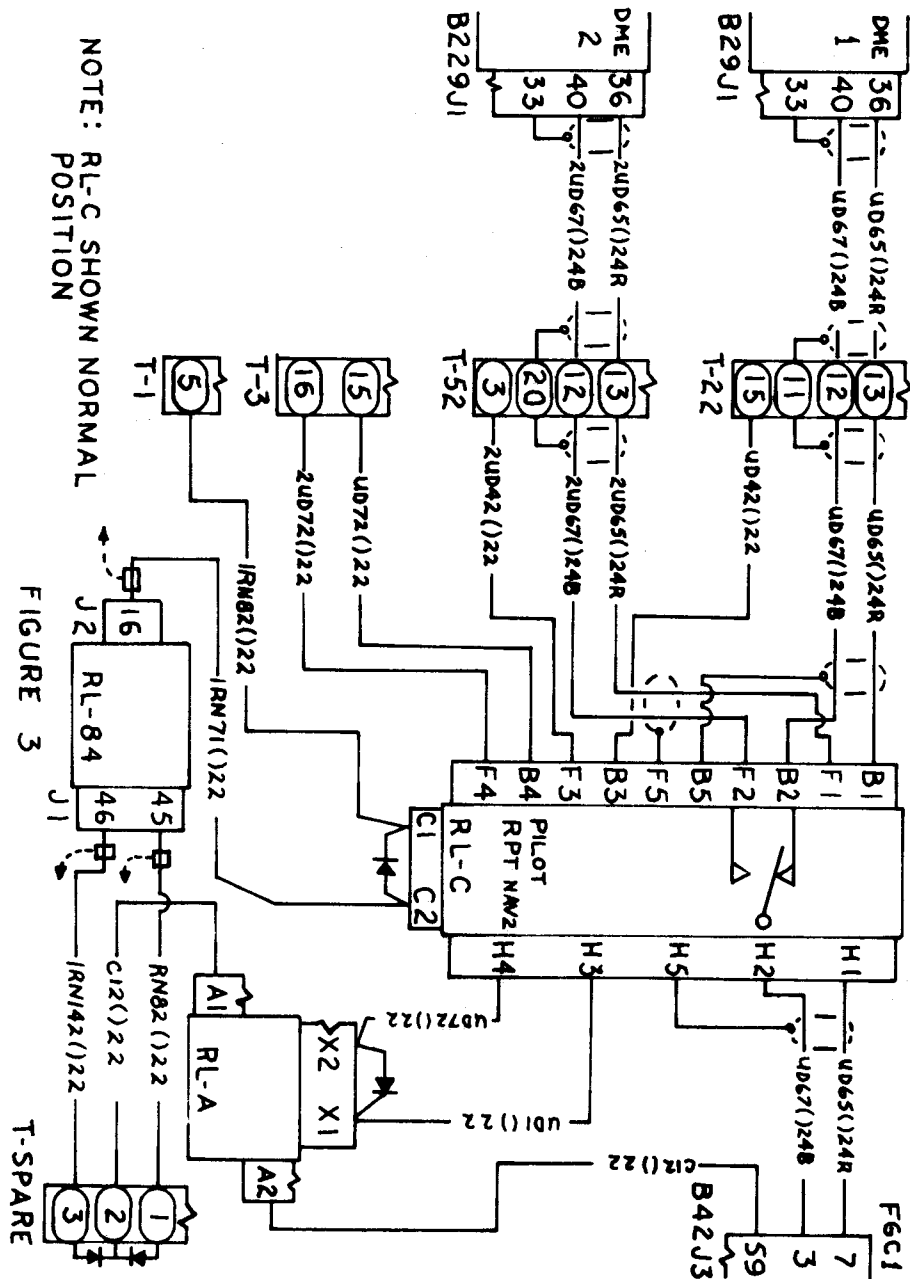
FIGURE 3

NOTE: RL-C SHOWN NORMAL POSITION

- B. Update 1124/1124A Wiring Diagram Manual and IPC to reflect  
wiring changes and parts additions as performed per this  
service bulletin.

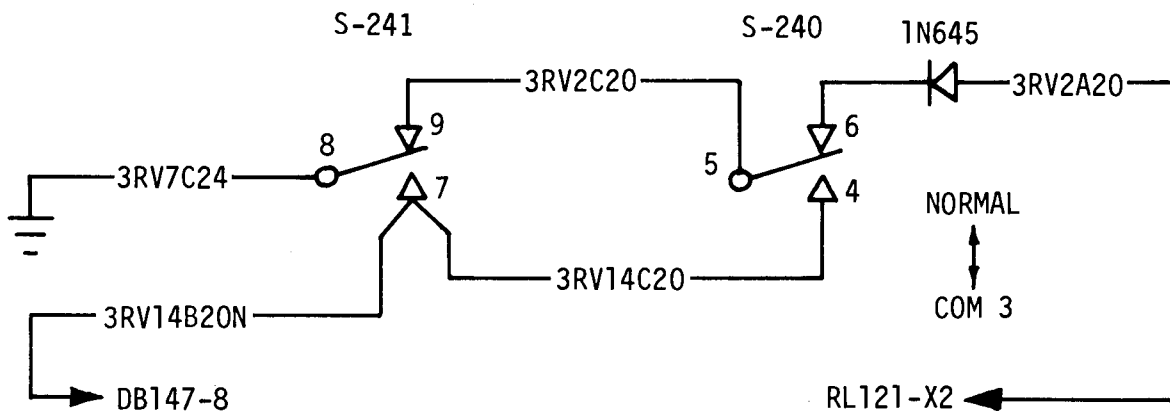
FIGURE 1B

COMM 3/NORMAL SWITCH CONFIGURATION AFTER MODIFICATION

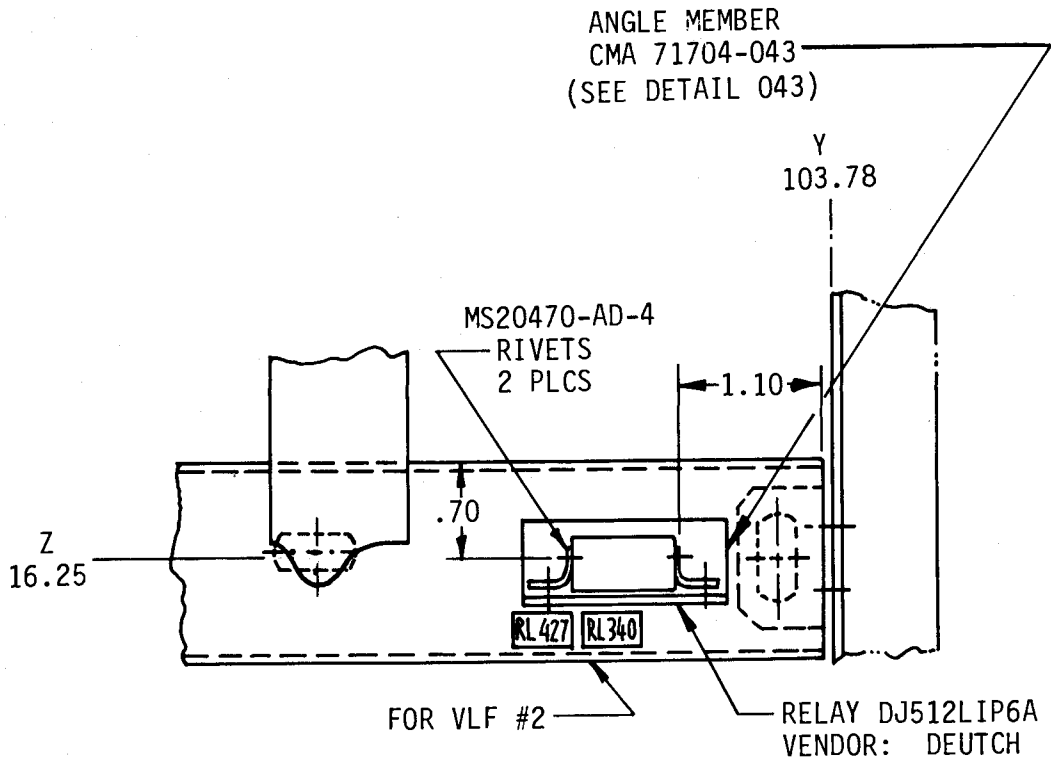
FIGURE 4.

VIEW LOOKING OUTB'D R.H.S.

1. ON AIRCRAFT MODEL 1124A, REPLACE EXISTING RELAY RL427 P/N ES0D4AD WITH P/N DJS12L1P6A (MFG. DEUTCH).
2. ON AIRCRAFT MODEL 1124 WITH FF 4, 5 OR 6, ADD NEW RELAY RL427 P/N DJSLIP6A (MFG. DEUTCH).
  - (1) USE ANGLE MEMBER P/N CMA71704-043 TO MOUNT RELAY.
  - (2) ON AIRCRAFT UP TO SERIAL NUMBER 453 WITH 2ND VLF REPLACE EXISTING MOUNTING BRACKET WITH ANGLE MEMBER P/N CMA71704-043 AS SHOWN BELOW:

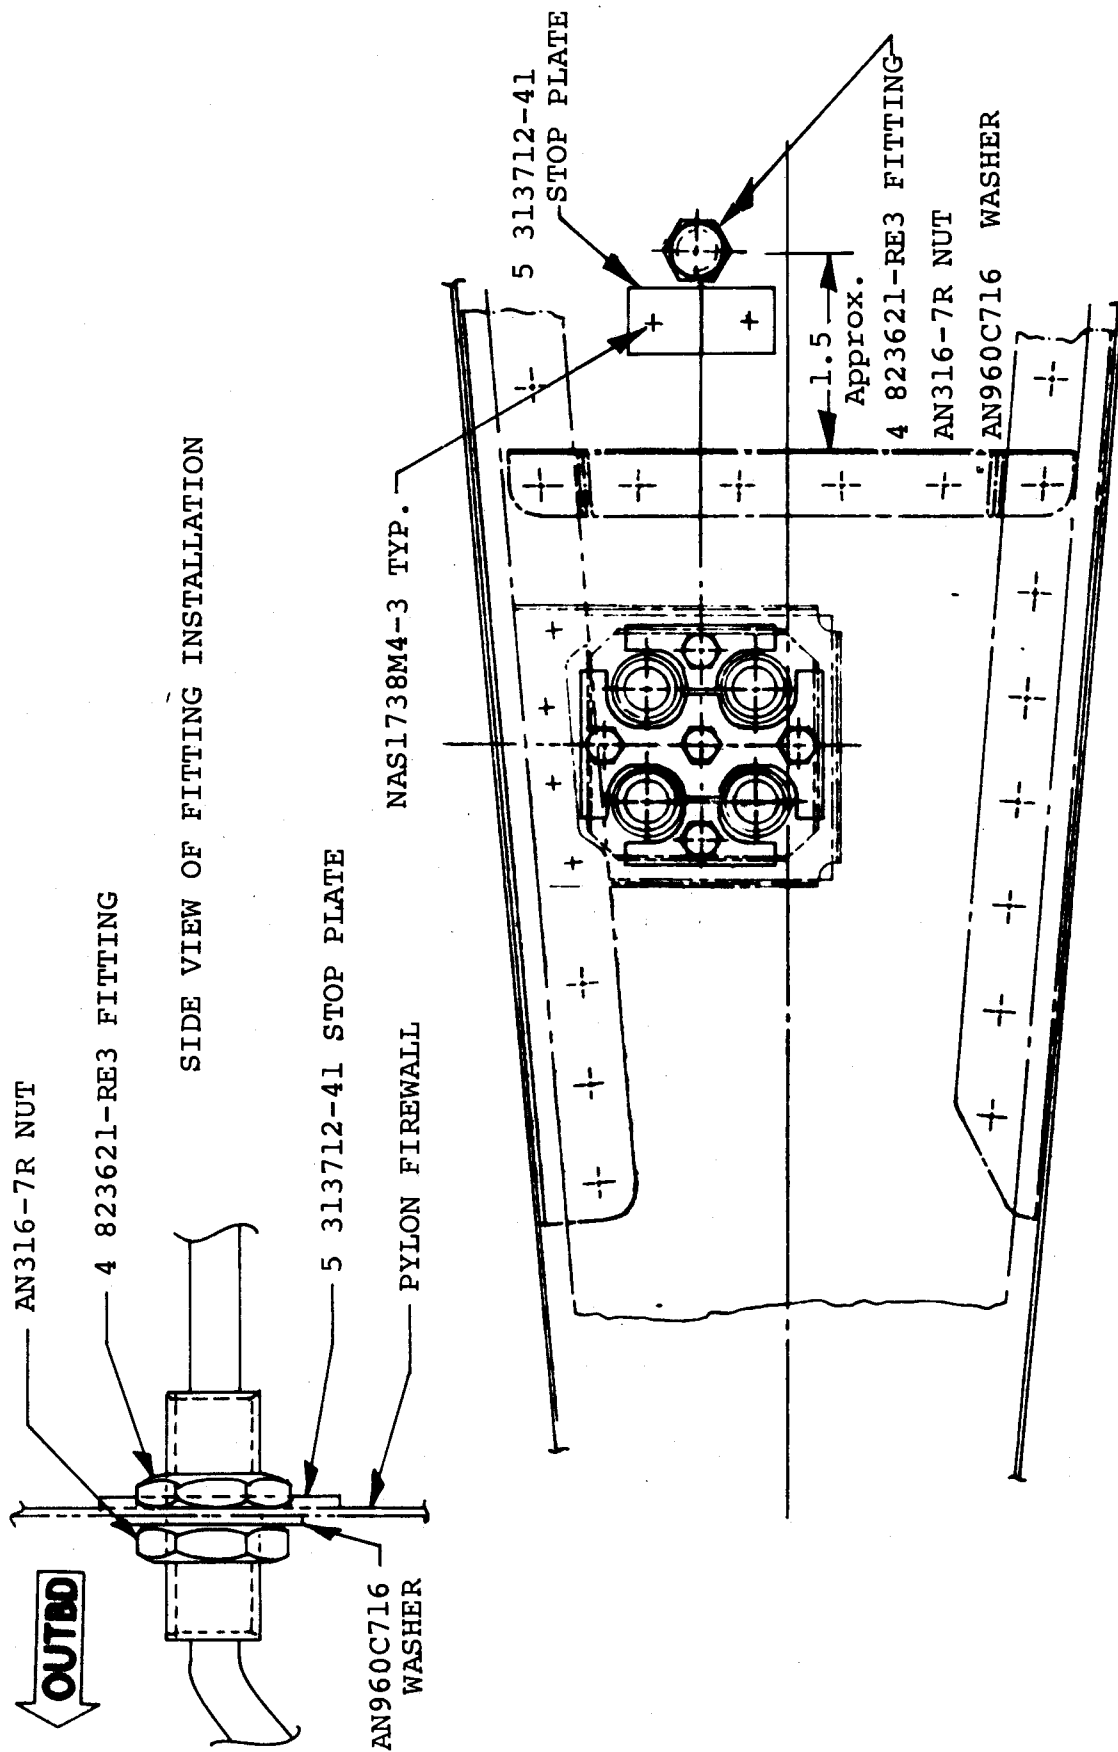
FIGURE 1: VIEW LOOKING INBD., L/H PYLON

- (1) Rerouting and replacement of the existing starter/generator field leads will eliminate chafing and resultant short circuits.
- (2) Installation of shielded leads from the starter generator will reduce EMI radiation (required if H-Field antennas are to be installed).

The starter/generator field circuit leads are replaced with shielded, twisted-pair wire and rerouted to avoid chafe points.

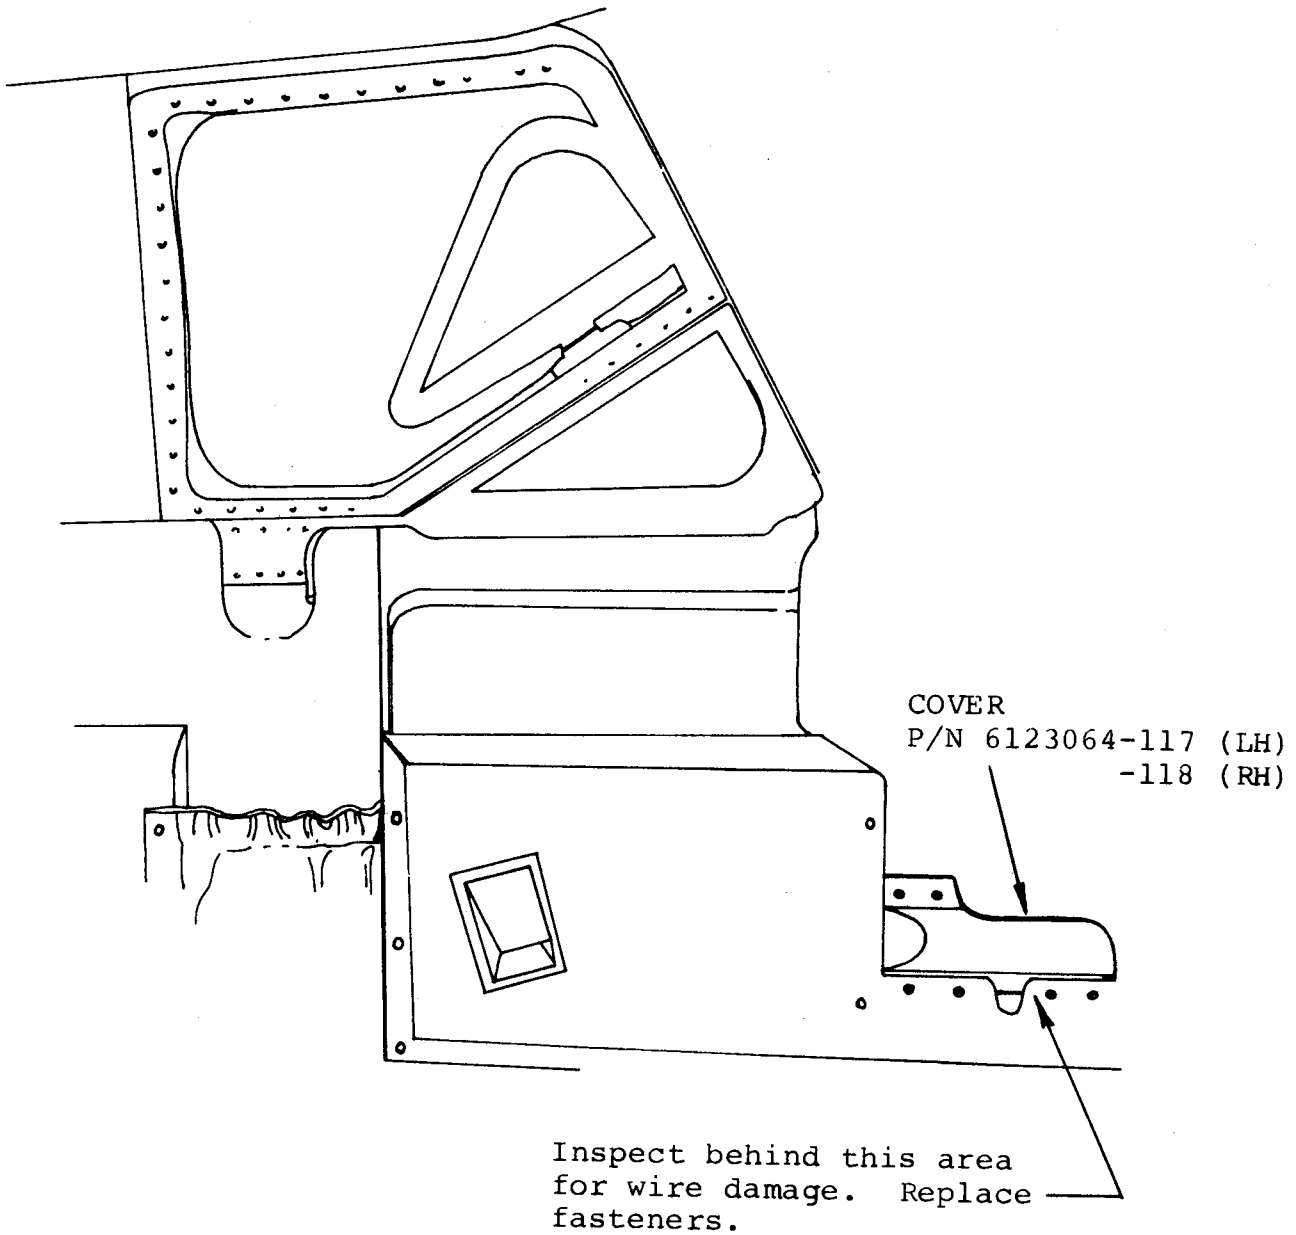
FIGURE 1

Service Bulletin No. 1124-25-006 dated January 4, 1985, titled "Inspection, Cockpit Wire Bundles - Rework Cockpit Trim Panels Left and Right Side," was accomplished this date \_\_\_\_\_.

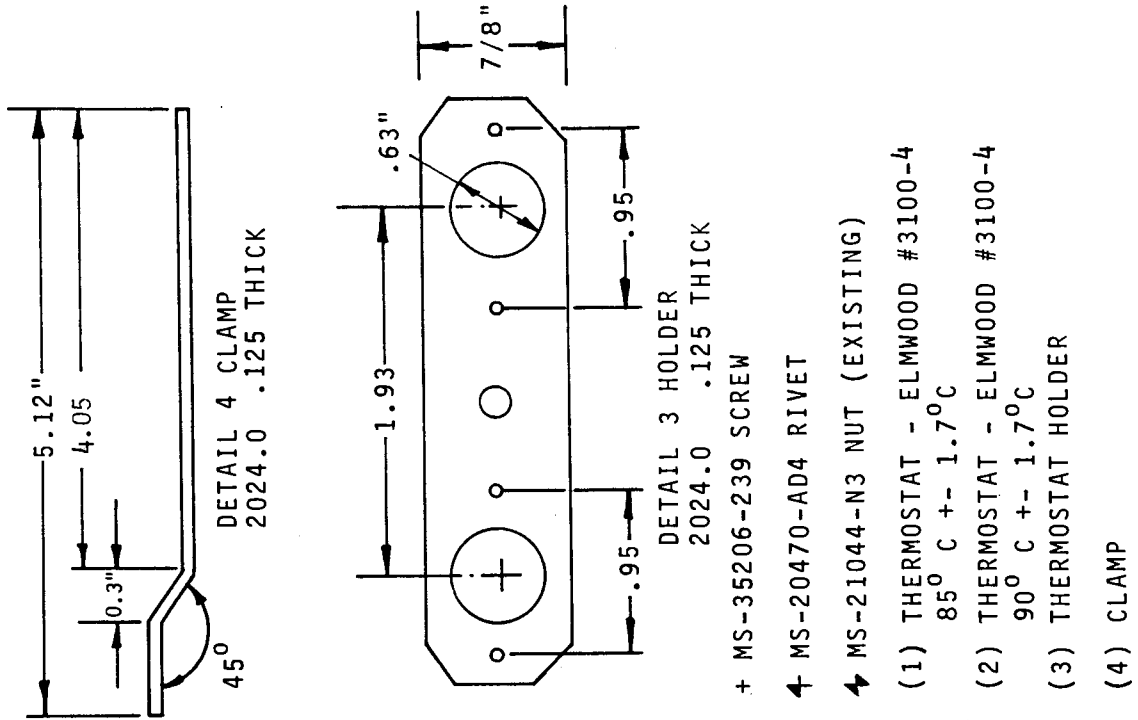
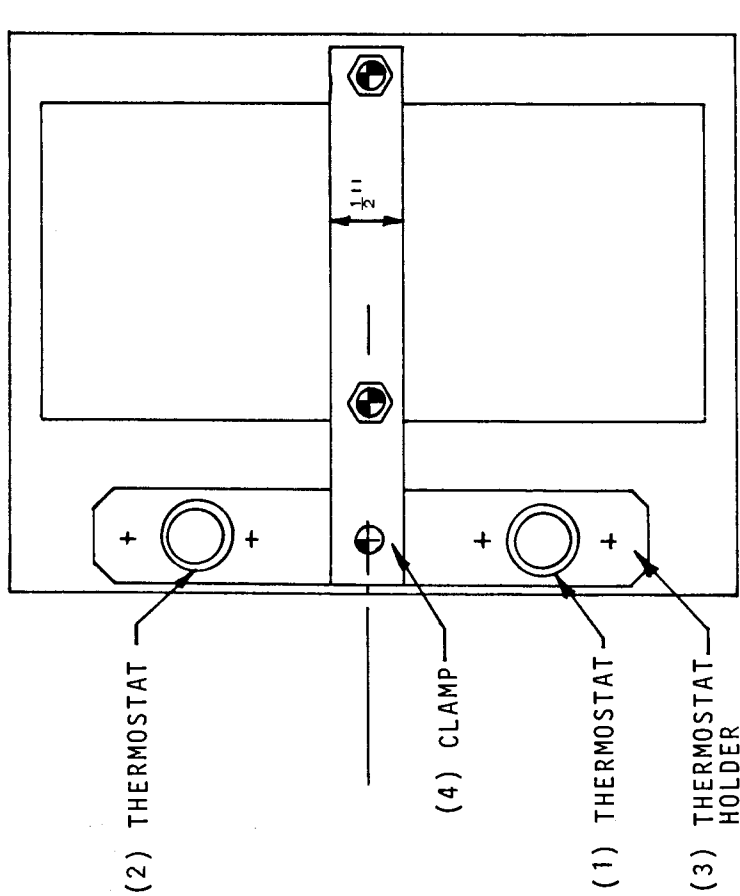
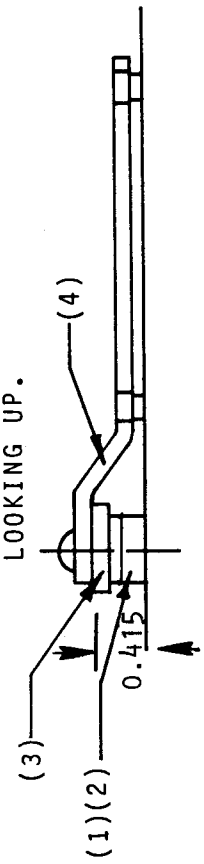
Figure 1

IMPROVEMENT OF HOT LIQUID CONTAINER  
P/N EL-M-100/28C & EL-M-100/28 EX.
