## **SERVICE BULLETIN**

### **SERVICE BULLETIN INDEX**

# **24-WESTWIND**

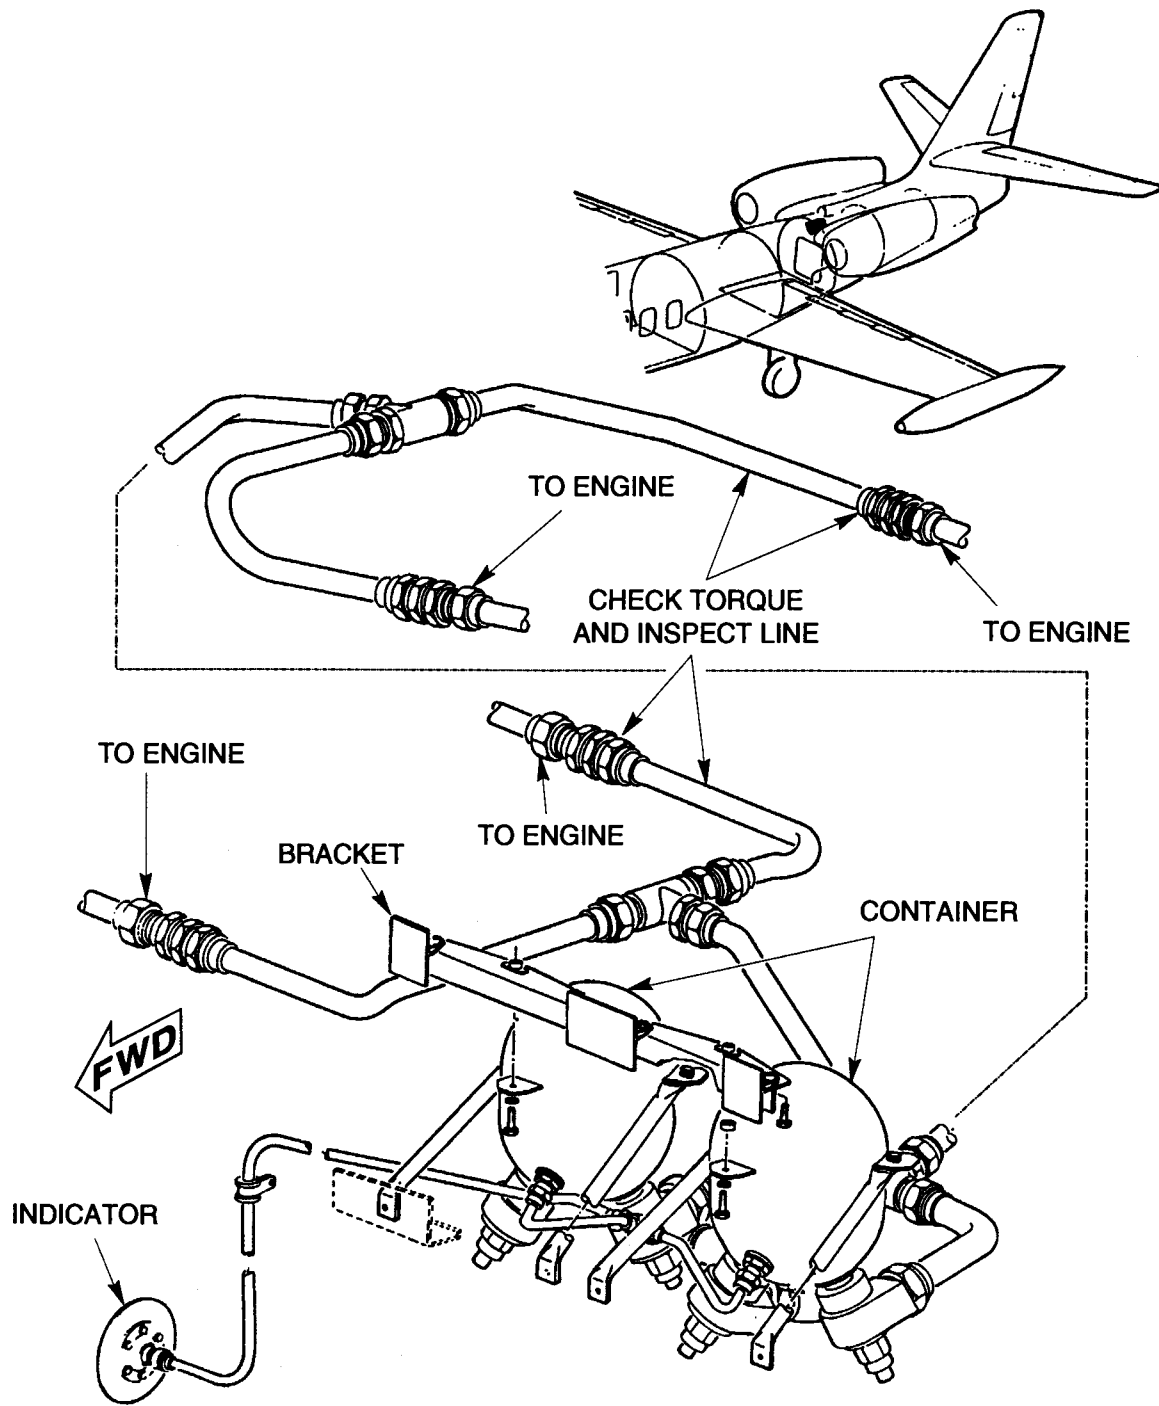
FIGURE 1

Field experience has revealed that the B-nut attached to firewall fitting inside pylon may be loose.

Extinguishing System Installation

- (1) Gain access to fire extinguisher lines by removing forward wall from aft baggage area.
- (2) Using a flashlight and mirror inspect lines for signs of external damage. Refer to Figure 1.
- (3) Using a 7/8 inch crows foot, 24 inch extension and ratchet, verify lines are tight on bulkhead fittings.
- (4) Install panel.

- (1) Gain access to fire extinguisher lines by removing oval panels on firewall. Refer to Figure 2.
- (2) Inspect lines for any signs of external damage. Refer to Figure 1.
- (3) Using a 7/8 inch wrench, verify lines are tight on bulkhead fittings.
- (4) Install panel.

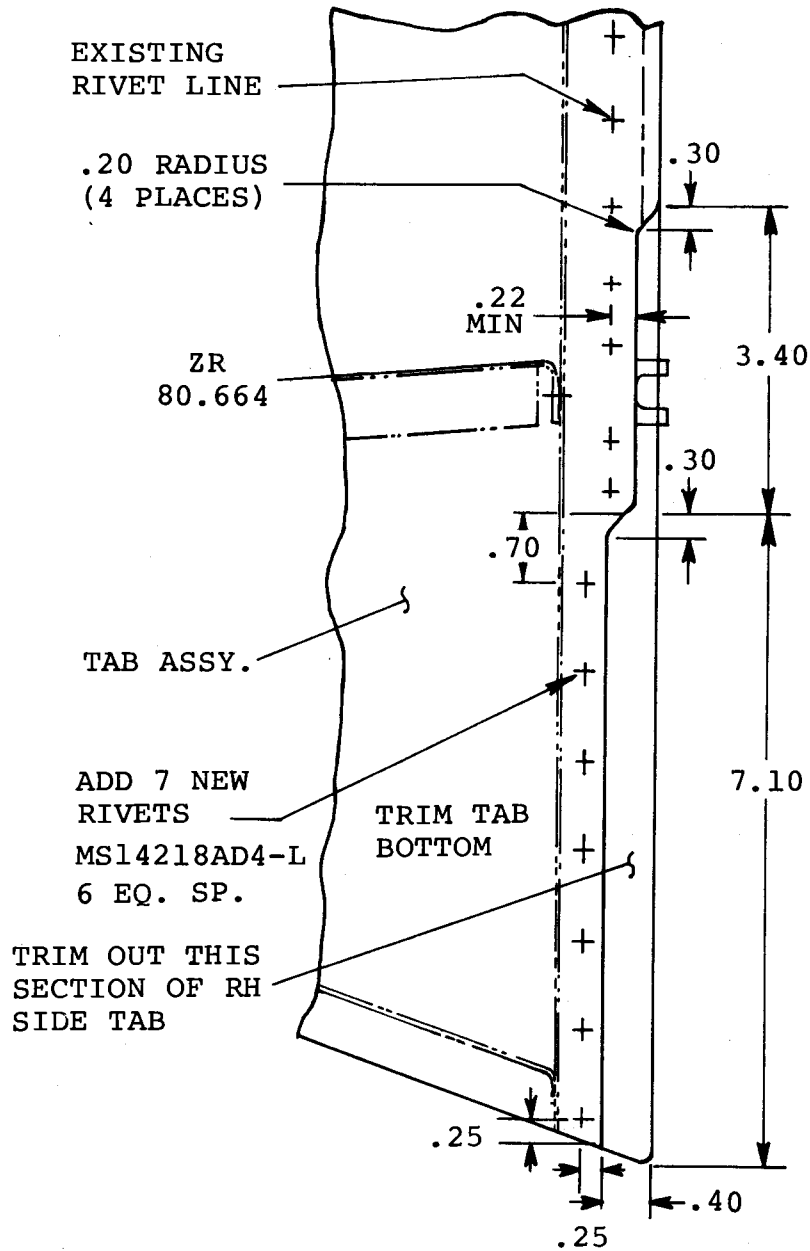
FIGURE 1  
CUTTING OF RUDDER SERVO TRIM TAB  
SHEET 1 of 2

It has become evident that interference and/or binding may occur between the trim tab leading edge and the rudder trailing edge on the right-hand side. This condition can occur should one of the two trim tab electrical actuators fail. The rudder trim is further actuated to the nose left limit. This bulletin describes a modification procedure to provide clearance by trimming spar and skin material from the trim tab right side leading edge. New rivets are installed aft of the existing rivet line. The remaining edge distances of skin-to-spar will determine the rivet pattern to be used for completing the modification.

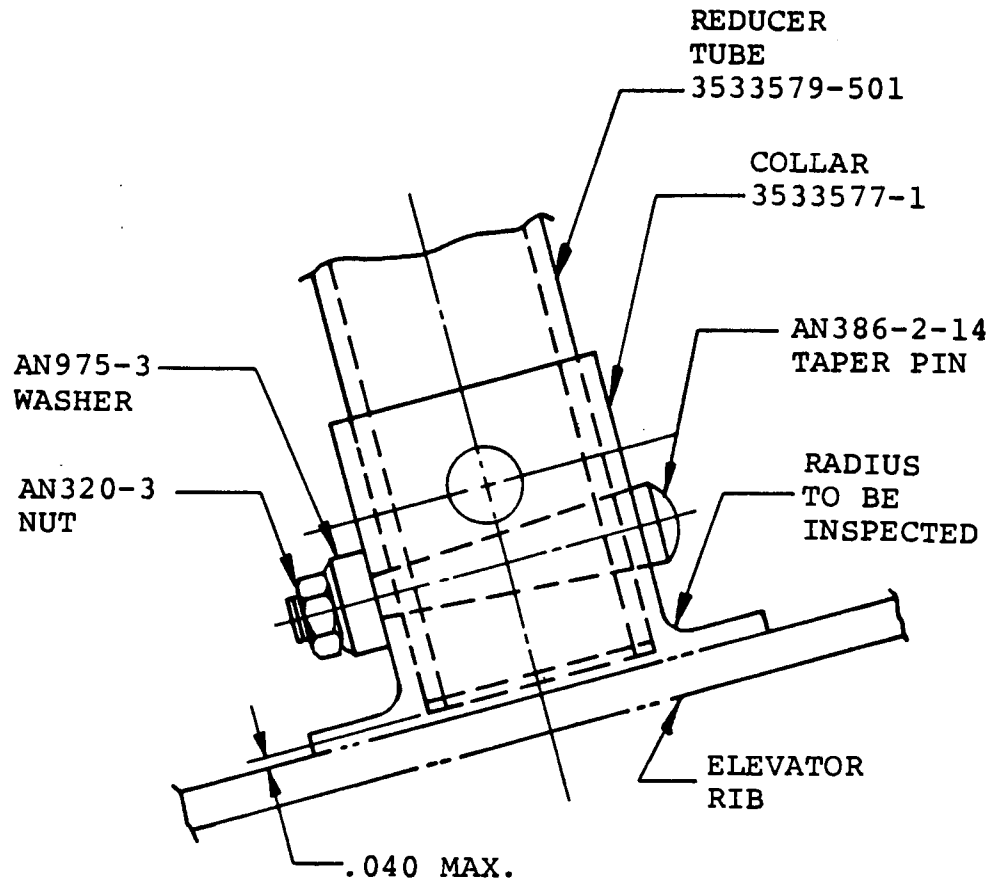
FIGURE 1

Misalignment of the collar flange attachments to the elevators, if not corrected, could induce cracks in the collars, leading to structural failure of the torque tube-elevator interface.

- I. Check the reducer tube in relation to collar flange. If the reducer tube is recessed in the collar by more than .040" (reference Figure 1), the collar and reducer tube must be replaced as per Part I, para. 2.D.

- C. Perform dye-penetrant inspection in radius of both collars (reference Figure 1).
- D. If no defects, proceed to step E. Defective collars must be replaced with a new reducer tube P/N 3533579-501 and collar P/N 3533577-1 as follows:

- C. Measure the gap between the collar flange and elevator rib. A maximum gap of .010" at any point is acceptable.
- D. If gap exceeds .010", remove paint from the collar and perform a dye-penetrant inspection in the radius of the collar (reference Figure 1).
- E. Defective collars must be replaced with a new reducer tube P/N 3533579-501 and collar P/N 3533577-1 as per Part I, para. 2.D.
- F. If no defects, remove the four bolts loosened in step B and install a shim, manufactured from aluminum to the dimensions of the flange with thickness as required to obtain a gap of .010" or less.
- G. Install the four bolts and washers securing the torque tube assembly to the elevator; torque bolts to 80-100 inch-lbs. and safety wire.
- H. Repaint the reducer tube collars as necessary, install fairings and return aircraft to service.

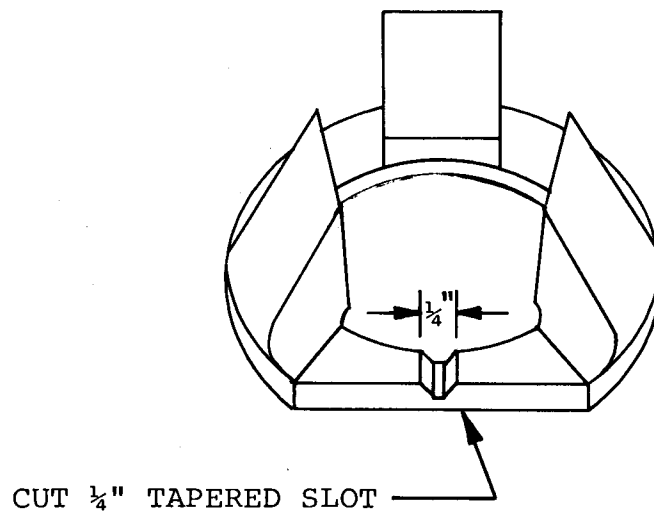
FIGURE 1

This service bulletin provides the means of draining moisture from the fuselage fuel probe base support and also ensures that sufficient clearance exists between the tubes and/or hoses routed along side the probes.

FUEL PROBE BASE SUPPORT

- (1) Defuel aircraft in accordance with Maintenance Manual, Chapter 12.
- (2) Remove electrical power from aircraft.
- (3) Remove external access side panels and access side covers from lower, fuselage tanks in accordance with Maintenance Manual, Chapter 28-10-00.
- (4) Remove external access side panels and access side covers from lower fuselage tanks in accordance with Maintenance Manual, Chapter 28-10-00.
- (5) Remove or loosen clamps securing probe to tubes.
- (6) Raise probe sufficiently to gain access to the base support.

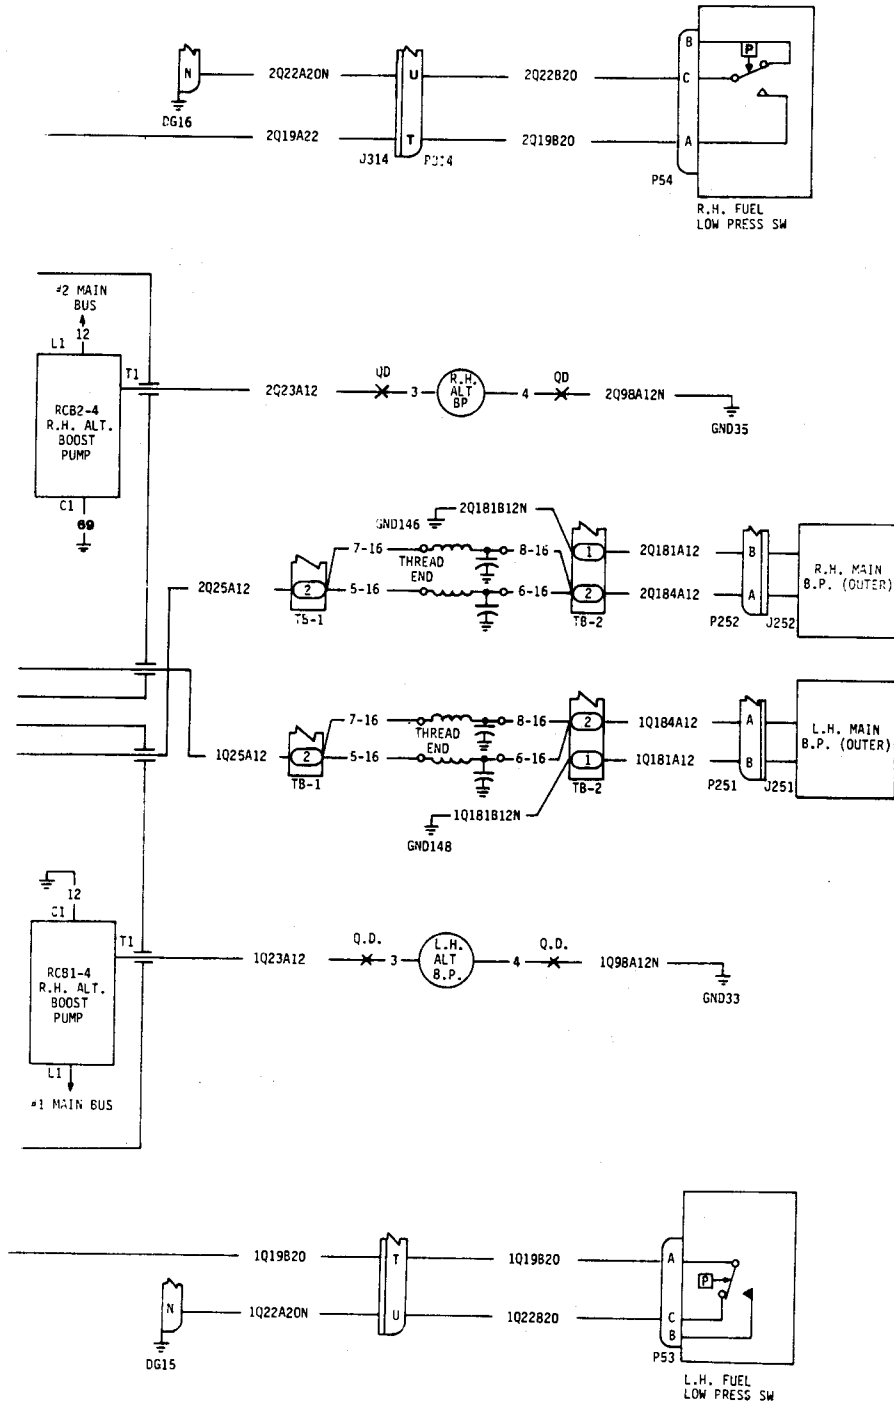
FIGURE 1  
(FOR AIRCRAFT S/N 181)

To eliminate possibility of EMI filter dormant failure that might lead boost pump to become inoperative.

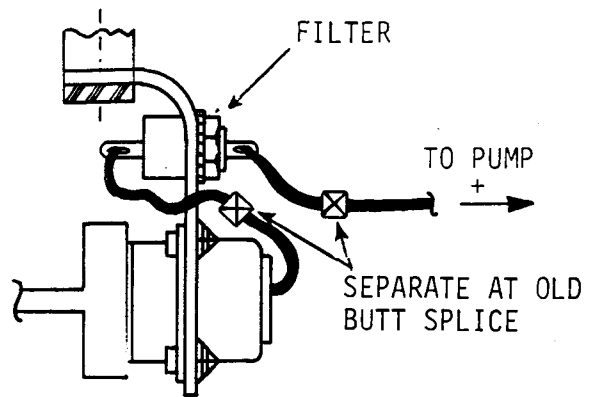
FIGURE 5

FUEL BOOST PUMP EMI FILTER/BRACKET INSTALLATION

For aircraft with filters installed on brackets attached to pumps (see Figure 5).

RECONNECT WIRES WITH  
NEW BUTT SPLICE AND  
DISCARD FILTER

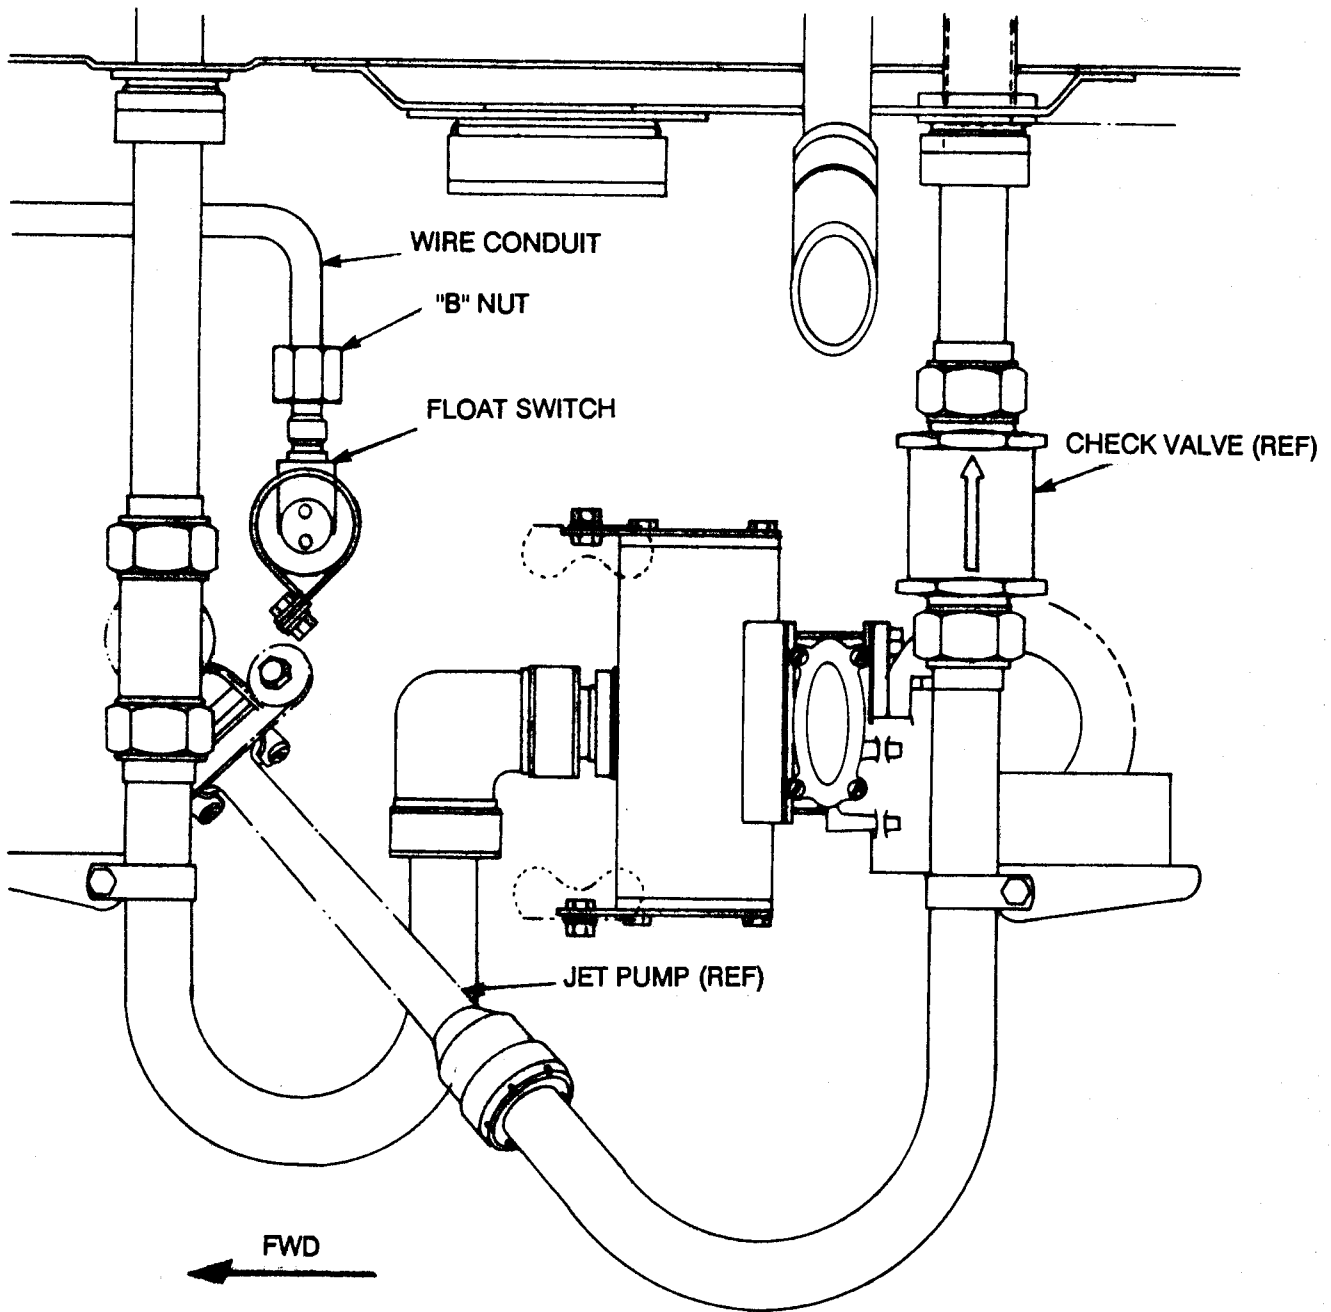
**FIGURE 1**

To prevent moisture from entering wiring conduit which could freeze and subsequently rupture conduit, causing fuel leakage.

**DETAIL A**  
**VIEW LOOKING DOWN THROUGH TIP TANK**  
**ACCESS OPENING - LEFT SIDE**

This service bulletin provides instructions for the purging of accumulated moisture and sealing of the tip tank float switch wire conduit.

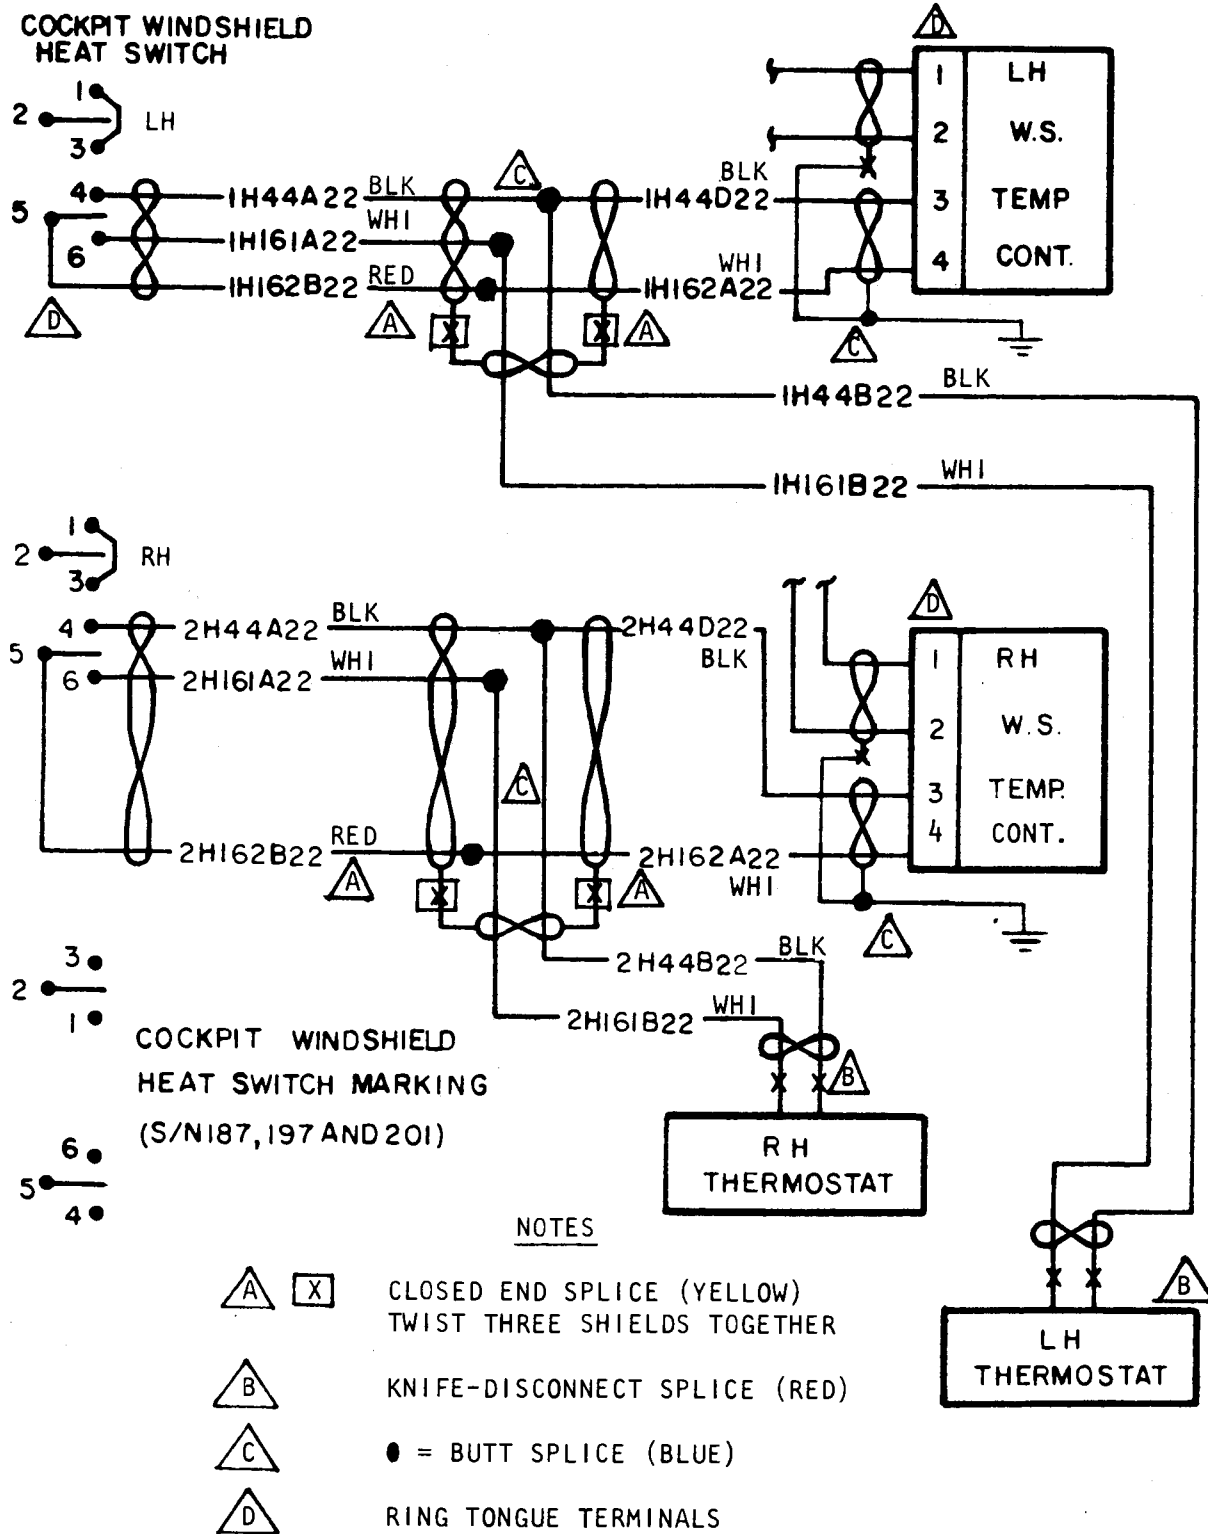
FIGURE 1 SHIELDED WIRING CONNECTIONS

PART I Induced voltages have been determined to be the cause of unwanted cycling of the windshield heat contactors, P/N 833044-1. This bulletin describes the steps necessary to remove unshielded wires and replace them with shielded wires that are properly grounded at each termination point.

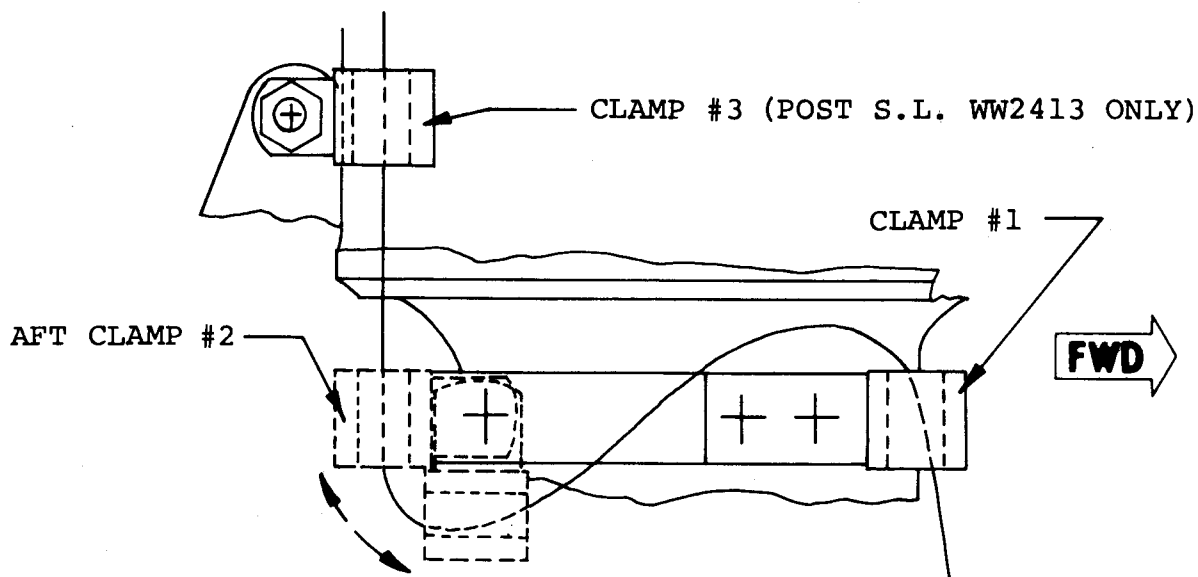
FIGURE 1: EXISTING INSTALLATIONS

NOTE: CLAMP #2 WILL BE FOUND IN EITHER POSITION AS SHOWN, ON EXISTING INSTALLATIONS.

B. Remove aft clamp #2 and loosen the attachment of clamps #1 & #3 to facilitate rerouting of wiring harness.

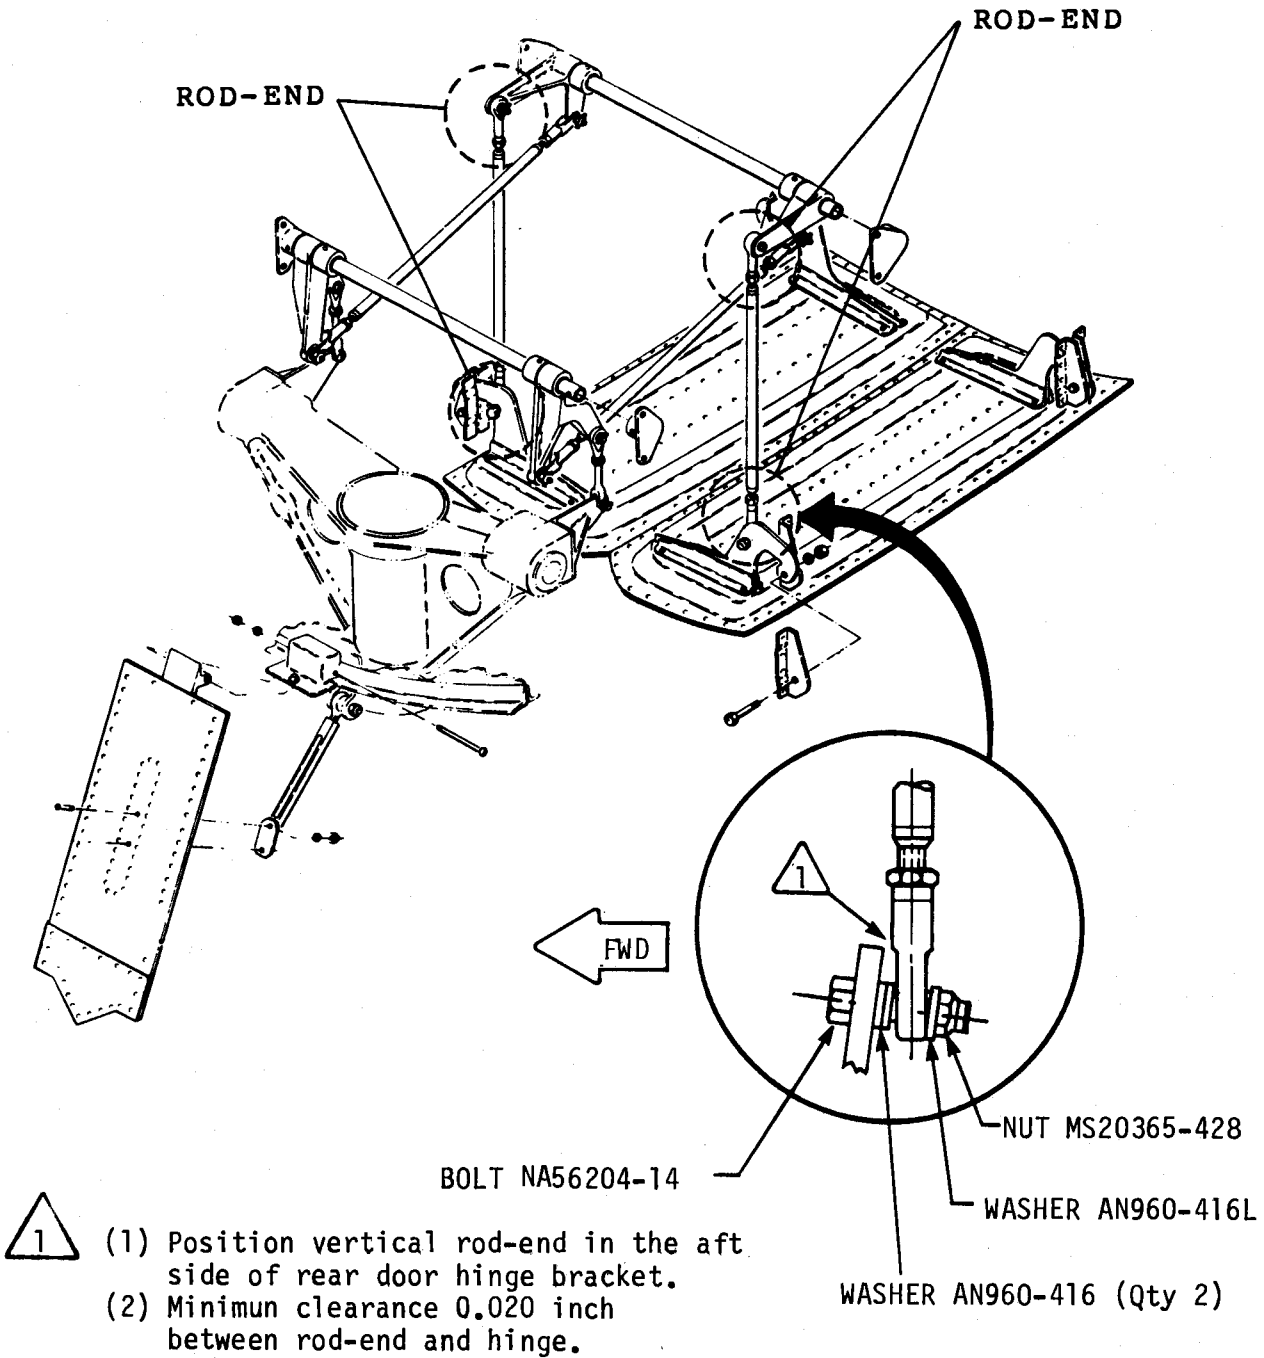
FIGURE 1

- A. Gain access to rod-ends installed in NLG door system (see Figure 1).
- B. Inspect rod-ends to determine if witness holes are present.
- C. If rod-ends have witness holes, no further action is required.
- D. If rod-ends do not have witness holes, remove and replace with rod-ends P/N F44-14MT in accordance with 1124/1124A Maintenance Manual chapter 32-20-00 maintenance practices.

Ensure that rigging of NLG doors are not altered during replacement (see Figure 1).
