SERVICE BULLETIN

SERVICE BULLETIN INDEX

24-WESTWIND

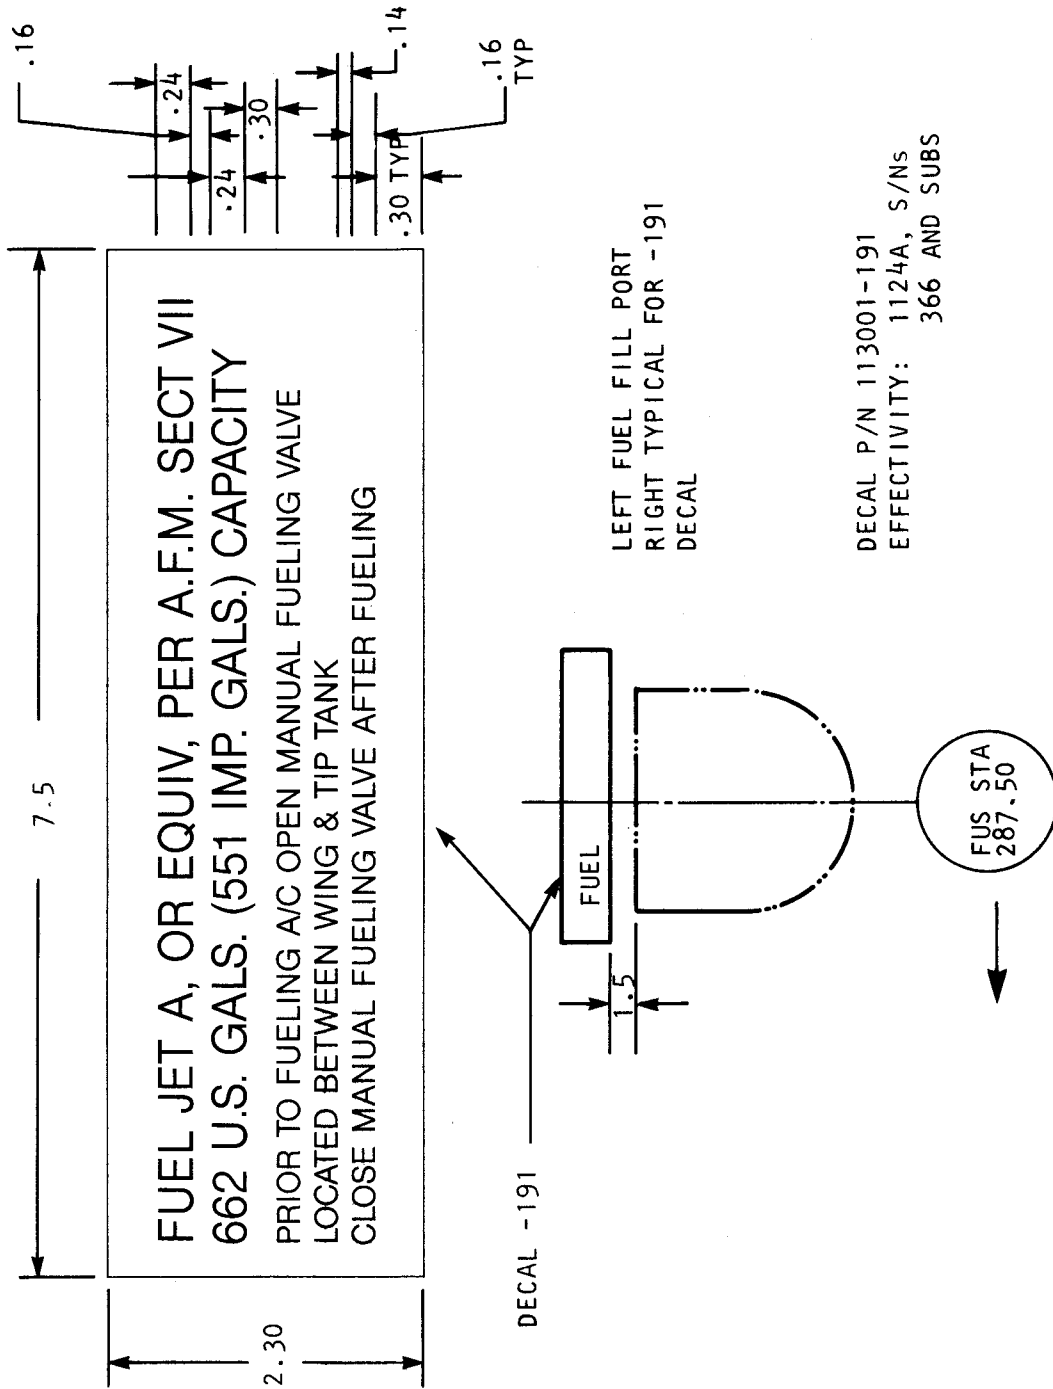
FIGURE 2

FUEL CAPACITY PLACARD LOCATION

Replace existing (3 each) placards on the overwing fuel filler ports and a section of single point refueling data placard. Install replacement placards or utilize other suitable methods of placarding.

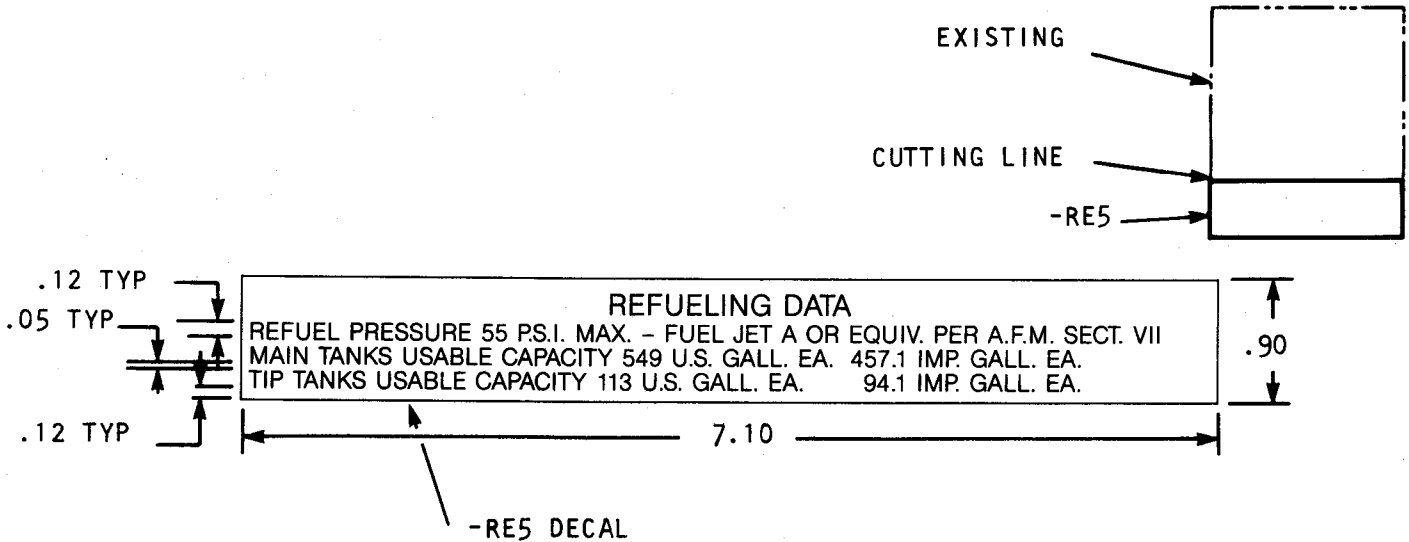
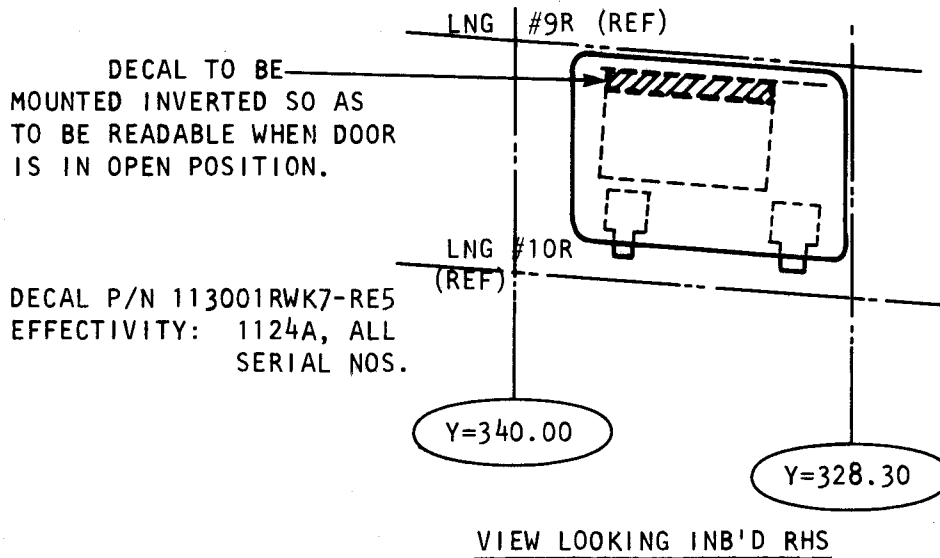
Figure 4

FUEL CAPACITY PLACARD LOCATION

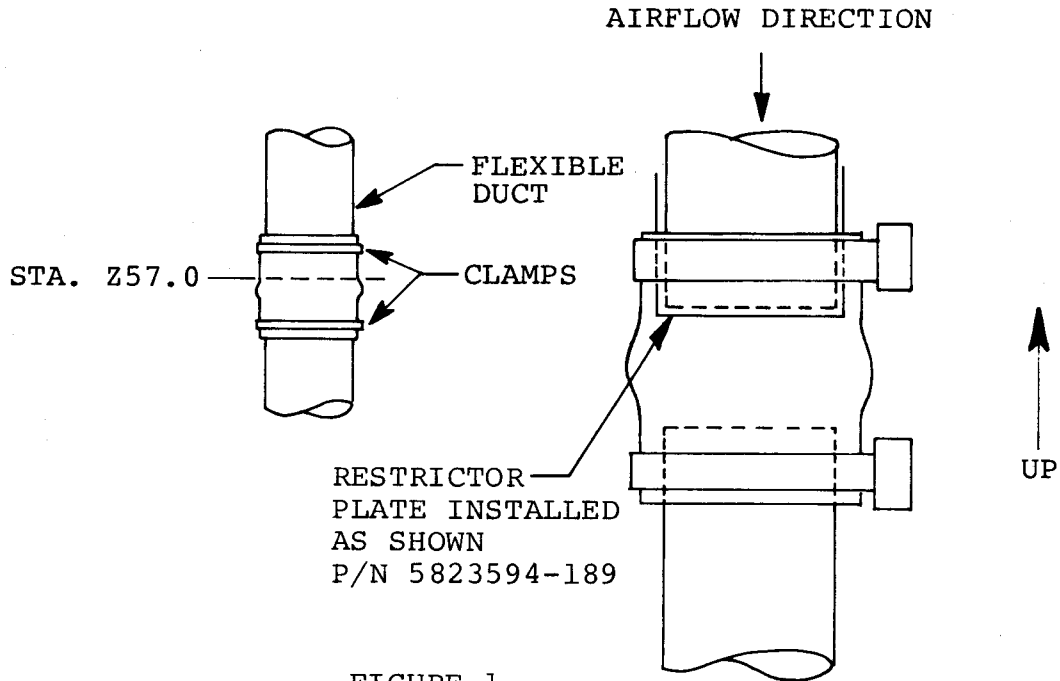
FIGURE 1

To reduce cooling airflow and resultant cold soaking inside both DC contactor boxes and the immediate area near subject air outlet which contributes to condensation in high humidity environments following extended flights.

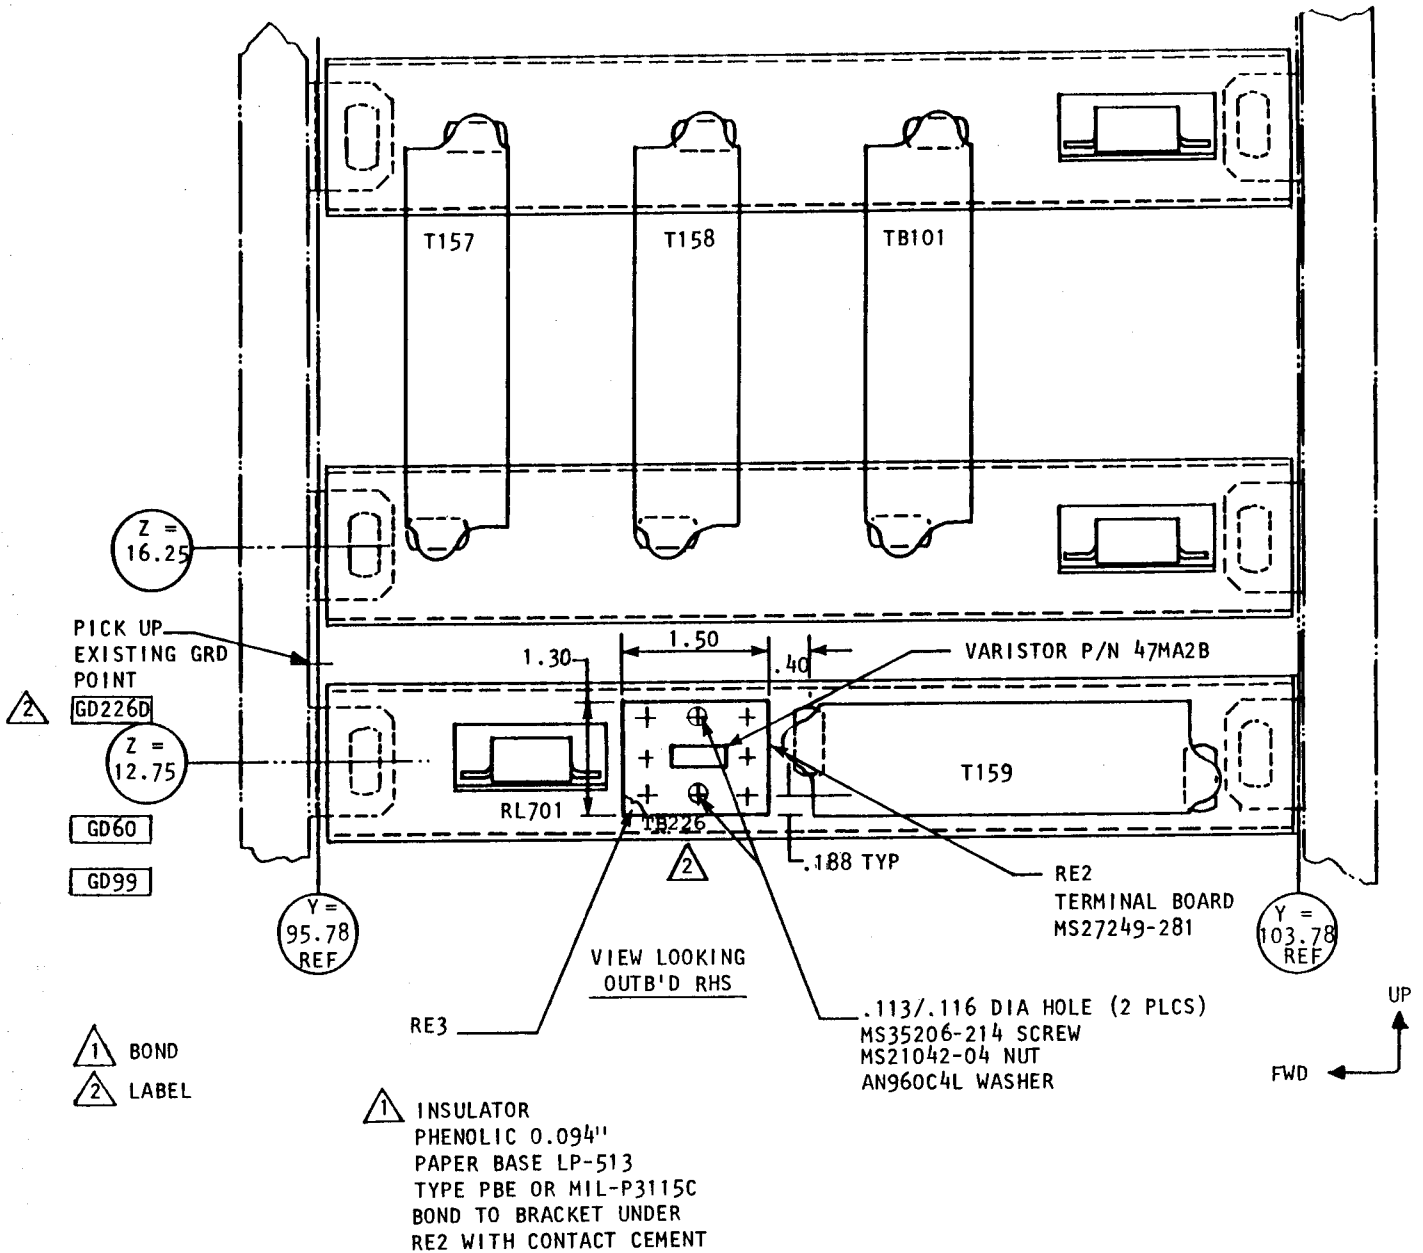
FIGURE 1

SUBJECT: AUTOFLIGHT - ELIMINATION OF 1124A OVERSPEED WARNING FAILURES

- (1) To isolate the Air Data Computer overspeed warning outputs from the Mach Warning Bell to prevent internal component damage to the ADC-80K.
- (2) To include additional VMO test circuit protection.

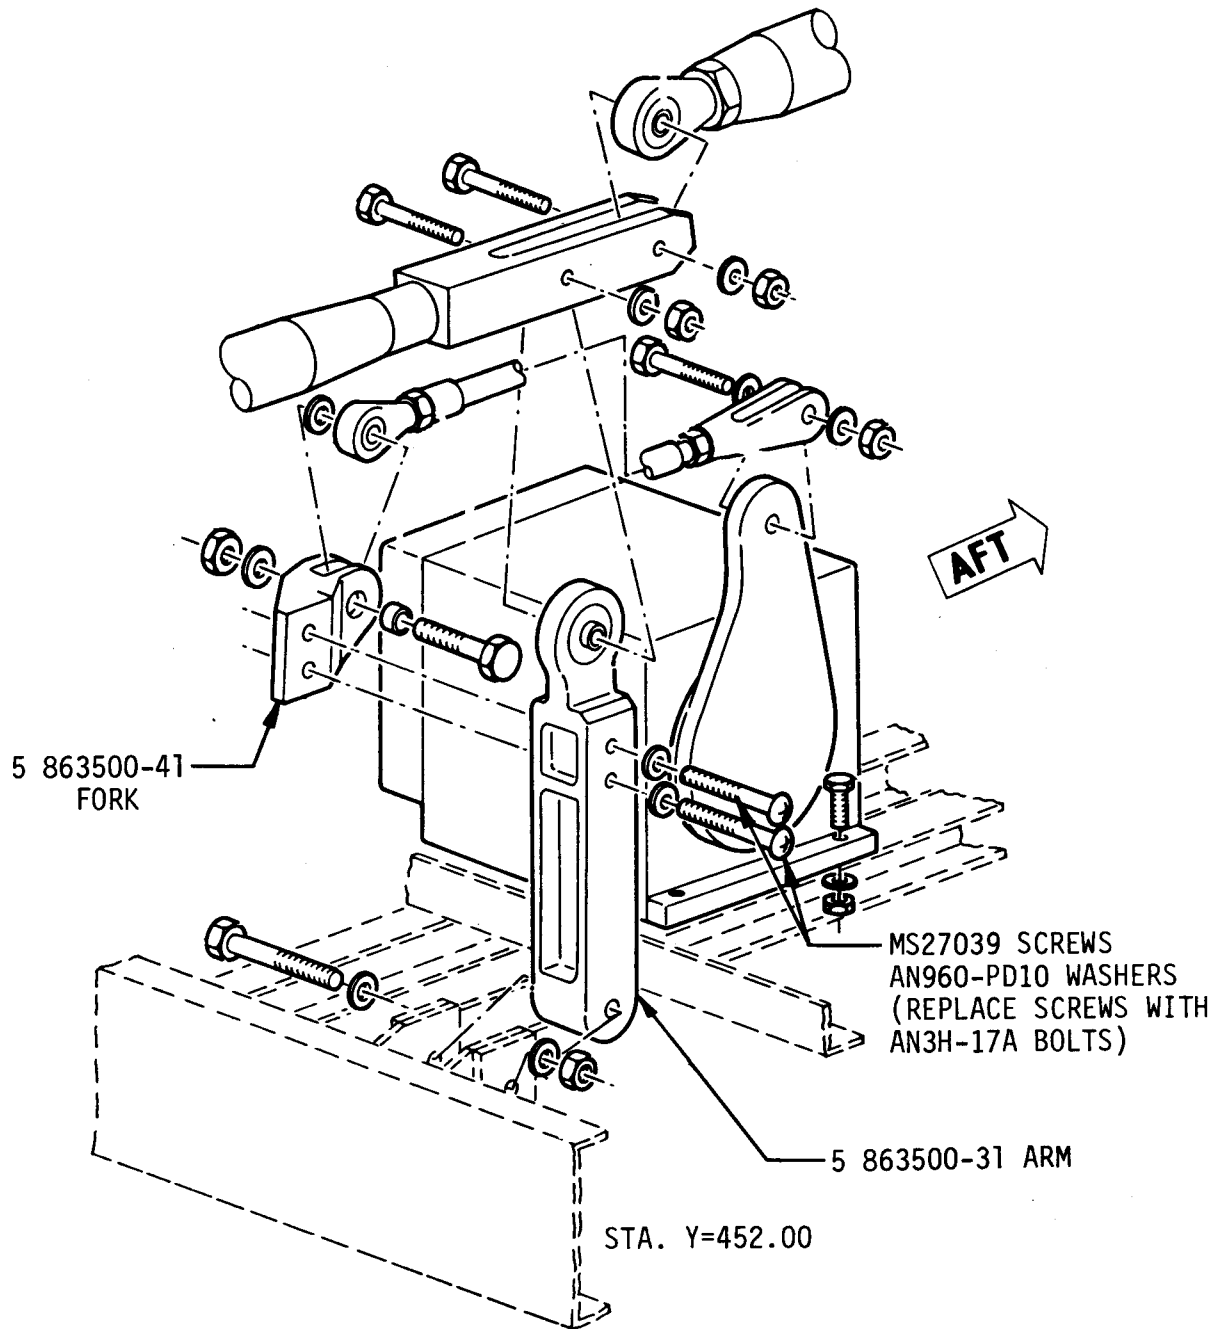
FIGURE 1

Replacement of existing select hardware to minimize the possibility of elevator and/or rudder control interference.

Service Bulletin No. 1124-22-072A dated September 12, 1986 titled "Auto Flight - Elevator and Rudder Servo Idler Arm - Install New Attach Bolts" has been accomplished this date _____.

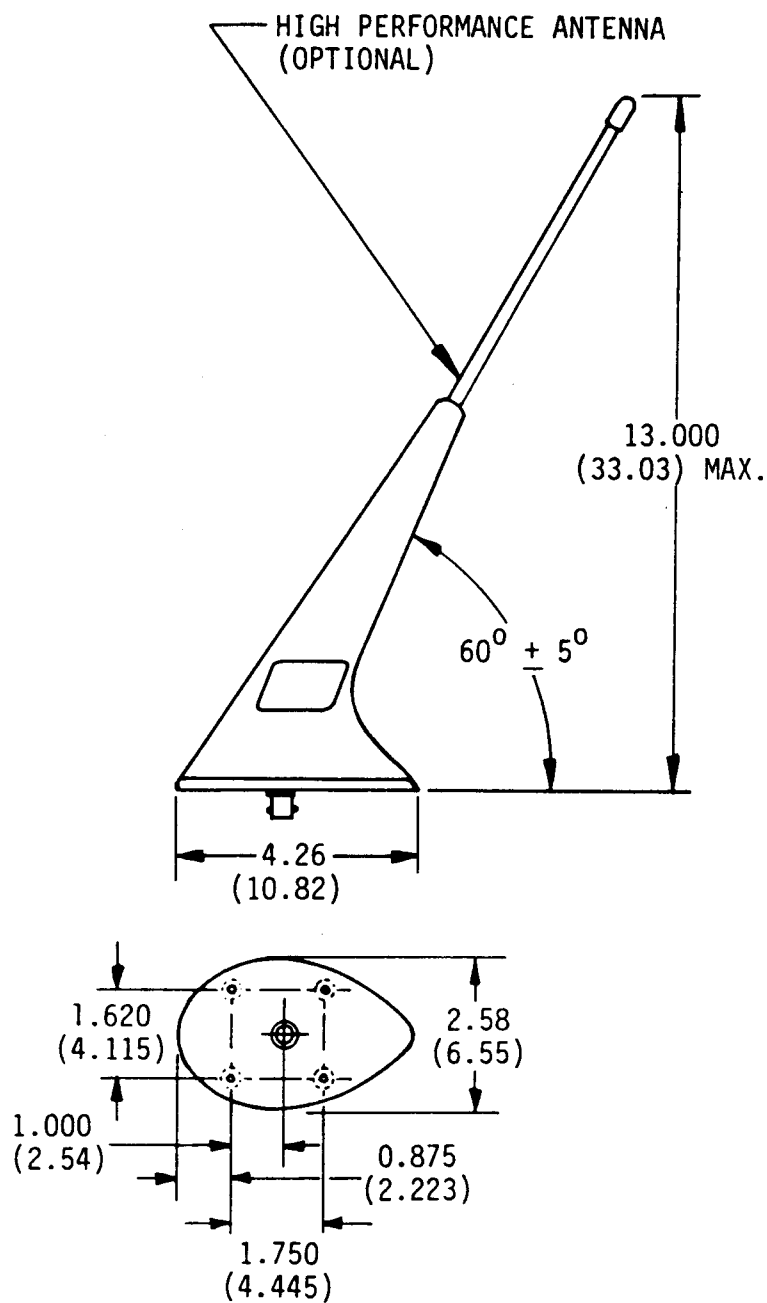
FIGURE 1

Service Bulletin No. 1124-23-073 dated January 15, 1986 titled "Communication - DMQ-18-1A ELT Antenna Hum Correction During High Speed Flight" has been accomplished this date

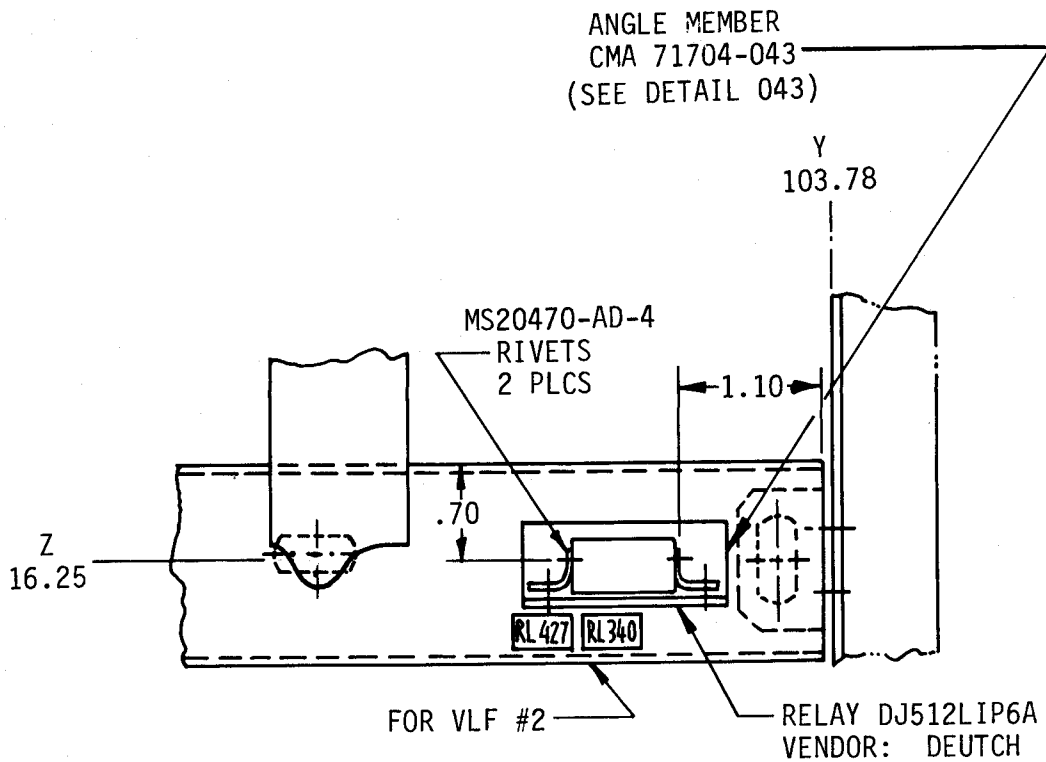
FIGURE 4.

1. ON AIRCRAFT MODEL 1124A, REPLACE EXISTING RELAY RL427 P/N ESOD4AD WITH P/N DJS12L1P6A (MFG. DEUTCH).
2. ON AIRCRAFT MODEL 1124 WITH FF 4, 5 OR 6, ADD NEW RELAY RL427 P/N DJSLIP6A (MFG. DEUTCH).
 - (1) USE ANGLE MEMBER P/N CMA71704-043 TO MOUNT RELAY.
 - (2) ON AIRCRAFT UP TO SERIAL NUMBER 453 WITH 2ND VLF REPLACE EXISTING MOUNTING BRACKET WITH ANGLE MEMBER P/N CMA71704-043 AS SHOWN BELOW:

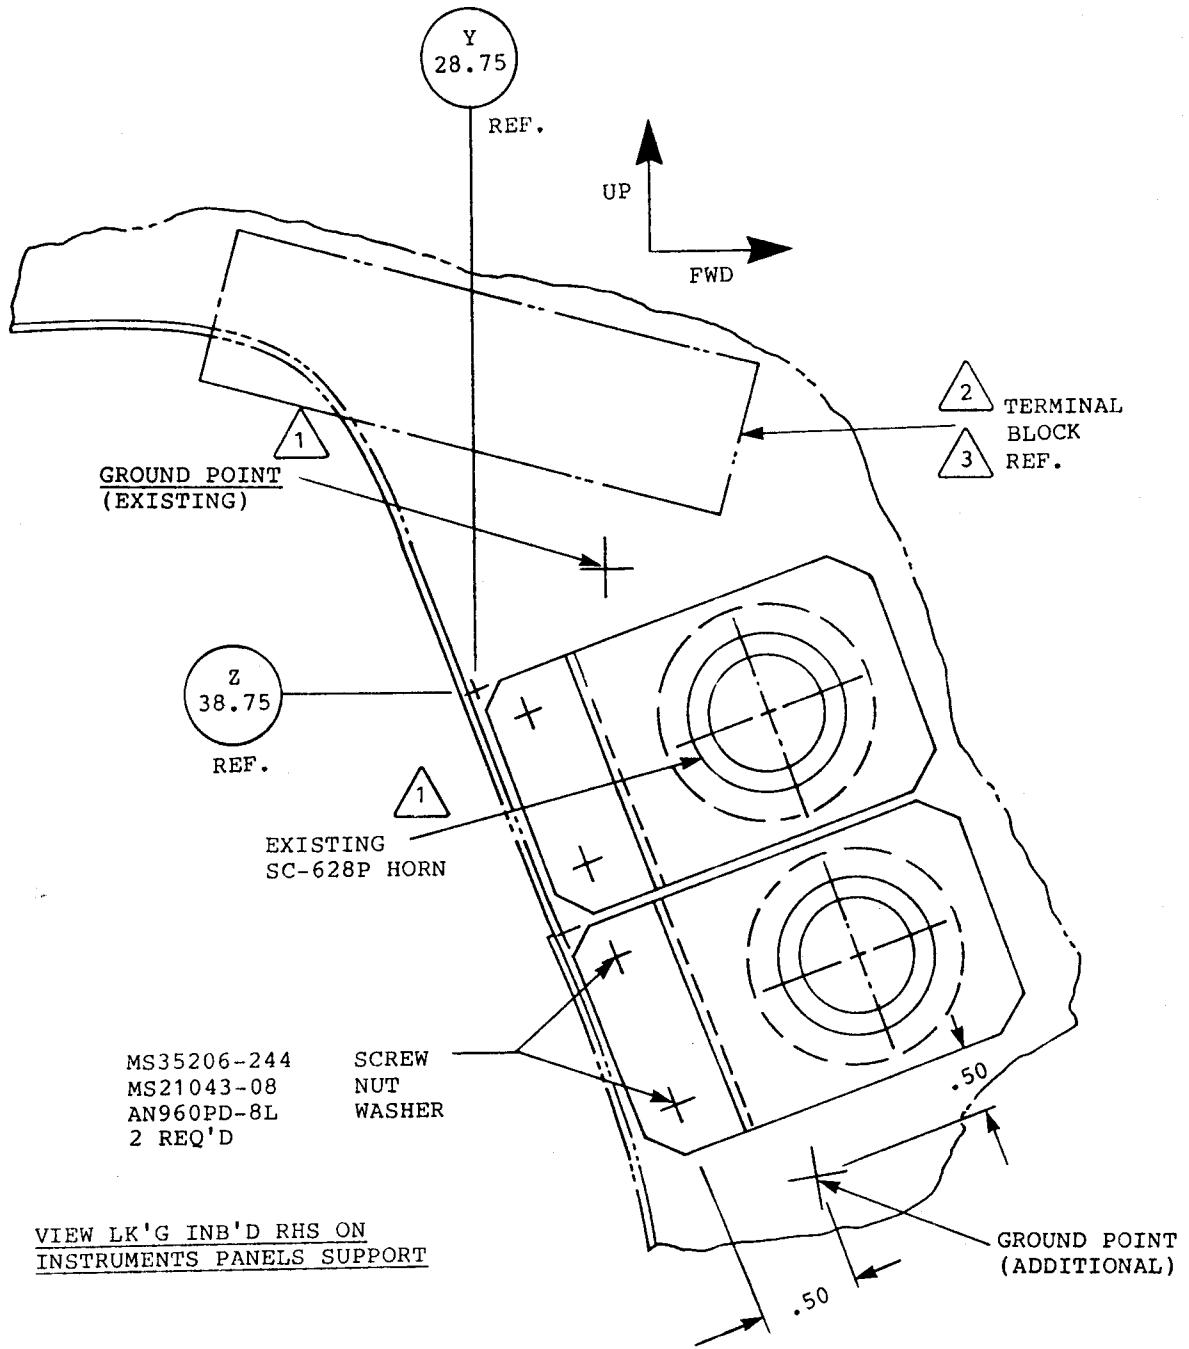
FIGURE 1

- △ 1 A/C IN COMPLIANCE WITH ORIGINAL SB 1124-26-022
- △ 2 A/C 152, 154, 174, 181, 185-239 (T-6)
A/C 240 AND SUBS (T-160)
- △ 3 T-6 MAY BE LOCATED ON U-CHANNEL UNDER COPILOT'S HSI ON SOME AIRCRAFT.

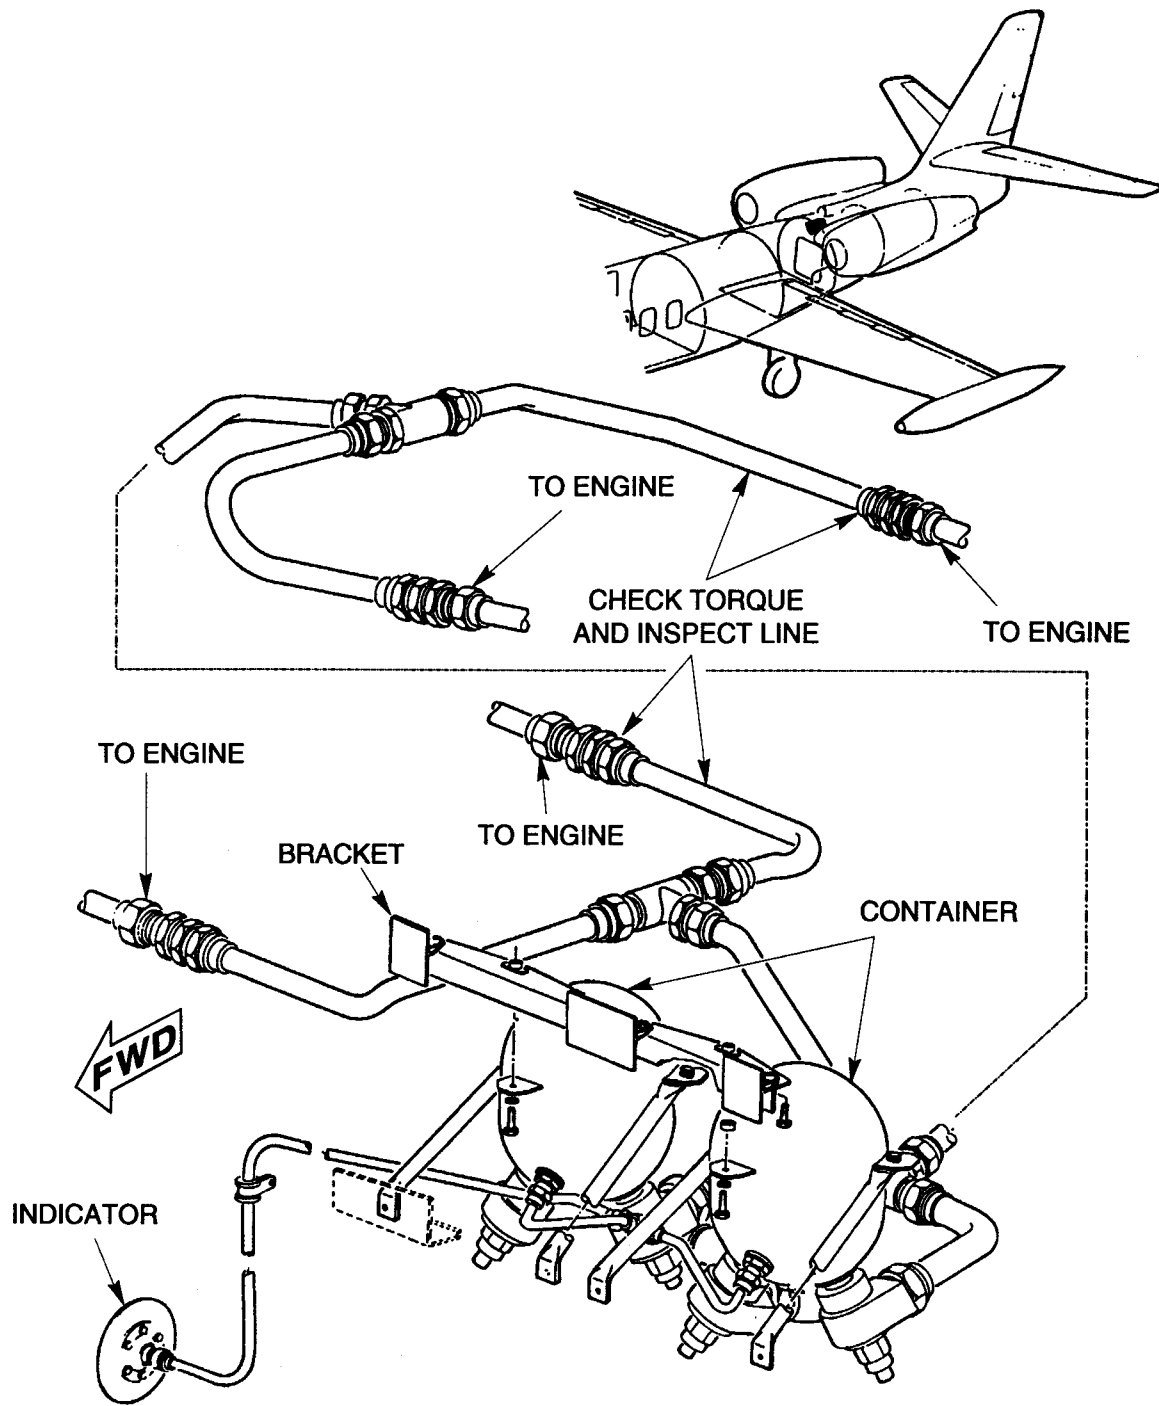
FIGURE 1

Field experience has revealed that the B-nut attached to firewall fitting inside pylon may be loose.

- (1) Gain access to fire extinguisher lines by removing forward wall from aft baggage area.
- (2) Using a flashlight and mirror inspect lines for signs of external damage. Refer to Figure 1.
- (3) Using a 7/8 inch crows foot, 24 inch extension and ratchet, verify lines are tight on bulkhead fittings.
- (4) Install panel.

- (1) Gain access to fire extinguisher lines by removing oval panels on firewall. Refer to Figure 2.
- (2) Inspect lines for any signs of external damage. Refer to Figure 1.
- (3) Using a 7/8 inch wrench, verify lines are tight on bulkhead fittings.
- (4) Install panel.

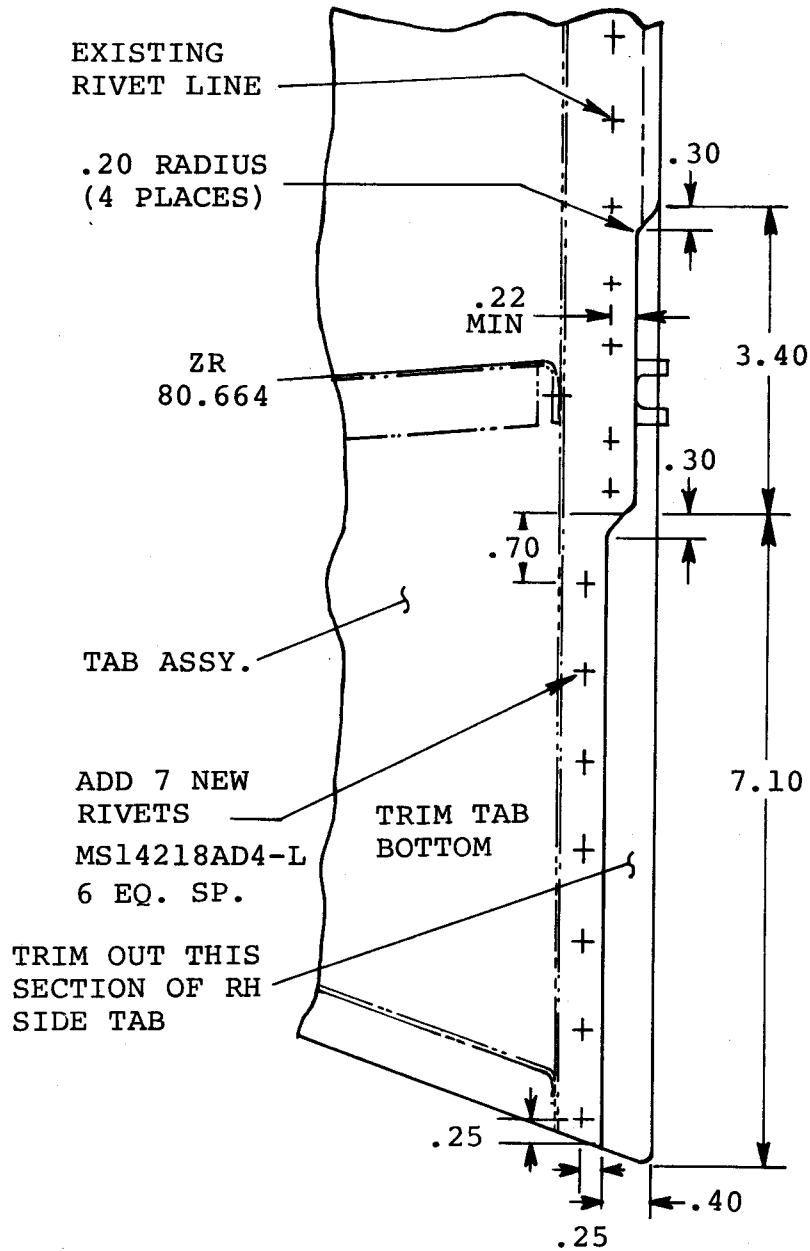
FIGURE 1
CUTTING OF RUDDER SERVO TRIM TAB
SHEET 1 of 2

It has become evident that interference and/or binding may occur between the trim tab leading edge and the rudder trailing edge on the right-hand side. This condition can occur should one of the two trim tab electrical actuators fail. The rudder trim is further actuated to the nose left limit. This bulletin describes a modification procedure to provide clearance by trimming spar and skin material from the trim tab right side leading edge. New rivets are installed aft of the existing rivet line. The remaining edge distances of skin-to-spar will determine the rivet pattern to be used for completing the modification.

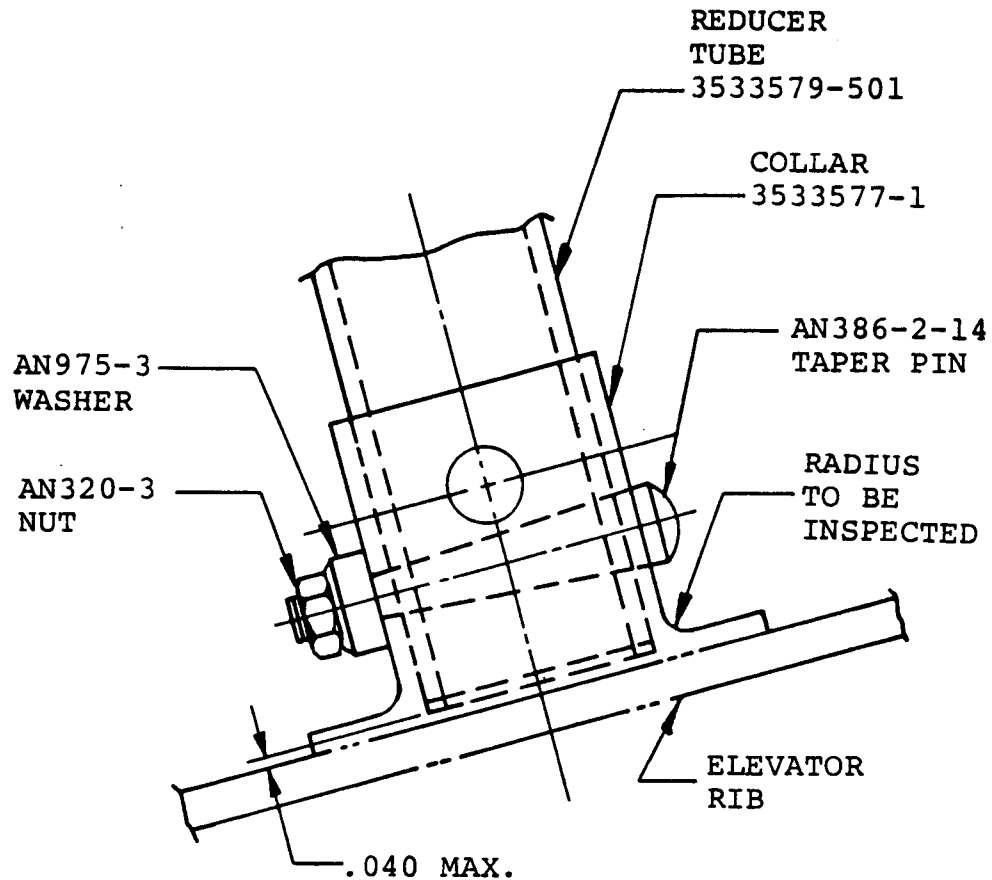
FIGURE 1

Misalignment of the collar flange attachments to the elevators, if not corrected, could induce cracks in the collars, leading to structural failure of the torque tube-elevator interface.

- I. Check the reducer tube in relation to collar flange. If the reducer tube is recessed in the collar by more than .040" (reference Figure 1), the collar and reducer tube must be replaced as per Part I, para. 2.D.

- C. Perform dye-penetrant inspection in radius of both collars (reference Figure 1).
- D. If no defects, proceed to step E. Defective collars must be replaced with a new reducer tube P/N 3533579-501 and collar P/N 3533577-1 as follows:

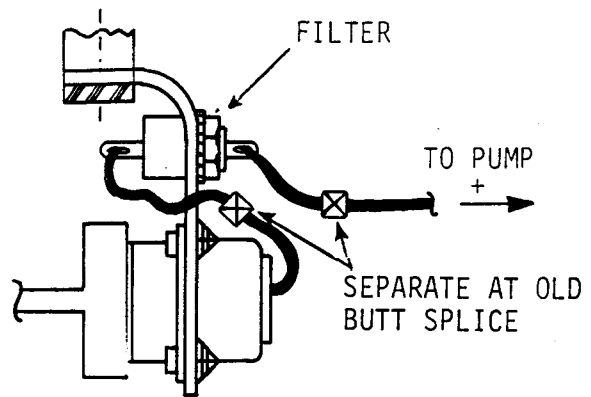
FIGURE 5

To eliminate possibility of EMI filter dormant failure that might lead boost pump to become inoperative.

FUEL BOOST PUMP EMI FILTER/BRACKET INSTALLATION

For aircraft with filters installed on brackets attached to pumps (see Figure 5).

RECONNECT WIRES WITH
NEW BUTT SPLICE AND
DISCARD FILTER

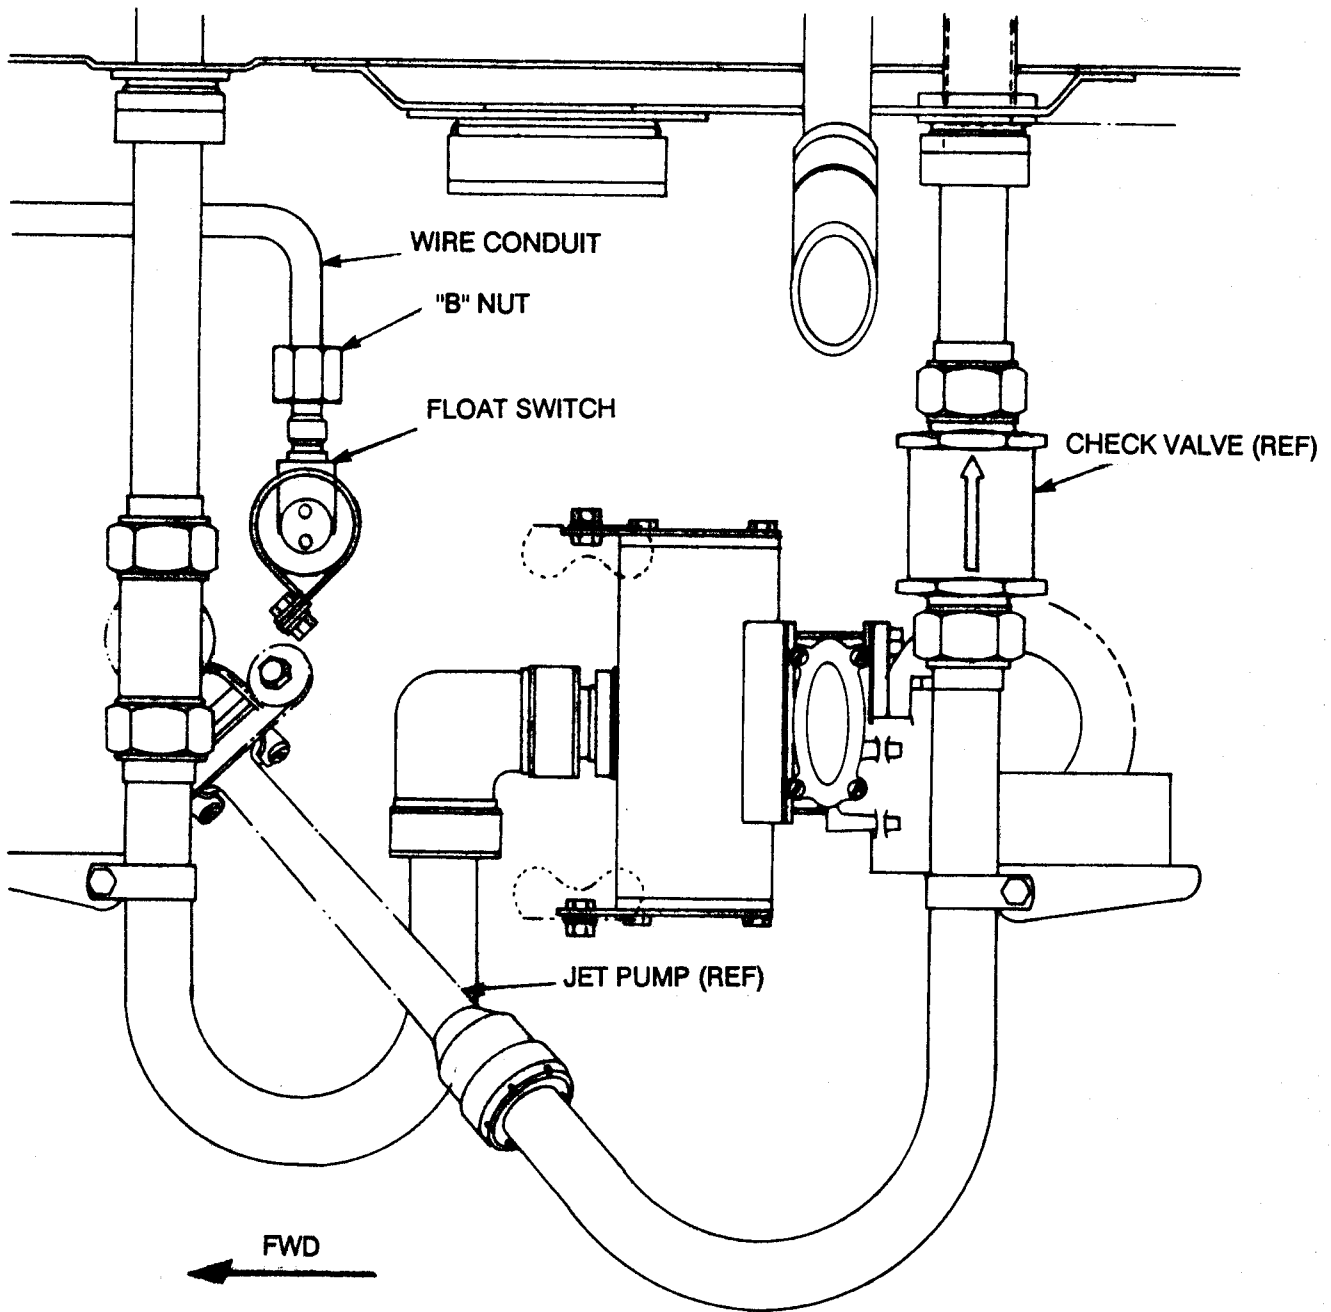
FIGURE 1

To prevent moisture from entering wiring conduit which could freeze and subsequently rupture conduit, causing fuel leakage.

DETAIL A
VIEW LOOKING DOWN THROUGH TIP TANK
ACCESS OPENING - LEFT SIDE

This service bulletin provides instructions for the purging of accumulated moisture and sealing of the tip tank float switch wire conduit.

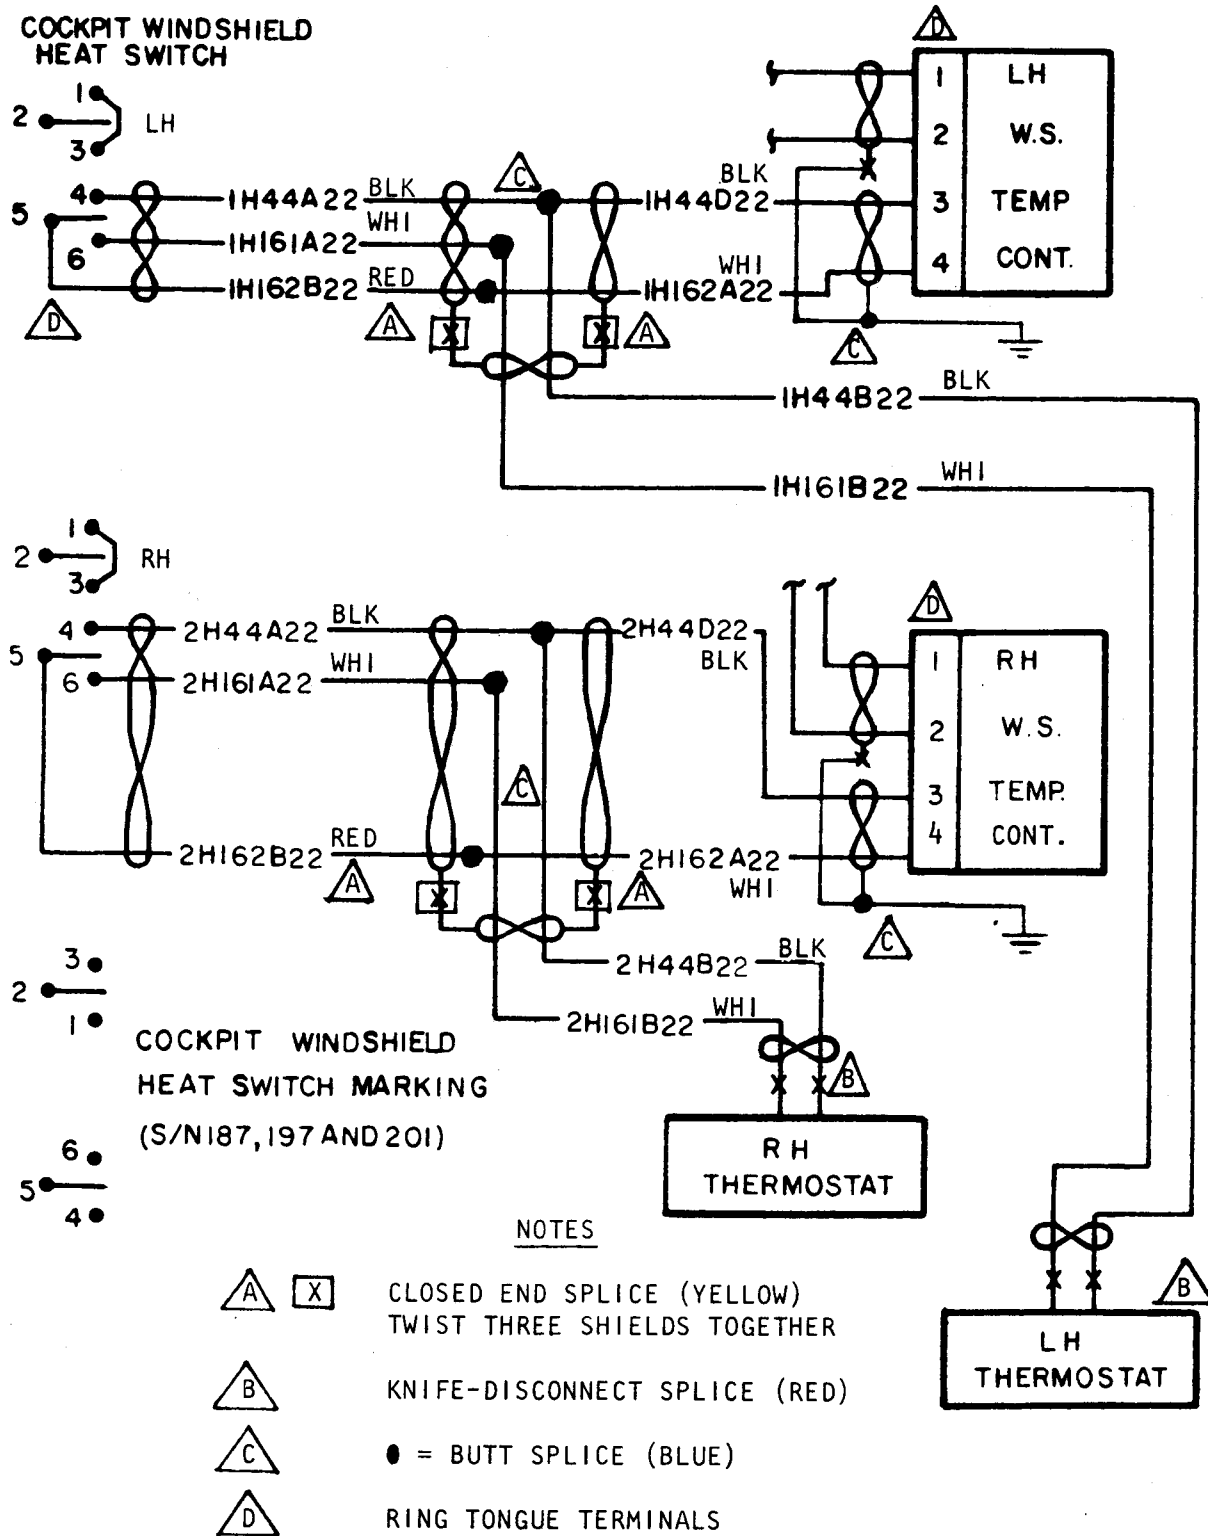
FIGURE 1 SHIELDED WIRING CONNECTIONS

PART I Induced voltages have been determined to be the cause of unwanted cycling of the windshield heat contactors, P/N 833044-1. This bulletin describes the steps necessary to remove unshielded wires and replace them with shielded wires that are properly grounded at each termination point.

Maintenance personnel should make a temporary correction to their aircraft Wiring Diagram to reflect changes performed in PART I of this bulletin.

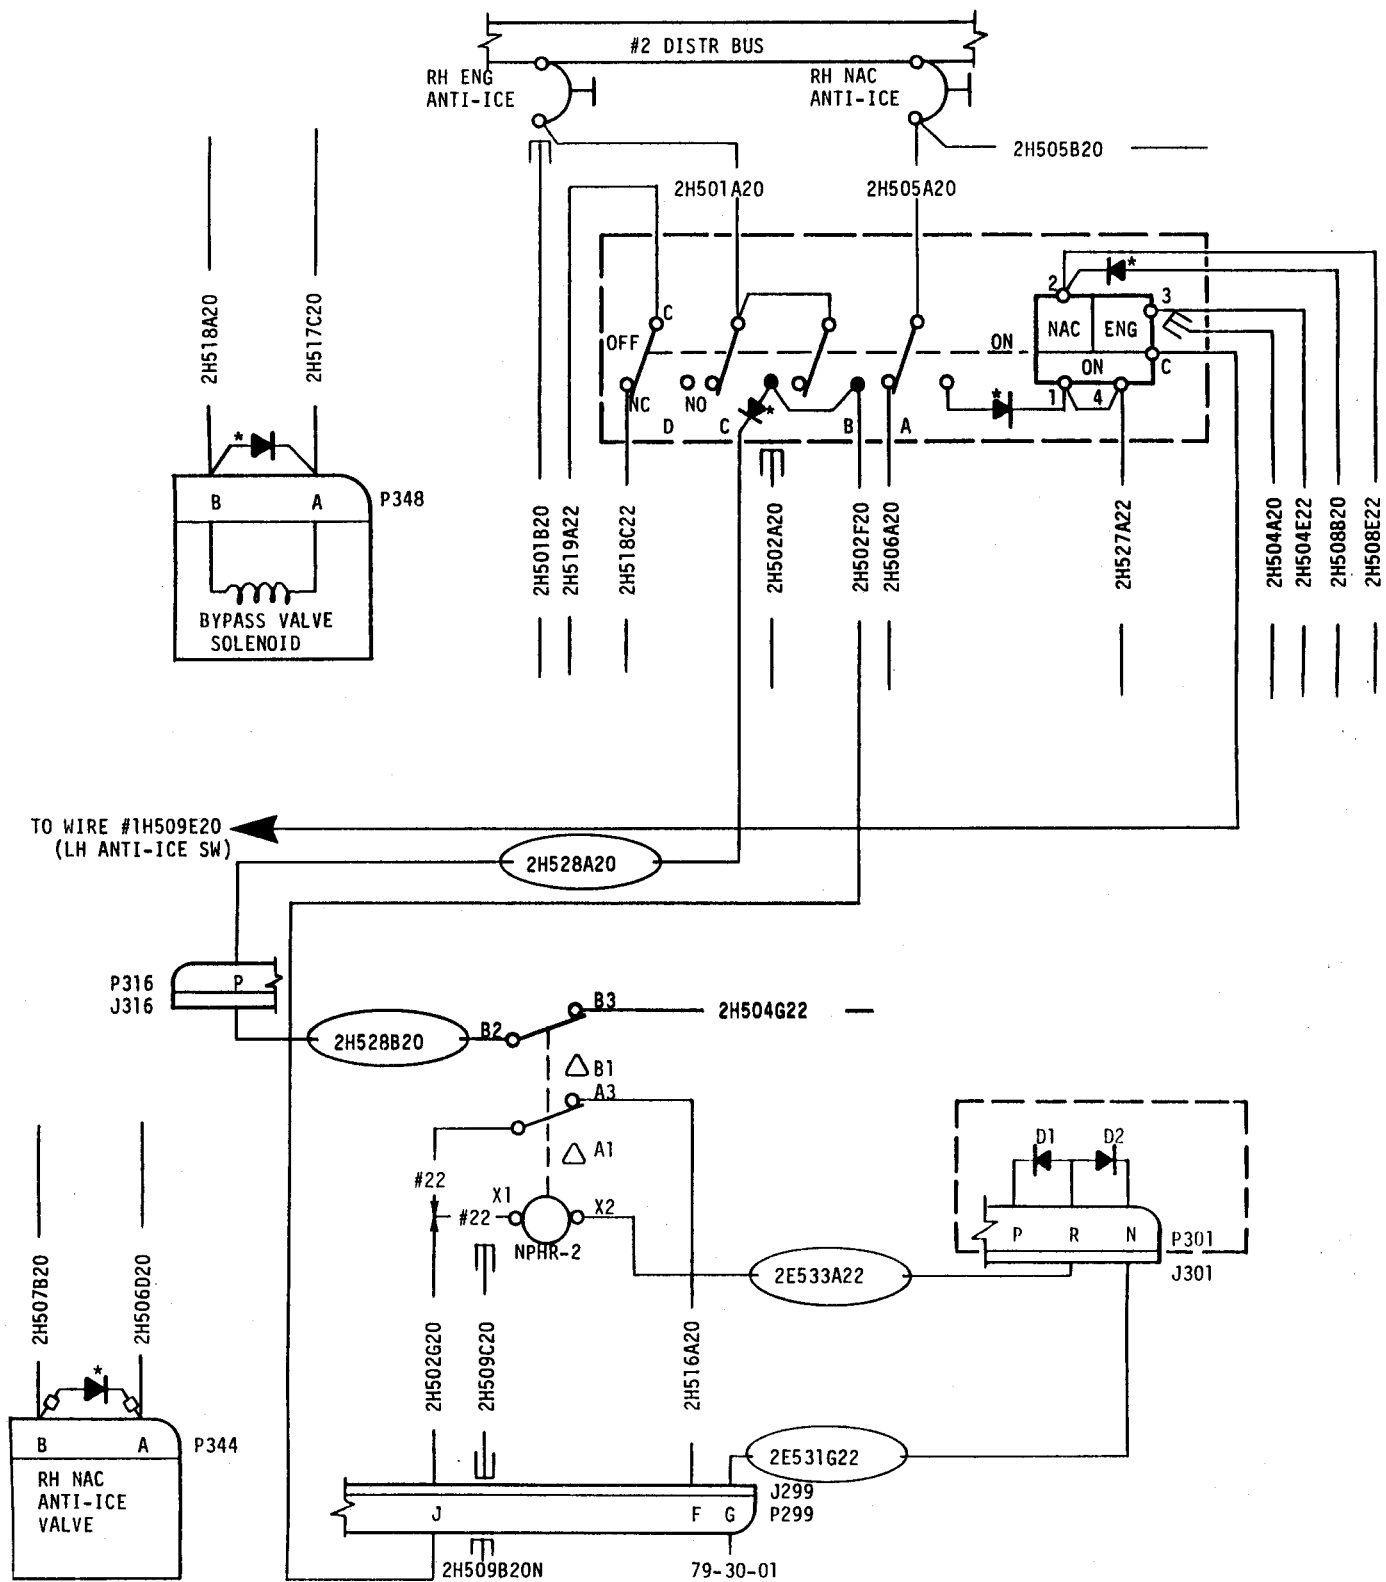
FIGURE 1

* ARC SUPPRESSION DIODES P/N 1N5552

B. Revise your Wiring Diagram Manual Chapter 30-20-01 and 21-00-01 per Figures 1 and 2 of this bulletin to reflect the changes accomplished by this Service Bulletin.

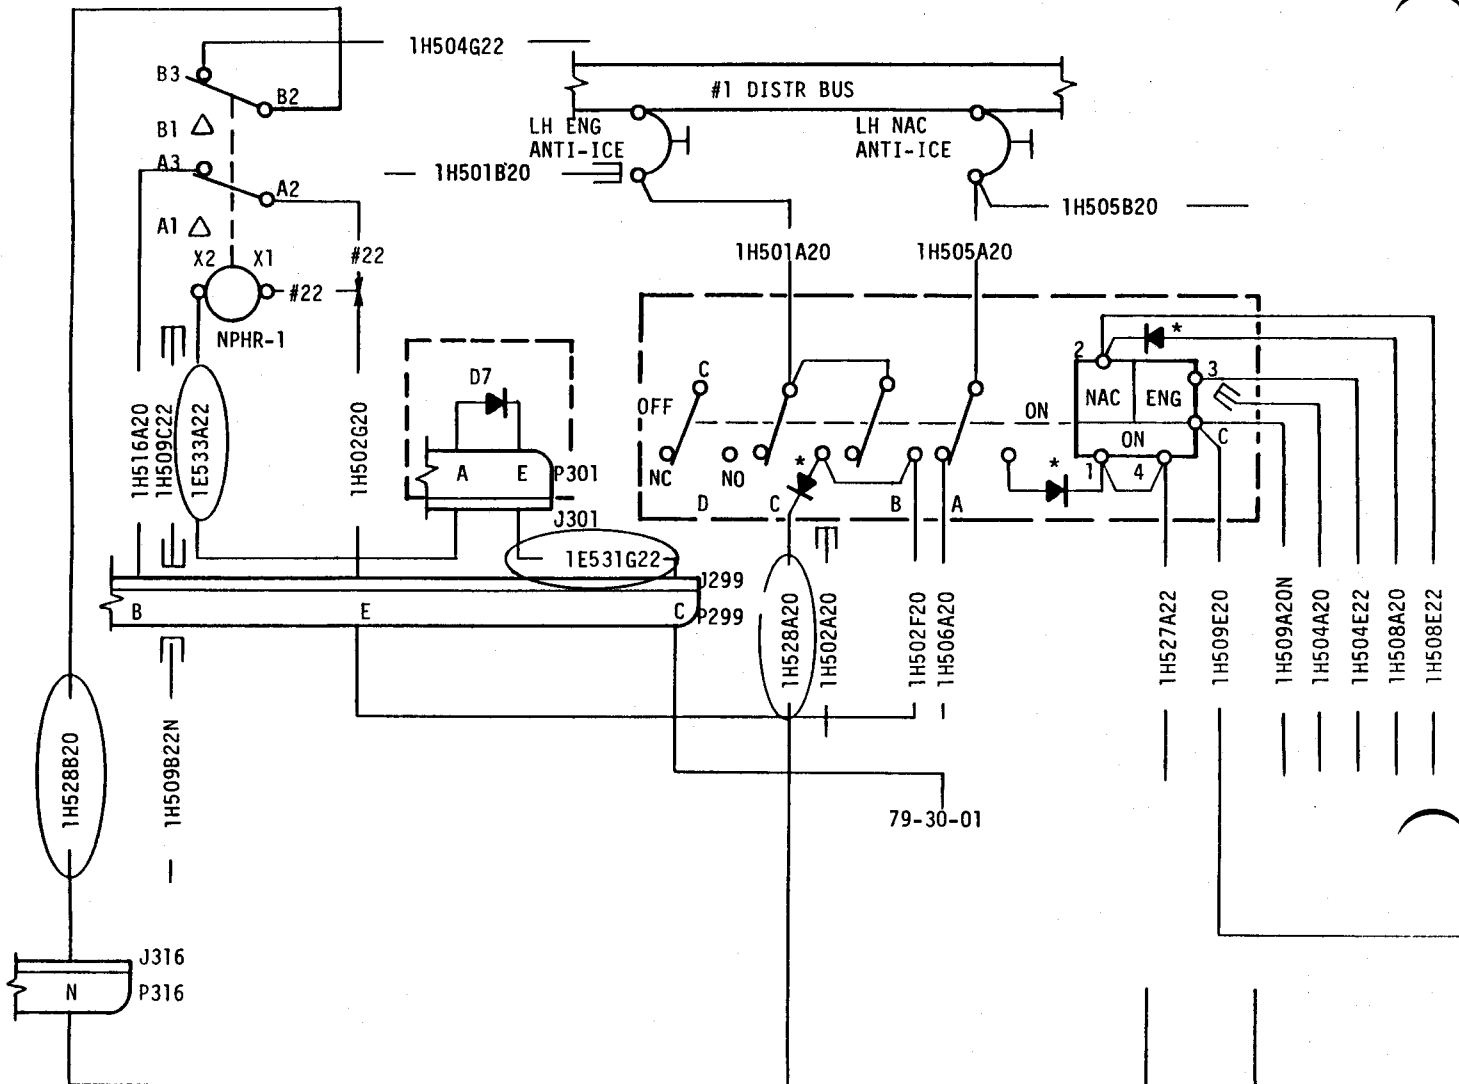
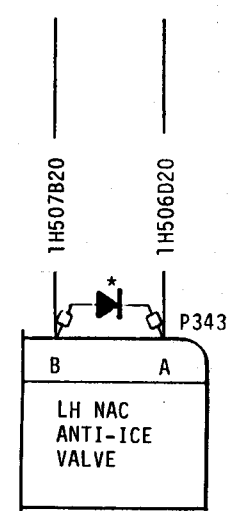
FIGURE 2

* ARC SUPPRESSION DIODE P/N 1N5552
