SERVICE BULLETIN

SERVICE BULLETIN INDEX

24-WESTWIND

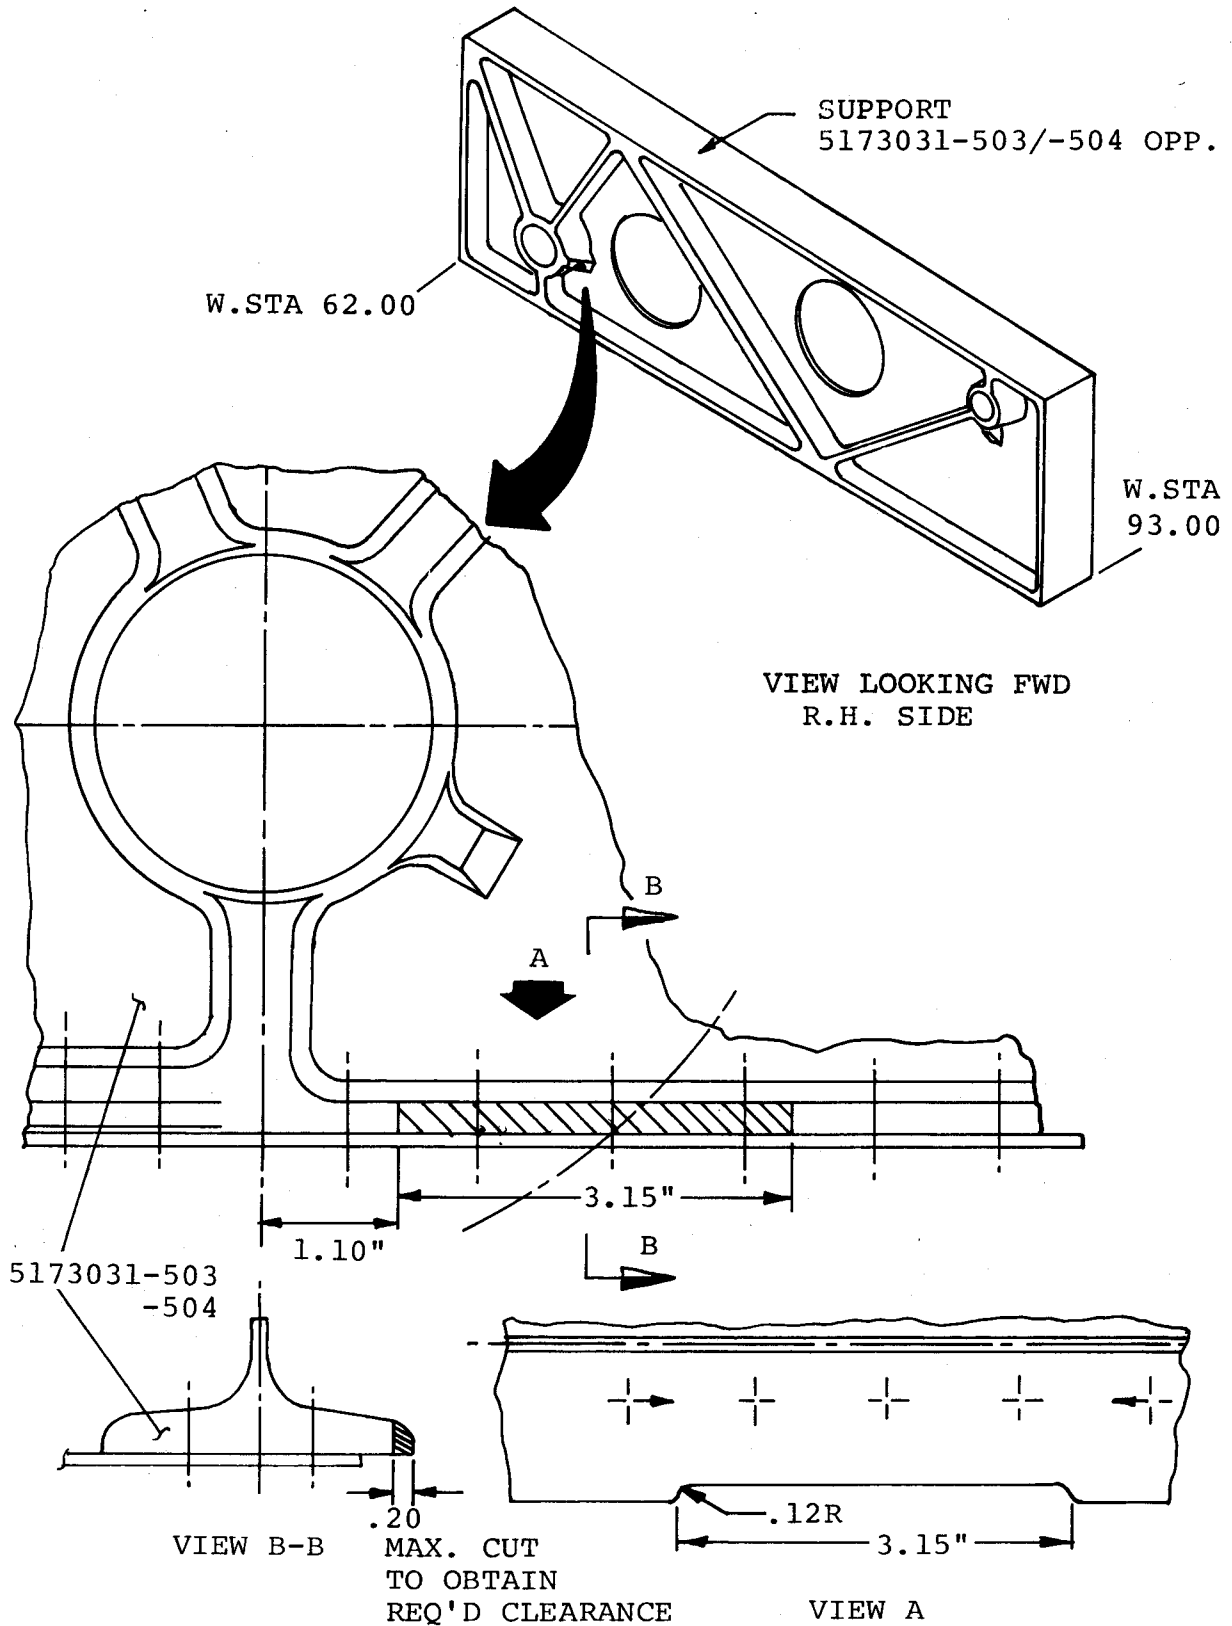
FIGURE 1

Improper torque may cause damage to the MLG actuating
cylinder inboard rod-end bearings and/or attach bolts.

- E. Visually inspect the rod-end bearings for cracks and freedom of rotation. Replace defective bearings.
- F. Using a magnifying glass (X5 minimum), inspect the (NAS6210-38 or NAS464-10LA38) attach bolts for cracks. Special attention should be focused on the radius under the head. Replace defective bolts with new NAS6210-38 bolts.

- (5) After final torque of the attach bolt, 2 threads should protrude through the nut. If not, replace bolt with an NAS6210-40 bolt.
- C. Slowly retract landing gear and ensure clearance of .16-.20 inches between bolt head and forward and aft wheel well support structure (P/N 5173031-503/-504 opp.).

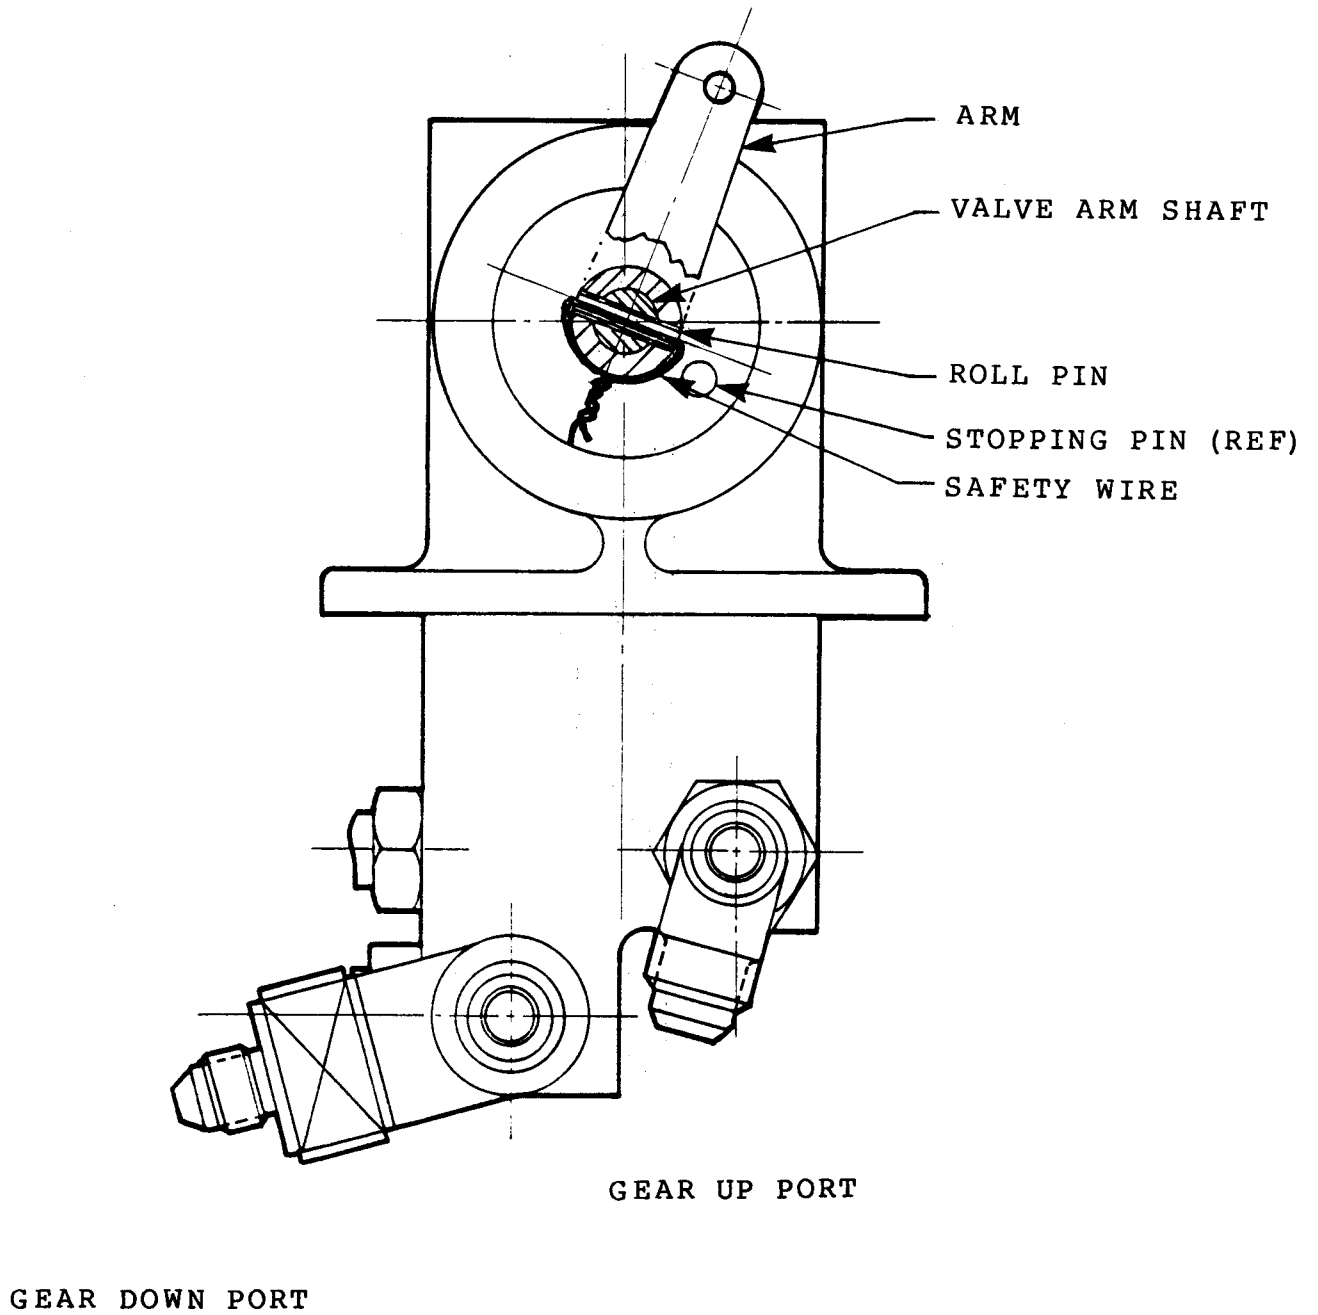
FIGURE 1

Service Bulletin No. 1124-32-094 dated December 16, 1987 titled "Landing Gear - Selector Valve Arm - Secure Roll Pin" has been accomplished this date_____.

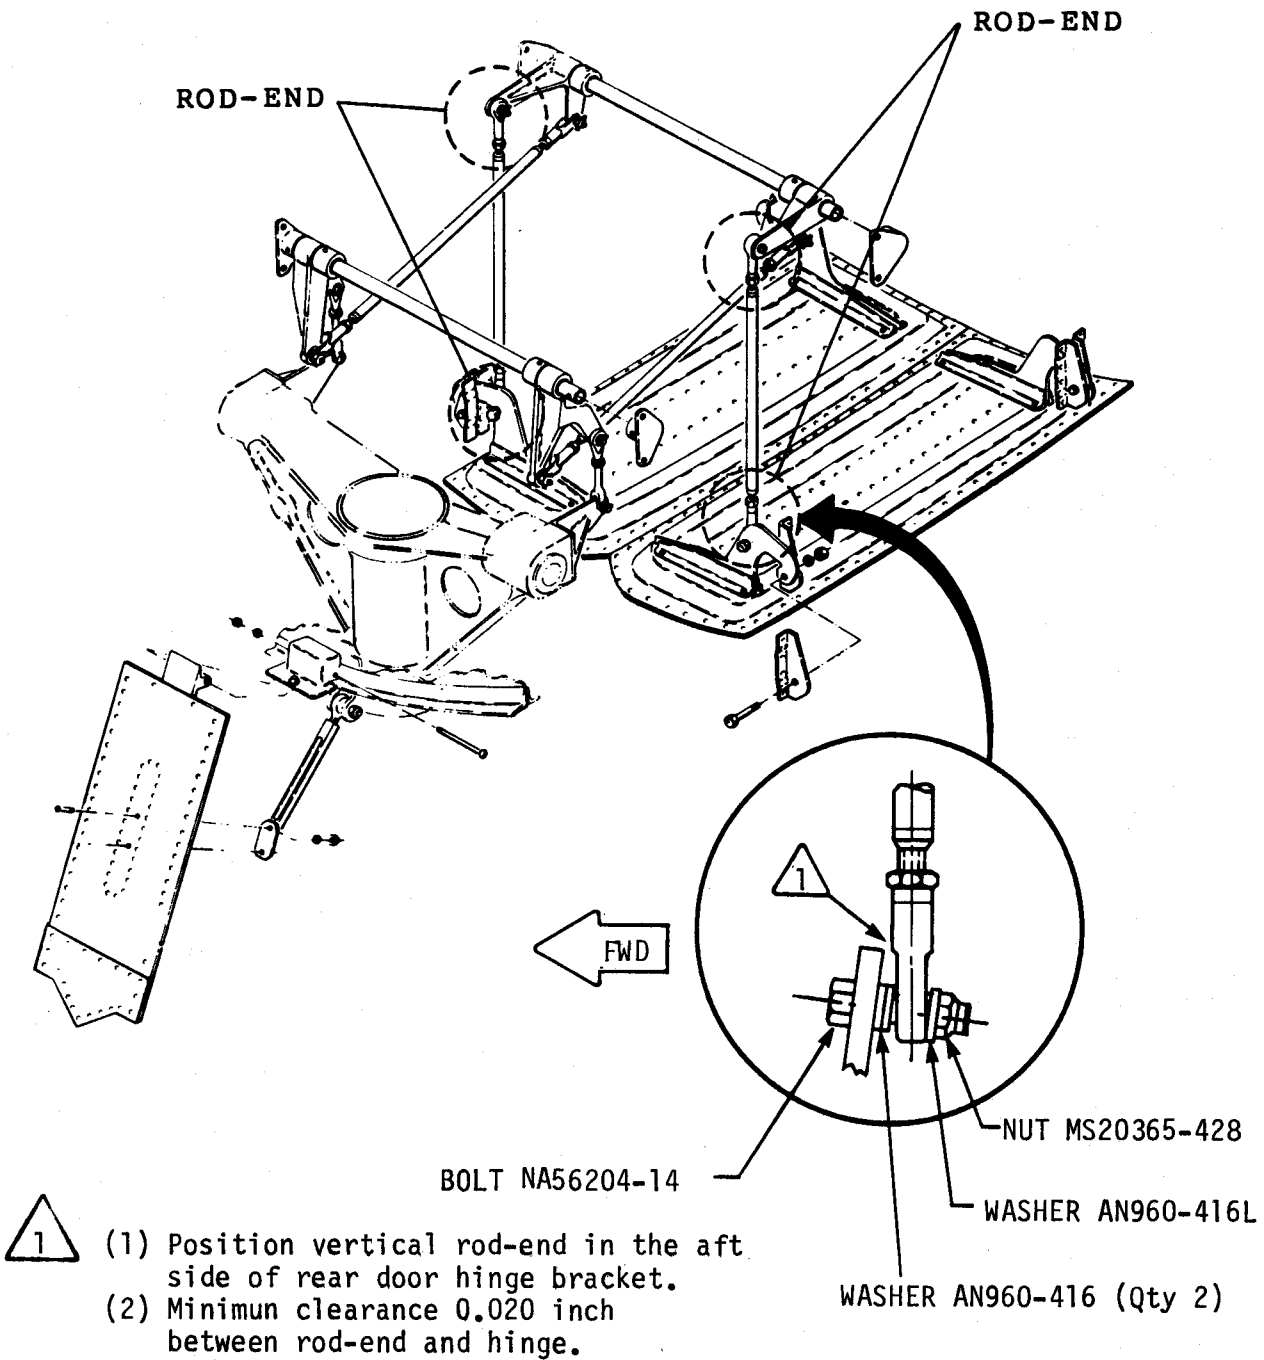
FIGURE 1

- A. Gain access to rod-ends installed in NLG door system (see Figure 1).
- B. Inspect rod-ends to determine if witness holes are present.
- C. If rod-ends have witness holes, no further action is required.
- D. If rod-ends do not have witness holes, remove and replace with rod-ends P/N F44-14MT in accordance with 1124/1124A Maintenance Manual chapter 32-20-00 maintenance practices.

Ensure that rigging of NLG doors are not altered during replacement (see Figure 1).
