IAI WESTWIND

SERVICE BULLETIN

1124 SERVICE BULLETIN INDEX

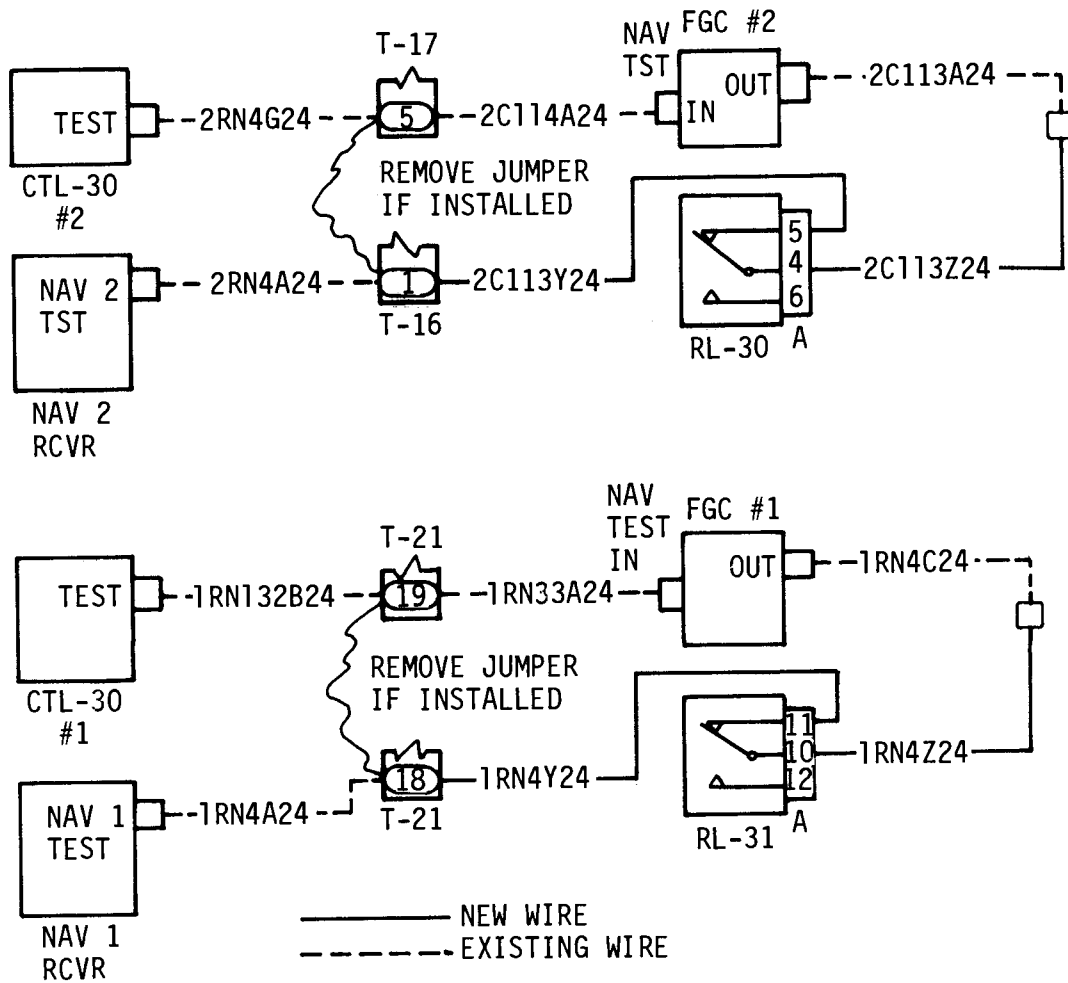
FIGURE 2

NAV TEST LOCK-OUT

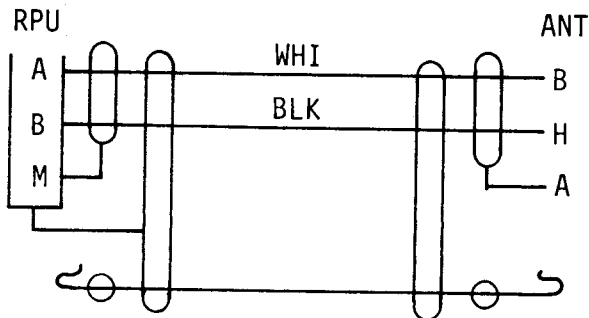
Replacement of existing VLF/Omega "E-Field" antenna to receiver/computer wiring with cabling containing greatly improved shielding will eliminate aircraft-generated electrical noise from degrading the VLF signals presented to the system for navigation.

- E. Bypass any connectors observed between antenna and receiver/computer, permitting an uninterrupted cable run.
- F. Connect new wiring as shown on Figure 1. Shield grounds must connect as shown.
- G. Ensure antennas are properly bonded. Should rebonding be necessary, apply Iridite to bare metal contact surfaces prior to reassembling and sealing antenna.

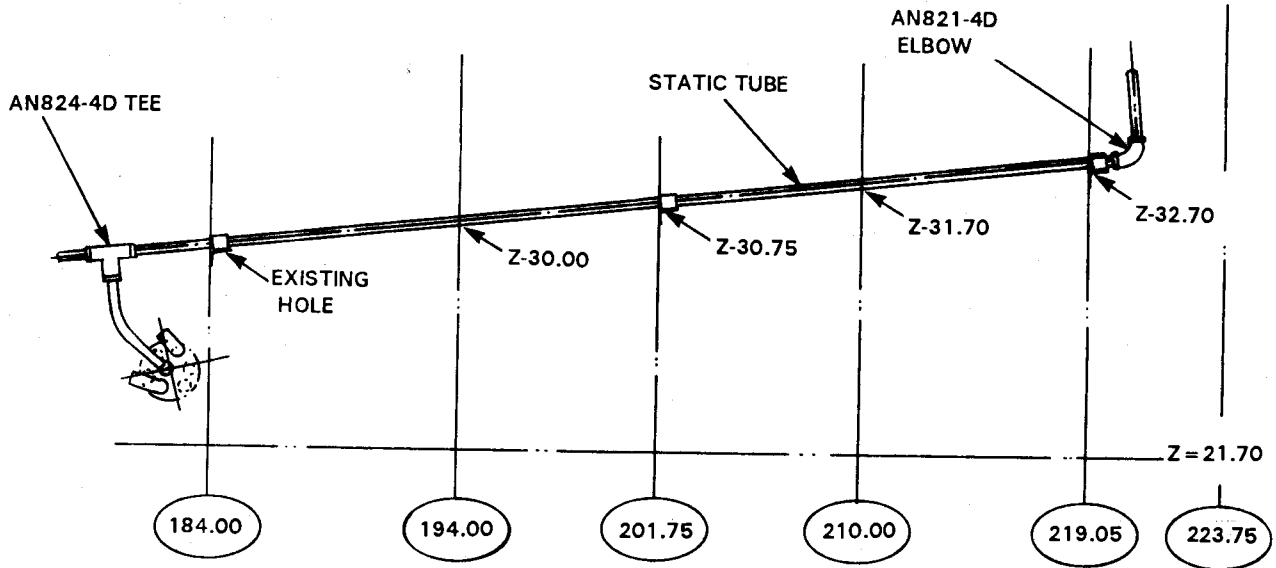
VIEW LOOKING OUTB'D R.H.S.
FIGURE 1

INCORRECT SLOPE

CORRECT SLOPE

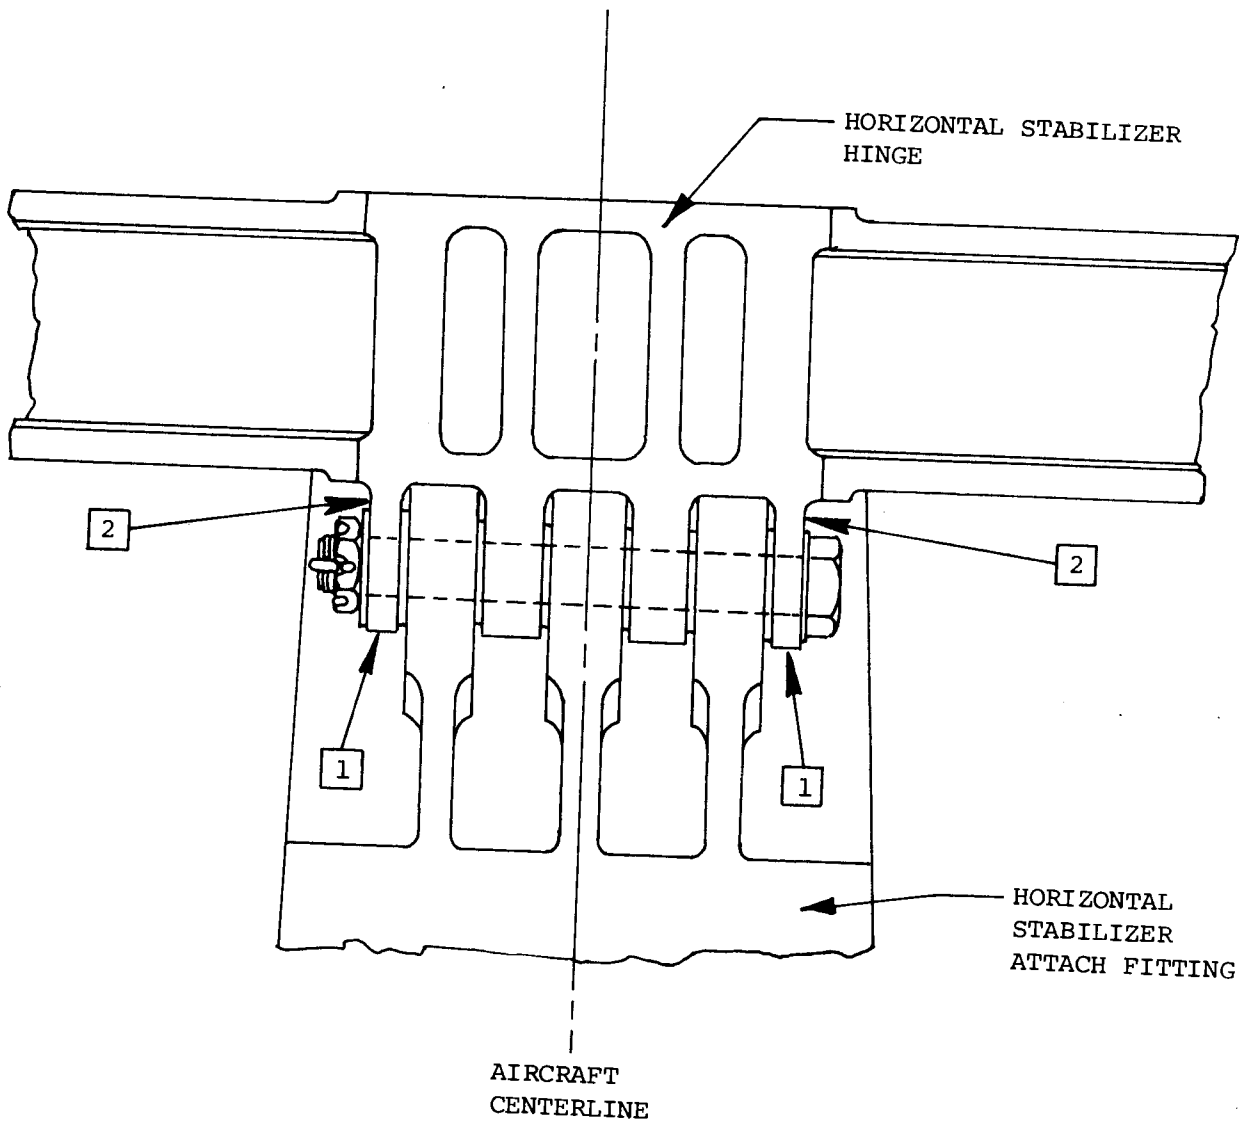
FIGURE 13

- (1.0) Inspection of Splice Assembly for Radial Play.
- (1.1) Clamp a dial indicator (.0005" per division) to the attach fitting so that the plunger is vertical and resting against the bottom of the left hand outboard hinge lug (location 1 in Figure 13).
- (1.2) Gently place 100 lbs. of sandbags on the R.H. stabilizer tip.
- (1.3) Zero dial indicator.
- (1.4) Move all sandbags to the L.H. stabilizer tip.
- (1.5) Record dial indicator reading.
- (1.6) Repeat Steps (1) thru (5) for the R.H. outboard hinge lug.
- (1.7) If the total reading of the dial indicator exceeds 0.010 inch, it is recommended to perform the improved installation as per Para. D.

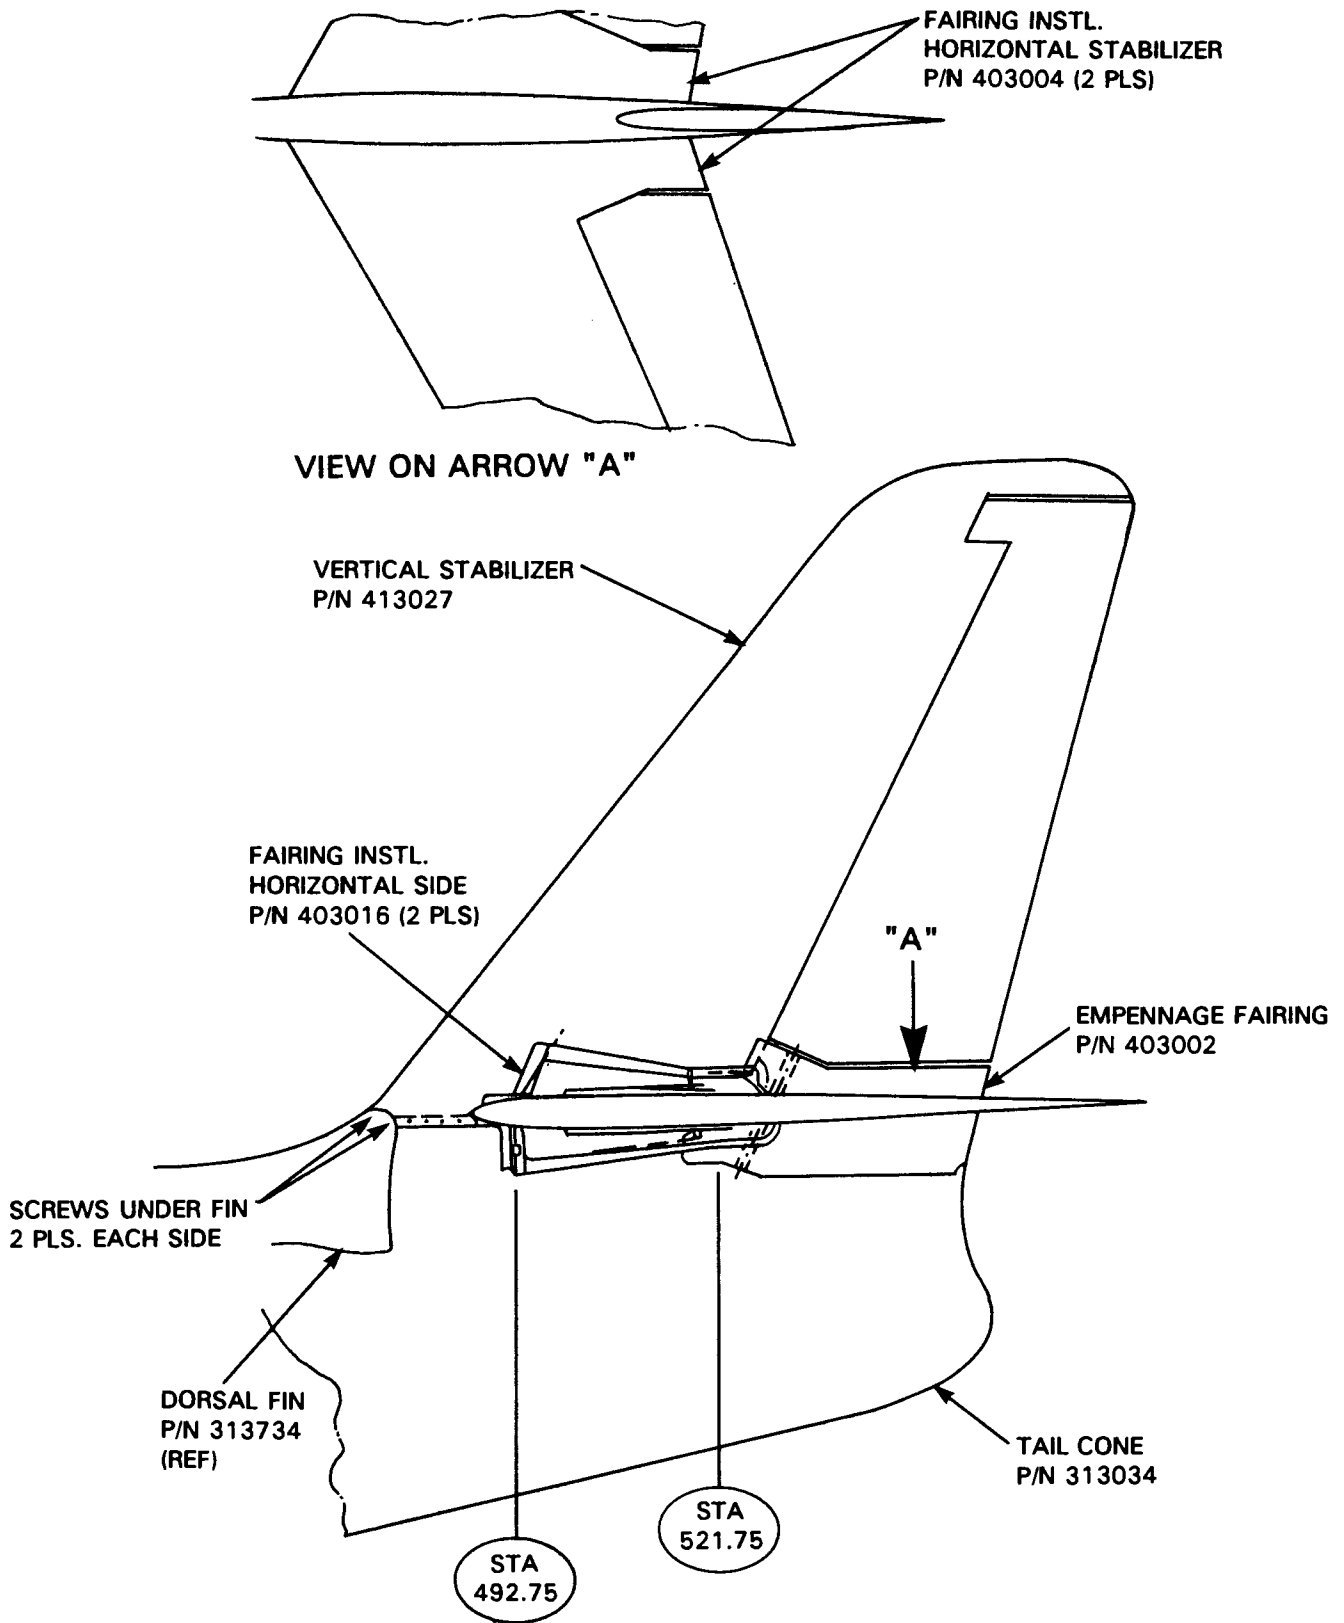
FIGURE 1

Reports from the field indicate that some stabilizer lower scissor fittings P/N 453514 have loosened or cracked in service. Reference Service Bulletin No. 1124-55-097.

- (1) Disconnect deicer boot lines.
- (2) Place a wood block between the fuselage banjo fitting and the stabilizer hinge fitting to prevent damage to these parts (fuselage station 521.75).
- (3) Support the stabilizer.
- (4) Disconnect stabilizer actuator by removing cotter pins, nuts, bolts, and washers. Tie actuator assembly away from horizontal stabilizer.
- (5) Remove six (6) each bolts P/N MS20006-34 attaching actuator fittings P/N 453022 to stabilizer forward spar and remove fittings. Reference Westwind Illustrated Parts Catalog, Chapter 55-10-00 Figure 3. Save bolts for re-use.

- (6) Drill out all fasteners attaching lower scissor fitting P/N 453514 to horizontal stabilizer.
- (7) Pilot countersink four (4) holes in doubler, P/N 453015-161 on top of stabilizer. Inspect hole condition. Refer to Figure 2 View "B".
- (8) Clamp-up doubler, P/N 453015-161 and skins, P/N 453015-167, left hand and -168 right hand. Refer to Figure 2 View "B".
- (9) Install four (4) blind bolts, P/N MS90353-08 or -U08, grip as required. If necessary use first standard over size. Fasteners are to be installed wet with sealant P/N PR1422. Refer to Figure 2 View "B".
- (10) Ensure that upper and lower doublers and skins are trimmed flush with vertical plane of the forward spar, P/N 453017, to clear new scissor/actuator fitting, P/N 453504.

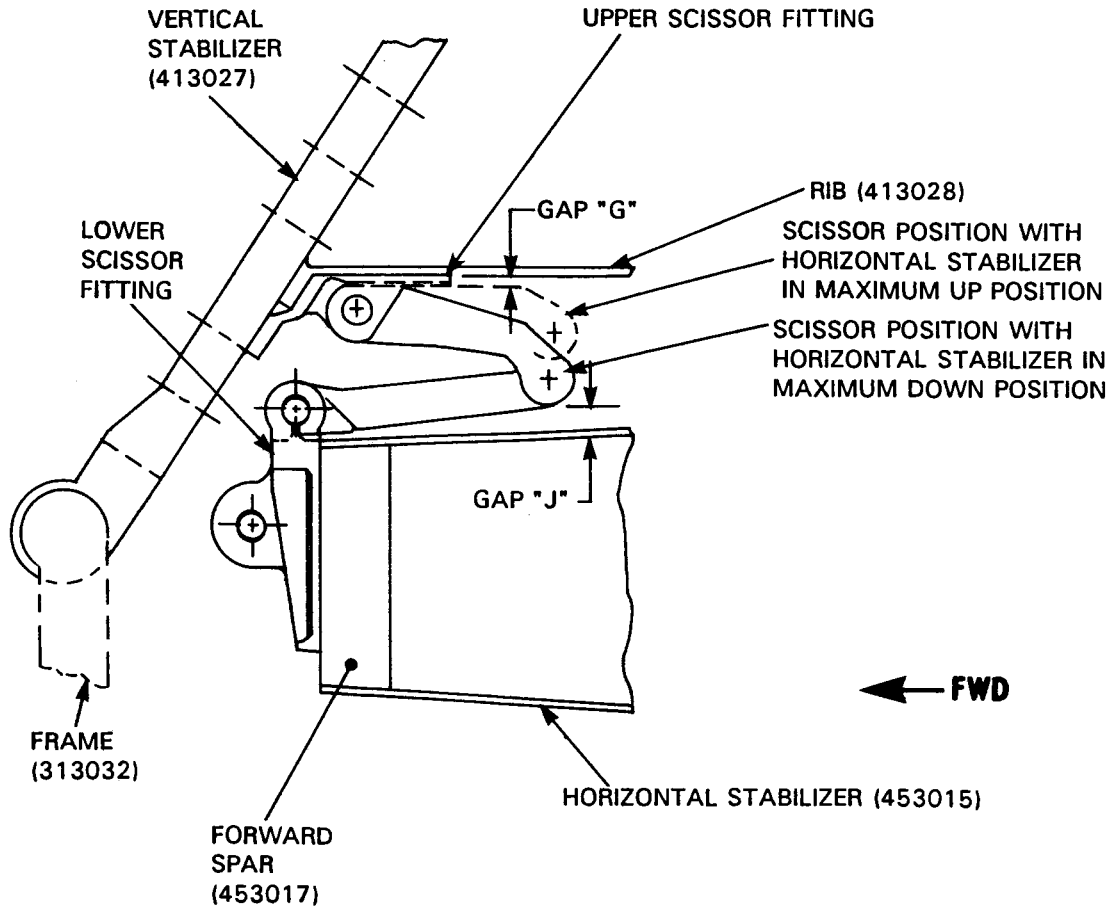
FIGURE 1

Reports from the field indicate some stabilizer upper scissor fittings P/N 453513-501 have loosened or cracked in service. Reference Service Bulletin No. 1124-55-021.

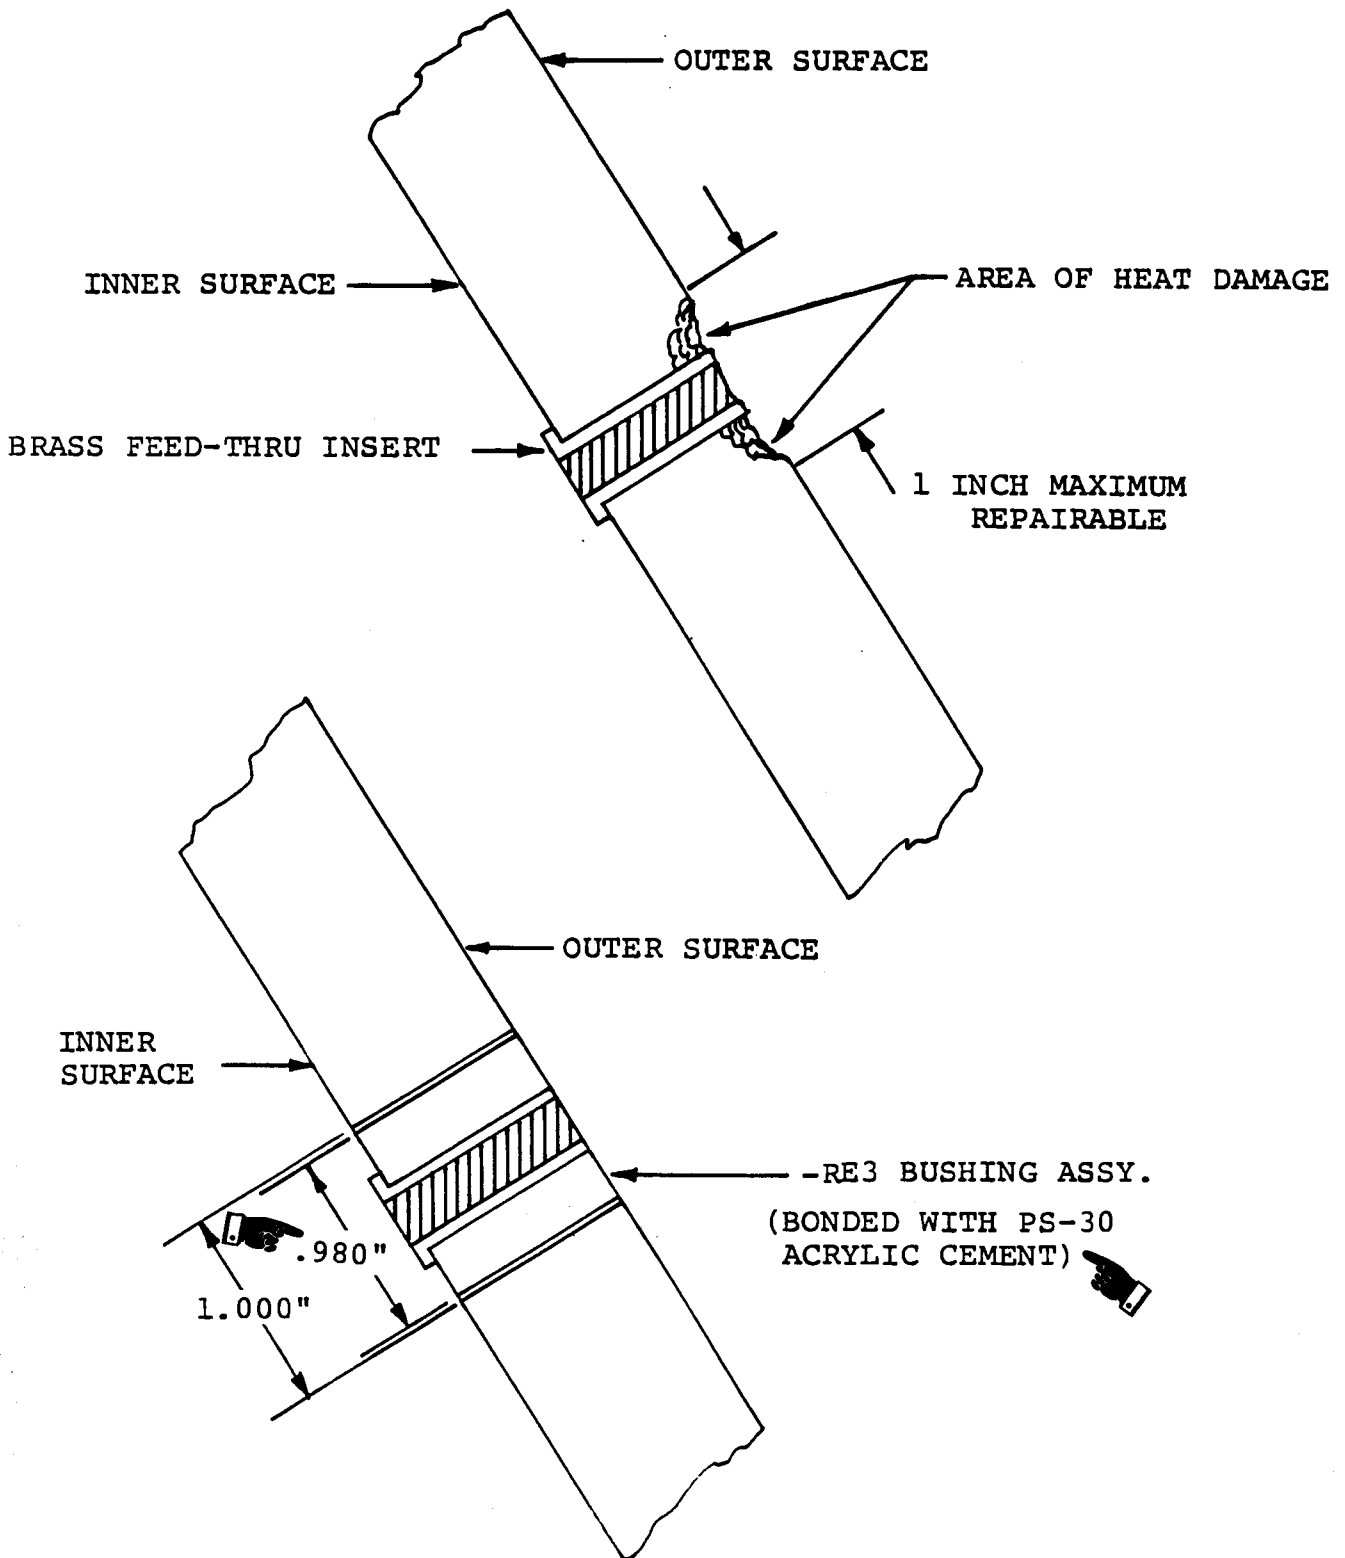
FIGURE 1

The windshield repair procedure provided may be used on windshield heat probe feed-through locations which have suffered localized heat damage due to arcing of the contact at that position.

The repair is approved for areas of affected surface damage one inch in diameter or less.

Repair to damaged areas exceeding one inch diameter is not approved.

Remove existing feed-through bushing, remove heat-damaged acrylic material, counterbore 1-inch hole through windshield at damage location and install P/N A01WW5343025-RE3, bushing assembly.

A. Removal of damaged area and feed-through hole preparation (refer to Figure 1).

- (1) Remove electrical power from aircraft.
- (2) Remove outer windshield panel to access damaged area per instructions in 56-10-01.
- (3) Remove electrical terminal assembly from feed-through.
- (4) Remove brass feed-through bushing.
- (5) Outer surface of inner windshield may be crystallized adjacent to the brass bushing. This crystallization must be removed prior to enlarging the feed-through hole in preparation for installation of the -RE3 bushing assembly.

- (1) Assure proper fit of -RE3 bushing into 1.000" hole. Loose fit should be .020".

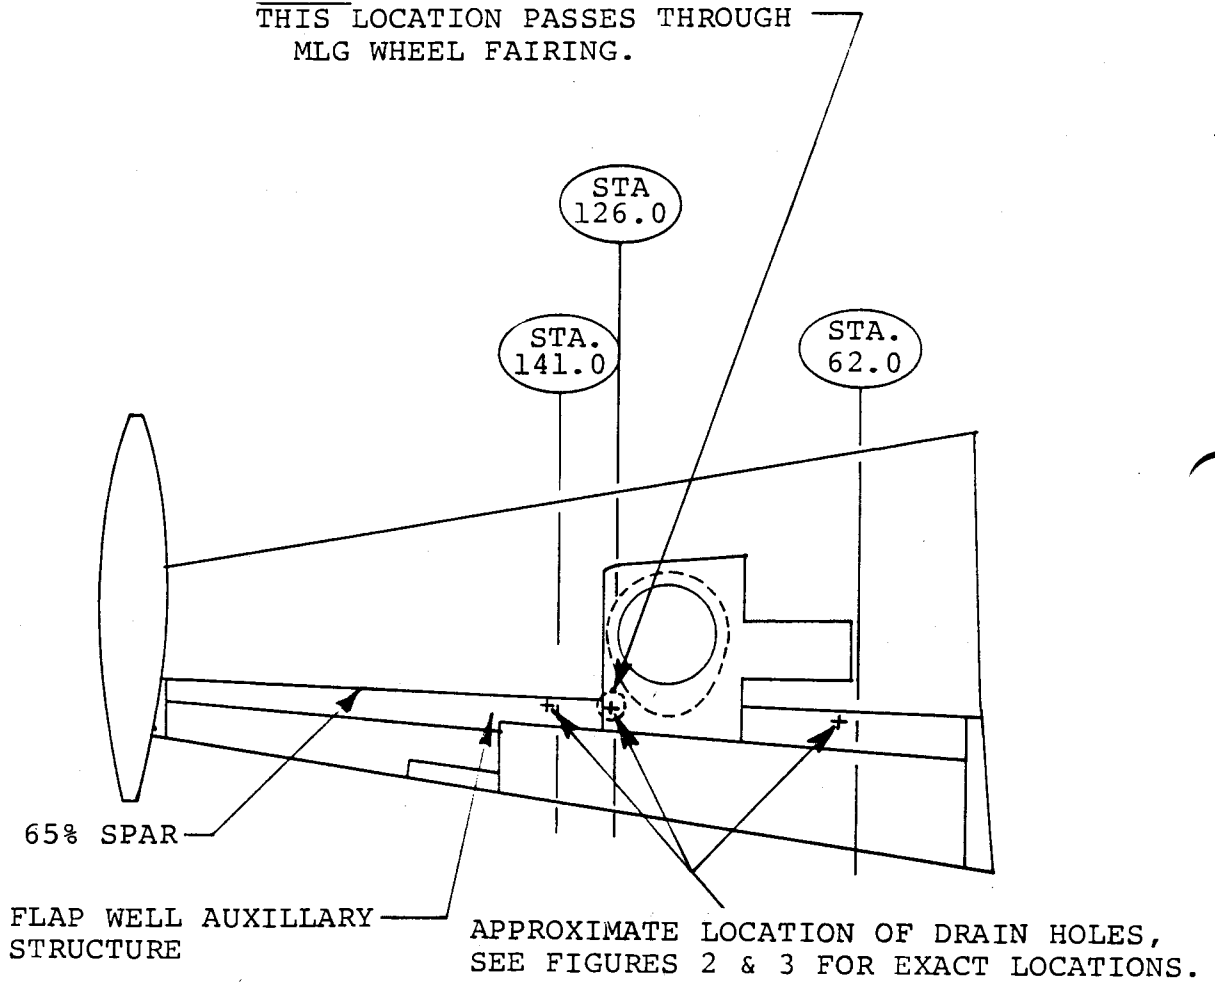
FIGURE 1

NOTE: DRAIN HOLE AT THIS LOCATION PASSES THROUGH MLG WHEEL FAIRING.

APPROXIMATE LOCATION OF DRAIN HOLES, SEE FIGURES 2 & 3 FOR EXACT LOCATIONS.
