IAEWESTWIND

SERVICE BULLETIN

1124 SERVICE BULLETIN INDEX

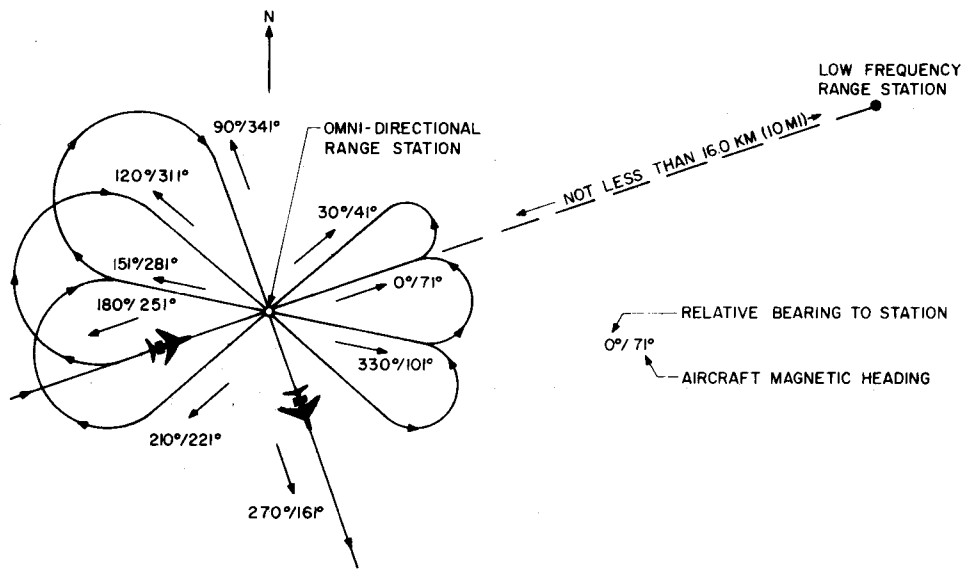
ADF-60 System, Calibration Pattern
Figure 2-35

- e. Repeat step d for each remaining aircraft magnetic heading. The test pattern should be flown with alternate left and right turns to prevent excessive precession of the gyros. The flight pattern of an aircraft performing this is shown in figure 2-35.

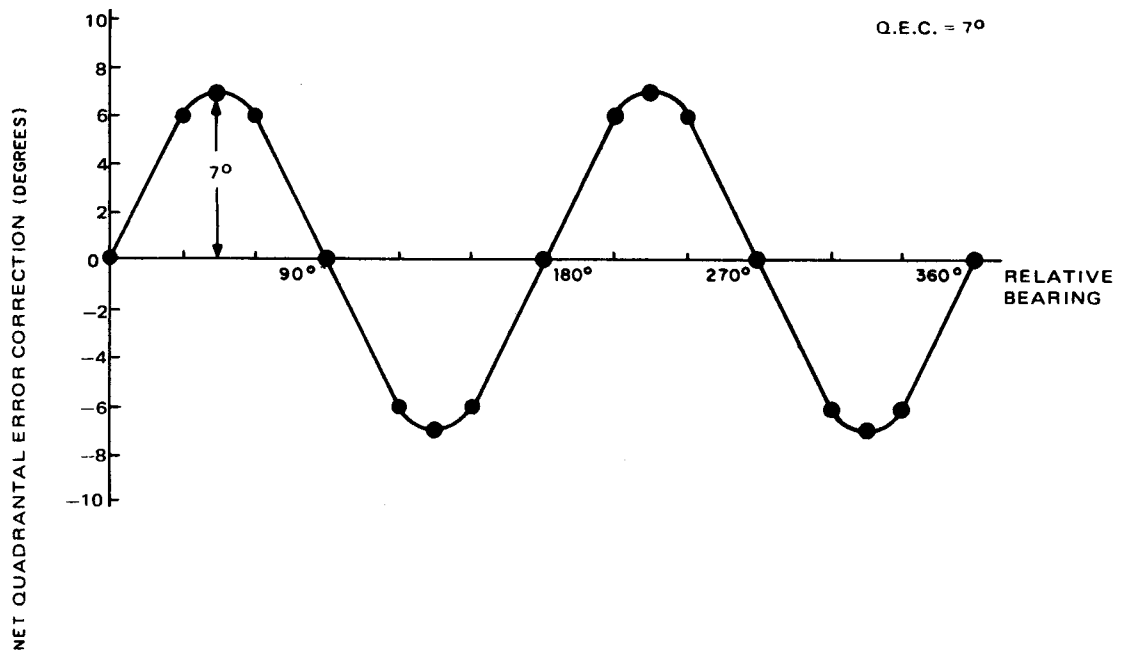
Sample Quadrantal Error Correction Curve
Figure 2-36

- g. Plot a graph of NET QEC against relative bearing to station. Figure 2-36 shows a sample graph using the data from figure 2-34.
- h. Critically examine QEC curve to see if it is reasonably regular and symmetrical. If it is not, check antenna location for aerials, projections near the antenna, and large openings in the fuselage (doors) which could cause irregularities in the rf field. If irregularities cannot be accounted for, repeat calibration using a different station and frequency. If second calibration produces a differently shaped curve, then the installation is questionable and the cause must be sought and eliminated.

Referring to figure 2-36, the peak value of QEC is 7°. This is the required NET QEC of the ADF-60 system as installed in the aircraft.

For sample error correction curve, figure 2-36, an additional 7 degrees of QEC are required. For an initial strapping of 10 degrees, the total required QEC is 17 degrees. Jumper wire connecting 4-8, 12-20 would be removed and 4-16 should be strapped (from figure 2-38).

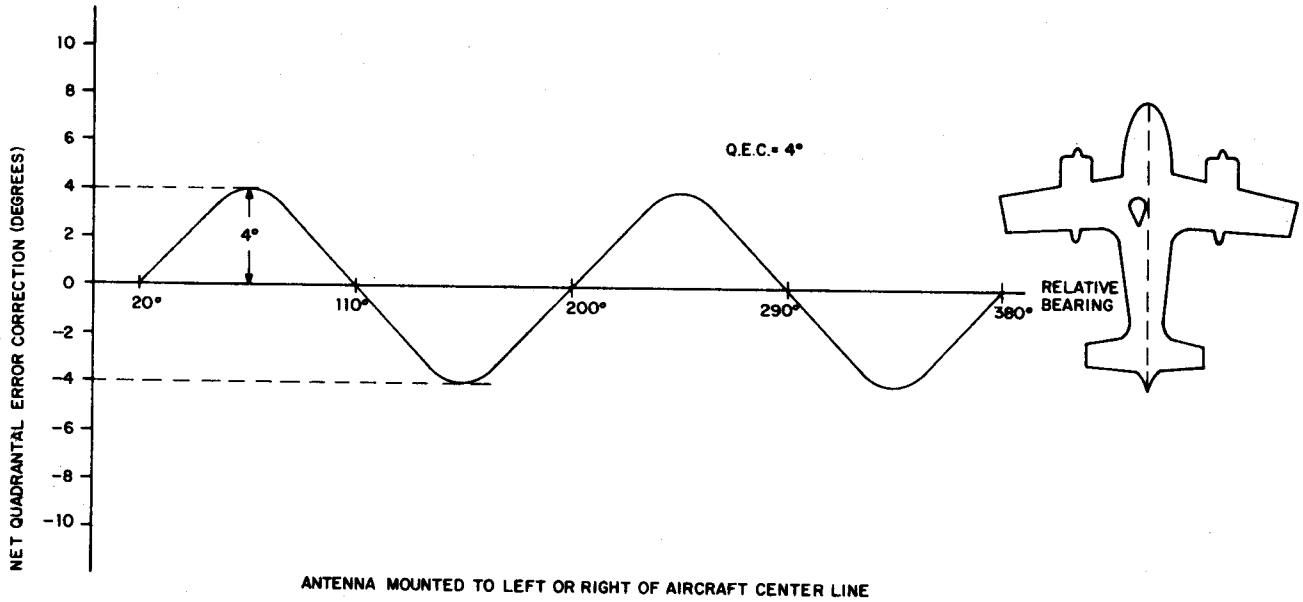
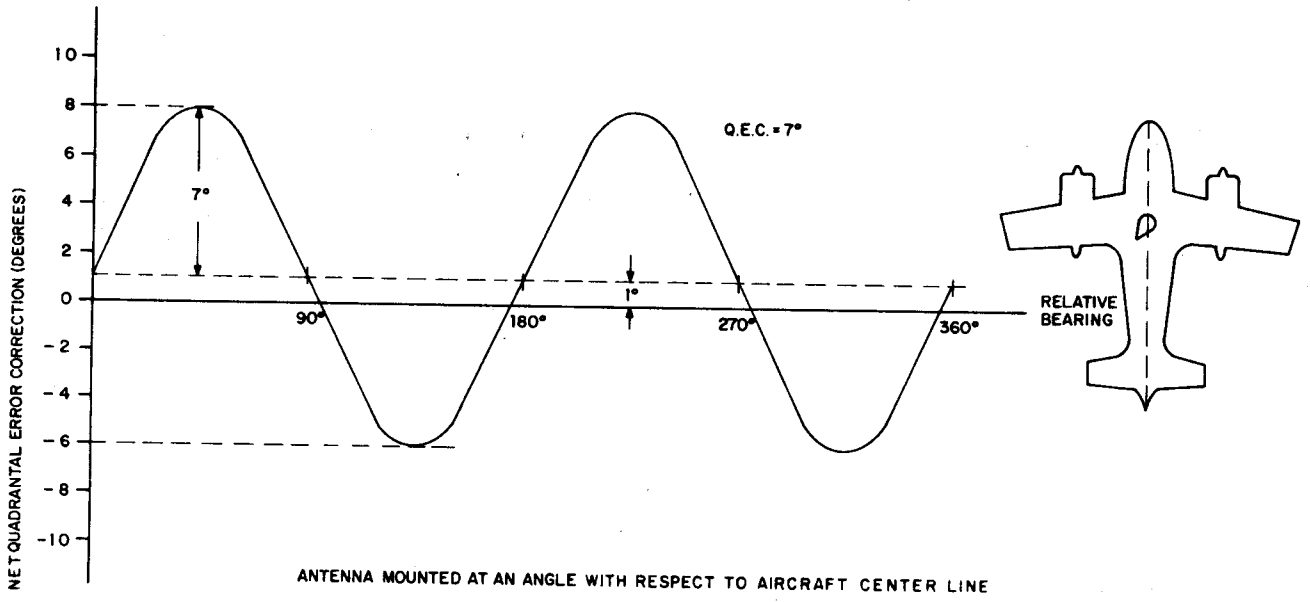
Quadrantal Error Correction Curves for Antenna Alignment Errors
Figure 2-37

aligned with respect to the aircraft fuselage. Refer to figure 2-37.

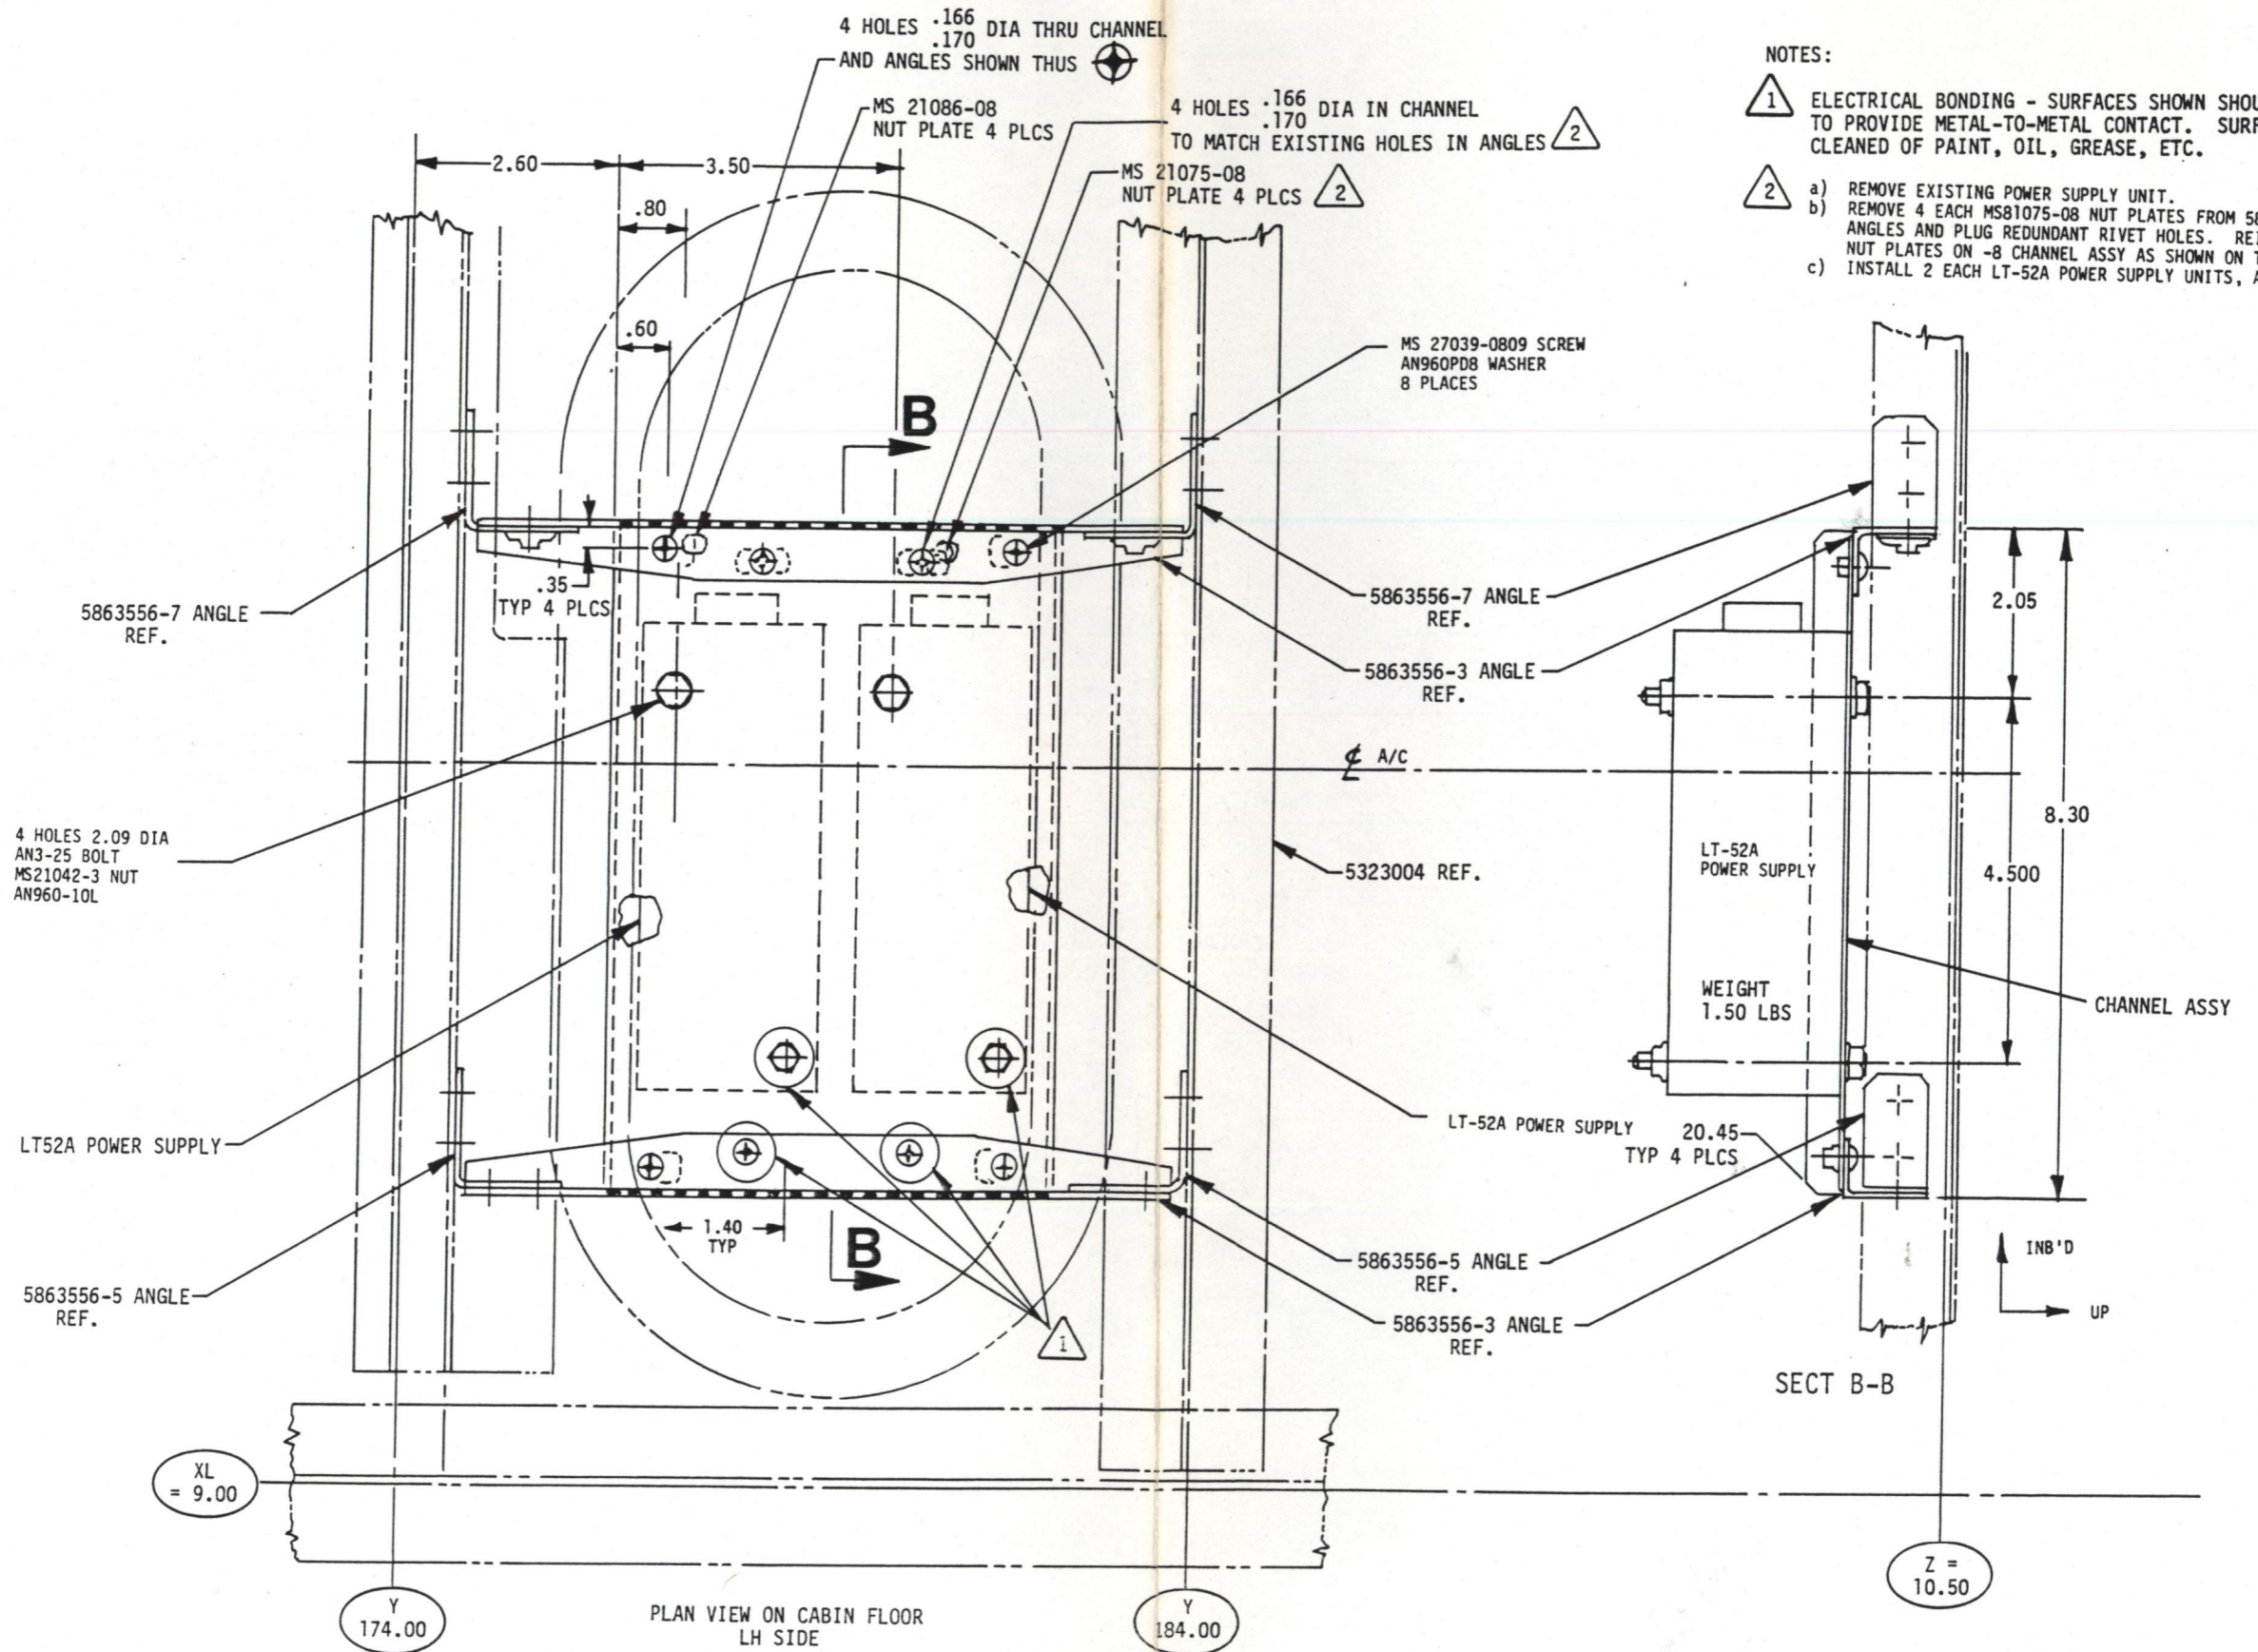
POWER SUPPLY INSTALLATION
FIGURE 1

- (1) To reduce display garbling due to power drain during engine start and initial system power up.
- (2) To provide improved logic and lighting voltage source to NCS, especially under low temperature and low bus voltage conditions.
- (3) The NCS-31 system microprocessor has an original vendor operating temperature range of +5° to +141° Fahrenheit. Ambient temperatures approaching the limits of these readings will cause the NCS to power up with garbled displays and cause the keyboard tuning to become erratic.

- (a) It is the intent of this service bulletin to minimize the effects of reduced input voltage to the NCS system, by providing adequate power sources.
- (b) The modifications described in this service bulletin will not correct for marginal or improper system operation caused by the NCS microprocessor or internal power supply, which can cause identical symptoms to those addressed by this service bulletin.

Replace Collins 639U-1 NCS power supply with two (2) KGS LT-52A power supplies in the event Part A does not completely remedy the problem.

Replace original EMP type PS-274 power supplies with the field repairable KGS type LT-52A.

- NOTES:
- 1 ELECTRICAL BONDING - SURFACES SHOWN SHOULD BE CLEANED TO PROVIDE METAL-TO-METAL CONTACT. SURFACES SHOULD BE CLEANED OF PAINT, OIL, GREASE, ETC.
 - 2 a) REMOVE EXISTING POWER SUPPLY UNIT.
b) REMOVE 4 EACH MS81075-08 NUT PLATES FROM 5863556-3 ANGLES AND PLUG REDUNDANT RIVET HOLES. REINSTALL NUT PLATES ON -8 CHANNEL ASSY AS SHOWN ON THIS DWG.
c) INSTALL 2 EACH LT-52A POWER SUPPLY UNITS, AS SHOWN.

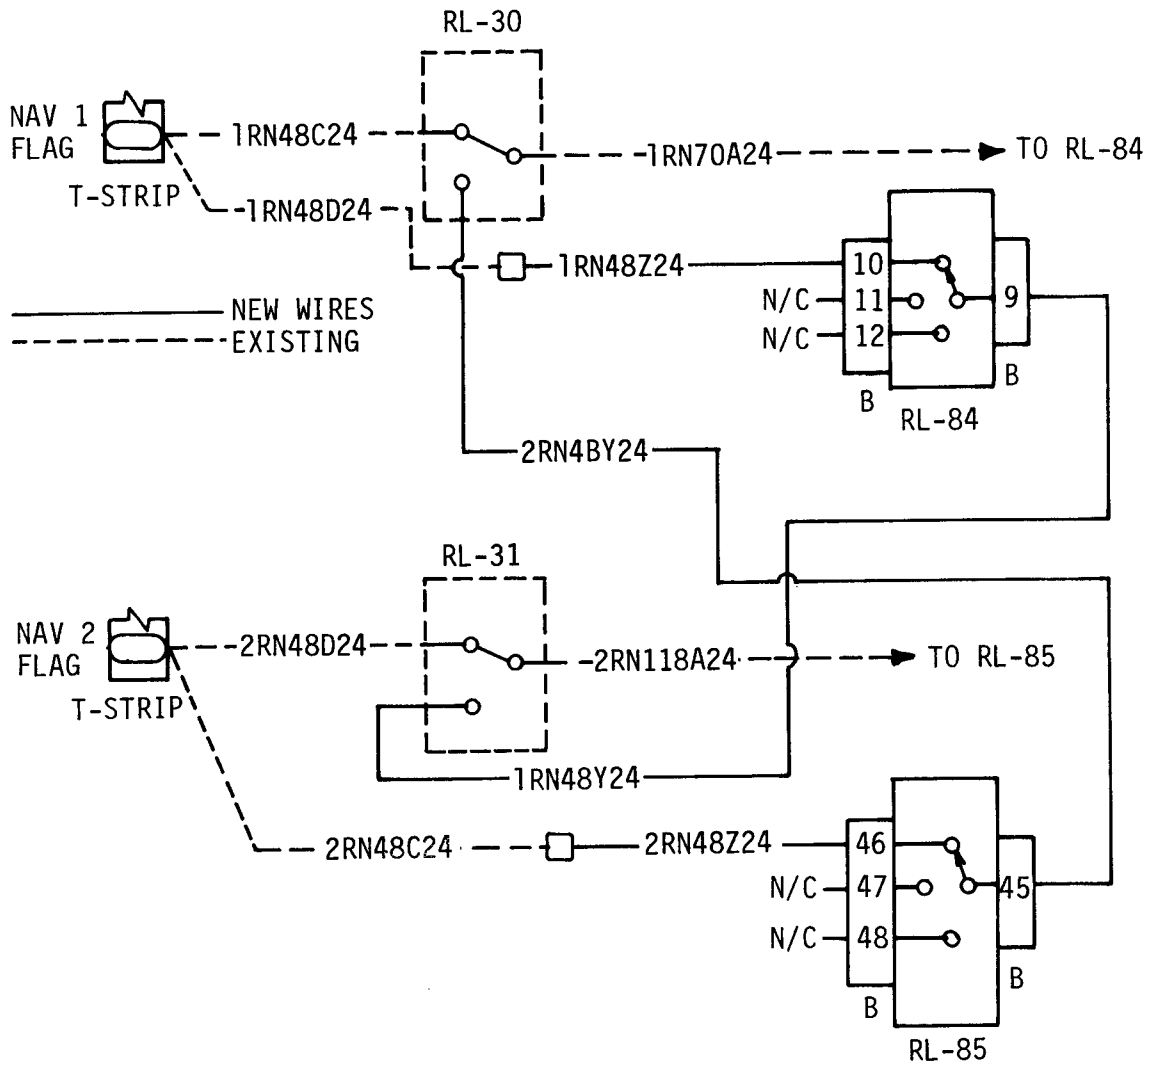
FIGURE 1

NAV FLAG SWITCHING

- C. Remove wire 1RN80A22 from RL84B-9 and the jumper wires from RL84B-10 and/or RL84B-11. Splice these wires together.
- (1) This will result in a pilot "RPT NAV 2" annunciation whenever "RPT NAV 2" is depressed, regardless of information displayed on the Pilot HSI. This prevents switching the HSI into a possible invalid operating condition.

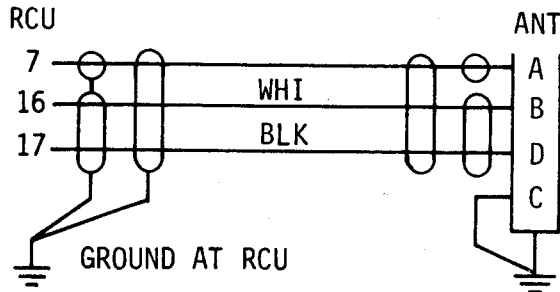
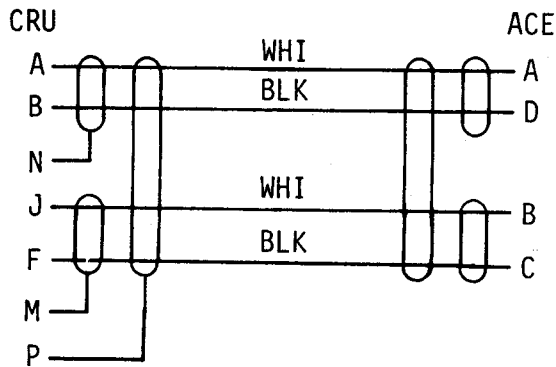
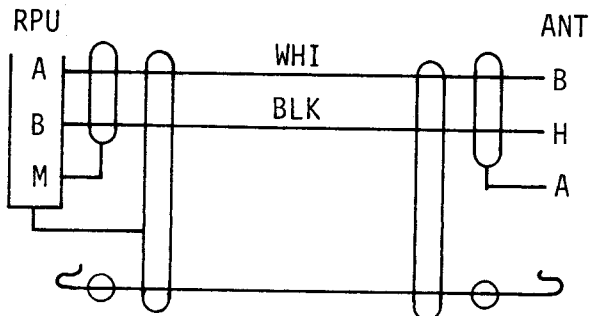
Replacement of existing VLF/Omega "E-Field" antenna to receiver/computer wiring with cabling containing greatly improved shielding will eliminate aircraft-generated electrical noise from degrading the VLF signals presented to the system for navigation.

- E. Bypass any connectors observed between antenna and receiver/computer, permitting an uninterrupted cable run.
- F. Connect new wiring as shown on Figure 1. Shield grounds must connect as shown.
- G. Ensure antennas are properly bonded. Should rebonding be necessary, apply Iridite to bare metal contact surfaces prior to reassembling and sealing antenna.

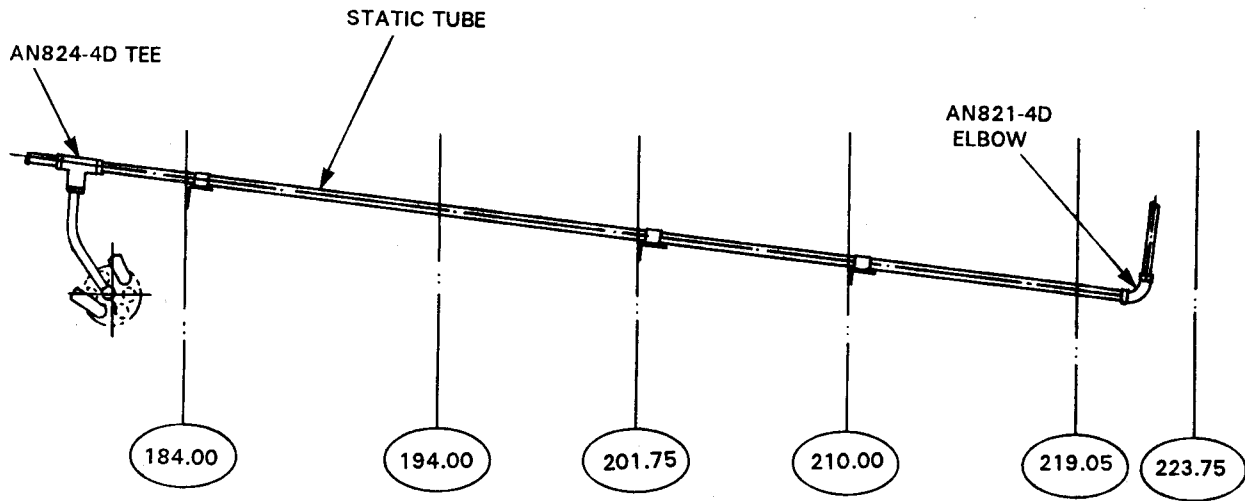
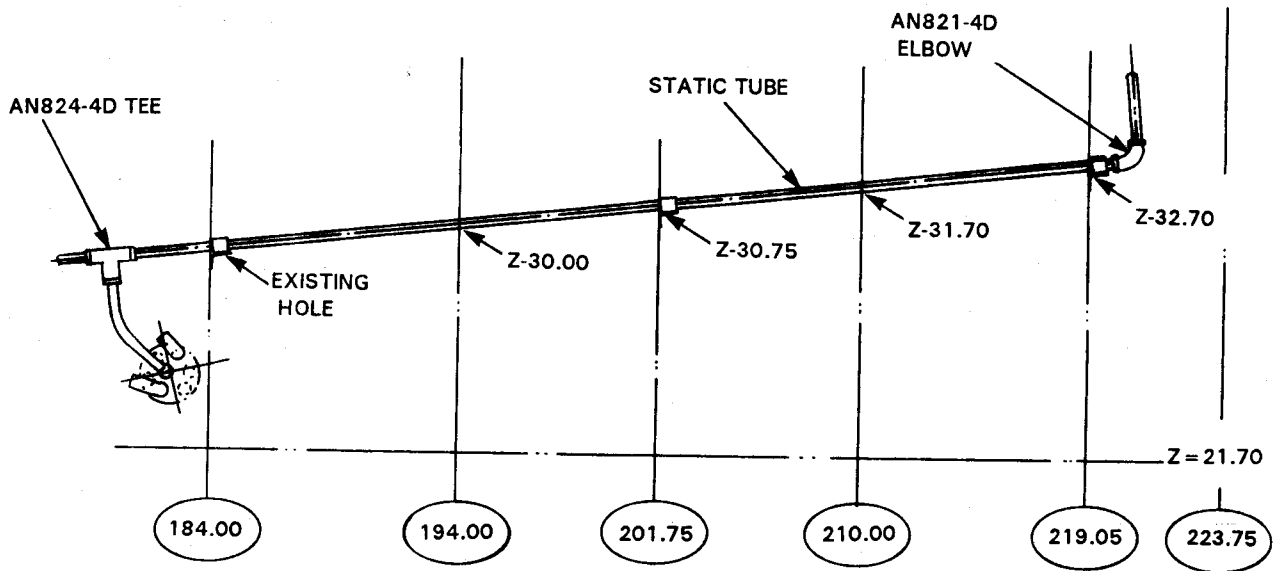
VIEW LOOKING OUTB'D R.H.S.
FIGURE 1

INCORRECT SLOPE

CORRECT SLOPE

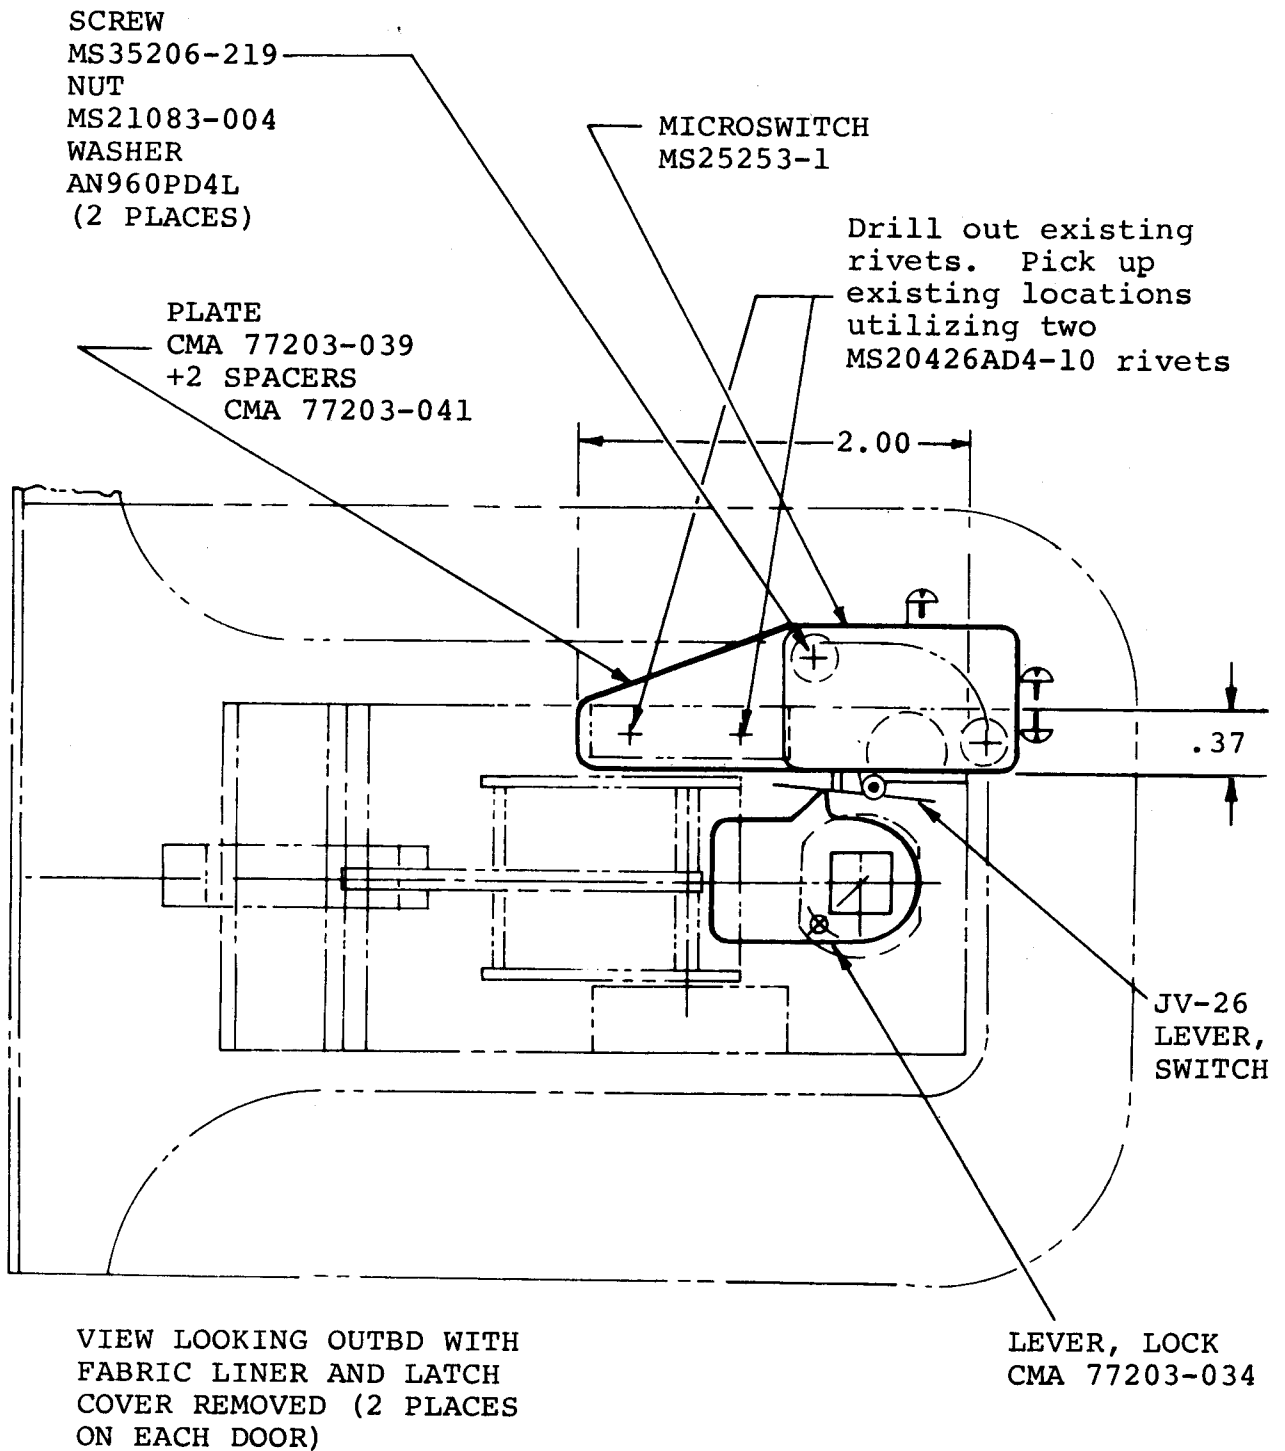
FIGURE 1

NEW MICROSWITCH INSTALLATION

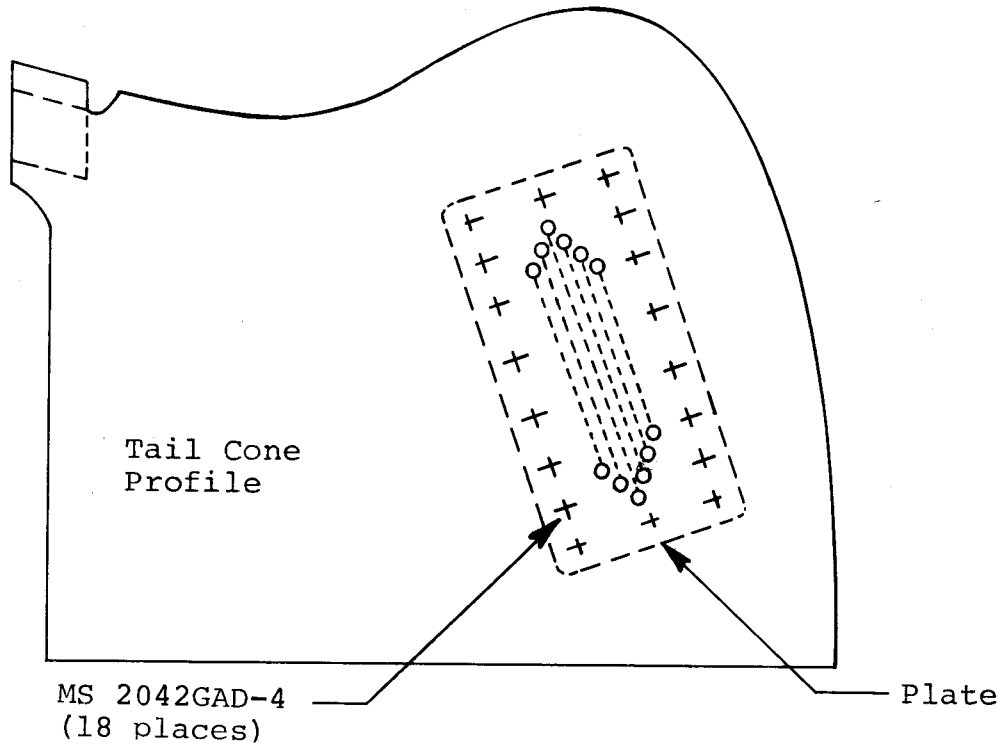
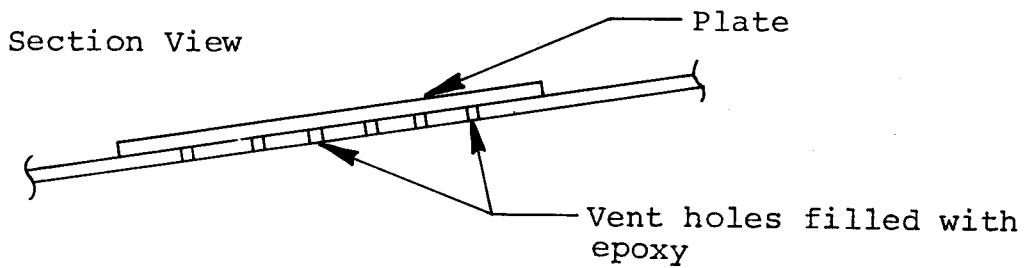
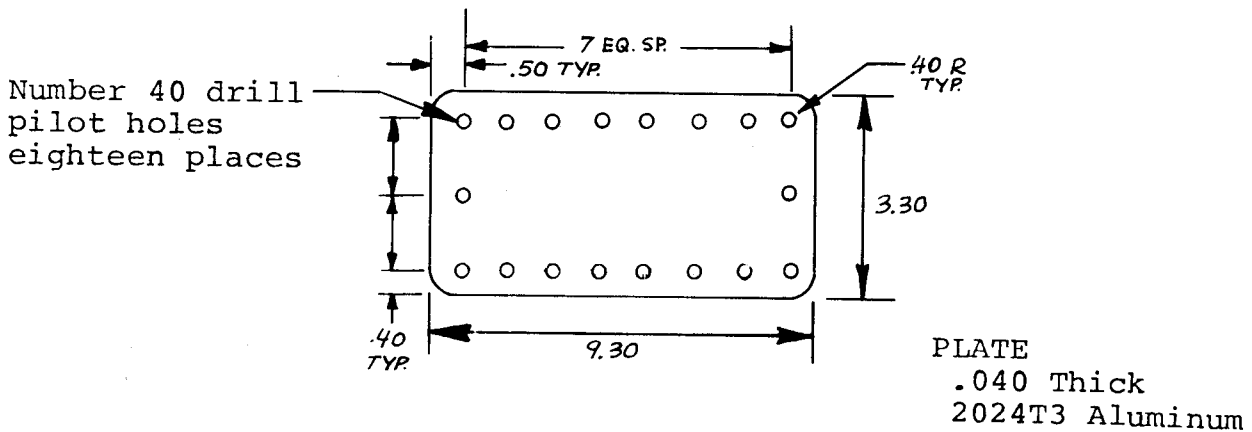
FIGURE 1

To reduce excessive airflow to electronic equipment.
To eliminate the collection of rain water and/or moisture in the tail cone area.

CLOSURE OF TAIL CONE VENT HOLES

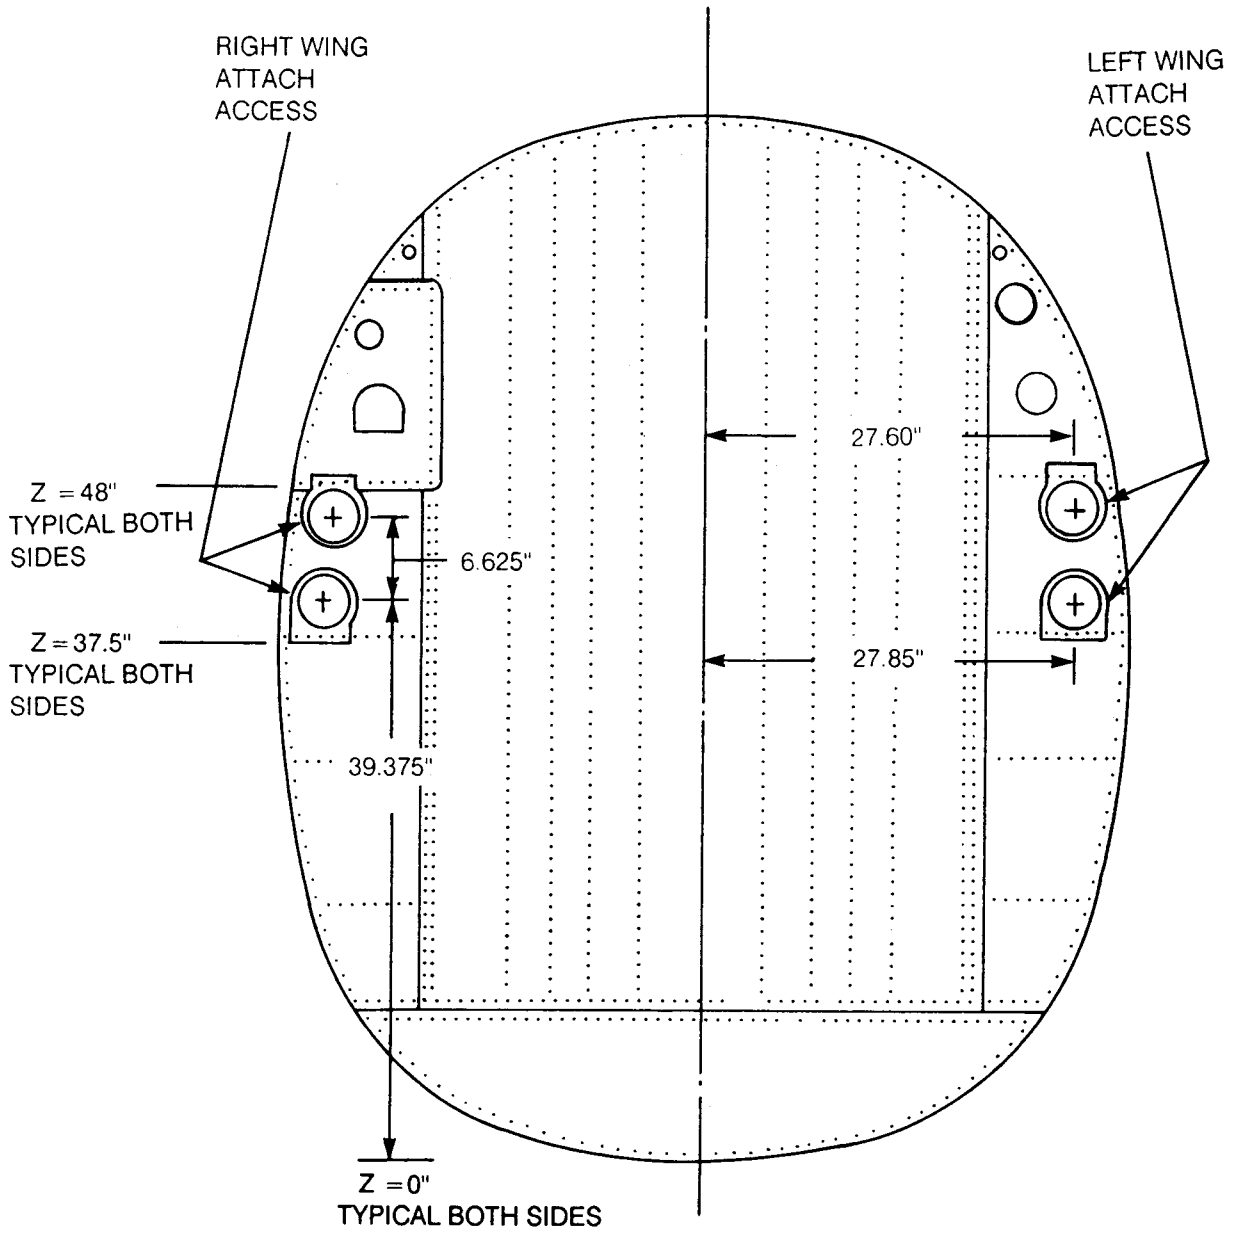
Figure 1

AFT PRESSURIZED BULKHEAD ASSEMBLY
VIEW - LOOKING AFT
STA 269.879

Service Bulletin 1124-53-101, dated March 7, 1990, titled "Fuselage - Enlarge Existing Wing Attachment Access Holes in the Aft Pressure Bulkhead at Fuselage Station 269.879," has been accomplished this date _____.

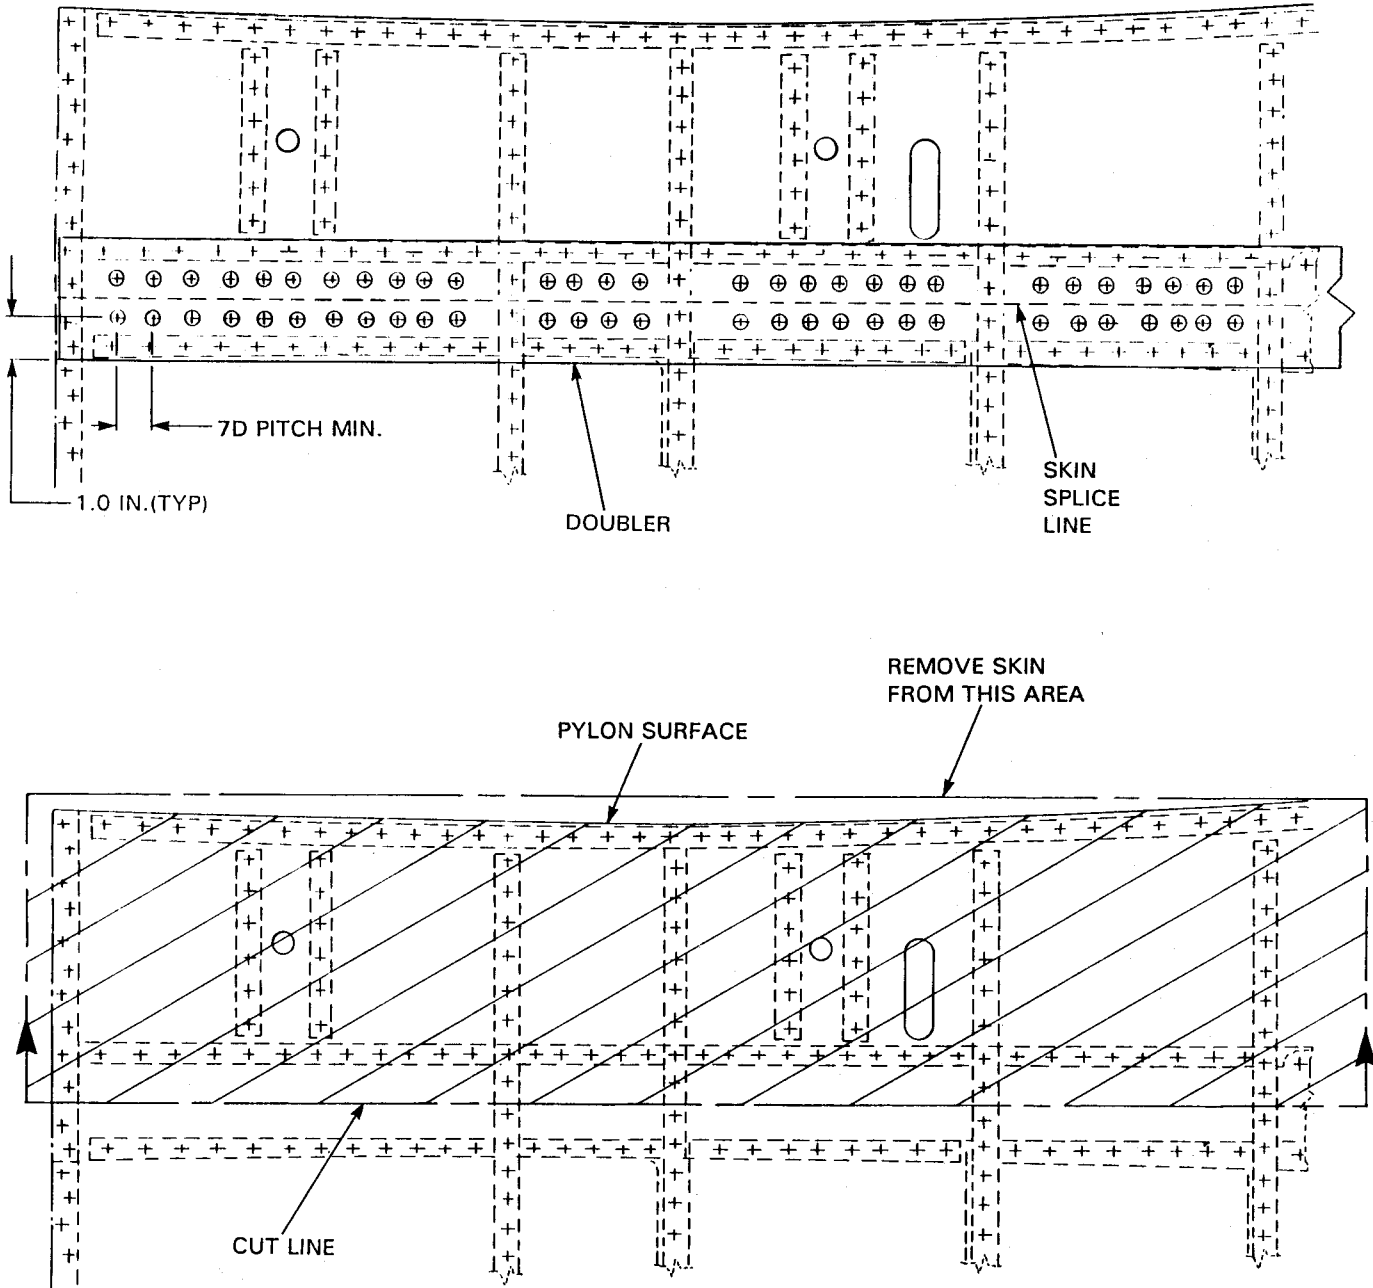
FIGURE 1

Grumman Aerospace has received reports from various model aircraft operators that corrosion has been found in cowl door skins in the area covered by stainless steel fire shields. Westwind engine cowlings are of similar design to those affected by corrosion.

- (1) Repair door by splicing a new section of skin.
- (2) Remove stainless steel fire shield and set aside for re-use.
- (3) Pull old skin as far away from substructure as possible to prevent damage to the substructure when cutting away old skin.
- (4) Cut off old skin following a line half way between the second and third rows of rivets. Care should be taken not to damage skin as it will be used as a template to cut new skin section. Refer to Figure 1.

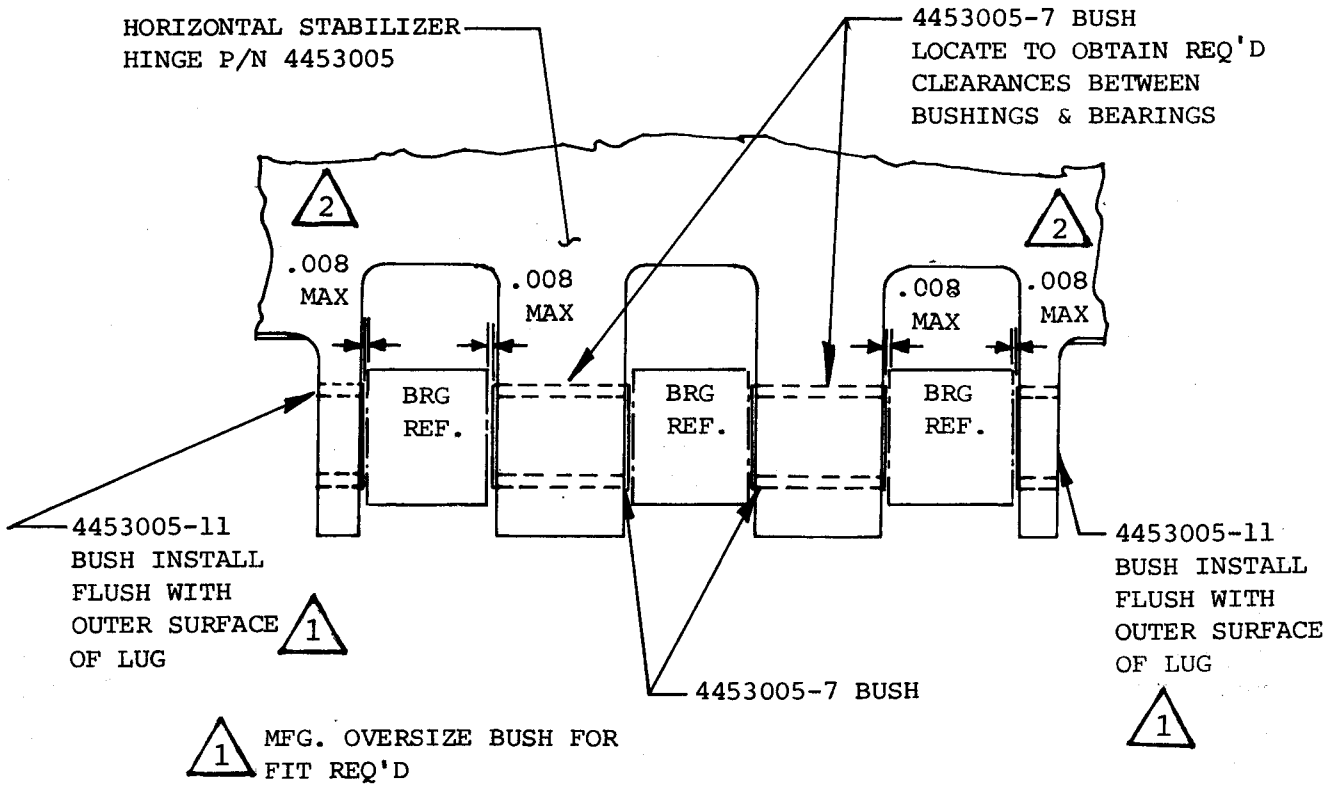
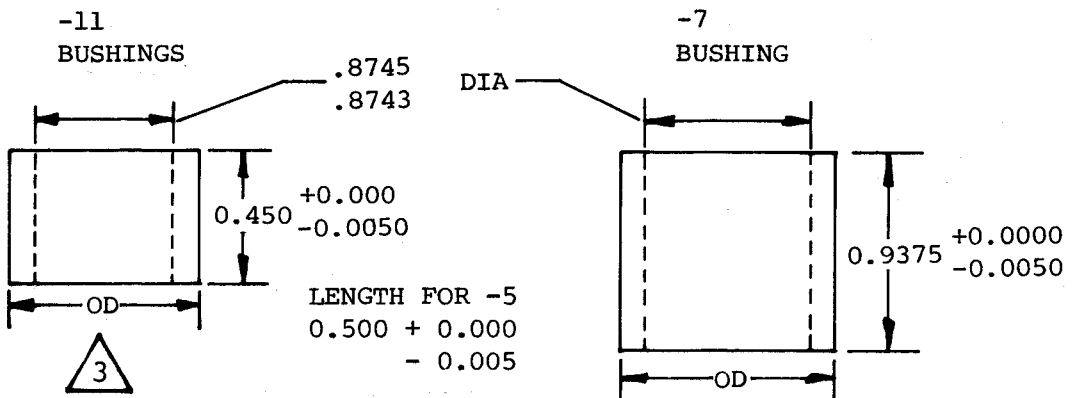
FIGURE 7

BUSHINGS TO BE MADE FROM ROD 4130 COND F-4

3 FABRICATE OD TO PROVIDE 0.001 TO 0.003 INCH INTERFERENCE FIT

If the above limits a,b,c are met, install 2 each P/N 4453005-11 and P/N 4453007-7 bushings. (See Figure 7). If the above limits a,b,d are met, fabricate one or more oversize bushings per Figure 7 and install. If one or more lug bores exceeds 1.0750", contact IAI for instructions. If limits a or b are not met, all 4 hinge bores must be honed oversize (1.0750" max.) using a 1/16" Sunnen hone. Oversize bushings per Figure 7 will be required.

- (4.6) Inspect the gaps between the attach fitting bearings and hinge bushings to ensure that axial clearances will be within specification when the stabilizer is reinstalled in the aircraft. Heat the hinge fitting before attempting to adjust the position of a bushing. (See Figure 7).
- (4.7) Hone all four bushings in line using 7/8" Sunnen hone.

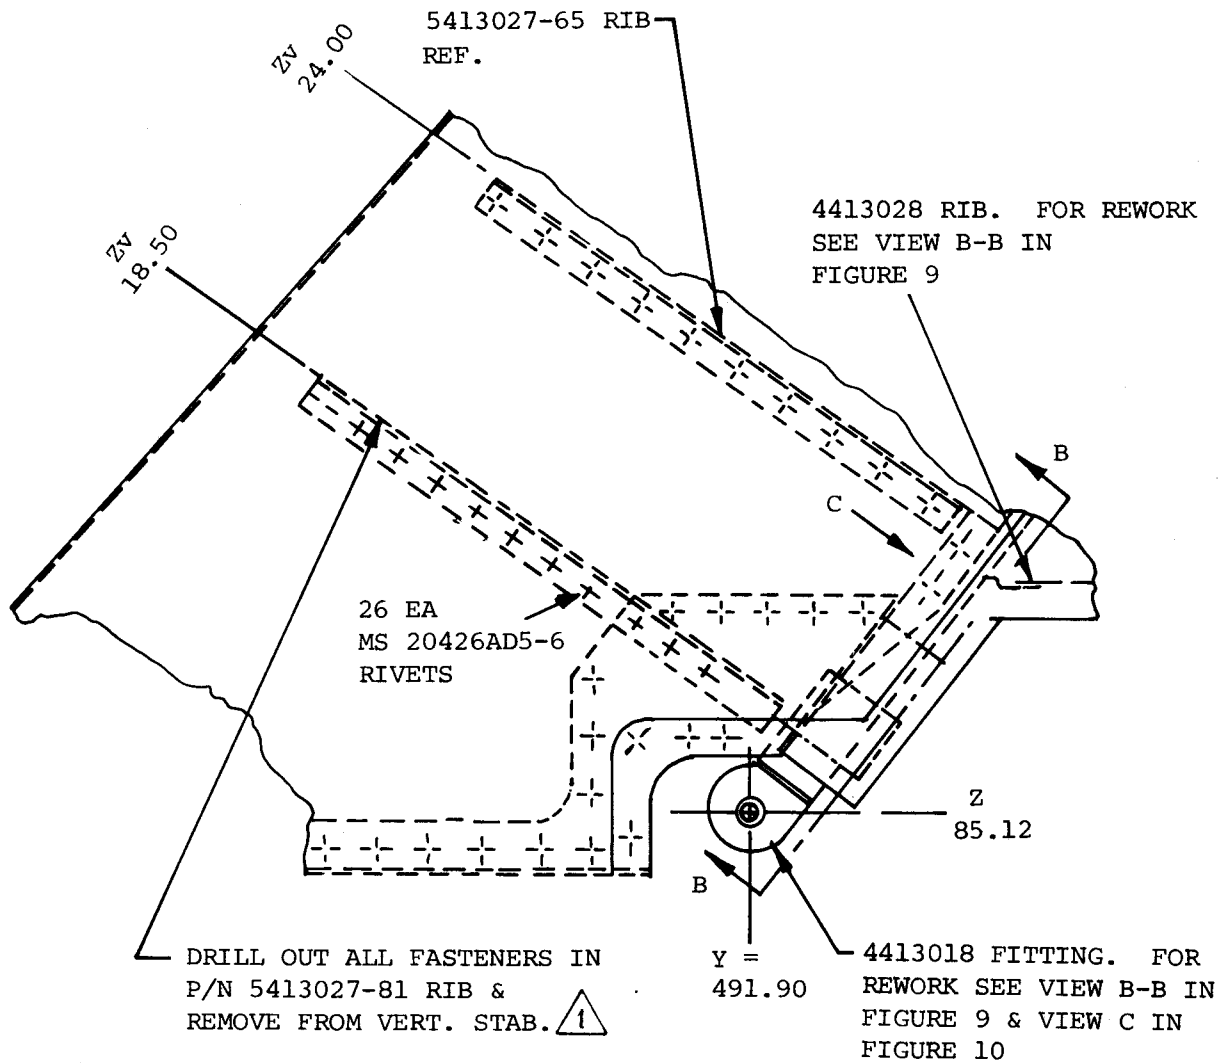
FIGURE 8

AFTER PLATE P/N 5413027 & NUT CHANNEL MS 21063 L4-9-3 HAVE BEEN INSTALLED, RIB P/N 5413027-81 MUST BE REINSTALLED

- (1.0) Drill out rivets and remove Vertical Stabilizer rib P/N 5413027-81. See Fig. 8.
- (1.1) Refer to Figures 8 and 9. Remove the two outboard AN4 bolts attaching 4413028 rib to forward spar of Vertical Stabilizer. Ream these two holes to 0.2651-0.2671 inch.

- (1.5) Torque NAS6604-14 & -14X bolts to 50 to 70 inch-lbs.
- (1.6) Install 5413027-81 rib in Vertical Stabilizer. See Figures 8 & 9.
- (1.7) Install Vertical Stabilizer. Torque forward attach bolts to 200 - 300 inch-lbs. Torque aft attach bolts as follows:

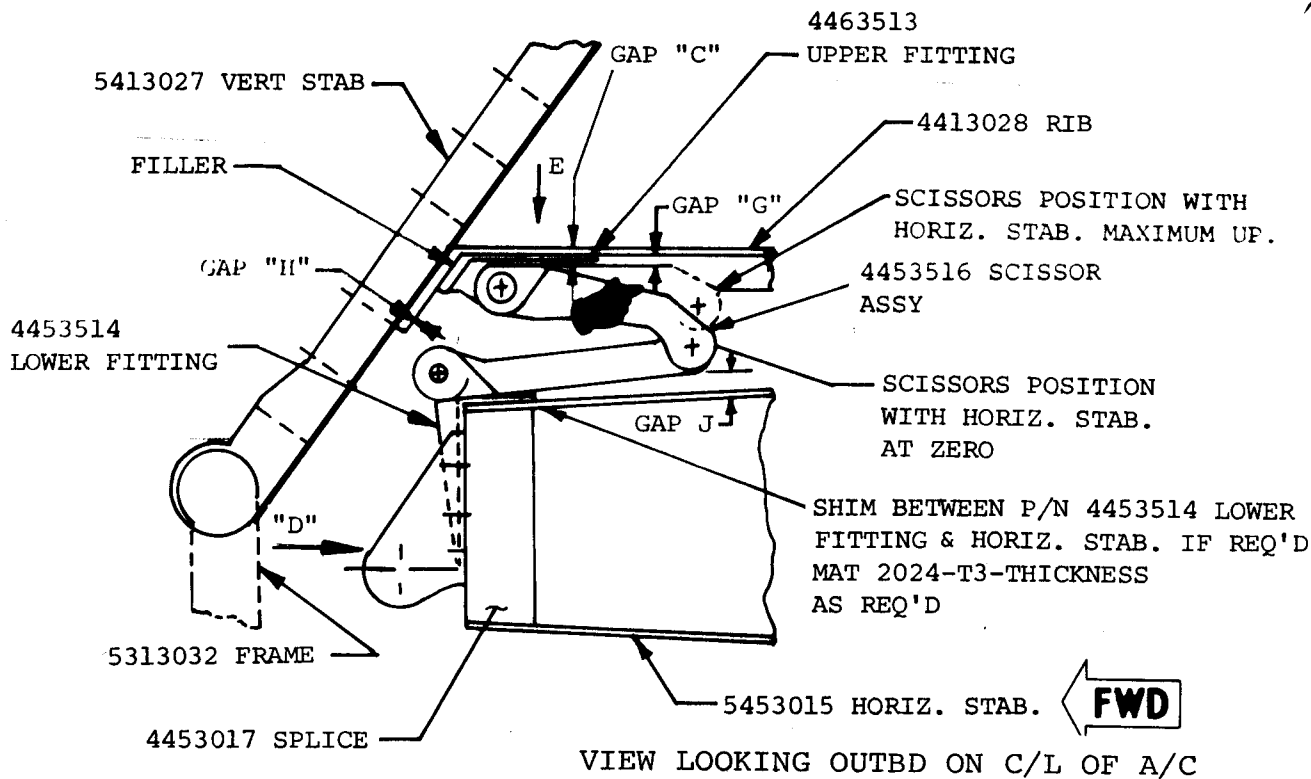
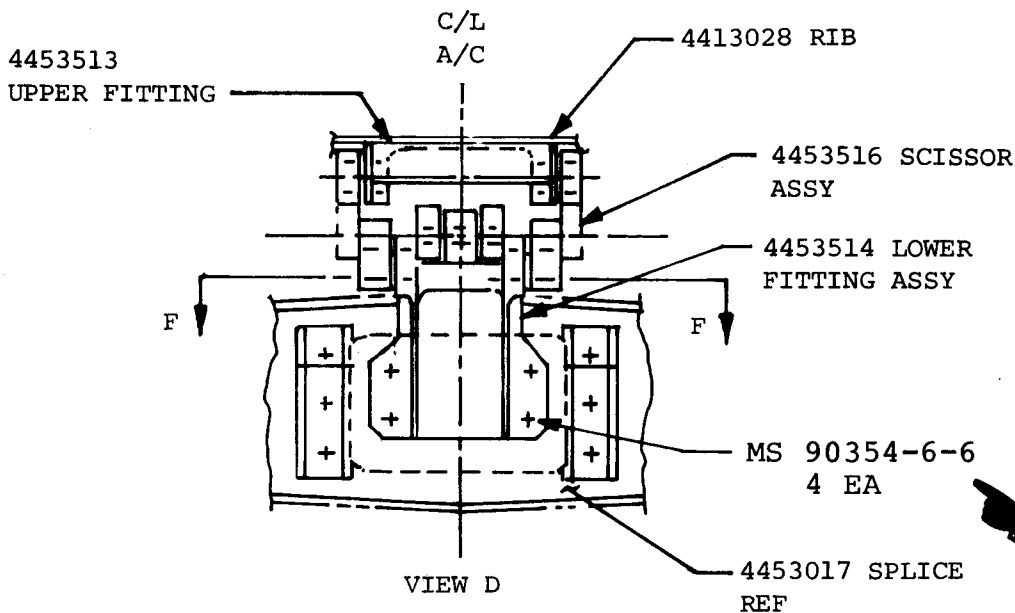
FIGURE 11

INSTALLATION OF SCISSORS ASSY

- (1.26) Install lower scissors fitting on the Horizontal Stabilizer per Figures 11 and 12. Shim as required between fitting and Horizontal Stabilizer. As each fastener is installed, ensure fitting remains aligned as marked and parallel to aircraft center line.

- (2.4) Disconnect Horizontal Stabilizer actuator.
- (2.5) Lift Horizontal Stabilizer to its maximum leading edge up position, so that scissors are fully closed. Tighten or loosen bolts attaching upper fitting until GAP "G" in Figure 11 measures 0.063". Measure GAP "H" and manufacture shim or filler of 2024-T3 alum to match upper fitting forward face and to fill GAP "H".
