IAEWESTWIND

SERVICE BULLETIN

1124 SERVICE BULLETIN INDEX

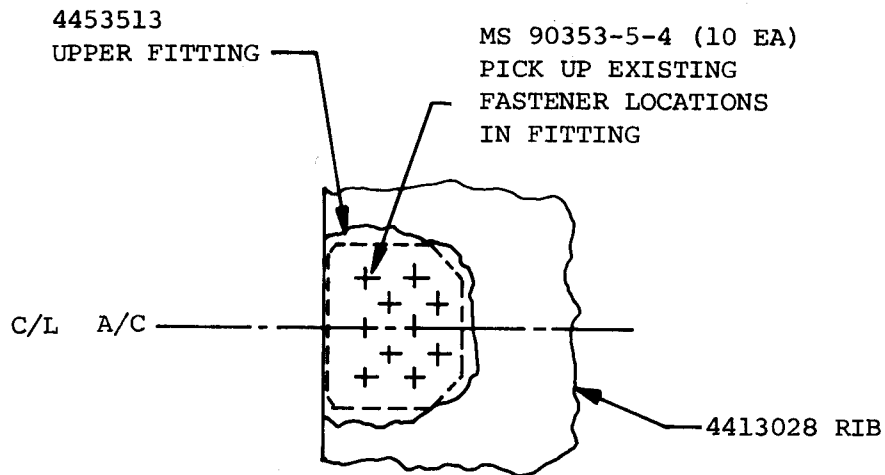
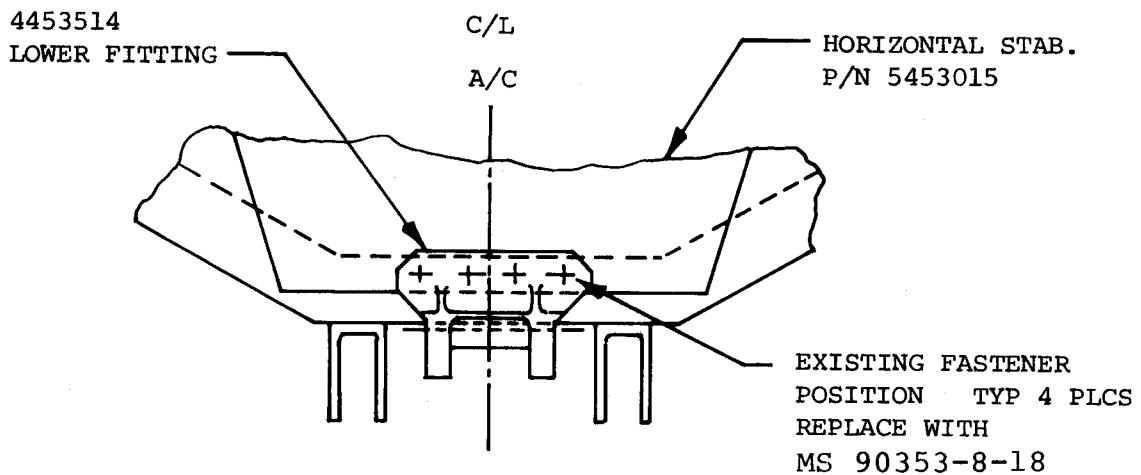
FIGURE 12

INSTALLATION OF
UPPER FITTING

INSTALLATION OF
LOWER FITTING

- (1.3) Install NAS6604-14X bolt with AN960C416L washer in center hole - do not tighten.
- (1.4) Loosen outboard bolts in upper attach fitting. Insert GAP "C" filler. Install MS90353-5-4 blind fasteners as shown in Figure 12, View E.

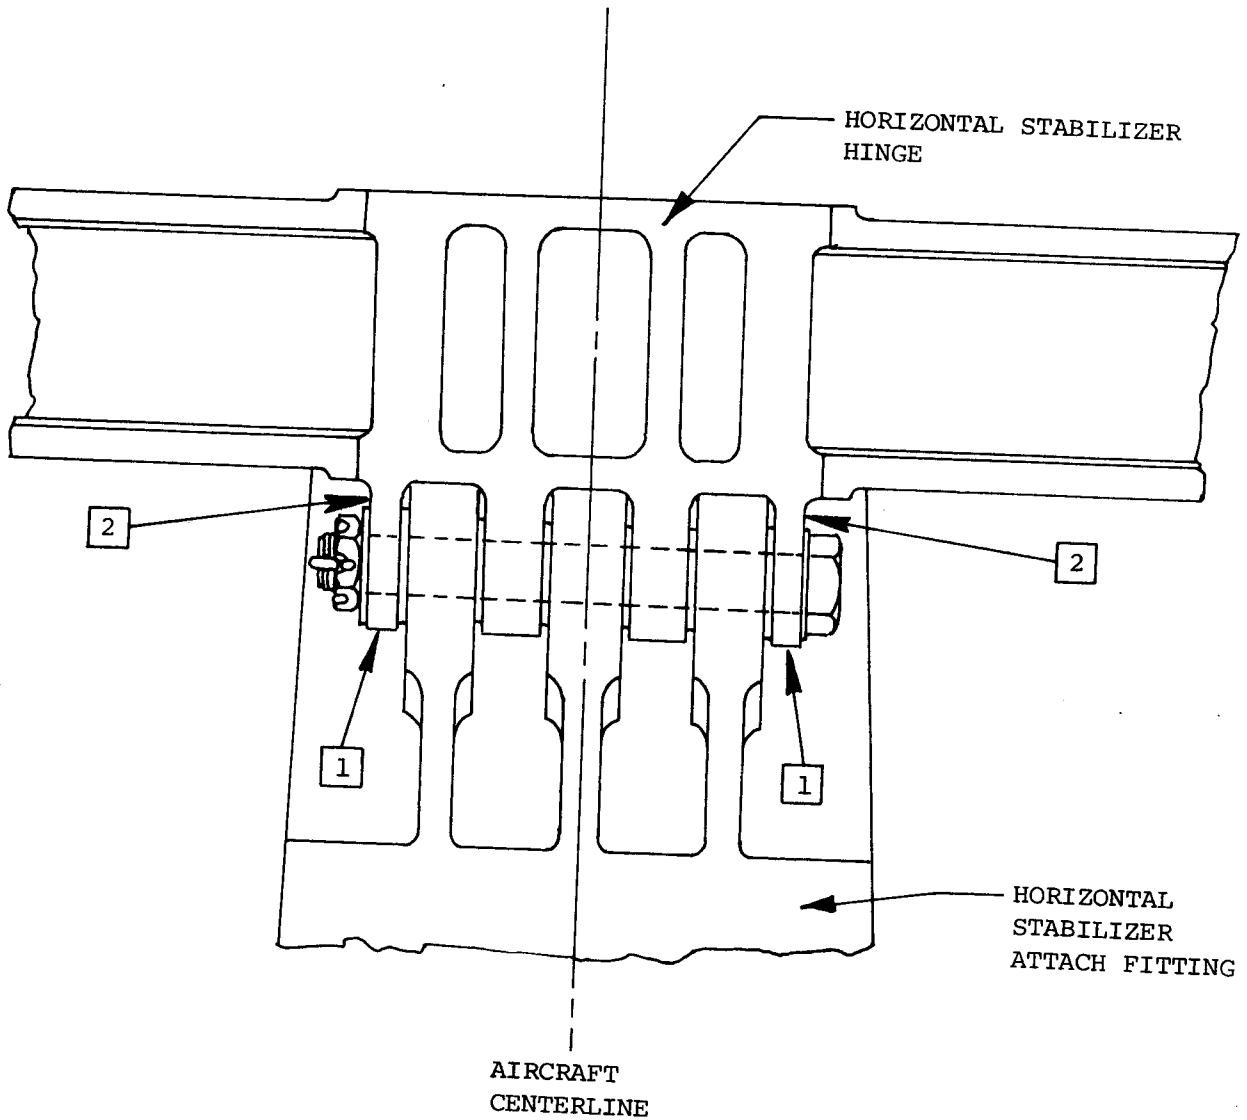
FIGURE 13

- (1.0) Inspection of Splice Assembly for Radial Play.
- (1.1) Clamp a dial indicator (.0005" per division) to the attach fitting so that the plunger is vertical and resting against the bottom of the left hand outboard hinge lug (location 1 in Figure 13).
- (1.2) Gently place 100 lbs. of sandbags on the R.H. stabilizer tip.
- (1.3) Zero dial indicator.
- (1.4) Move all sandbags to the L.H. stabilizer tip.
- (1.5) Record dial indicator reading.
- (1.6) Repeat Steps (1) thru (5) for the R.H. outboard hinge lug.
- (1.7) If the total reading of the dial indicator exceeds 0.010 inch, it is recommended to perform the improved installation as per Para. D.

- (2.0) Inspection of Splice Assembly for Axial Play.
- (2.1) Clamp the dial indicator to the attach fitting so that the plunger is horizontal and resting against the face of one of the outboard hinge lugs (location 2 in Figure 13).

HORIZONTAL STABILIZER HINGE INSPECTION

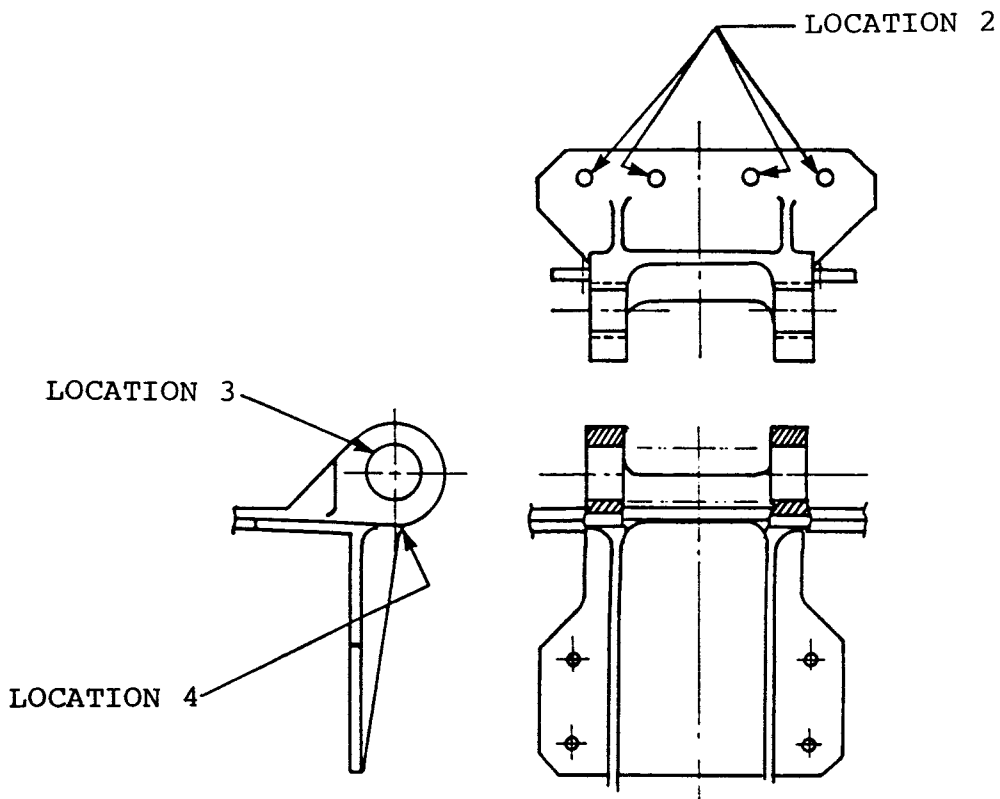
LOWER FITTING P/N 453514-503
FIGURE 2

Reports from the field indicate that some stabilizer lower scissor fittings P/N 453514 have loosened or cracked in service. Reference Service Bulletin No. 1124-55-097.

- (6) Drill out all fasteners attaching lower scissor fitting P/N 453514 to horizontal stabilizer.
- (7) Pilot countersink four (4) holes in doubler, P/N 453015-161 on top of stabilizer. Inspect hole condition. Refer to Figure 2 View "B".
- (8) Clamp-up doubler, P/N 453015-161 and skins, P/N 453015-167, left hand and -168 right hand. Refer to Figure 2 View "B".
- (9) Install four (4) blind bolts, P/N MS90353-08 or -U08, grip as required. If necessary use first standard over size. Fasteners are to be installed wet with sealant P/N PR1422. Refer to Figure 2 View "B".
- (10) Ensure that upper and lower doublers and skins are trimmed flush with vertical plane of the forward spar, P/N 453017, to clear new scissor/actuator fitting, P/N 453504.

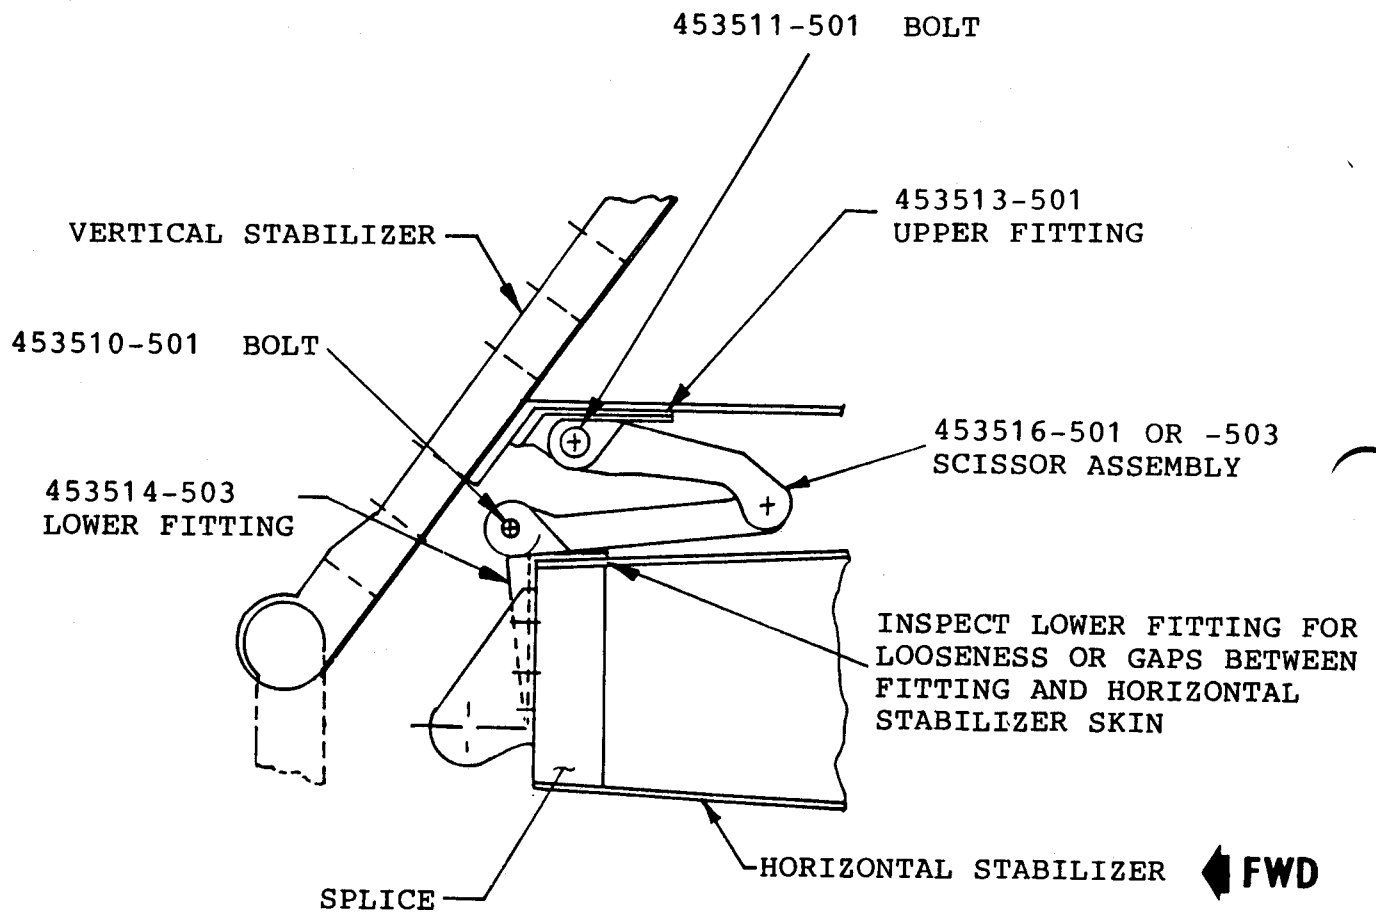
SCISSORS ASSEMBLY INSTALLATION
FIGURE 5

Several cracked and/or loosened lower fittings of scissors assembly have been detected in service.

- D. Inspect lower fitting (P/N 453514-503) for loose rivets or gaps between fitting and horizontal stabilizer skin (see Figure 5).
- E. If looseness and/or gaps between lower fitting and stabilizer skin are found, remove the scissors arms by removing the 2 bolts (P/N 453511-501) and bolt (P/N 453510-501).

For reinstallation instructions of the scissors assembly and for procurement of replacement parts, contact Astra Jet Corporation, Wilmington, Delaware.

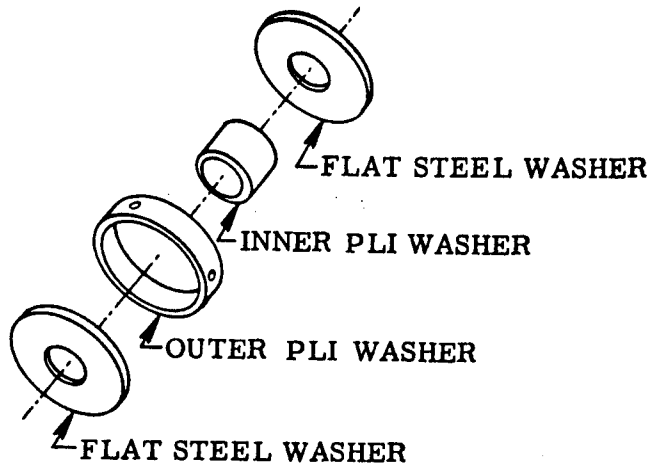
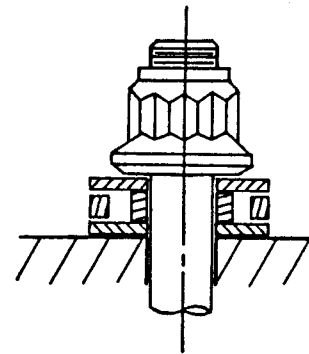
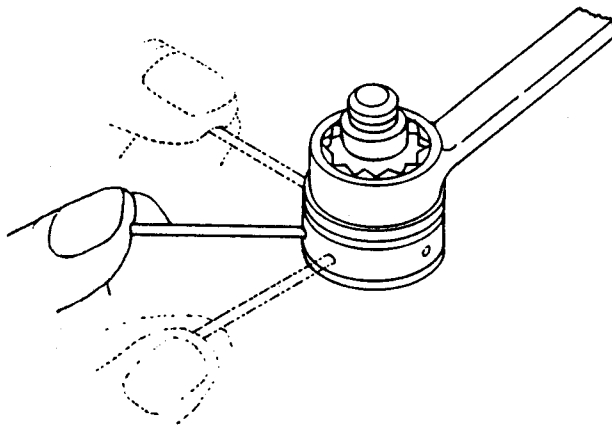
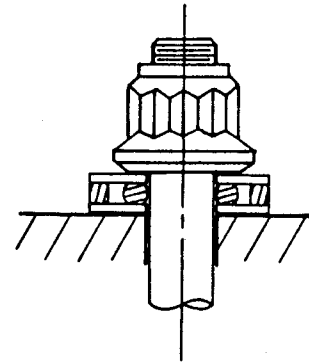
FIGURE 2

Do not overtighten. If nut is tightened more than 1/8 turn beyond point where outer PLI washer becomes immovable, the entire bolt, nut and washer assembly must be replaced.

INSTALLATION OF PRE-LOAD INDICATING WASHERS UNDER NUTS

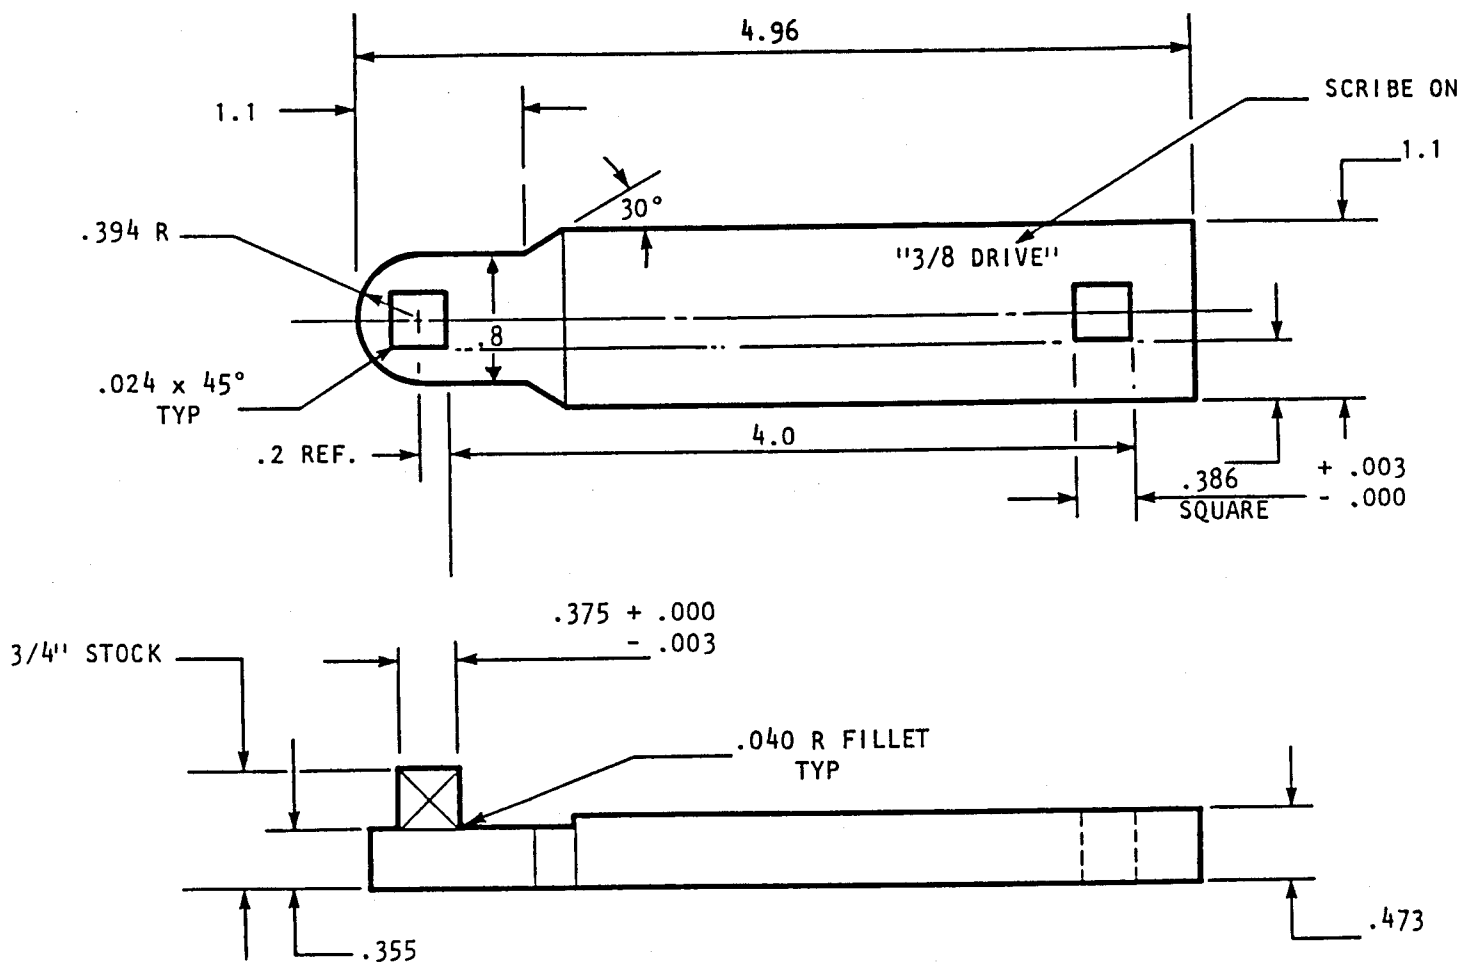
FIGURE 3

TORQUE WRENCH ADAPTOR

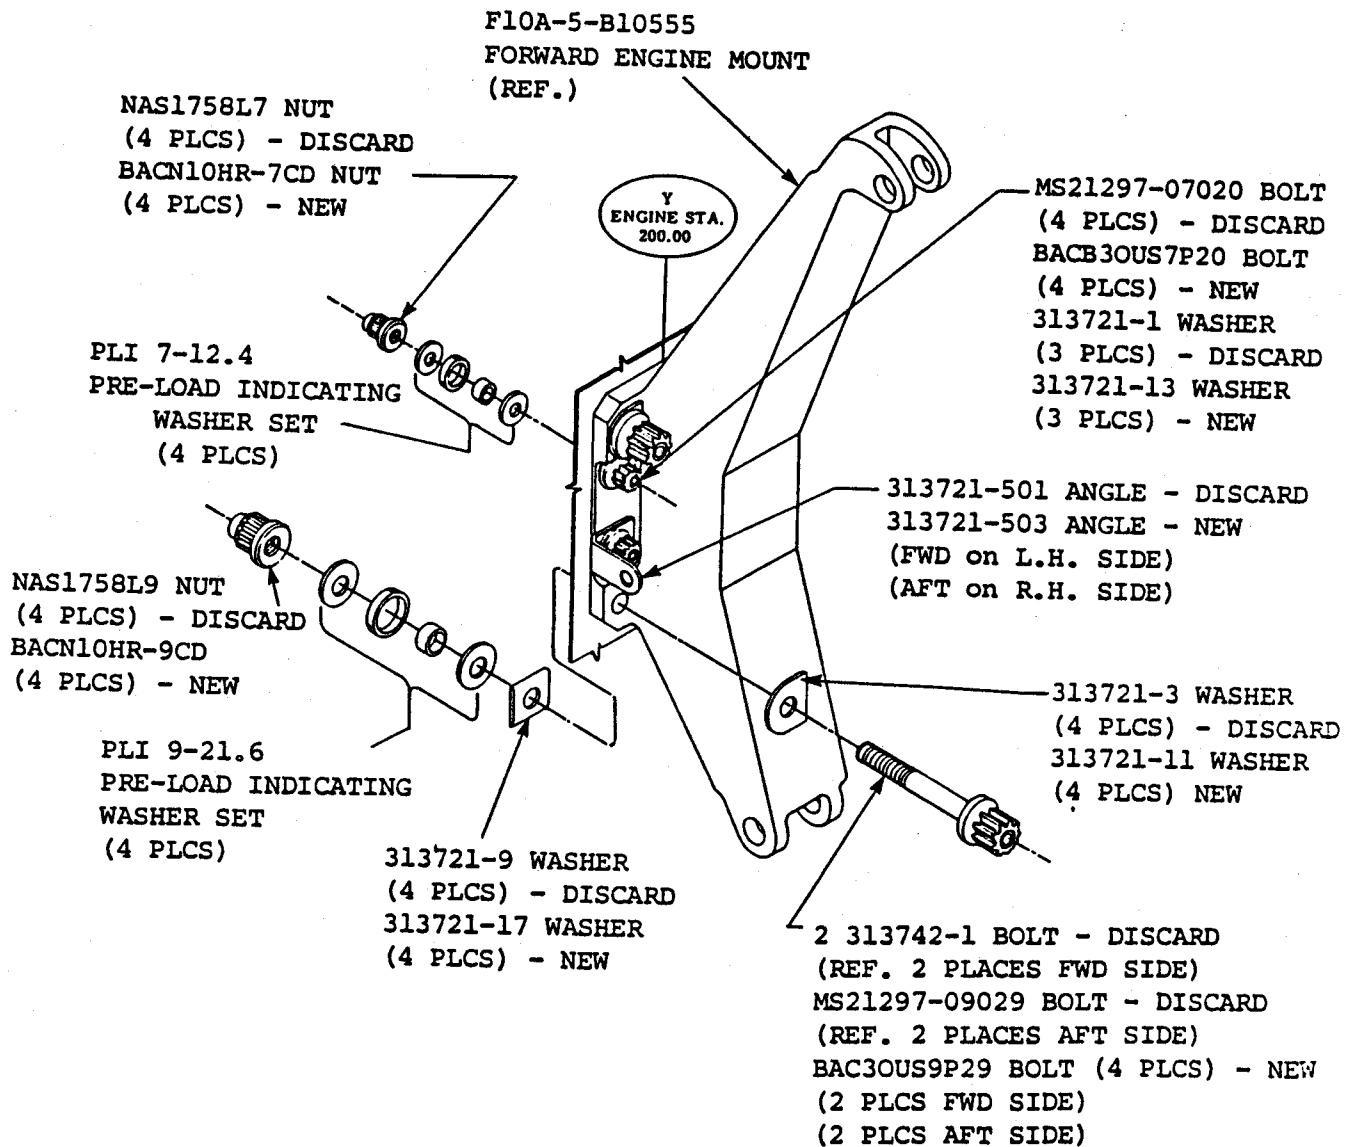
FIGURE 1

To prevent potential stress corrosion failure of the forward engine mount mounting bolts and nuts made from H-11 steel.

INSTALLATION OF FORWARD ENGINE MOUNT
ATTACHMENT FASTENERS

- A. Remove engine. Reference 1124/1124A Maintenance Manual, Chapter 71-00-00.
 - B. Remove panels necessary to access forward engine mount fastener nuts. (See PART I, Steps A through D of this service bulletin.)
 - C. Remove and replace forward engine mount attach fasteners, one at a time, as follows:
 - (1) Remove and discard old fasteners, bolt, nut, washers under bolt head and nut and PLI washer assy (see Figure 1).
 - (2) Check for surface defects in fastener holes such as corrosion, scratches, nicks or cuts intersecting a part surface.
- R
R

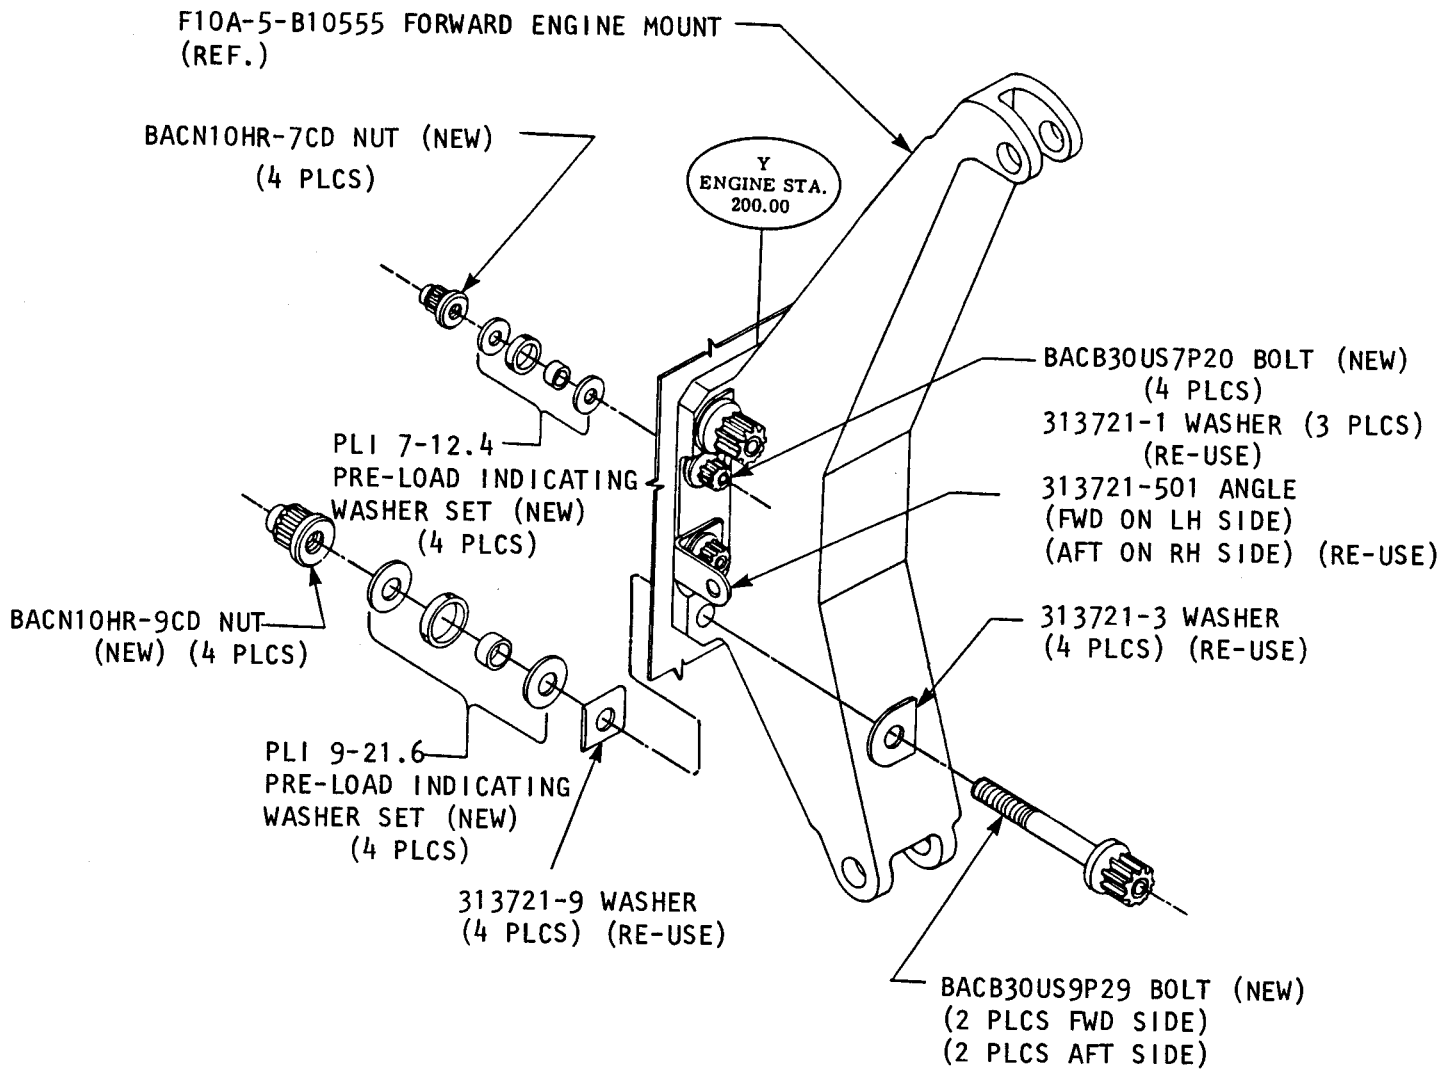
FIGURE 1

To prevent potential stress corrosion failure of the forward engine mount mounting bolts and nuts made from H-11 steel.

INSTALLATION OF FORWARD ENGINE MOUNT
ATTACHMENT FASTENERS

PART II of this service bulletin provides instructions to replace the engine mount attach fasteners.

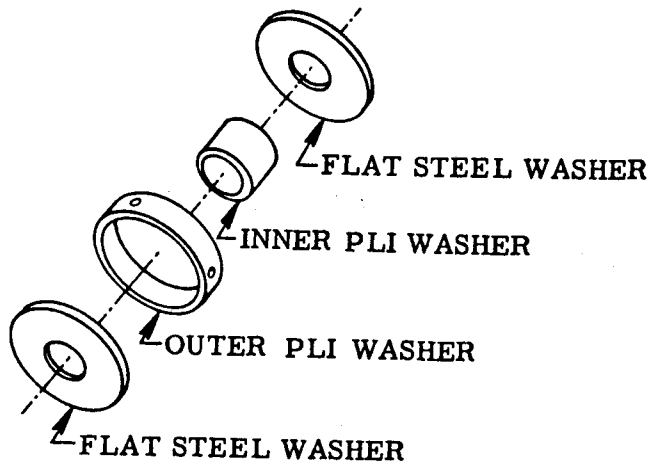
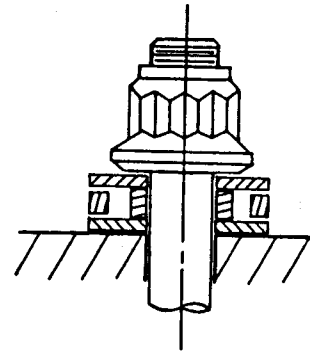
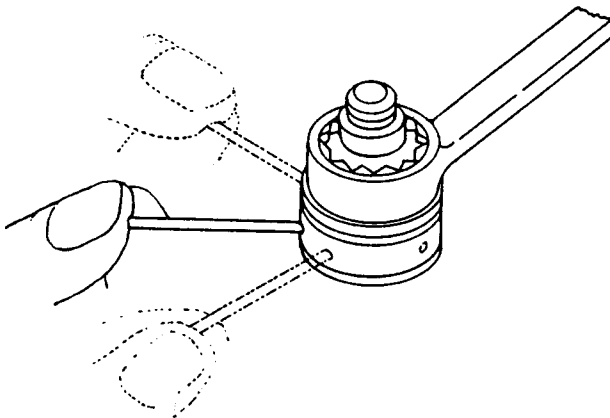
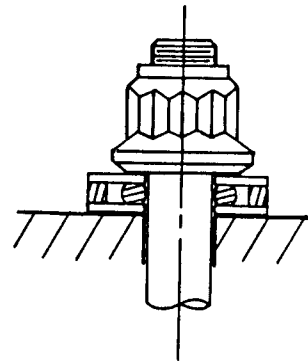
FIGURE 2

INSTALLATION OF PRE-LOAD INDICATING WASHERS UNDER NUTS

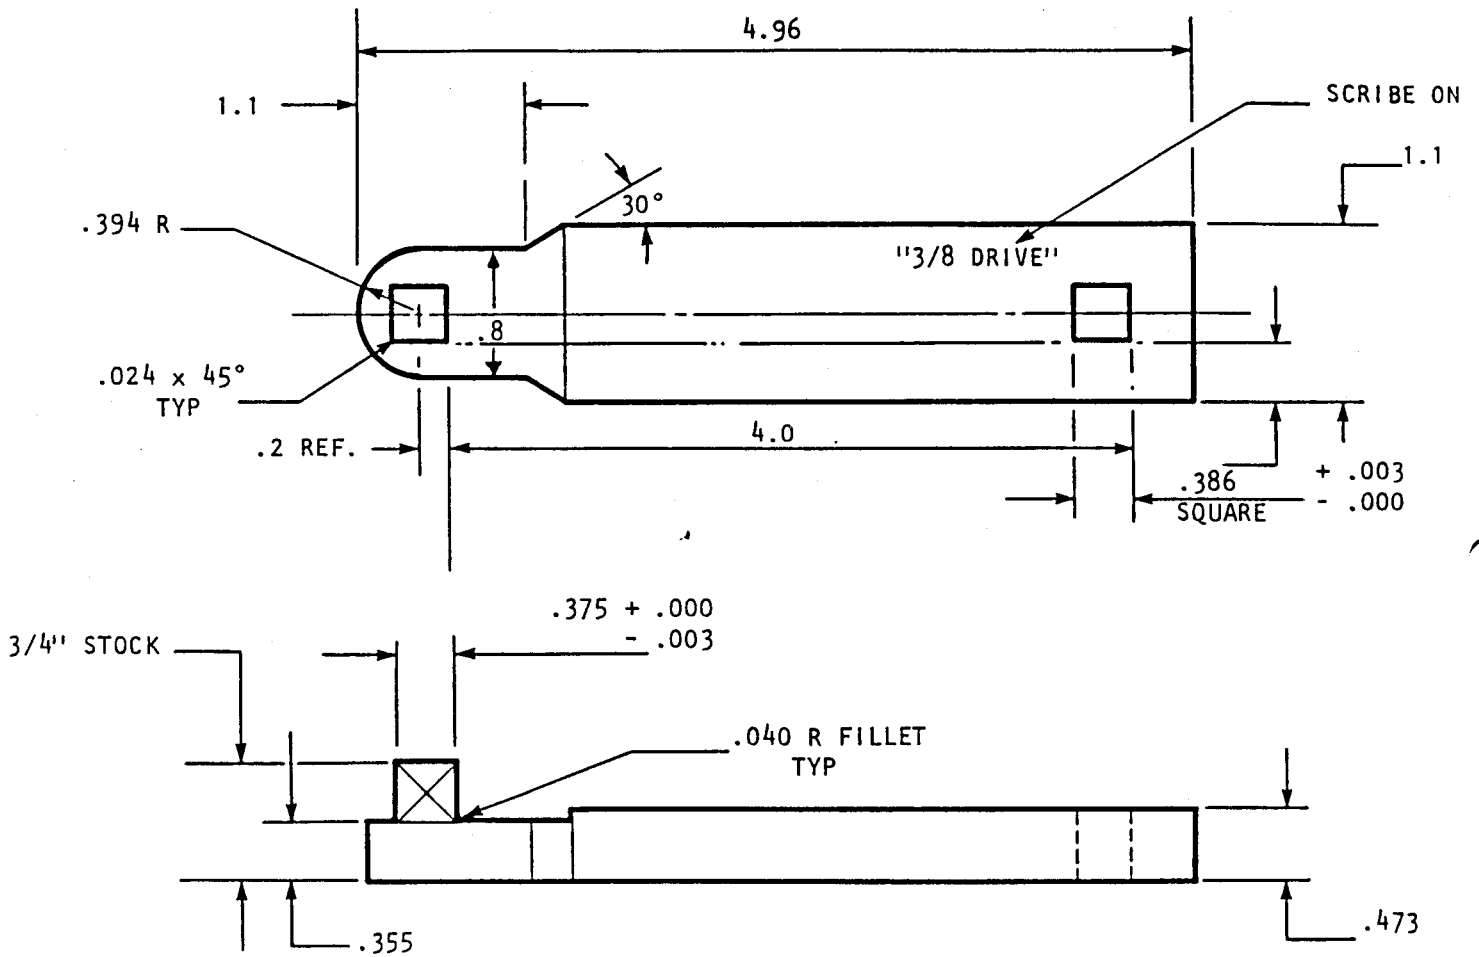
FIGURE 3

TORQUE WRENCH ADAPTOR

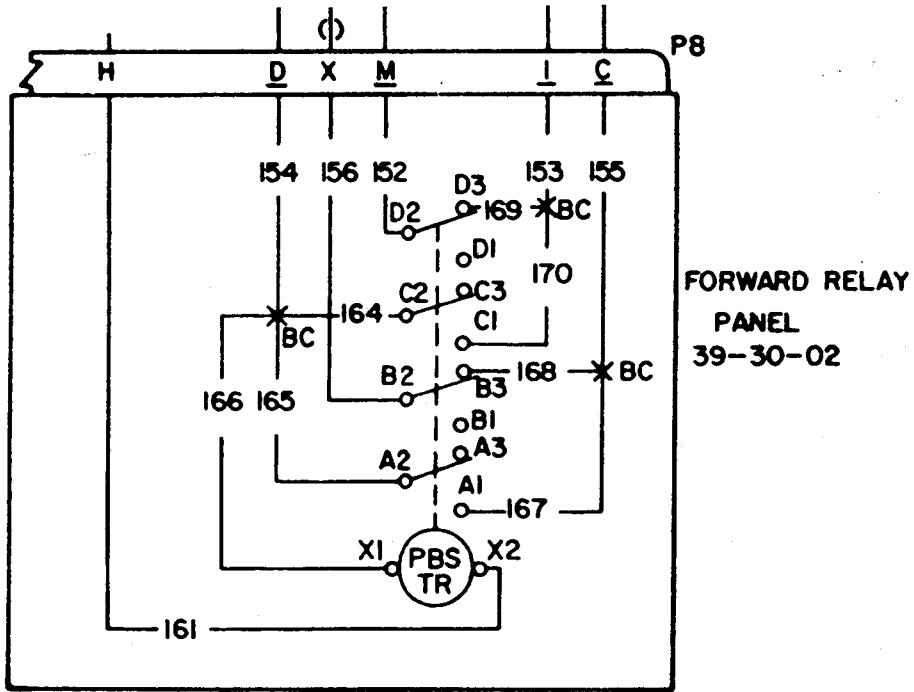
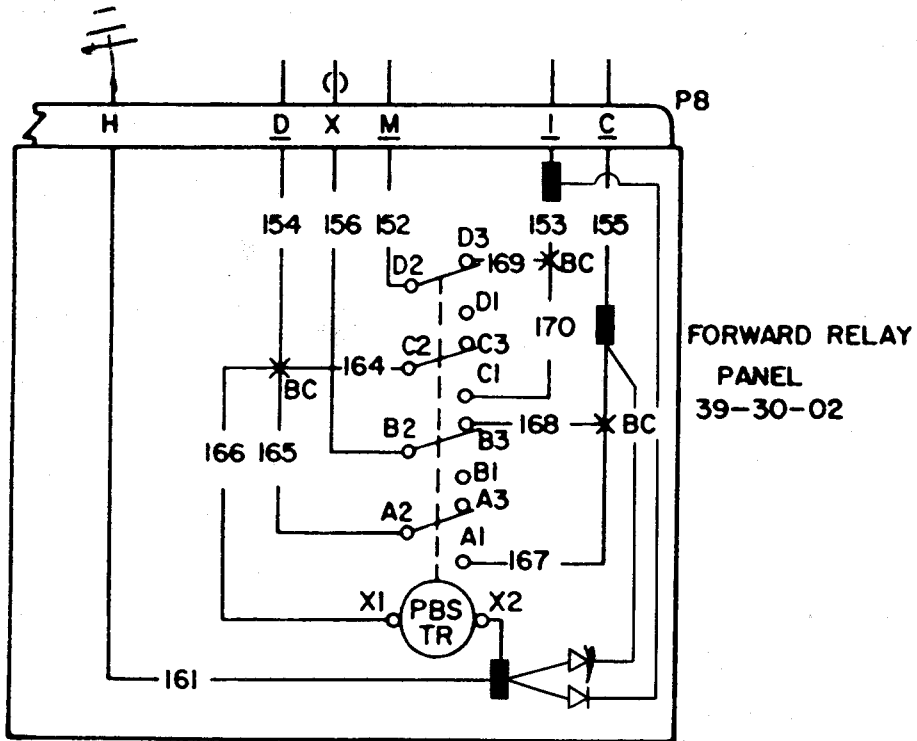
**PIGGY BACK SOLENOID TEST RELAY WIRING
FIGURE 1**

Service Bulletin 1124-78-111 dated May 27, 1992, titled "Exhaust - Thrust Reverser Fault Test Switch Reliability Improvement (AFC 2084)", has been accomplished this date _____.

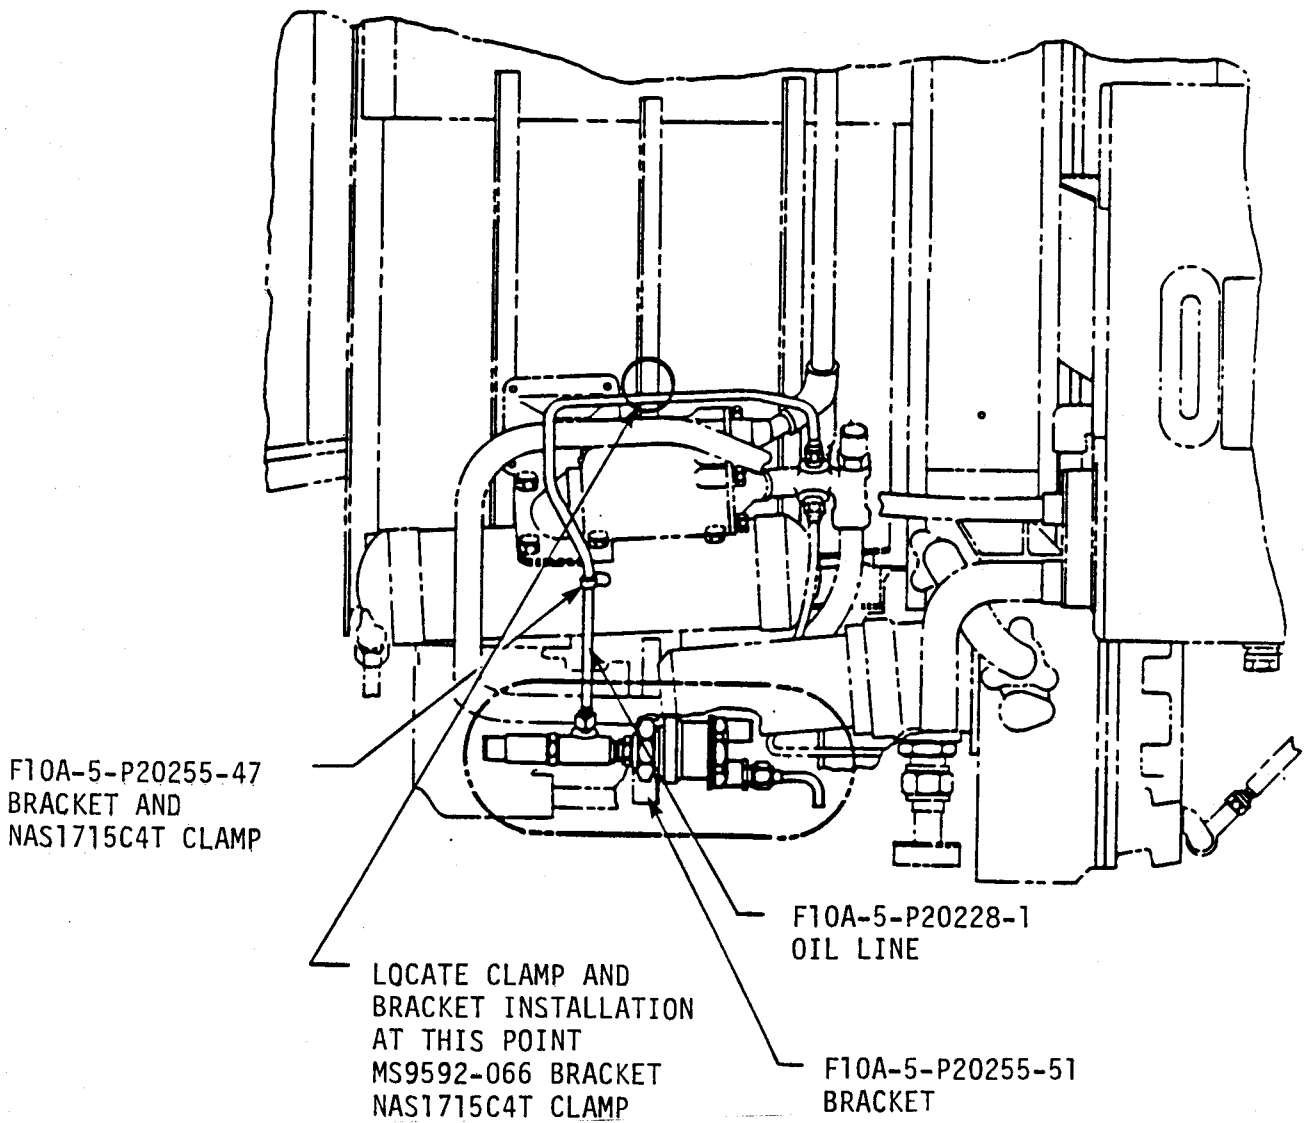
FIGURE 2

NEW ENGINE OIL LINE INSTALLATION
