LETTER OF TRANSMITTAL

TO: HOLDERS OF 1124/1124A WESTWIND MANUALS

SERVICE DATA

SERVICE DATA CHAPTER INDEX

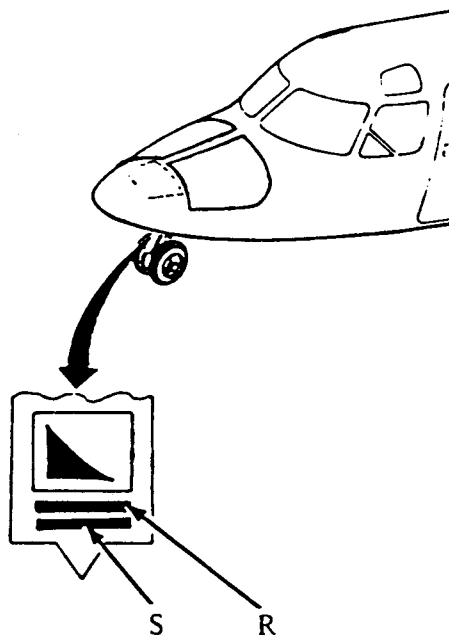
DETAIL R

1. Review the towing procedures in the 1124/1124A Westwind Maintenance Manual [reference attached pages 1 through 4 (9-10-00)].
2. Inspect placards installed on nose gear door, reference Figure 1 below, for existence, condition and legibility. Missing or deteriorated placards should be replaced.

WARNING
SCISSOR ASSY MUST BE CONNECTED
AT ALL TIMES WHEN OPERATING AIRCRAFT

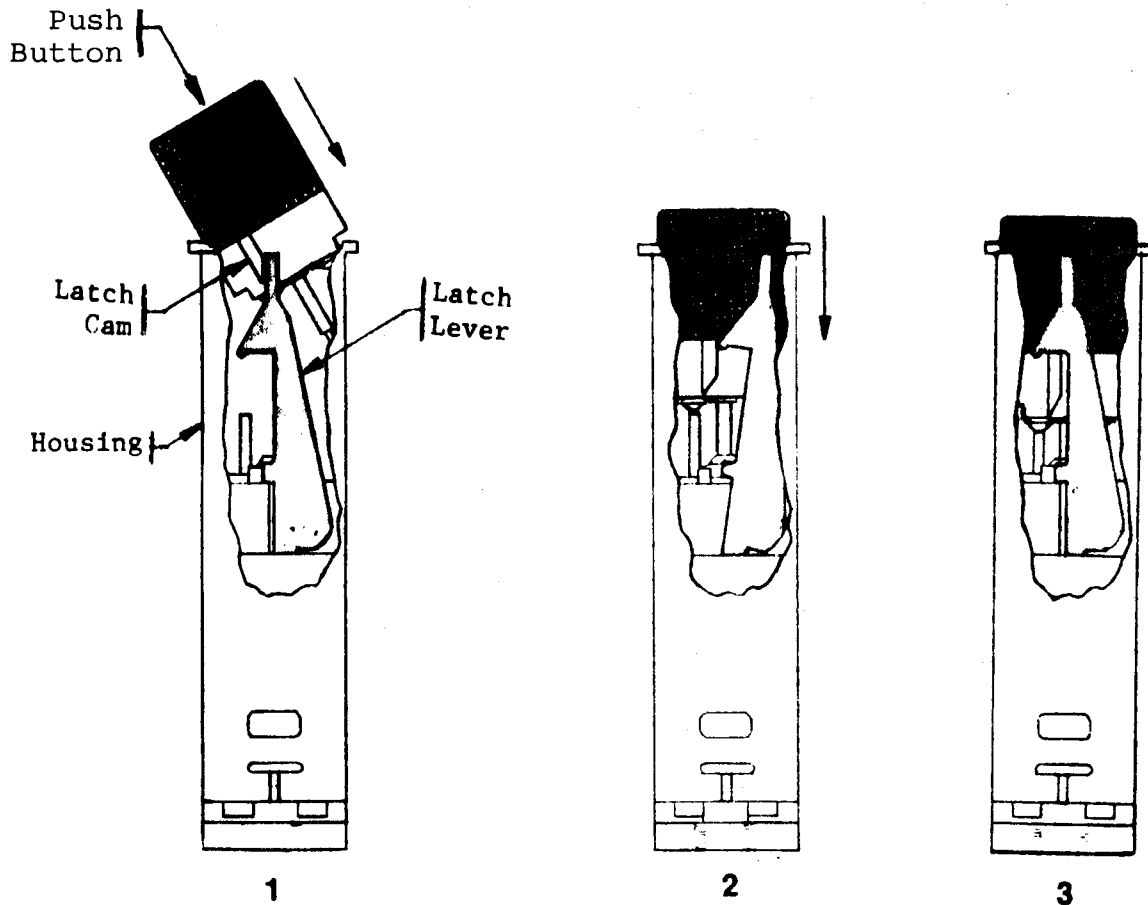
CAUTION: Do not force pushbutton into housing without allowing the cam to move the latch lever into the proper locking position. Forcing the pushbutton may trap the latch lever between the cam and the housing causing the pushbutton to jam and be nonoperative. INSTALL LAMPS IN PUSHBUTTON BEFORE INSERTING IN HOUSING. THIS IS IMPORTANT FOR EASY REMOVAL OF PUSHBUTTON.

1. Position pushbutton so bottom of legend faces latch lever. This places cam on the pushbutton in position to engage the latch lever. Tilt the pushbutton so that angle on the cam will push the latch lever to the right as the pushbutton is advanced into the housing toward the switch/indicator module.
2. The pushbutton is advanced downward into the housing, and at the same time straightened up to index into the switch/indicator module. This will allow the latch lever to ride on the side of the cam, moving it outward.
3. As the pushbutton is pushed downward into the engaged position, the latch lever will move over the top of the cam, locking onto the cam. This engagement of the latch lever will retain the pushbutton in the switch/indicator housing, while allowing for additional downward movement for switch actuation.

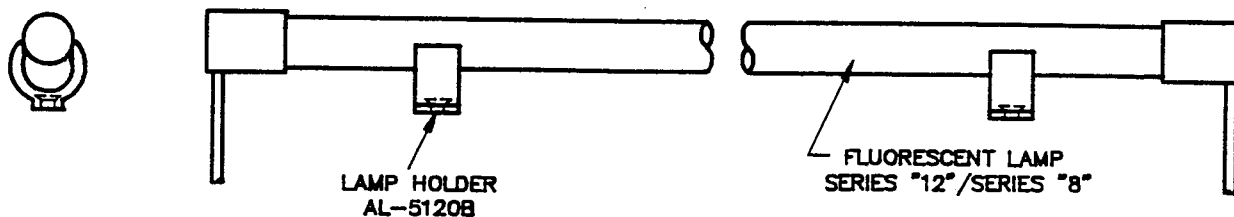
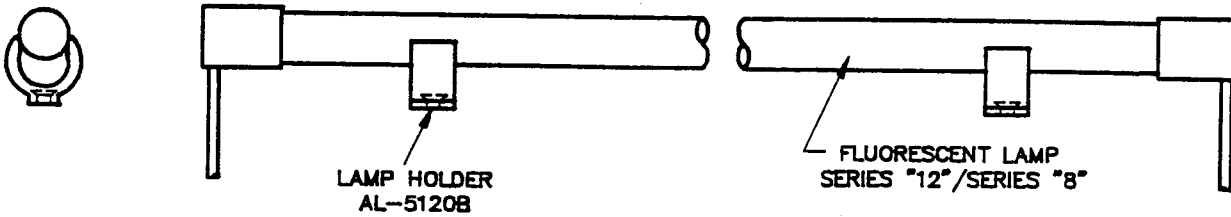
Figure 4 LAMP PLACEMENT

The lamp holder has been redesigned to facilitate removal and installation of lamps. The new part, AL-5120B, is a direct replacement for 31.87/AL-0519 Lamp Holder.

4.4.1 Place lamp on top of the holders (see Figure 4).

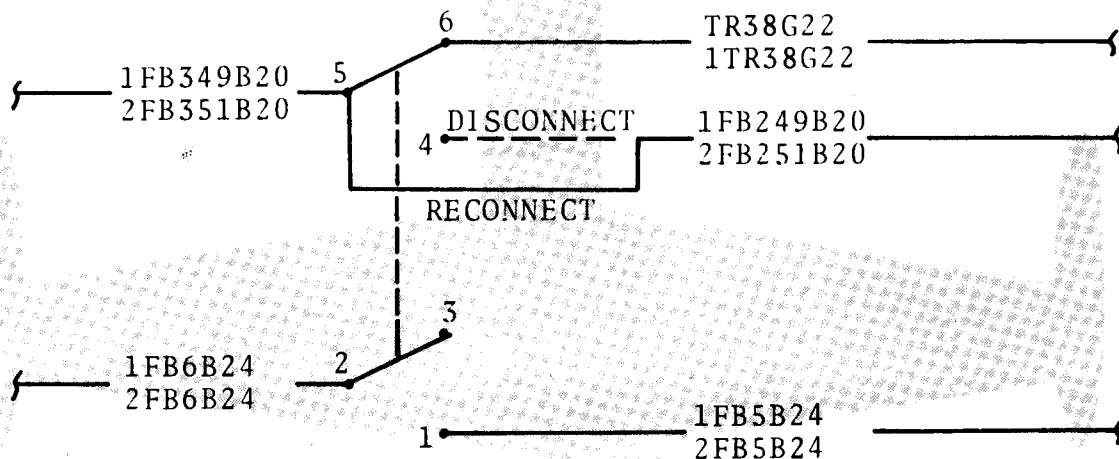
S31(#1) or S32(#2) DG SELECTOR SWITCH

The following modification will allow operation of the flight director and RNS 300 systems, without heading warning, when compass switch is moved to "DG" or free position.

These changes will still allow for proper system failure warnings.

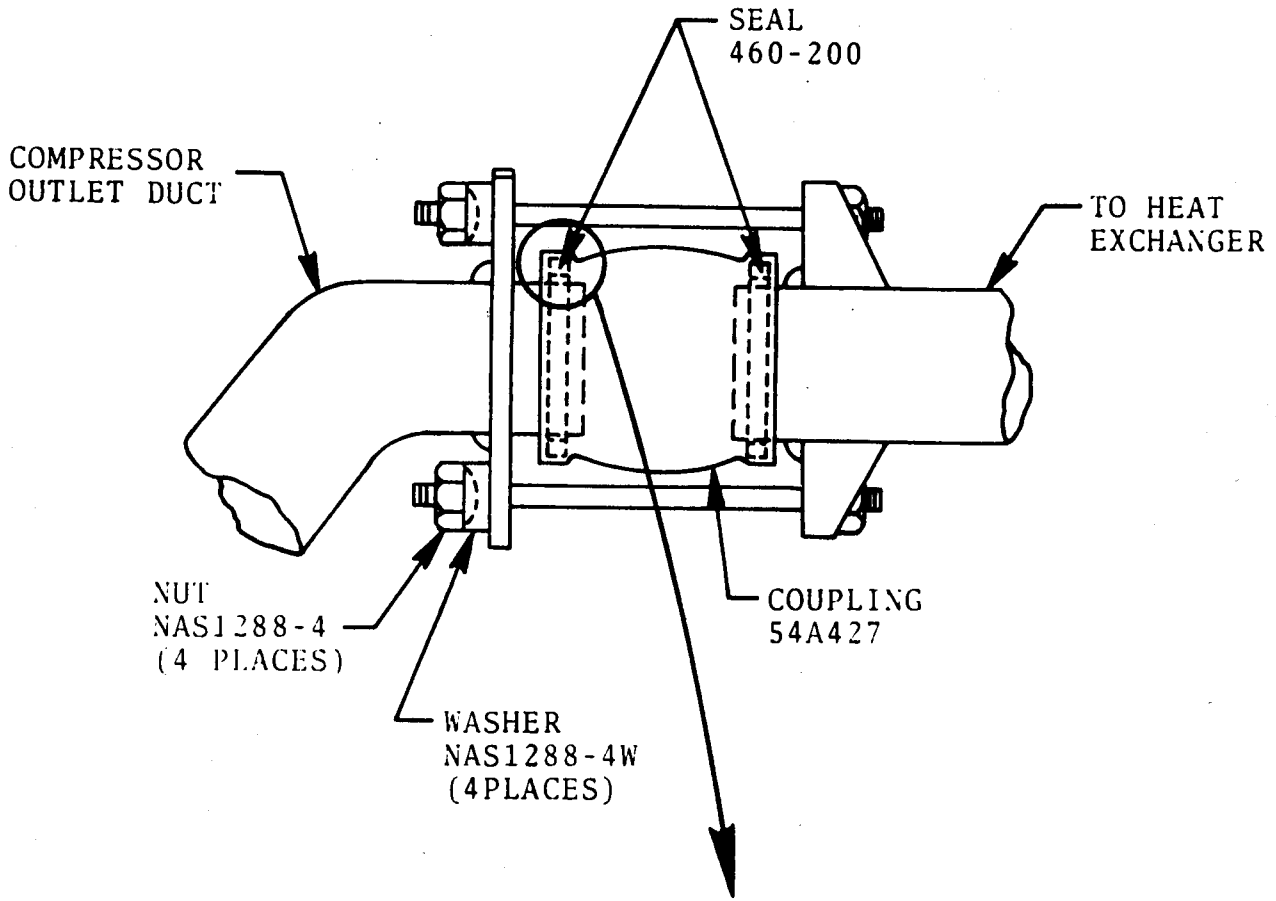
FIGURE 1 COOLING TURBINE
COUPLING

To further assure proper installation of refrigeration unit caution should be exercised in assembly of the Peri-Seal Coupling P/N 54A27 (located in the duct from the compressor outlet of the turbine to the secondary heat exchanger). New seals P/N 460-200 should be installed wherever Peri-Seal Coupling is disassembled or leakage is suspected. Reassemble Peri-Seal Coupling per Figure 1.
