LETTER OF TRANSMITTAL

TO: HOLDERS OF 1124/1124A WESTWIND MANUALS

SERVICE DATA

SERVICE DATA CHAPTER INDEX

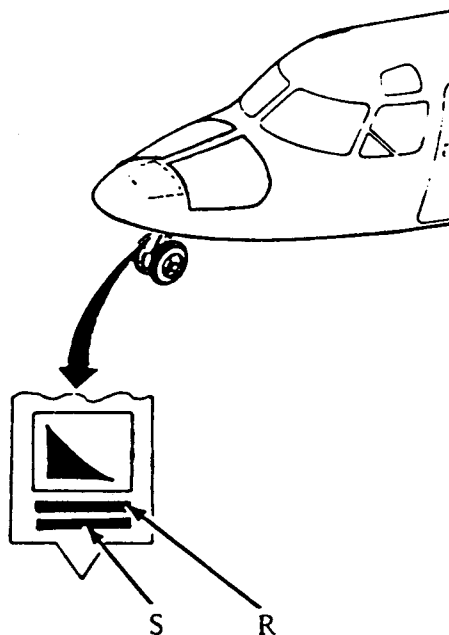
DETAIL R

1. Review the towing procedures in the 1124/1124A Westwind Maintenance Manual [reference attached pages 1 through 4 (9-10-00)].
2. Inspect placards installed on nose gear door, reference Figure 1 below, for existence, condition and legibility. Missing or deteriorated placards should be replaced.

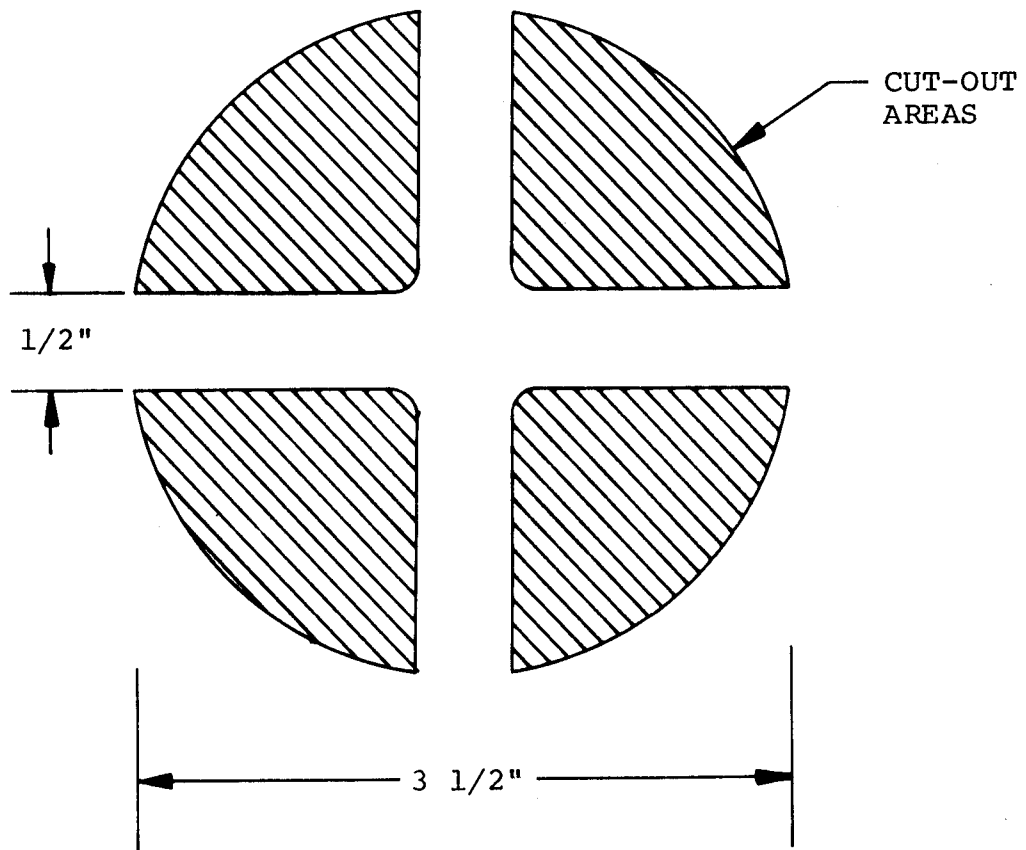
FIGURE 2

CUT-OUT SPEAKER GRIDES (6 PLACED)

- (5) Locate factory drilled speaker grid on side wall panels. (See Figure 3).
- (6) Trace cut-out pattern on speaker grids as shown in Figure 2. Cut and remove sections in outer plastic panel, foam core, and inner plastic panel.

- (7) Modify remaining speaker grids including grid for speaker located behind the Divan (if installed).
- (8) Reinstall cabin side-panels and return aircraft to service.

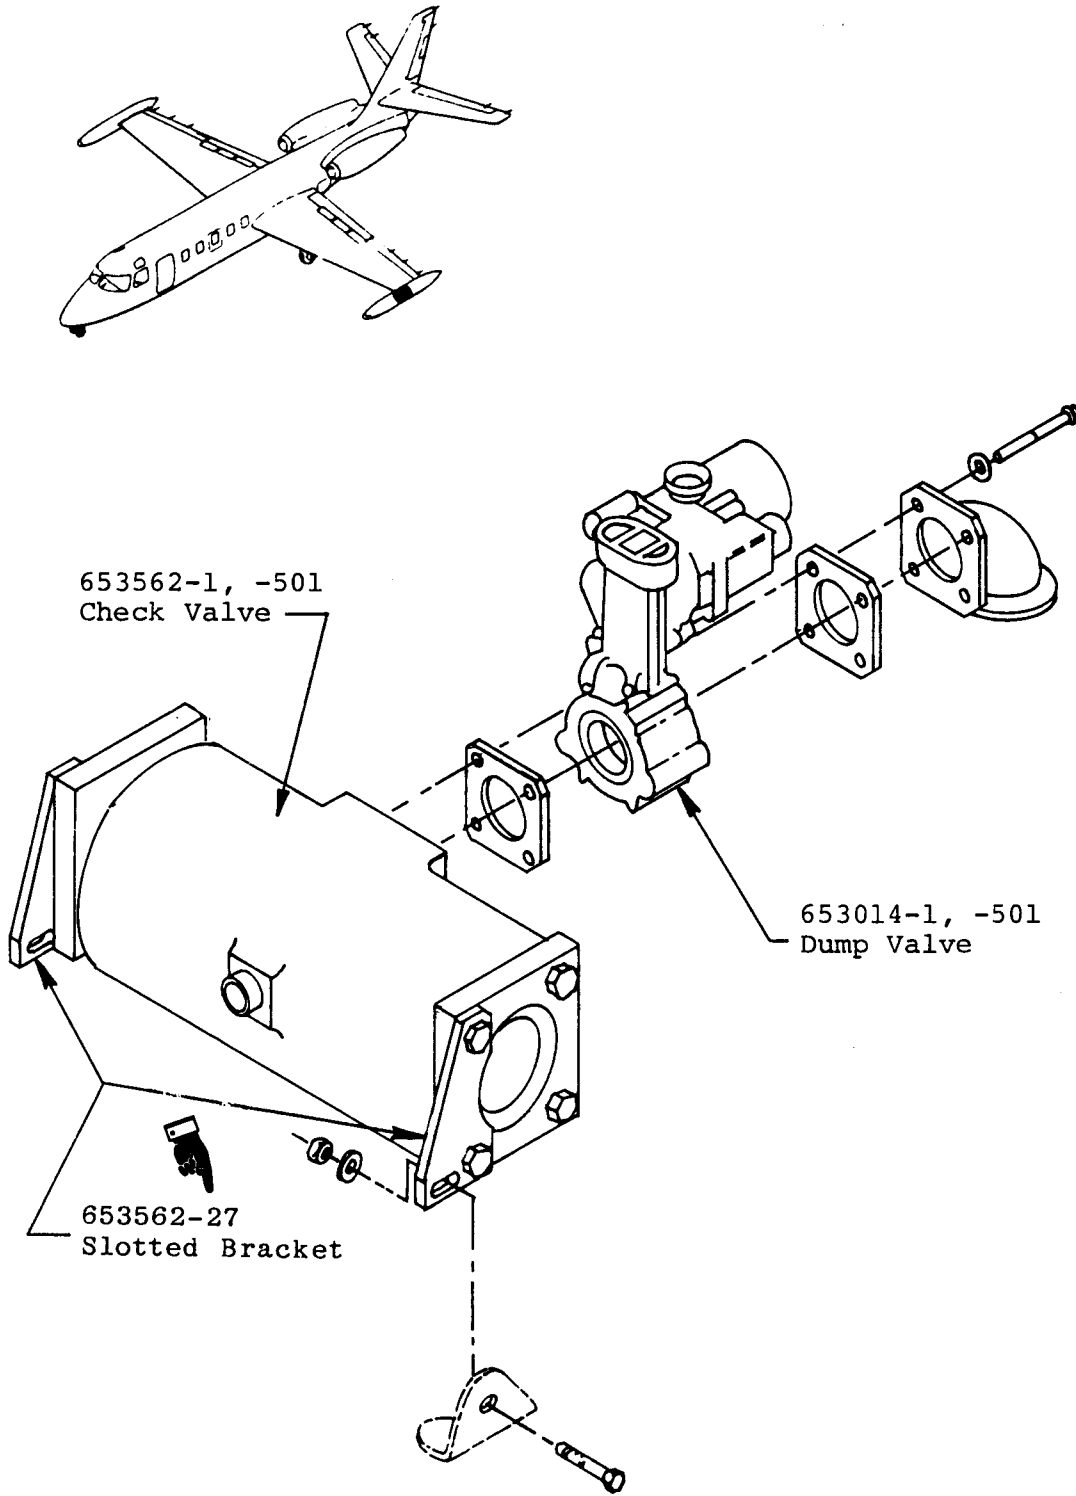
FIGURE 1 (RIGHT HAND SAME)

The referenced fuel dump valves differ in width by .250". To allow interchangeability, P/N 653562-13 or 653562-23 check valve mounting brackets are replaced with two 653562-27 brackets. The replacement brackets are slotted to allow the 653562-1, -501 check valve to be shifted forward or aft sufficiently to allow either style dump valves to be installed. It is recommended that this modification (Figure 1) be accomplished at the next dump valve replacement.

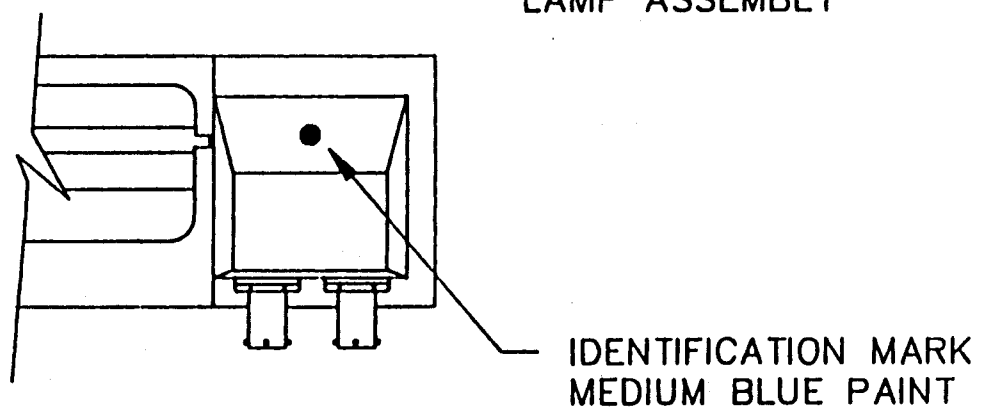
FIGURE A-1

TYPICAL VIEW -
ONE END OF 6 mm
LAMP ASSEMBLY

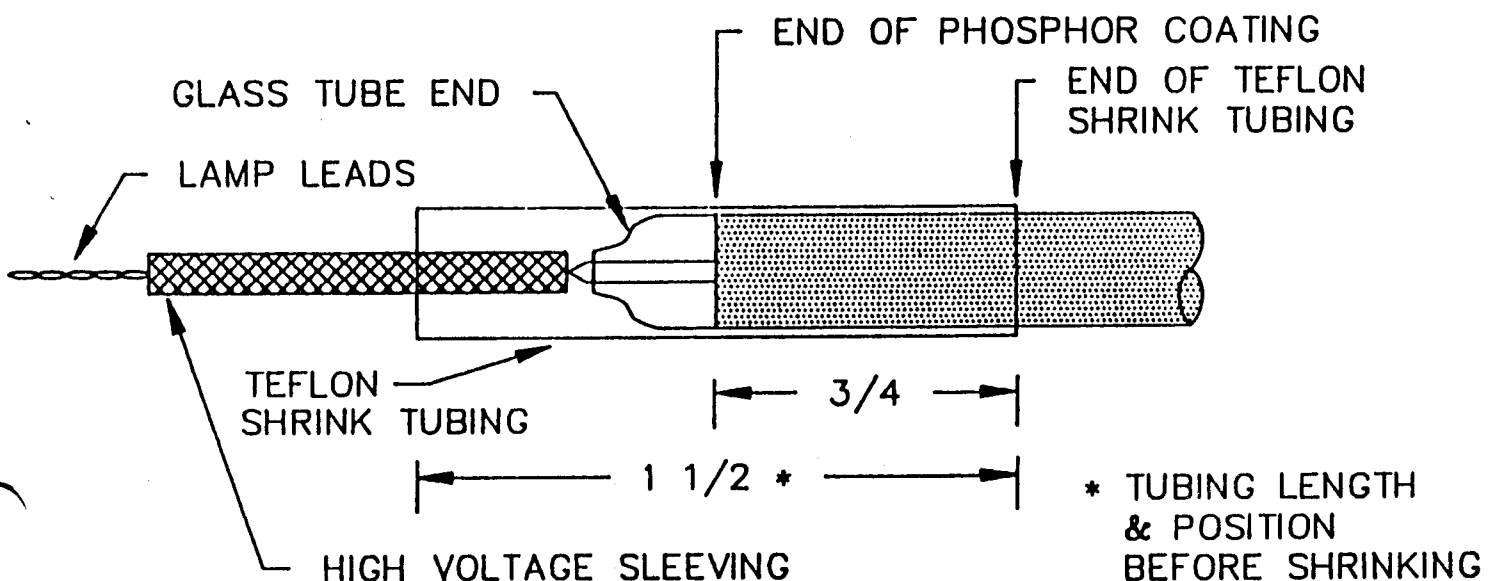
FIGURE B

TYPICAL VIEW -
ONE END OF 6 mm LAMP
WITH INSULATION SLEEVING RETRO-FIT

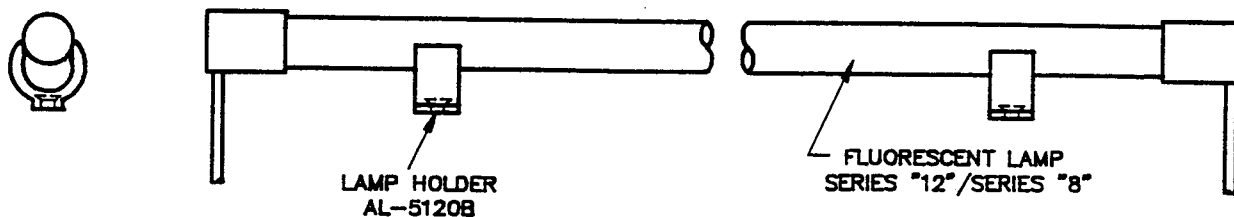
Figure 4 LAMP PLACEMENT

The lamp holder has been redesigned to facilitate removal and installation of lamps. The new part, AL-5120B, is a direct replacement for 31.87/AL-0519 Lamp Holder.

4.4.1 Place lamp on top of the holders (see Figure 4).

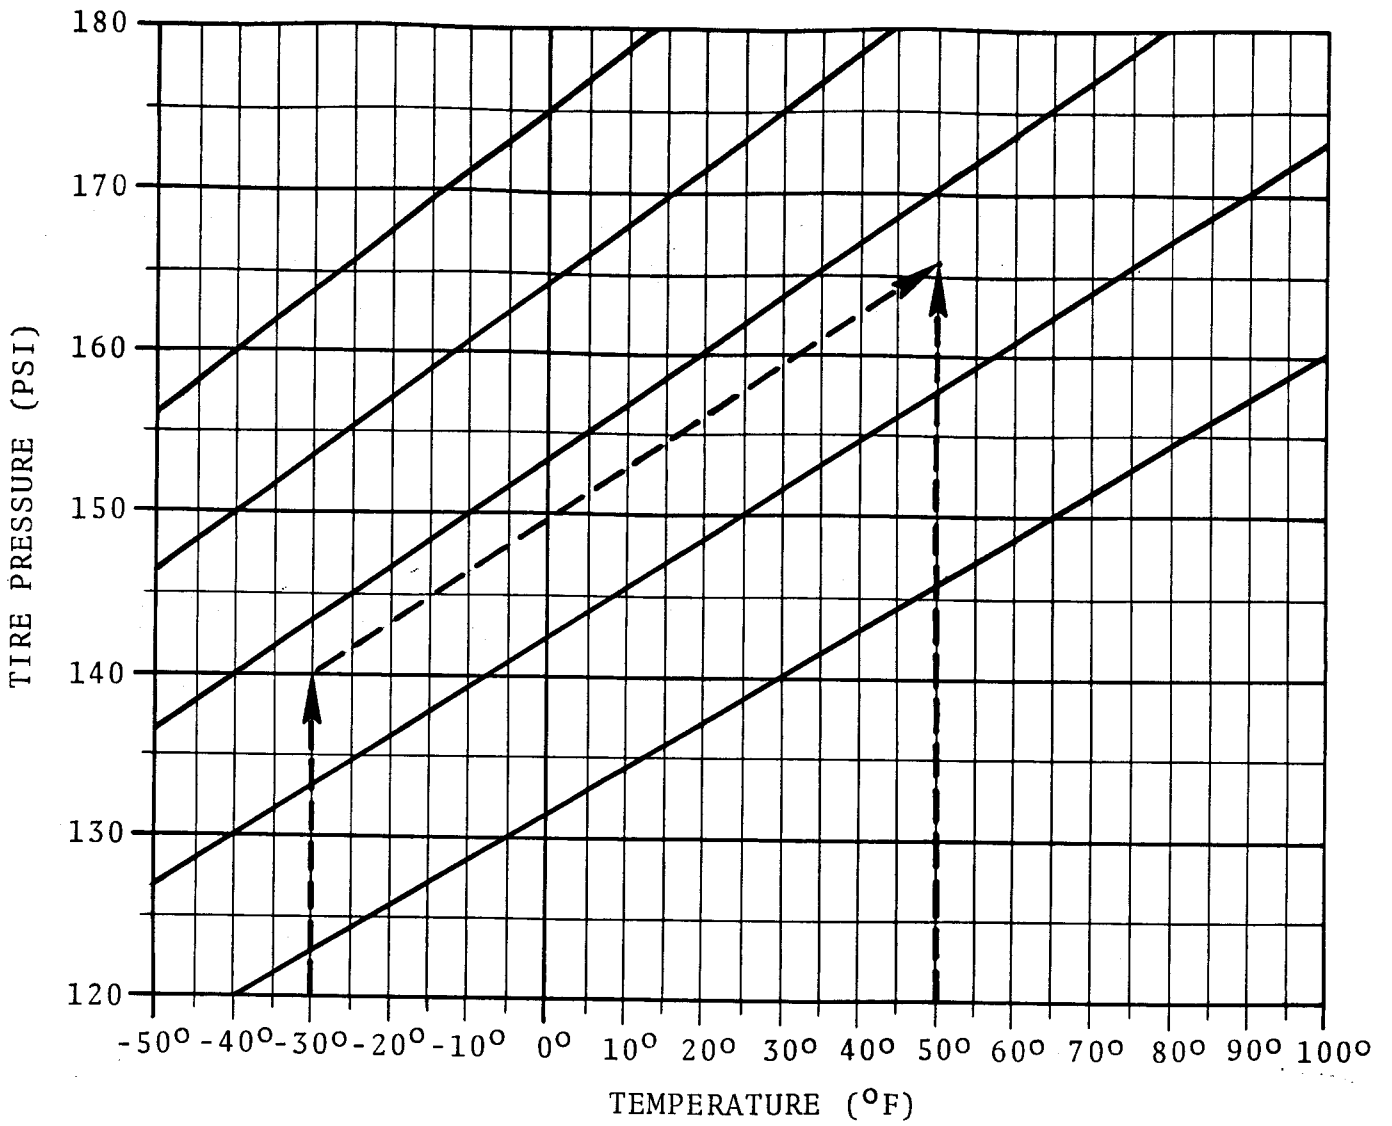
FIGURE #1

Figure 1 illustrates that with an expected destination temperature of -30°F , tire pressure should be increased to 166 psi with an ambient temperature of 50°F .

3. The allowed leakage rate of a mounted and inflated tire is 5% or approximately 8 psi in 24 hours. Also, tire pressure will fluctuate with temperature. For each 5°F of temperature change the tire pressure will change approximately 1.5 psi. For these reasons, TIRE PRESSURE SHOULD BE CHECKED DAILY. If large temperature changes are to be encountered, then tire pressure should be serviced prior to each flight. When operations are to be made from a moderate temperature to a colder temperature, then tire pressure should be adjusted so that the pressure upon arrival will be approximately 140 psi. Use Figure 1 as a guide to adjust tire pressure to maintain a minimum of 140 psi. After returning to moderate temperatures, tire pressure should be reduced to the recommended pressure of 155 psi.

4. Goodyear recommends a maximum tire pressure of 166 psi be observed, however in some cases it may be necessary to exceed this value to insure adequate tire pressure upon arrival at a destination where very cold ambient temperatures are expected. Be advised that operations with tire pressures in excess of 166 psi will tend to reduce wheel and bolt life, depending on gross weight and taxi distances.

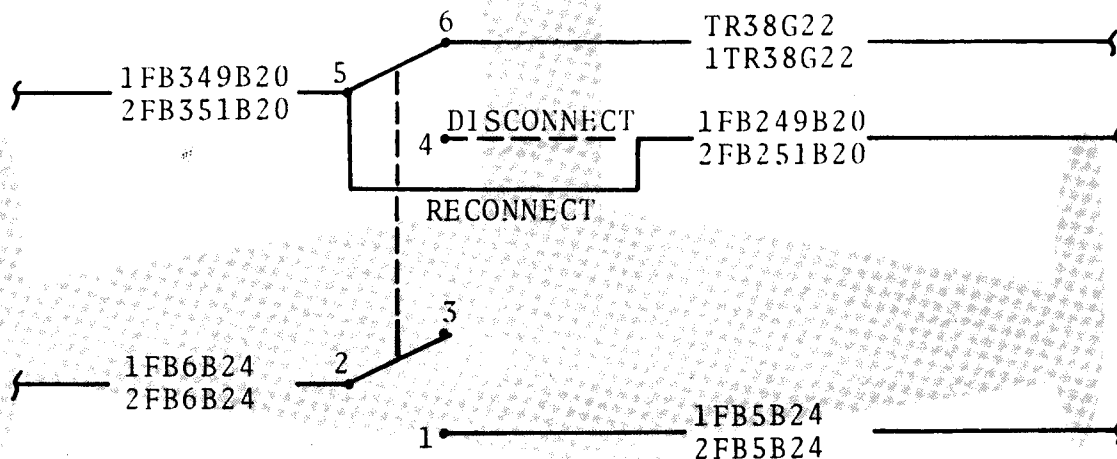
S31(#1) or S32(#2) DG SELECTOR SWITCH

The following modification will allow operation of the flight director and RNS 300 systems, without heading warning, when compass switch is moved to "DG" or free position.

These changes will still allow for proper system failure warnings.

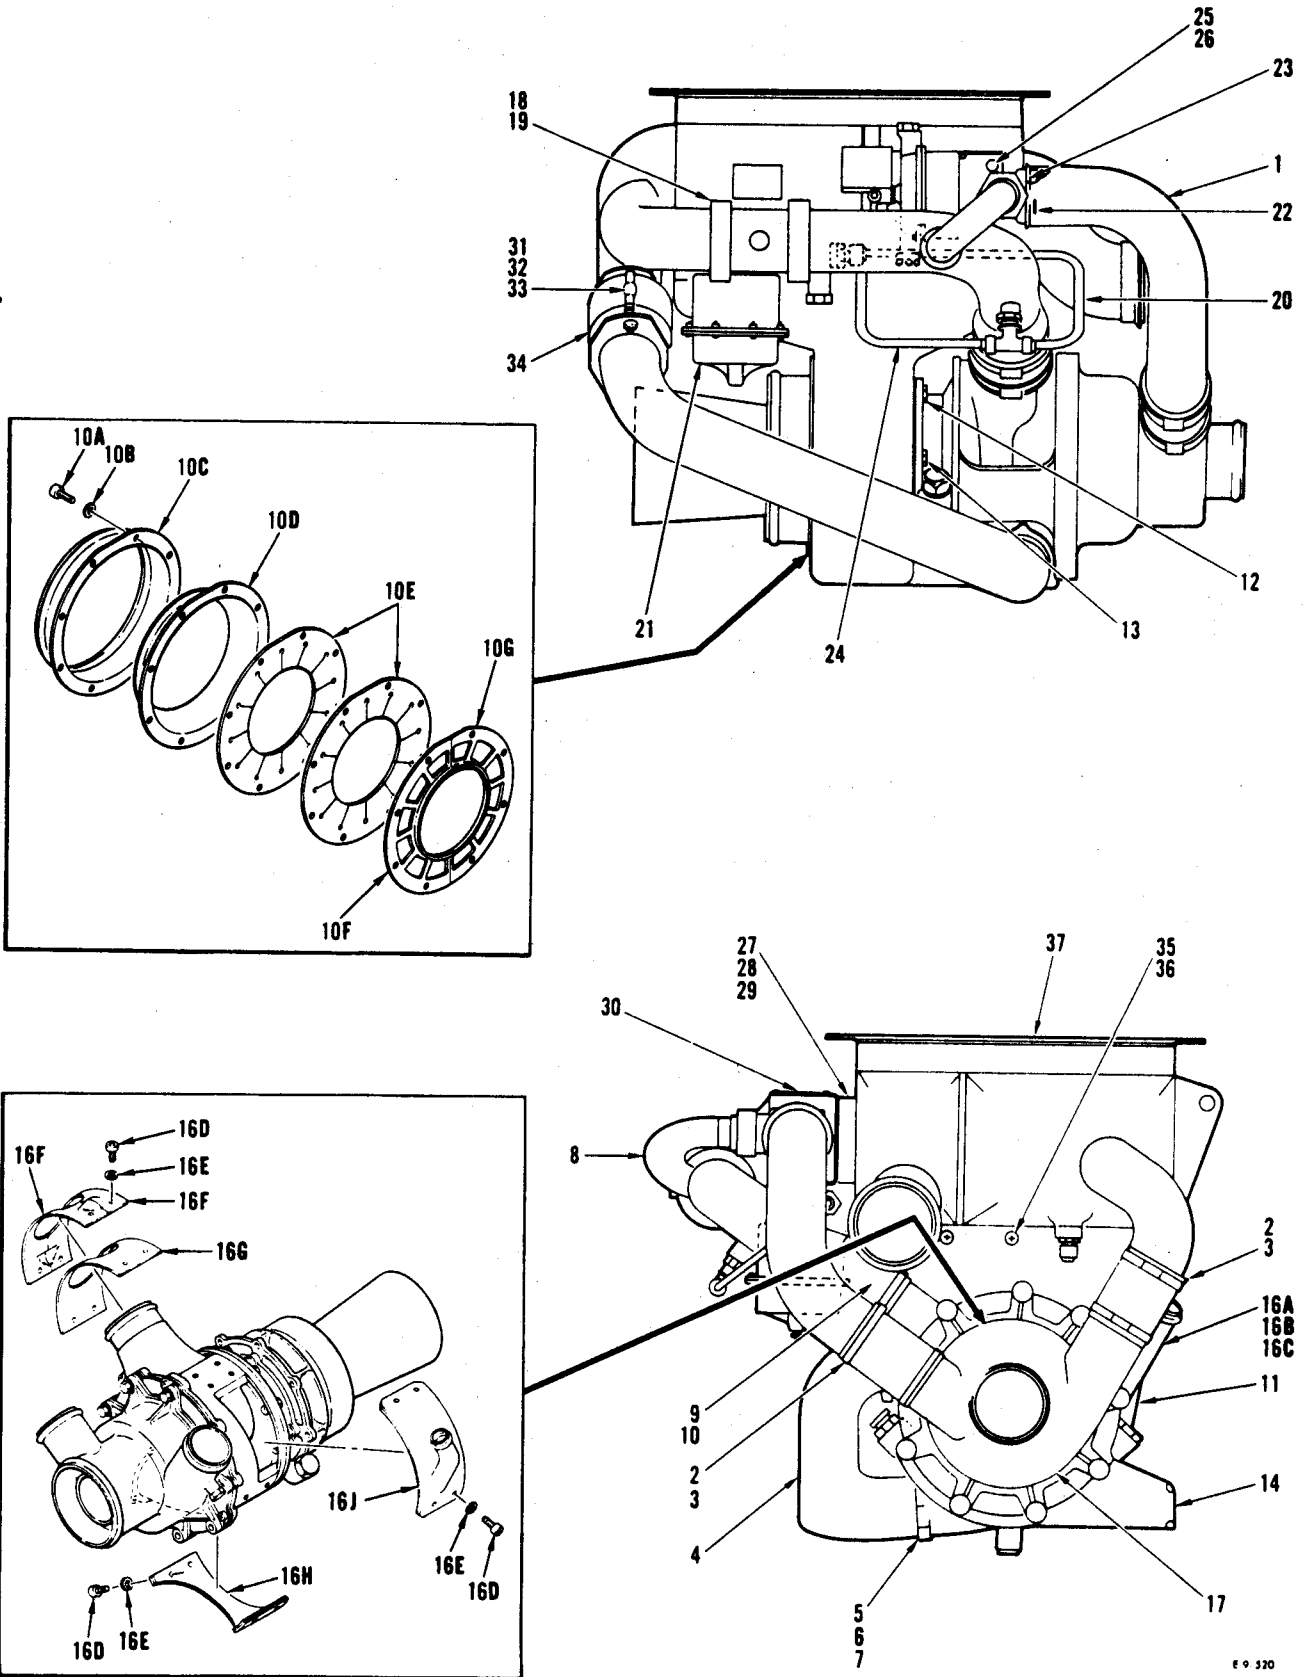
Aircraft Refrigeration Unit
Figure 1

NOTE: Install turbine in sequence noted during removal. When installing turbine bracket assembly (14, figure 1), torque the two turbine bolts 20 to 25 pound-inches.

- (2) Install new 2201977-1 Adapter Assembly with new 2201979-1 Cover Plate on replacement 572375-2 Cooling Turbine, using four new AN960PD10L Washers and four new NAS1351C3-10 Screws as shown in figure 2.

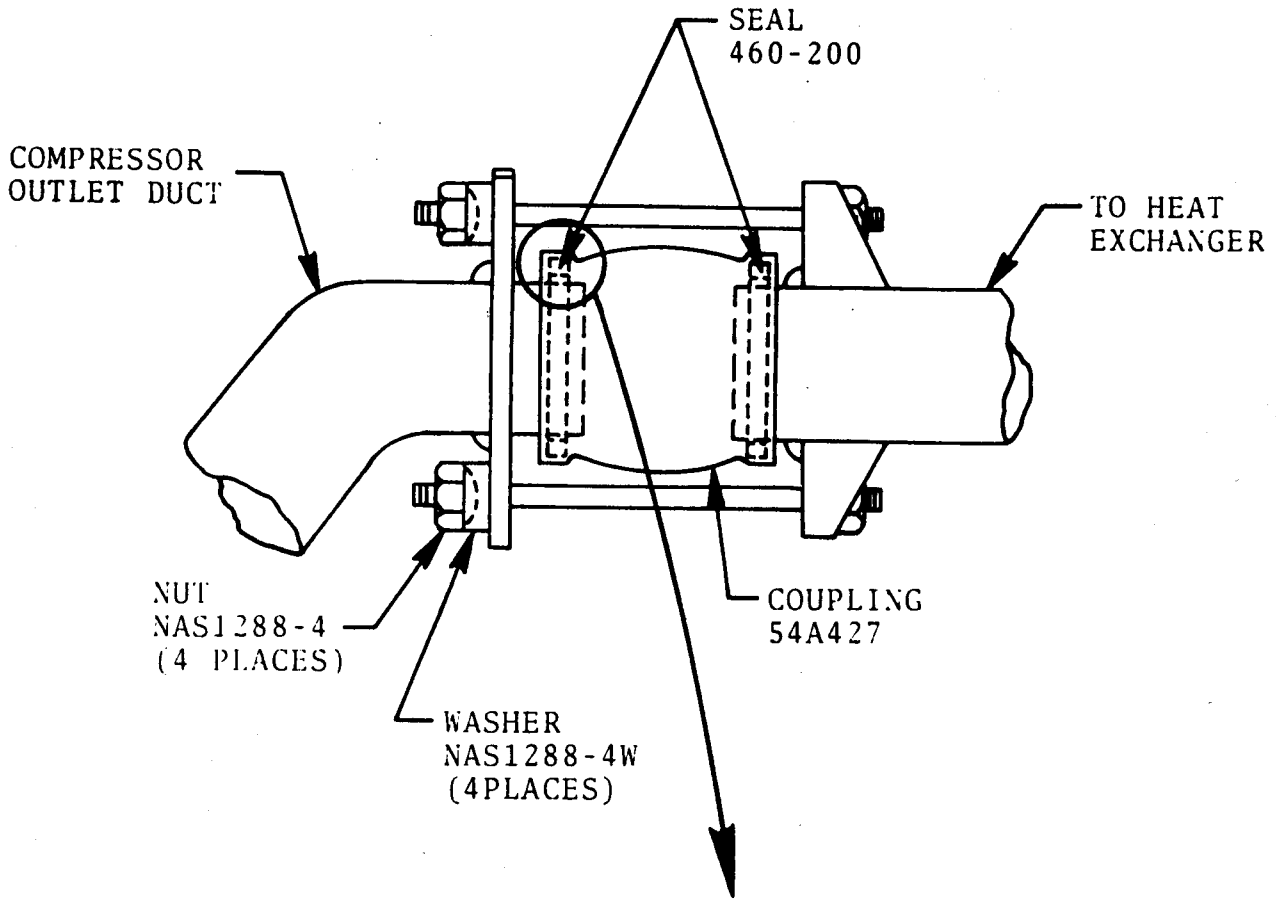
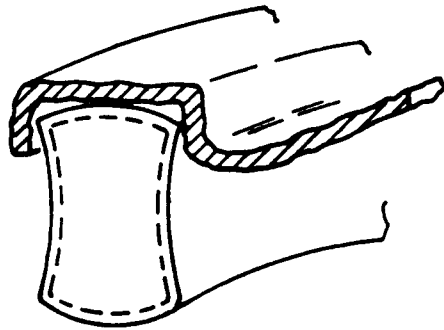
FIGURE 1 COOLING TURBINE
COUPLING

To further assure proper installation of refrigeration unit caution should be exercised in assembly of the Peri-Seal Coupling P/N 54A27 (located in the duct from the compressor outlet of the turbine to the secondary heat exchanger). New seals P/N 460-200 should be installed wherever Peri-Seal Coupling is disassembled or leakage is suspected. Reassemble Peri-Seal Coupling per Figure 1.

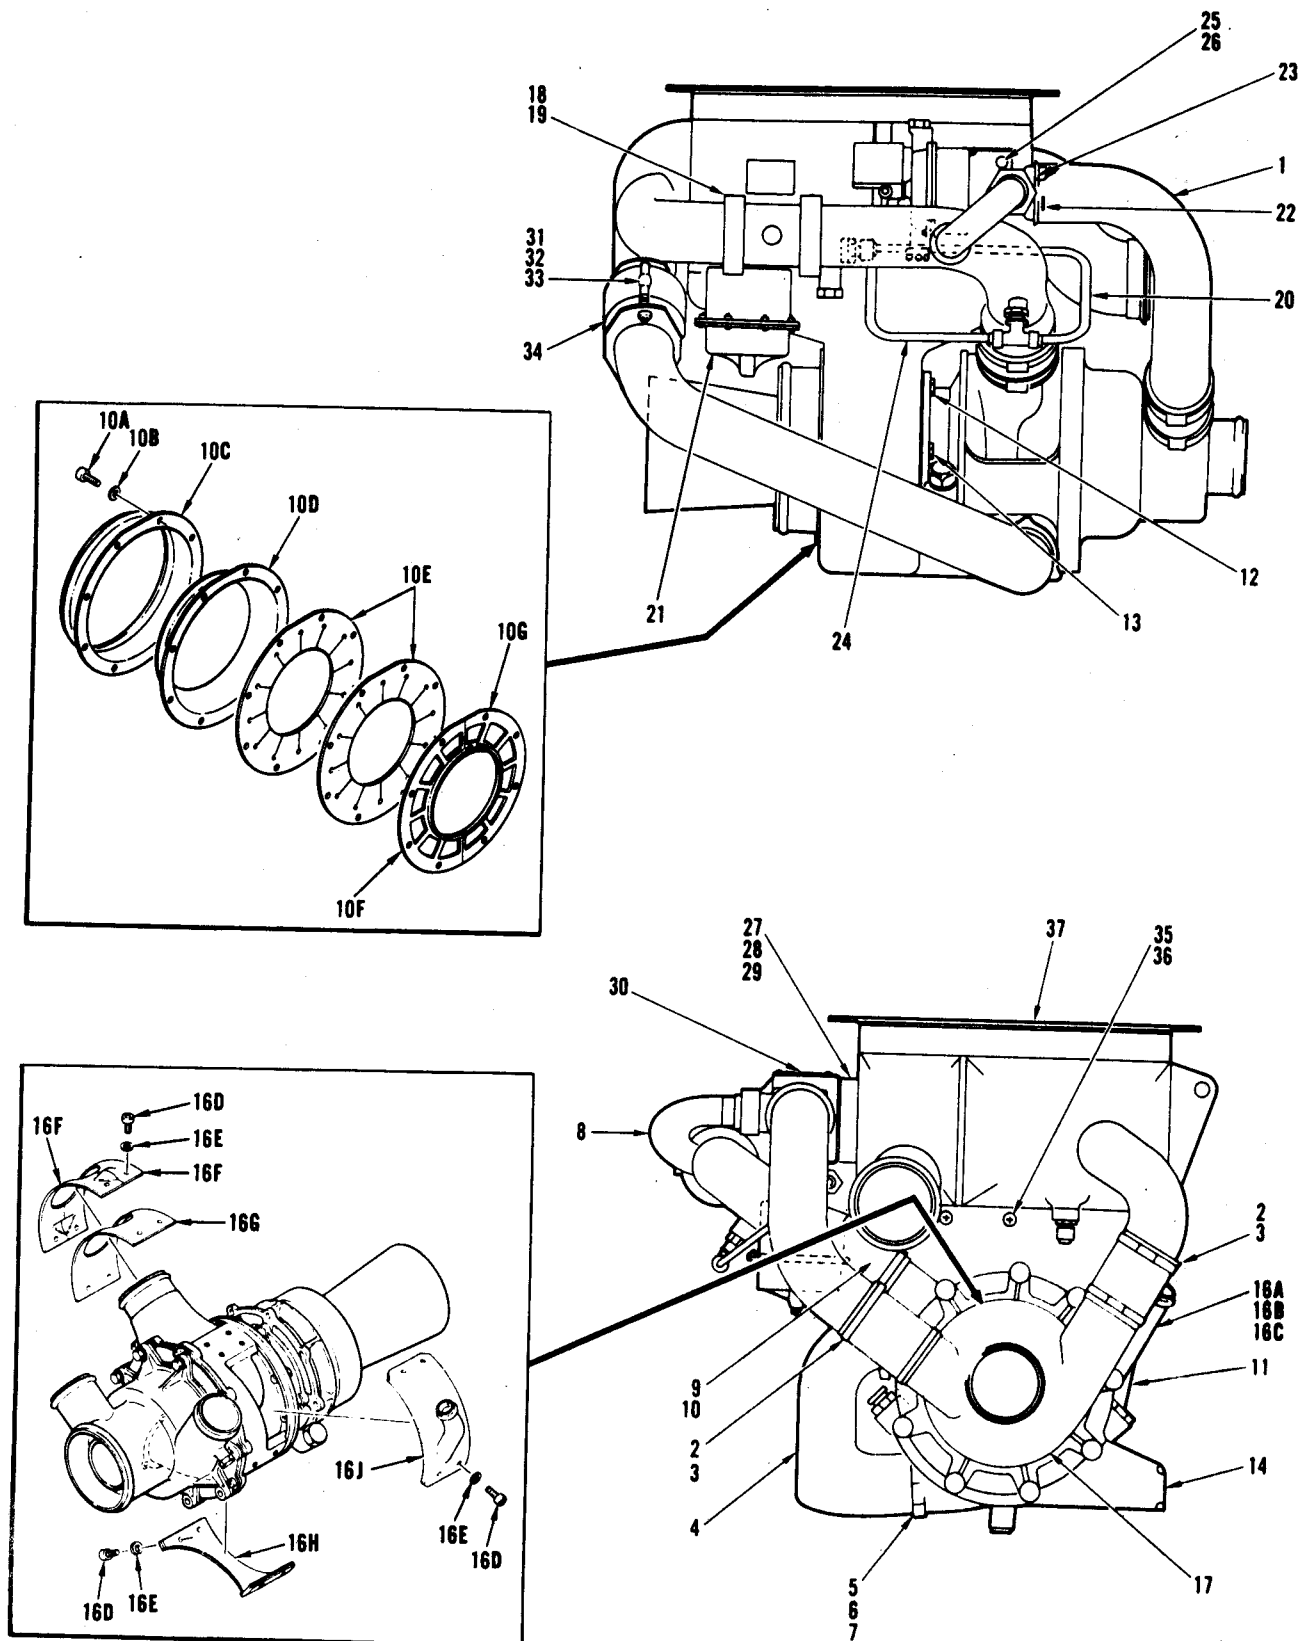
Figure 2. Aircraft Refrigeration Unit

- e. Remove screws (10A), washers (10B), flange (10C), dampener (10D), flappers (10E), and retainer halves (10F, 10G). If flappers (10E) are torn, wrinkled, or show evidence of deterioration, replace flappers.

- g. Install compressor outlet duct assembly (4) by installing nuts (31), washers (32), studs (33), and coupling (34).
- h. Install modulating and shutoff valve (30) by installing bolts (25), washers (26), and shims (27, 28, 29).

- i. Install fluid pressure regulating valve (21) by installing clamps (18) and packing (19).
- j. Connect turbine inlet duct by installing clamps (2) and hose (3).
