SERVICE INFORMATION LETTER

SERVICE INFORMATION LETTER INDEX

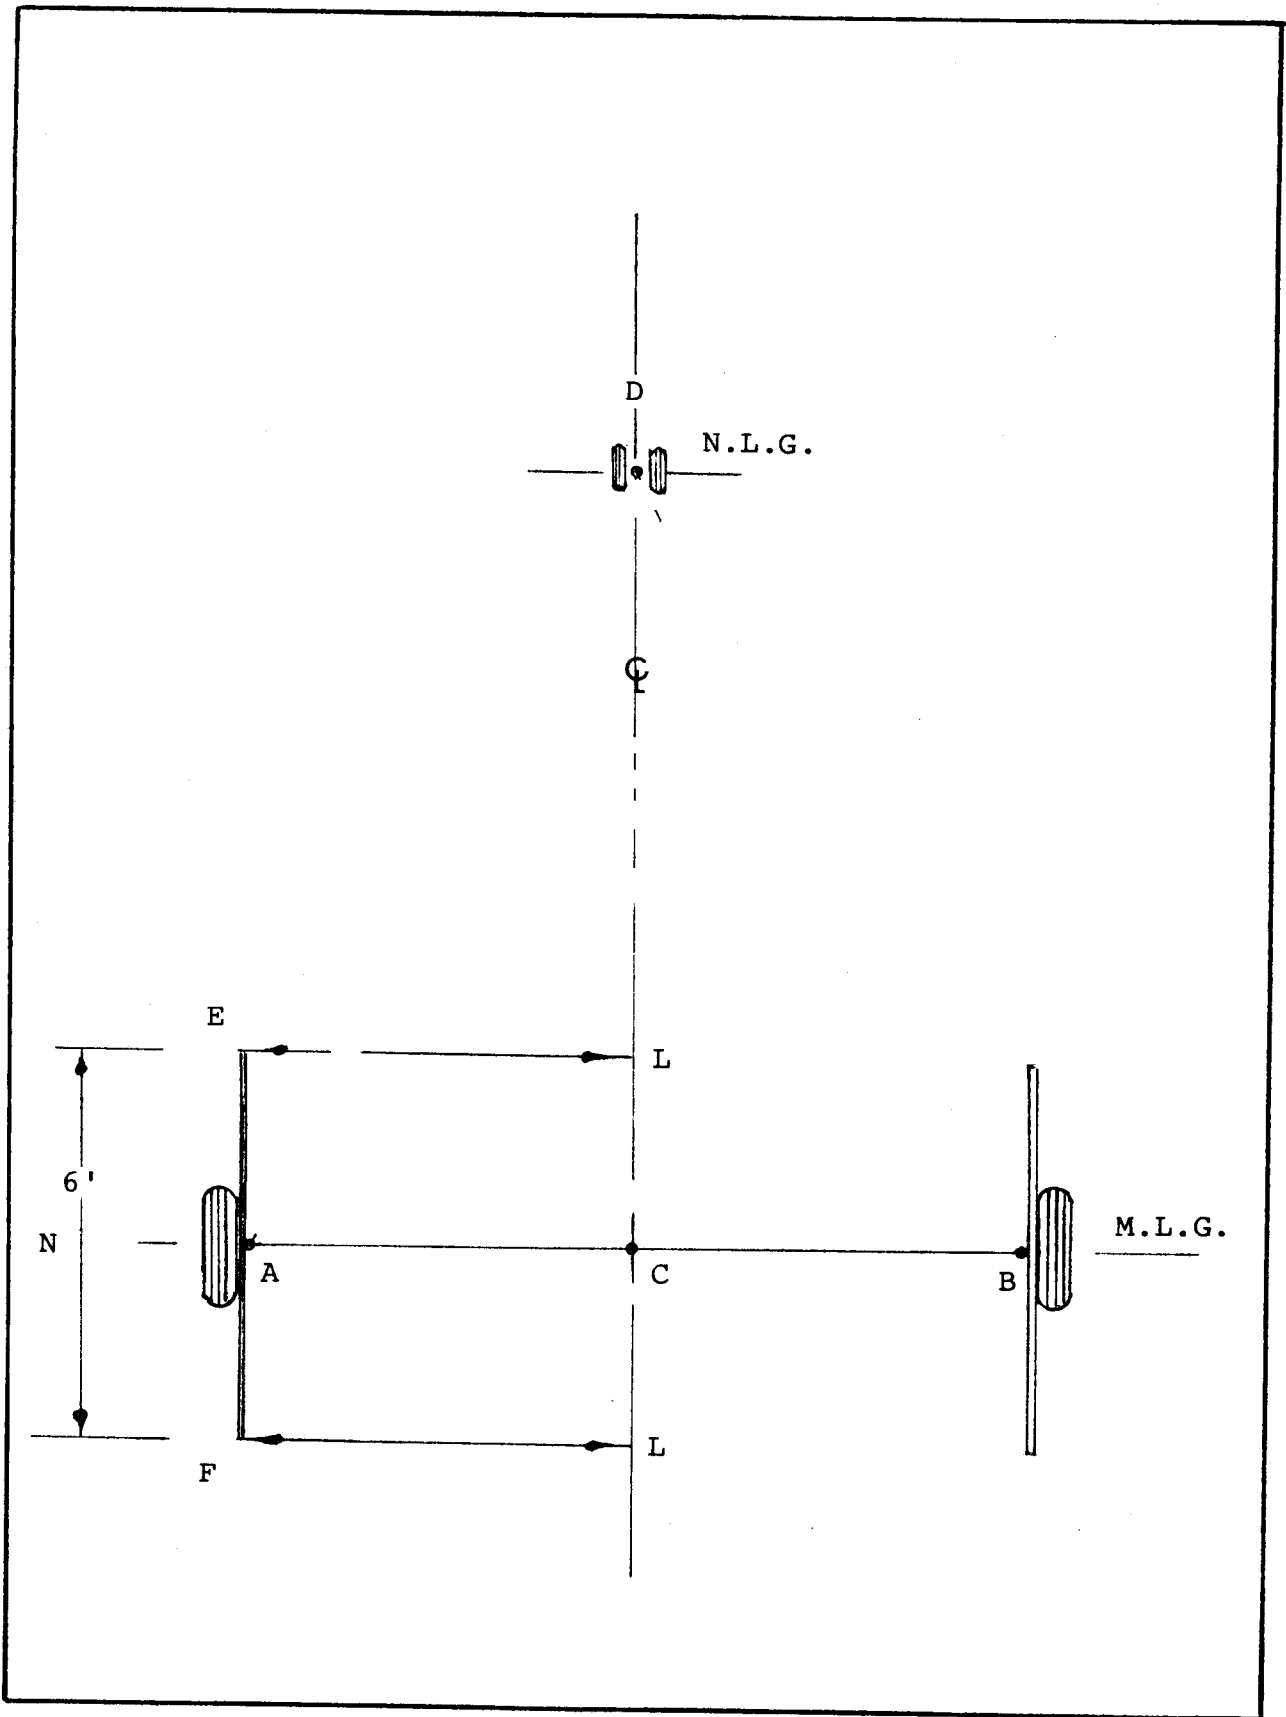
FIGURE 1

PURPOSE: CHANGE OF PARALLELISM PROCEDURES TO MINIMIZE TIRE
WEAR BY TOE-OUT ADJUSTMENT.

- d. Repeat steps 5 and 7 to check adjustment.
 - e. Install locking key on upper end of lower scissor arm.
 - f. Install bolt, washer and nut securing the locking key to the upper end of lower scissor arm. Torque nut to 50-70 in/lbs.
8. Remove straight edge and spacer from wheel.
9. Repeat step (7) on the opposite wheel.
10. Replace fuses in jet pack and check standby horizon operation.
11. Remove the aircraft from jacks.

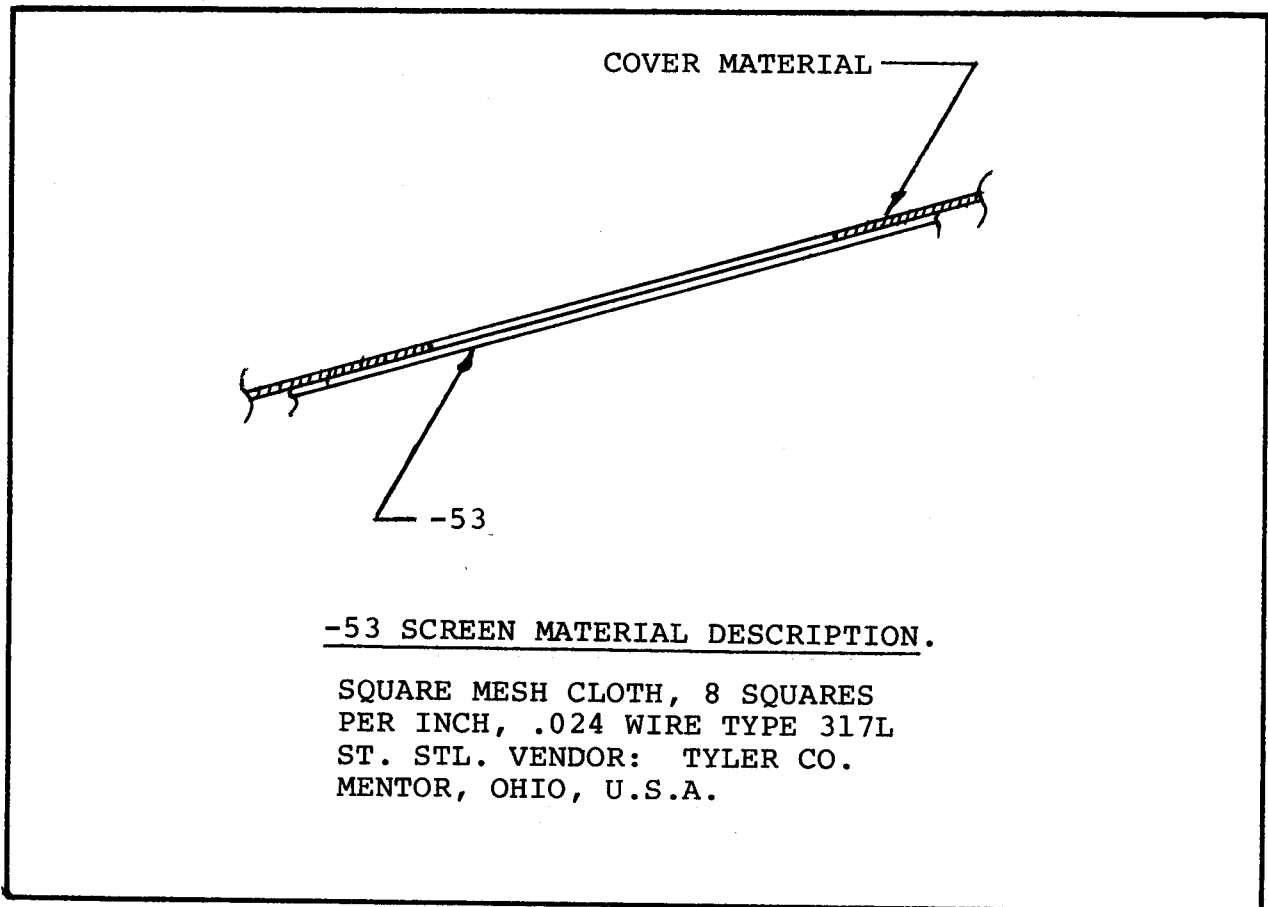
-53 SCREEN MATERIAL DESCRIPTION.

SQUARE MESH CLOTH, 8 SQUARES
PER INCH, .024 WIRE TYPE 317L
ST. STL. VENDOR: TYLER CO.
MENTOR, OHIO, U.S.A.

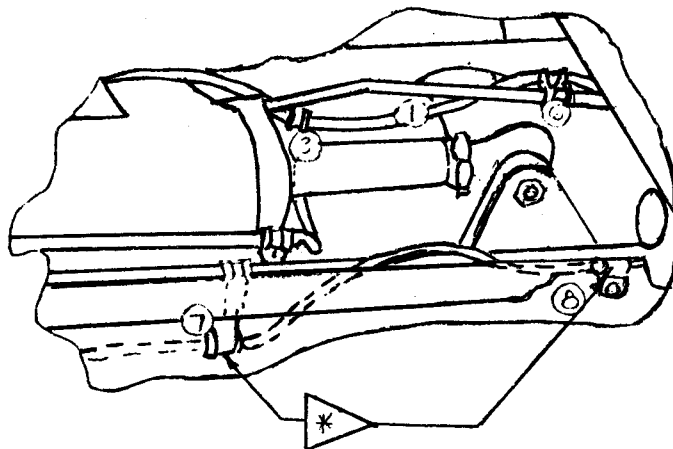
FIGURE 1

THRUST REVERSER WIRING
(L/H NACELLE ONLY)

WRAP SUFFICIENT TAPE AT 7 & 8
(GT100AY0101108) AROUND WIRE
BUNDLE TO RESTRICT SLIDING
THRU CLAMPS

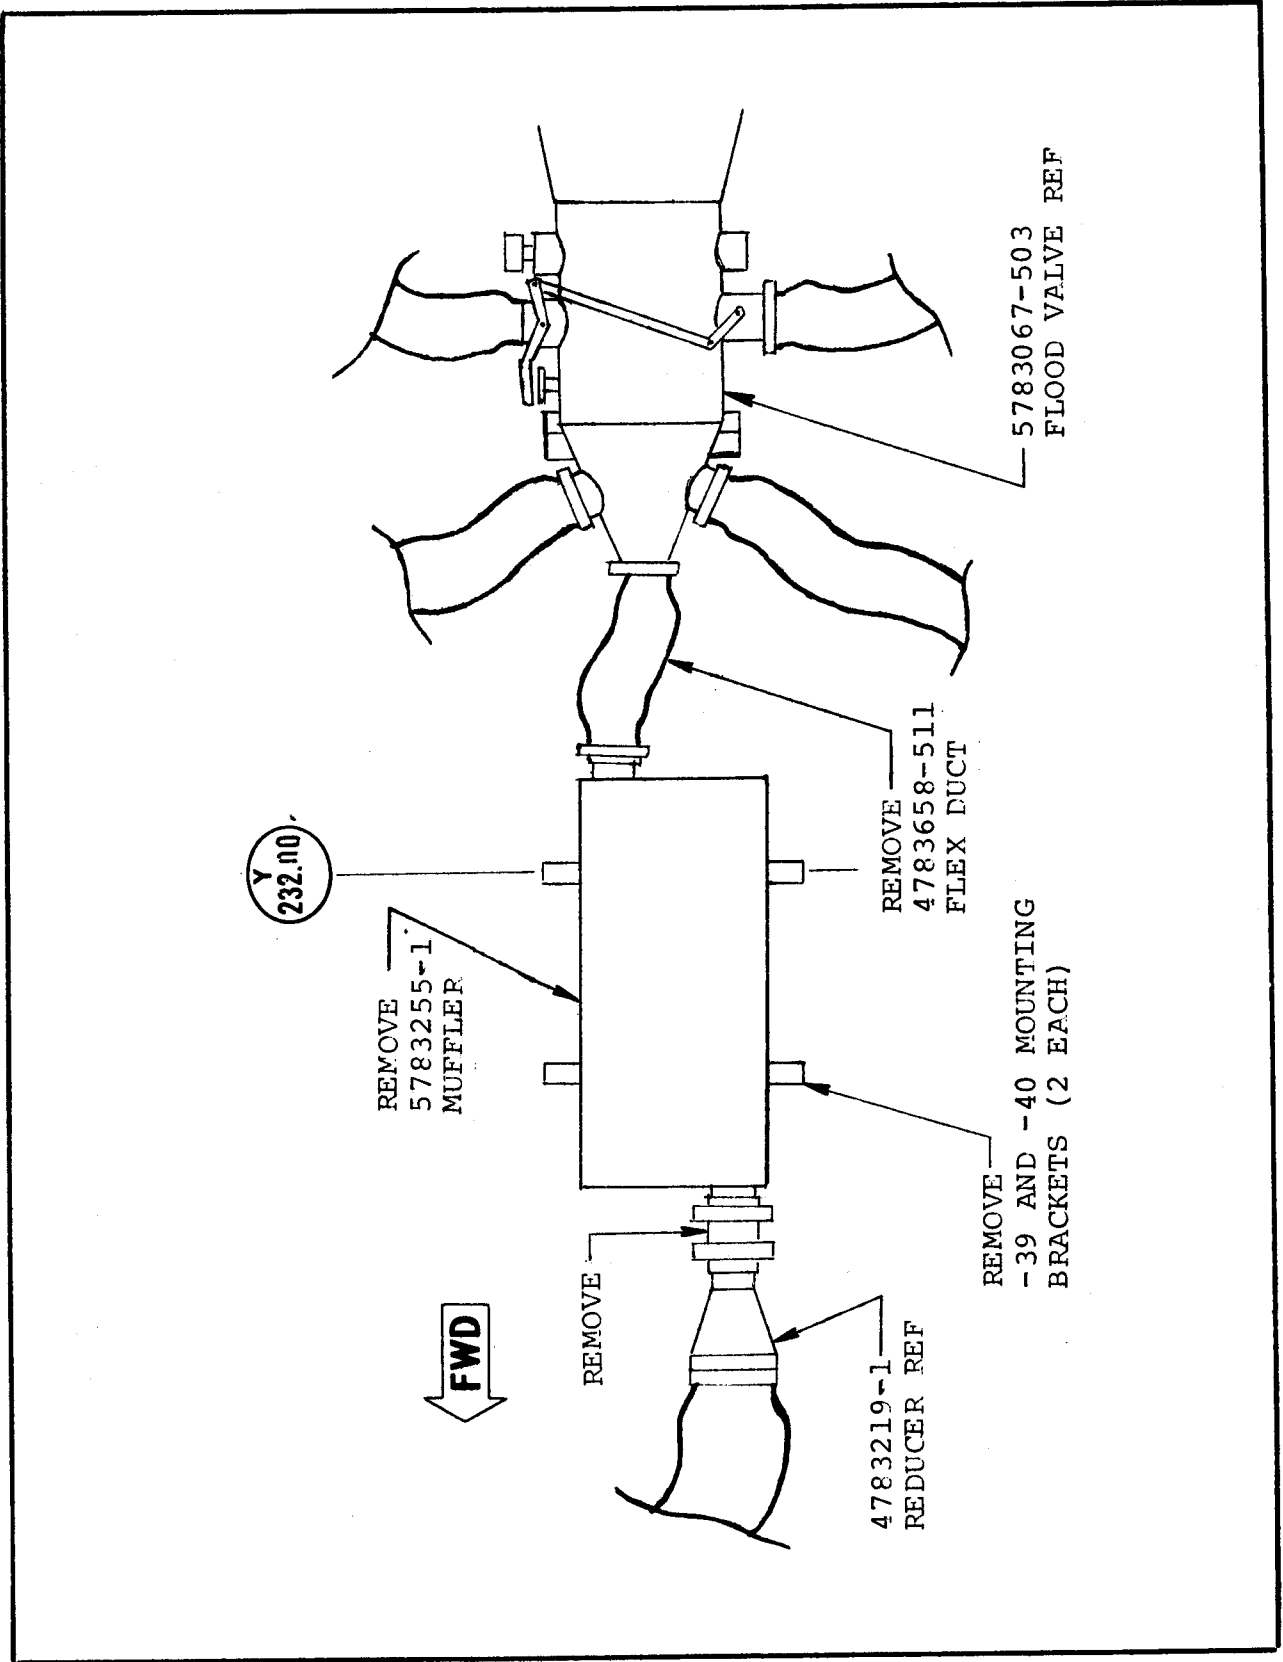
FIGURE 1

EFFECTIVITY: MODEL 1124 AIRCRAFT, S/N 187, 188, AND 189
SUBJECT: REMOVAL OF AIR-CONDITIONING MUFFLER
COMPLIANCE: AT NEXT 150 HOURS INSPECTION.
APPROVAL: I.A.I. ENGINEERING.
PURPOSE: TO INCREASE THE FLOW OF CONDITIONED AIR
TO COCKPIT.

1. Gain access to air-condition muffler under the floor in rear cabin area.
2. Remove floor as required to enable work.
3. Disconnect and remove Muffler P/N 5783255-1, Flex Duct P/N 4783658-511, coupling duct, and Clamps P/N U84-210SH. Drill out rivets of -39 and -40 muffler mounting brackets; remove brackets. (SEE FIGURE 1)
4. Install Flex Duct P/N 4783658-523 between Reducer P/N 4783219-1 and Flood Valve P/N 5783067-503, using 2 each Clamps P/N U84-210SH originally removed (SEE FIGURE 2).
5. Relocate one -40 bracket to provide support for Flex Duct P/N 4783658-523, and secure with NAS1398D4-2 rivets. Install Clamp P/N MS21919DG35; locate and drill .190 dia. hole in -40 bracket for proper alignment of Flex Duct. Secure Clamp to bracket with AN3C4 Bolt, AN960-10L Washers (2 required), and MS20365-1032 Nut. (SEE FIGURE 2)
6. Close up floor and reinstall interior.

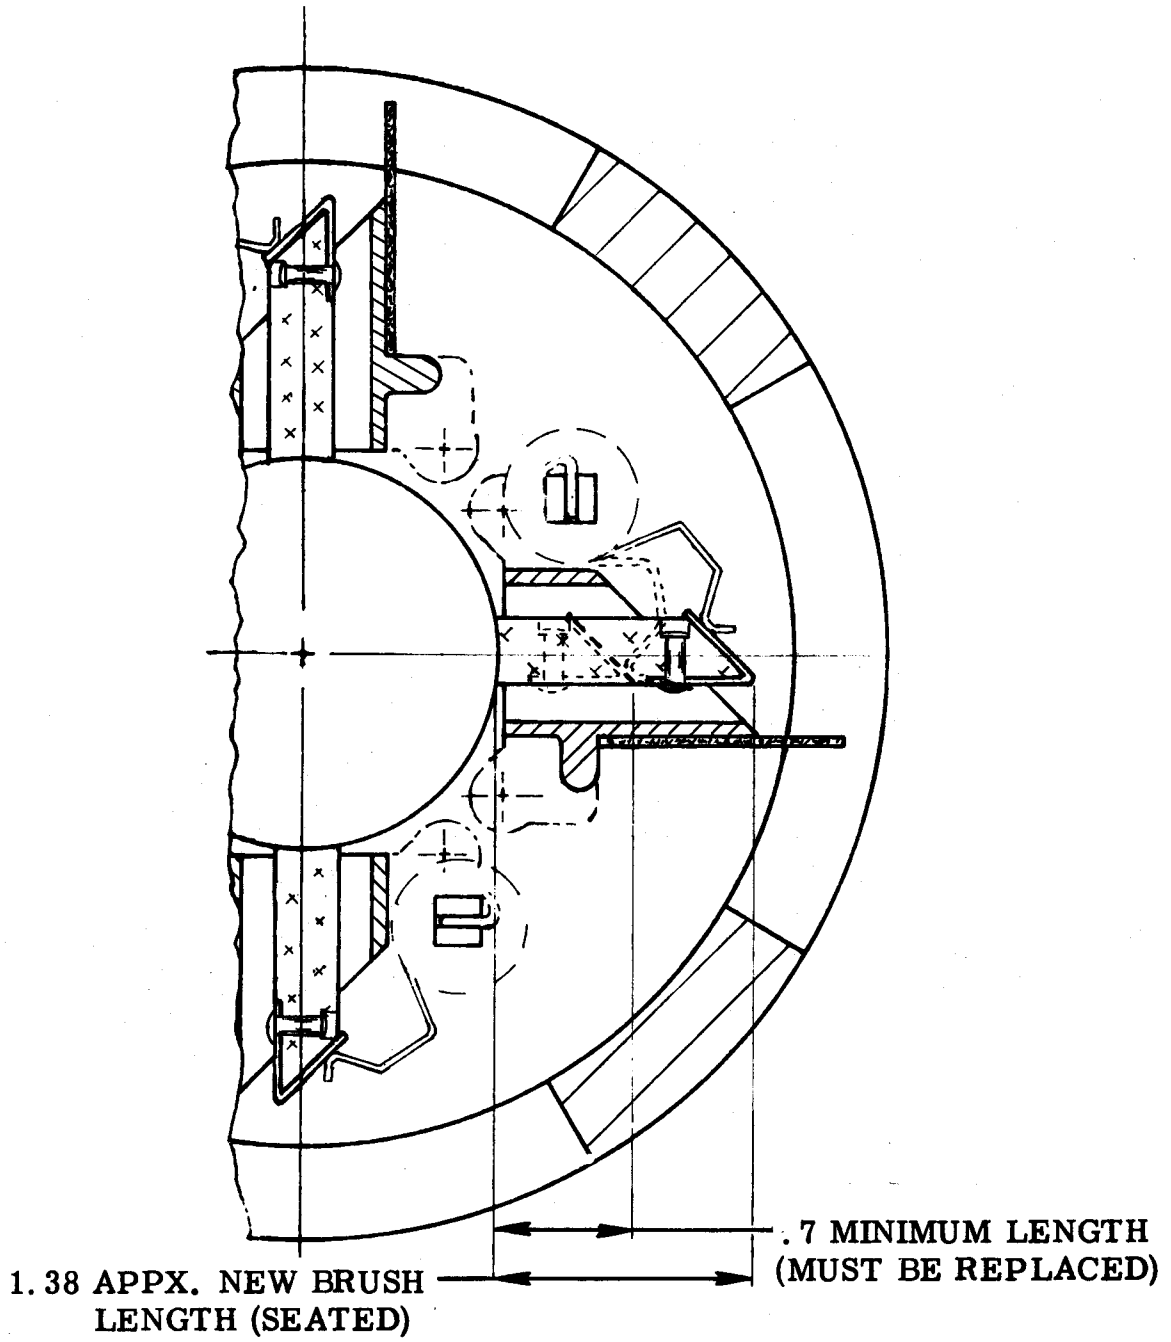
MEASUREMENT OF STARTER-GENERATOR BRUSHES

5. A newly installed brush has an approximate over all length of 1.38 inch (Seated). It is recommended the brush assemblies be replaced when brushes are worn to a length of .875 inch, or 450 operating hours, whichever occurs first. Brushes must be replaced when worn to a .70 inch overall length. (SEE FIGURE 2).

CONTINUED USE OF THE STARTER-GENERATOR WITH ANY BRUSH OF MINIMUM LENGTH OR LESS WILL LIKELY RESULT IN DAMAGE TO THE COMMUTATOR AND FAILURE OF THE STARTER-GENERATOR.

BRUSH FULLY WORN
(MUST BE REPLACED)

6. Make a judgement of remaining usable brush wear length and estimated operating hours. Any brush with less than 50 hours estimated operating time remaining requires the starter-generator to be scheduled for brush assembly replacement.

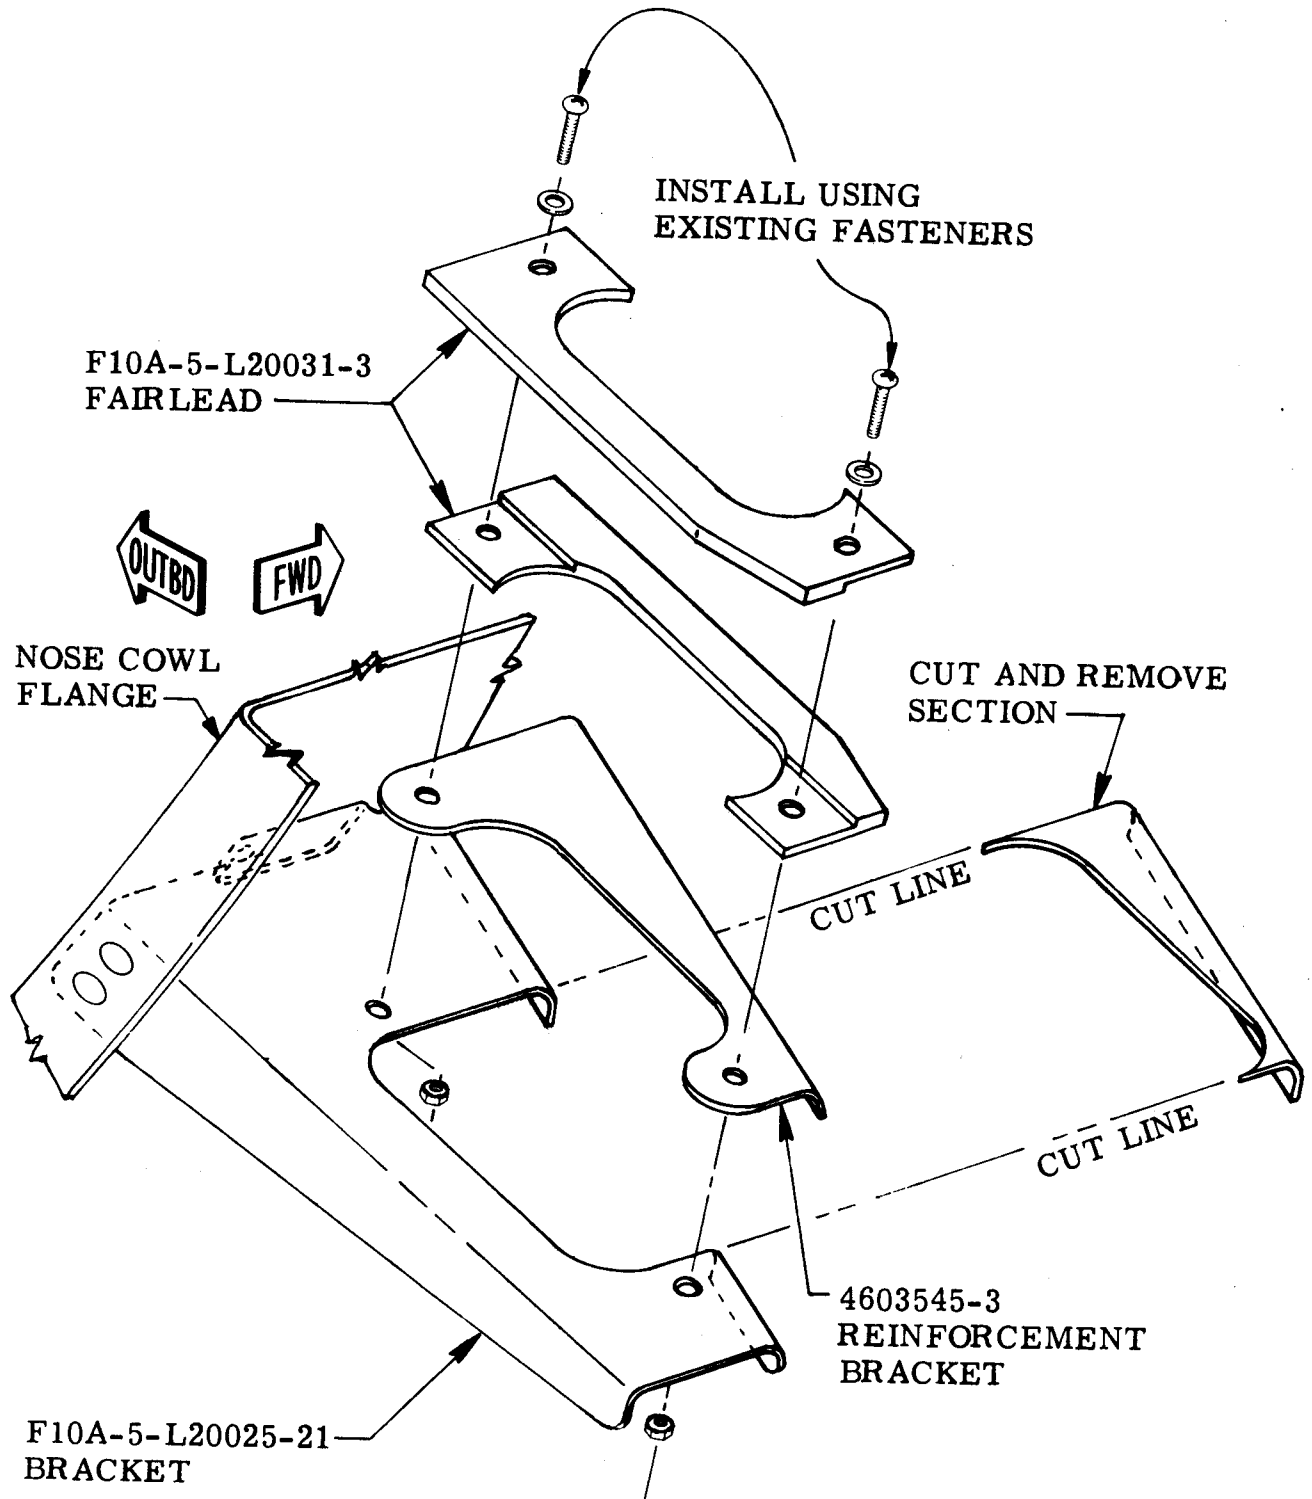
FIGURE 1

GENERATOR CABLES SUPPORT BRACKET INSTALLATION
- REWORK -

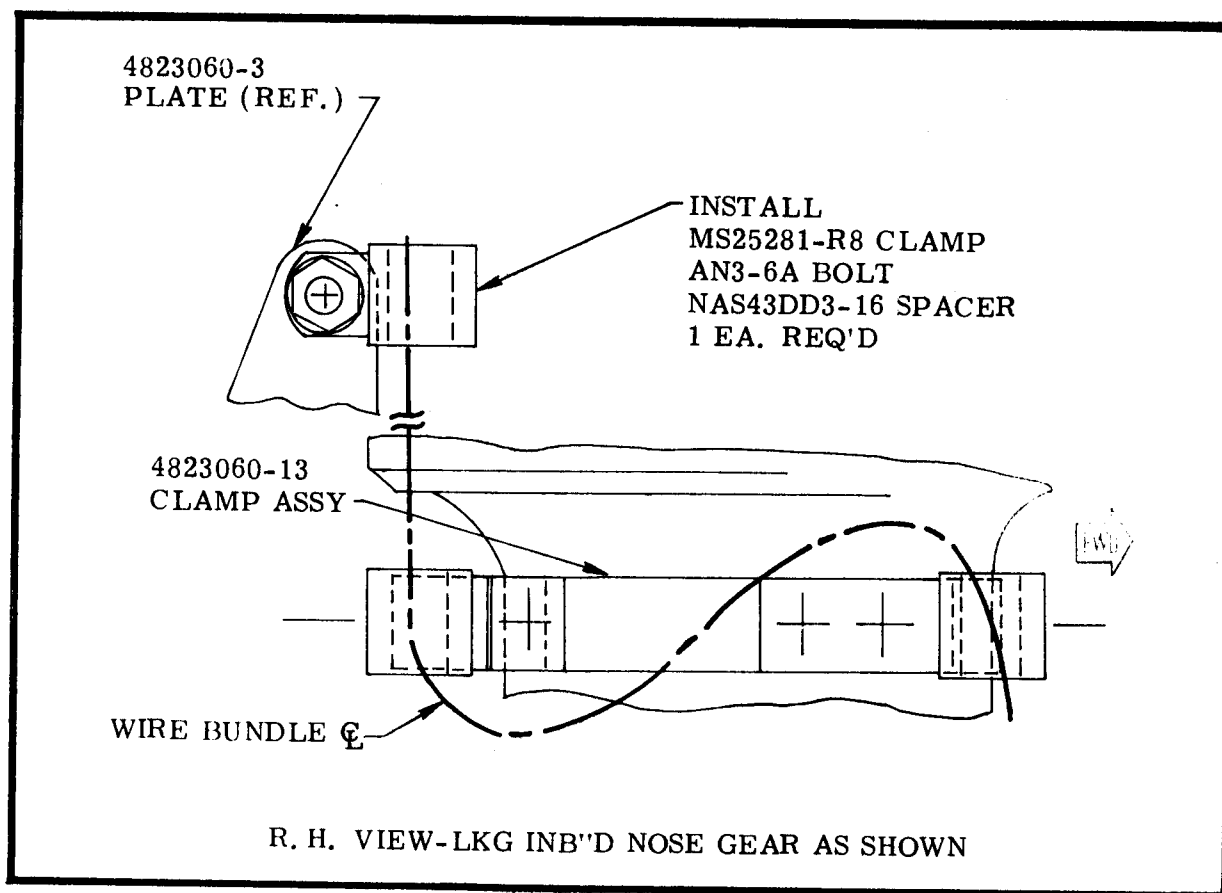
FIGURE 1

Make appropriate entry in aircraft permanent maintenance records as follows:
Service Letter No. WW-2413, dated December 20, 1977, entitled "Wire Chaffing
in Nose Gear Well" accomplished _____ (Date) _____.

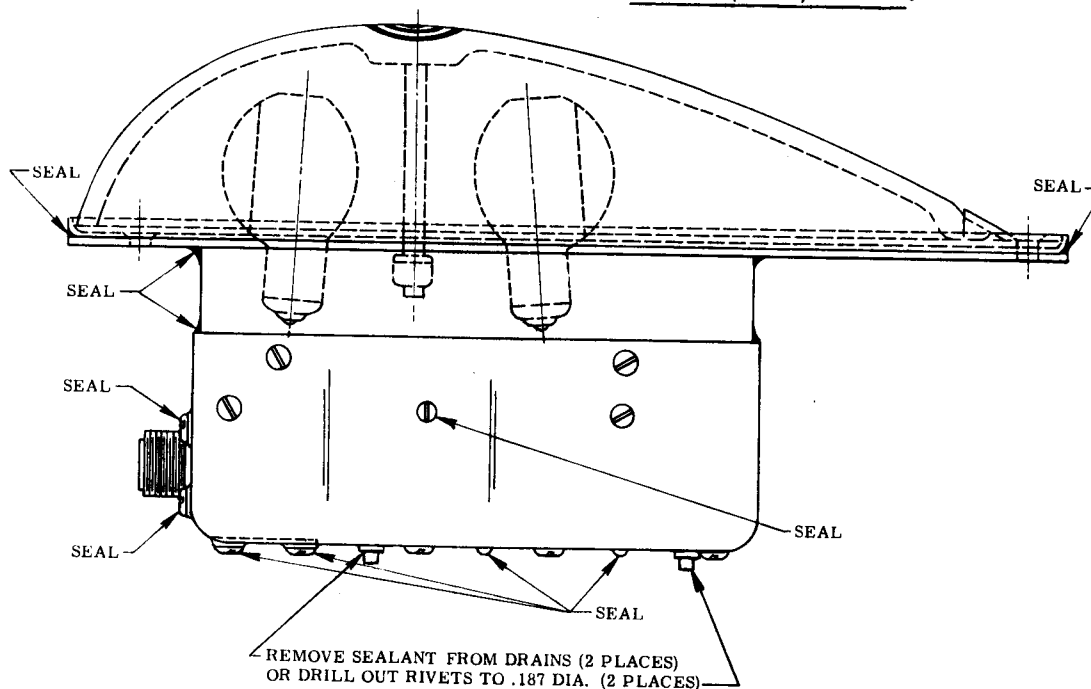
FIGURE 1

CLEARANCE OF DRAINS AND APPLICATION OF SEALANT

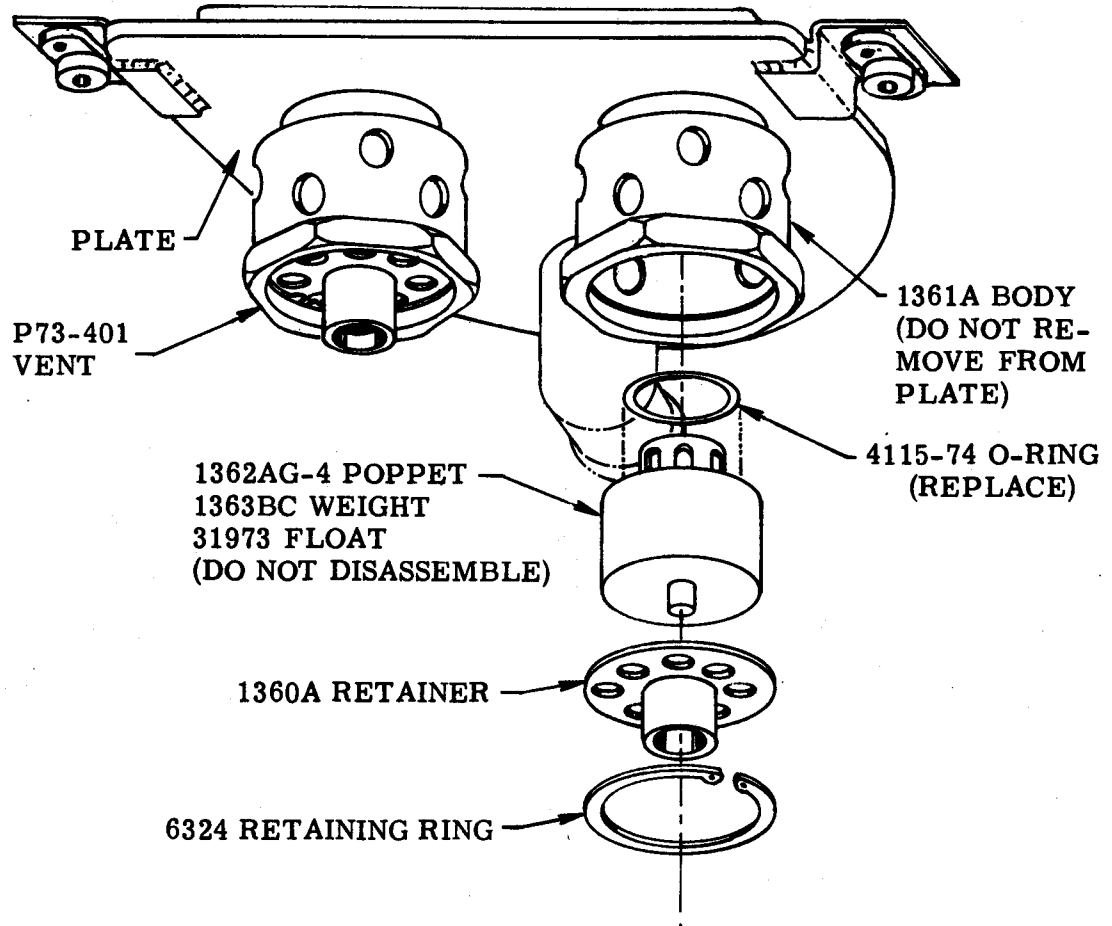
FIGURE 1

TYPICAL 5653112 FUEL VALVE ASSEMBLY

4. Perform inspection of O-rings and functional testing of the fuel vent valve assembly as follows:
 - A. Prior to installation, inspect for any surface defects on the O-rings; if no defects are detected, assemble the valves. (SEE FIGURE 1)

- D. Remove assembly from fuel and check tubing for fuel, indicating seal leakage. If any leakage is detected, replace faulty O-ring(s) and repeat immersion test until no leakage is detected.

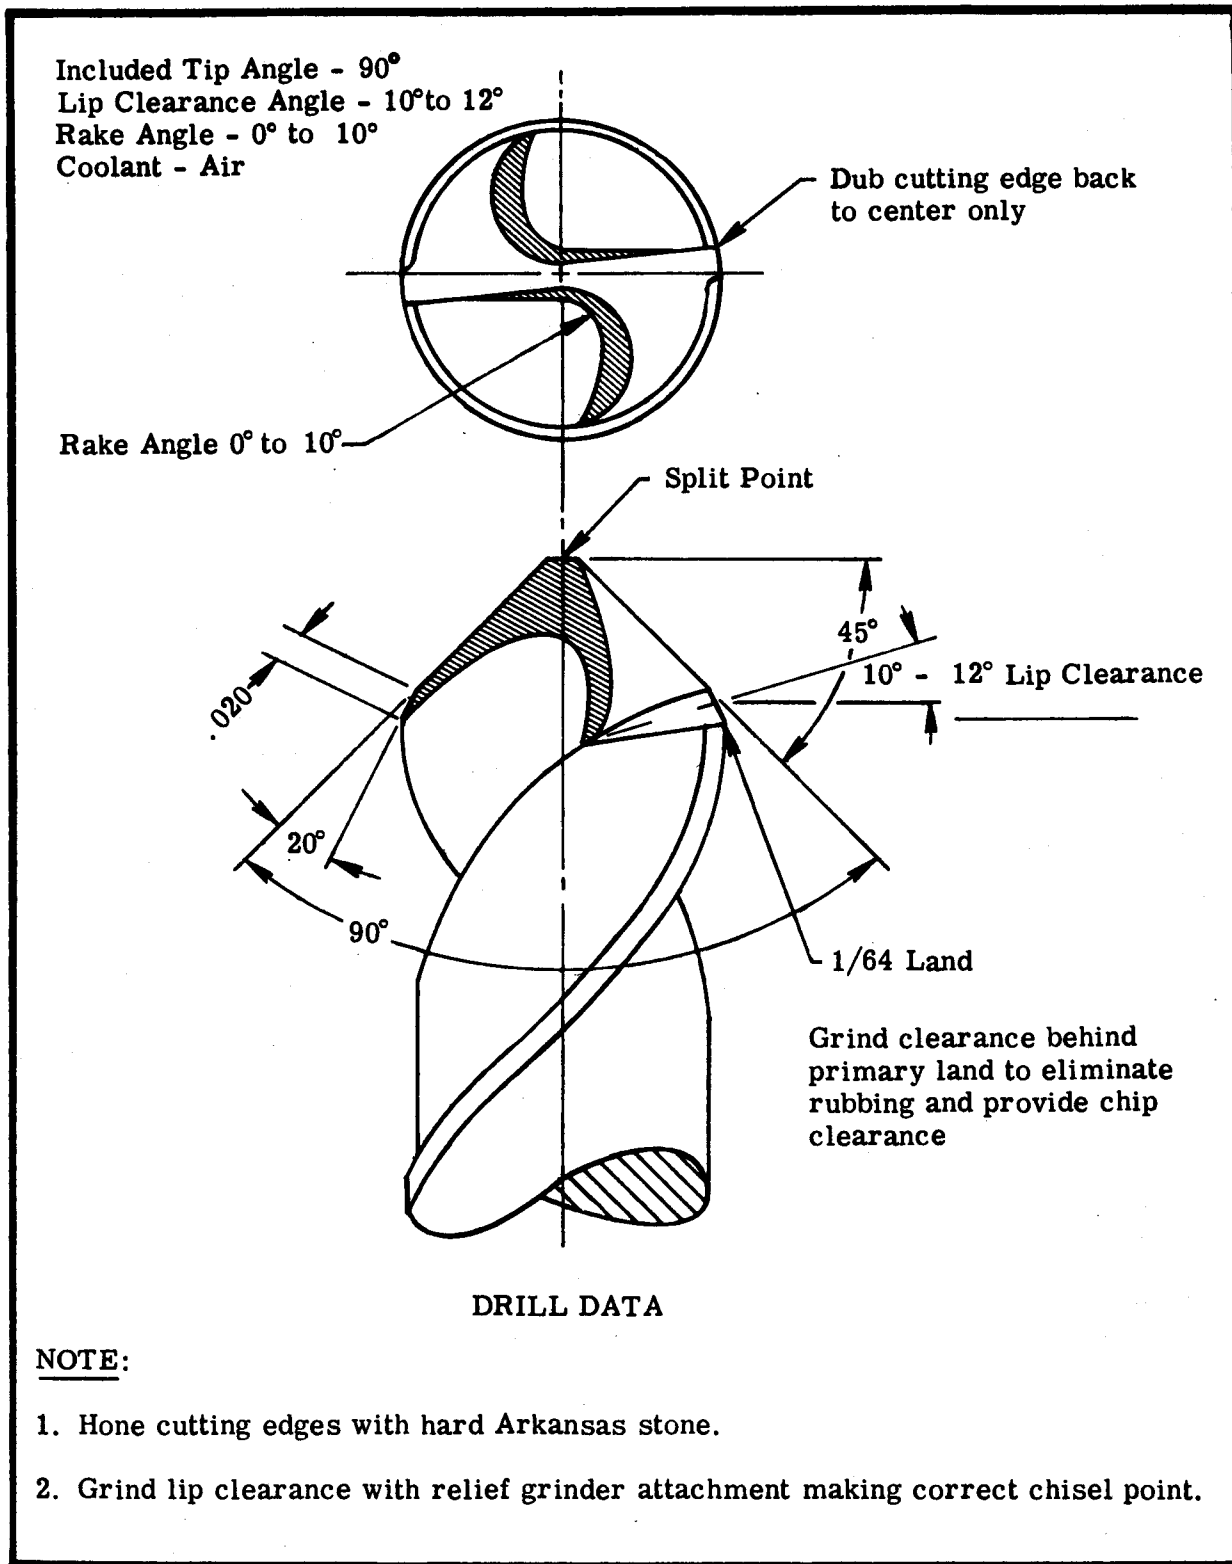
FIGURE 3

- A. Holes drilled in Plexiglas windows shall be smooth and transparent.
- B. The hole must be free of crazing or any defect which would concentrate strain at one point.

NOTE 1: Drill must be suitable for drilling acrylics. A drill modified to conform to the one depicted in Figure 3, is recommended. See Part III "Drilling Holes in Plexiglass" before beginning drilling operations.

1. This procedure covers the drilling of holes, the special drills to be used, and the quality of the finished hole.
2. The following equipment may be required:
 - A. Air nozzle for cooling
 - B. Vaseline for lubricant
3. Drilling process:
 - A. Prepare the proper drill using Figure 3 as a guide. (SEE Part I, Para. 3, Note 2 for recommended drill.)

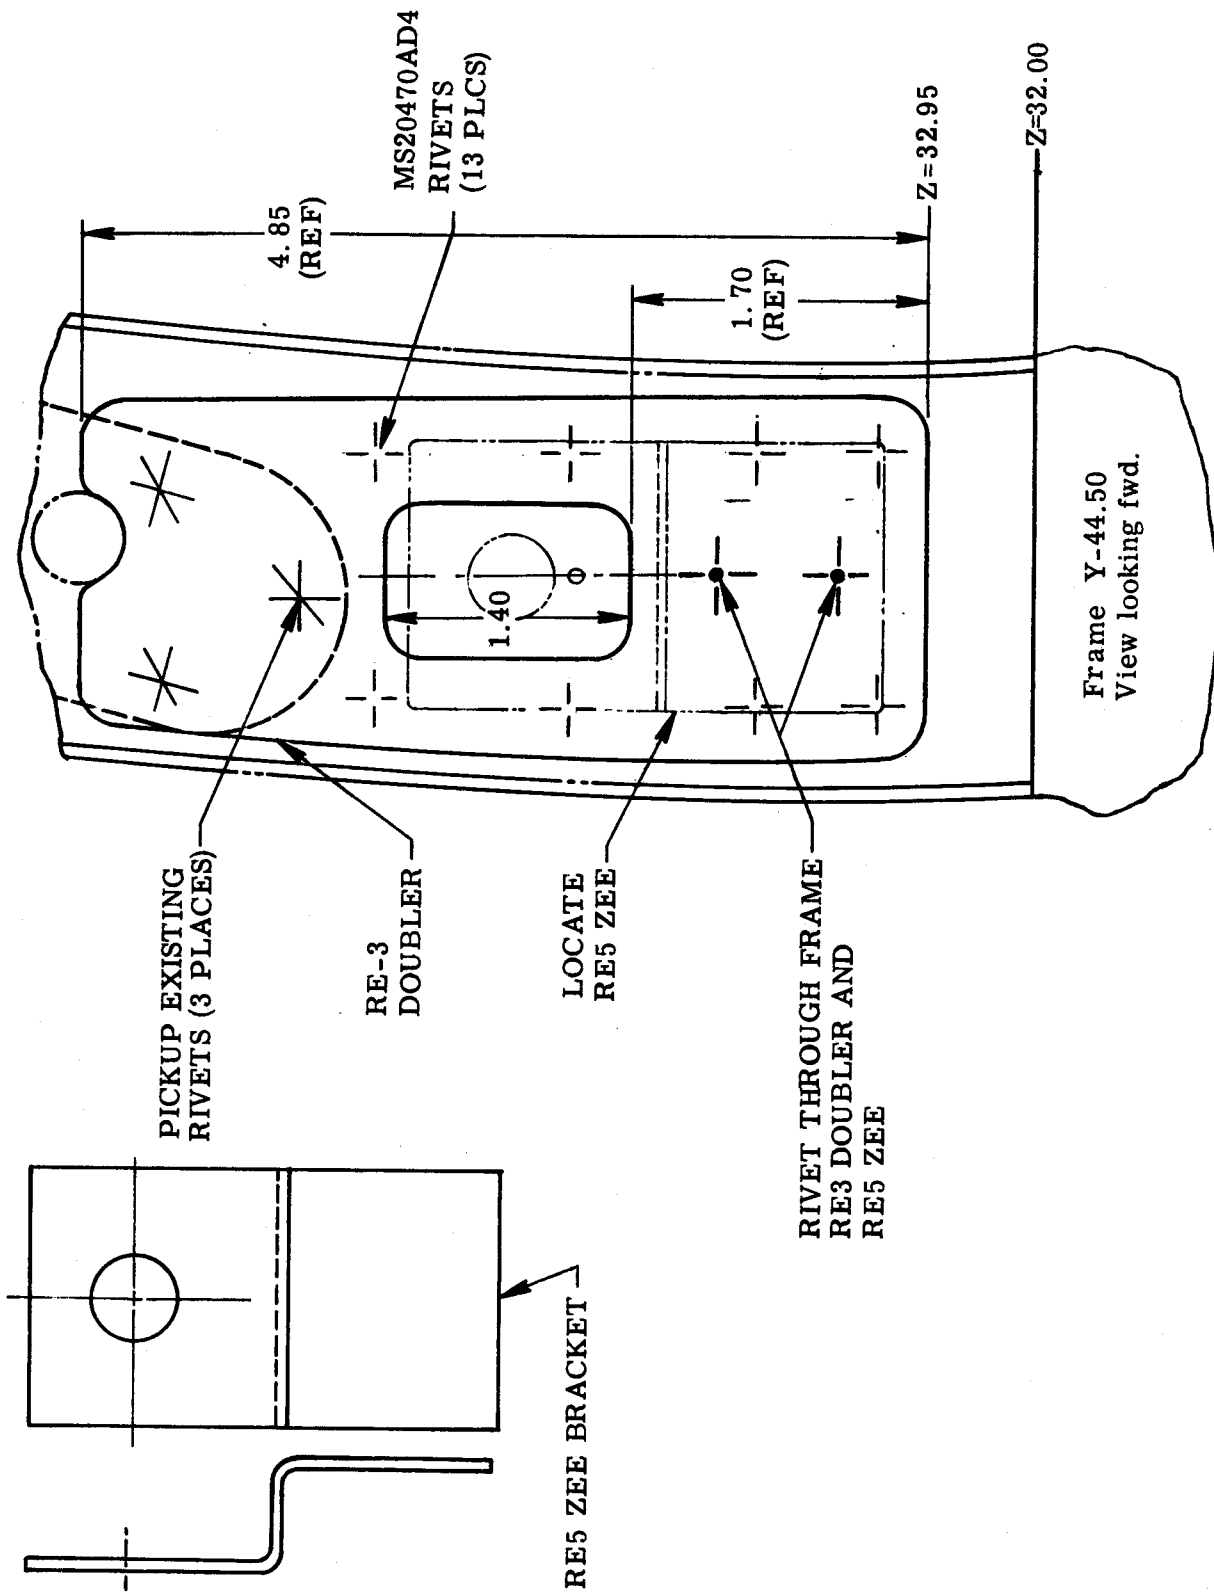
FIGURE 1

DOUBLER AND BRACKET INSTALLATION

6. Install RE3 doubler and RE5 zee bracket on Fus. Sta. 44.50 frame in accordance with Figure 1.
7. Temporarily replace pilots side panel to permit locating and marking position for RE7 placard installation. Mark center of hole to be drilled to accommodate nose steering sensitivity switch installation.

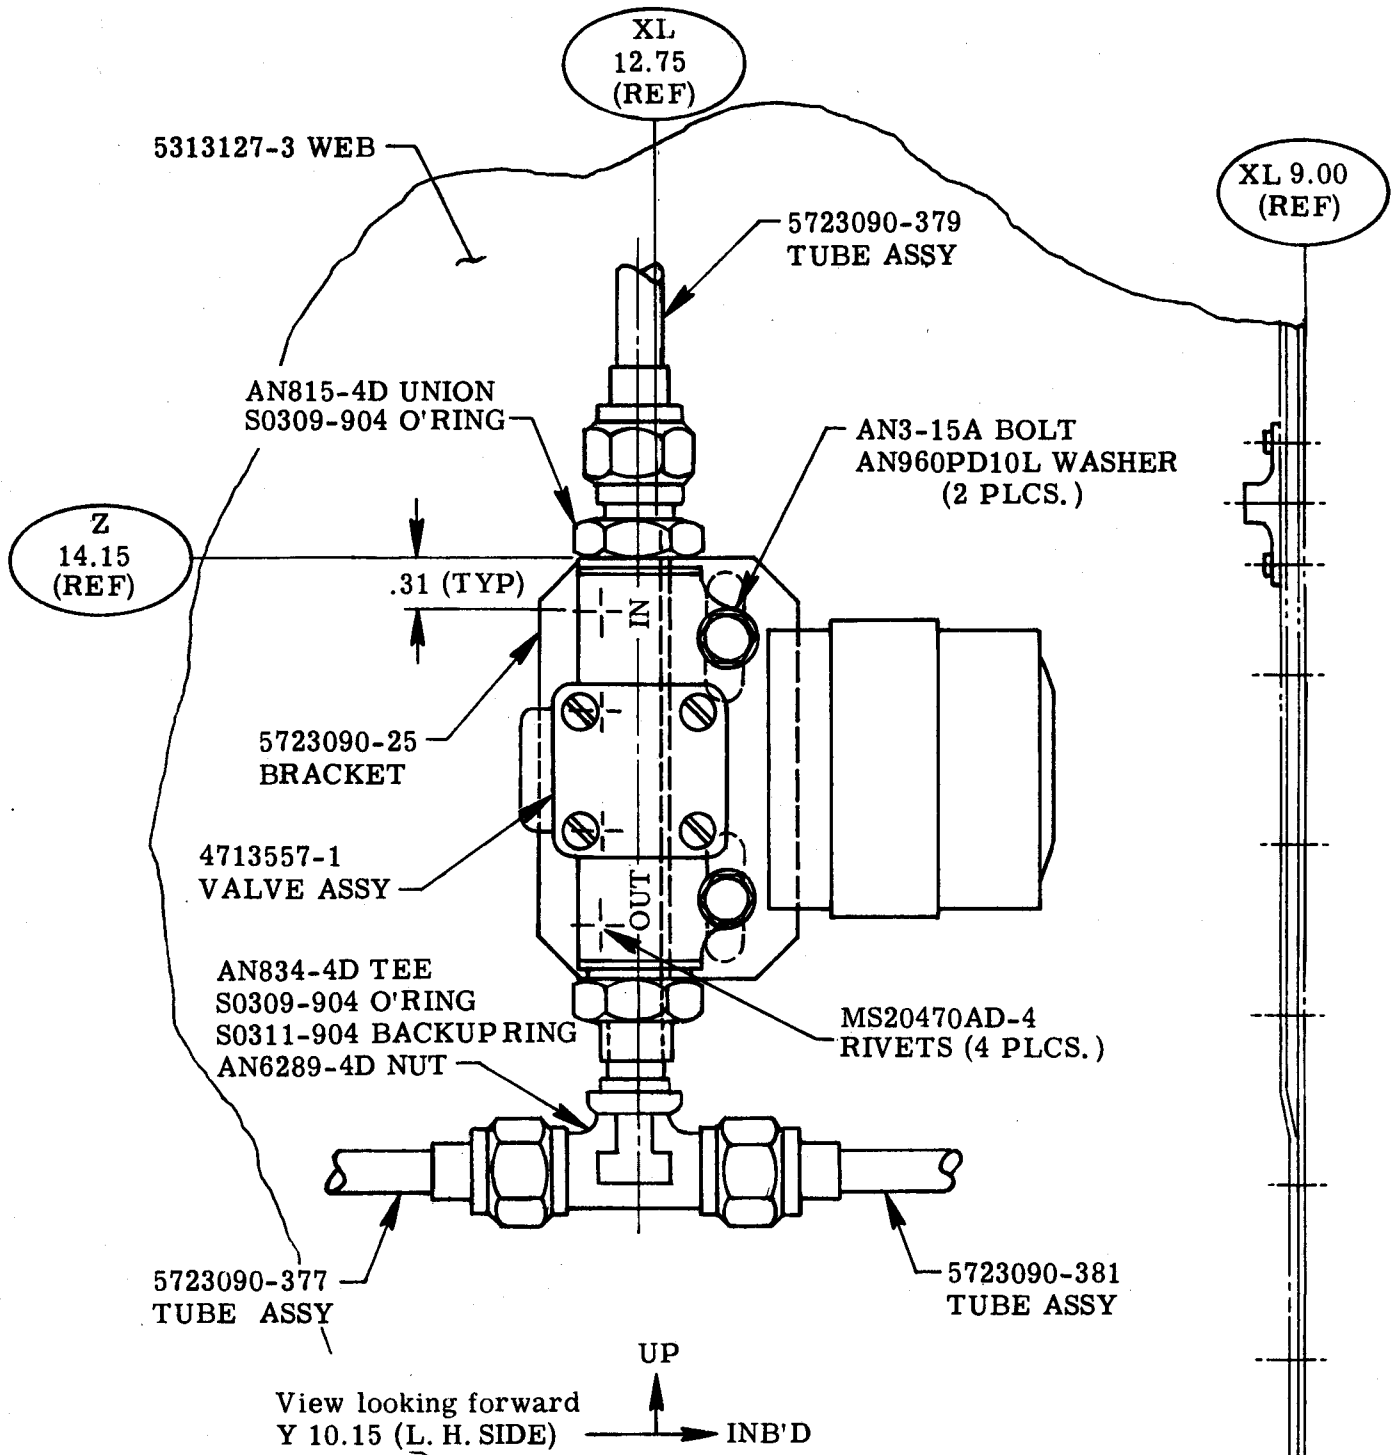
FIGURE 3A

SOLENOID VALVE INSTALLATION

1. Reference Figure 3A:
 - A. Tubing P/N 5723090-377 changed to 6723088-377.
 - B. Tubing P/N 5723090-379 changed to 6723088-379.
 - C. Tubing P/N 5723090-381 changed to 6723088-381.
2. The MS3106E-14S-9S Connector in Kit "B" is replaced by Connector P/N MS3456L-10SL-4S or MS3108B-10SL-4S.
3. Clamping information for tube P/N 6723088-349 or (-377) as applicable.
 1. Drill a 0.190 - 0.194 hole in the Y-10.15 bulkhead at the intersection of Fuselage Station X-16.0 and Z-21.6.
 2. Install hydraulic tubing support clamp P/N MS21919DG4, using an AN3-12A bolt, NAS43DD3-50 bushing and MS21042-3 nut.
 3. The required hardware for Para. 2 may be obtained from local source.

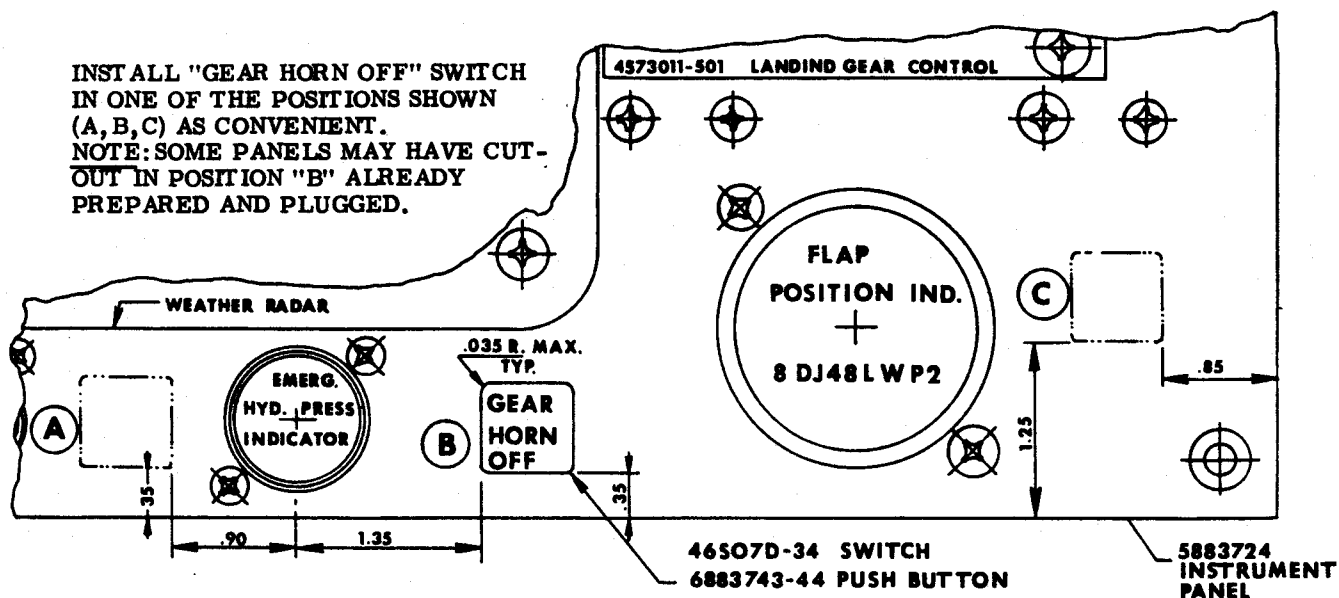
1. Installation of Gear Horn Off switch per Para. 3 of Service Letter may interfere with the panel lighting Printed Circuit Card.
2. The Gear Horn Off switch may be mounted in the center instrument panel per illustration.

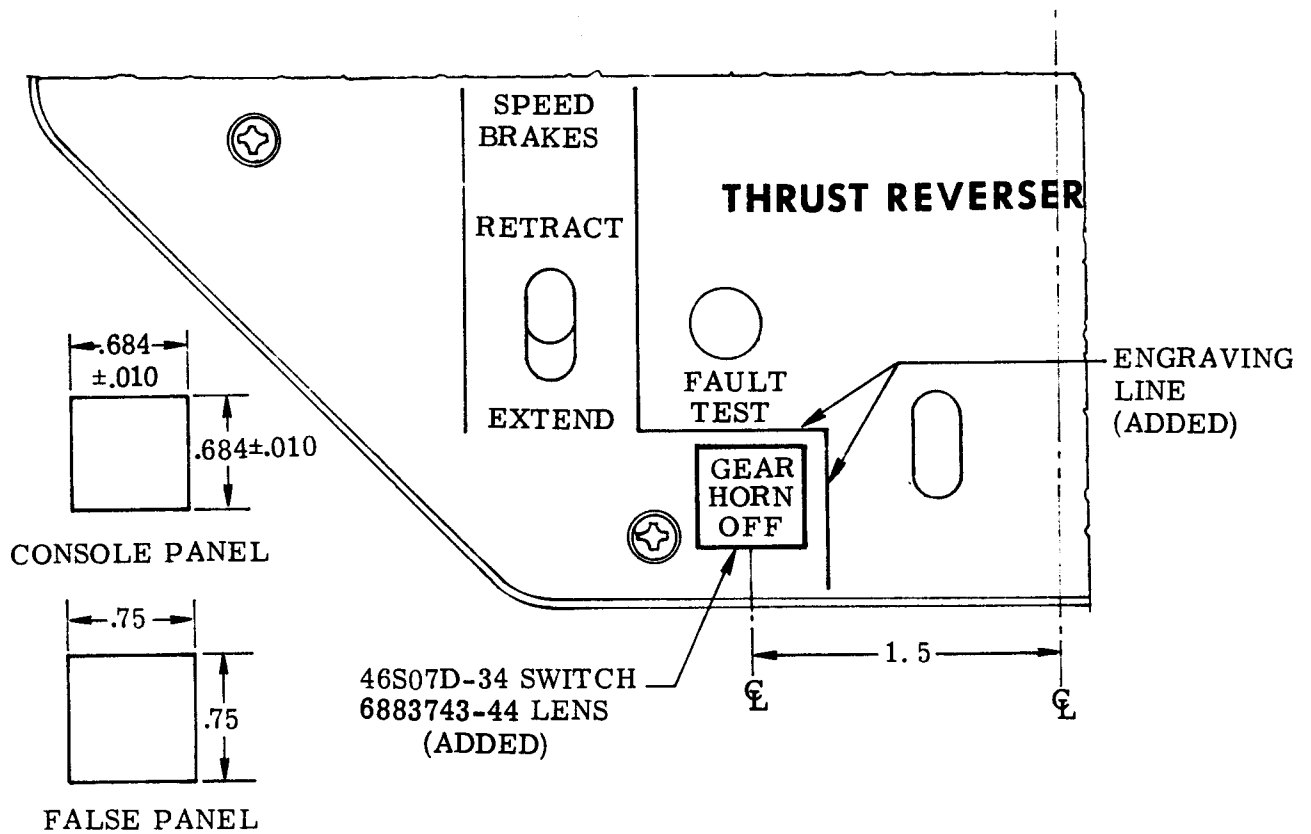
FIGURE 1

GEAR HORN OFF SWITCH INSTALLATION
(PILOTS PEDESTAL)

1. Place switch on console and trace hole pattern for false panel cut-out.
2. Remove false panel and cut 0.75 in. square hole per pattern. Smooth edges.
3. Re-install false panel and mark hole pattern for switch mounting in console.
4. Remove false panel and cut $0.684 \pm .010$ in square hole per pattern for switch. Smooth edges and apply zinc chromate to reworked area.
5. Install switch.
