SERVICE INFORMATION LETTER

SERVICE INFORMATION LETTER INDEX

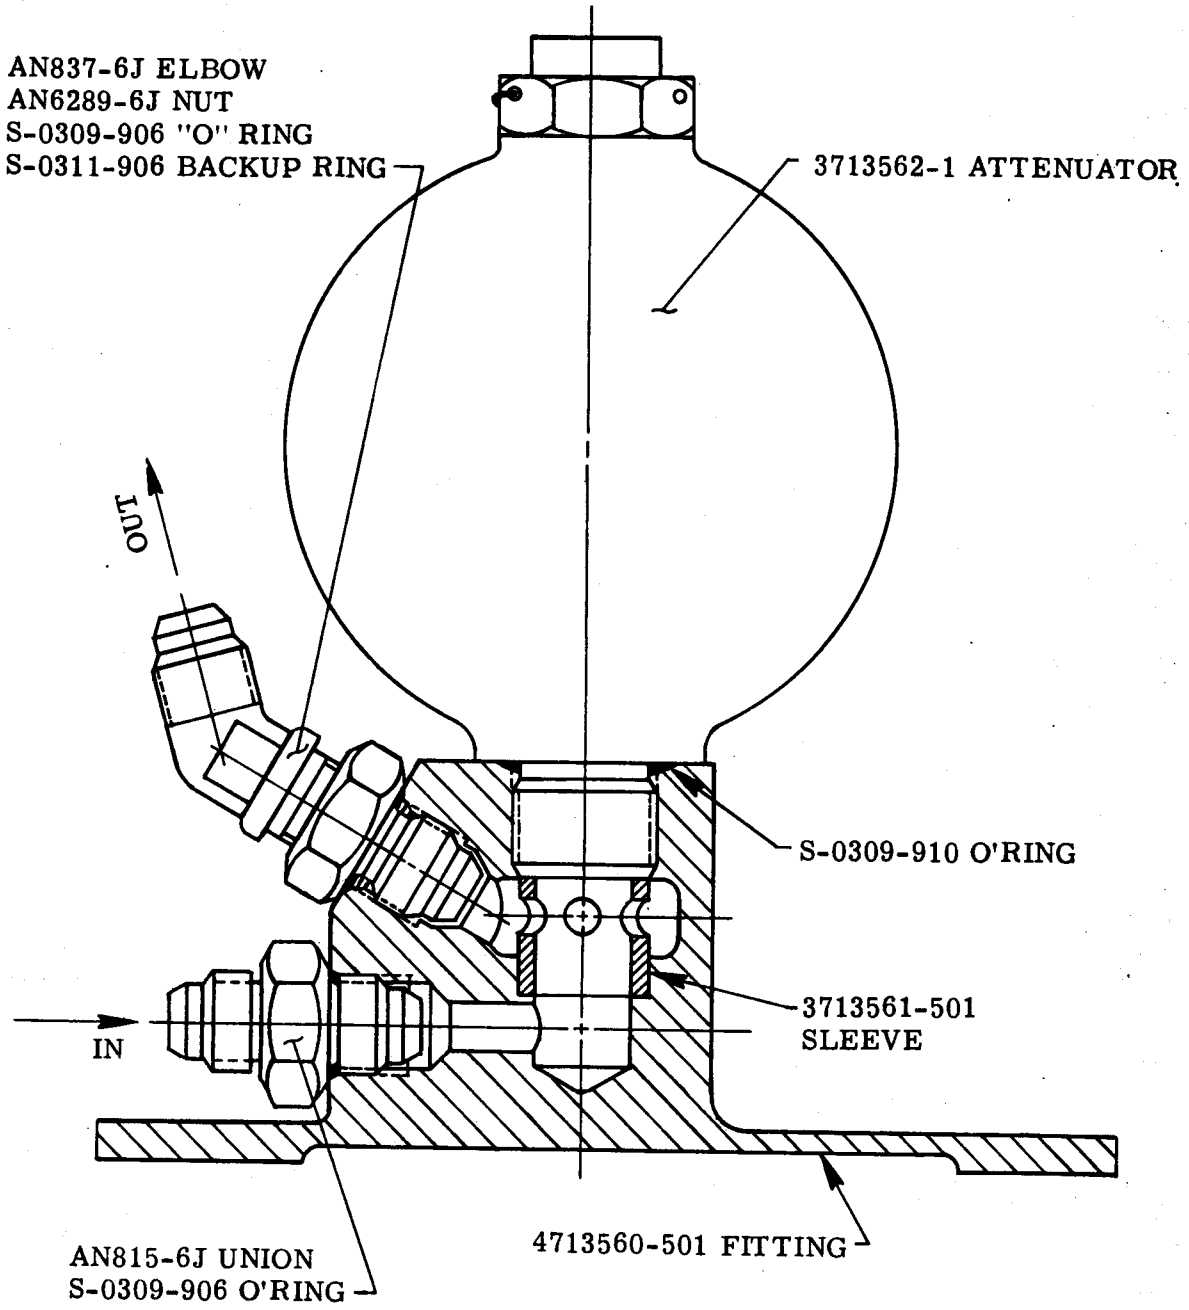
FIGURE 6

ATTENUATOR ASSEMBLY

7. Install an AN837-6J elbow with AN6289-6J nut, S0311-906 backup ring, S0309-906 O-ring in the outlet port of each P/N 4713560-501 fitting, per Figure 6.

8. Install an AN815-6J union with S0309-906 O-ring in the inlet port of each P/N 4713560-501 fitting, per Figure 6.
9. Install new Fitting P/N 4713560-501, with new MS9136-01 gasket, on R. H. forward pad of the accessory gearbox on each engine. (See Figures 2 and 3).

19. Install new tube P/N 3603548-7 between outlet port of fitting P/N 4713560-501 and quick disconnect fitting, per Figure 3.
20. Refer to Figure 6 and install a sleeve P/N 3713561-501, attenuator P/N 3713562-1, with a S0309-910 O-ring on each accessory drive pad fitting P/N 4713560-501. Torque and safety wire attenuators, per Figure 3.

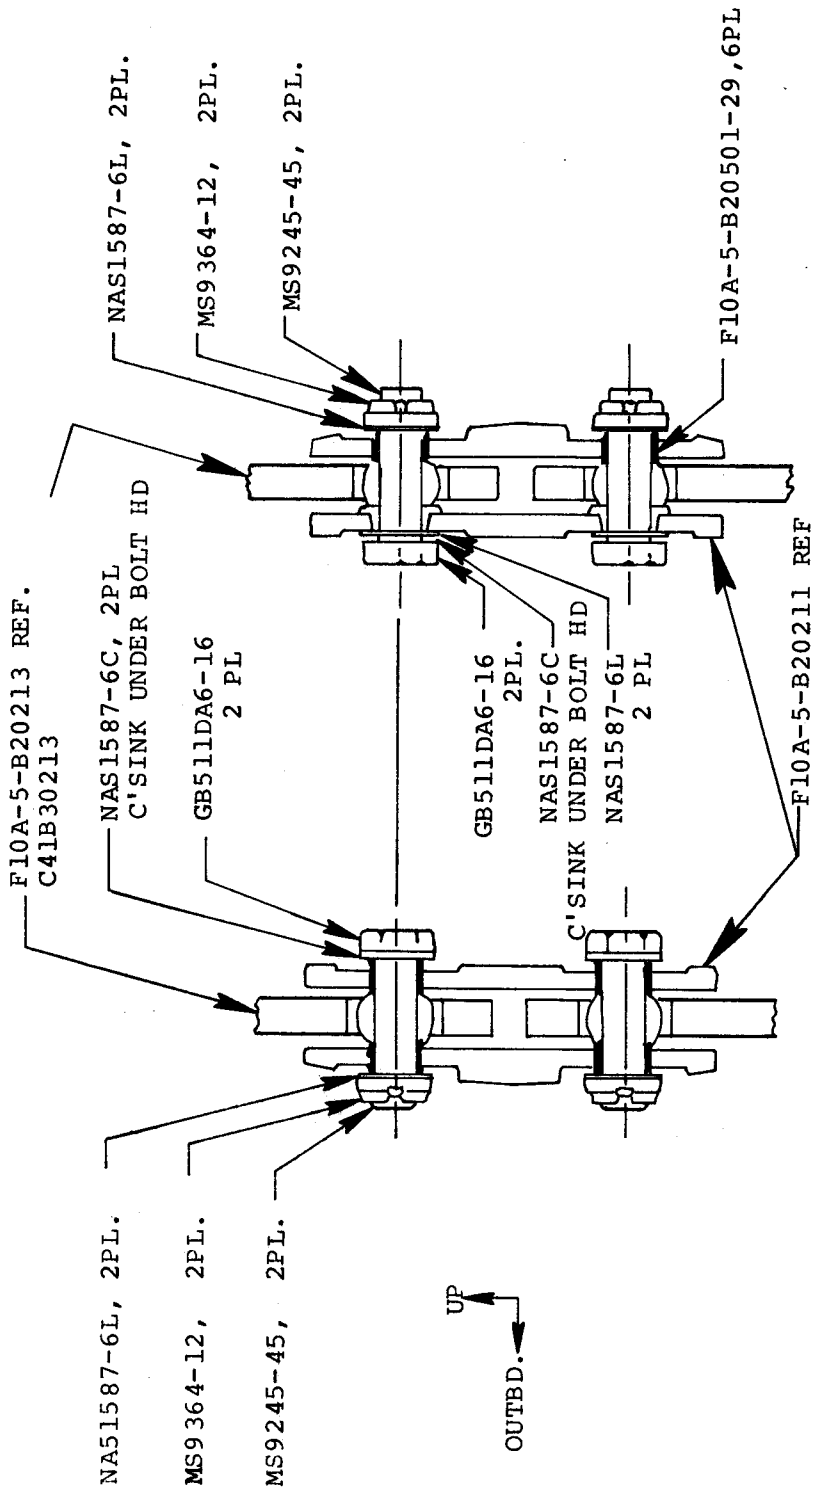
FIGURE 1

NOTE: Observe the outer lug of the outboard pivot joint for signs of fretting, scoring, etc. If fretting is observed, polish out the wear marks, checking to be sure that the lug thickness does not go under .100 inch.

LH NAC-T/R DOOR PIVOT

1. Prepare aircraft for maintenance by opening T/R doors, and removing stang covers. Disconnect hydraulic power, turn off all electrical power and disconnect aircraft batteries.
2. Remove and discard the F10A-5-C20500-11 secondary latch and replace with F10A-5-C20500-15, as per Chapter 78-30-00, 1124 Westwind Maintenance Manual.
3. Remove T/R doors and discard the sleeve bushings P/N F10A-5-B20501-13, the NAS1587-6 washers and any other damaged washers. (Ref: Figure 3, Item 13, Chapter 78-30-00 1124 IPC).

5. Rotate the T/R doors and check for the following condition at the pivots:
 - A. Inboard pivot joint - the bolt, shoulder bushing, sleeve bushing and self aligning ball are designed to remain stationary relative to the axial rotation of the T/R door. This is because the bolt is clamped to the fitting.

- B. Outboard pivot joint - the bolt, sleeve bushing and self aligning ball are designed to rotate with the T/R door. However, depending on the relative friction of the joint, the bolt assembly may remain stationary during rotation of the door.
6. If it is found that the inboard pivot hardware is rotating, the following procedure is recommended:
- A. Remove cotter pin and back off castellated nut to be sure it is loose.
 - B. Torque nut up to a minimum of 90 in-lb; then continue tightening until cotter pin hole is aligned with slots in nut.

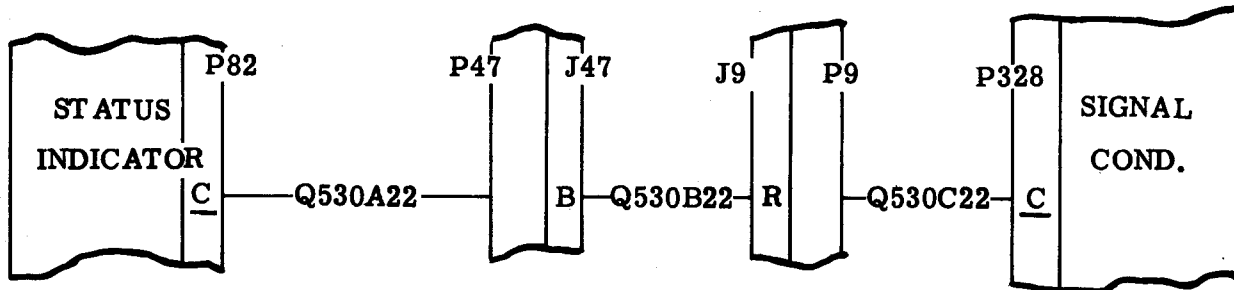
FIGURE 1

WIRING SCHEME

3. Gain access to signal conditioner unit in aircraft nose compartment.
4. Install per Figure 1 and identify new wires as follows:
 - A. Wire Q530C22 between pin C of P328 connector and pin R of P9 connector.

- D. Install and secure P328 connector at signal conditioner, and install and secure P82 connector at status indicator.

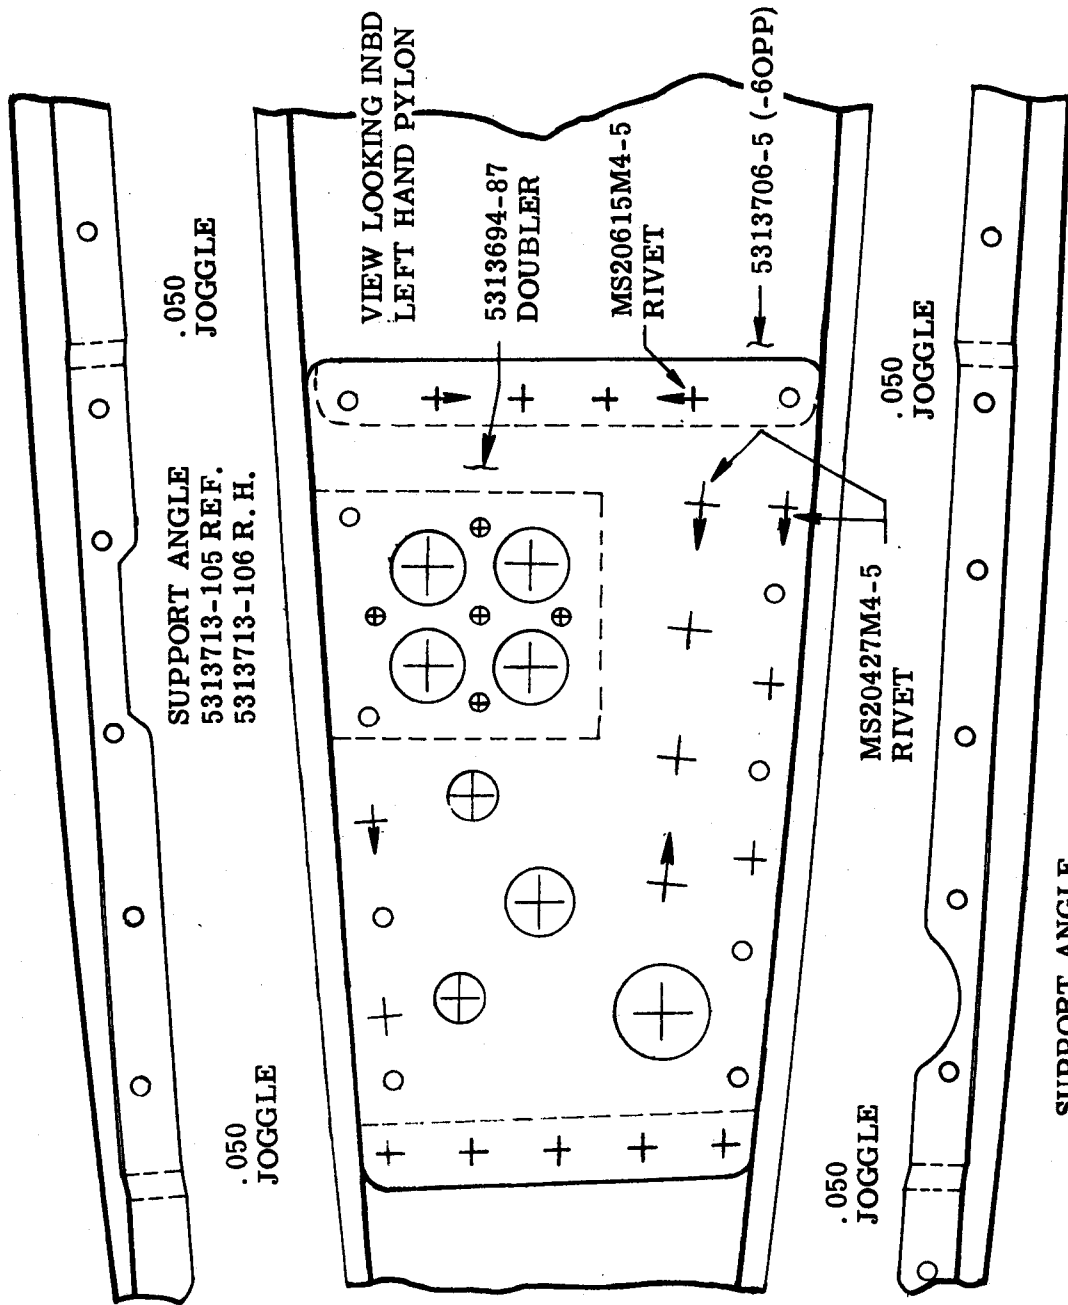
DOUBLER INSTALLATION
Figure 1

3. Remove electrical cables support plate and withdraw electrical cables from firewall.
4. Inspect firewall for cracks. If firewall is cracked, proceed as follows:

- A. Remove existing firewall beginning at forward end and make a vertical cut aft of cracked area.
 - B. Fabricate a replacement section using 301 1/2 hard stainless .016 thick. Match drill holes to existing firewall and replace section, picking up existing rivet pattern. Fabricate and install a 1.25 inch wide doubler over butt joint using AISI 321 annealed stainless .025 thick.

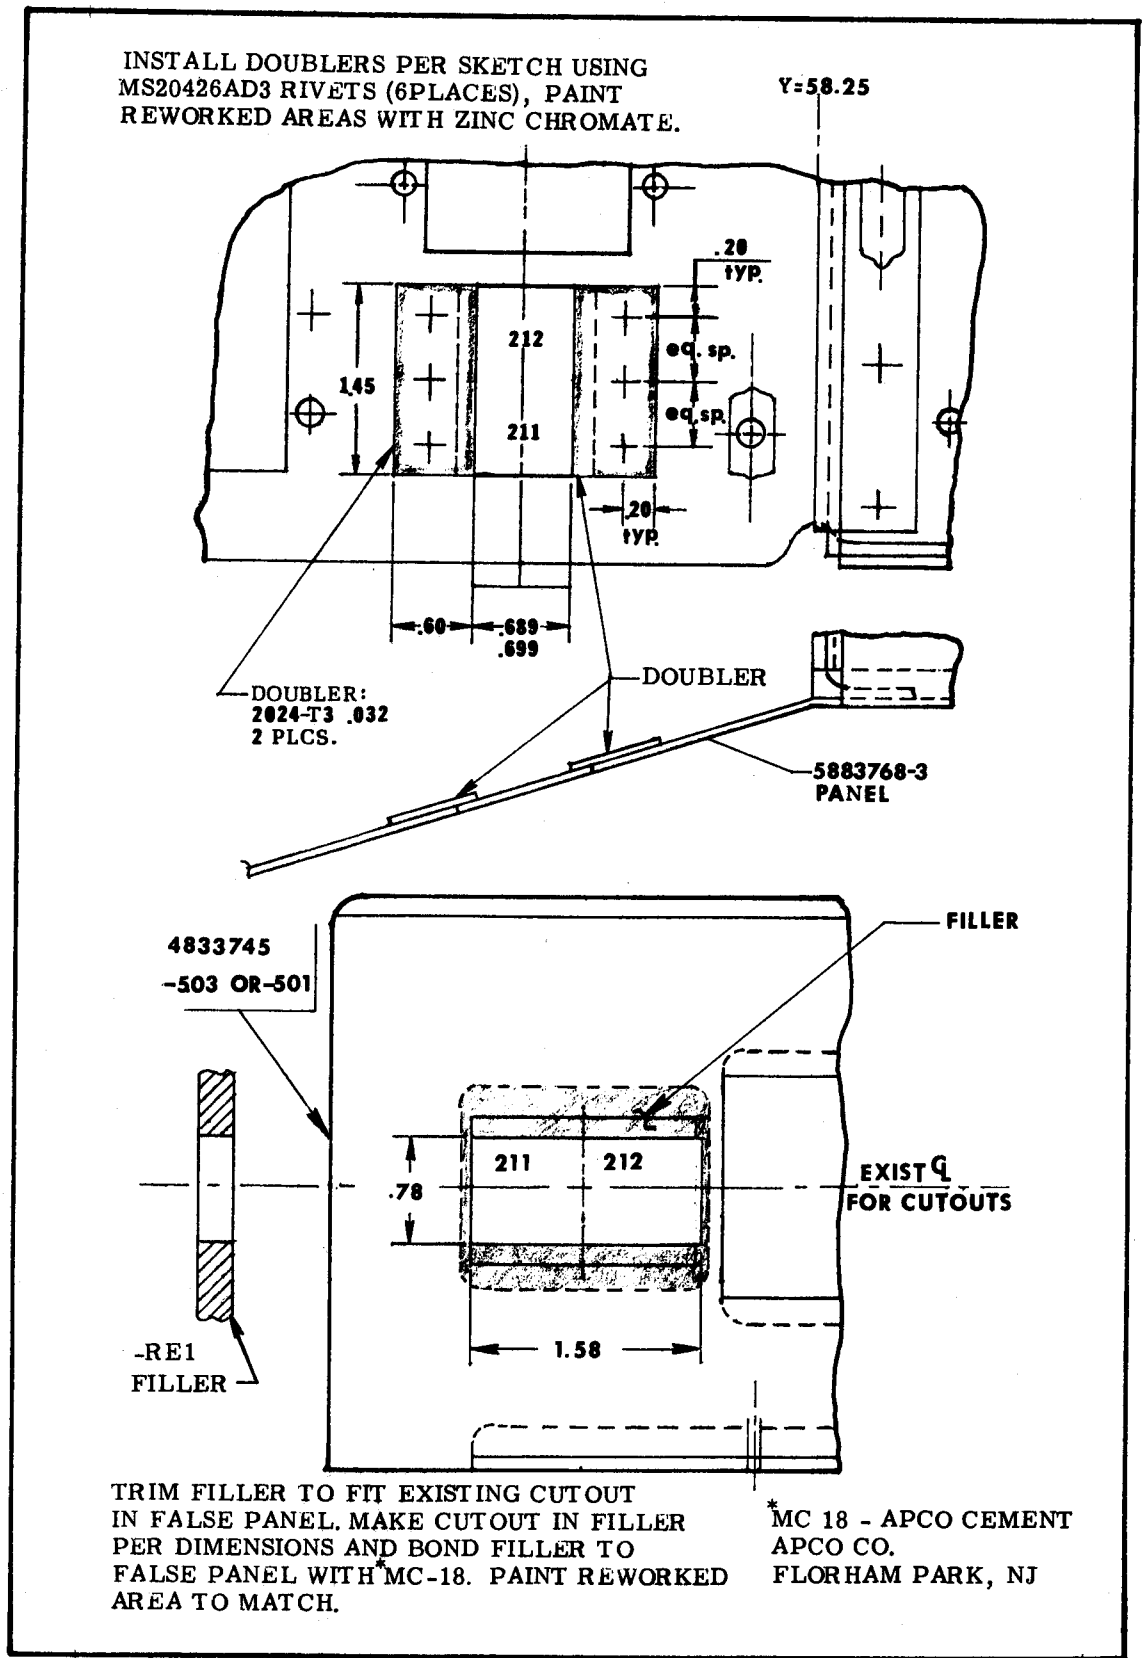
FIGURE 1

SWITCH PANEL REWORK SCHEME

INSTALL DOUBLERS PER SKETCH USING MS20426AD3 RIVETS (6 PLACES), PAINT REWORKED AREAS WITH ZINC CHROMATE.

TRIM FILLER TO FIT EXISTING CUTOUT IN FALSE PANEL. MAKE CUTOUT IN FILLER PER DIMENSIONS AND BOND FILLER TO FALSE PANEL WITH MC-18. PAINT REWORKED AREA TO MATCH.

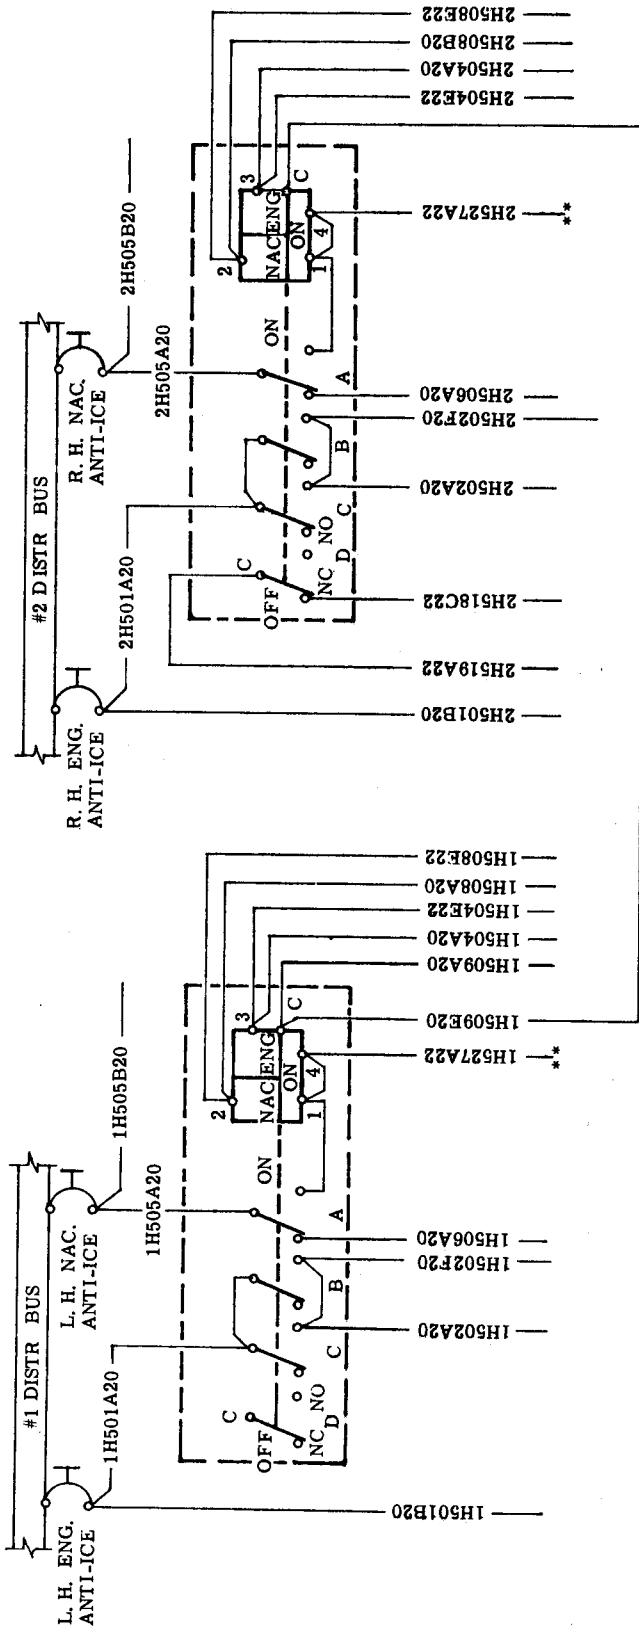
ANTI-ICE SWITCH WIRING SCHEME
 SWITCH P/N 6883743-72
 FIGURE 6

EFF. -S/N 244, 245, 248, 250 THRU 282 AND RETROFIT FOR
 3072500-1 ENGINE WHEN USED IN COMBINATION
 WITH 3072500-2 ENGINE.

10. Repeat Step 9 to remove connectors P338 and P340 in RH nacelle (Conical Spinner engine only).
11. If engines are mixed per Para. 2 of Special Conditions, replace non-conical spinner engine Anti-Ice control switch, aircraft S/N 152, 154, 181, 187 thru 243, 246, 247 and 249 and wire switch per Figure 6.

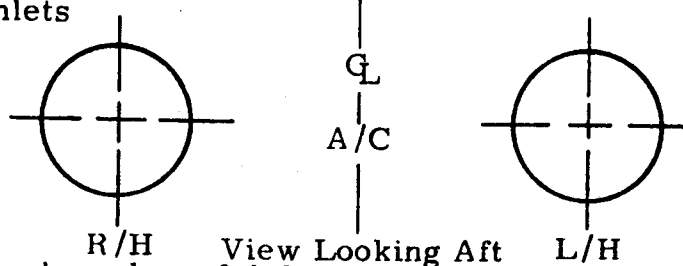
Indicate approximate location and number of loose or missing rivets found in the LH & RH Nacelle Inlets

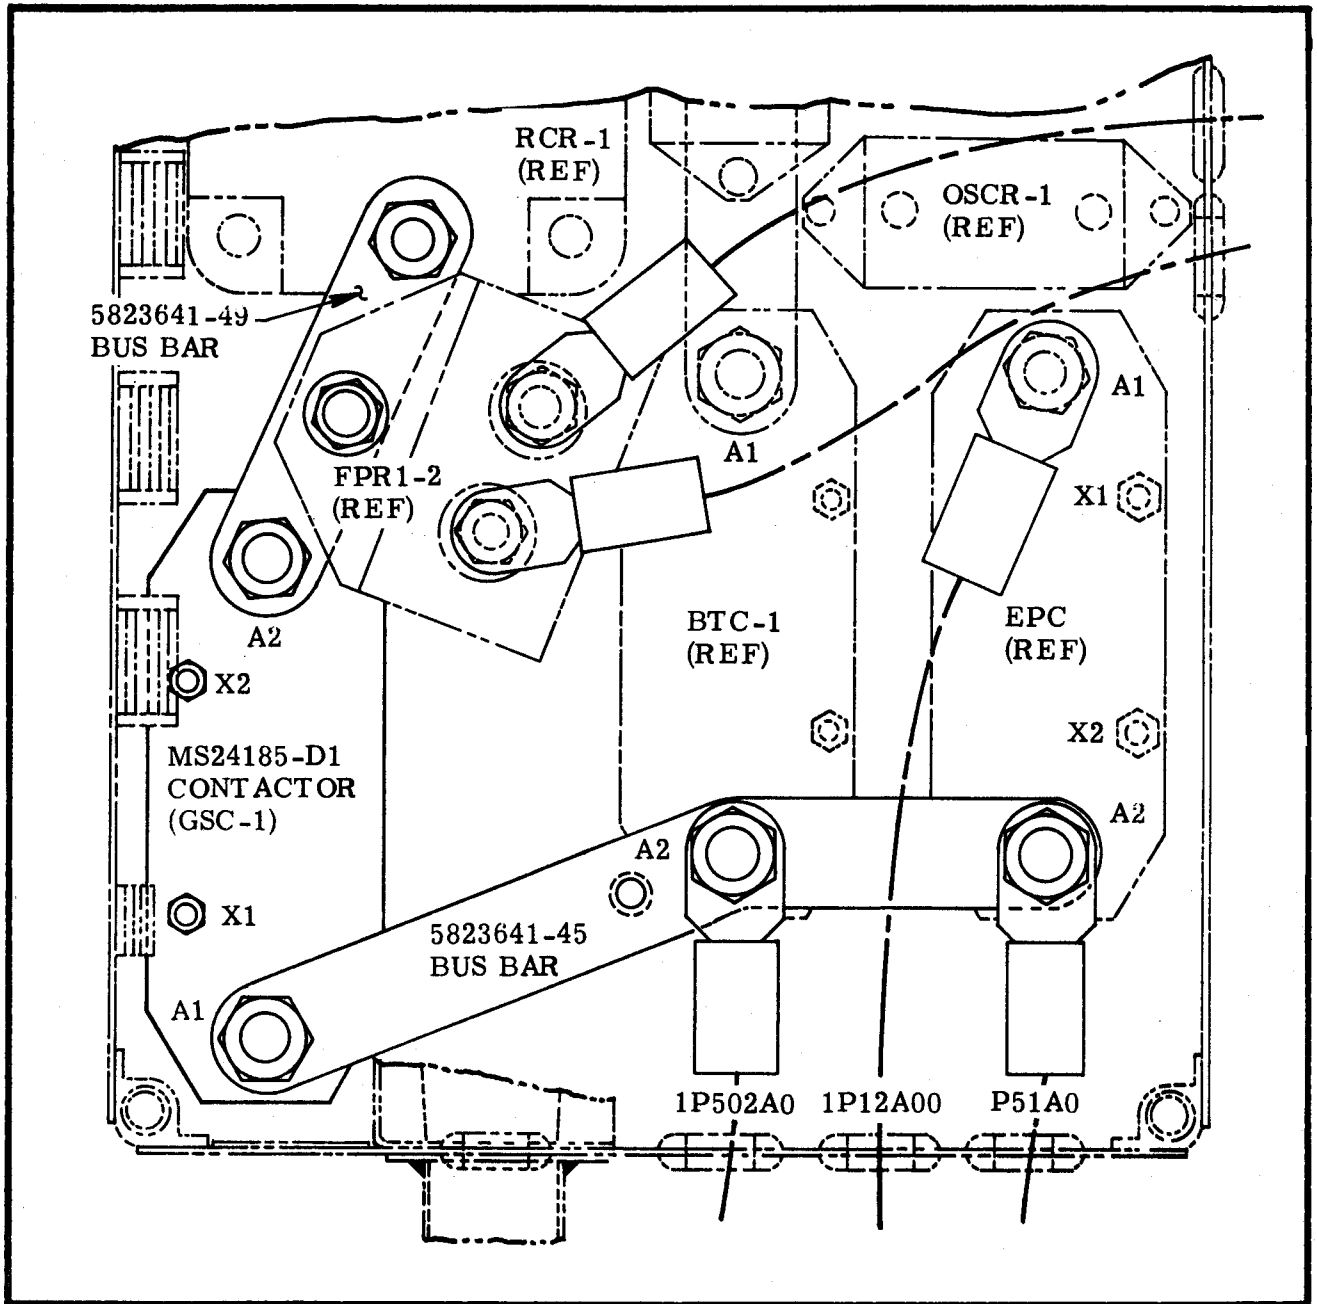
FIGURE 1

L. H. DC CONTACTOR BOX

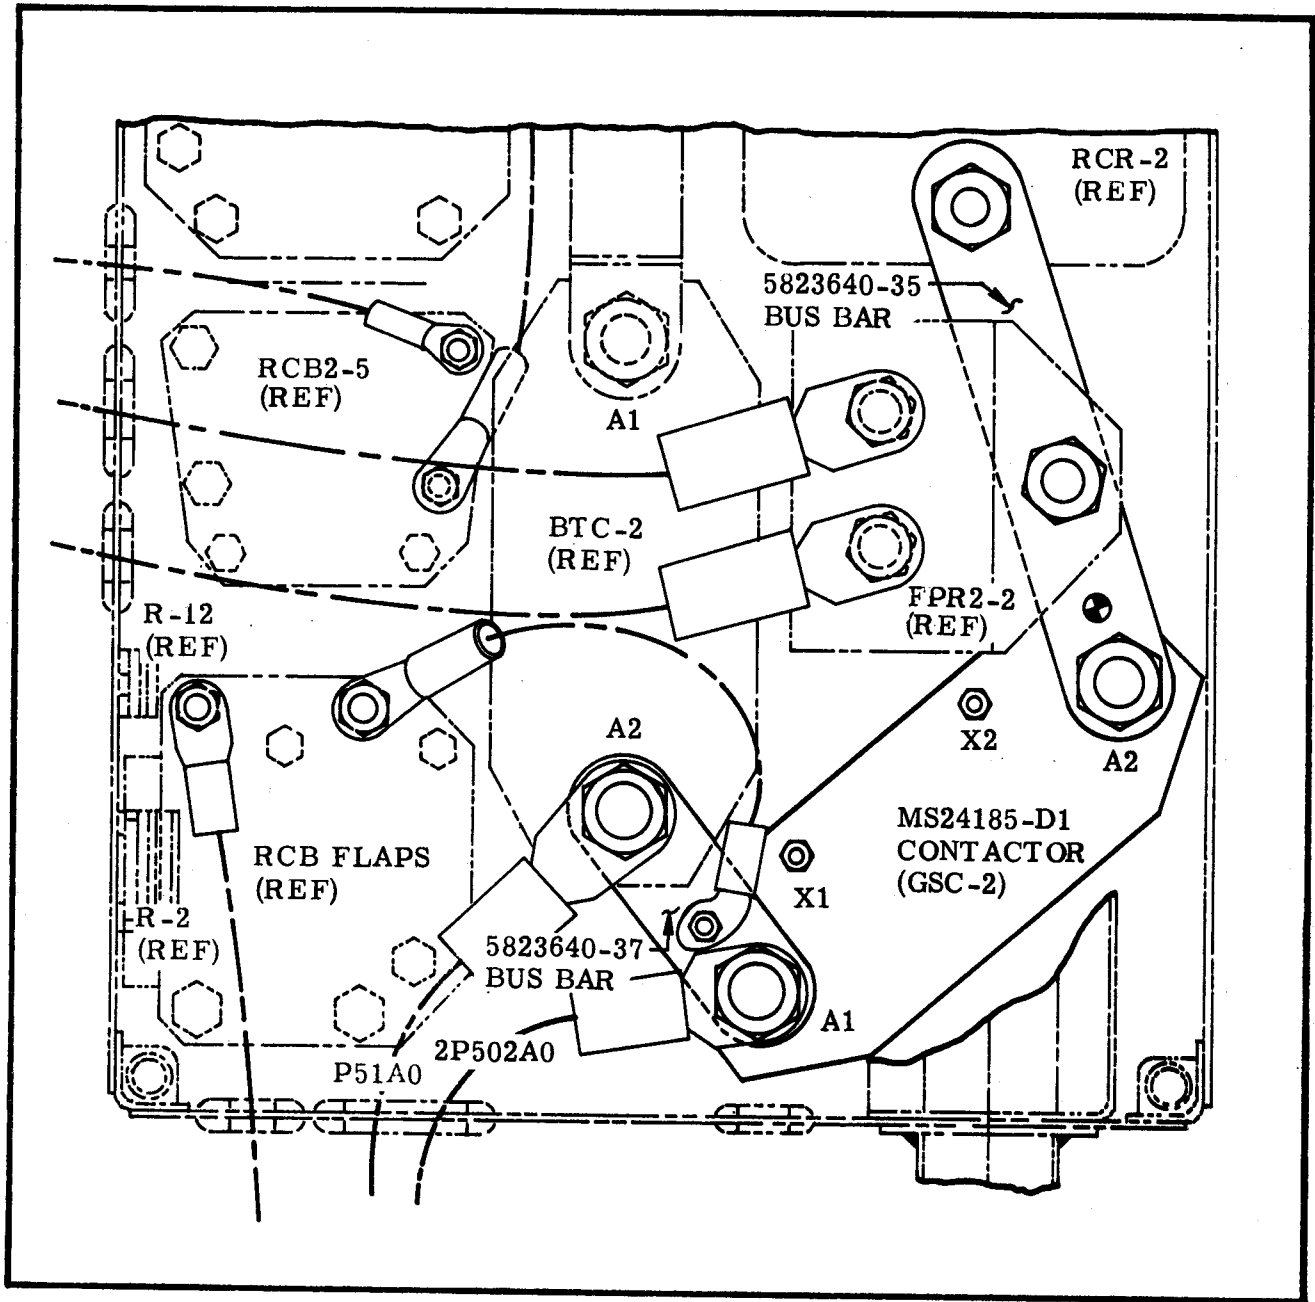
SUBJECT: REPLACEMENT AND REWORK OF GENERATOR START CONTACTOR
BUS BARS

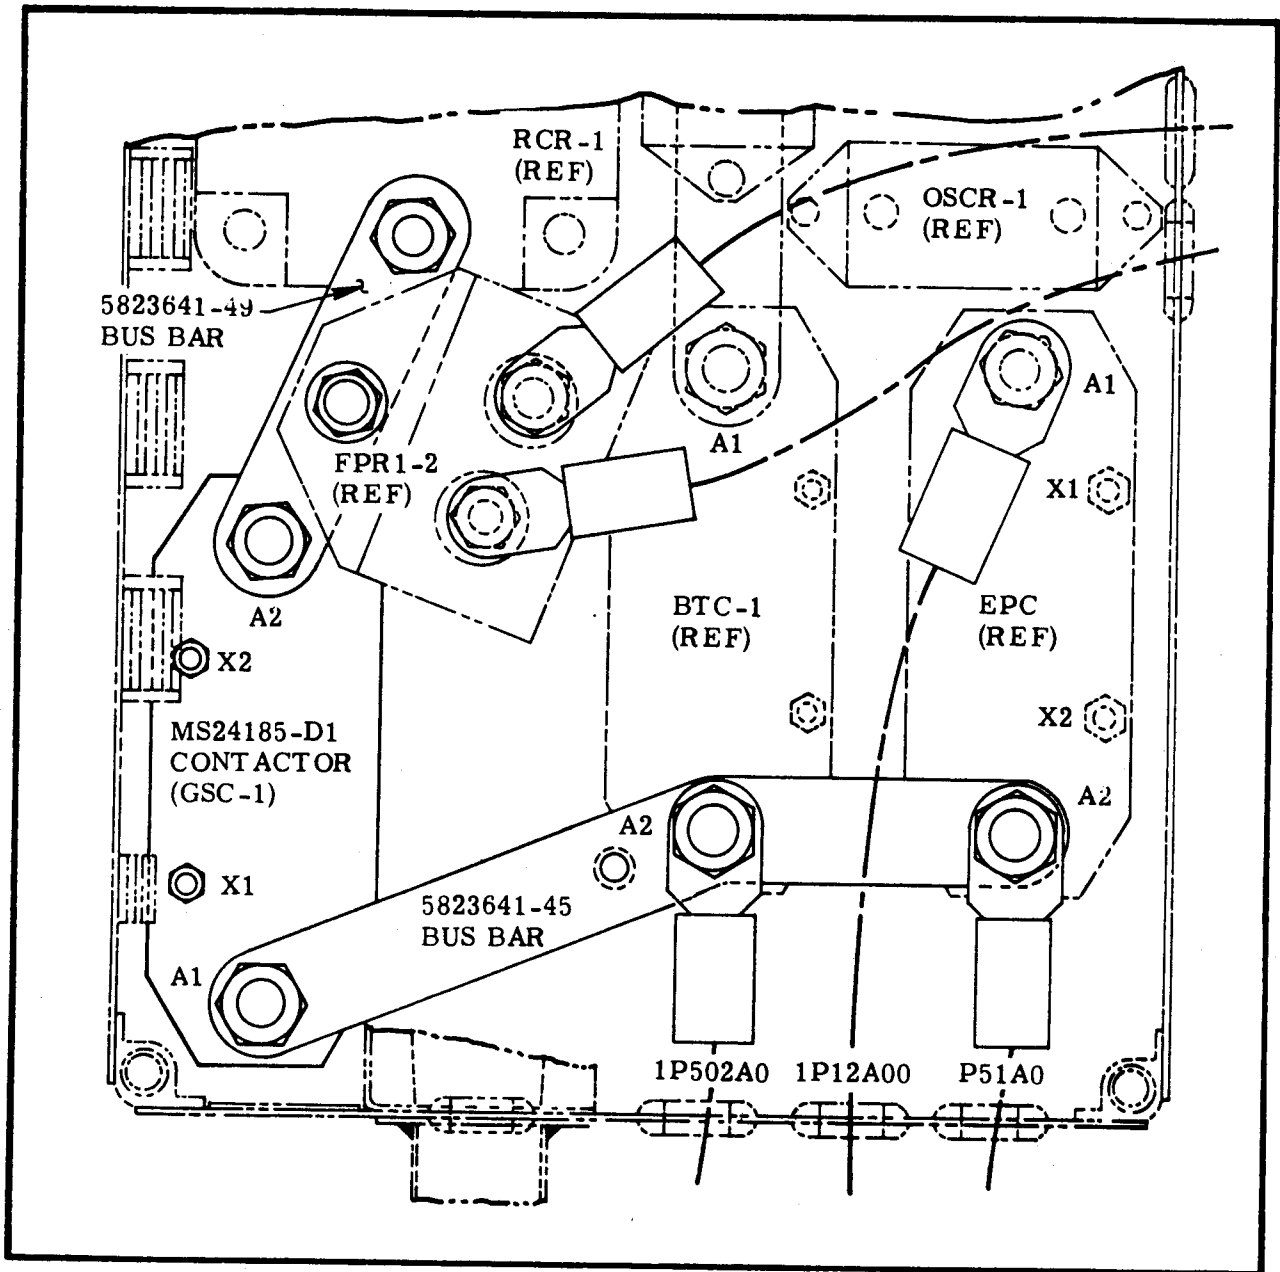
FIGURE 1

SUBJECT: REPLACEMENT OF GENERATOR START CONTACTOR (GSC)

L. H. DC CONTACTOR BOX

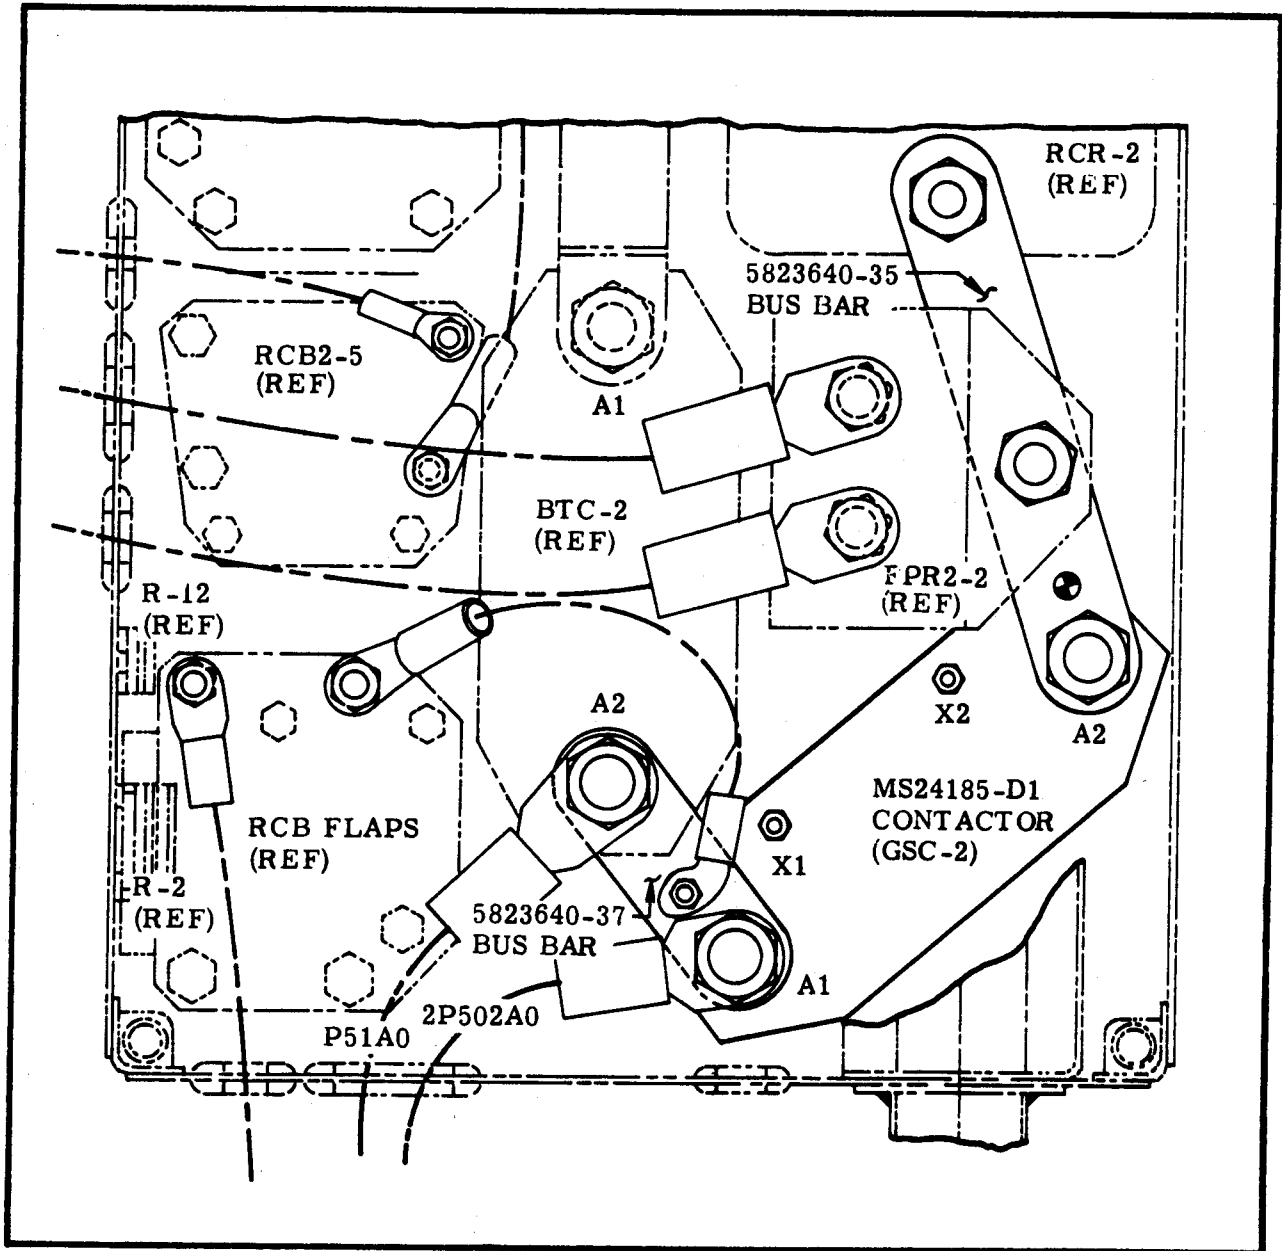
FIGURE 2

R. H. DC CONTACTOR BOX

5. To replace GSC-2 in RH Contactor box refer to Chapter 39-30-07, Page 1, for component identification. Remove GSC-2 and the 5823640-5 and -6 bus bars by repeating the sequence of events in preceding Paragraph 3.

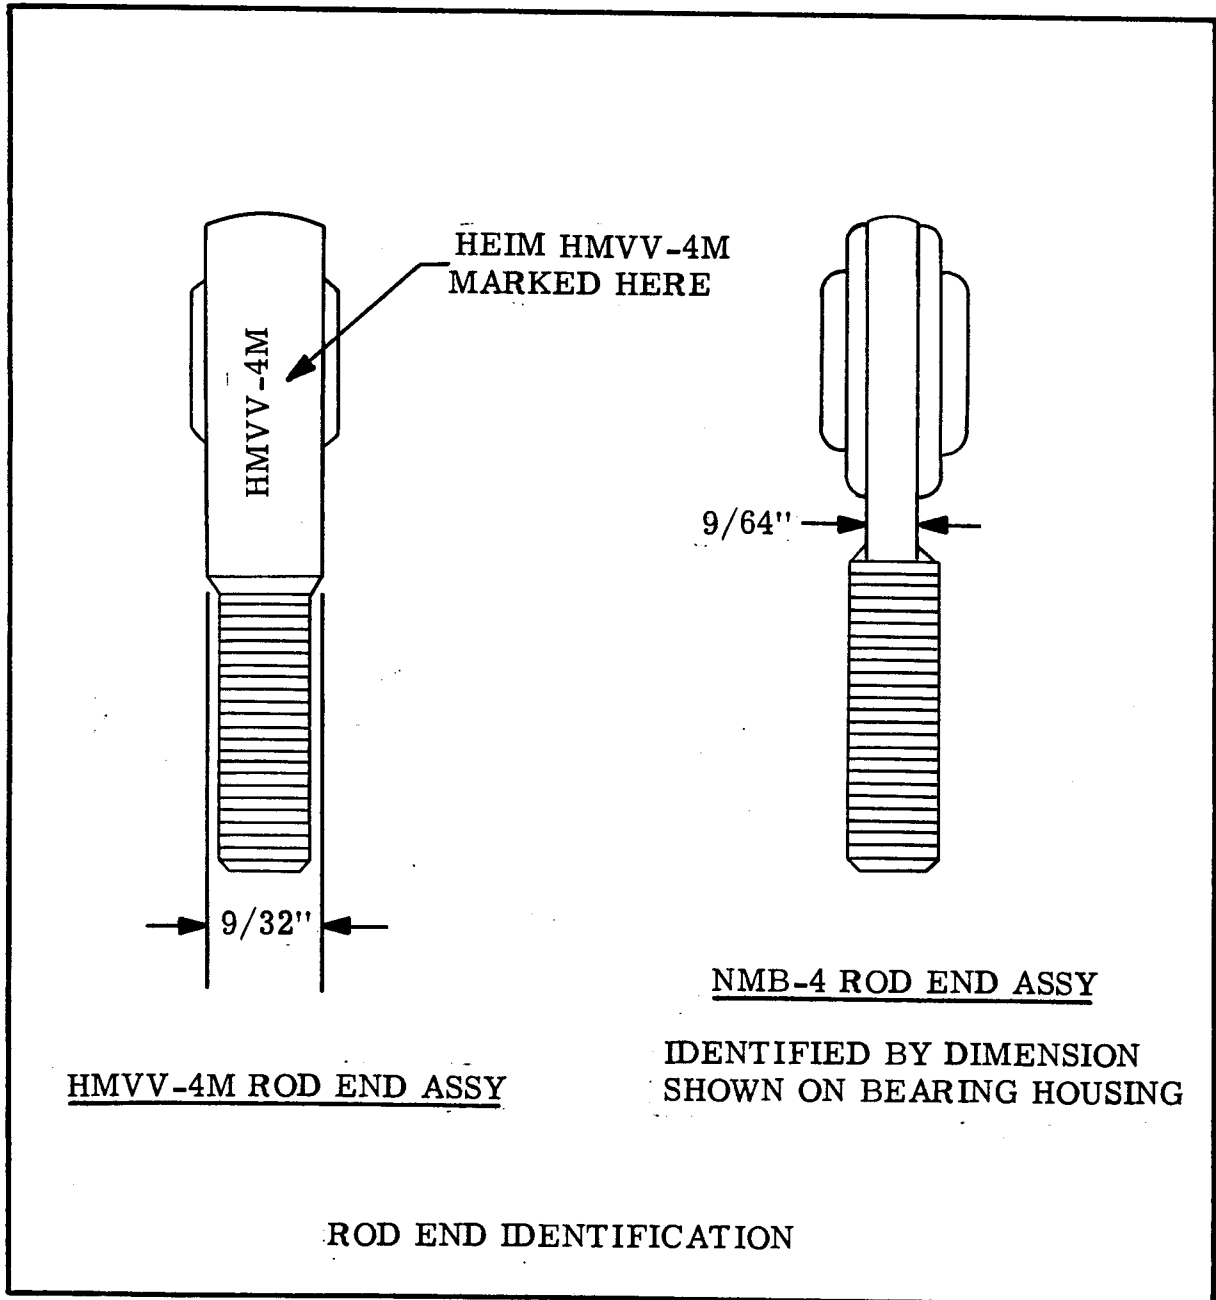
FIGURE 1

SUBJECT: REPLACEMENT OF TRIM TAB ACTUATOR ROD END ASSY

1. Inspect rod end of Aileron and Rudder trim tab actuators to identify actuators equipped with the "NMB-4" rod end assy.
2. Replace rod ends, as required, with new "HMOVV-4M" rod end assemblies and adjust to proper "ZERO" position in accordance with Chapter 27-10-00 and 27-20-00 Adjustment and Test, 1124 Maintenance Manual.
3. Check trim tab actuators for proper operation and security of attachment.

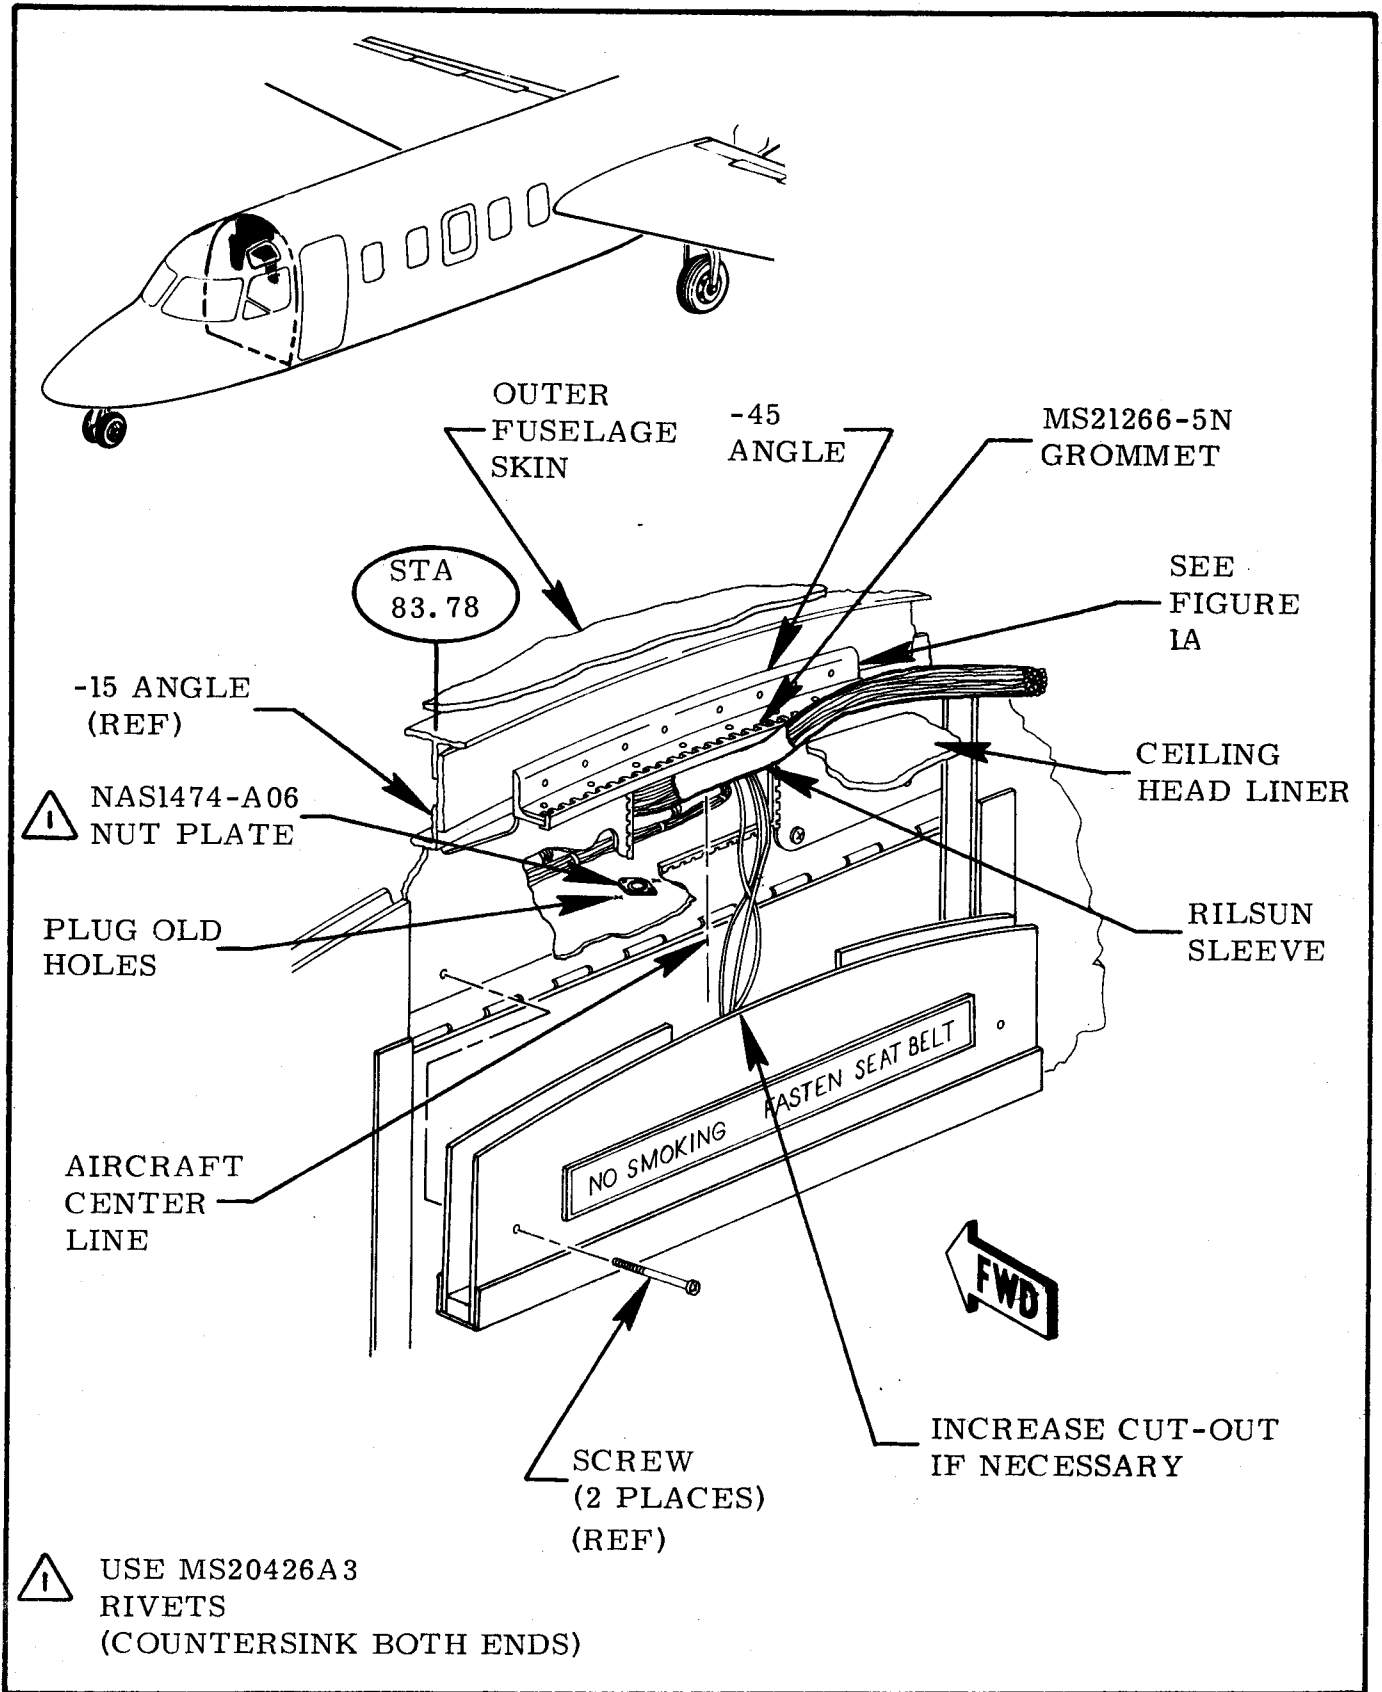
FIGURE 1

WIRE BUNDLE INSTALLATION

1. Remove cabin headliner aft of warning sign, located at Fus. Sta. Y-83.78.
2. Release aft circuit breaker panel, located on fwd side of Fus. Sta. Y-83.78.
3. Inspect wire bundle for chafing and/or adequate clearance between fuselage frame and warning sign, (See Figure 1).
4. If evidence of chafing is detected, repair damaged wires as necessary.
5. If additional clearance or chafe protection for wire bundle is required, one or more of the following procedures should be used.
 - A. Spread wire bundle, in order to reduce diameter.
 - B. Add "Rilsun" sleeve chafe protection to wire bundle.
 - C. Increase cut-out of warning sign support structure adjacent to wire bundle.
 - D. Trim edge of 5313548-45 angle, add RE-3 strip and bond MS21266-5N grommet to fuselage frame per details of Figure 1.

- E. On aft circuit breaker panel, replace center aft nutplate (MS21075-06) with NAS1474-A06 nutplate per detail of Figure 1, and plug existing holes of original nutplate installation.
6. Replace equipment removed for Inspection/Rework purposes and return aircraft to service.

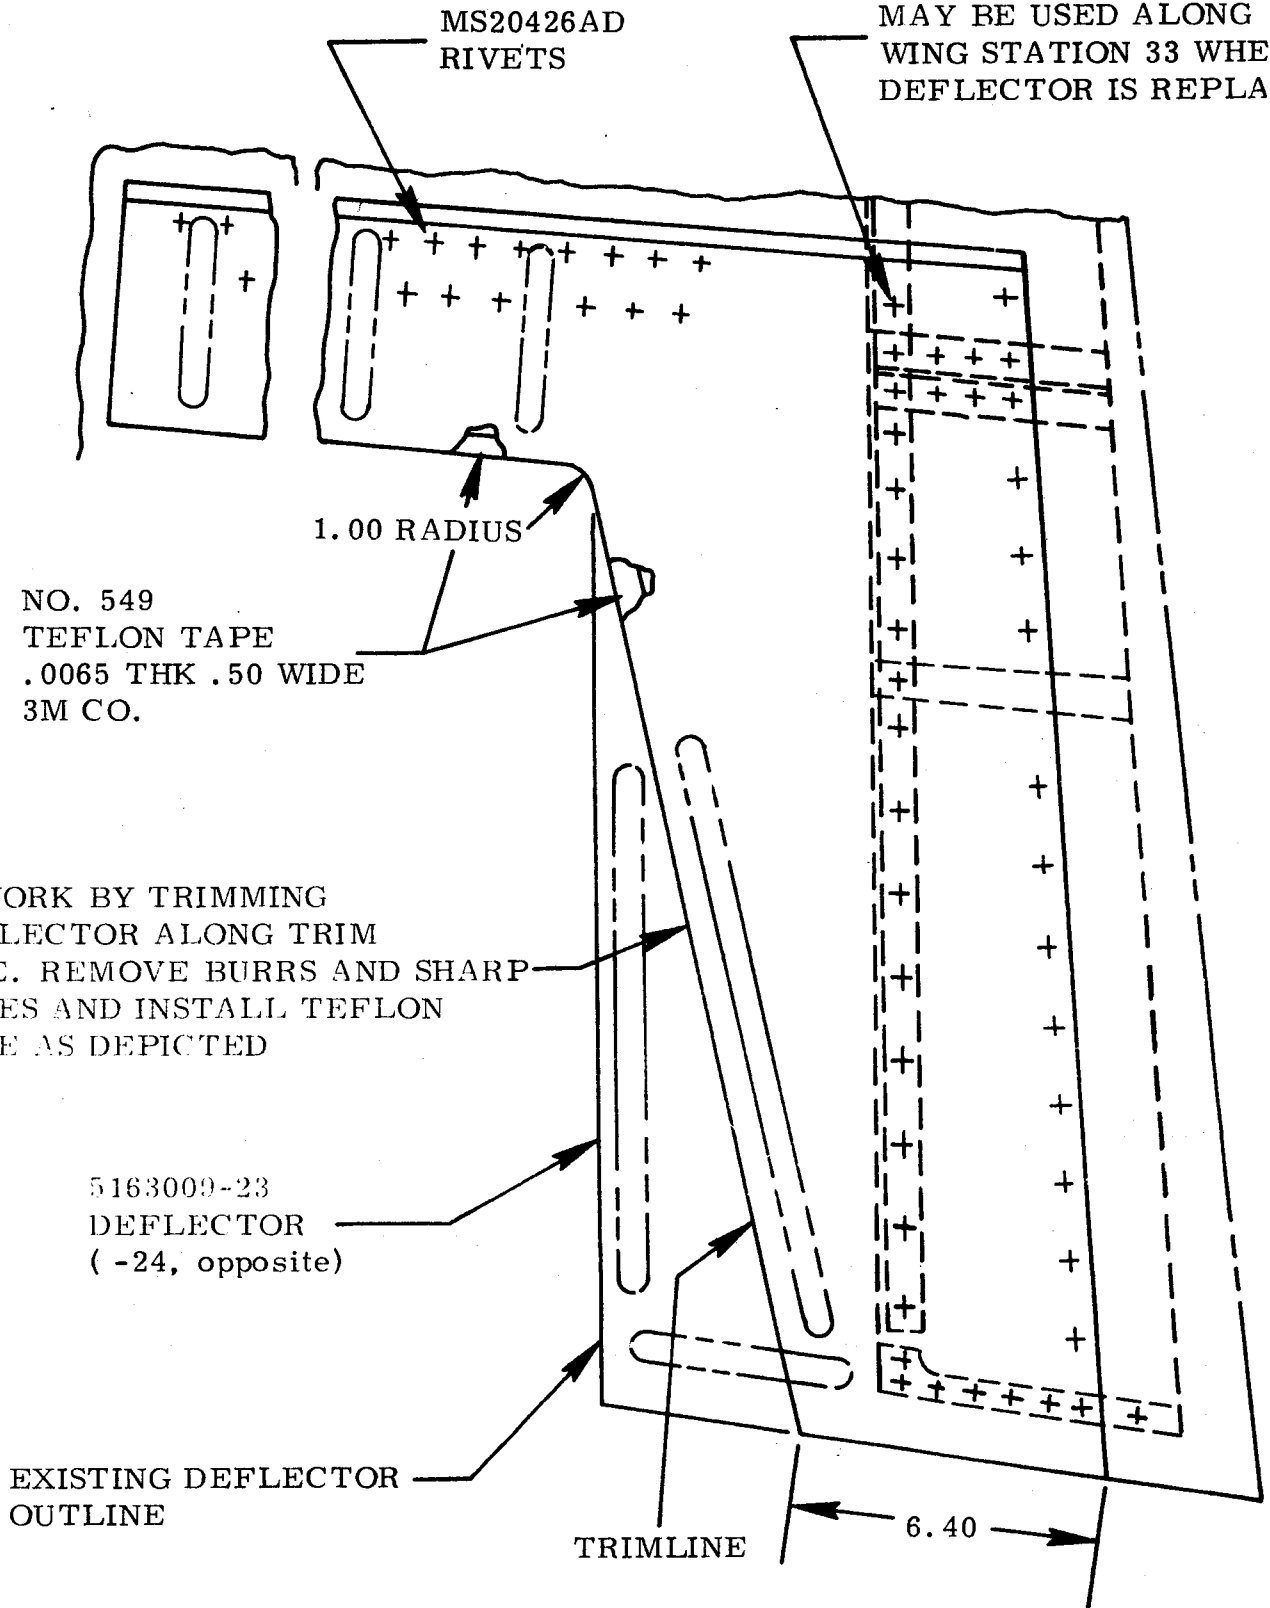
FIGURE 1

REASON: CRACKS OCCURING IN DEFLECTORS ARE DIFFICULT TO REPAIR, REWORK OF DEFLECTOR OR REPLACEMENT WITH REDESIGNED DEFLECTOR IS RECOMMENDED

FLAP DEFLECTOR

1. Extend and/or remove wing flap, if required, to permit rework or replacement of flap deflector.
2. Refer to Figure 1, which depicts deflector installation, and rework per rework details. If replacement is required, drill out existing rivets to remove deflector.
3. Install replacement deflector, picking up existing rivet holes, per Figure 1.
4. Prime and paint reworked area to match existing paint.
5. Reinstall components removed to permit rework and return aircraft to service.

NAS1339B4 RIVETS
MAY BE USED ALONG
WING STATION 33 WHEN
DEFLECTOR IS REPLACED
