SERVICE INFORMATION LETTER

SERVICE INFORMATION LETTER INDEX

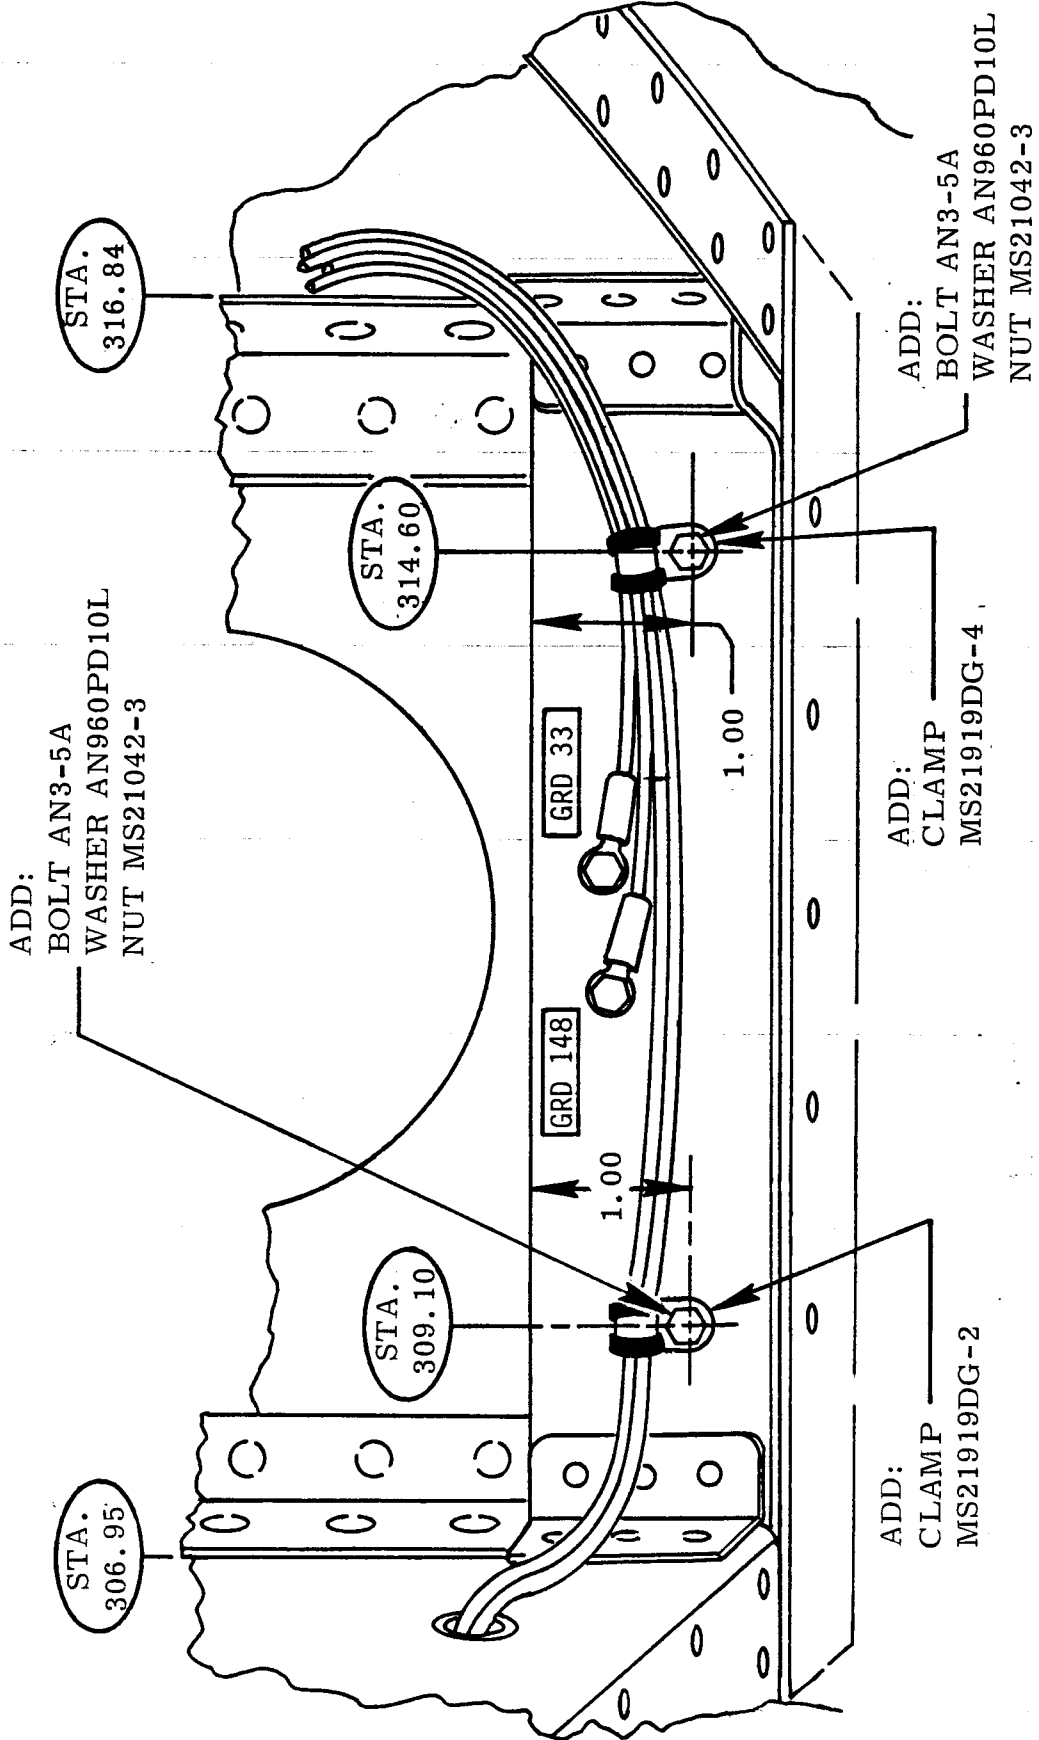
FIGURE 1 WIRE BUNDLE CLAMPING

VIEW LOOKING INBD AT LEFT HAND SIDE OF FUEL SUMP (R.H. OPP.)

1. Remove LH and RH fuel boost pump access panels.
2. Refer to Figure 1, for wiring installation and inspect boost pump ground wires for evidence of chafing. Replace damaged wires, if required.
3. Install cable clamp wire supports per Figure 1, on LH and RH sides.
4. Reinstall boost pump access panels.

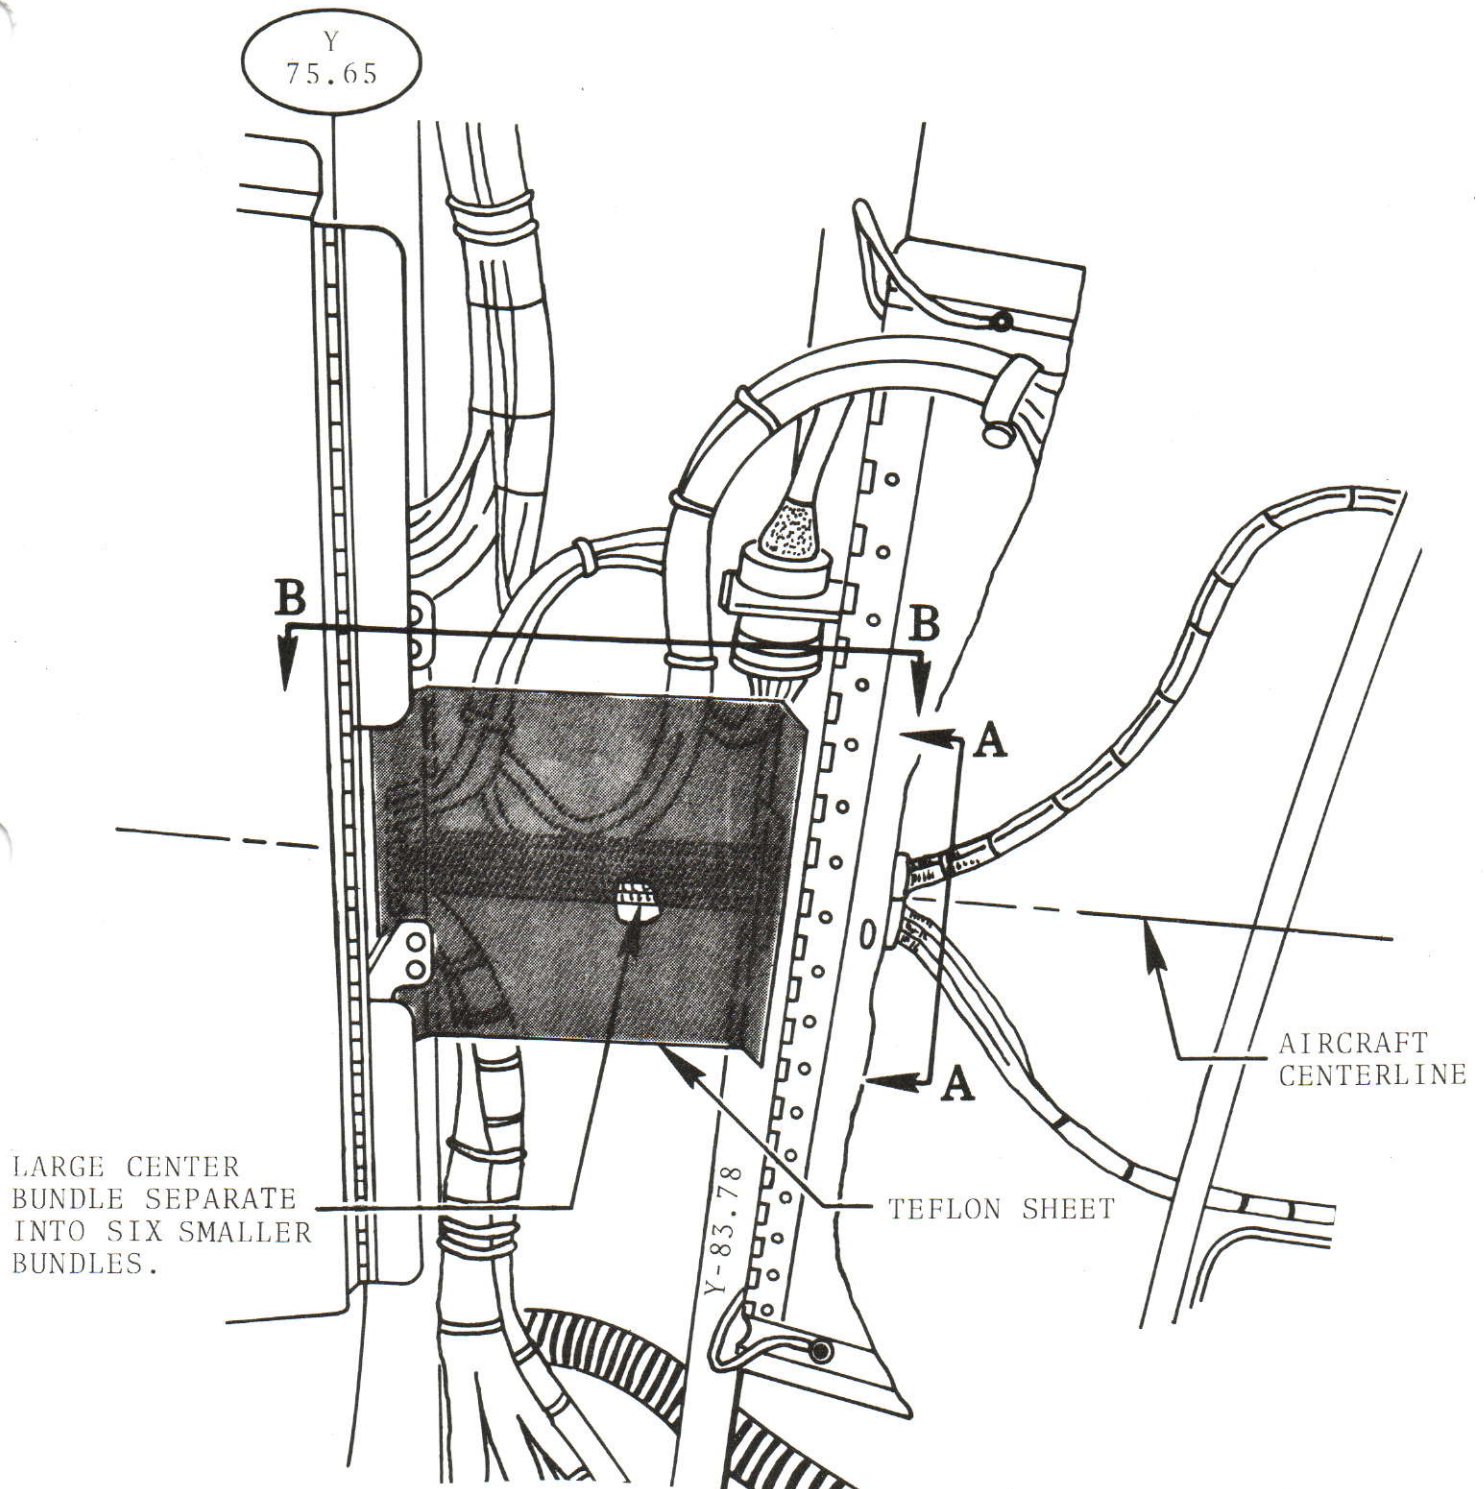
FIGURE 1 REWORK AREA

VIEW LOOKING UP WITH COCKPIT
AFT CIRCUIT BREAKER PANEL OPEN

1. Turn off all electrical power and disconnect batteries.
2. Remove cabin headliner aft of warning sign located at Fus. Sta. Y= 83.780.
3. Unlatch forward and aft cockpit overhead circuit breaker panels and allow them to swing down.
4. Check wire bundles in area over both circuit breaker panels for chafing, pay special attention to large bundle at center aft edge of forward panel.
5. Protect or repair chafed wires as necessary before proceeding to step 6.
6. With forward and aft circuit breaker panels down, spread center wire bundle coming from fwd overhead panel, passing over aft overhead panel (Going to Terminal Board AB & AC) to a minimum of six separate bundles as shown on Figure 1.
 - (a) Wrap each bundle with scotch tape.
 - (b) Maintain bundle separated by installing pendant cable ties.
 - (c) Check bundles for adequate clearance to circuit breaker terminals as panels are closed.

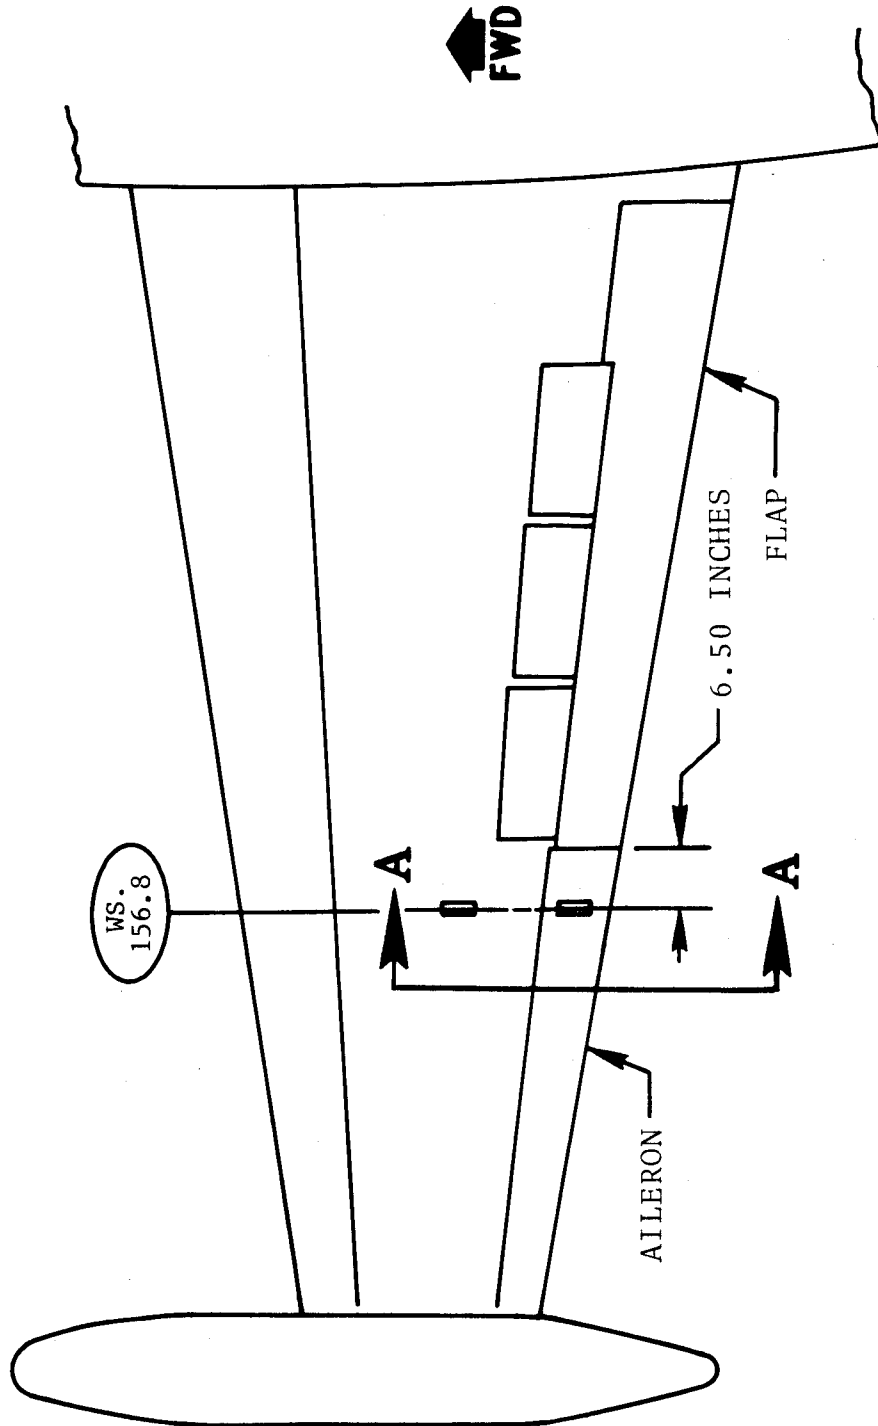
FIGURE 1 STREAMLINE RIGGING CHECK

- A. Aileron freeplay below 0.030 inch is acceptable.
- B. Aileron freeplay between 0.030 and 0.050 inch requires checking for loose bearings or attaching bolts.
- C. Aileron freeplay above 0.050 inch is unacceptable and loose or worn bearings and attaching hardware must be replaced, as required.

VIEW LOOKING DOWN L.H. WING (R.H. OPPOSITE)

1. Install a 3/16 inch rig-pin in aileron control pulley, aft of Fus. Sta. 316.00 bulkhead per Aileron and Tab - Adjustment/Test, Chapter 27-10-00, Para. 2. A. (4).
2. Check all attaching bolts between aileron control pulley and ailerons for proper torque.
3. With aileron tab in streamline position (in order to eliminate tab freeplay) measure and record the "no load" freeplay of aileron trailing edge at Wing Sta. 156.8, left and right side, Per Figures 1 and 2.
4. The total freeplay shall not exceed 0.050 inch. If necessary, replace rod end bearing assembly on push-pull rod P/N 513020-501.

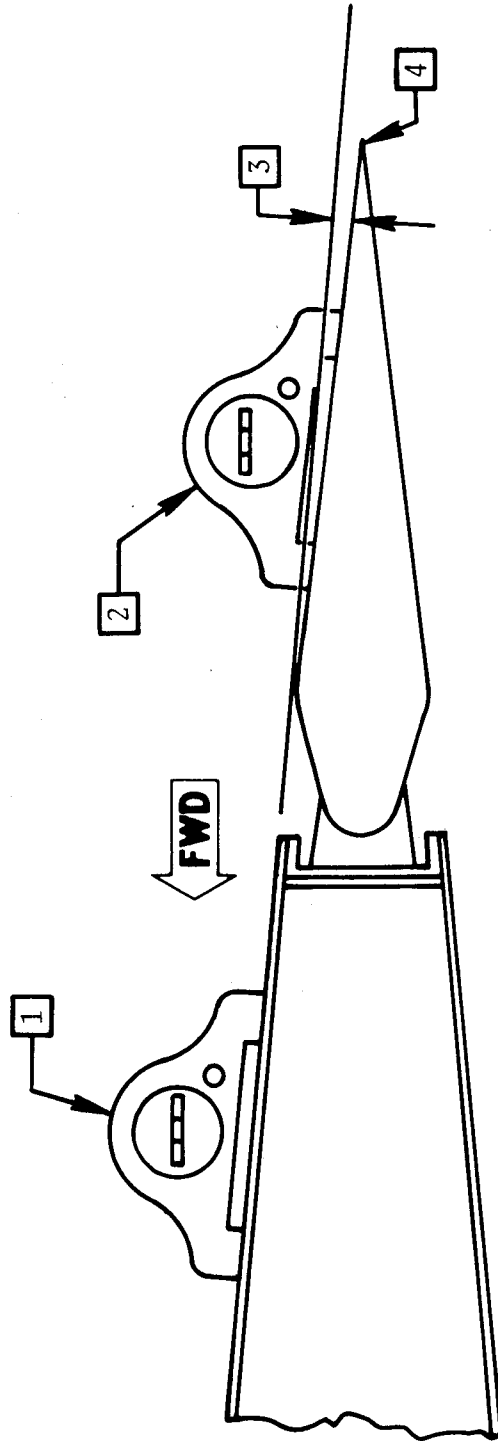
- 1 SET PROTRACTOR TO "0".
- 2 MOVE PROTRACTOR TO THIS LOCATION AFTER IT HAS BEEN ZEROED.
- 3 AILERON IS STREAMLINED IF PROTRACTOR READS $2^{\circ} 30' \pm 0^{\circ} 15'$.
- 4 CHECK FOR AILERON FREE PLAY (VERTICAL-MOVEMENT, PER STEP 4 OF INSTRUCTIONS, AT THIS POINT.)

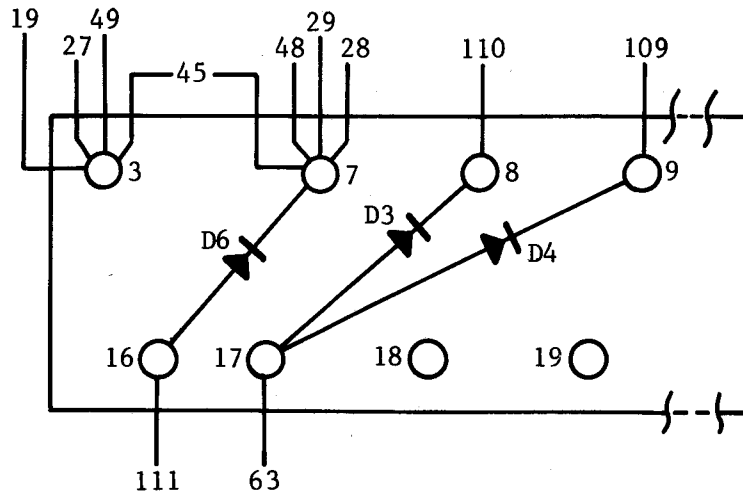
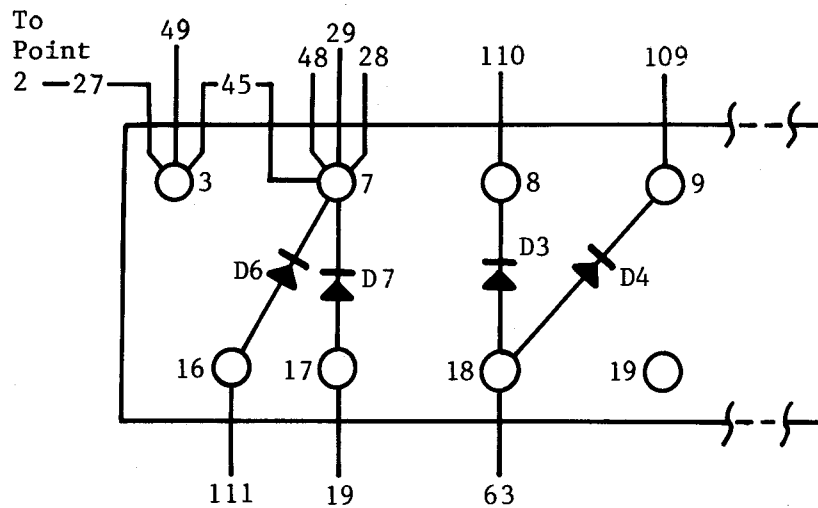
FIGURE 1 ADDITION OF DIODES

REASON: TO PREVENT LEAK PATH BETWEEN BATTERY BUS AND DISTRIBUTION BUS

FLAP CONTACTOR BOX (WAS CONFIG.)

FLAP CONTACTOR BOX (NOW CONFIG.)

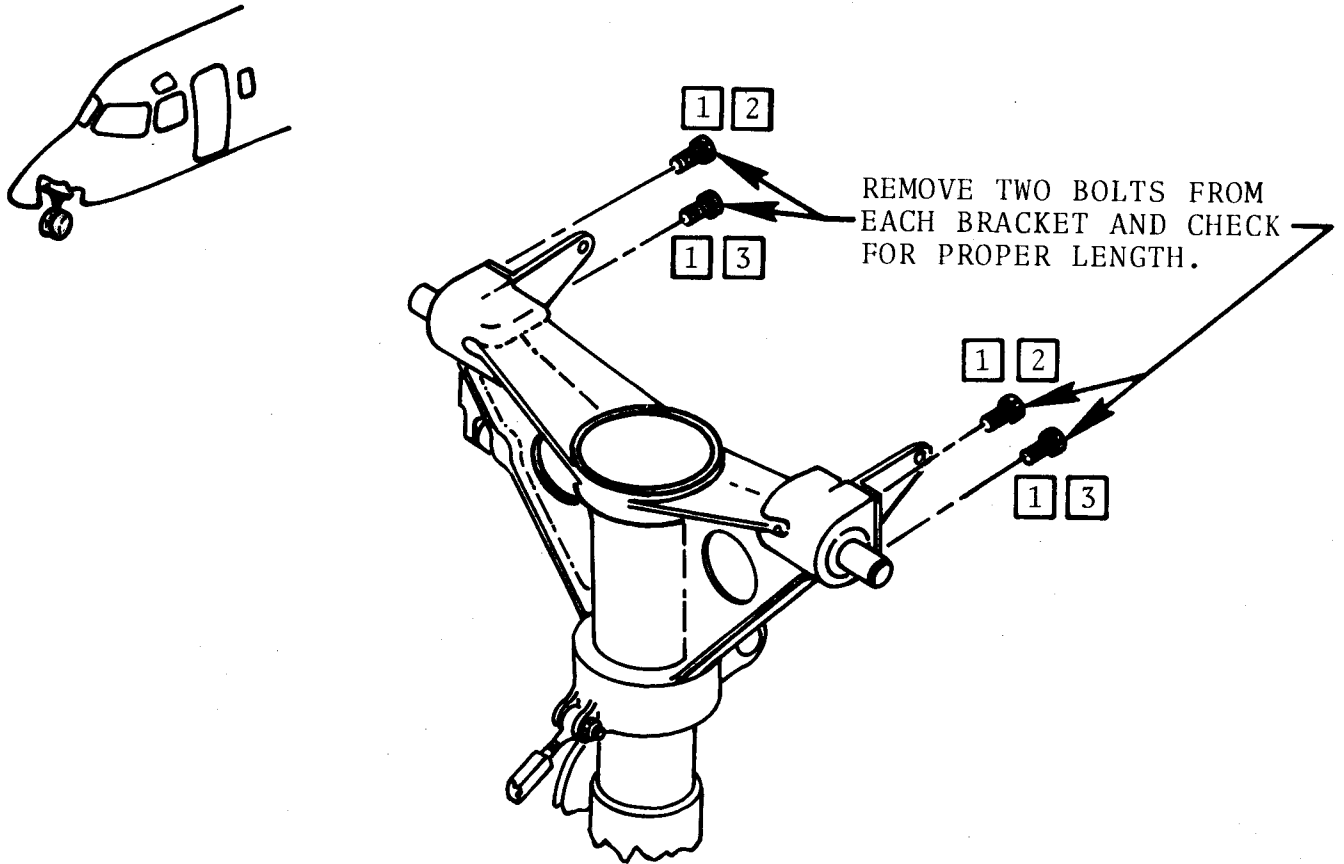
- 1 SHOULD BE AN4H6A (GRIP 5/16" LENGTH 25/32") IN THE TOP AND BOTTOM. THREE WASHERS MUST BE UNDER THE HEAD OF EACH LOWER BOLT AND ONE UNDER THE HEAD OF EACH UPPER BOLT.
- 2 TOP BOLT MUST BE AN4H6A.
- 3 ALTERNATE BOLT FOR LOWER LOCATION IS AN4H5A (GRIP 3/16" LENGTH 21/32") IF THE AN4H5A BOLT IS USED PLACE ONE WASHER UNDER ITS HEAD.

Should AN4H5A or AN4H6A bolts bottom out when installed, it will be necessary to measure hole depth, add regular thickness washers or select proper length bolt to obtain maximum thread engagement between bolt and strut outer body.

5. Replace incorrect bolts with bolt P/N AN4H6A (Upper) and P/N AH4H5A (Lower).

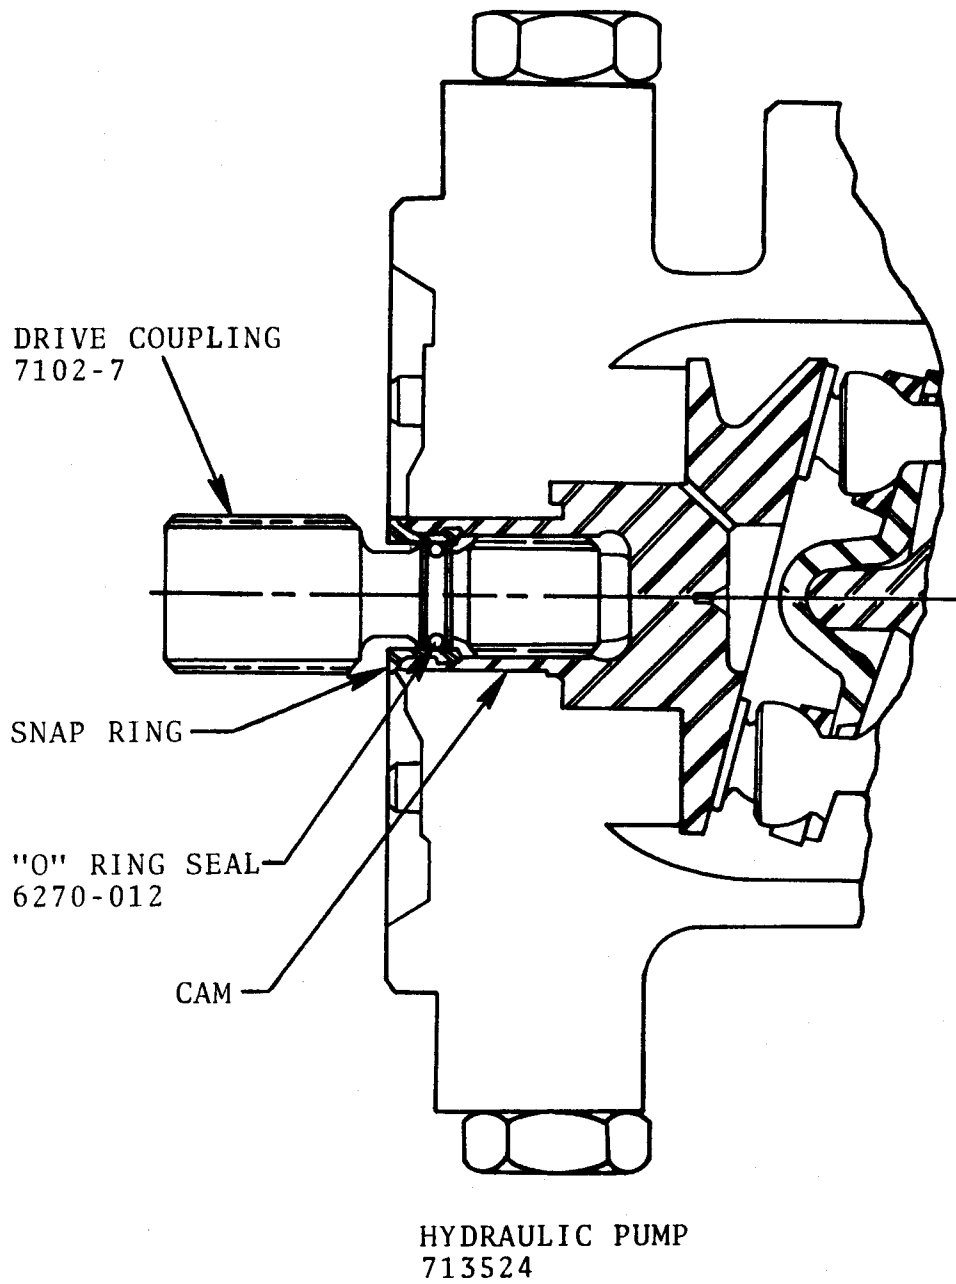
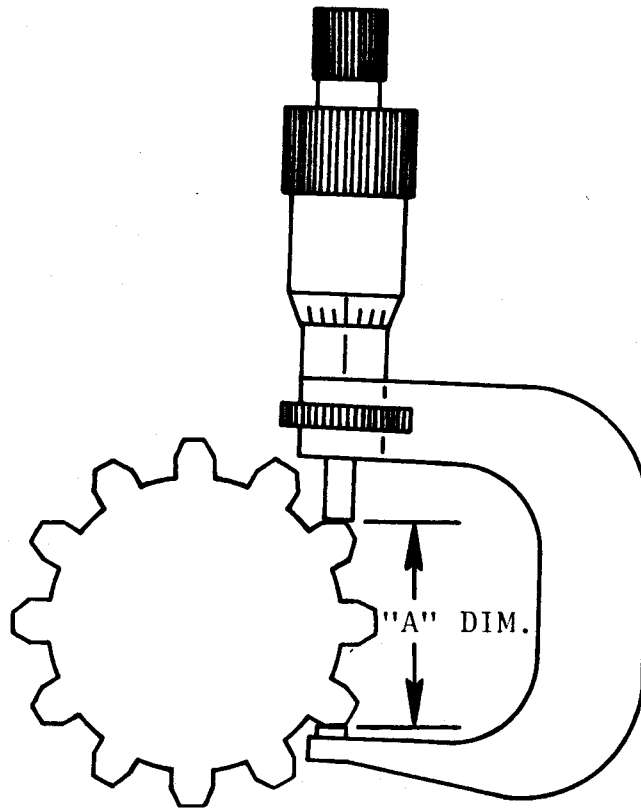
REASON: TO INSURE ADEQUATE LUBRICATION AND REDUCE CAM
AND COUPLING WEAR IN THE HYDRAULIC PUMP.

If splines are worn beyond limits on pump end, both coupling and cam in pump will require replacement. Pump should be returned to Atlantic Aviation for an exchange unit. If coupling is not worn beyond limits proceed with step 6.

- CANCELLED*
1. Open both engine cowlings to gain access to both engine driven hydraulic pumps.
 2. Remove hydraulic pumps from both engines.
 3. Remove drive coupling P/N 7102-7 from both pumps by removing snap ring. See Figure 1.
 4. Clean all grease from drive coupling, pump and engine female splines.
 5. Inspect drive coupling splines for excessive wear. See Figure 2 for wear limit and check procedure.

NO. OF SPLINE TEETH	MEASUREMENT ACROSS NUMBER OF TEETH	DIM "A" MIN
10	2	.135
11	2	.174
12	3	.348
16	3	.358
21	4	.420
24	4	.511

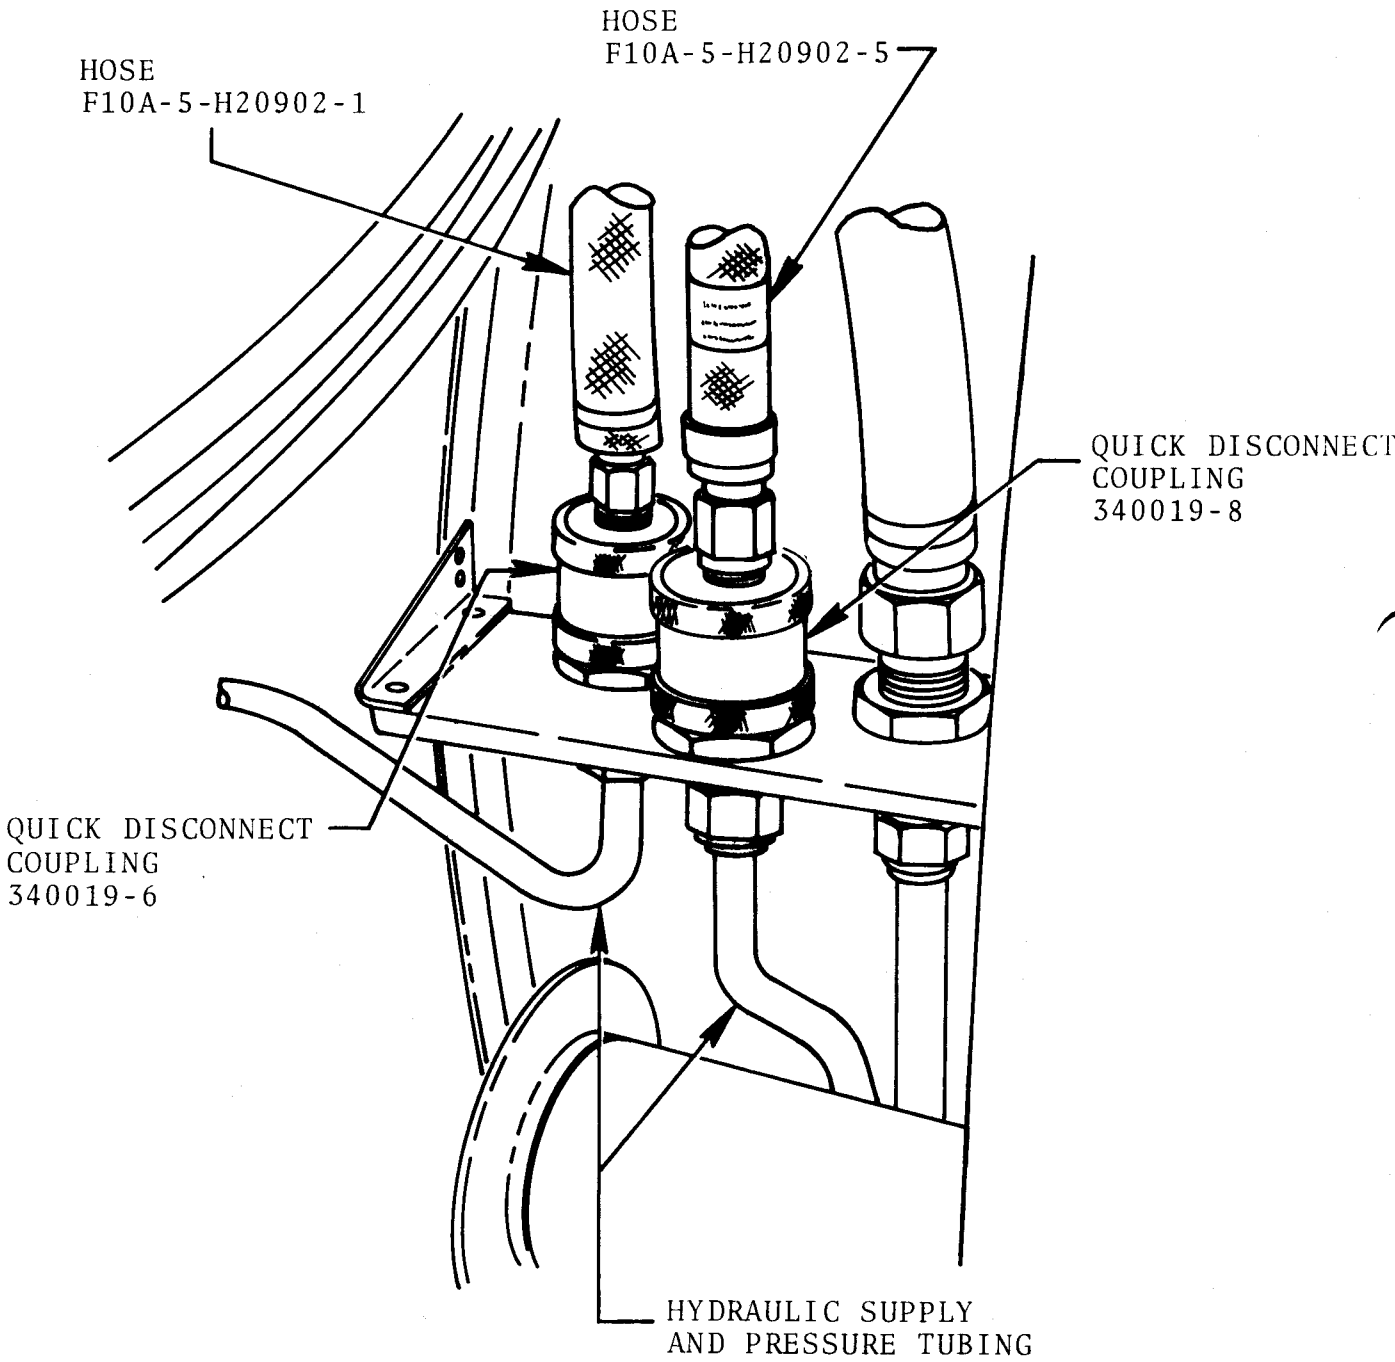
FIGURE 1 HYDRAULIC QUICK DISCONNECT
BEFORE MODIFICATION

REASON: LEAKAGE PROBLEMS IN QUICK DISCONNECTS CAN BE RESOLVED BY REPLACING THEM WITH TEE FITTINGS. THE MORE RELIABLE COUPLING HALF OF THE QUICK DISCONNECT IS RETAINED AND INSTALLED ON THE TEE FITTING TO FACILITATE HOOK UP OF A GROUND HYDRAULIC UNIT.

14. Pressurize hydraulic system and leak check all tubing, hoses, fittings and quick disconnects in reworked area.
15. Return aircraft to service.

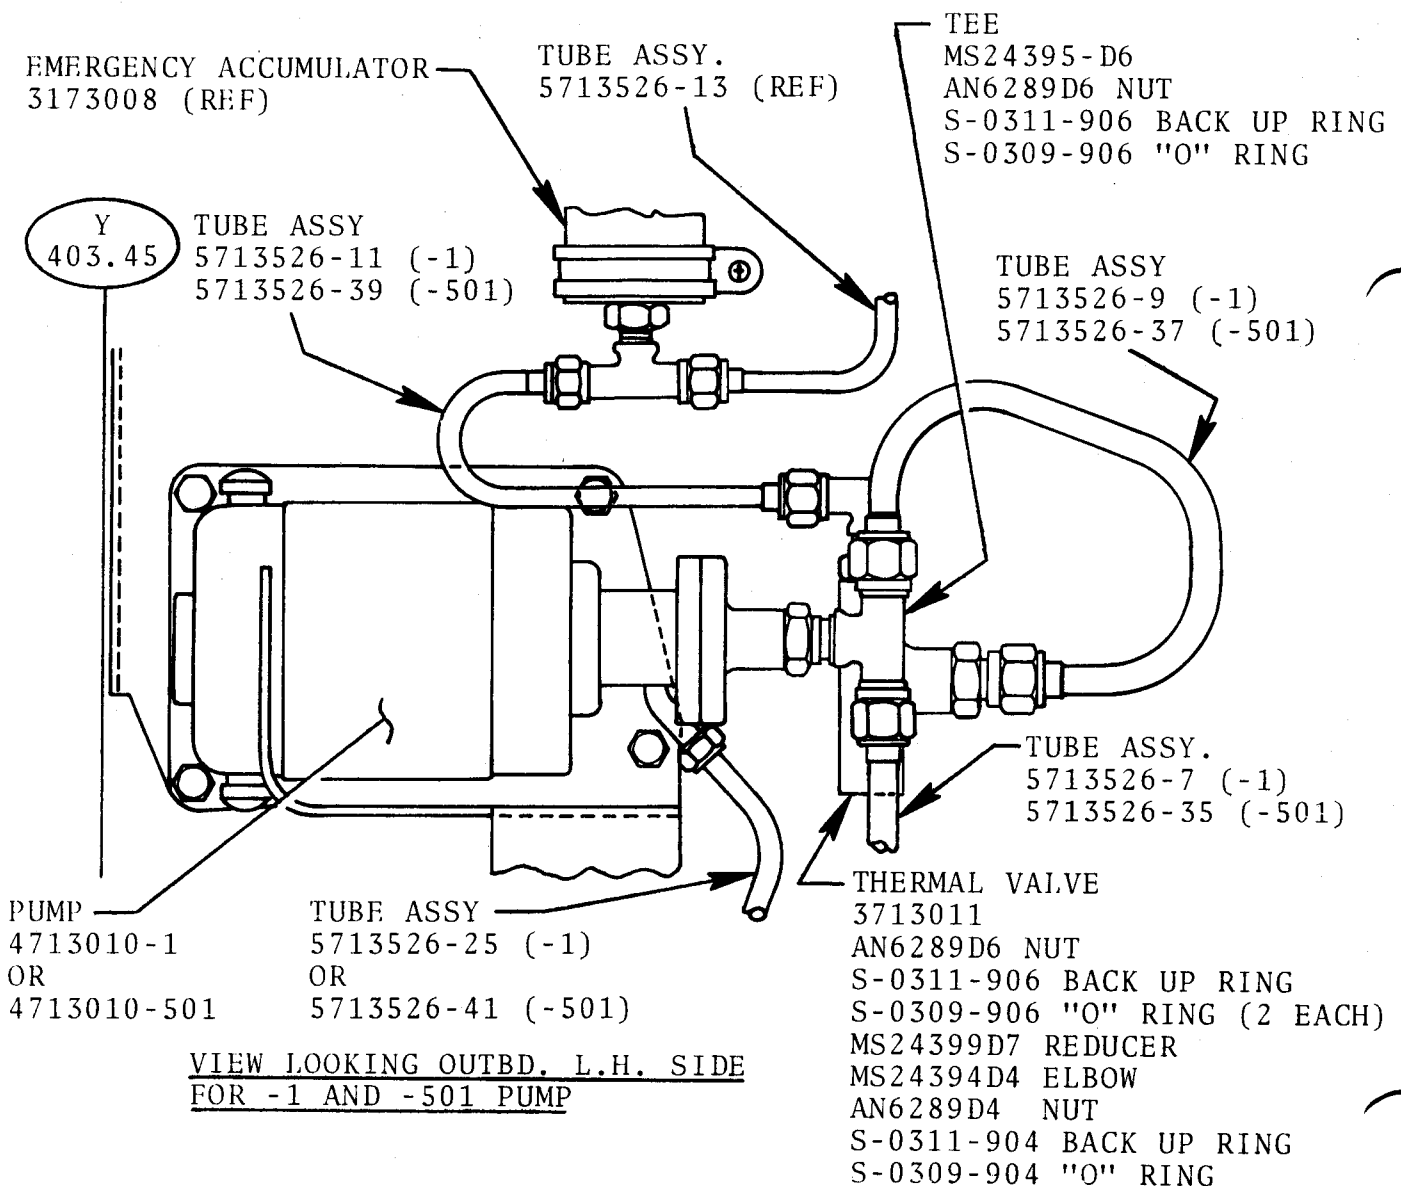
FIGURE 1 EXISTING INSTALLATIONS

REASON: HYDRAULIC PUMPS P/N 4713010-1 AND -501 HAVE BEEN DISCONTINUED BY THE VENDOR. REPLACEMENT PUMPS EITHER NEW OR OVERHAULED MAY NOT BE AVAILABLE IN SPARES STOCK.

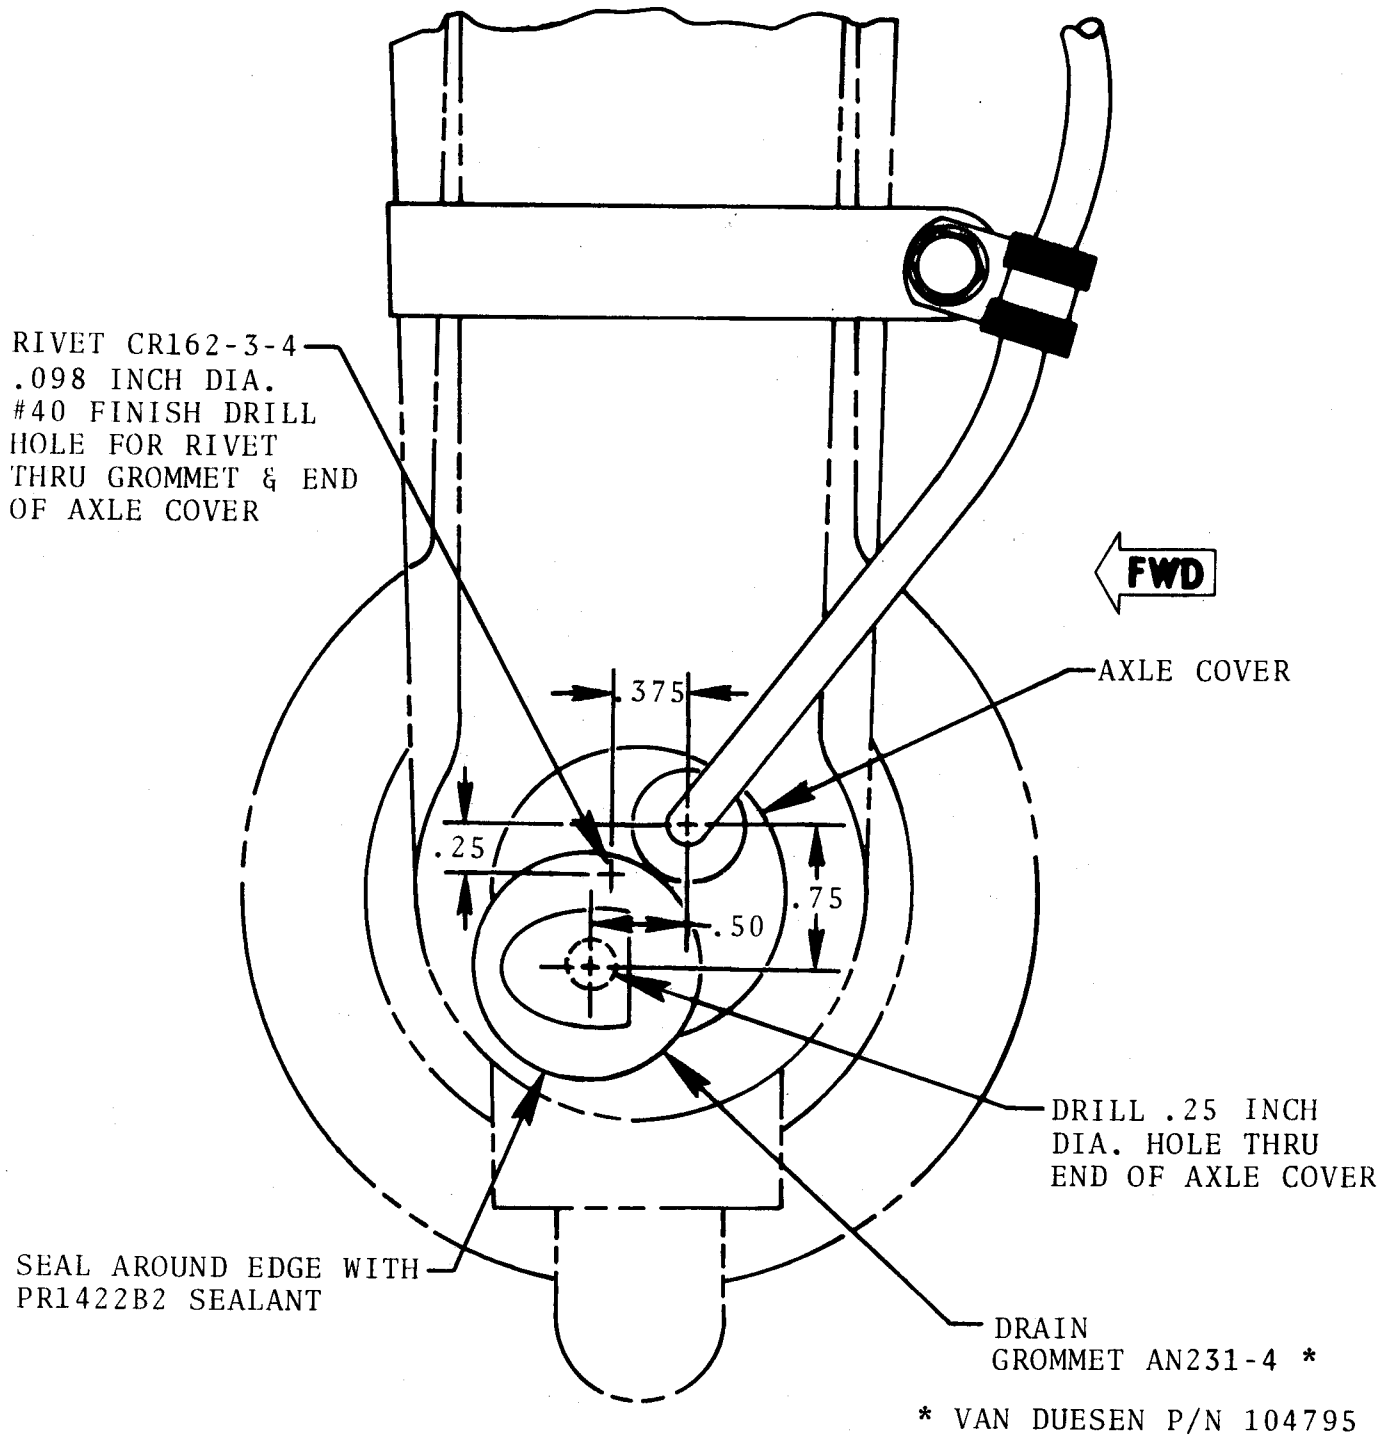
VIEW LOOKING INBOARD AT LH. MAIN WHEEL (RH. OPP.)

REASON: TO PROVIDE FOR ESCAPE OF CONDENSATION MOISTURE FROM INSIDE MAIN GEAR AXLES.

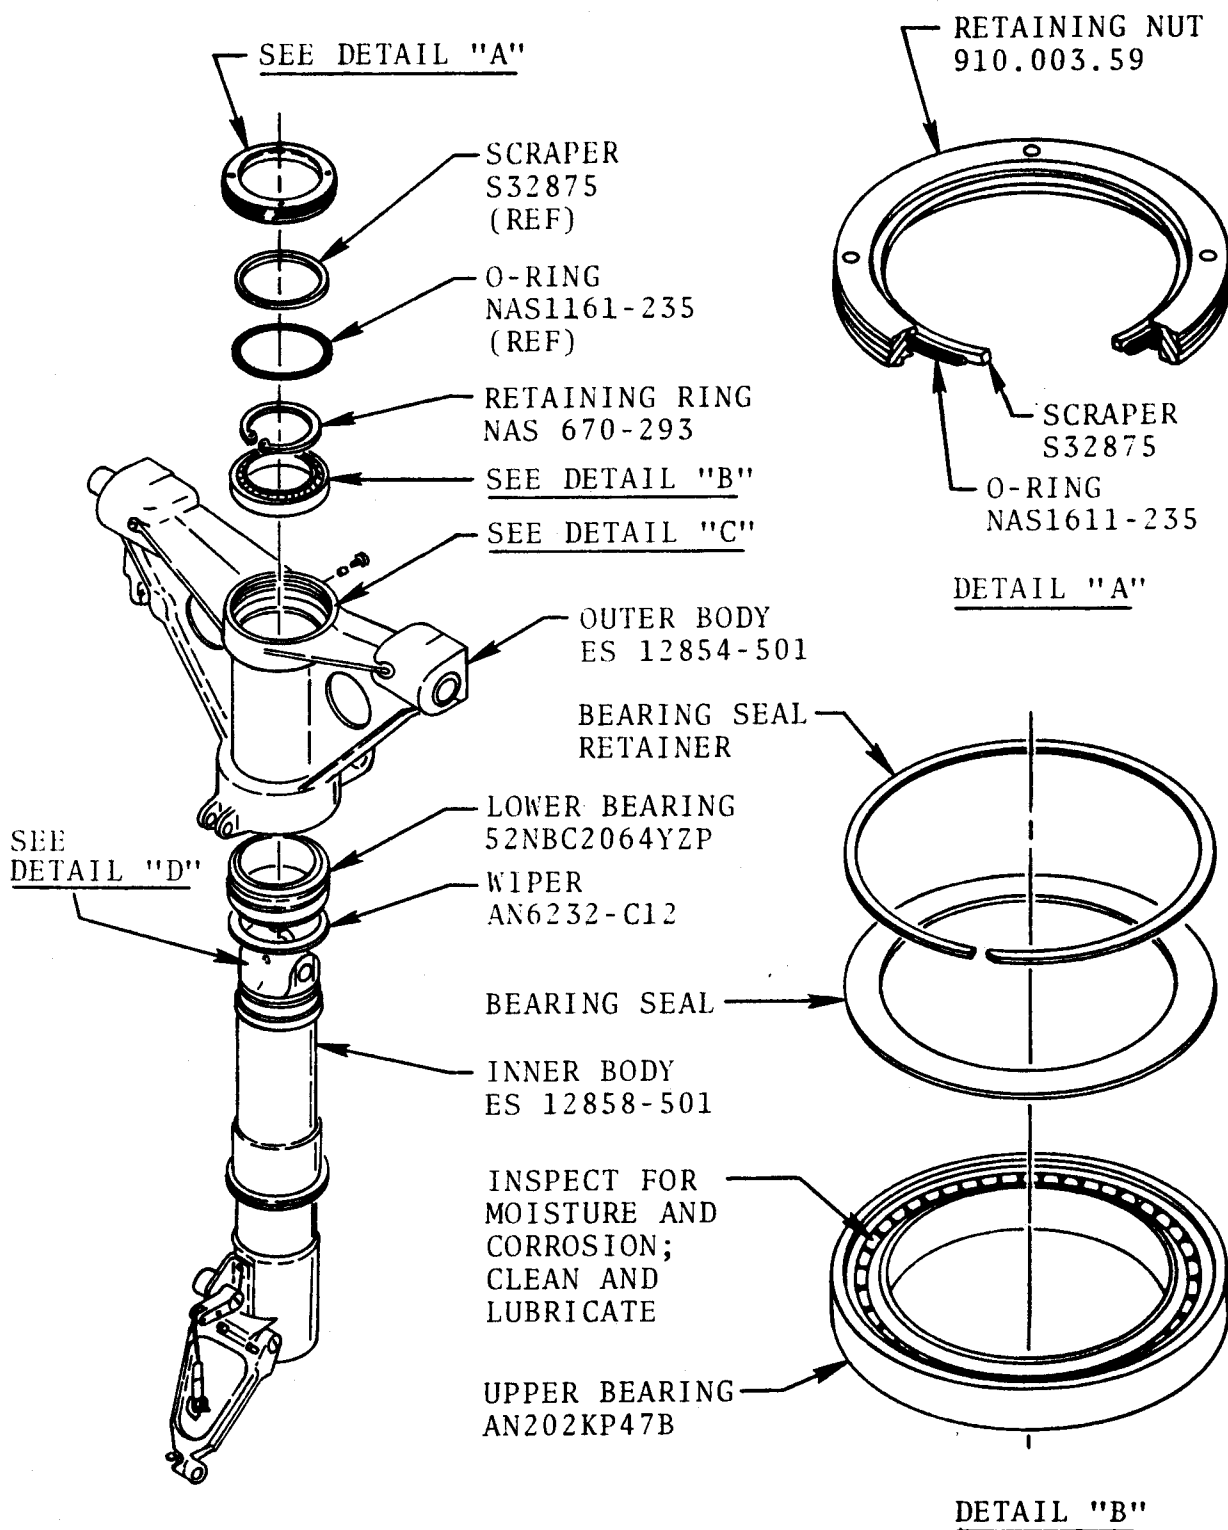
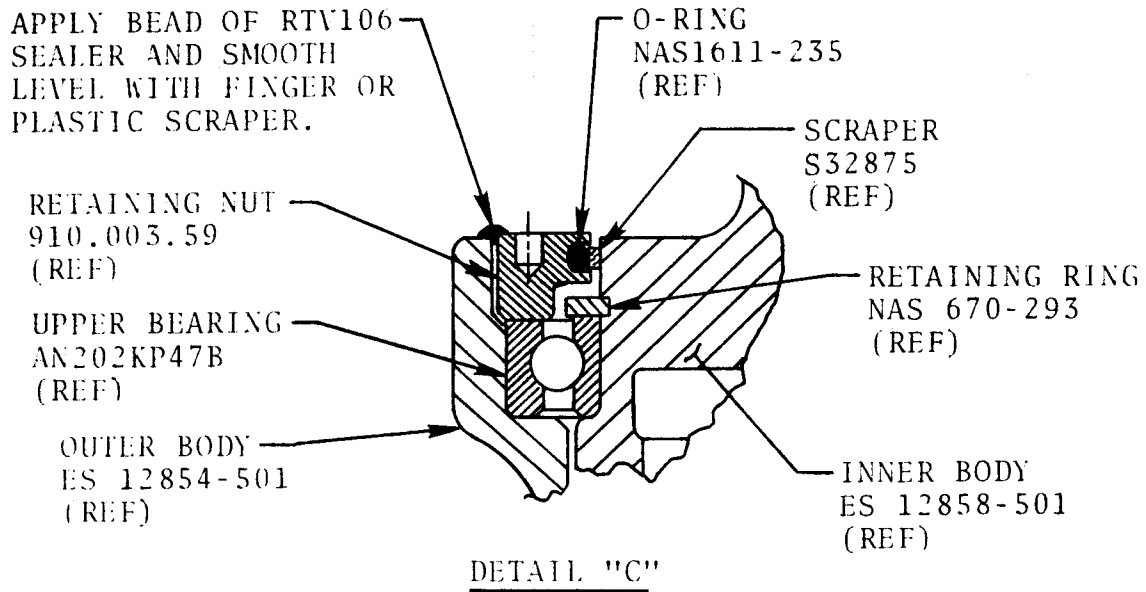
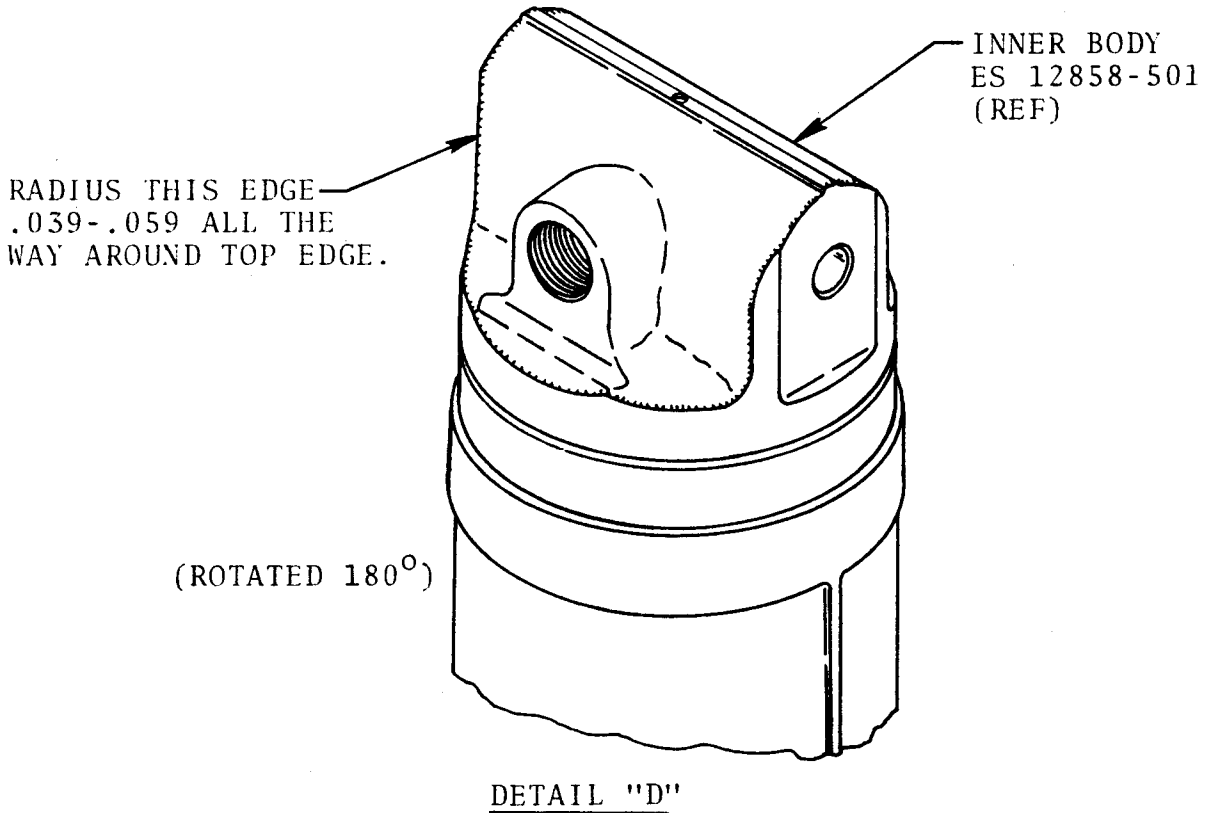
Figure 1 Nose Strut Assembly(sheet 1 of 2)

REASON: To Improve upper strut bearing retaining nut seal and reduce potential for moisture accumulation in nose strut bearings.

1. Remove inner body of nose strut from outer body per 1124/1124A Westwind Maintenance Manual, Chapter 32-20-00.
2. Remove bearing seal and retainer from one side of upper bearing. Reference Detail "B" for Figure 1. Lower bearing should not be disassembled. Inspect both bearings for evidence of moisture or corrosion.

NOTE: Defective bearings must be replaced. Leave off seal and retainer from one side of upper bearing only or remove seal and retainer from one side of new upper bearing before reassembly.

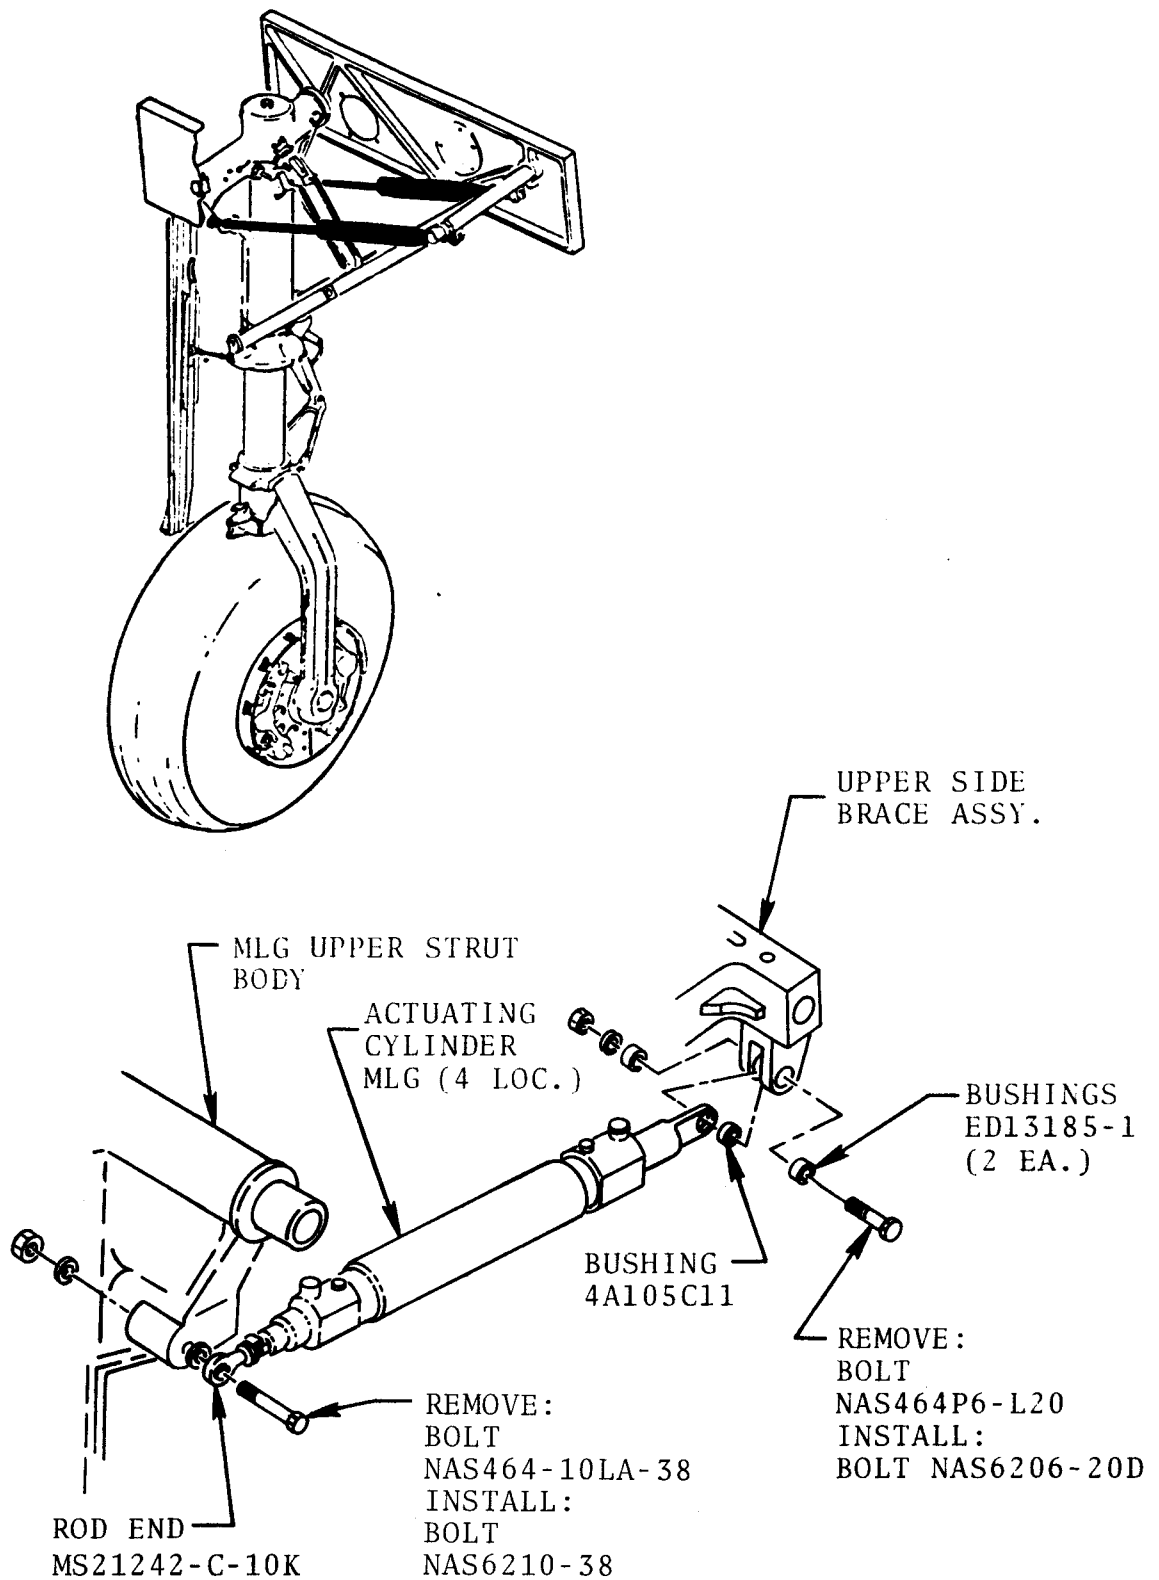
FIGURE 1 ACTUATING CYLINDER ATTACH BOLT REPLACEMENT

R This service letter requires the replacement of unplated or corroded bolts and
R inspection for corrosion at MLG actuating cylinder attach points.
R

- E. If bolts were difficult to remove, check for evidence of corrosion in the MLG upper strut body lug holes. Clean out corrosion as required and assure that hole does not exceed 0.626 inch diameter.

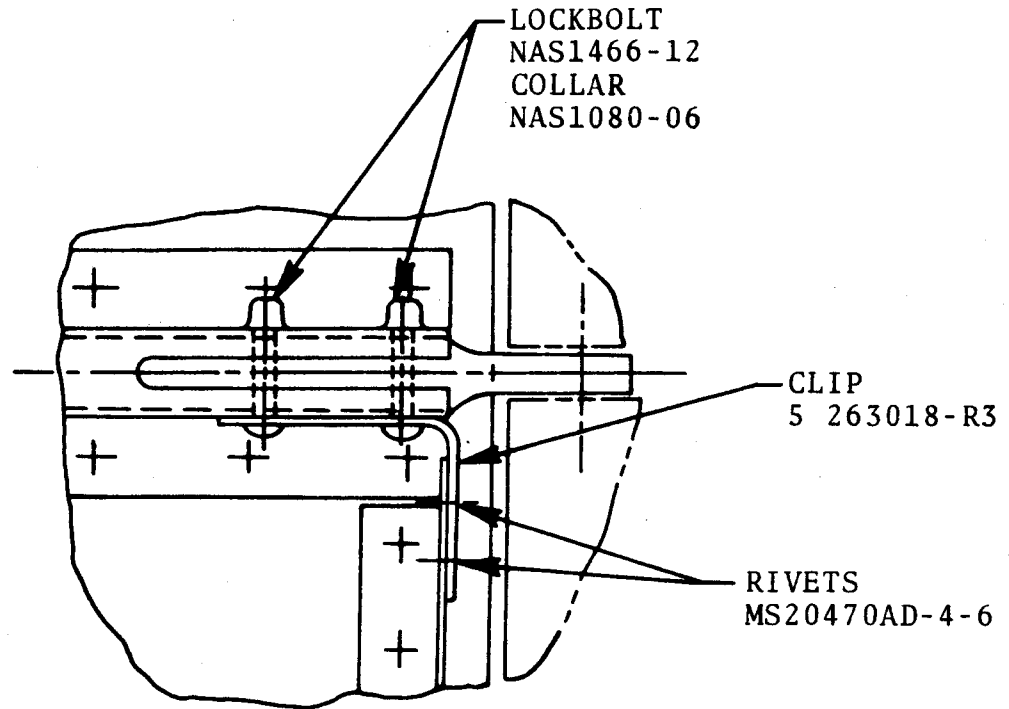
VIEW ON FWD. INBD. CORNER - L.H.S.

To establish standardized repairs for areas of the MLG strut doors that are subject to cracking. Cracking appears to be the result of operations in flight when the gear is down and the strut door is buffeting.

FIGURE 1 INSPECTION OF STRUT DOOR

- A. Visually inspect the MLG strut door attachments for looseness at hinge points, actuator rod ends and rod end attach bolts. Excessive looseness should be corrected by replacing affected part or parts.
- B. Lubricate all moving parts on the MLG strut door using an oil can.
- C. Visually inspect MLG strut door hat section reinforcements and skin for cracks.
