SERVICE INFORMATION LETTER

SERVICE INFORMATION LETTER INDEX

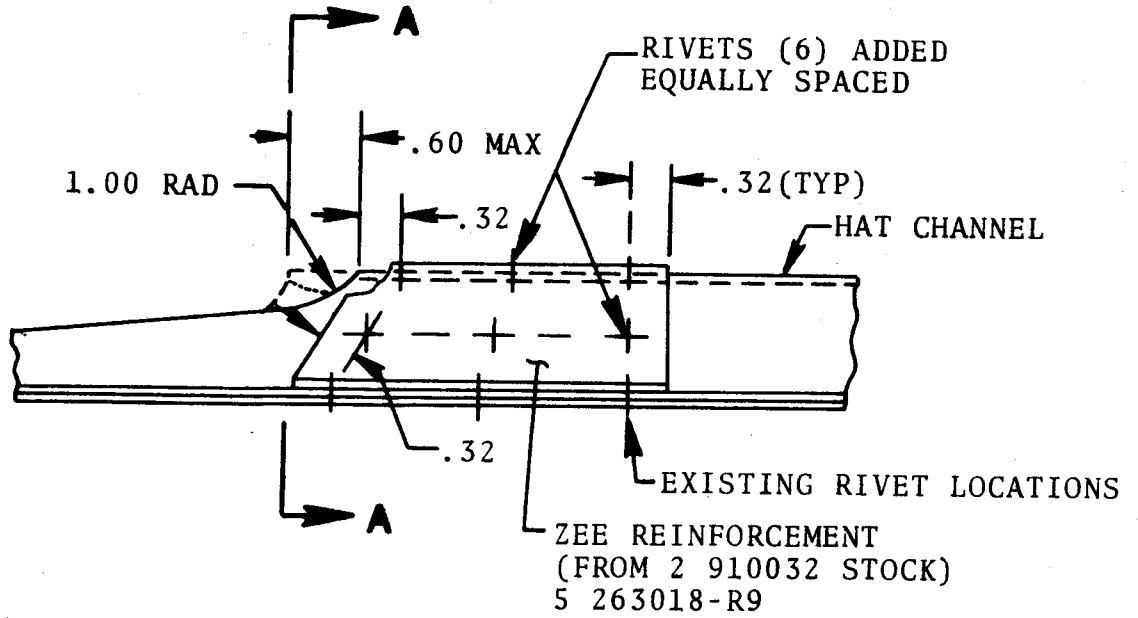
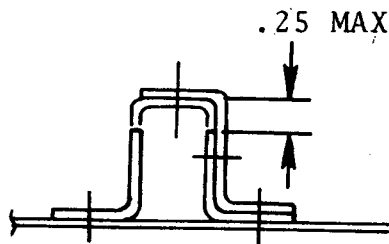
FIGURE 3 REPAIR OF CRACK RUNNING ALONG RIVET LINE OF HAT CHANNEL IN DOOR SKIN.

- (3) Finish per Step 2.E.
- G. To repair a skin crack running along one of the rivet lines where the hat channel is attached, accomplish the following:
- (1) Carefully drill out rivets attaching skin to hat channel in area of crack to allow installation of patch plate P/N 5 263018-R13.
 - (2) Cut out cracked area to allow flush patch P/N 5 263018-R11 to be fit into skin.
 - (3) Locate new patch plate P/N 5 263018-R13 and patch P/N 5 263018-R11 and drill per Figure 3. Feathered edge of patch plate should rest against door skin.

Patch plate P/N 5 263018-R13 may be fabricated from .025 Stainless Steel 1/4" Type 301. Size to be 4 inches X 8 inches with edges feathered back .025 inch from each edge. Patch P/N 5 263018-R11 may be fabricated from .050 Alclad Alum. 2024-T3. Size .50 inch X 5 inches. Ref. Figure 3 for fabrication of patch and patch plate.

- (4) Install patch and patch plate with MS20426AD-4 rivets with head on skin side. NAS1739E-4 blind rivets may be used along center of hat channel.
 - (5) Finish per Step 2.E.
- H. Repair of cracks at tapered end of hat channels may be repaired per Figure 4 or 5 depending on length of cracks as follows:
- (1) For cracks no longer than .040 refer to Figure 4.
 - (a) Trim out cracked section of hat channel as shown in Figure 4.
 - (b) Fabricate zee reinforcement P/N 5 263018-R9 from P/N 2 910032 stock per Figure 4.
 - (c) Carefully drill out three rivets holding hat channel to door skin to allow installation of zee reinforcement.

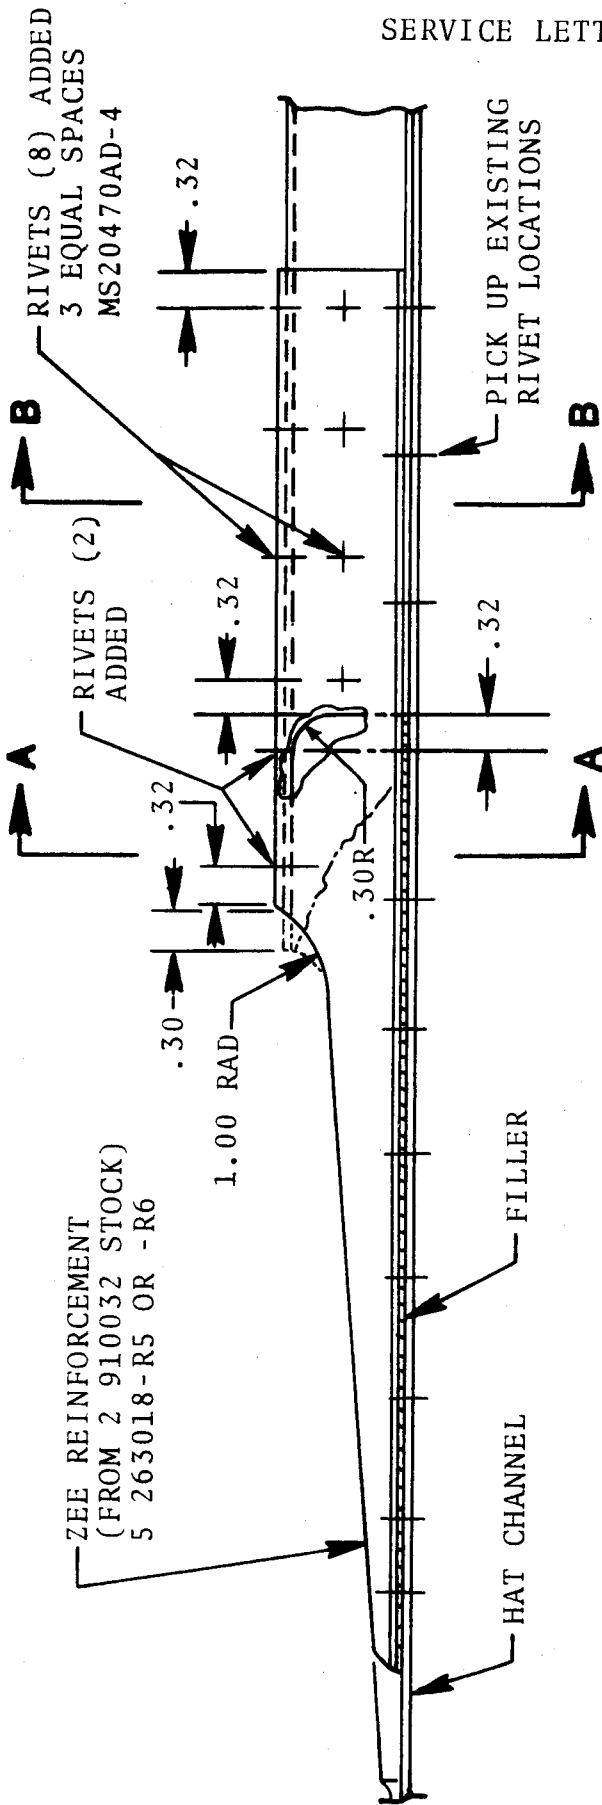
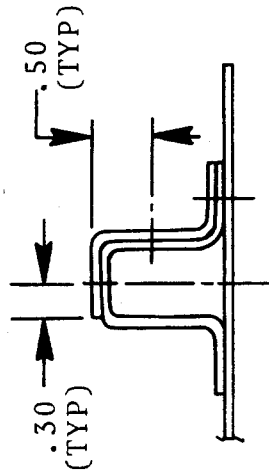
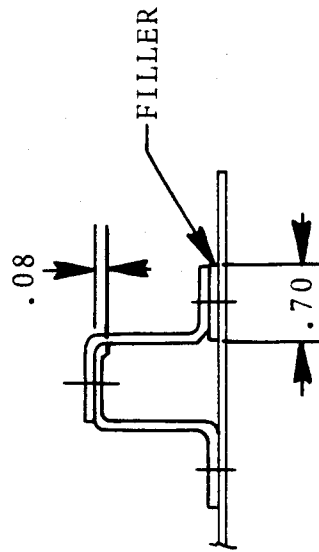
FIGURE 5 REPAIR OF CRACK AT TAPERED END OF HAT CHANNEL (CRACK GREATER THAN .040 INCH)

- (2) For cracks exceeding .040 inch in length refer to Figure 5.
- (a) Drill out rivets attaching hat channel flange to door skin on side that is cracked to allow installation of zee reinforcement shown in Figure 5.

- (b) Trim out cracked section of hat channel as shown in Figure 5, removing a portion of the hat channel flange where it is riveted to door skin.
 - (c) Fabricate filler P/N 5 263018-R7 from .063 Alclad Alum. 2024-T3 .070 inch X 8 inches.

- (f) Install zee reinforcement and filler strip with MS20426AD-4 rivets where original 11 were removed and add 10 new MS20426AD-4 rivets.
- (3) Finish areas repaired per Step 2.E.

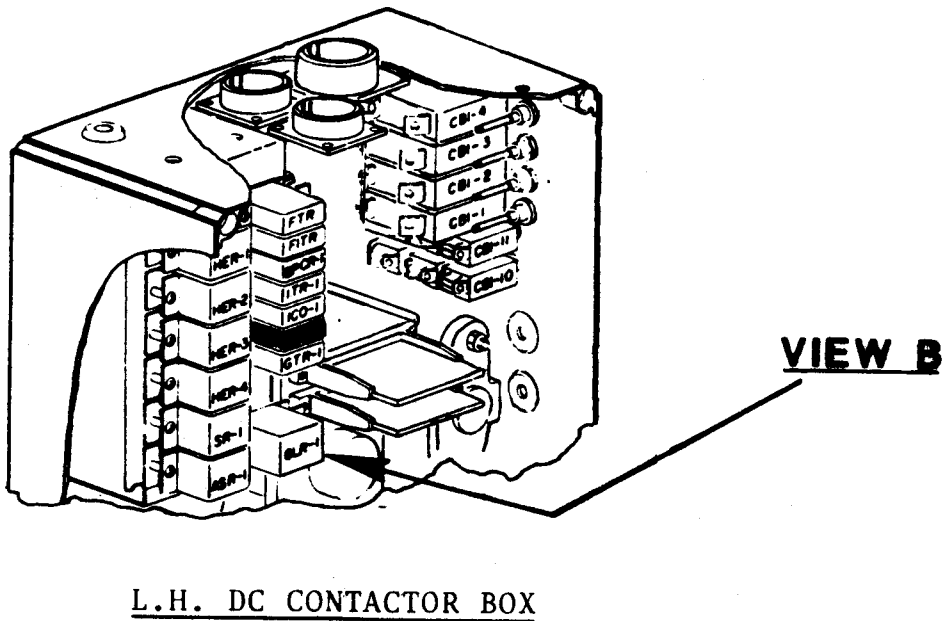
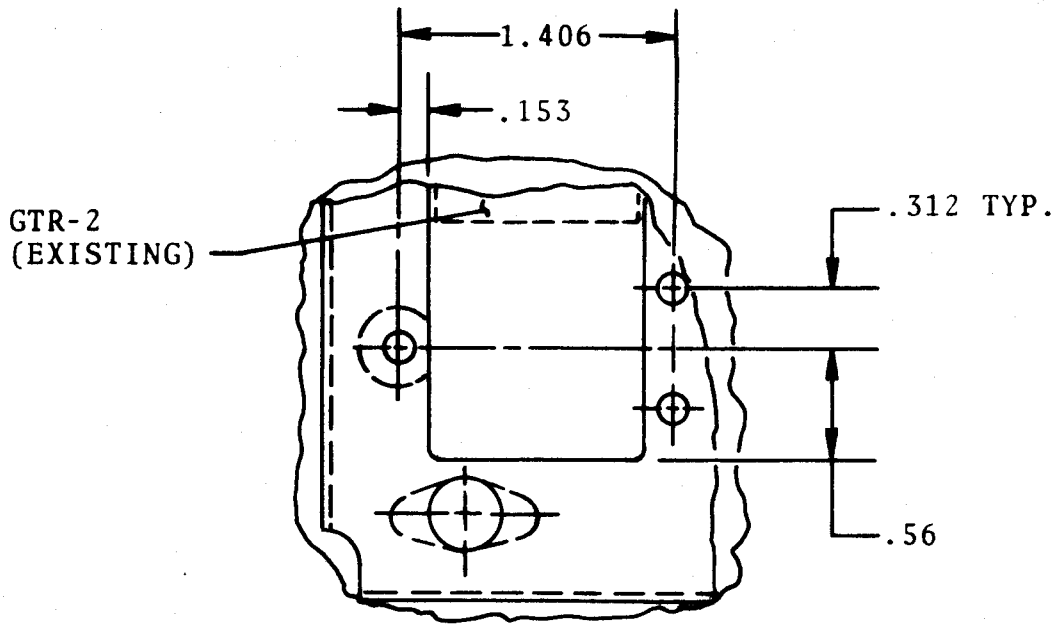
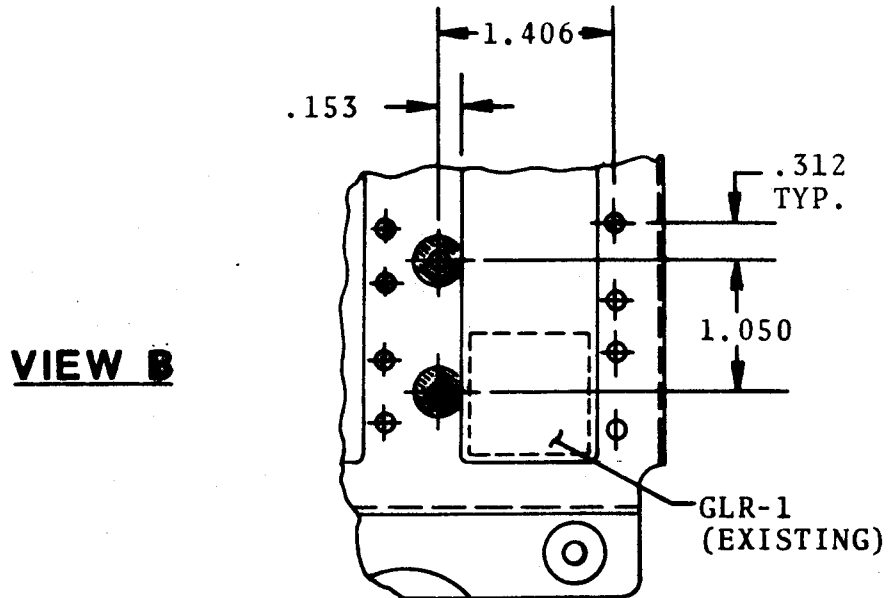
FIGURE 2 NEW RELAYS -
MOUNTING DETAIL

To provide a more reliable fuel computer control relay. The existing relay P/N MS27401-2 is rated at 10 AMPS and has a tendency for the relay contacts to burn and possibly fuse closed. The replacement relay is rated at 25 AMPS and should be able to withstand normal loads without any contact problems.

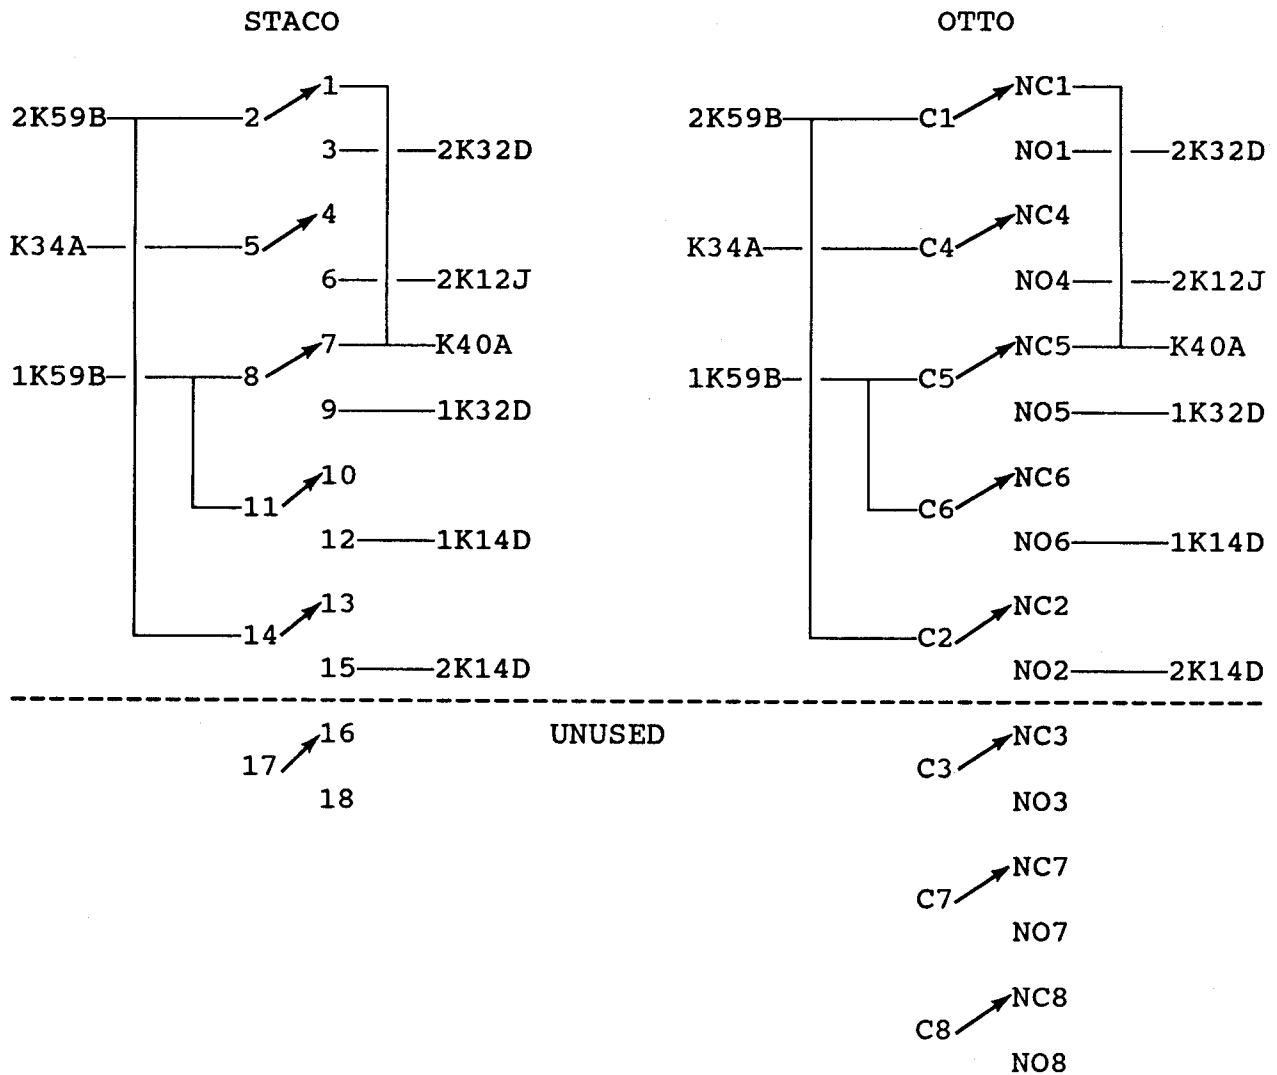
FIGURE 1

Aircraft originally were equipped with Staco P/N 30271-18N Thrust Reverse Fault Test Switches, which are no longer available. An alternate switch, P/N 10120-2, from Otto Controls is approved for replacement.

During replacement of the Thrust Reverse Fault Test Switch, replace Staco switch P/N 30271-18N with Otto Controls switch P/N 10120-2. Because terminal identification is different on the two switches, refer to Figure 1 and the 1124/1124A Westwind Wiring Diagram Manual, Chapter 78-30-01, to compare the original Staco terminal numbers and connecting wires for proper connection to Otto Controls switches.

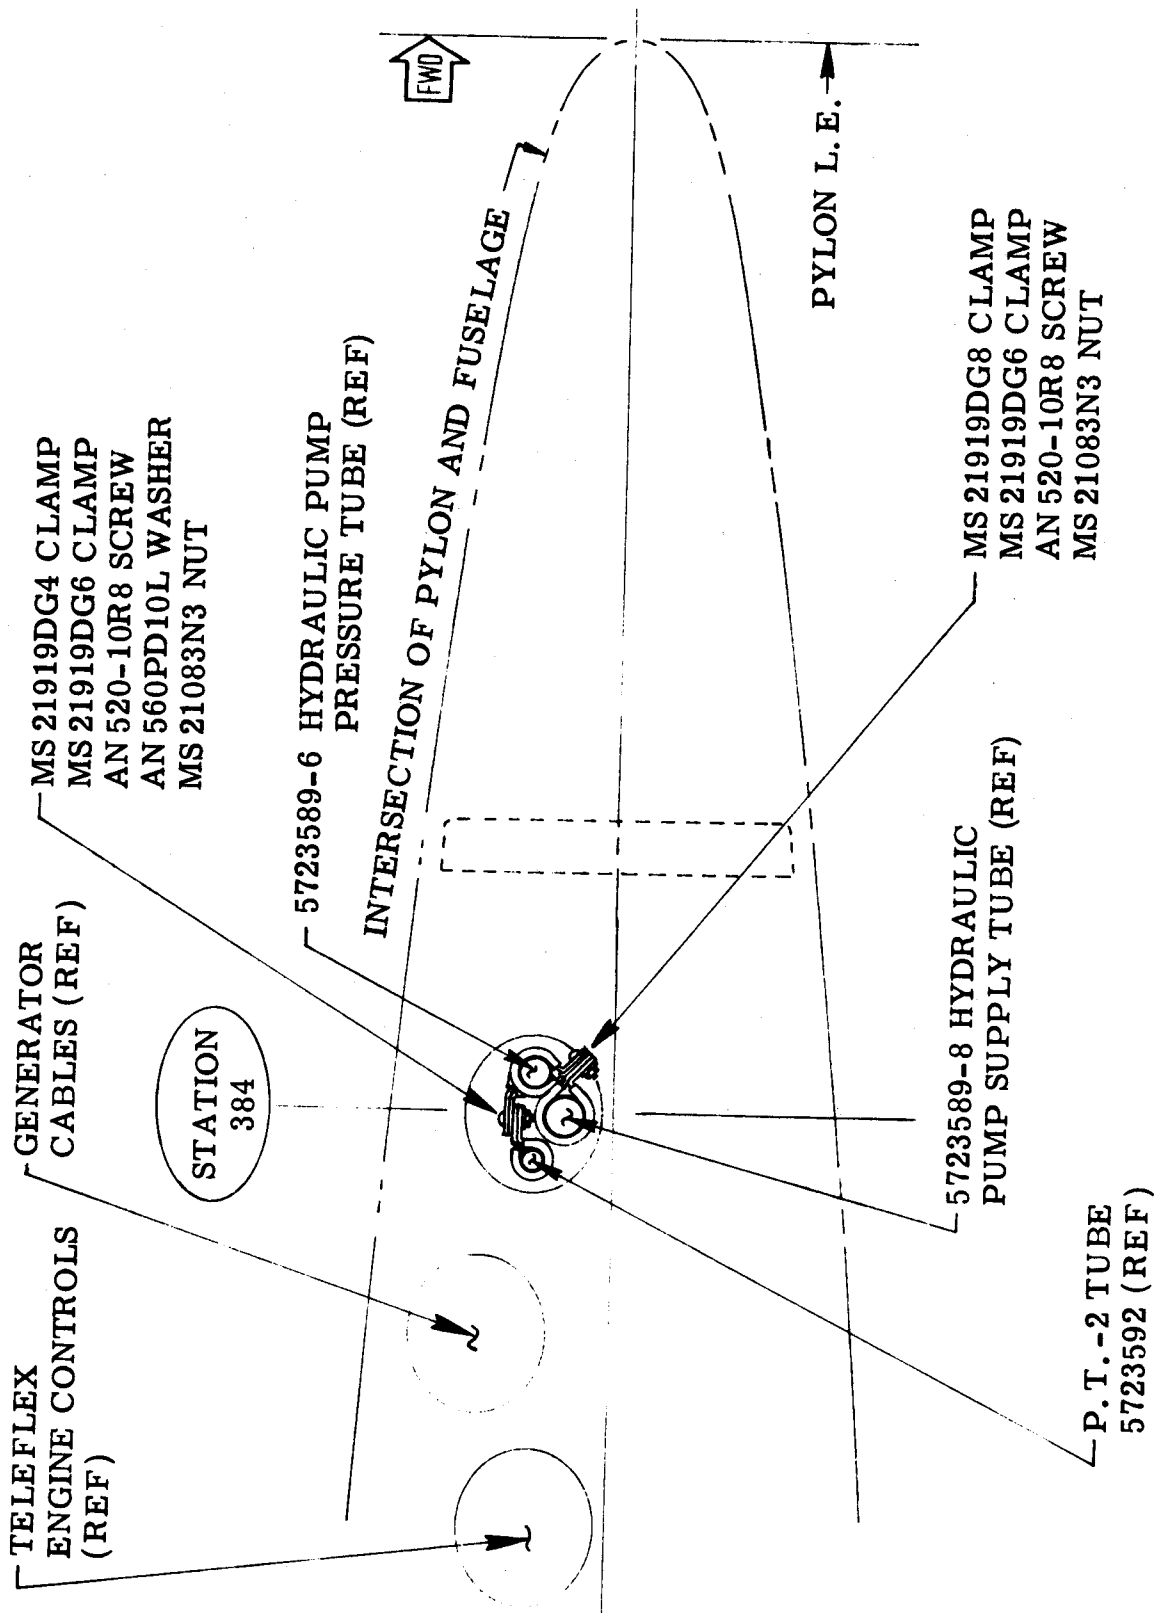
FIGURE 1

VIEW - INSIDE AIRFRAME TOWARD L. H. ENGINE PYLON

INSTALLATION OF TUBING CLAMPS

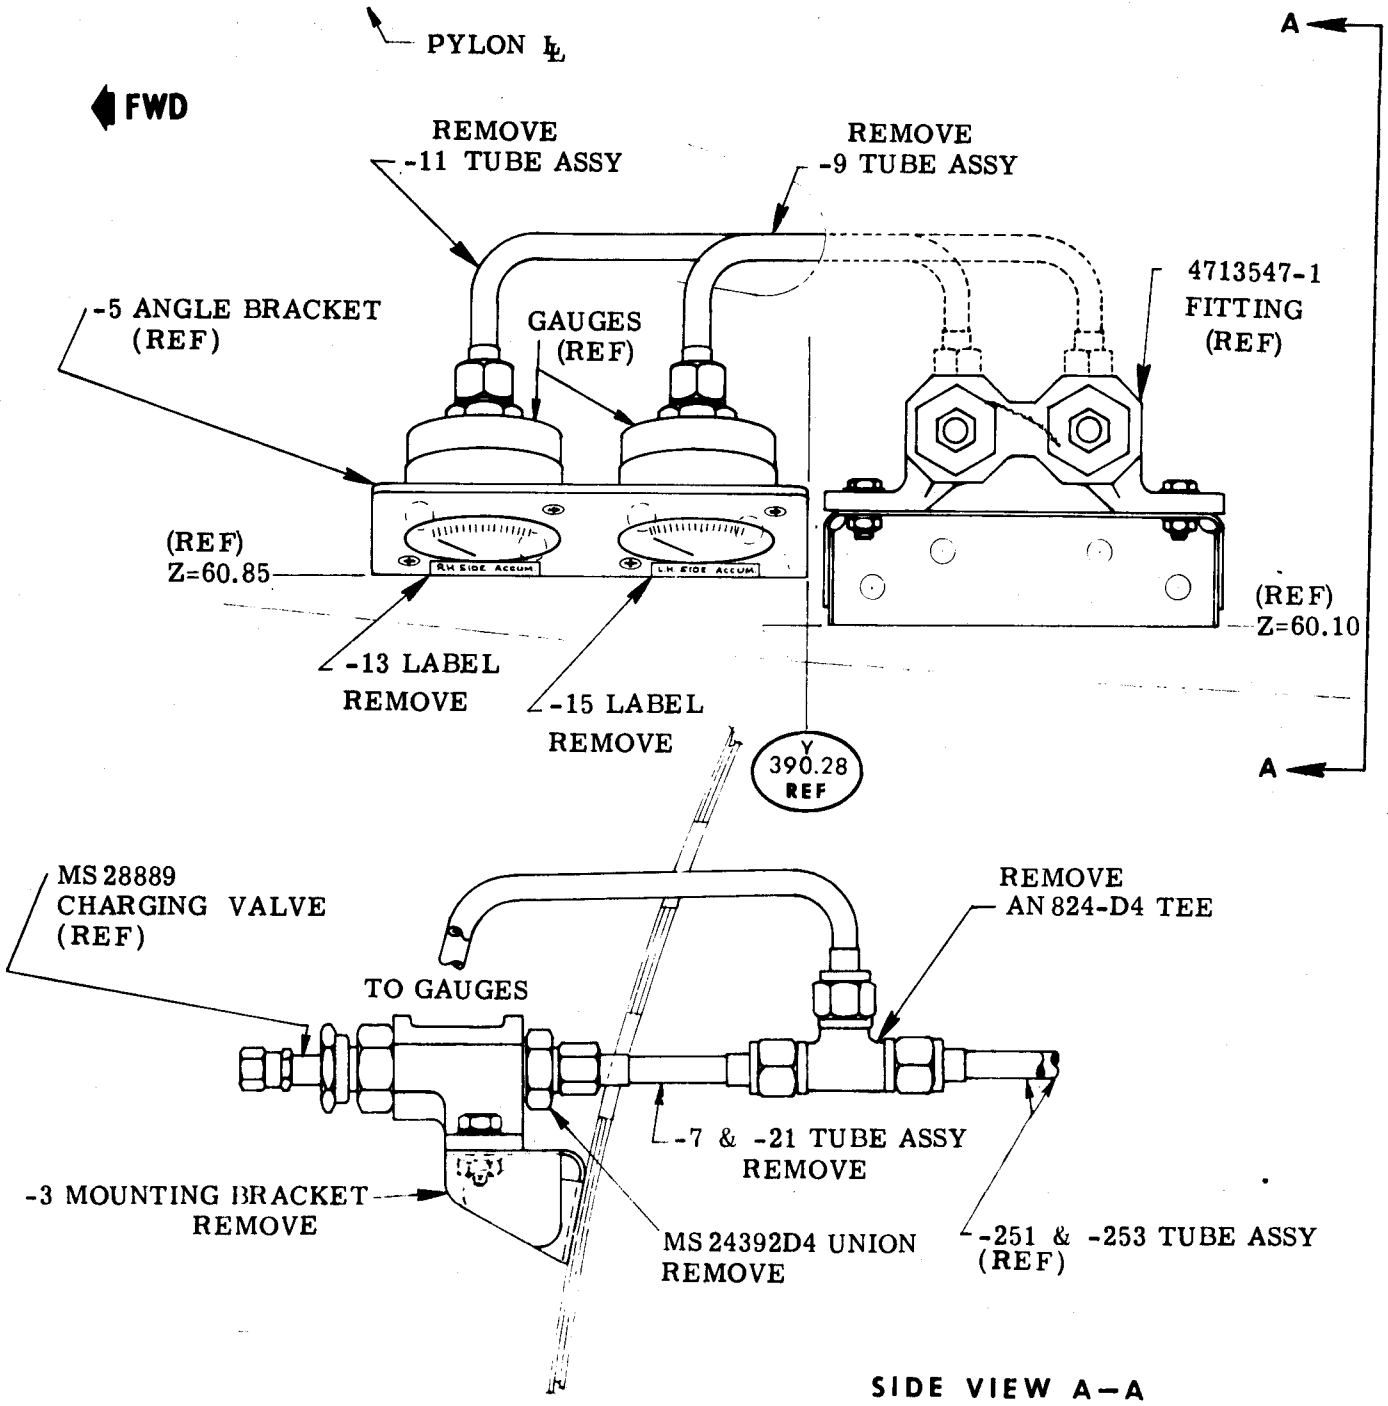
FIGURE 2

PRESENT CONFIGURATION OF NITROGEN GAUGES AND CHARGING VALVES

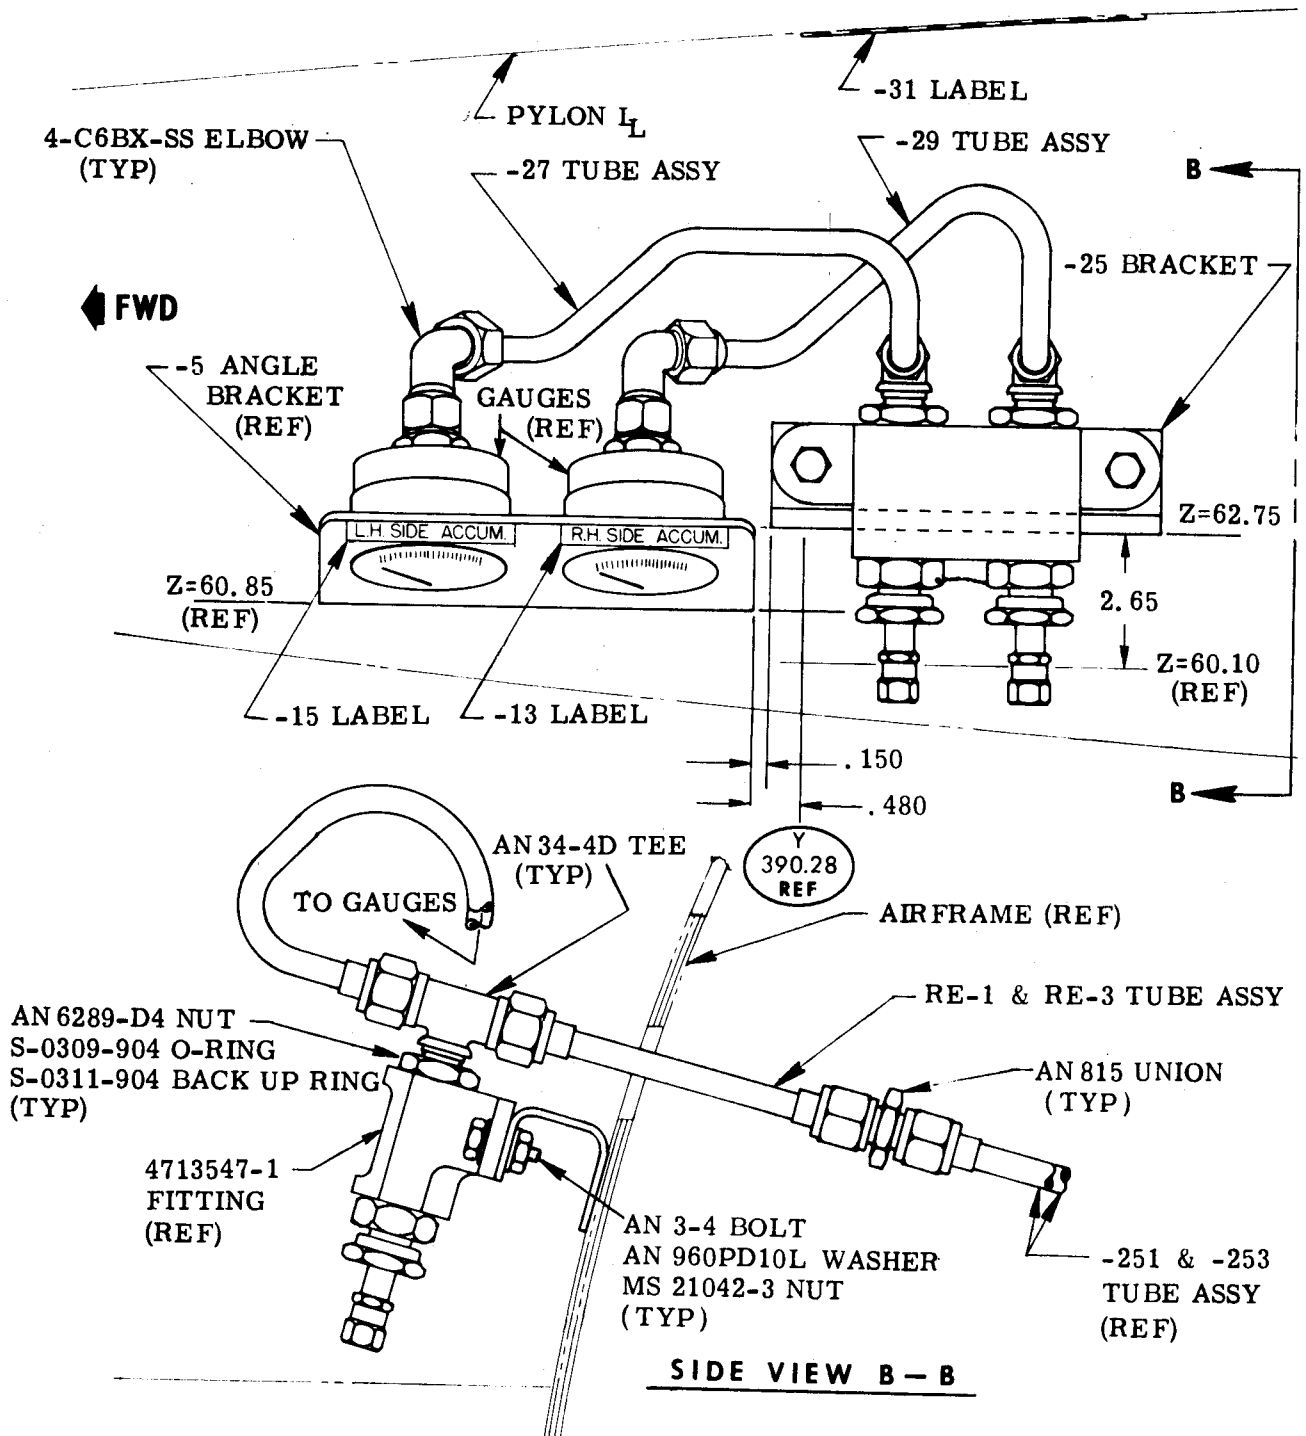
RELOCATION OF NITROGEN GAUGES AND CHARGING VALVES
 FIGURE 3

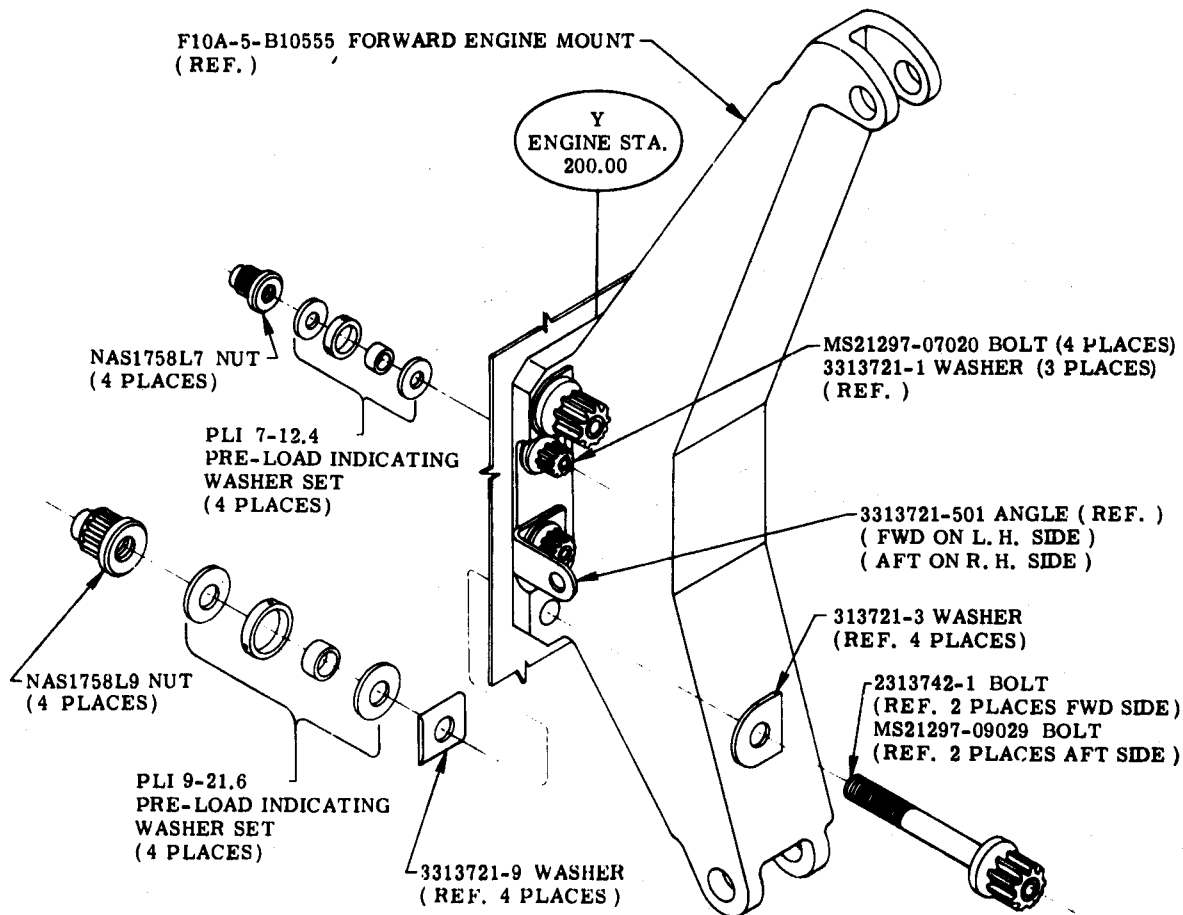
FIGURE 1

INSTALLATION OF PRE-LOAD INDICATING WASHERS
ON FORWARD ENGINE MOUNT ATTACHMENT BOLTS

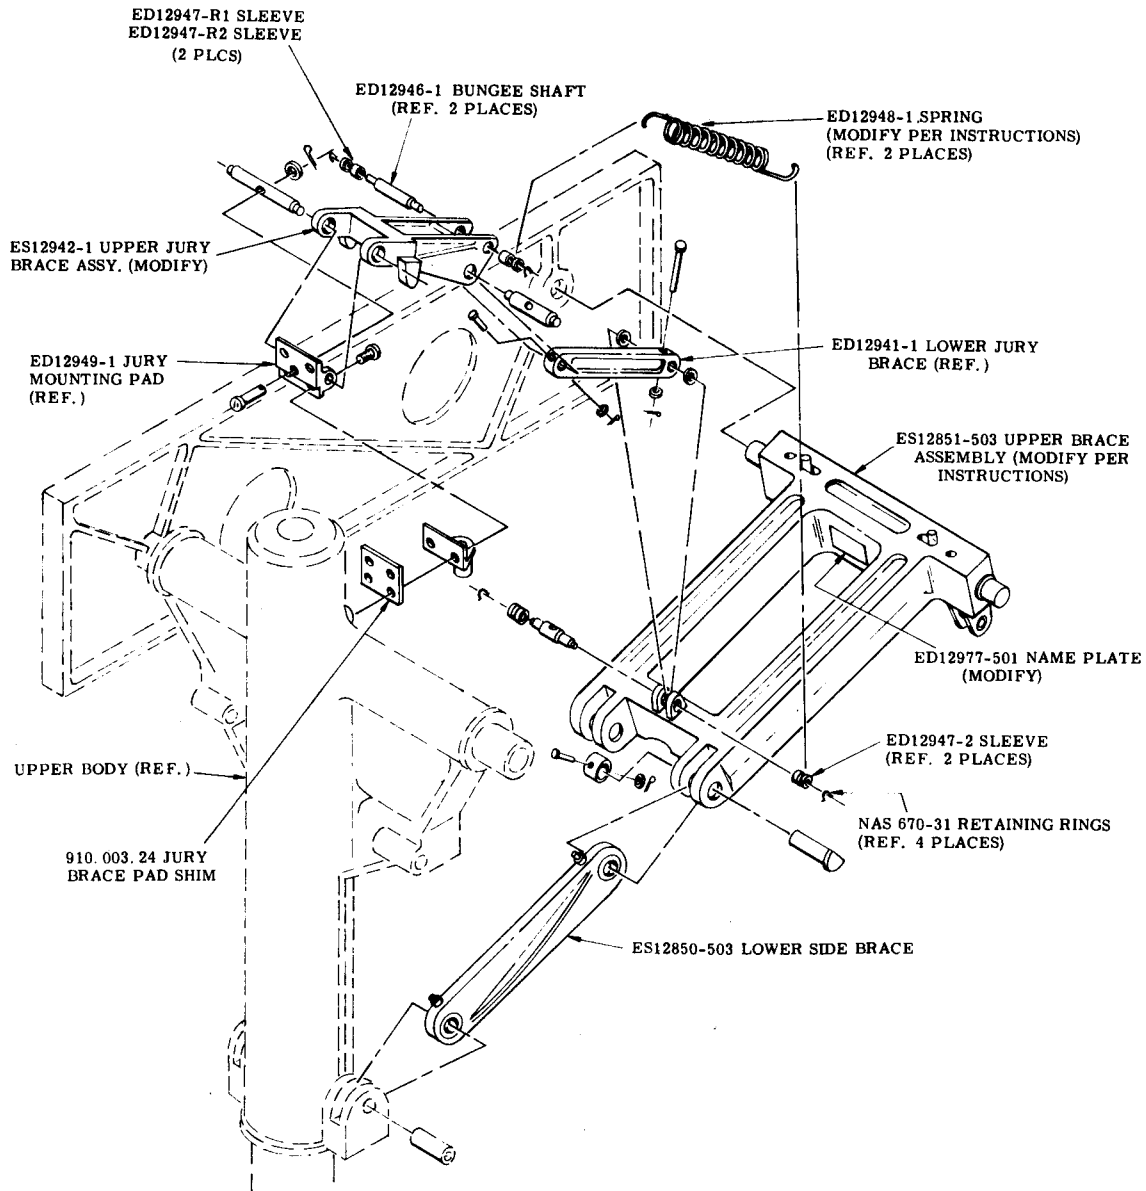
FIGURE 1

SIDE AND JURY BRACE ASSEMBLY
EA1681-503 MODIFICATION TO EA1681-505

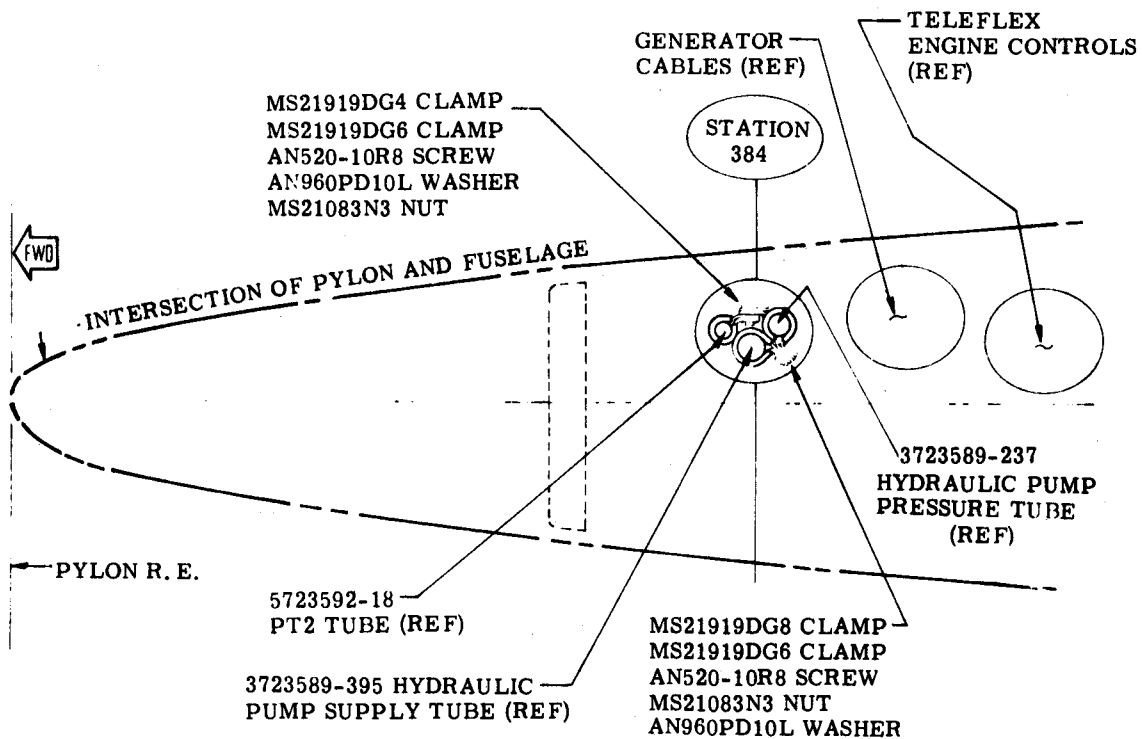
VIEW - INSIDE AIRFRAME TOWARD R. H. ENGINE PYLON
 INSTALLATION OF TUBING CLAMPS
 FIGURE 1

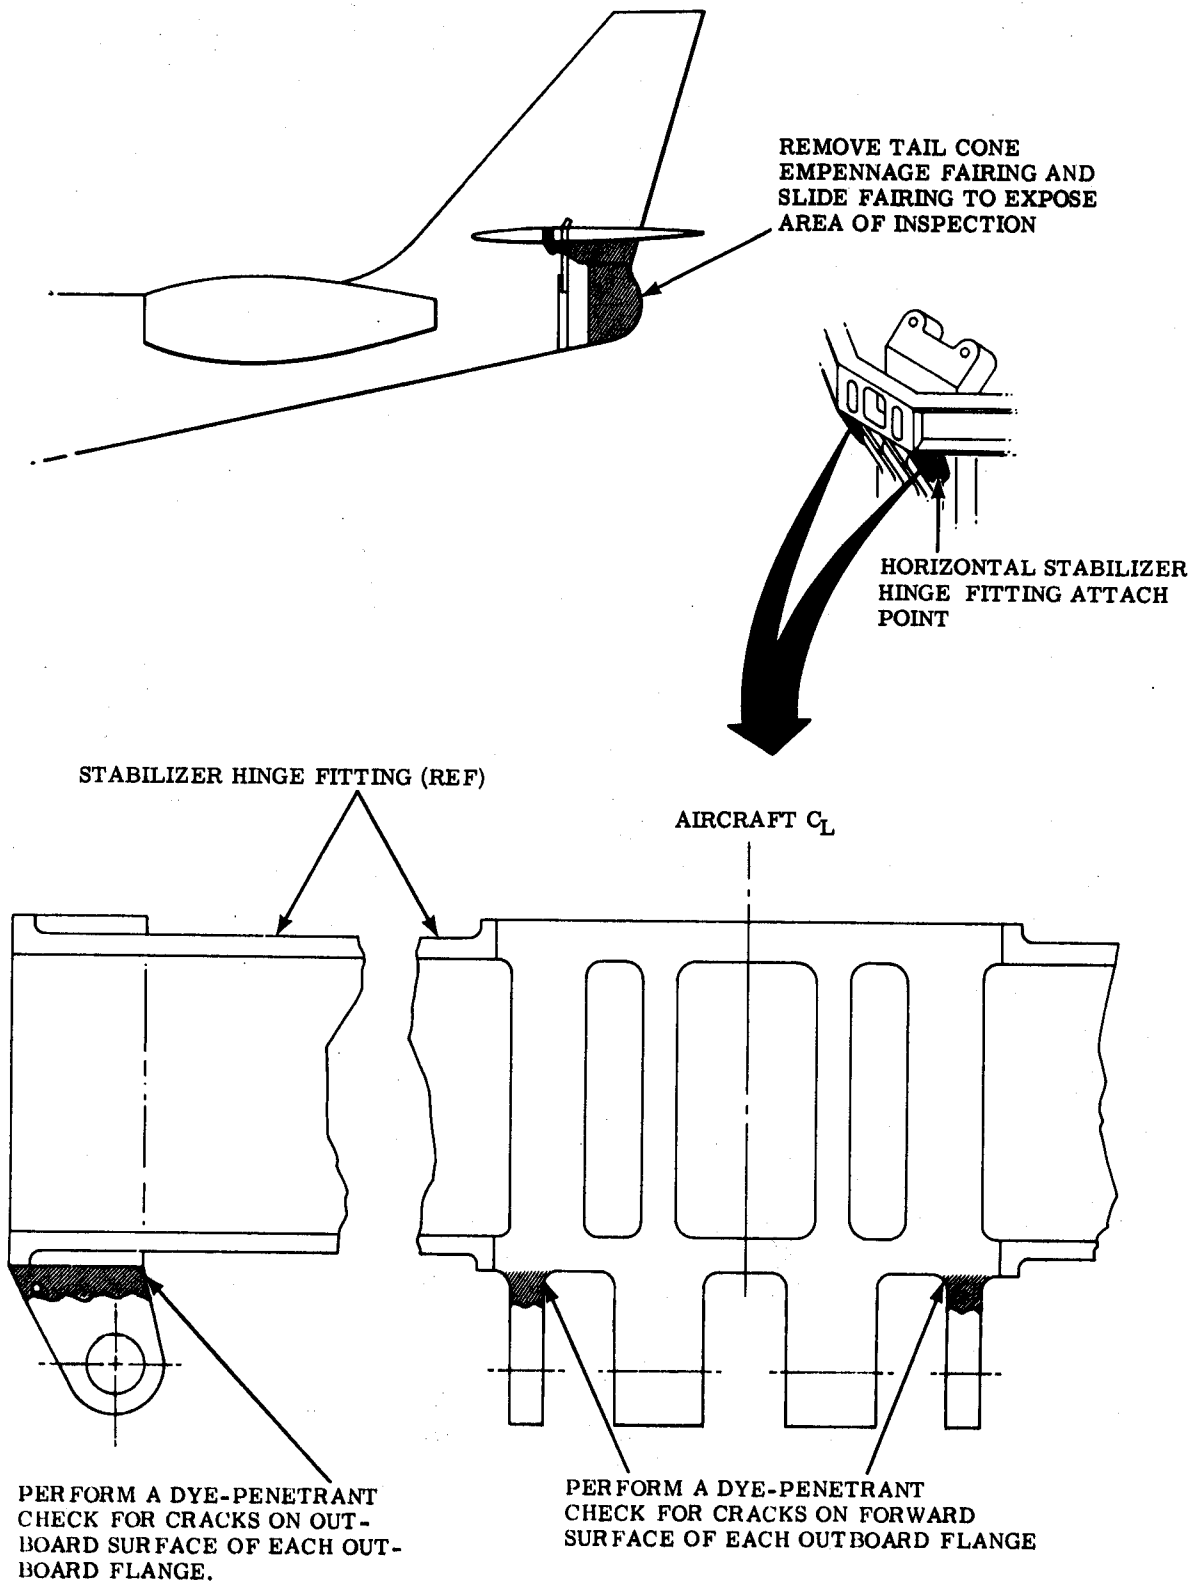
Figure 1.

PURPOSE: TO DETERMINE IF HORIZONTAL STABILIZER HINGE LUGS ARE
CRACKED. TO CHANGE HINGE PIN NUT AND TO CHANGE HINGE
PIN NUT TORQUE TO 20-30 INCH-POUNDS.

1. Remove tail cone, disconnect tail light and remove empennage fairings.
2. Remove and discard hinge pin safety wire. Do not remove hinge pin.
3. Remove paint and primer from outboard lugs of hinge (See shaded area depicted in Figure 1).
4. Perform Dye-Penetrant inspection of outer surfaces of each outboard flange and the forward surface of each outboard flange (See Figure 1).
5. If hinge is cracked, arrangements must be made with an approved Service Facility for replacement of hinge fitting.
6. If hinge is satisfactory, repaint exposed surfaces with Zinc Chromate primer.
7. Remove and discard existing hinge pin nut P/N 5403001-3. Retain existing AN960-14L washer. Inspect hinge pin threads for damage due to over-torque. If damaged replace hinge pin P/N 2453007-3.

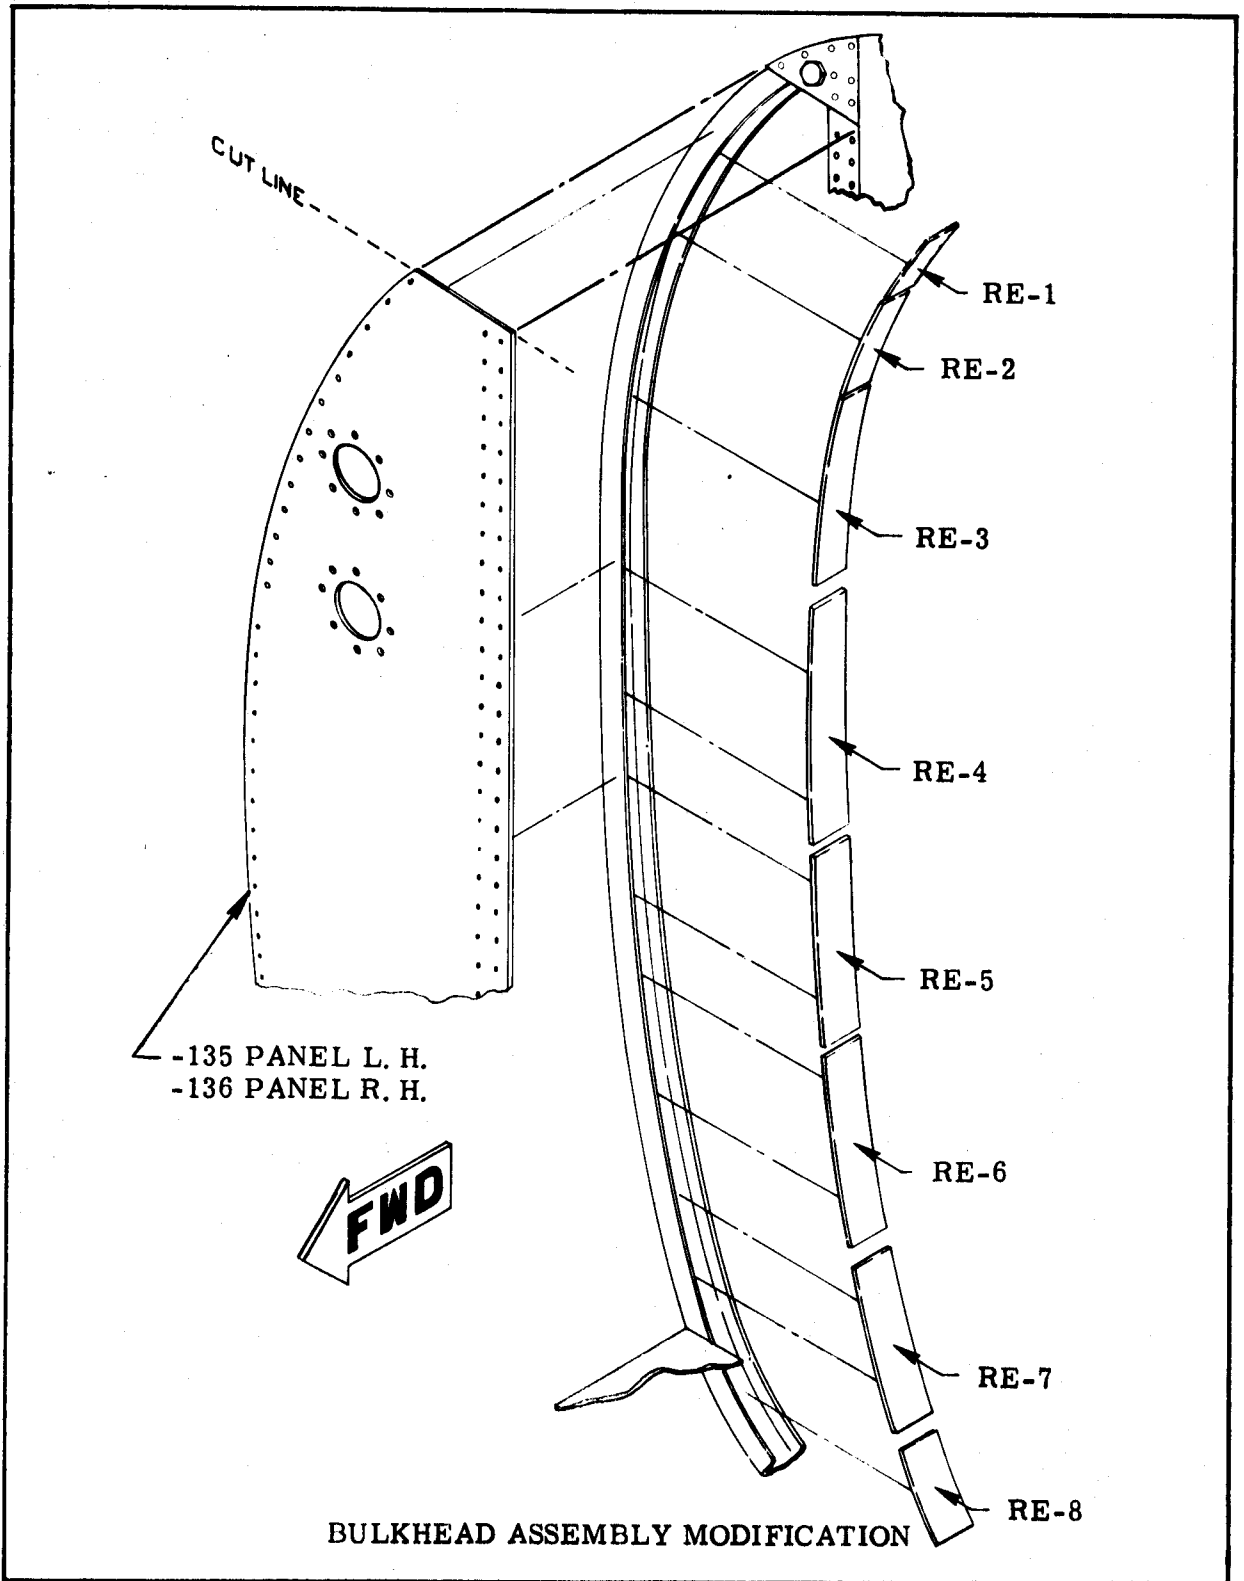
FIGURE 2

PURPOSE: TO PREVENT CRACKING OF THE "U-CHANNEL" IN THE AFT PRESSURE BULKHEAD

1. Remove interior so as to have free access to the entire area of the Aft Pressure Bulkhead Assembly.
2. Remove wiring, plugs, ducting, fittings, etc. , as necessary to facilitate removal of insulation and sound proofing covering the R. H. and L. H. panels. (SEE FIGURE 1)
3. Mark "cut line" on upper portion of R. H. and L. H. panels. Drill out rivets below "cut line" securing panels to the airframe and pull panels loose. (SEE FIGURE 2)

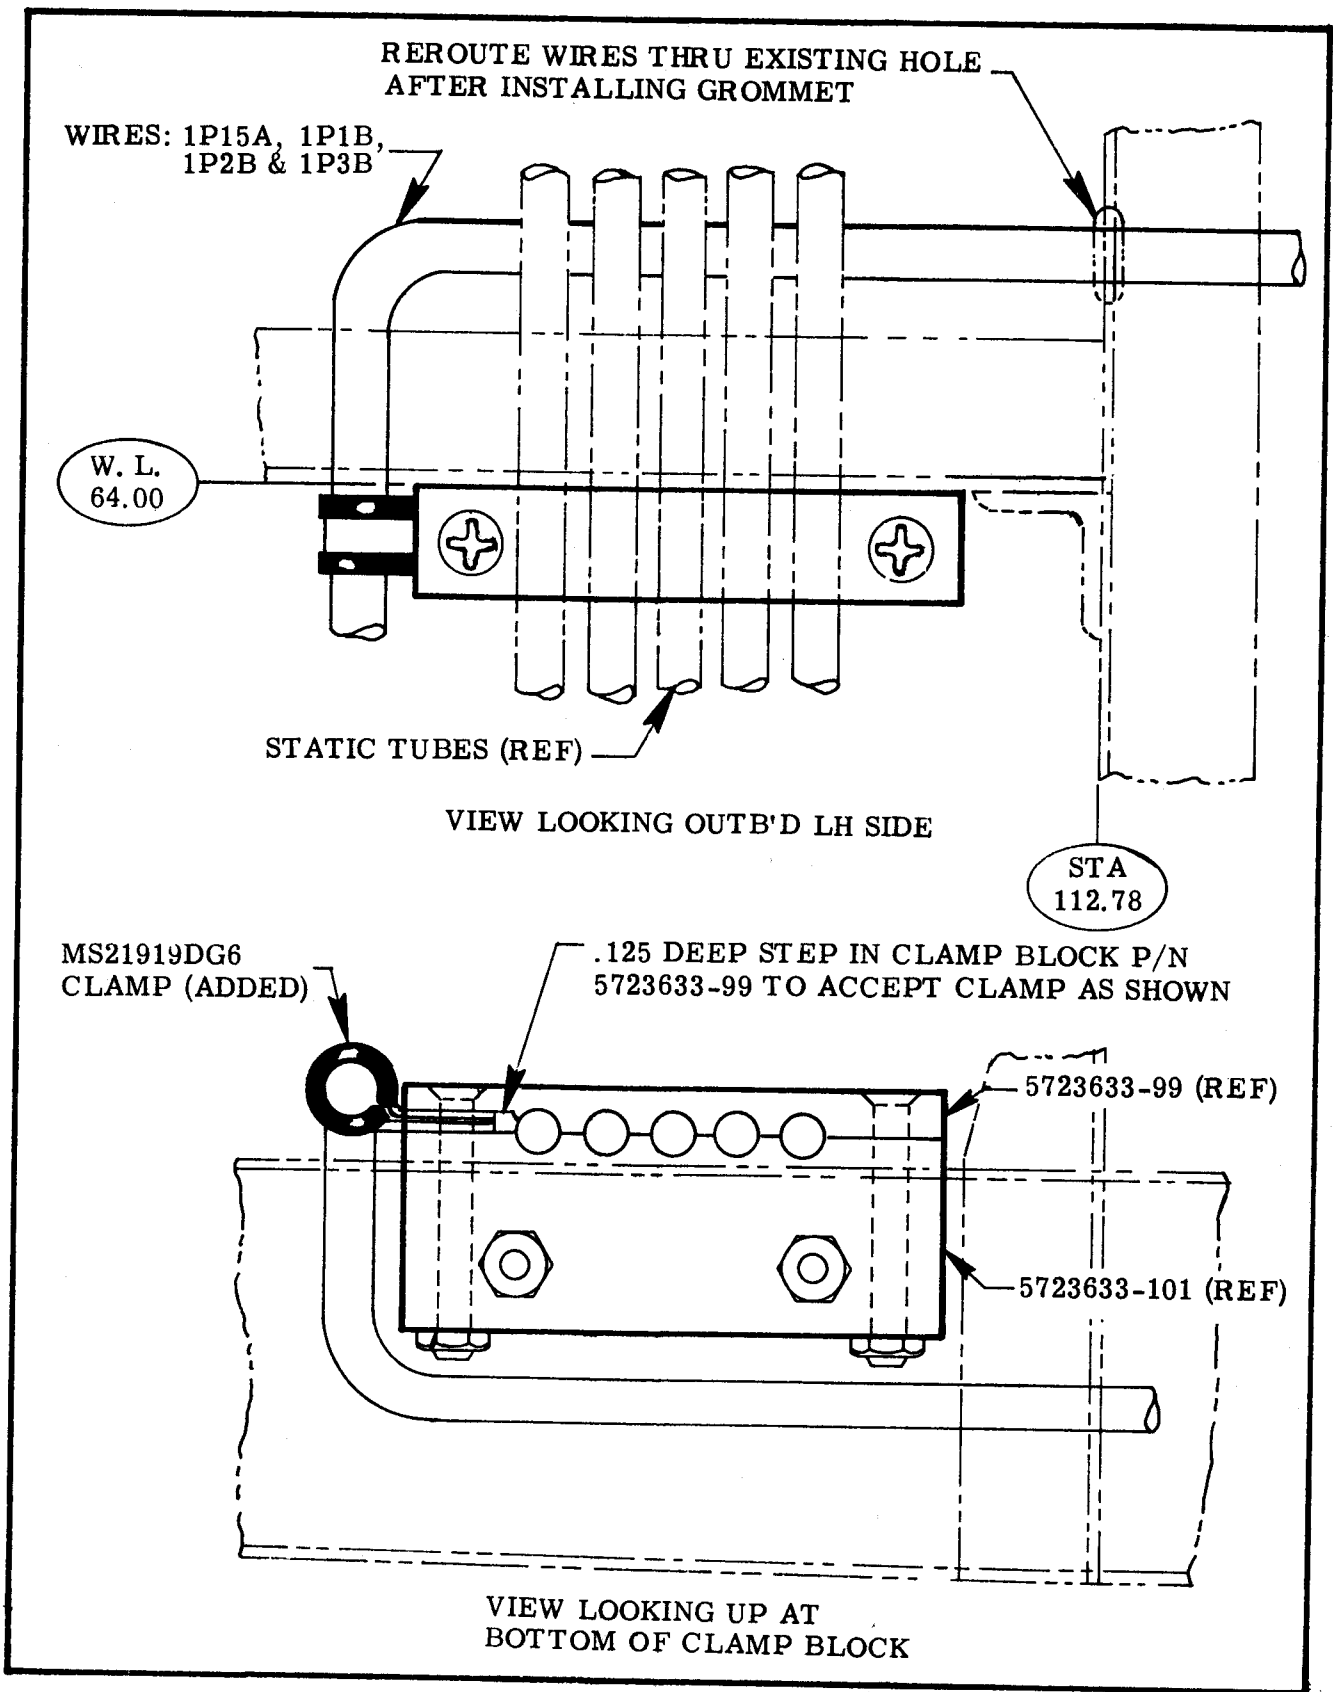
FIGURE 1

1. Remove upper hot liquid container in galley aft of Fus. Sta. 112, LH side.
2. Inspect electrical wire bundles located behind upper corner of container for evidence of chafing marks or damaged insulation.
3. If chafing is evident or damaged insulation is discovered, proceed to Part II of these Instructions. If chafing is not discovered, the aircraft may be continued in service at Operators discretion, provided the upper container is removed, loose electrical wiring is secured and a Placard is installed prohibiting the installation and use of the container until the proper routing and protection of electrical wiring is accomplished in accordance with Part II of these Instructions.

3. Reroute wires and install MS21919DG6 support clamp per Figure 1, and reconnect wires to terminal board "AC".
4. Replace or repair any wiring damaged by chafing, as determined by inspection per Part I of these Instructions.
