SERVICE INFORMATION LETTER

SERVICE INFORMATION LETTER INDEX

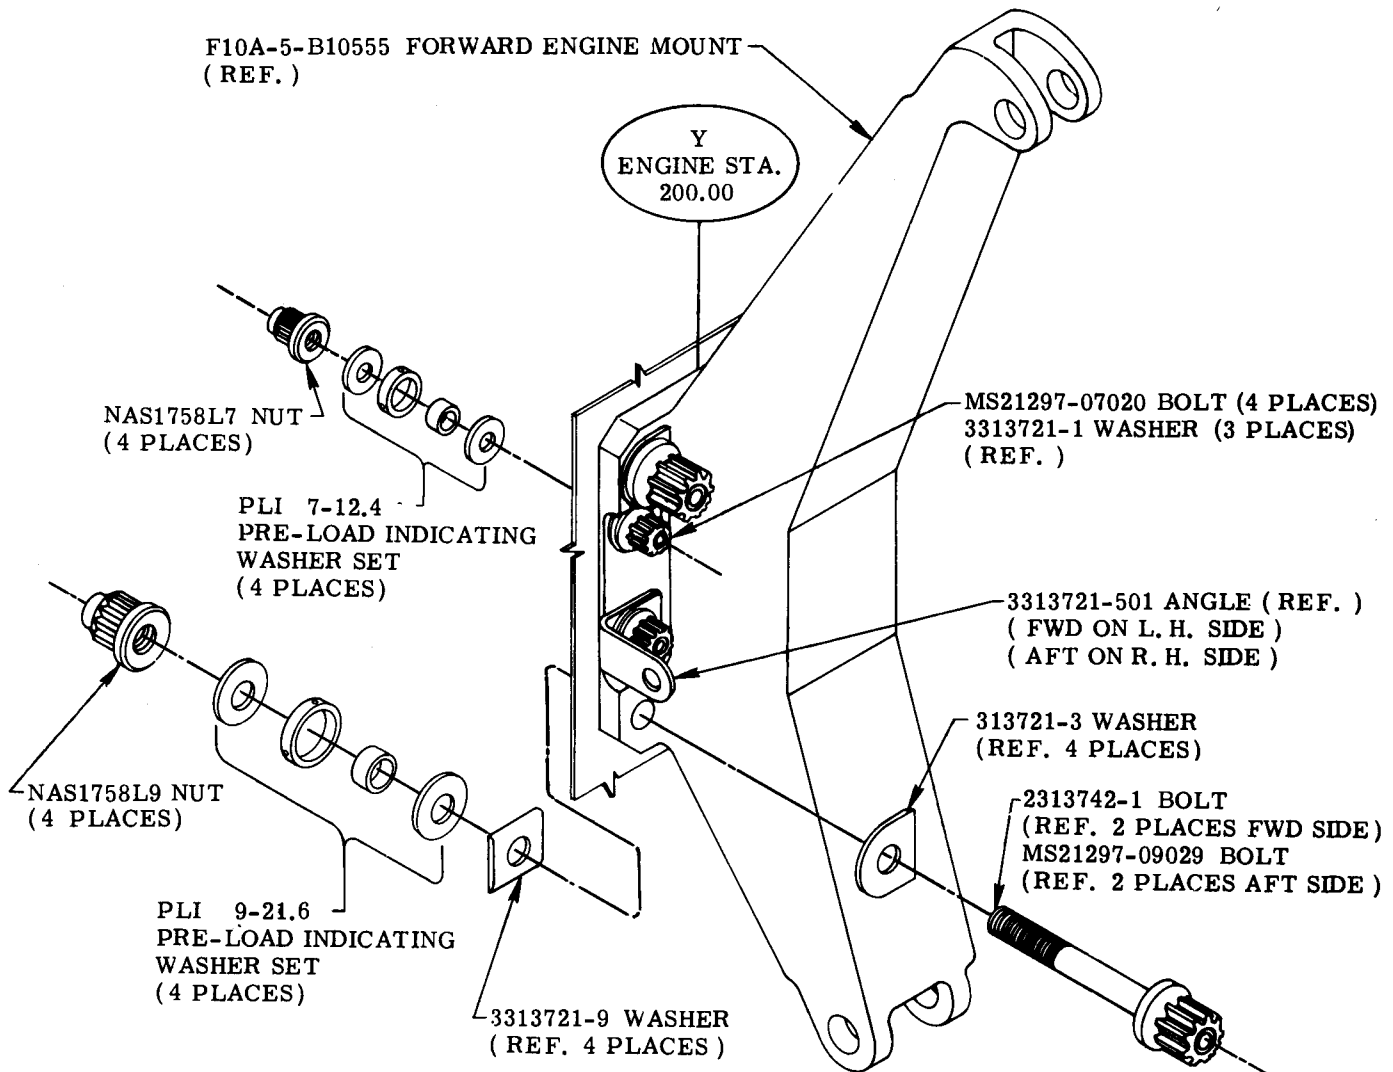
FIGURE 1

CAUTION: DO NOT OVER TIGHTEN. IF NUT IS TIGHTENED MORE THAN 1/8 TURN BEYOND POINT WHERE OUTER PLI WASHER BECOMES IMMOVEABLE. THE ENTIRE BOLT, NUT AND WASHER ASSEMBLY MUST BE REPLACED.

- A. Clean only those parts to receive sealant with methyl ethyl ketone (MEK).
 - B. Apply stripe of sealant across end of exposed bolt end, down the nut and across the PLI washers so that any turning action will break the stripe seal.
8. Replace fireshielding inside pylon. Connect fire extinguisher fitting and then reconnect engine throttle controls. Replace access panels.
9. Repeat for other engine forward mount.

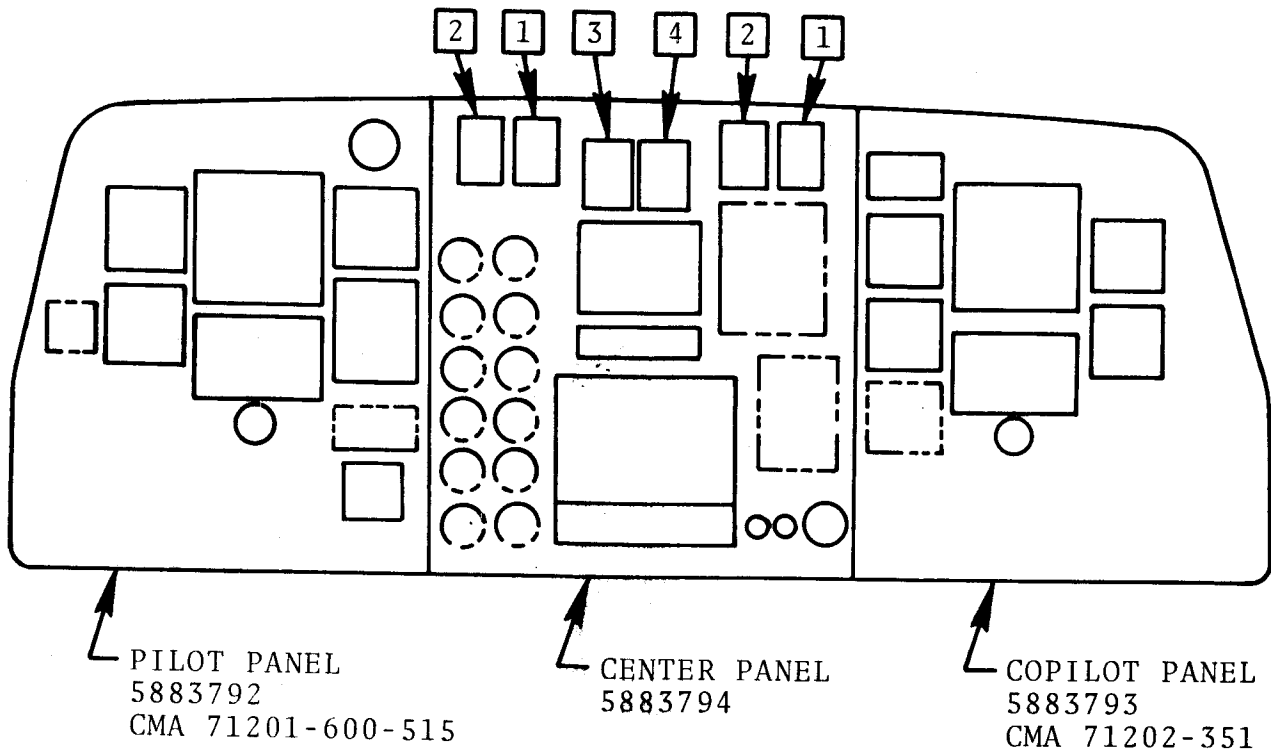
FIGURE 1 CLT-20, 30, 60 and 90 LOCATIONS

- 1 COMM CONTROL CLT-20
- 2 NAV CONTROL CLT-30
- 3 ADF CONTROL CLT-60
- 4 ATC CONTROL CLT-90

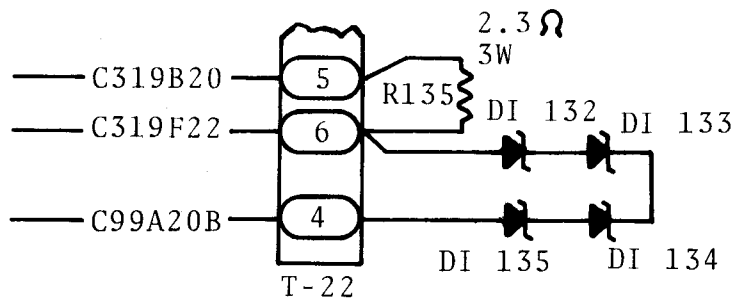
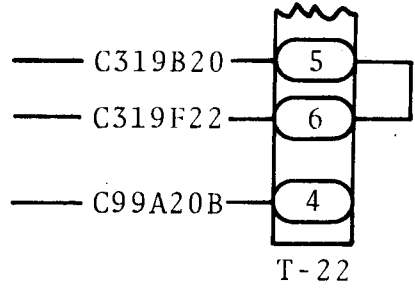
FIGURE 1

To avoid possible overheating of subject resistors or diodes due to inverter overvoltage protection circuit failure.

SEE WIRING MANUAL
CHAPTER 22-10-01

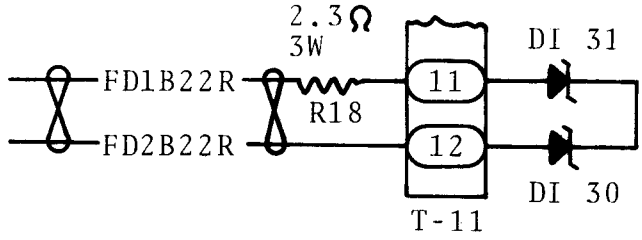
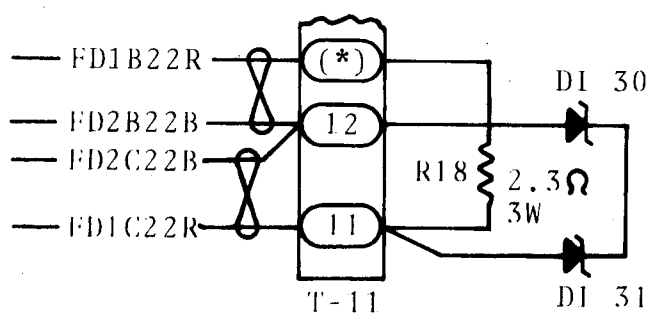
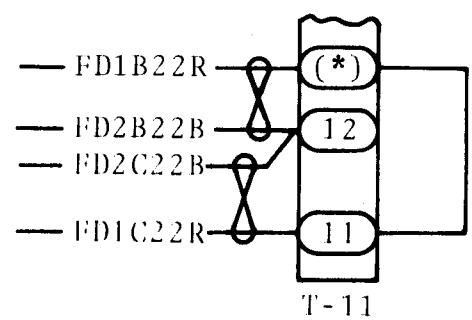
FIGURE 2

(*) PIN # 20 = S/N 152, 185 AND 186
PIN # 17 = S/N 154, 181 AND 187 THRU 238

SEE WIRING MANUAL
CHAPTER 22-10-08

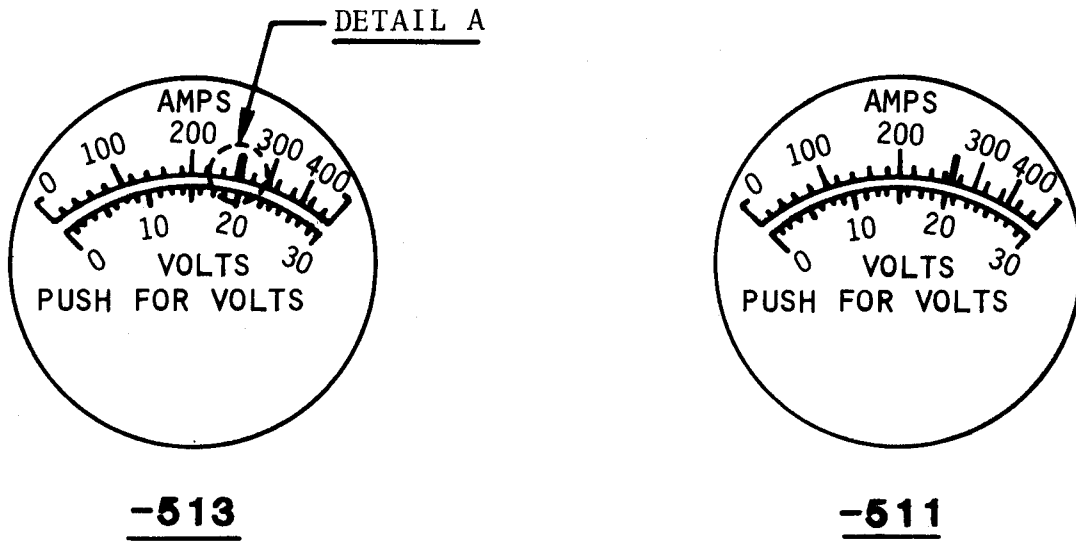
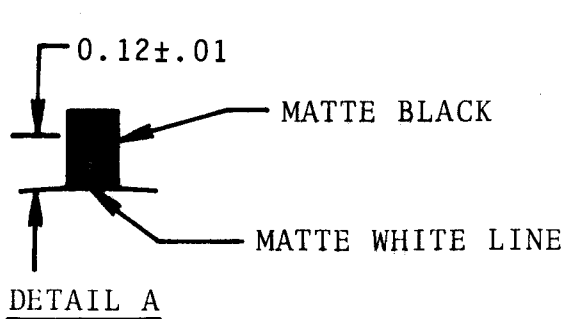
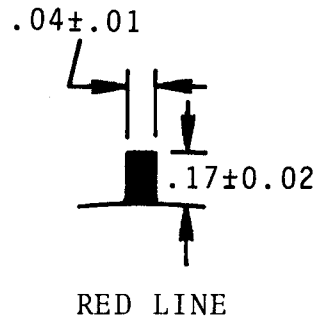
FIGURE 1 AMMETER MARKINGS

REMOVAL OF RED LINE
AND REMARKING OF
WHITE INDEX LINE

DIMENSIONS
(FOR EITHER -511
or -513 MARKING)

Make the following entry in the airplane log book: Service Bulletin No. WW-24-27 dated July 6, 1982, titled "General Electric DC Starter Generator Model 2CM504D2D Limitations and Ammeter Markings", has been accomplished this date.

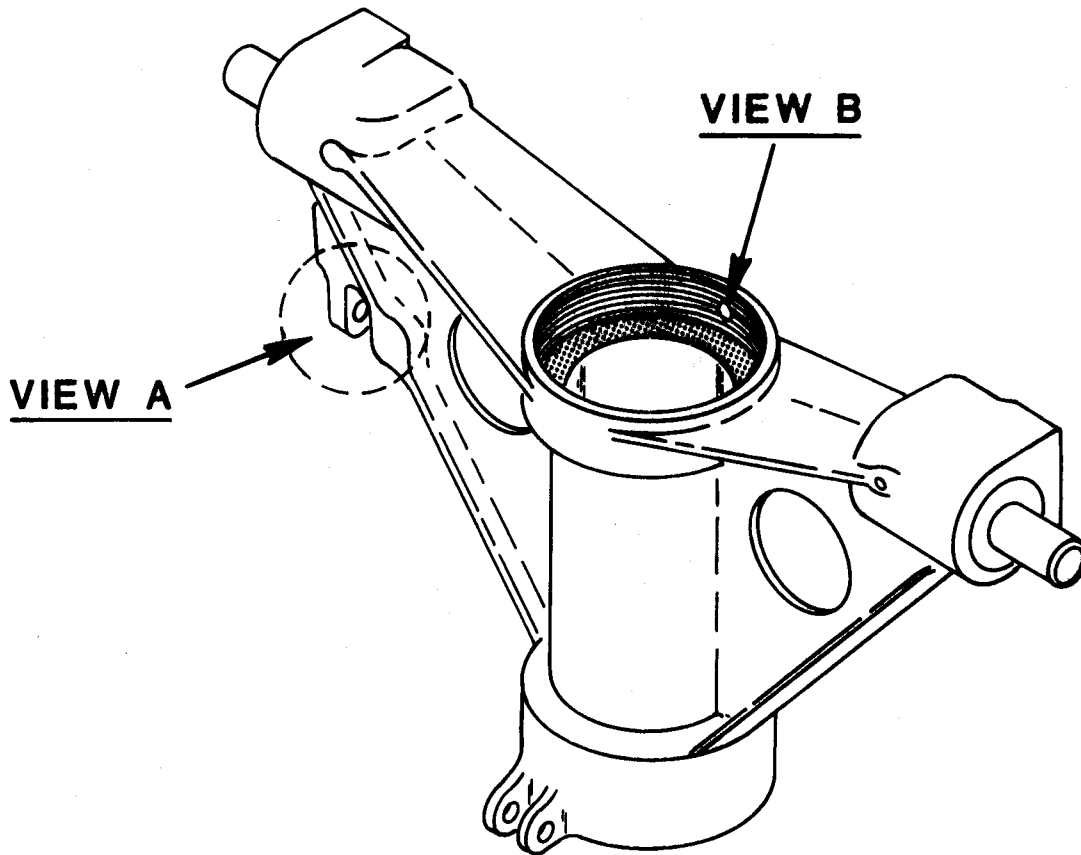
FIGURE 1 AREAS OF INSPECTION

To detect and/or relieve fatigue cracks that develop in the upper NLG outer strut-body forging.

This service bulletin details the inspection and method to detect cracks at three locations on the NLG outer strut-body.

The outer strut-body forging is disqualified for further flight if a crack is detected in any of the three areas unless it can be blended out in accordance with the rework limits of 2.F. of this service bulletin. Corrosion in excess of the limits of 2.F will also disqualify the outer strut-body for flight.

VIEW A — INSPECTION AND REWORK (AREA A)

- D. Clean outer strut-body and strip paint from areas to be inspected. See Figure 1.
- E. Inspect the following areas for cracks and/or corrosion using dye penetrant or fluorescent inspection method and a 10-power magnifying glass:
- Area A - Roots of lug where retraction cylinder attaches to outer strut-body.
 - Area B - The area where the upper bearing retaining nut threads meet the threaded hole for the retaining nut lock-screw.
 - Area C - The upper bearing bore shoulder area. This inspection is required on P/N ES12854-1 or struts manufactured from 7079-T6 aluminum alloy only.

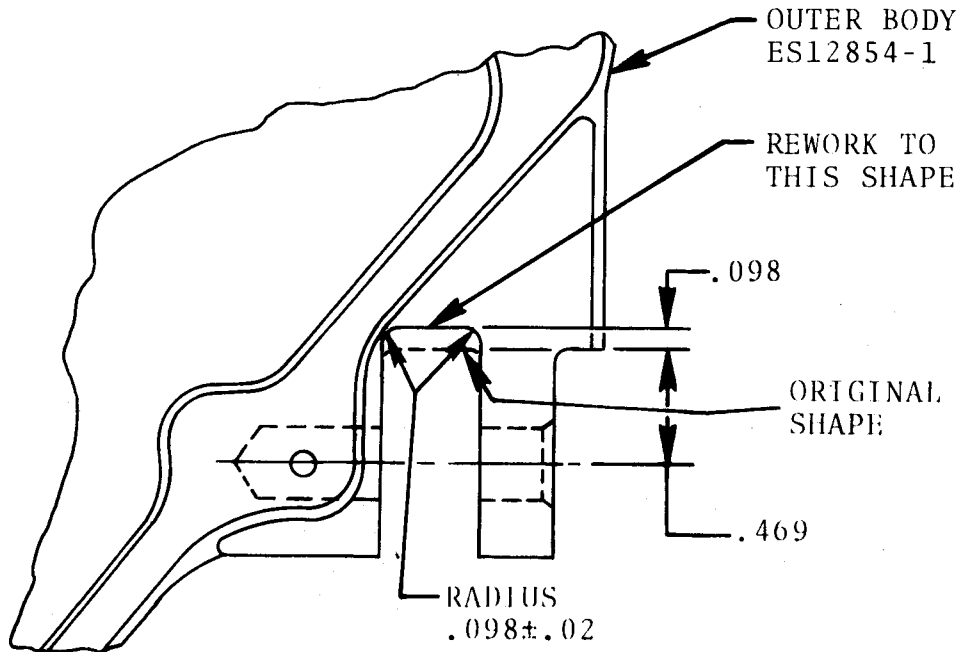
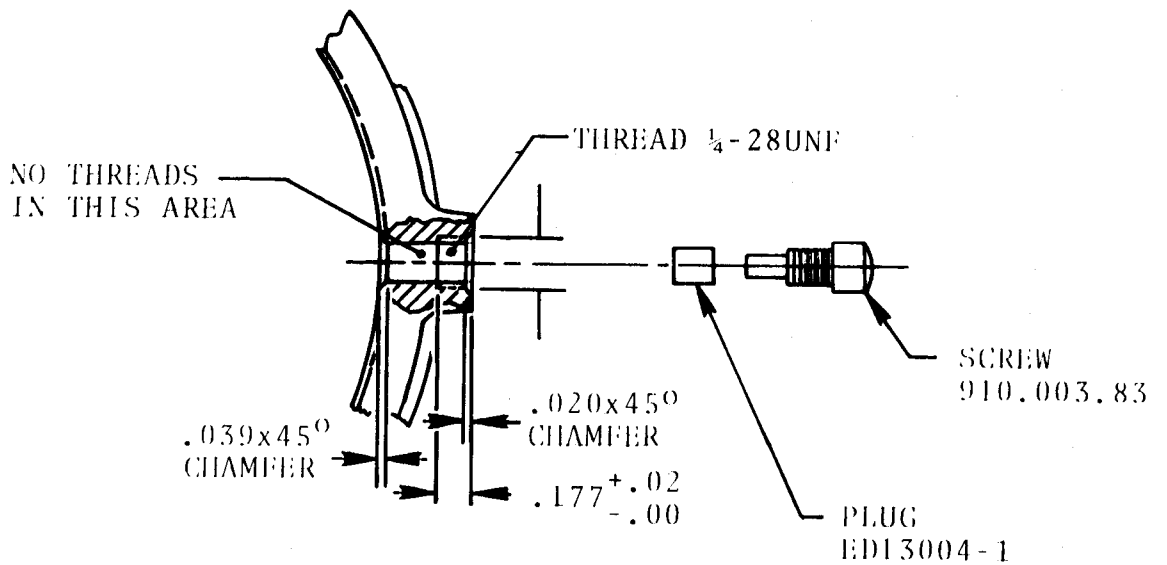
FIGURE 2 REWORK AREAS

Rework of Area A to relieve stress is not required on some replacement struts, i.e. P/N ES12854-501. Careful inspection of P/N ES12854-501 struts will be necessary to determine if rework has already been accomplished. See Figure 2 for dimensions. Reworked struts should be marked with an "A" in the area of the strut part number (strut part number should be located on the aft side of the barrel portion of the strut body). Struts which have been reworked but not marked or struts that are reworked in accordance with this service bulletin should be marked with "A" in the area of the strut part number.

Rework of Area B to relieve stress is not required on some replacement struts P/N ES12854-501. Reworked struts will not have the upper bearing retaining nut lock-screw hole threaded all the way through.

- F. Cracks or corrosion found in the aforementioned inspection may be blended out with a .157 inch diameter rotary file and then polished with 400 grit paper as long as they do not exceed the following limits:
- (1) Corrosion in the bearing bore shoulder may not exceed a depth of .039 inches.
 - (2) Cracks may not exceed .118 inches in length and .039 inches in depth.
 - (3) Treat all reworked areas with Alodine 1201.
- G. Rework of Areas A and B must be accomplished to remove cracks and may also be accomplished to relieve stress that could cause cracking in the future. Reference Figure 2. (Rework will not be necessary if it has already been accomplished. Refer to NOTES in paragraph 1.C. of this bulletin).

- b. Reinspect cut area for cracks before polishing.
 - c. Polish cut area with 400 grit paper.
 - d. Treat bare metal with Alodine 1201.
- (2) Accomplish rework of Area B as follows:
 - a. Drill and ream lock screw hole, through outer strut body, to a diameter of $.211 + .008$ inch
- .000

- d. Carefully clean any burrs from hole and threads, especially at hole/thread intersection.
- e. Reinspect area for cracks.
- f. Polish hole and chamfered areas.
- g. Treat area with Alodine 1201.
